**ALBERTA TRANSPORTATION
GEOHAZARD ASSESSMENT
PEACE REGION (PEACE RIVER DISTRICT)
2022 INSPECTION**

Site Number	Location	Name	Hwy	km
PH079-1	160 km East of High Level	West of Garden River	58:14	16.8-19.6*
Legal Description		UTM Co-ordinates		
NW14-111-3-W5		11U E 651,925	N	6,502,976

PH079-1: HWY 58:14 WEST OF GARDEN RIVER
2022 GEOHAZARD ASSESSMENT

DWG No. 32121-PH079-1

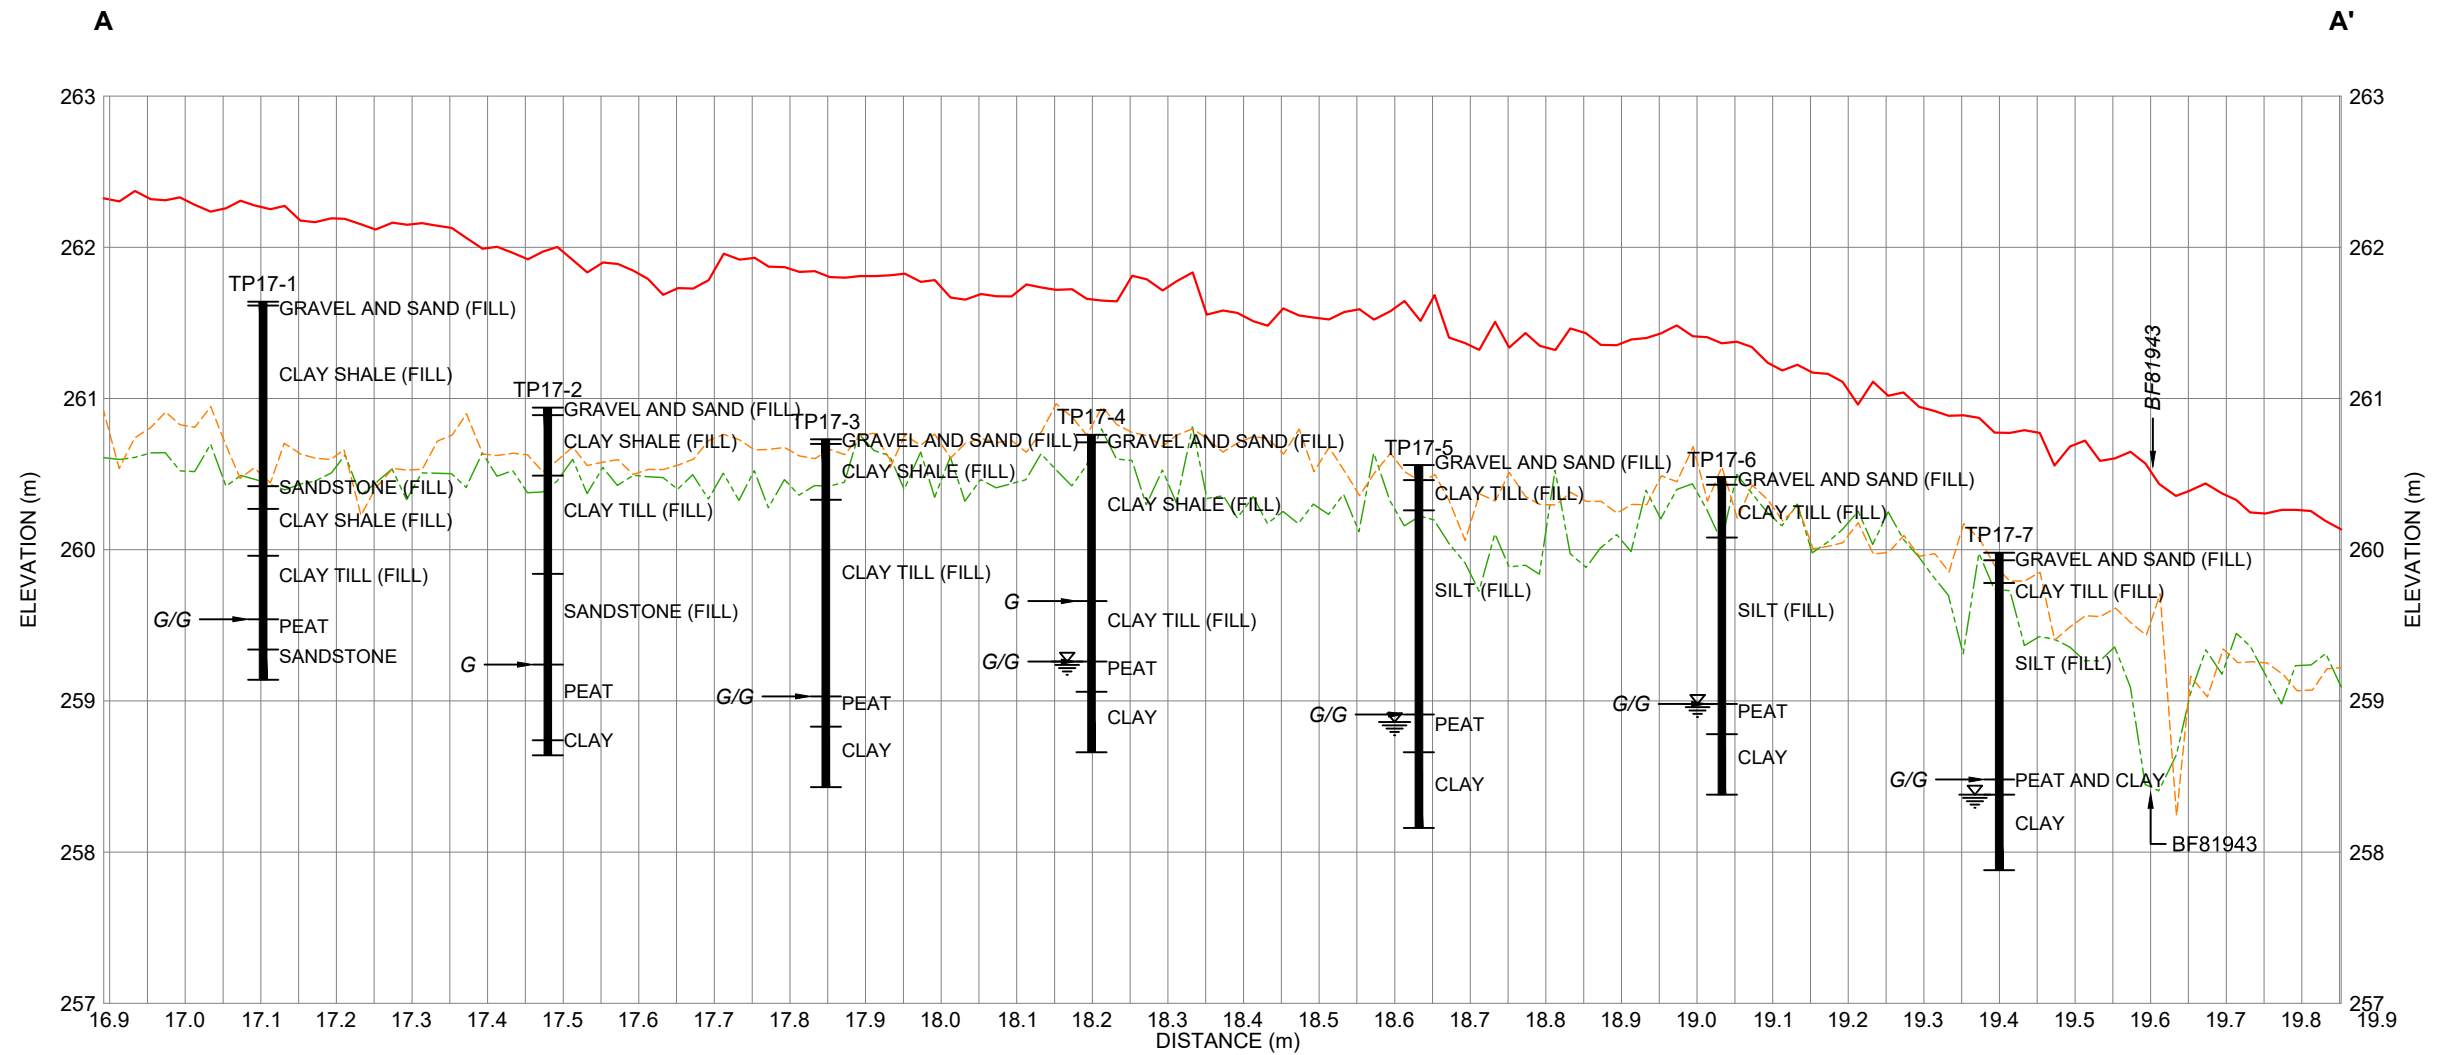
DWG No. 13351-PH079-1-2

Thurber completed test pitting and survey of this highway. Test pit logs were attached to the 2018 Geohazard report. The attached site plan was based on this survey and the profile (Drawing 17288-2) is also attached for reference (stick logs show the soil profile).

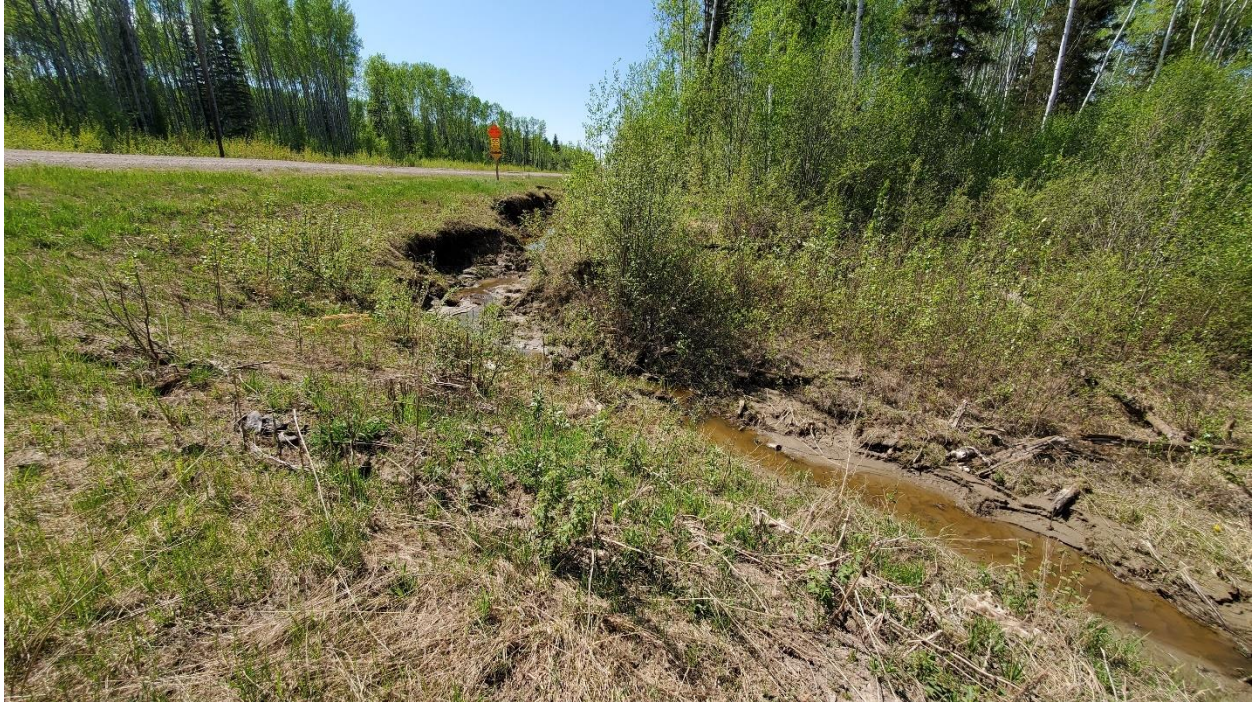
Photo 1 – Looking east at rutting on May 27, 2018 (AT photo)

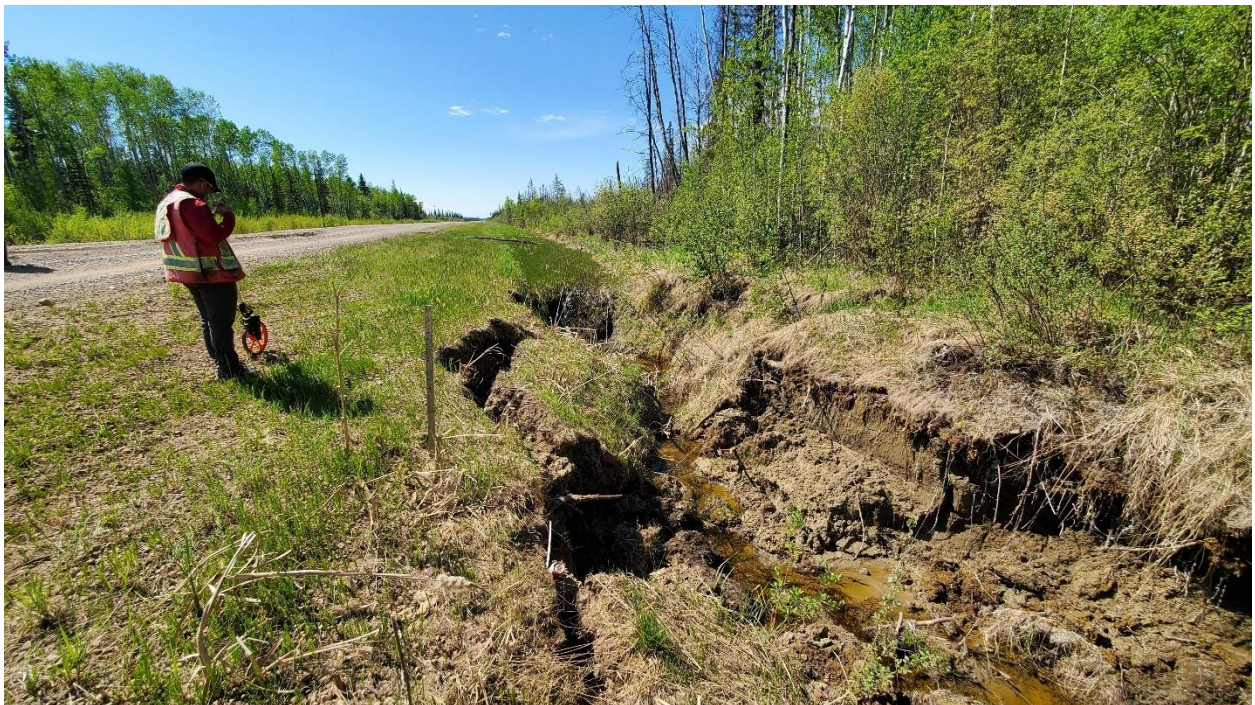
Photo 2 – Looking west at rutting during gravel placement on May 30, 2018 (AT photo)
