**ALBERTA TRANSPORTATION
GEOHAZARD ASSESSMENT PROGRAM
PEACE REGION – HIGH LEVEL
2020 INSPECTION**

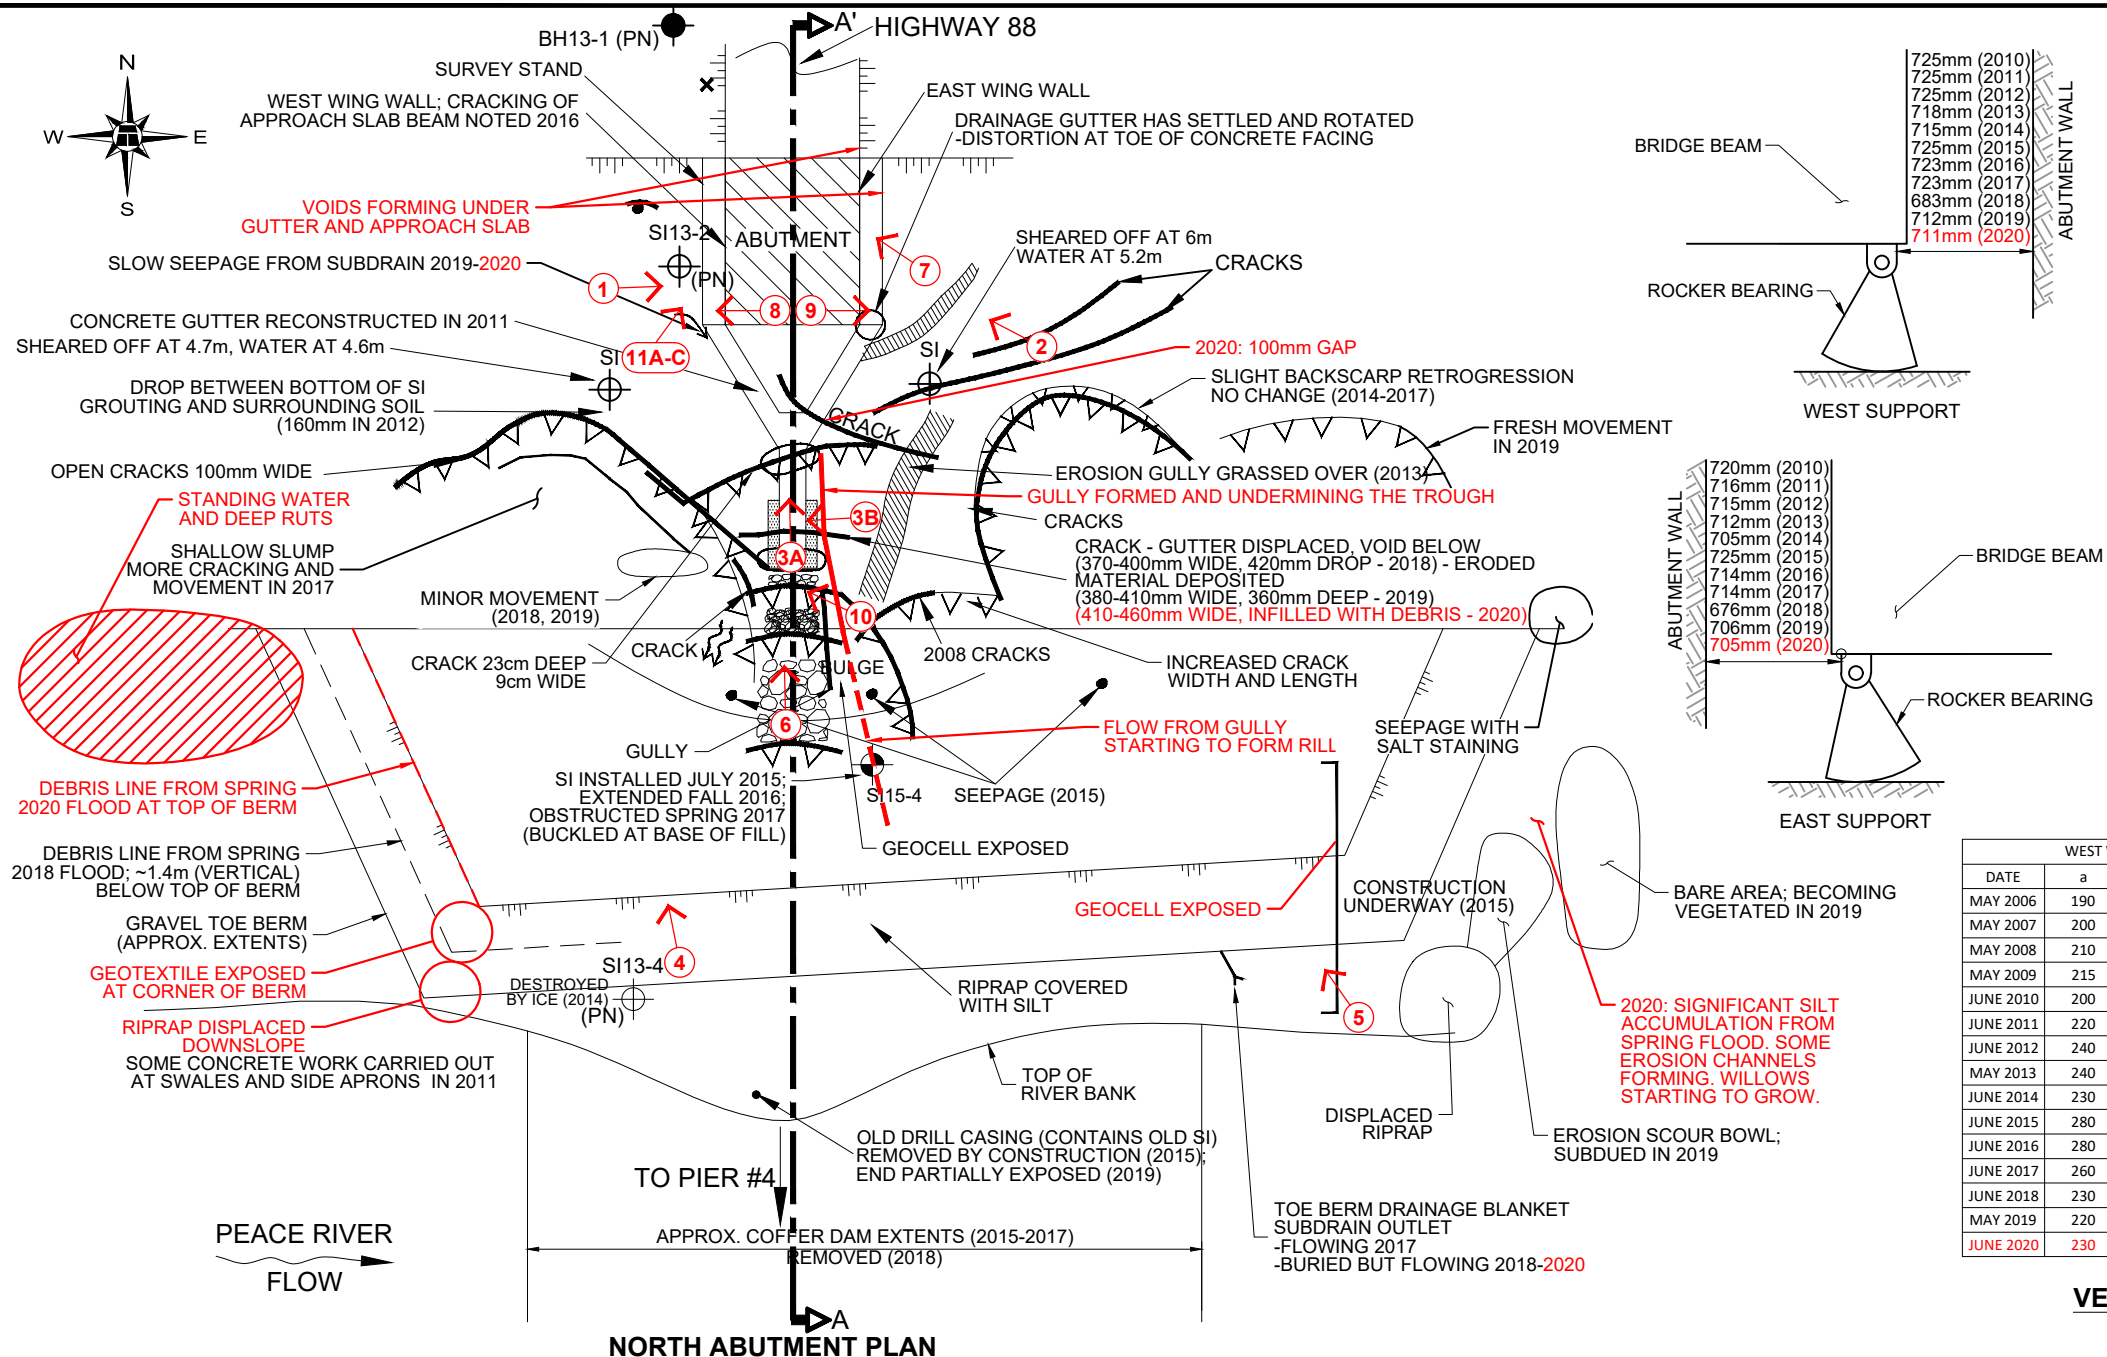
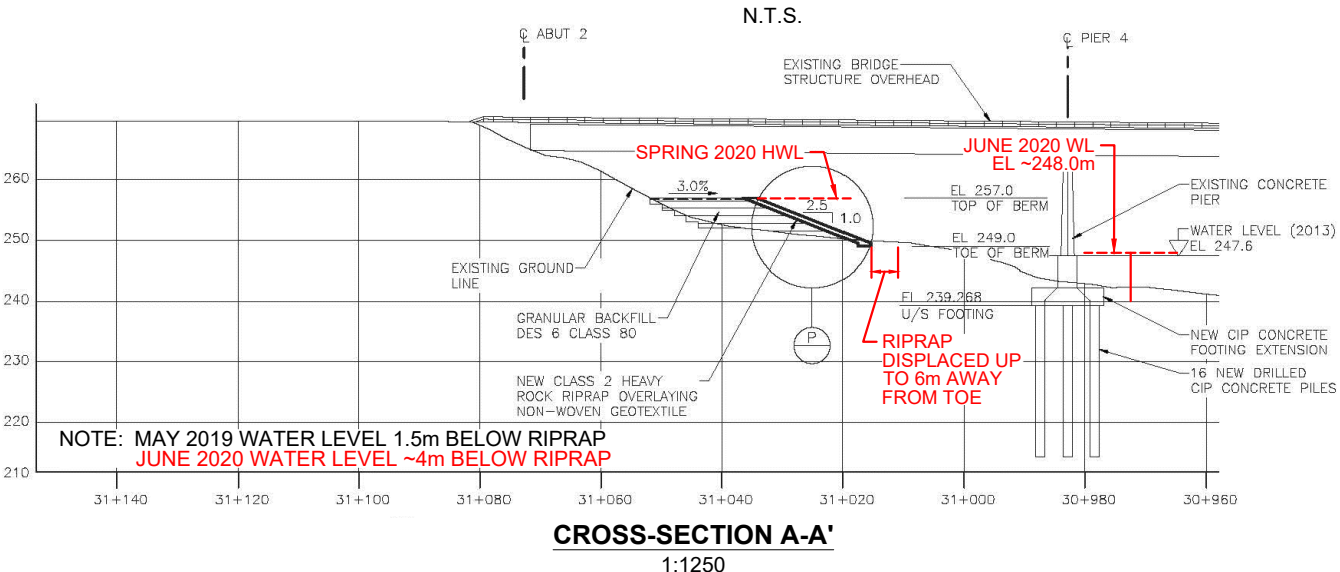
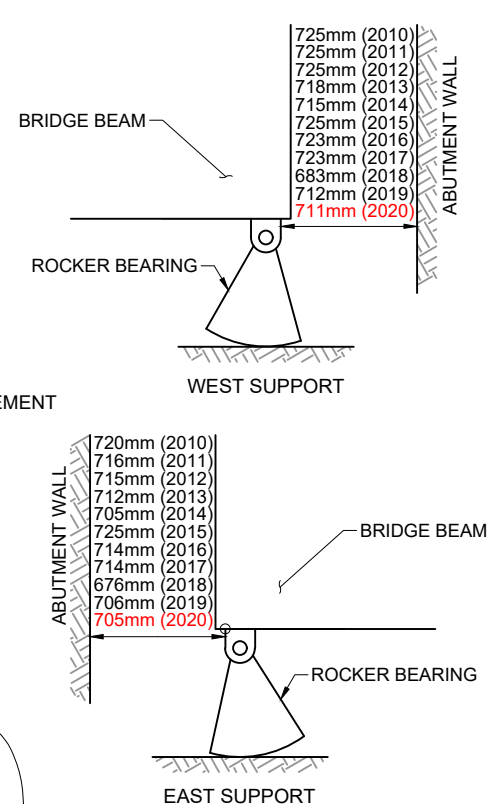
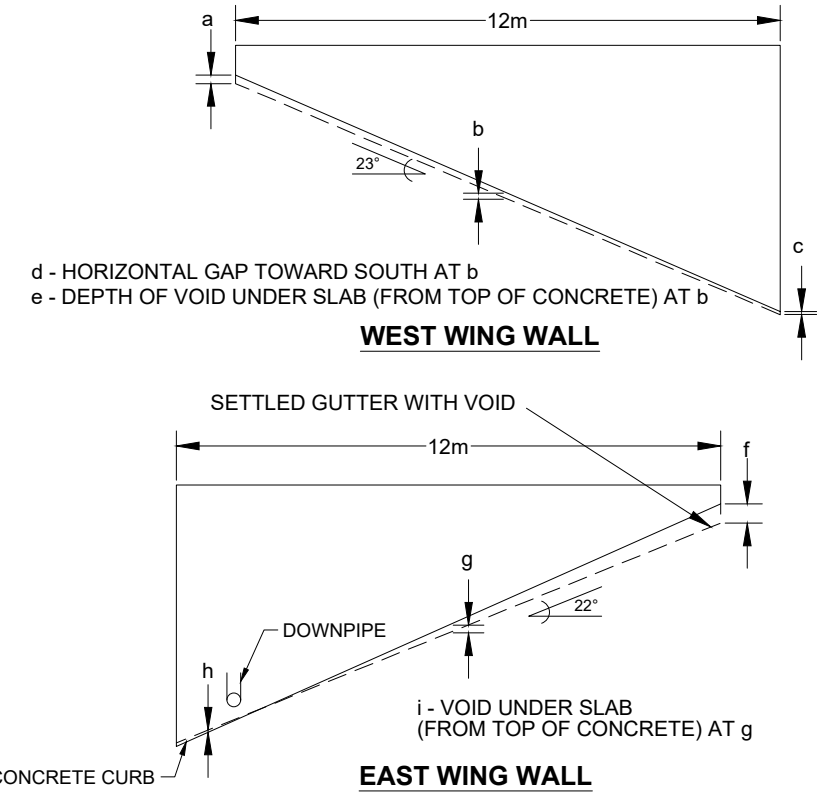
WEST WING WALL MEASUREMENT (mm)

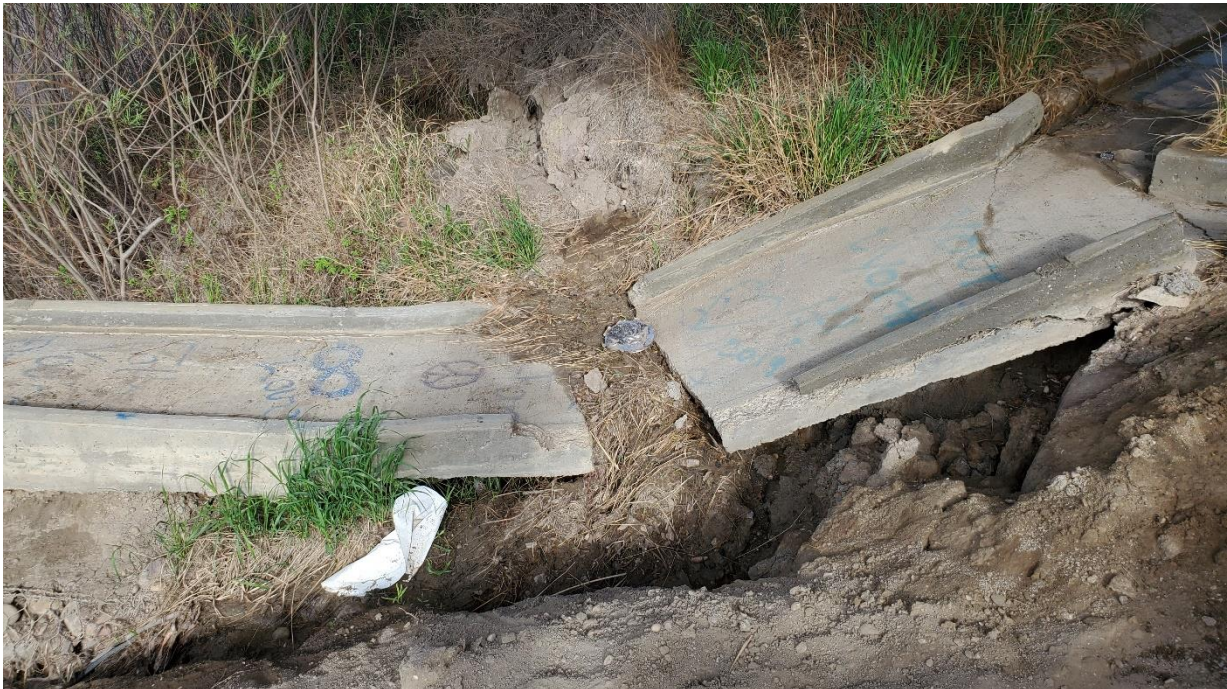
Photo 3B, North – Looking west at cracked and shifting north abutment concrete gutter. Void below the lower portion of the slab up to 350 mm (measured from top of concrete).

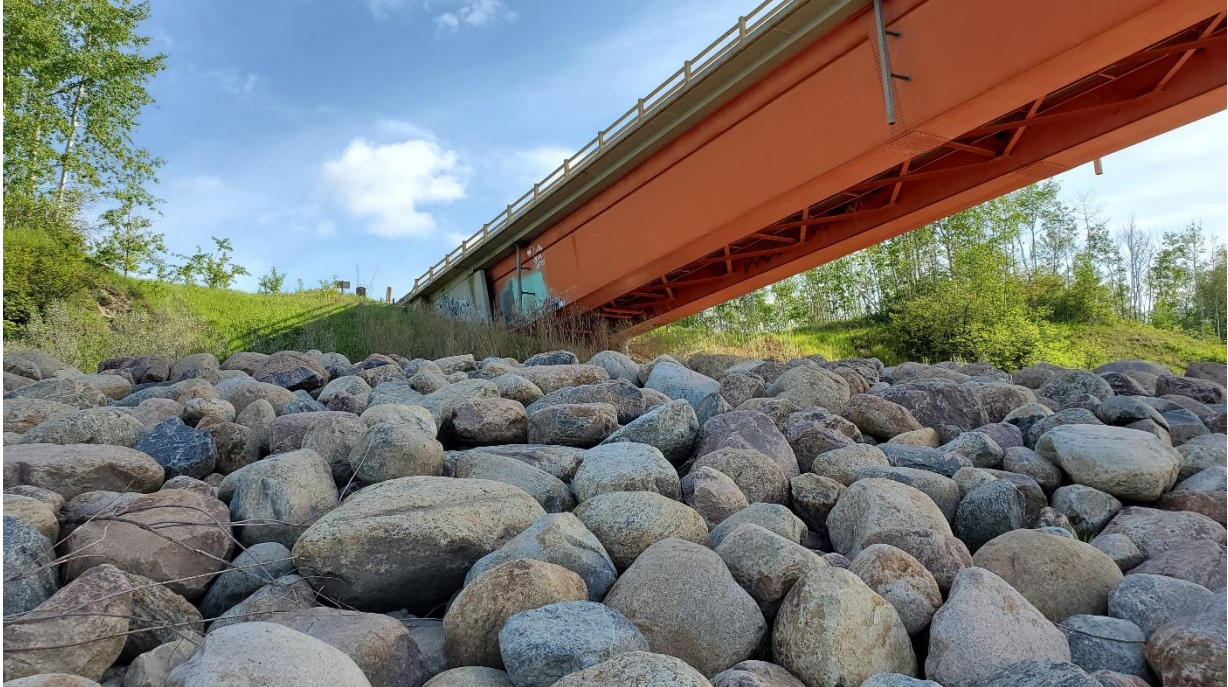
Photo 4, North – Looking north at west side of north abutment.

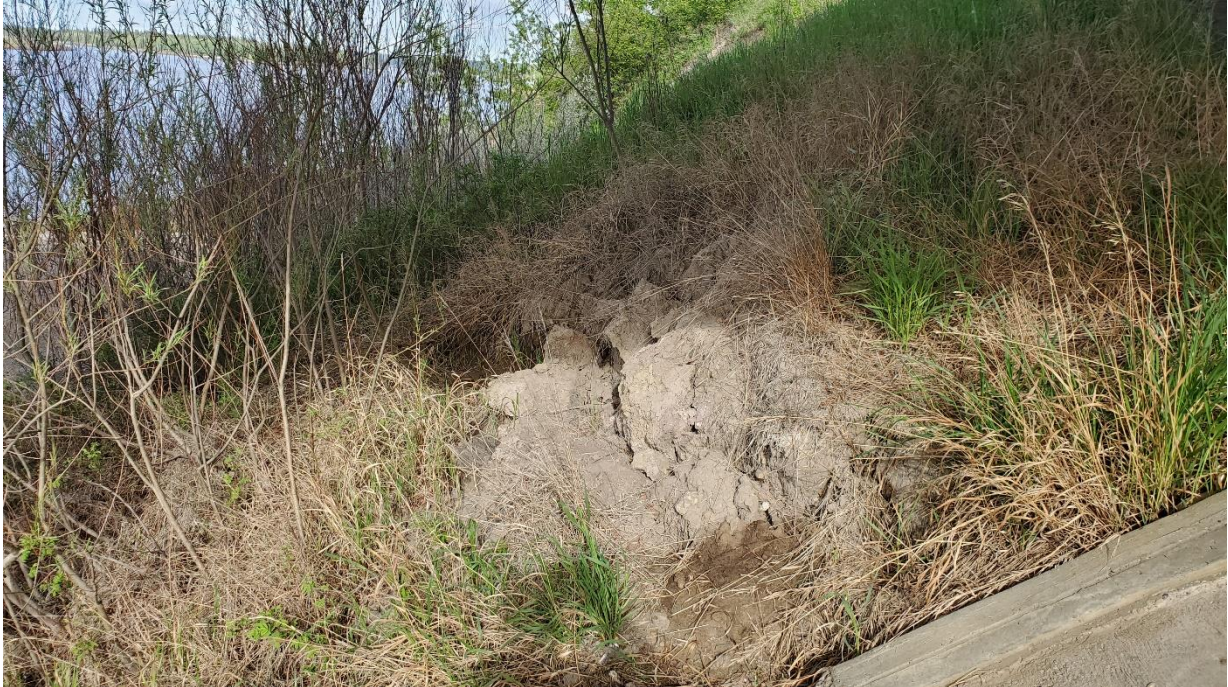
Photo 10, North – Looking northwest at tension cracks on the east side of the north abutment.

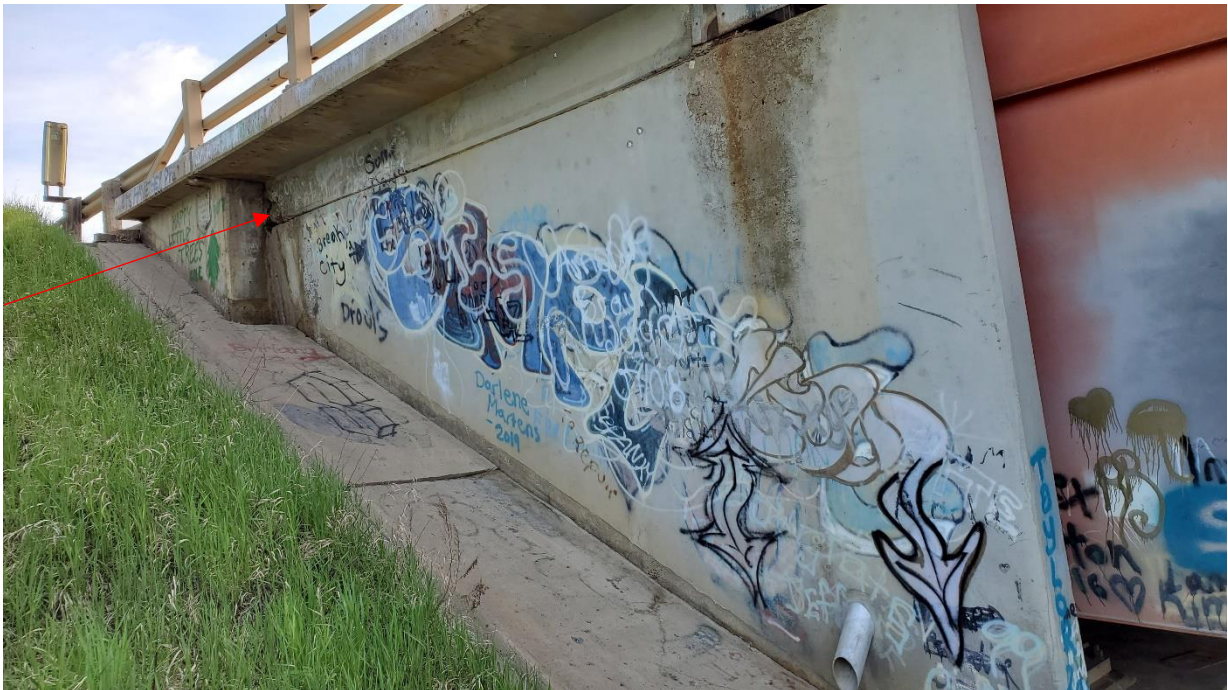
Photo 11A, North – Looking northeast at north abutment west side wing wall. Cracking of beam denoted by red arrow shown in Photo 11B.

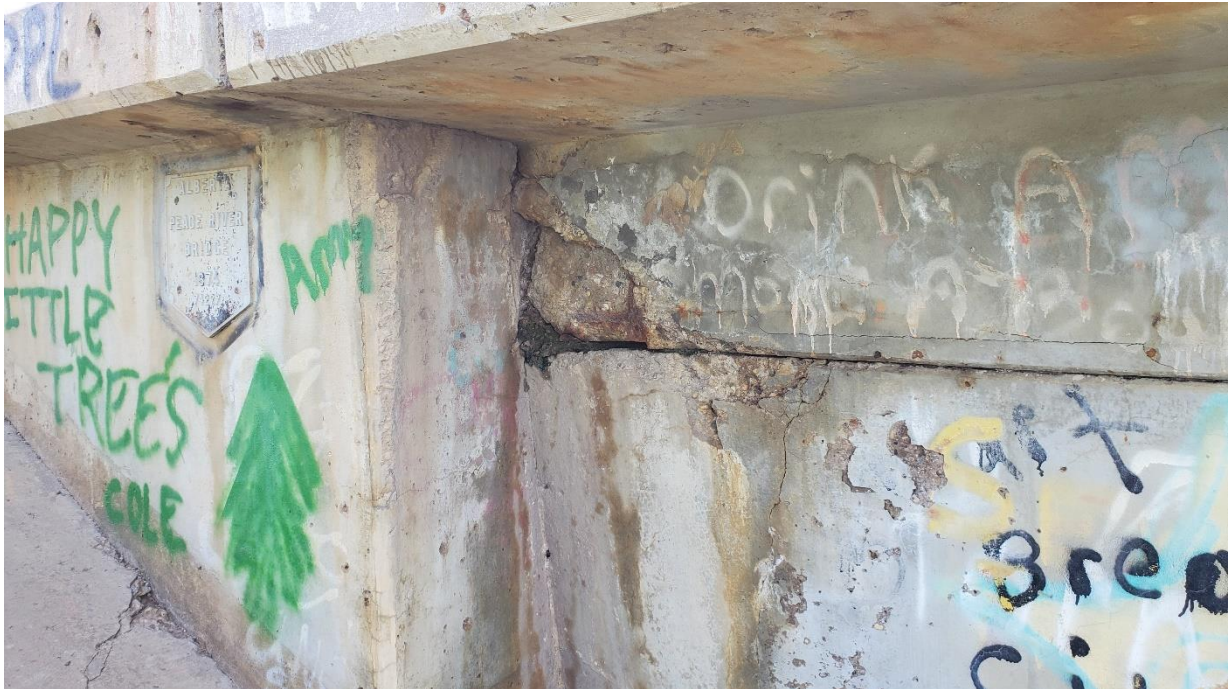
Photo 11B, North – cracking of approach slab beam above west side wingwall.

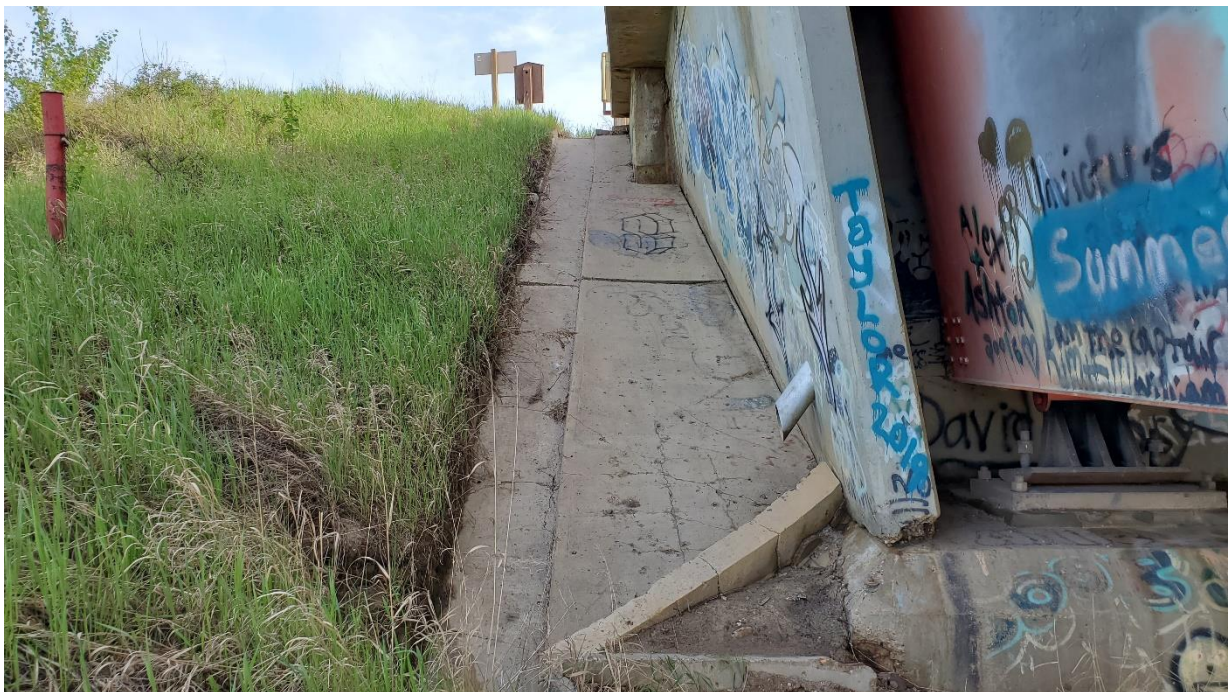
Photo 11C, North – Hump of material creeping into concrete drainage trough adjacent to west wingwall.

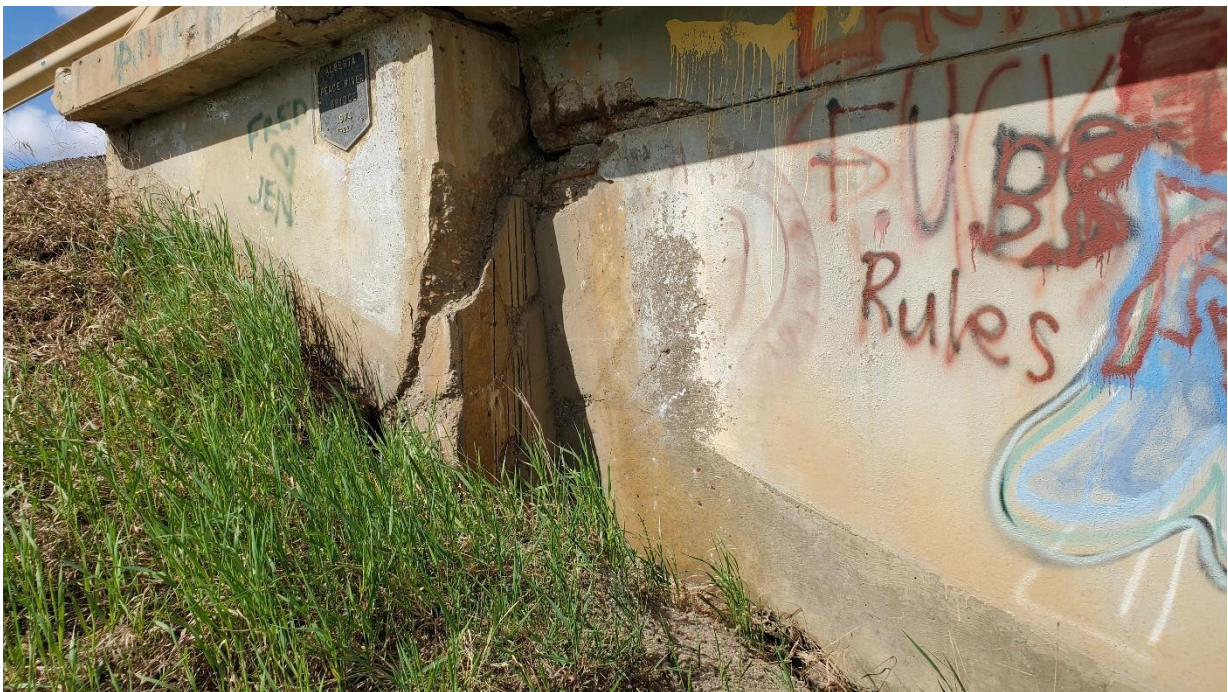
Photo 16B, South – Looking southwest at spalling on south abutment wall.

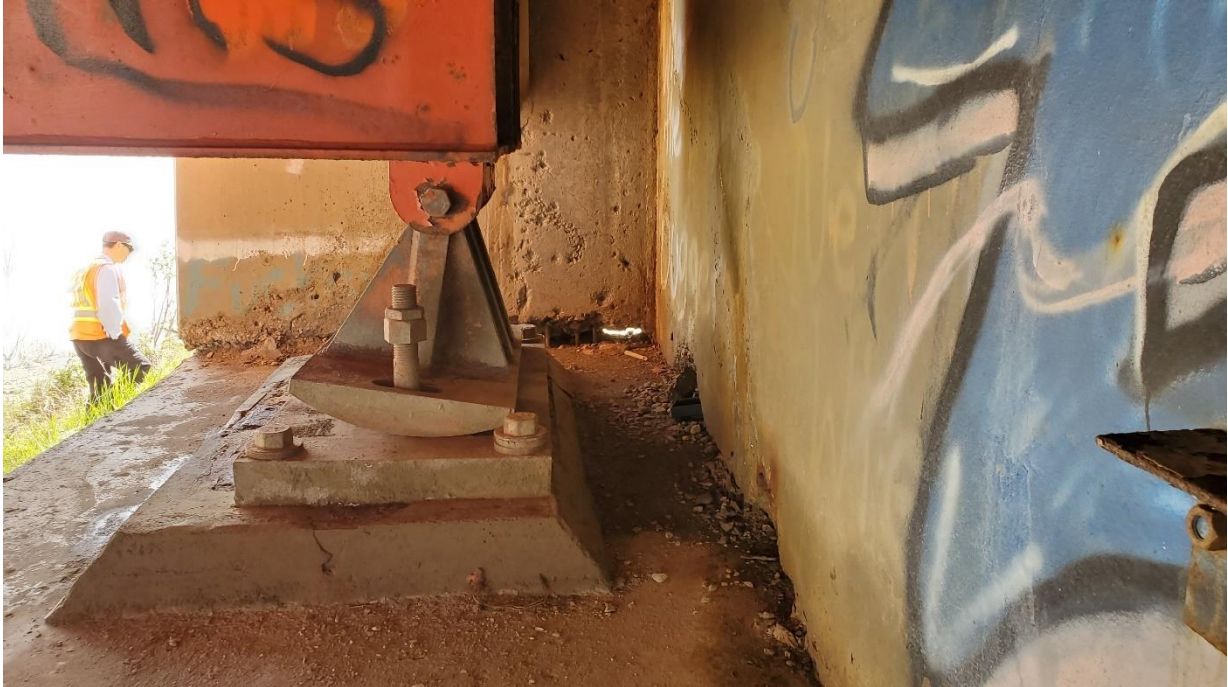
Photo 17, South – Looking east at south abutment east rocker bearing.

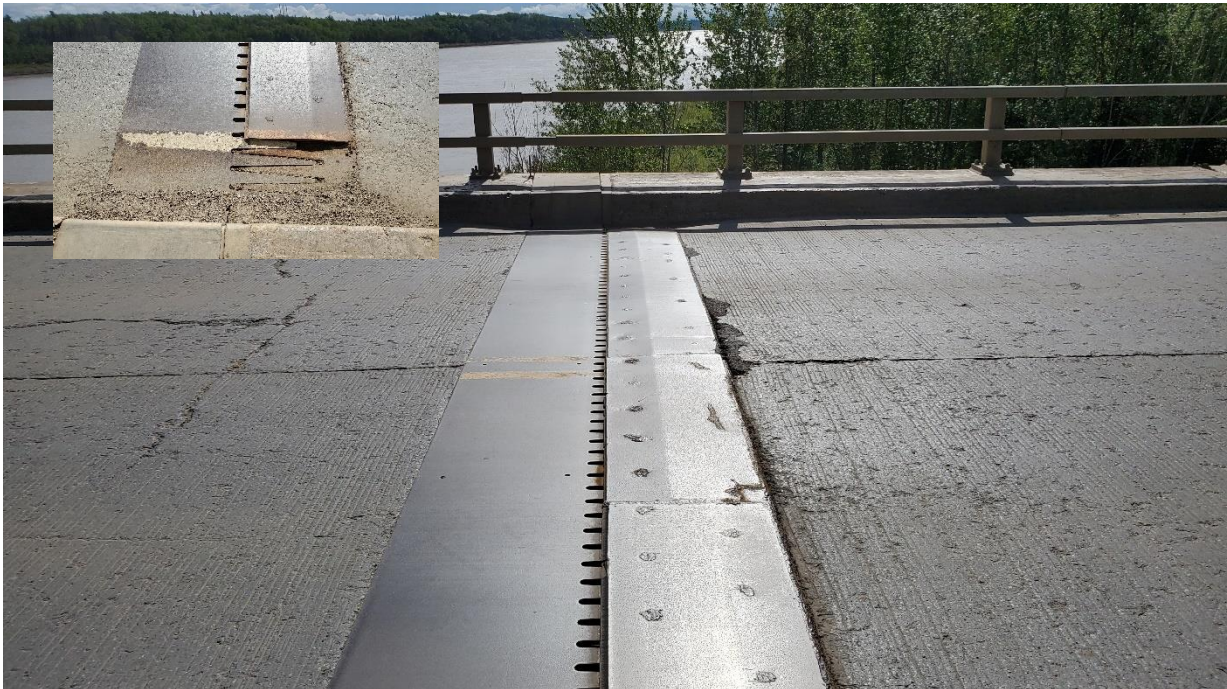
Photo 22, South – Looking east at south abutment finger joints which was covered with a plate between the 2017 and 2018 visits. Plate is loose and rusting at south side (see inset).

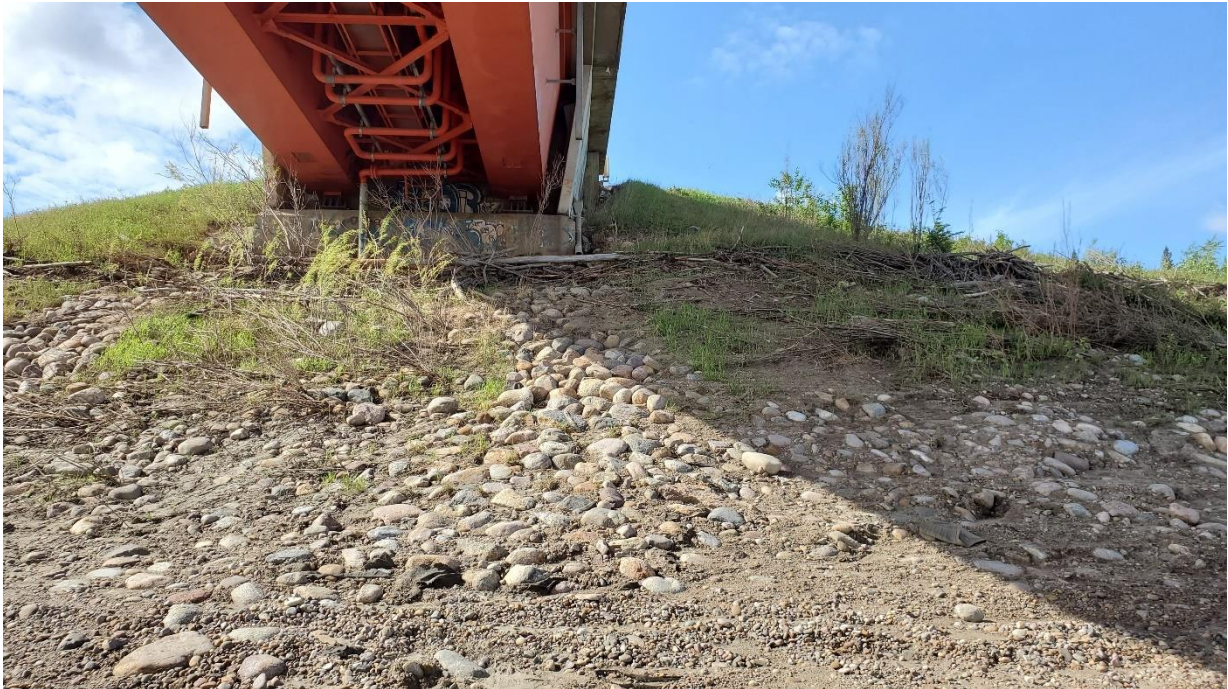
Photo 23A, South – Riprap placed in 2015 on south headslope below west deck drains.
