**ALBERTA TRANSPORTATION
GEOHAZARD ASSESSMENT
PEACE REGION (PEACE RIVER DISTRICT)
2022 INSPECTION**

Site Number	Location	Name	Hwy	km
PH048-1 (S) PH048-2 (N)	Northwest of Fort Vermillion, Alberta	Fort Vermillion Bridge (BF74227-1) Abutments	88:18	29.47 (South) 29.96 (North)
Legal Description		UTM Co-ordinates		
South Abutment: SE29-108-13-W5M		11U E 550,889	N	6,473,826
North Abutment: NE29-108-13-W5M		11U E 550,950	N	6,474,310

PH048-1: HWY 88, FT. VERMILION BRIDGE (NORTH ABUTMENT) - km 29.96

**PH048-1: HWY88, FT. VERMILION BRIDGE
(SOUTH ABUTMENT) - km 29.47
2022 GEOHAZARD ASSESSMENT**

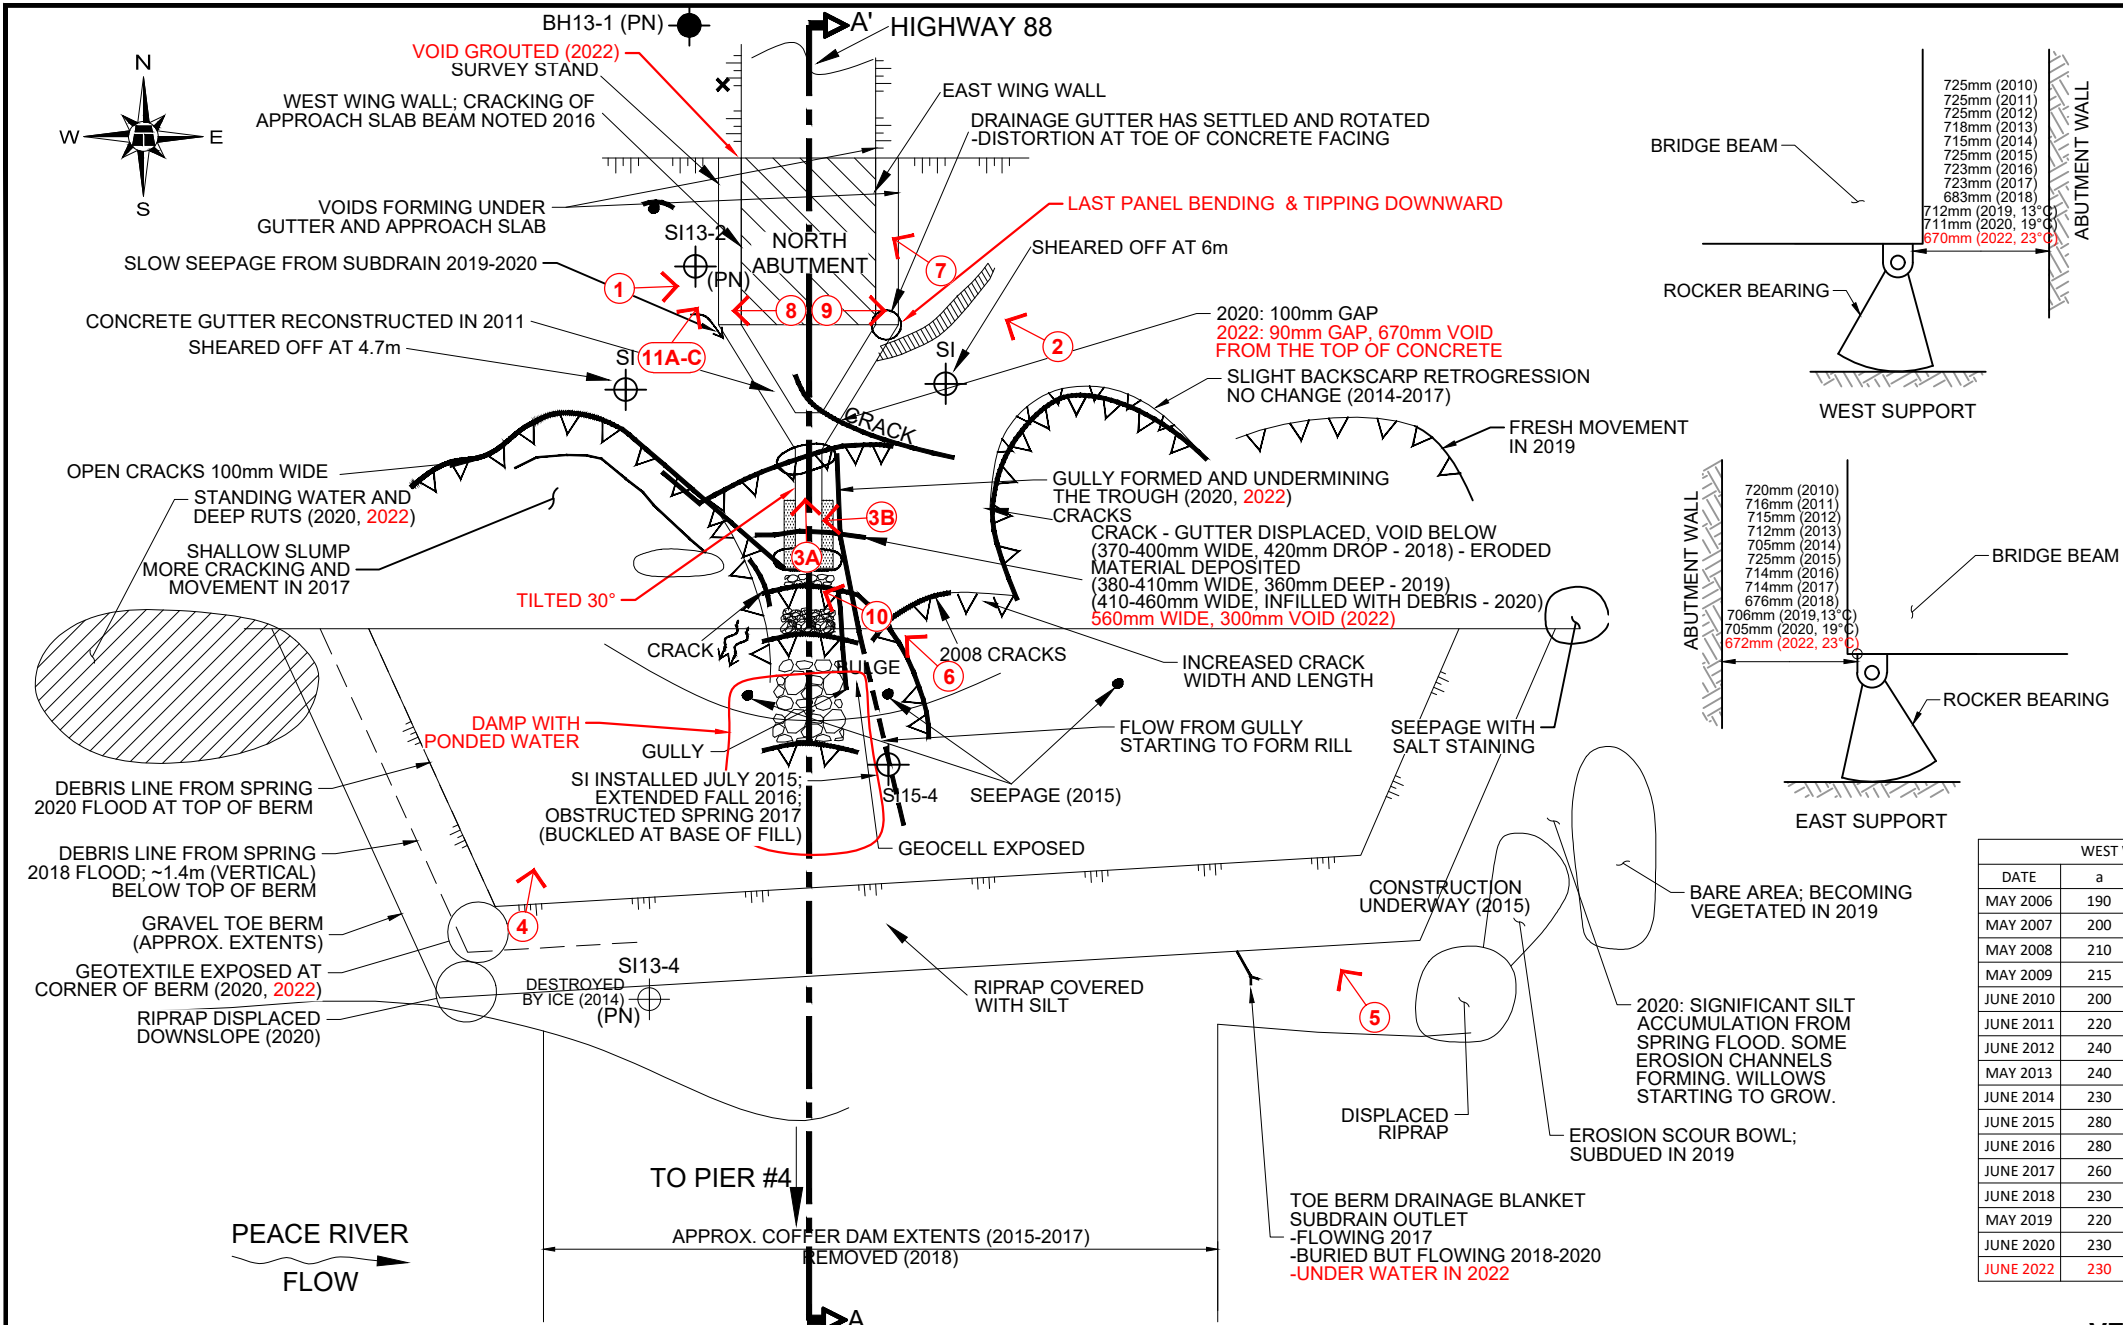
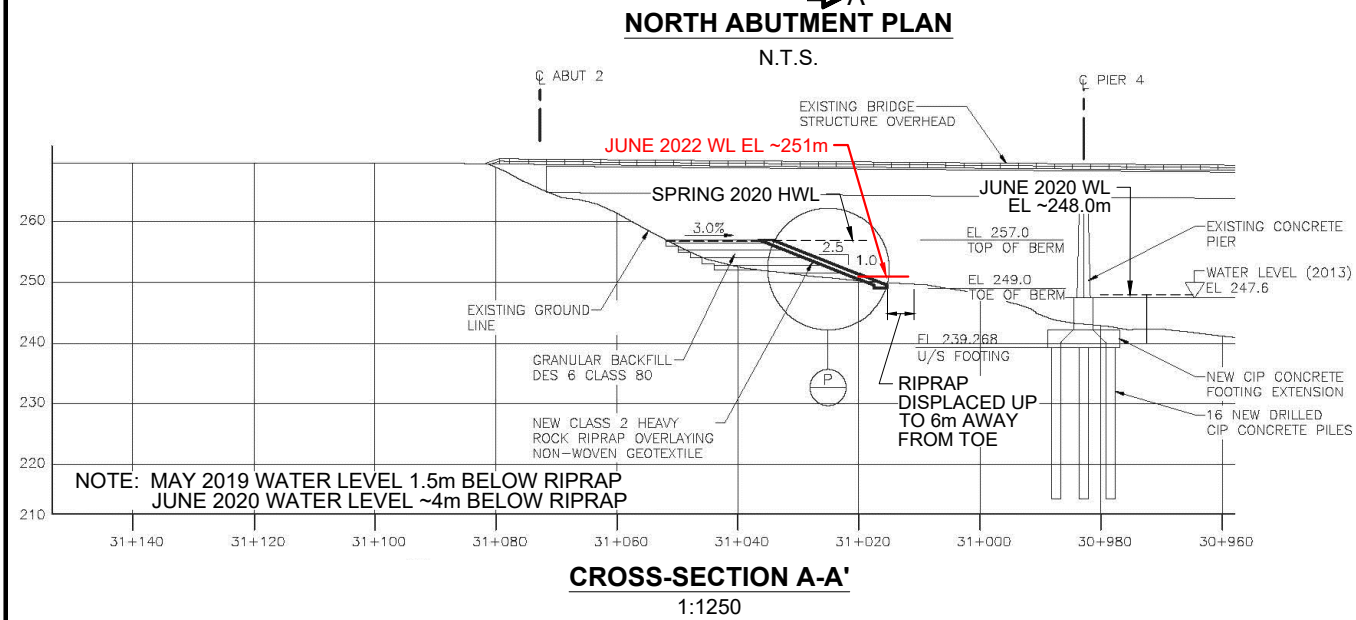
DWG No. 32121-PH048-1-1

WEST WING WALL MEASUREMENT (mm)					
DATE	a	b	c	d	e
MAY 2006	190	150	65	-	-
MAY 2007	200	160	75	120	-
MAY 2008	210	200	50	110	280
MAY 2009	215	210	60	110	290
JUNE 2010	200	180	45	120	-
JUNE 2011	220	215	60	123	-
JUNE 2012	240	220	70	130	290
MAY 2013	240	220	80	130	290
JUNE 2014	230	220	70	145	330
JUNE 2015	280	240	70	150	330
JUNE 2016	280	-	-	160	300
JUNE 2017	260	240	85	150	310
JUNE 2018	230	240	90	150	230
MAY 2019	220	240	-	160	240
JUNE 2020	230	230	90	160	255
JUNE 2022	230	235	90	180	-

EAST WING WALL MEASUREMENT (mm)				
DATE	f	g	h*	i
MAY 2006	420	230	75	-
MAY 2007	285	100	90	-
MAY 2008	315	100	70	750
MAY 2009	250	100	70	750
JUNE 2010	475	235	75	-
JUNE 2011	490	260	75	-
JUNE 2012	520	270	60	770
MAY 2013	520	290	60	840
JUNE 2014	510	270	55	605
JUNE 2015	560	220	35	750
JUNE 2016	560	-	35	600
JUNE 2017	540	300	40	630
JUNE 2018	560	360	20	610
MAY 2019	600	360	-20	650
JUNE 2020	640	375	-20	730
JUNE 2022	630	390	60	600-870

VERTICAL DISPLACEMENTS AT NORTH ABUTMENT
N.T.S.
CROSS-SECTION TAKEN FROM
ISSUED FOR CONSTRUCTION DRAWINGS (CH2M HILL, SEPTEMBER 19, 2014)

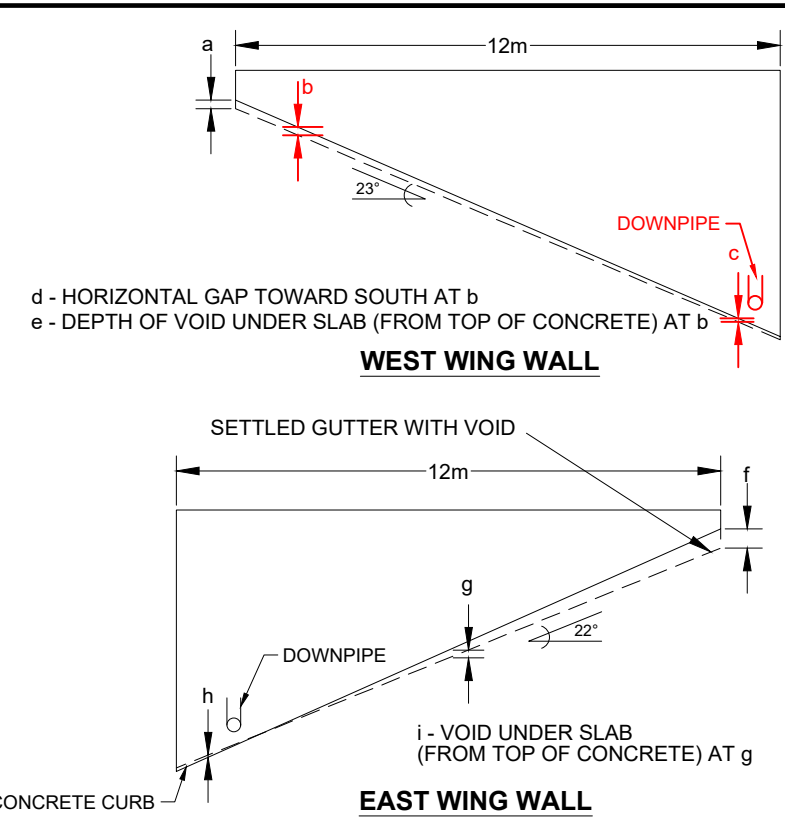
DWG No. 32121-PH048-1-2

ABUTMENT SETTLEMENTS (MEASURED BELOW ABUTMENT PILE CAP)			
LOCATION	SETTLEMENT (mm)		IN 2012
	IN 2010	IN 2011	
1m FROM THE EAST WING WALL	120	140	STUB WALL ADDED IN FRONT OF VOID IN 2011
AT THE PIPE	140	175	
2m FROM THE WEST WING WALL	80	90

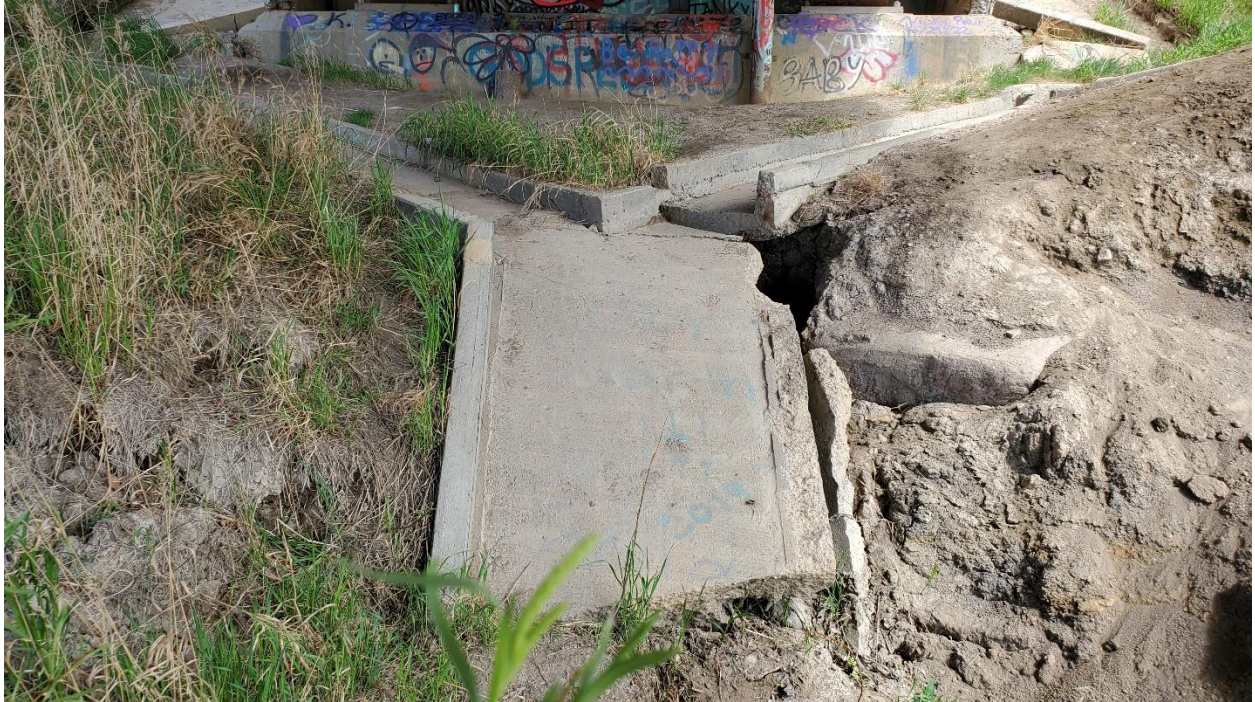
The displacements of the slope are likely adding vertical and lateral loads on the bridge abutment piles. The drainage gutters along the wing walls continue to settle and rotate as the headslope fill settles and rotates. Ongoing slope movement has resulted in cracking and separation of a portion of the gutter, which will contribute additional water into the slope causing further undermining of the gutter and gabion baskets. The concrete trough below the bridge has noticeably deteriorated since 2020 and the formation of erosion gullies beside and below will lead to an increased rate of movement.

Photo 3A, North – Looking north at north abutment concrete gutter. Void below the gutter is up to 670 mm deep.

- It is recommended that the concrete gutters at the north abutment be removed and rebuilt ensuring a controlled drainage path down to and across the toe berm. A combination of concrete, half-round culverts, and erosion control products could be used. This will be done as part of the planned rehabilitation.

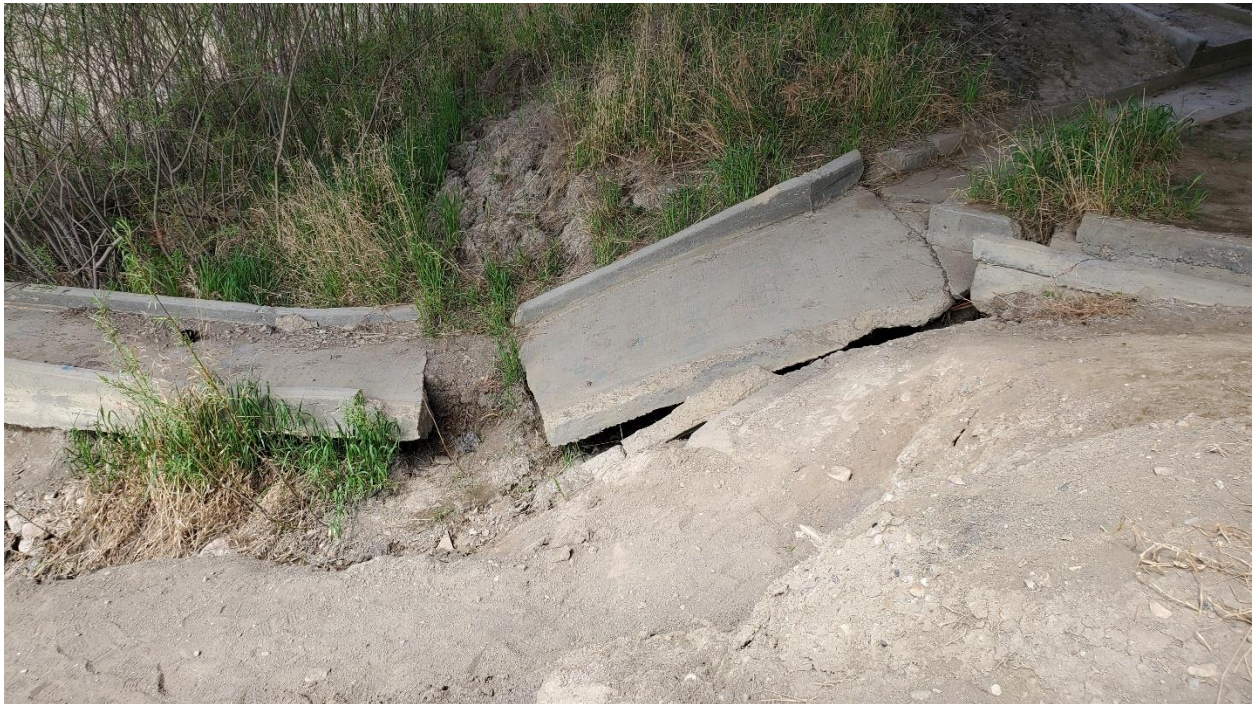
Photo 3B, North – Looking west at cracked and shifting north abutment concrete gutter. Void below the lower portion of the slab up to 300 mm (measured from top of concrete).

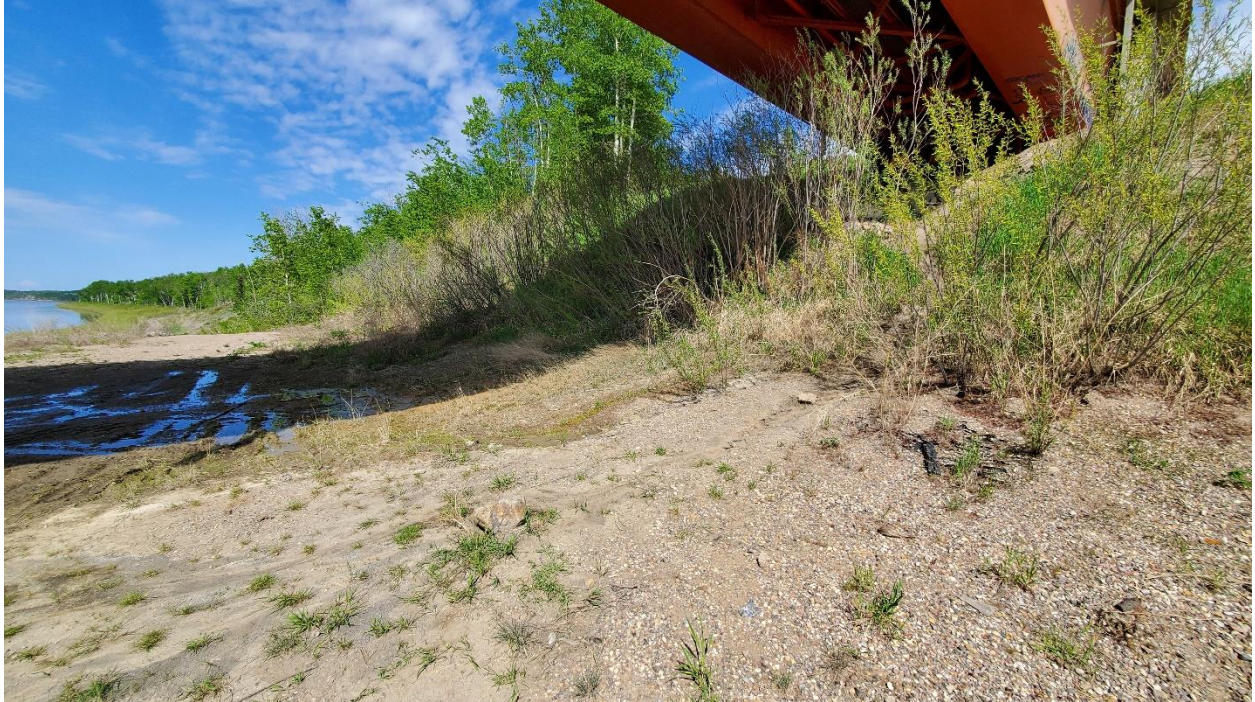
Photo 6, North – Seepage along toe of headslope face just above the top of the toe berm which is ponding on the surface of the berm.

- The upper part of the north headslope should be regraded on both sides of the abutment to a flatter inclination to improve drainage along the slope and reduce driving forces on the shallower slip surfaces that may be present. Subdrains should also be installed to dewater the upper slope. This will be done as part of the planned rehabilitation.

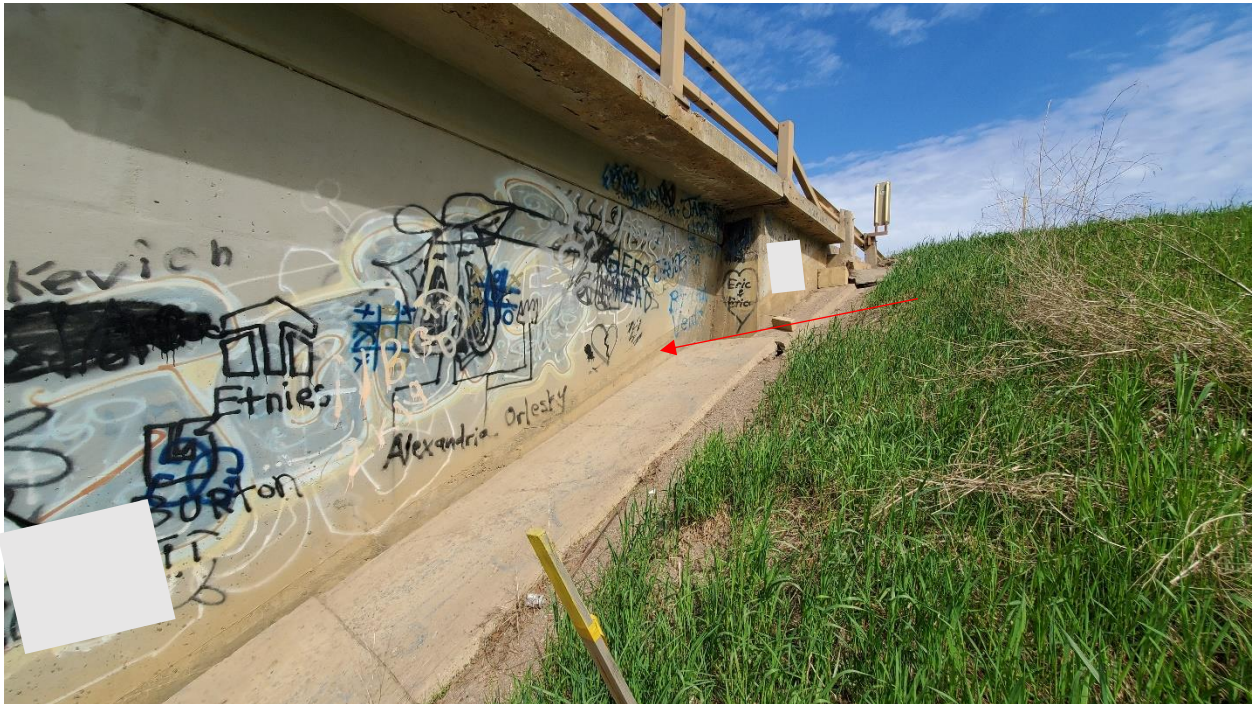
Photo 7, North – Looking northwest at gap between the concrete gutter and north abutment wing wall resulting from settlement of abutment fill.

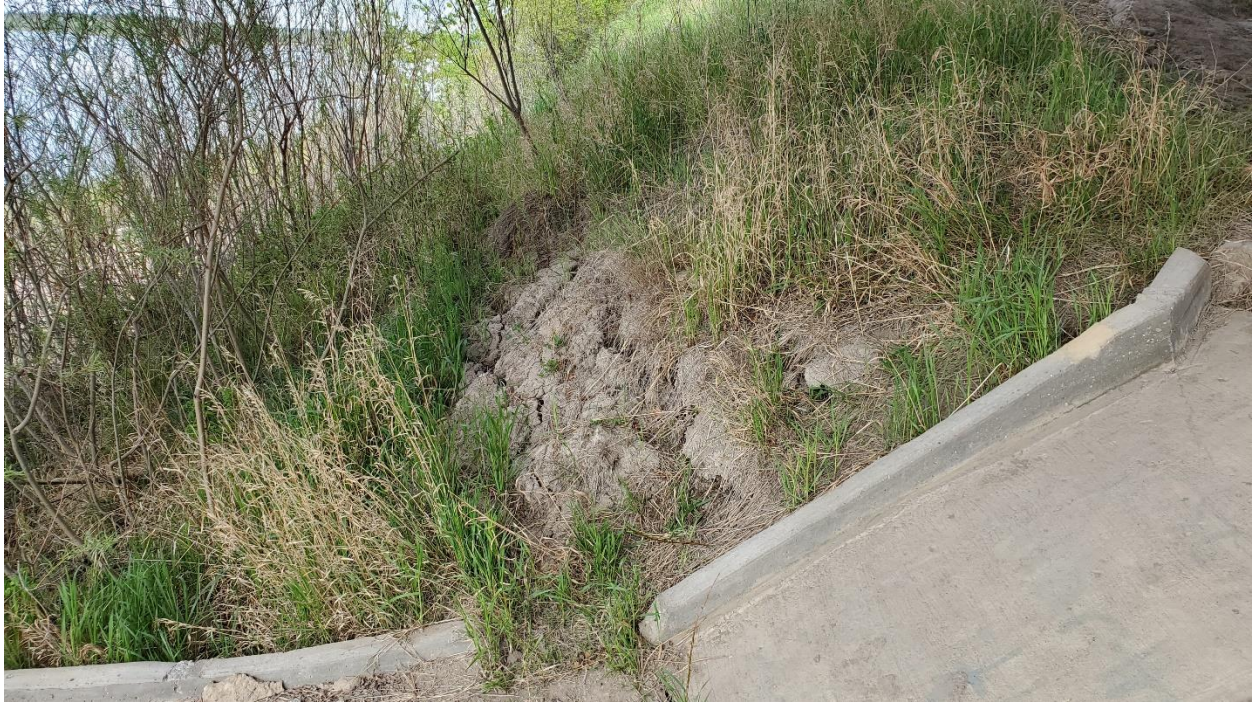
Photo 10, North – Looking northwest at tension cracks on the east side of the north abutment.

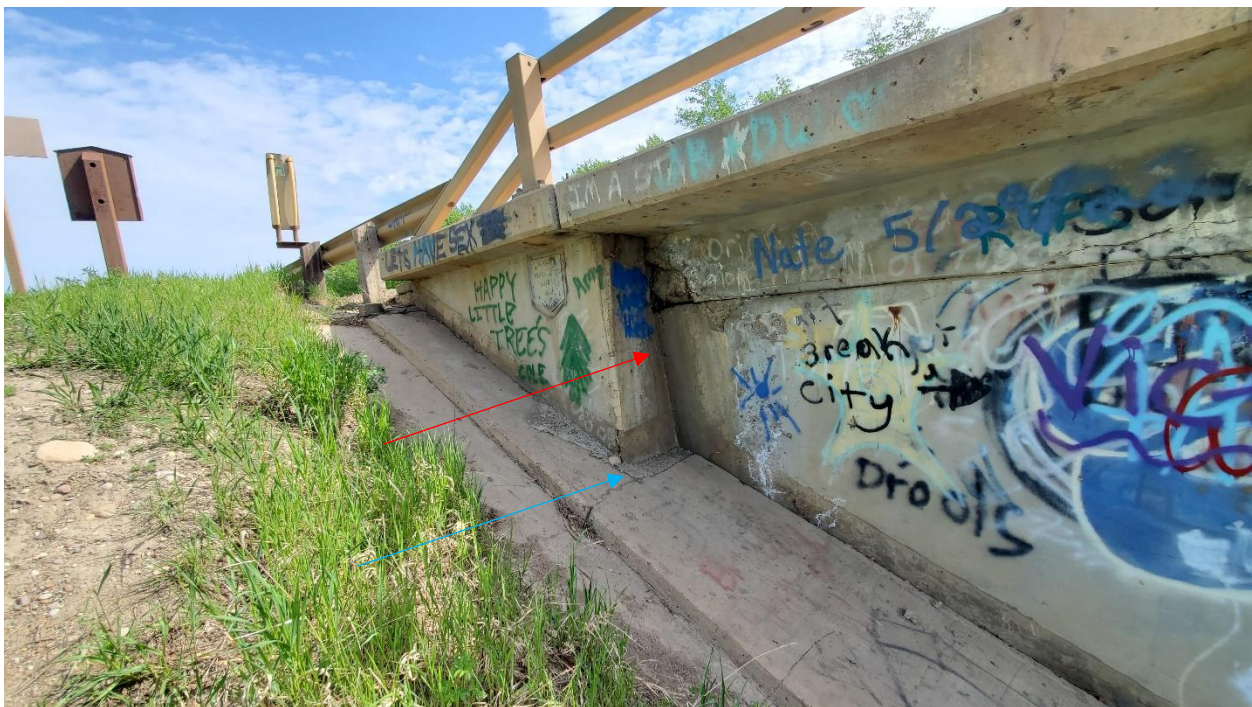
Photo 11A, North – Looking northeast at north abutment west side wing wall. Blue arrow shows recent grouting of voids. Cracking of beam denoted by red arrow shown in Photo 11B.

- The concrete in the wing walls is in poor condition and should be assessed by a bridge engineer to determine when structural repairs are warranted.

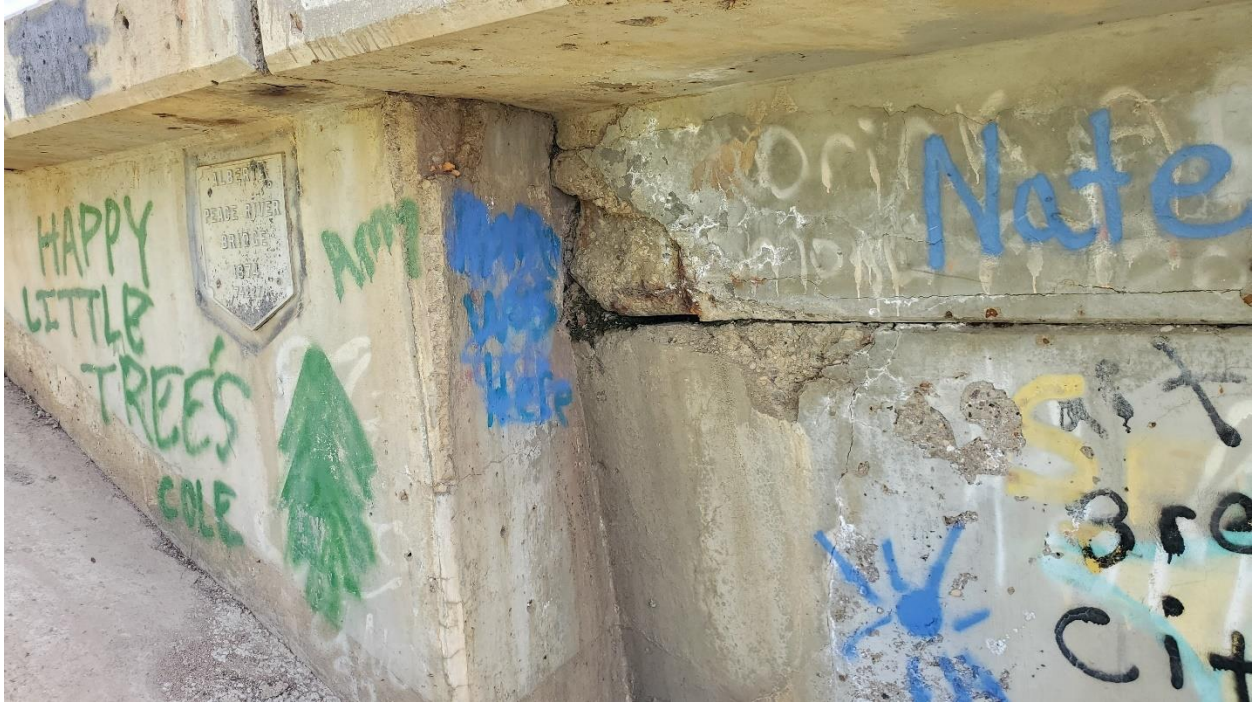
Photo 11B, North – cracking of approach slab beam above west side wingwall.

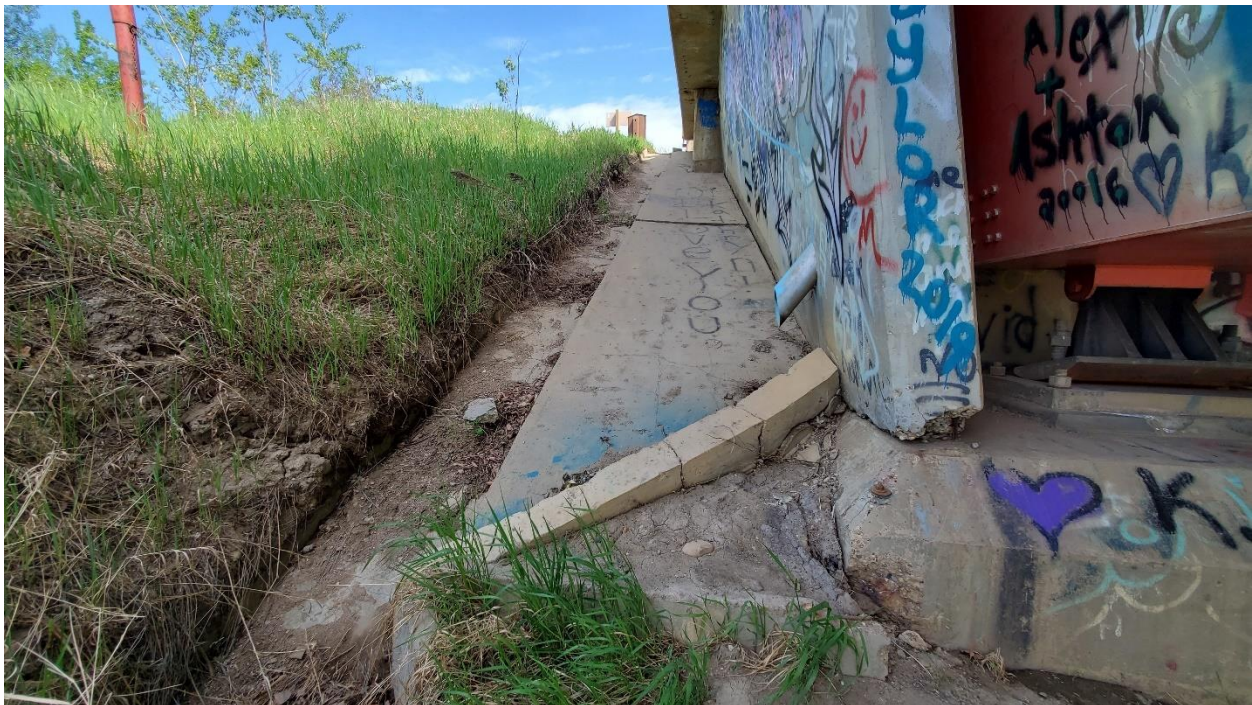
Photo 11C, North – Hump of material creeping into concrete drainage trough adjacent to west wingwall.

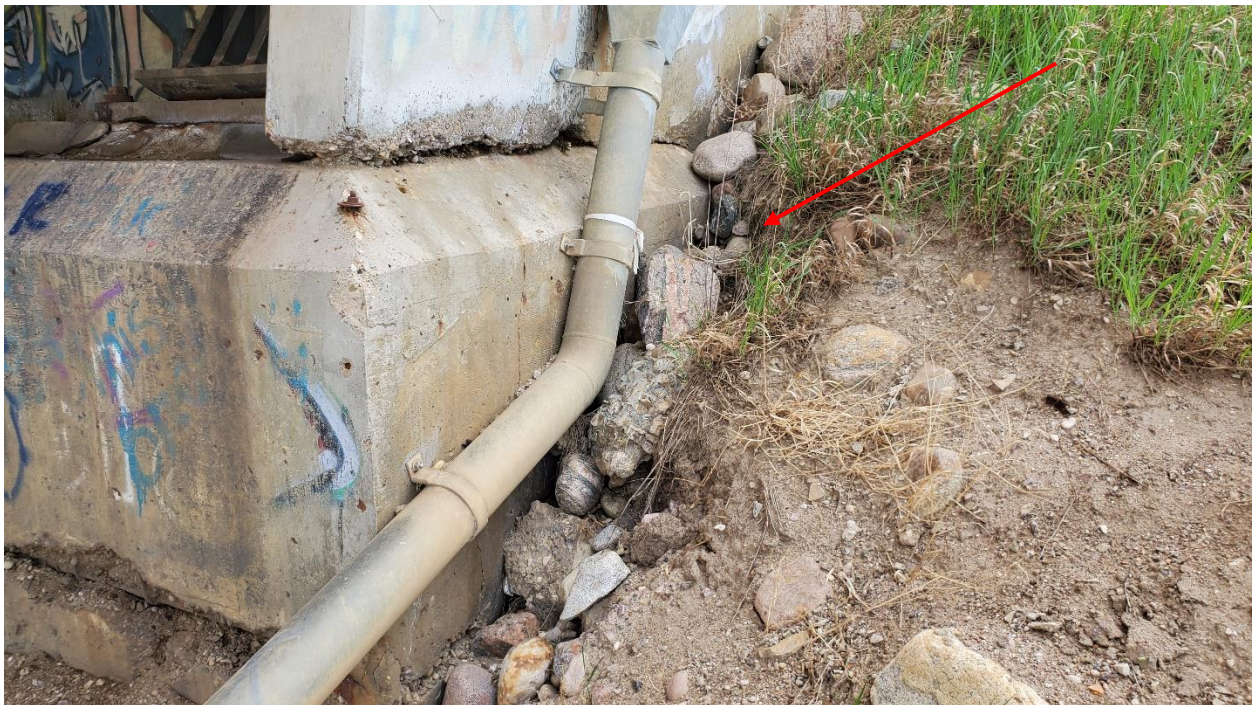
Photo 13, South – Looking southeast at south abutment west side wing wall. Erosion occurring at the base of the wall.

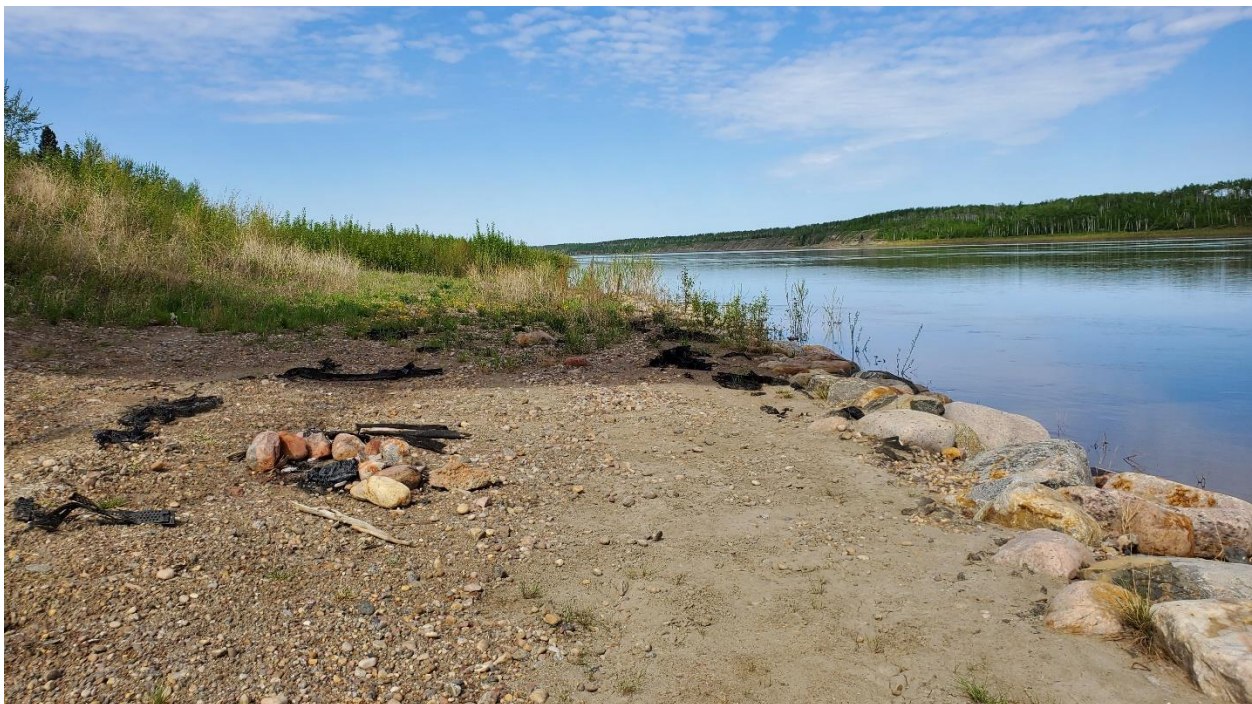
Photo 15, South – Looking west at new toe berm at south riverbank. Erosion of gravel at the top of toe berm occurred with high flood levels in Spring 2018 and 2022 exposing the GeoCell at several locations.

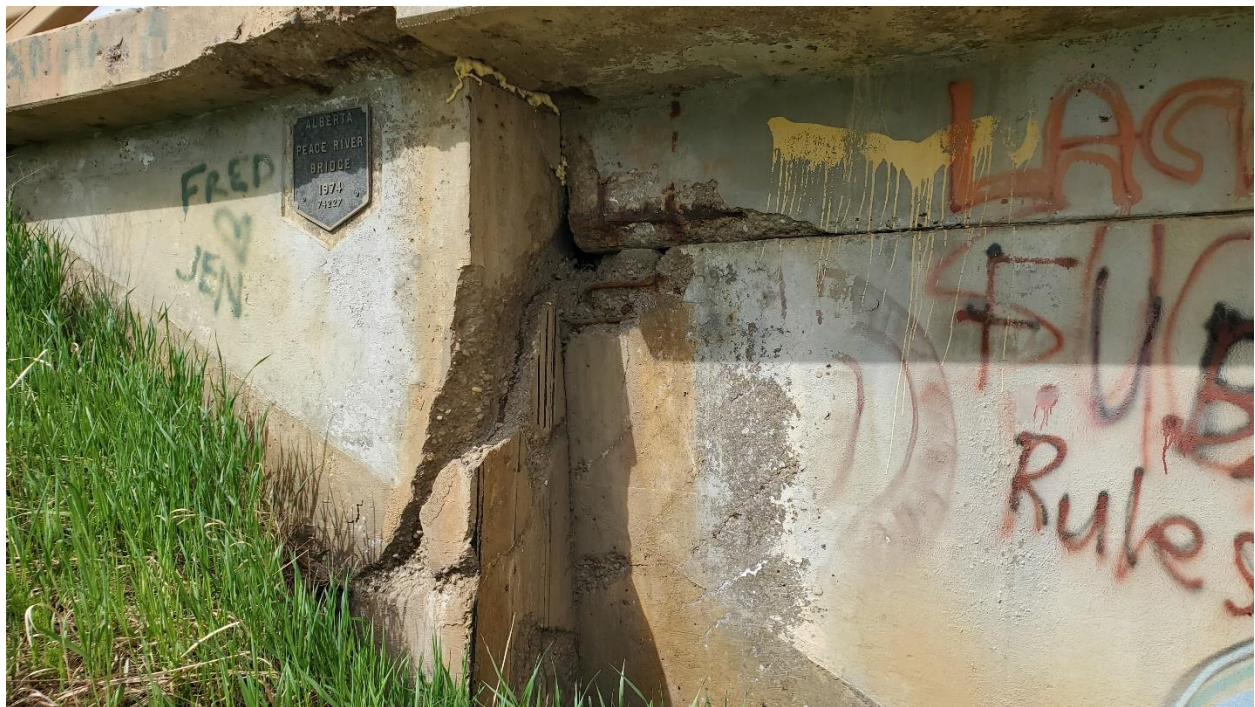
Photo 16B, South – Looking southwest at spalling on south abutment wall.

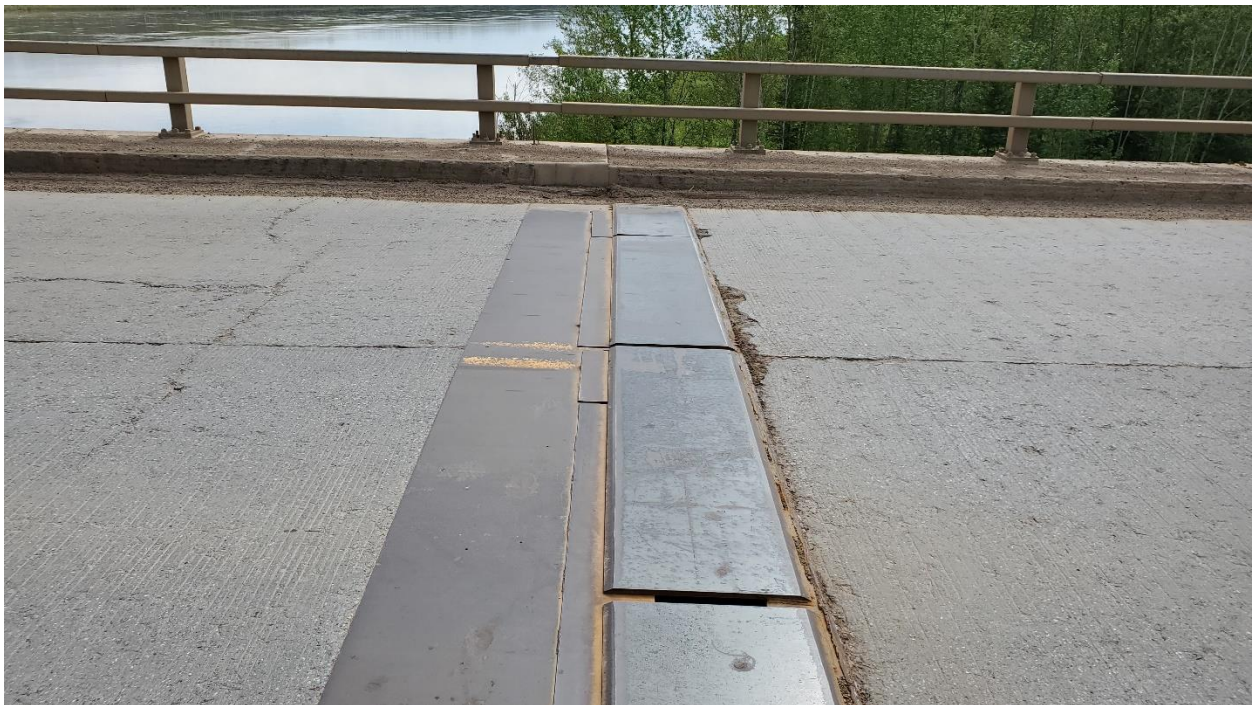
Photo 22, South – Looking east at south abutment finger joints which was covered with a plate between the 2017 and 2018 visits and repaired prior to the 2022 visit.
