July 28, 2022

**ALBERTA TRANSPORTATION GRMP (CON0022164)
PEACE REGION (PEACE RIVER DISTRICT)
INSTRUMENTATION MONITORING RESULTS – SPRING 2022**

SITE PH048: HWY 88:18, FORT VERMILION BRIDGE

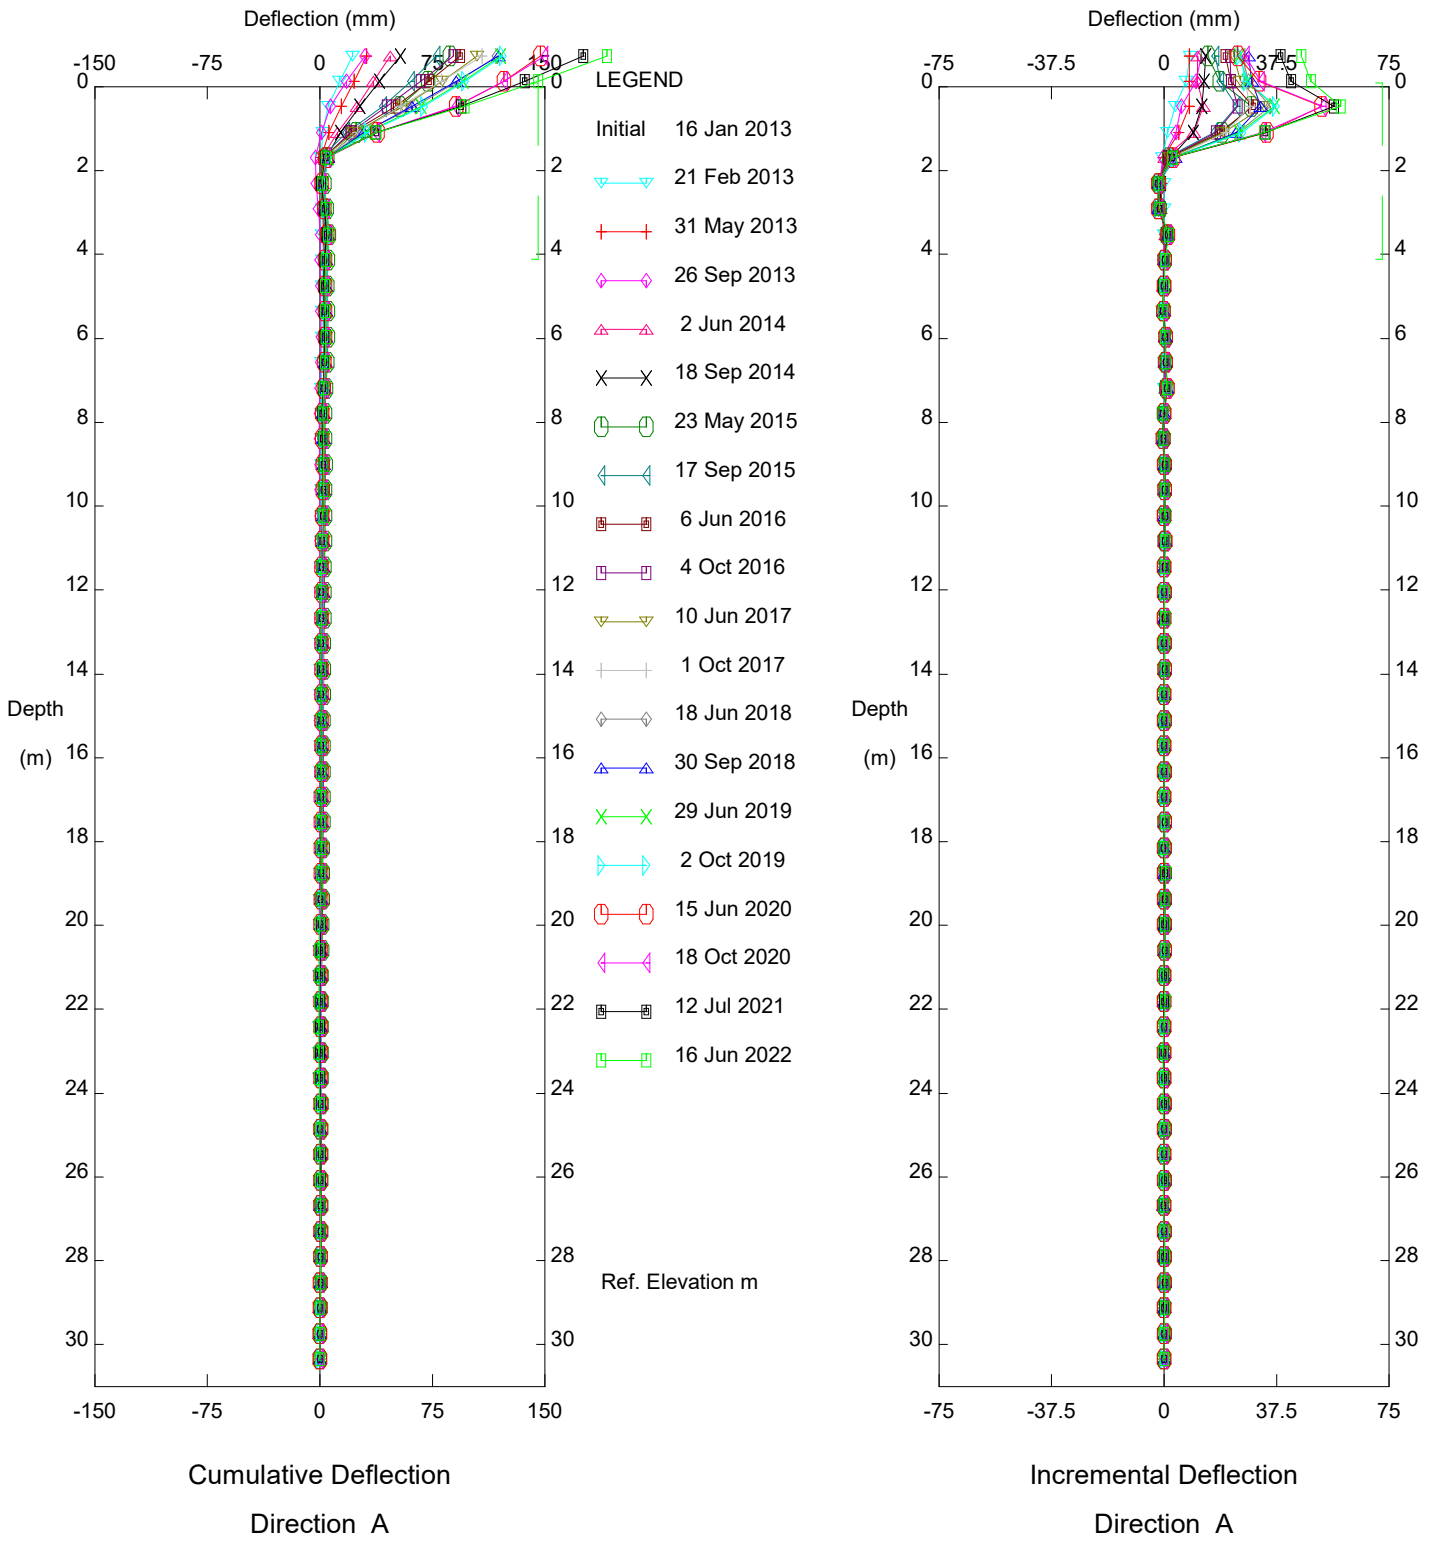
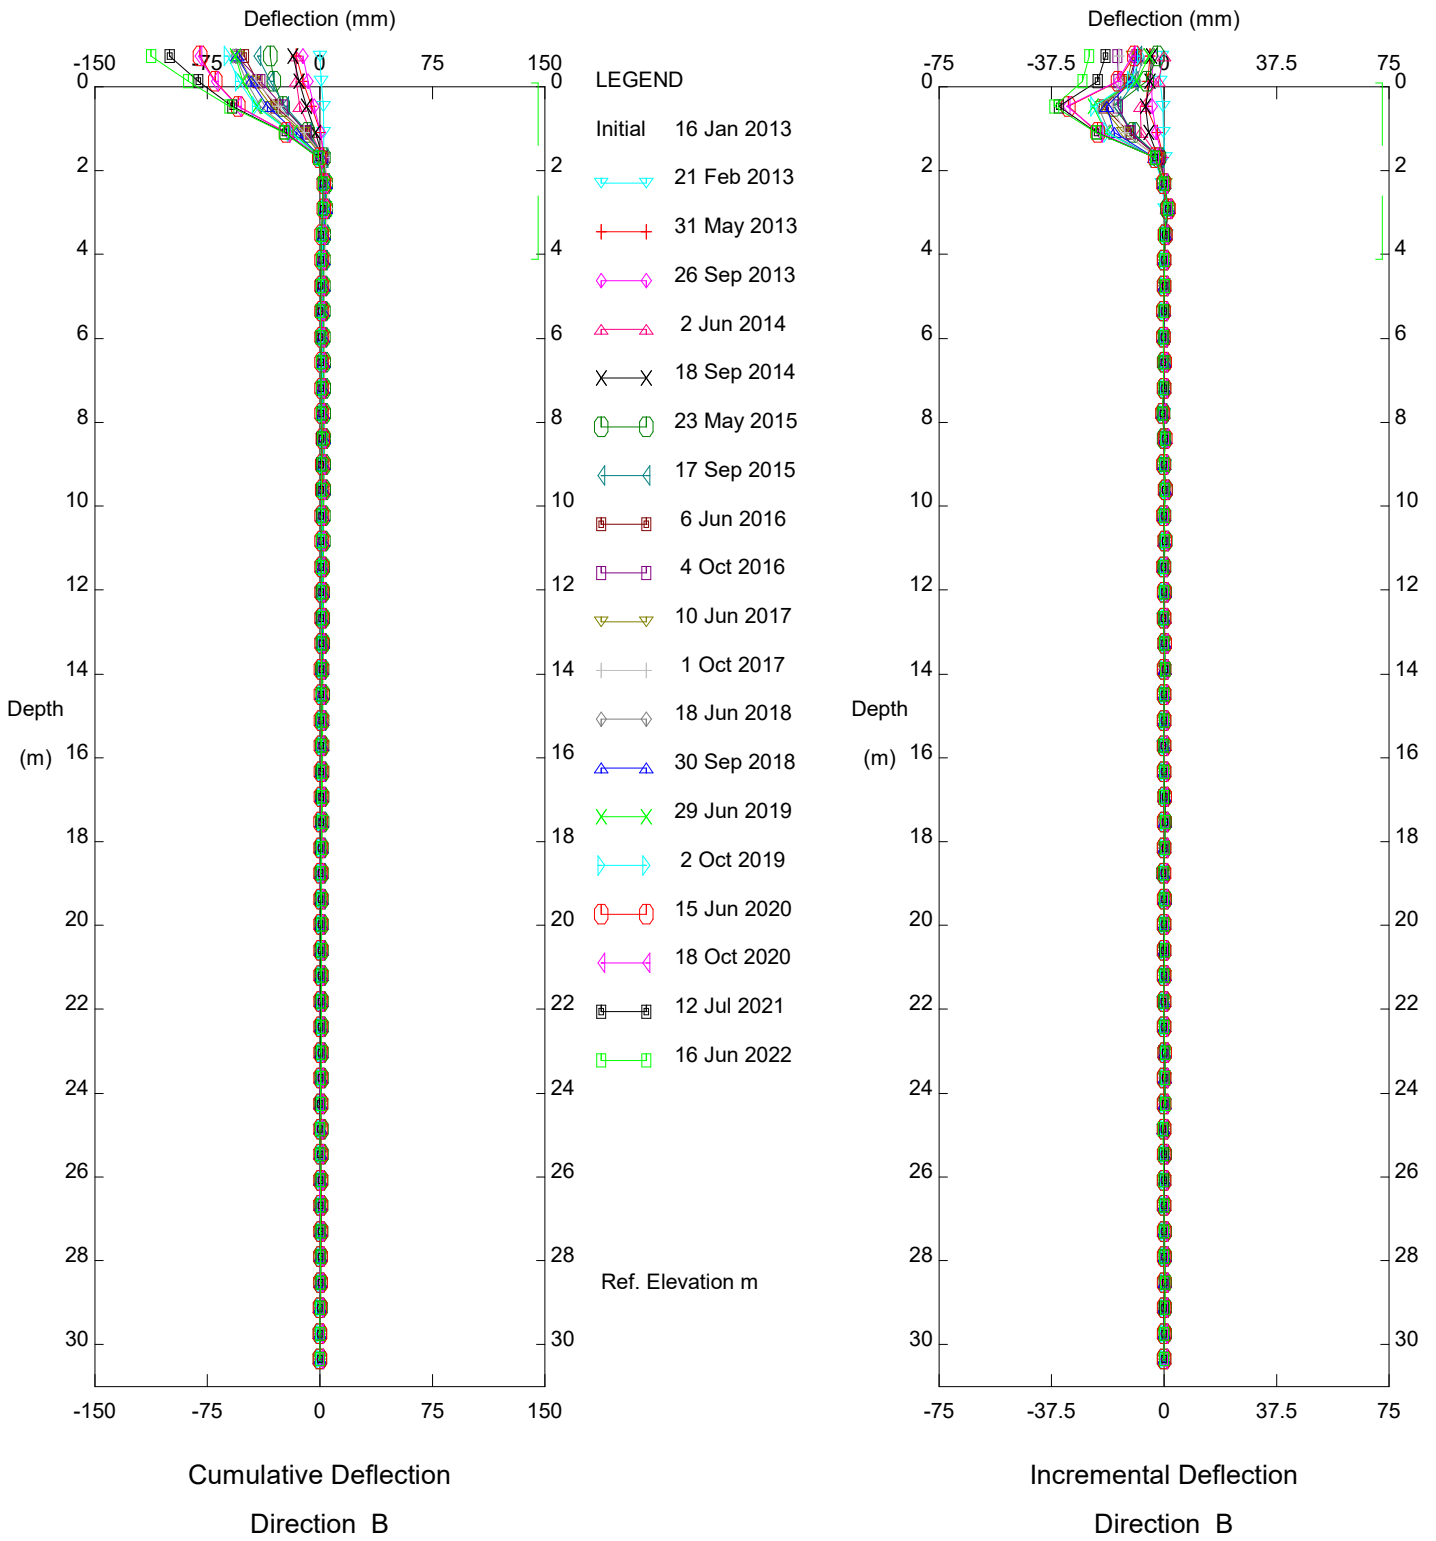
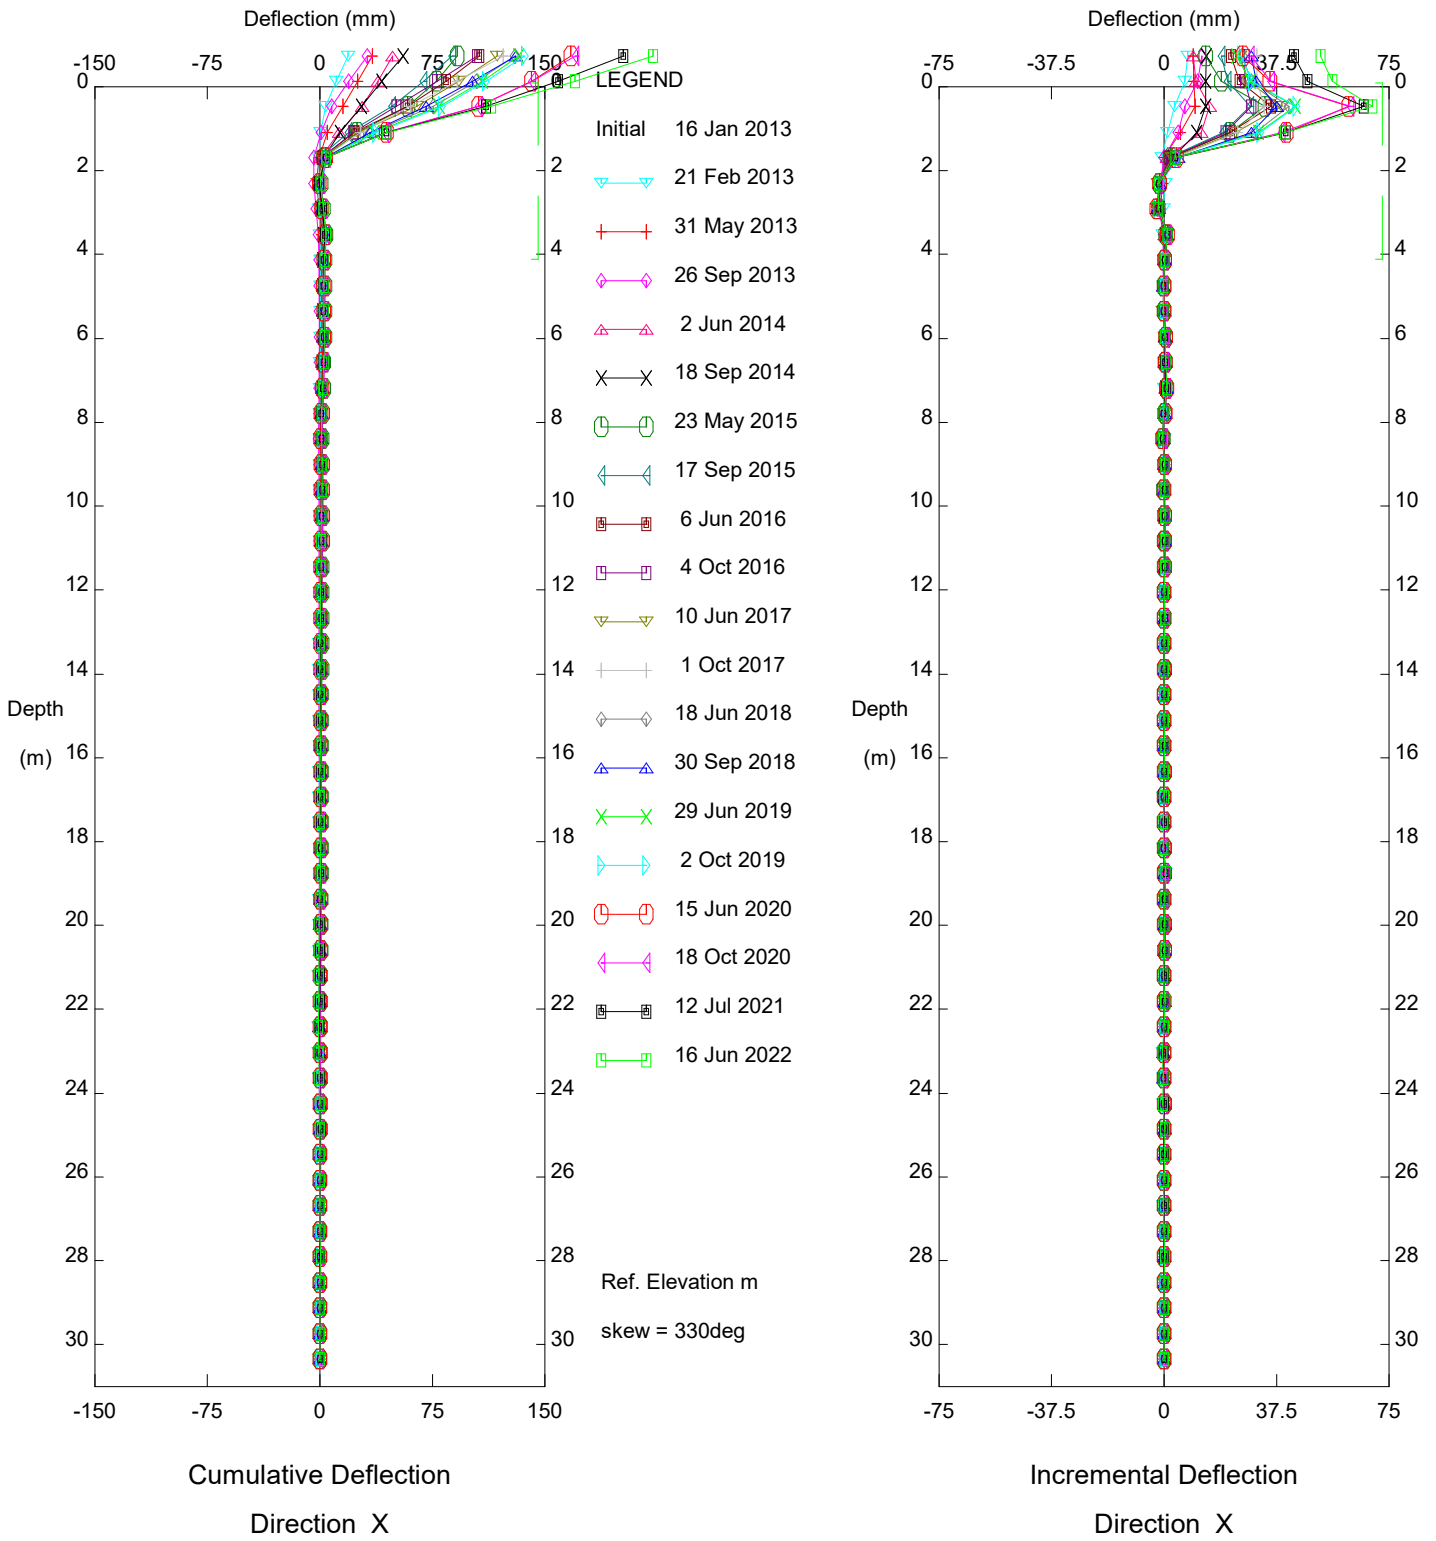
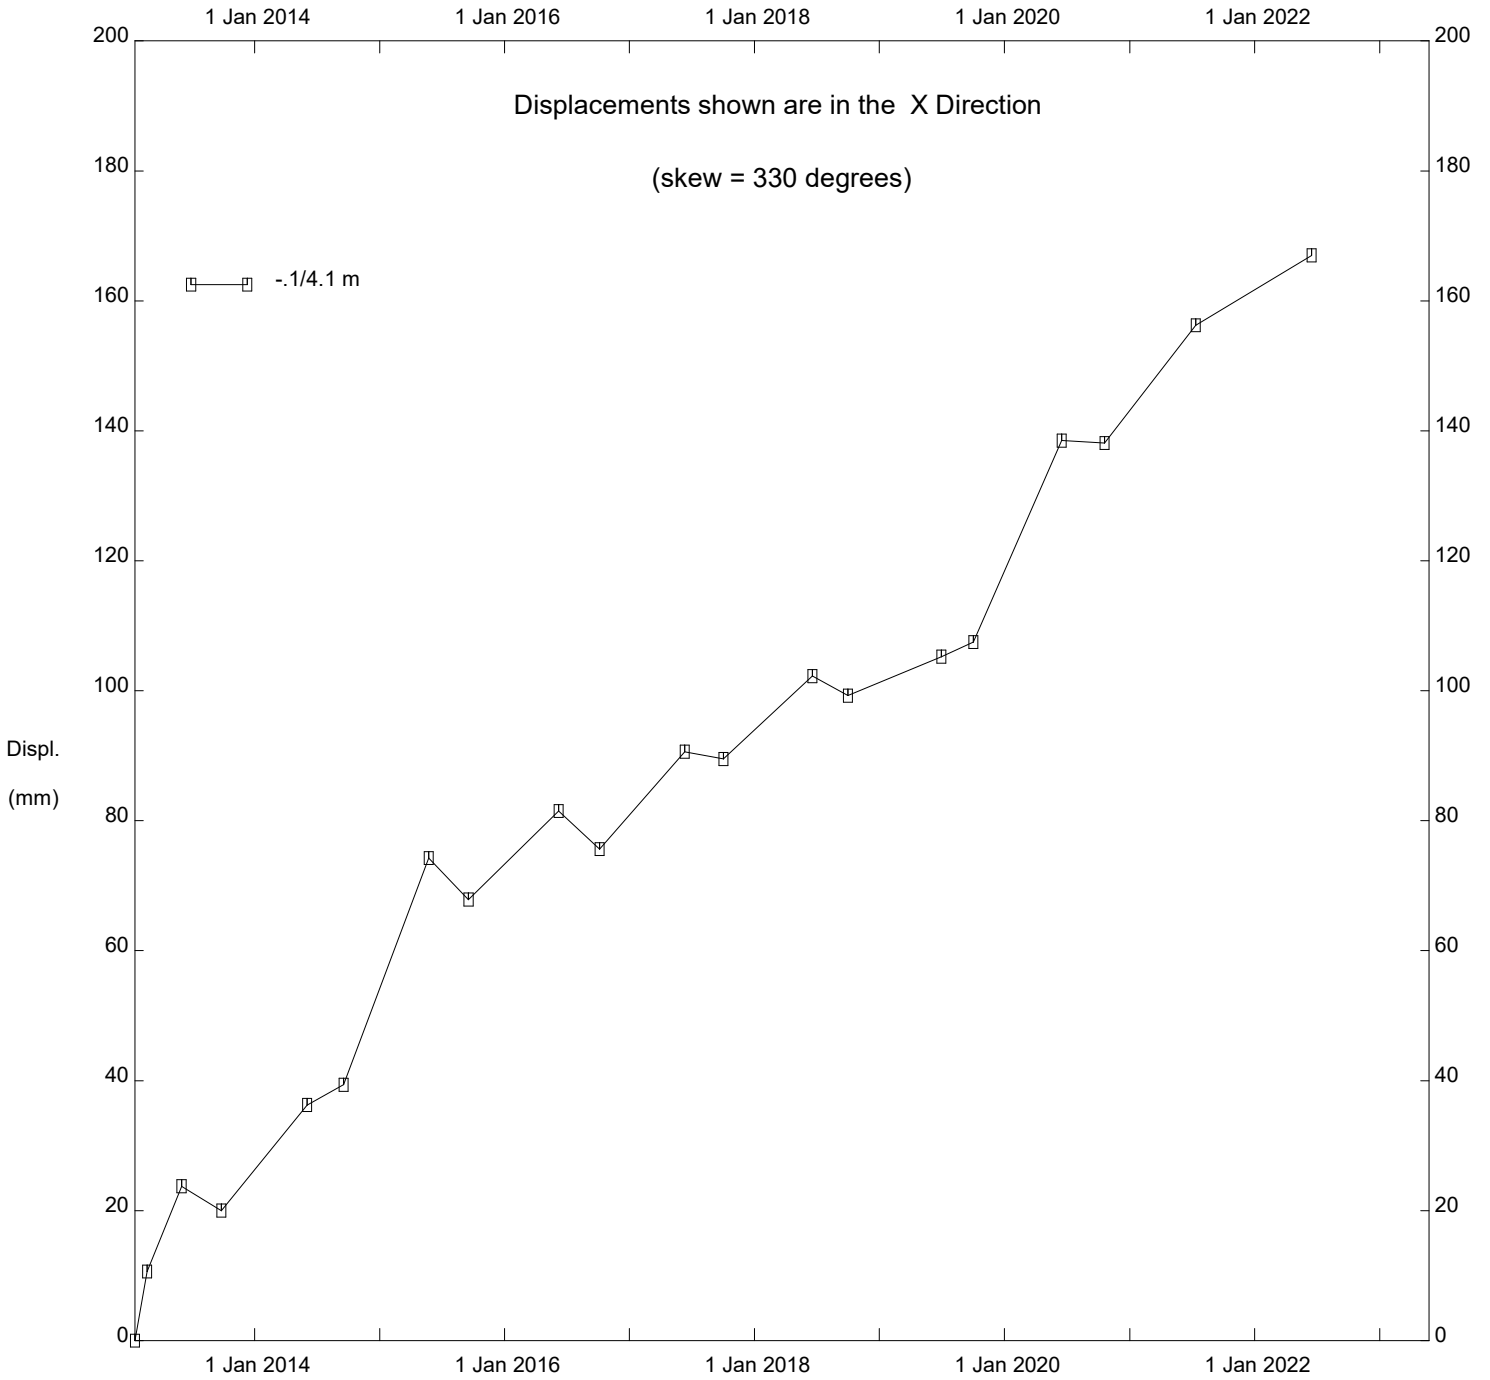
Fort Vermillion Bridge (PH048), Inclinator SI13-2

Slope inclinometer SI13-2 showed a rate of movement of 11.5 mm/yr over 0.0 m to 4.1 m depth since the spring of 2021 readings. SI13-2 has shown a cumulative movement of 167.0 mm over this shallow zone. The movement has been somewhat cyclical (higher rate in spring, slower or negative in fall) and has an overall rate (since initialization) of 18.4 mm/year. The movement rate since the spring of 2020 is lower than the overall rate.

SI13-2 is measuring some upper headslope fill rotation that has been occurring for a while at this site. Thurber has recommended in the past that the headslope fill be cut back to a flatter angle and some subdrains be installed to intercept some springs and lower the water level to help stabilize this upper headslope area.

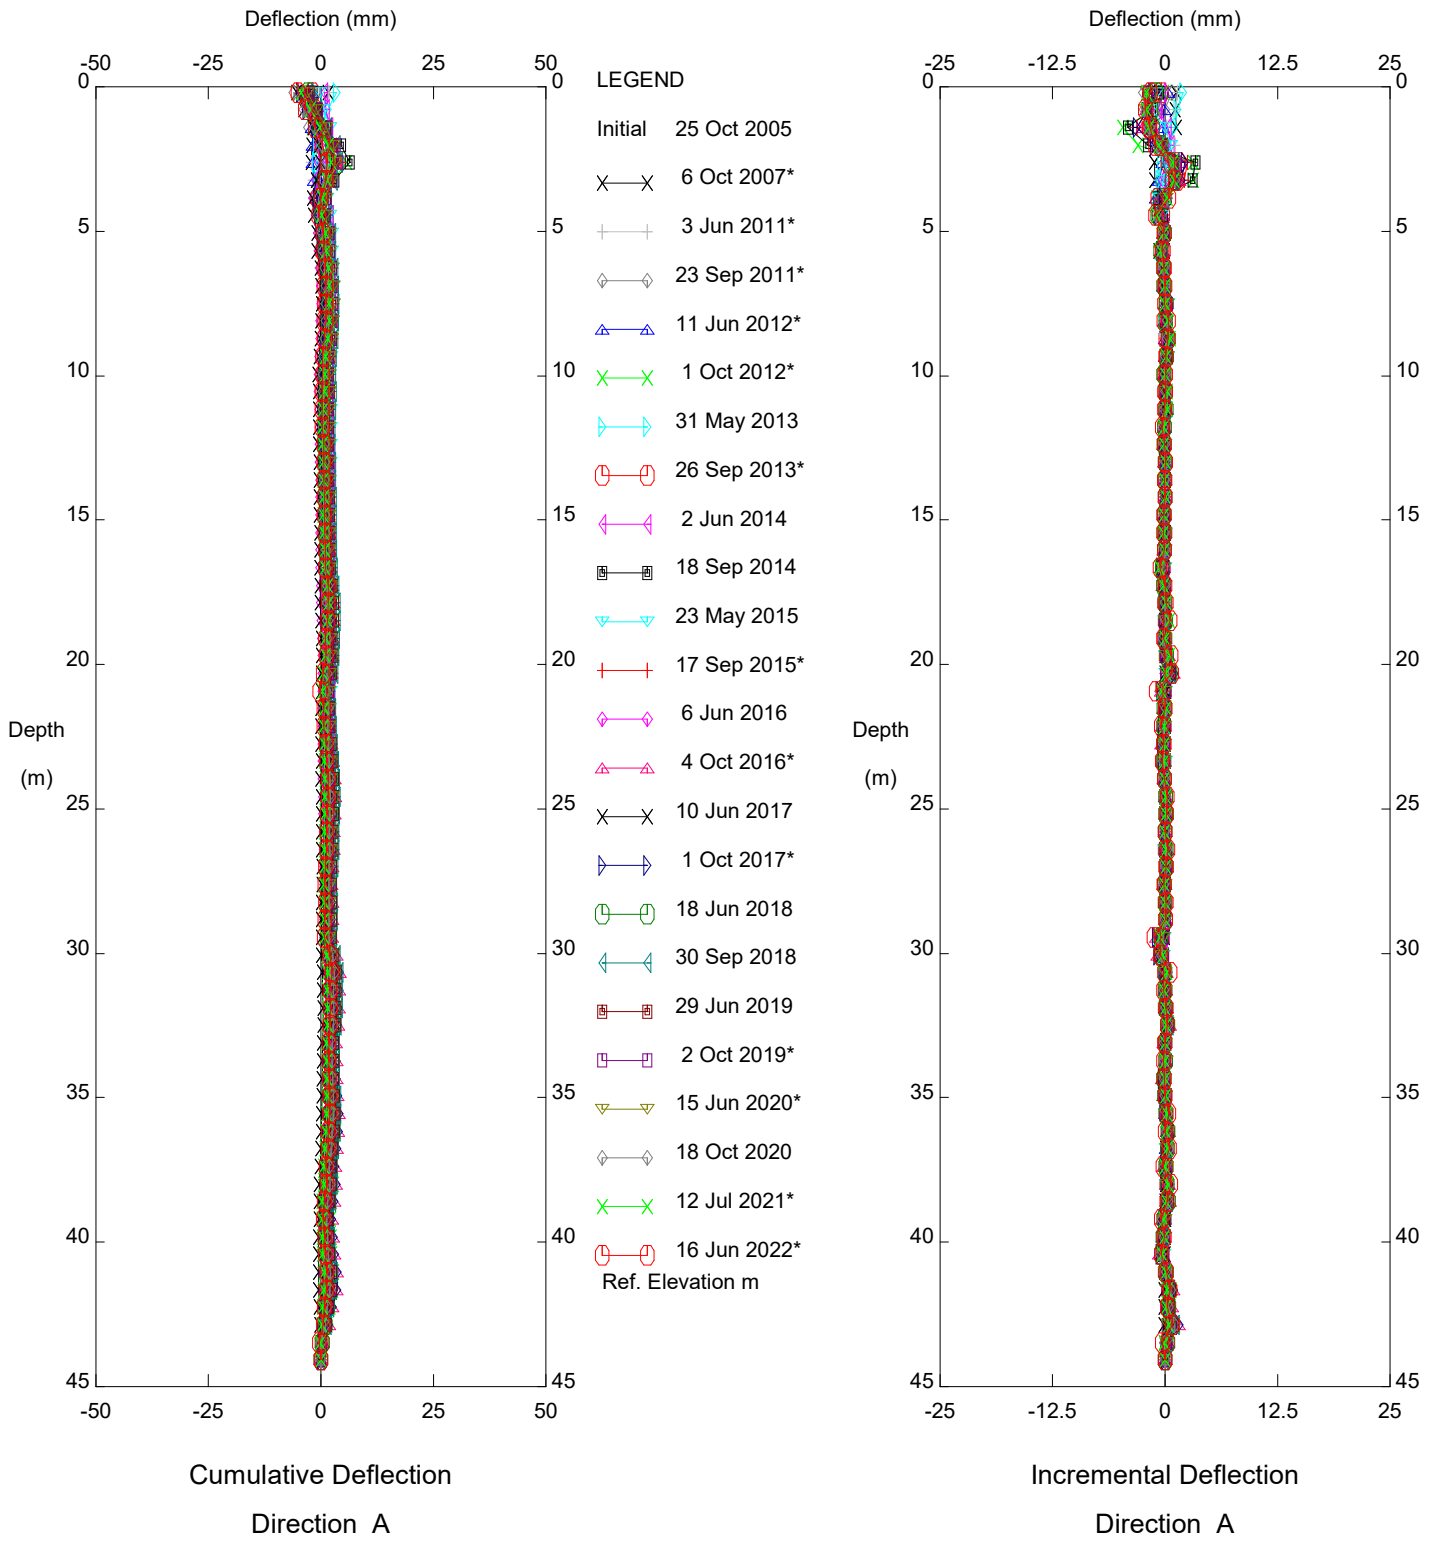
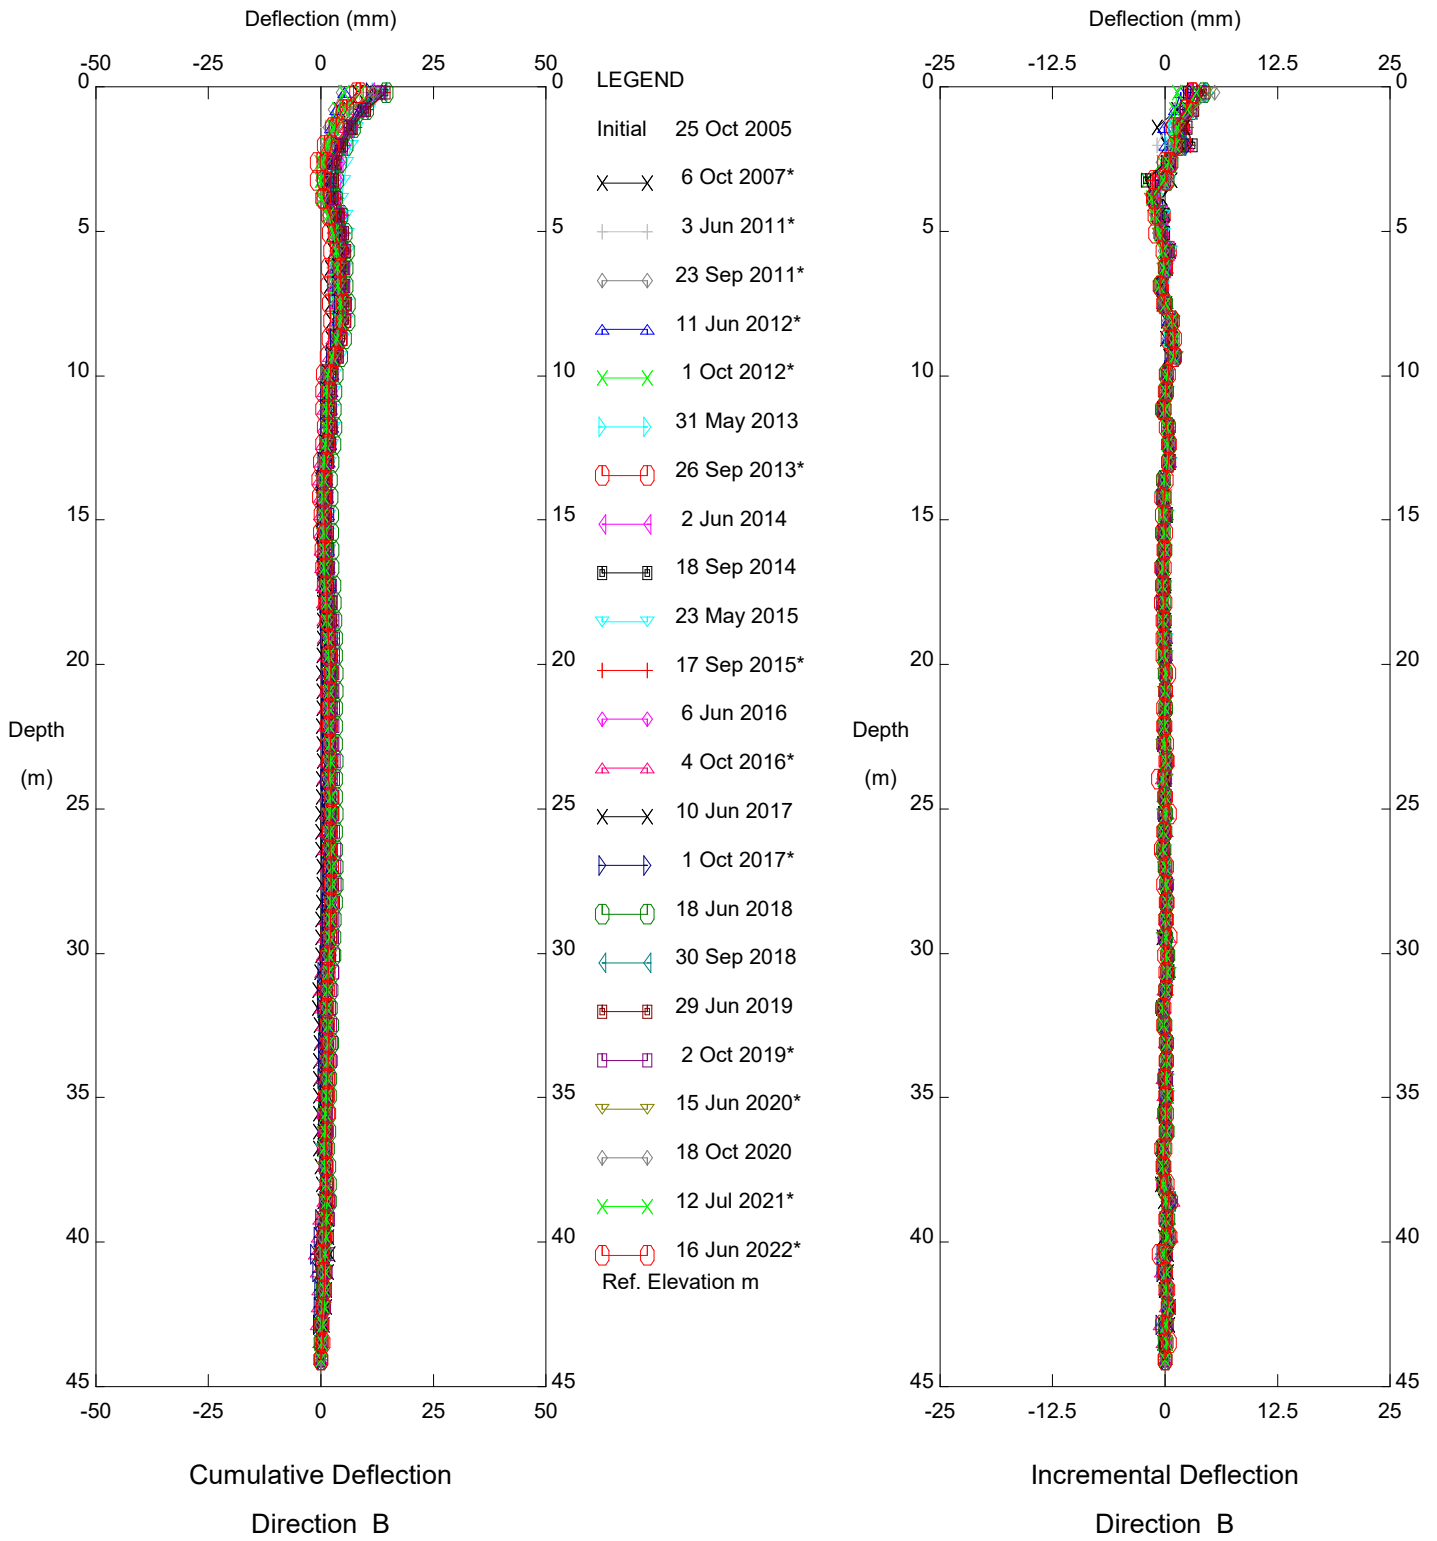
Fort Vermillion Bridge (PH048), Inclinator SI-3

Slope inclinometer SI-3 continued to show no discernible movement.

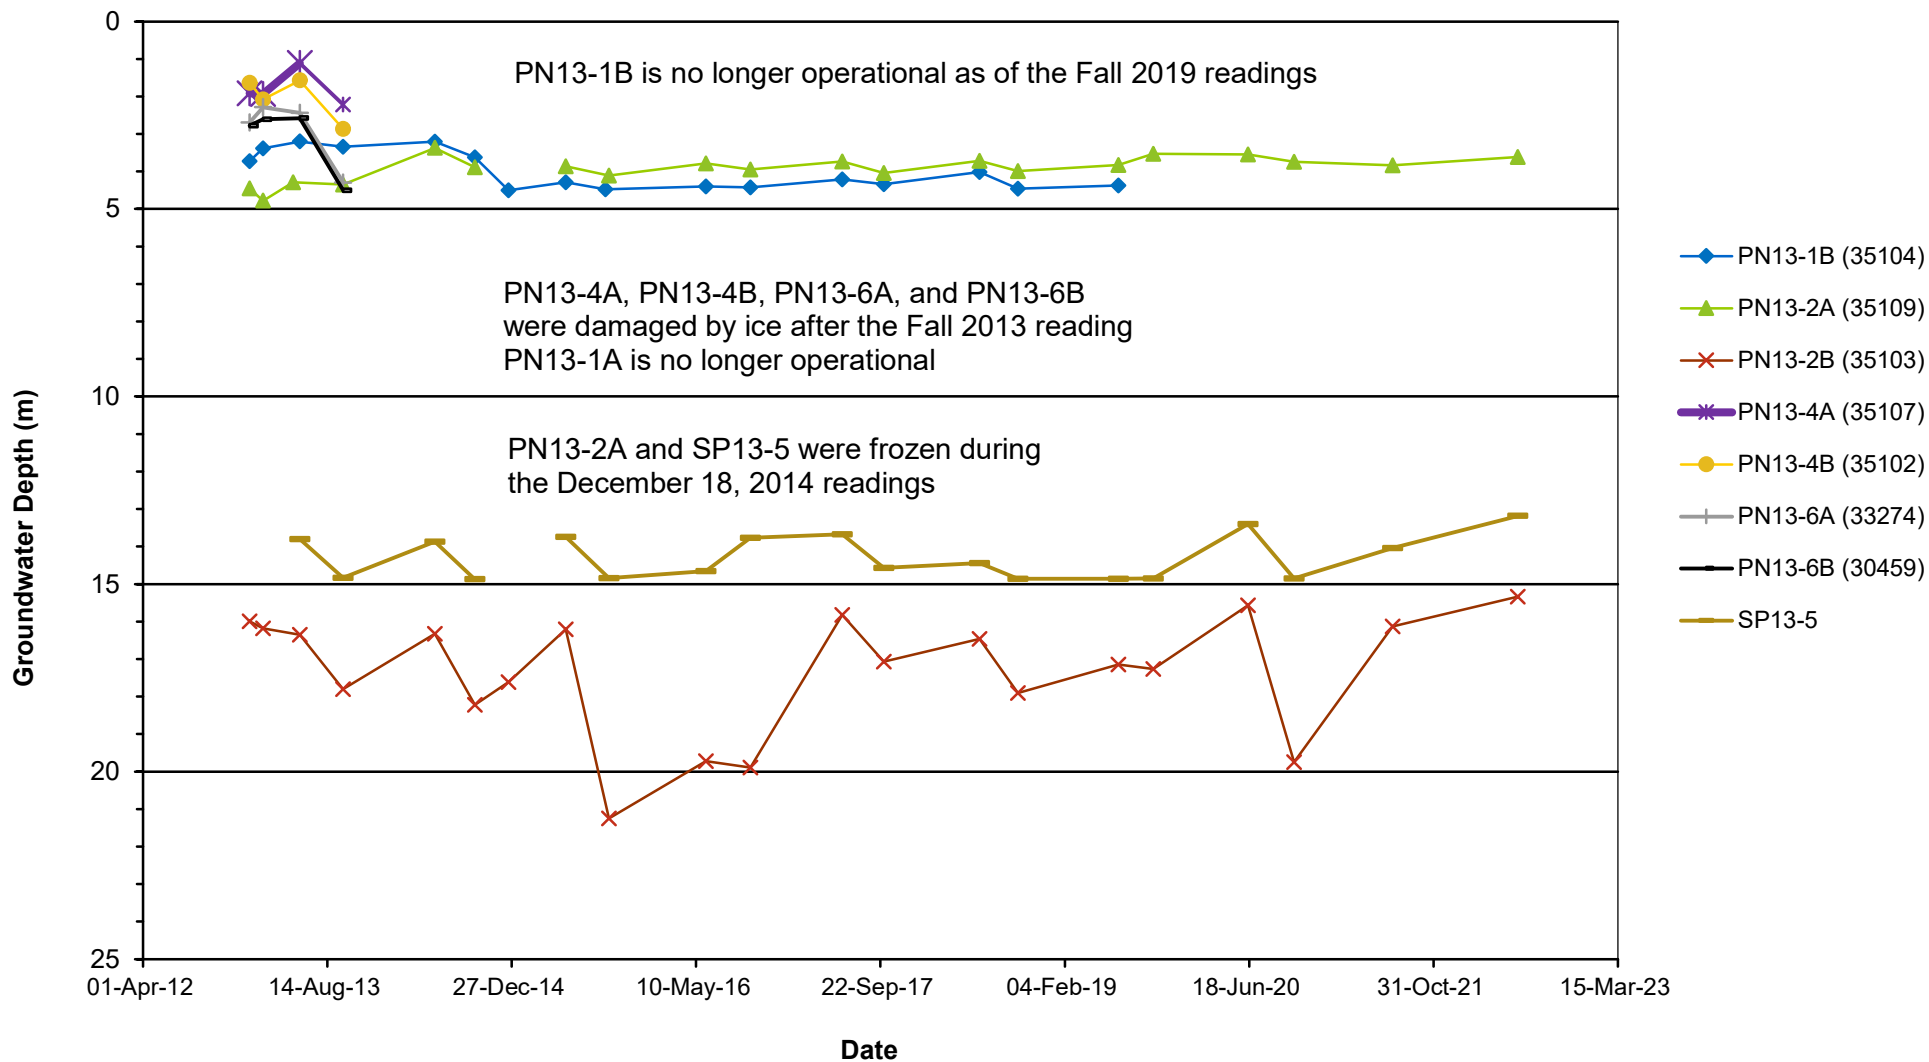
**FIGURE PH048-1
PIEZOMETER DATA FOR HWY 88:18: FORT VERMILION BRIDGE**

Pneumatic piezometers PN13-2A and PN13-2B showed increases in groundwater level of 0.22 m and 0.80 m, respectively, since the spring of 2021 readings. PN13-2B had the highest recorded water level since the instrument was initialized. PN13-2B showed a relatively large increase in water level since the spring reading. Pneumatic piezometer readings are summarized in Table PH048-2 above and are plotted on Figure PH048-1 in Appendix A.

Standpipe piezometer SP13-5 showed an increase in groundwater level of 0.86 m since the spring of 2021 readings and showed the highest recorded water level since the instrument was initialized. Standpipe piezometer readings are summarized in Table PH048-3 above and are plotted in Figure PH048-1 in Appendix A.
