**ALBERTA TRANSPORTATION  
GEOHAZARD ASSESSMENT PROGRAM  
PEACE REGION – SWAN HILLS DISTRICT  
2019 CALL OUT INSPECTION**

<b>Site Number</b>	<b>Location</b>	<b>Name</b>	<b>Hwy</b>	<b>km</b>
SH32	0.9 km W. Hwy 750	South Embankment Slide	679:06	26.2
<b>Legal Description</b>		<b>UTM Co-ordinates (NAD 83)</b>		
SE28-76-14-W5		11U N 6,163,235	E 556,162

<b>Date</b>	<b>PF</b>	<b>CF</b>	<b>Total</b>
<b>Previous Inspection:</b>				
<b>Current Inspection:</b>	June 25, 2019	11	3	33 (Landslide basis)
<b>Road AADT:</b>	280	<b>Year:</b>	2018	
<b>Inspected By:</b>	Barry Meays (Thurber) Ed Szmata (AT)			
<b>Report Attachments:</b>	<input checked="" type="checkbox"/> Photographs <input checked="" type="checkbox"/> Plans <input checked="" type="checkbox"/> Maintenance Items

**EMBANKMENT SLIDE HWY 679:06, KM 26.2  
JUNE 25, 2019 CALLOUT PLAN AND SECTION**

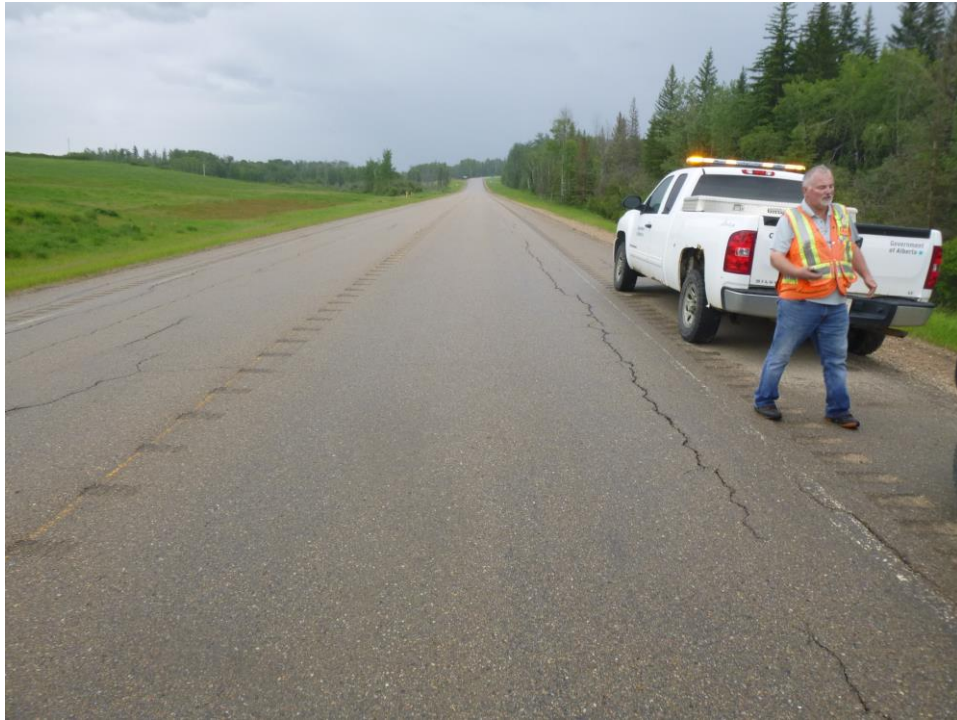
Photo 1 – Looking east along Hwy 679 above the slide site towards Hwy 750 in the background.

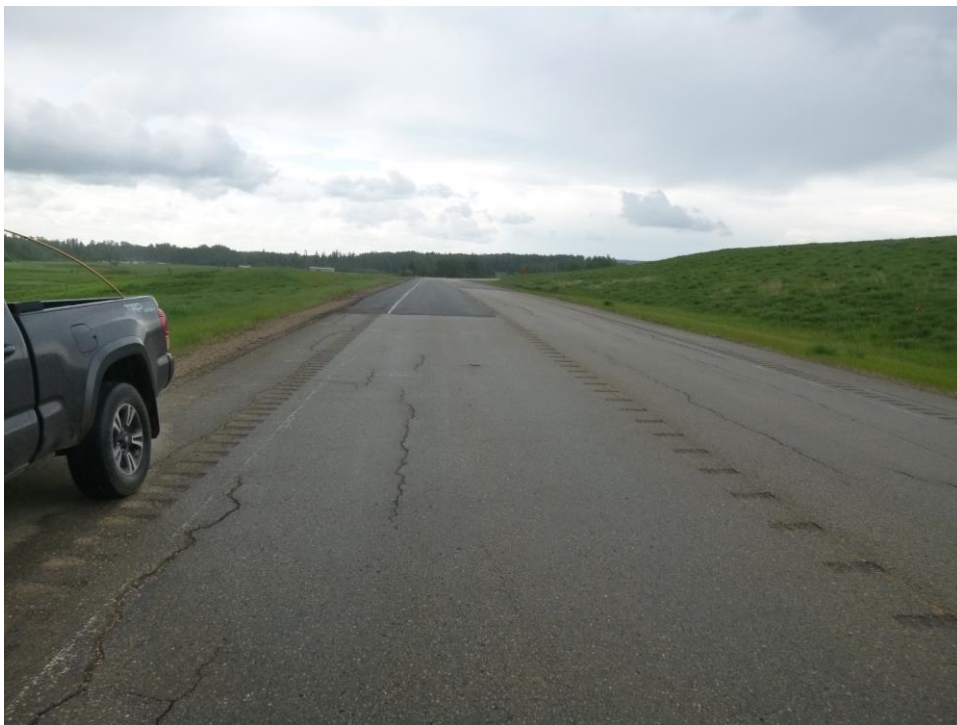
Photo 2 – Looking west along Hwy 679 above the slide site.

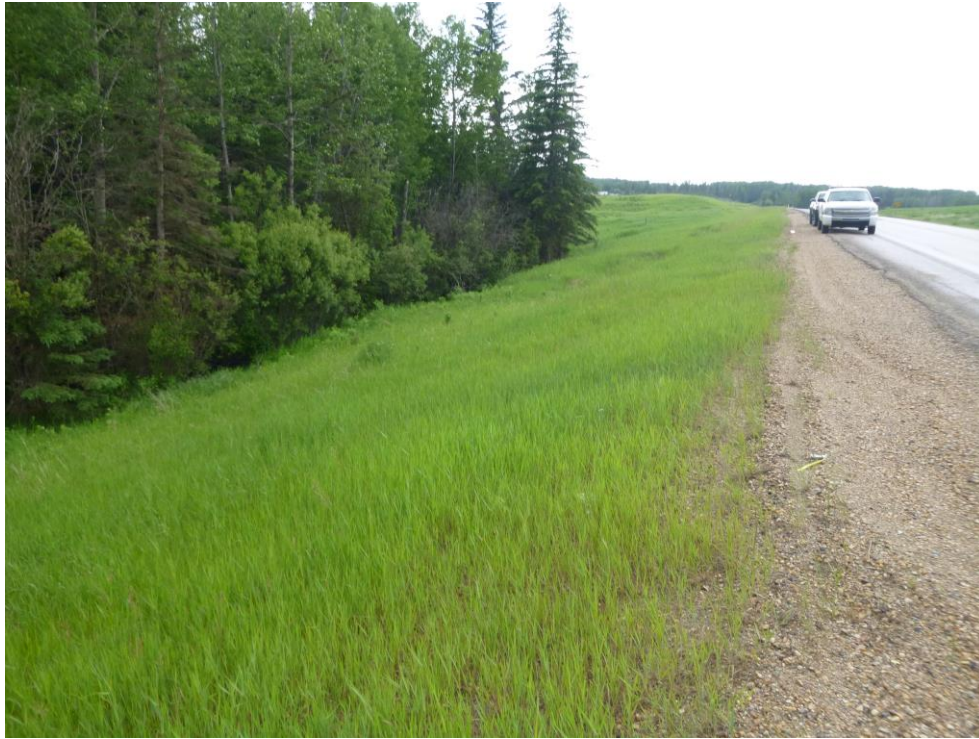
Photo 3 – Looking west across the south hwy embankment (the slide is below the trucks).

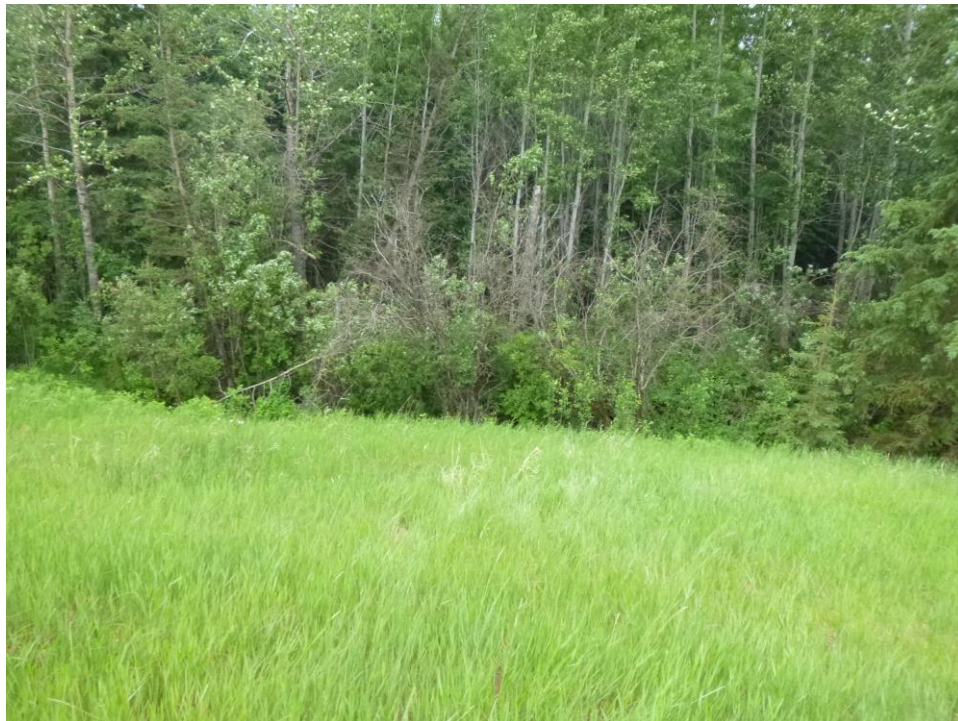
Photo 4 – Looking south down along the slide from the edge of the highway.

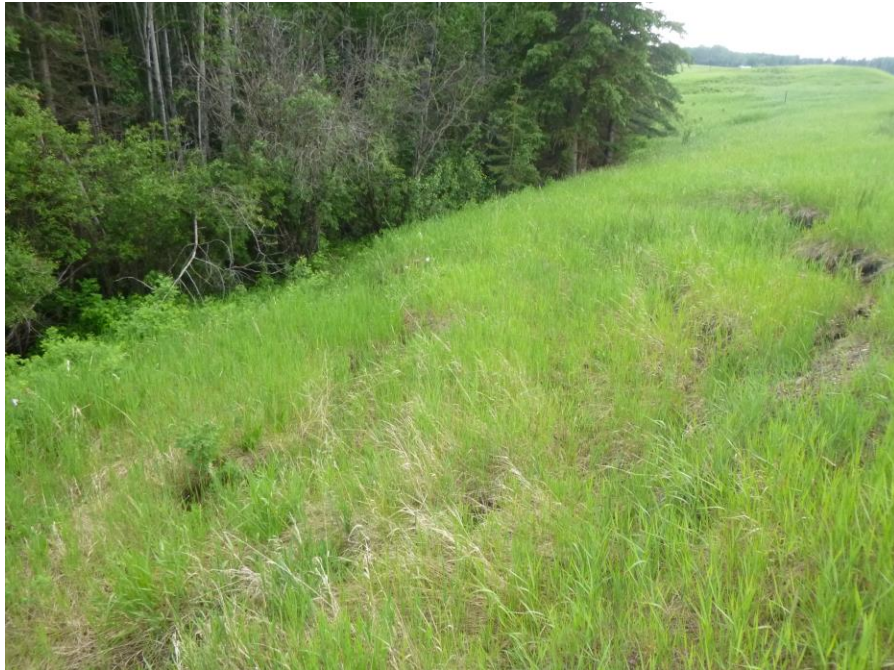
There is not an immediate threat to the highway, as the scarp of the landslide was about 5.9 m from the edge of the pavement (3.6 m from the edge of the gravelled shoulder). However, the landslide will continue to grow in size if not dealt with, eventually retrogressing into the eastbound shoulder and possibly the driving lane.

Photo 5 – A close-up view of the slide scarp (looking west) in the south hwy embankment.

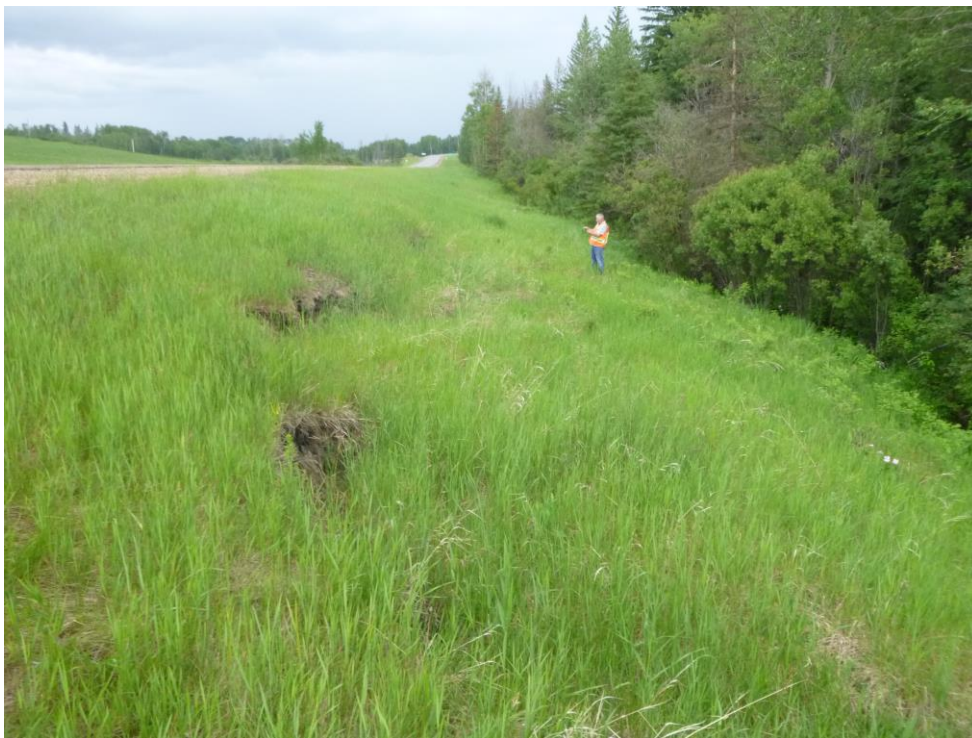
Photo 6 – Looking east across the slide site.

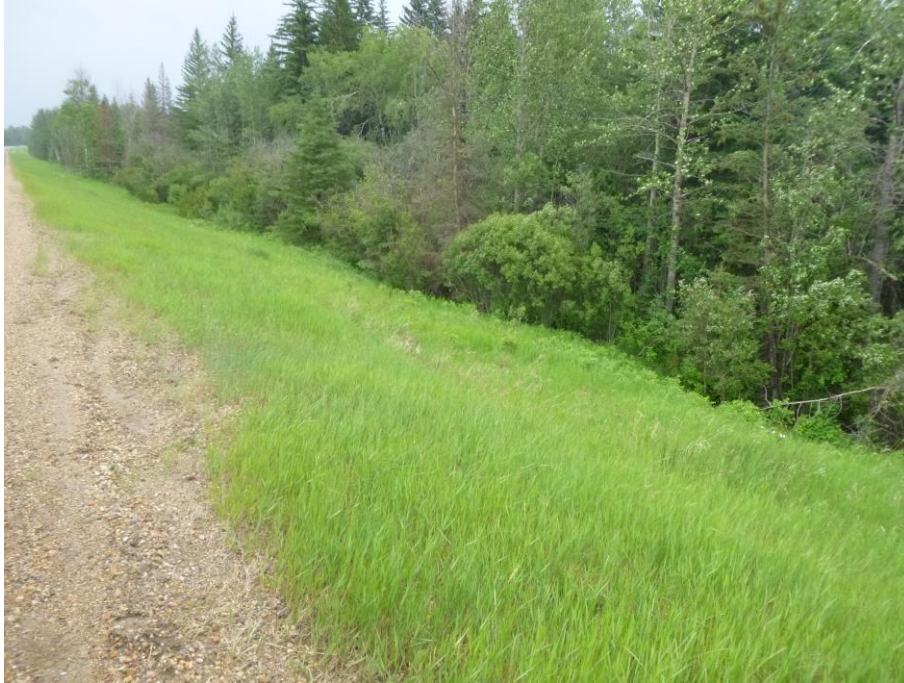
Photo 7 – Looking southeast across the slide. Note the very dense forest extending over the stream and right up to the toe of the south hwy embankment.

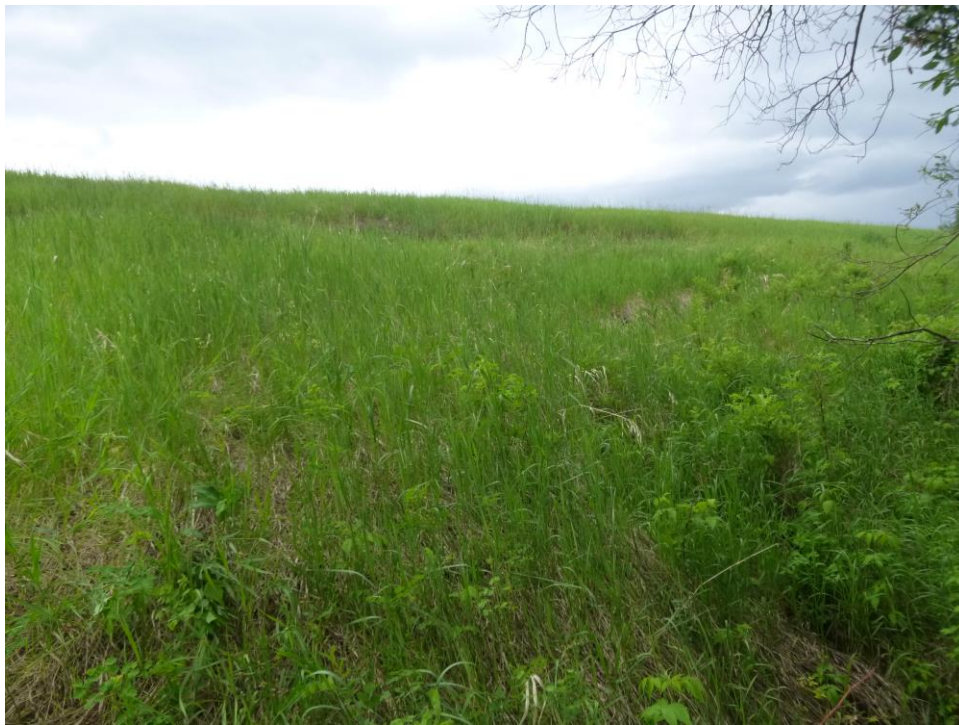
Photo 8 – Looking north up at the slide from the toe of the hwy embankment.

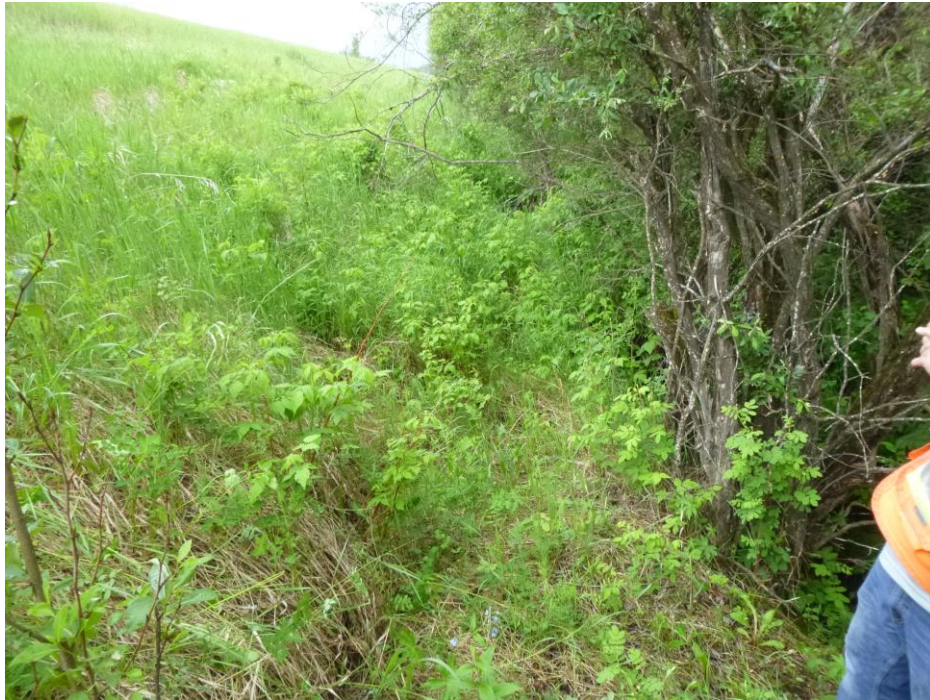
It appears that the landslide may have occurred due to stream channel erosion along the toe of the embankment slope, as some subsidence was observed adjacent to the north bank of the stream channel outside the toe near the west end of the landslide. The slide may have been present in a smaller form in the past, and only recently retrogressed further up the embankment slope.

Photo 9 – Looking east along the toe of the hwy embankment and edge of the stream at subsidence at the west edge of the slide.

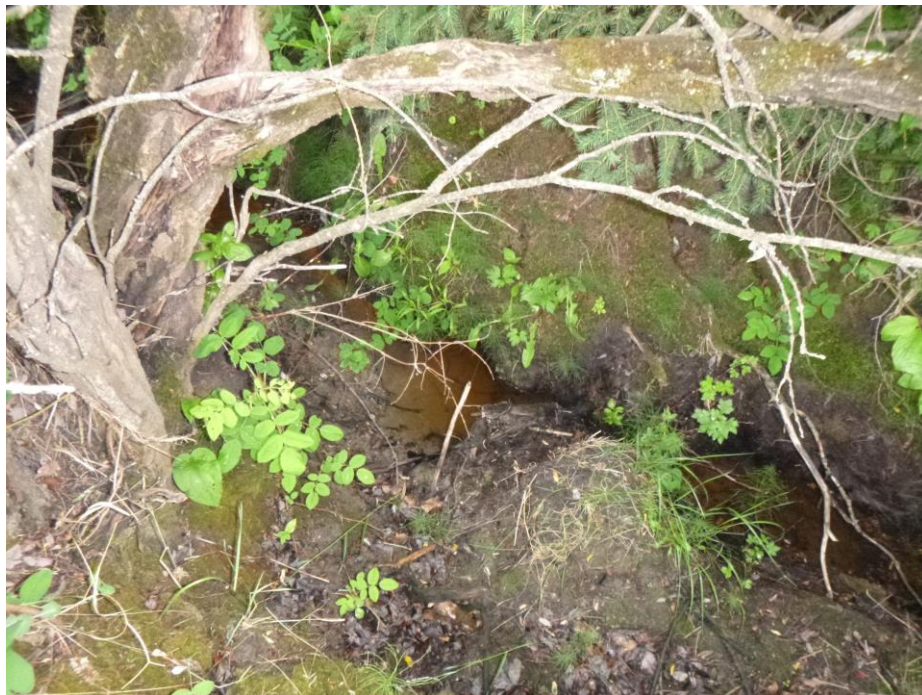
Photo 10 – Looking south at the stream below the west end of the slide. The streambed is in the order of 0.5 m wide here.

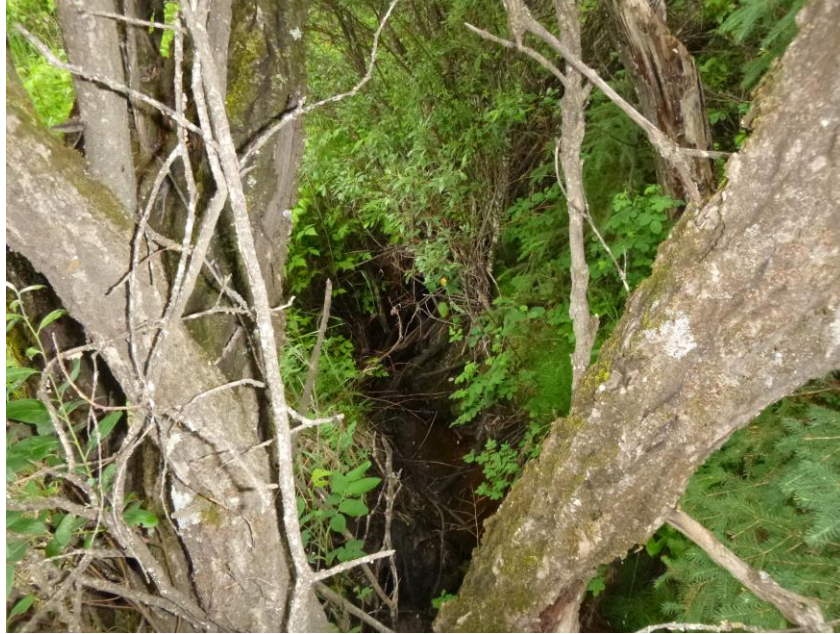
Photo 11 – Looking east along the stream from the west end of the slide.

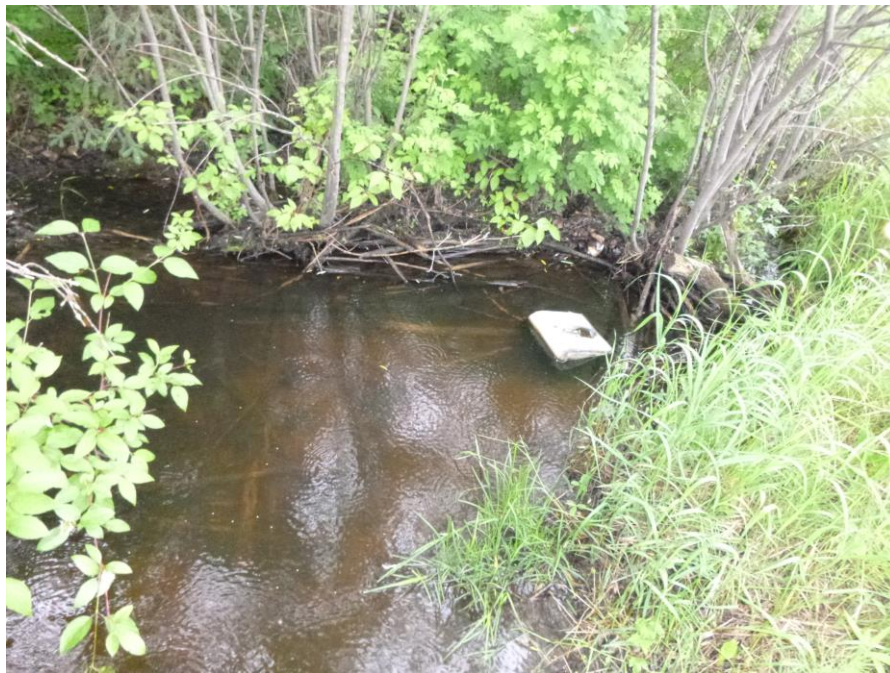
Photo 12 – Looking south across the stream near the east end of the slide site. Note the stream is about 8 m wide here.
