ALBERTA TRANSPORTATION AND  
ECONOMIC CORRIDORS GRMP  
PEACE REGION – (PEACE RIVER DISTRICT)  
INSTRUMENTATION MONITORING - SPRING 2025

| Site Number | Location | Name | Hwy | km |
|---|---|---|---|---|
| SH036 | HWY 679:06 | Prairie Echo | 679:06 | 8.2 |

| <b>Current Monitoring:</b> | 5-June-2025 | <b>Previous Monitoring</b> | 18-Sep-2024 |

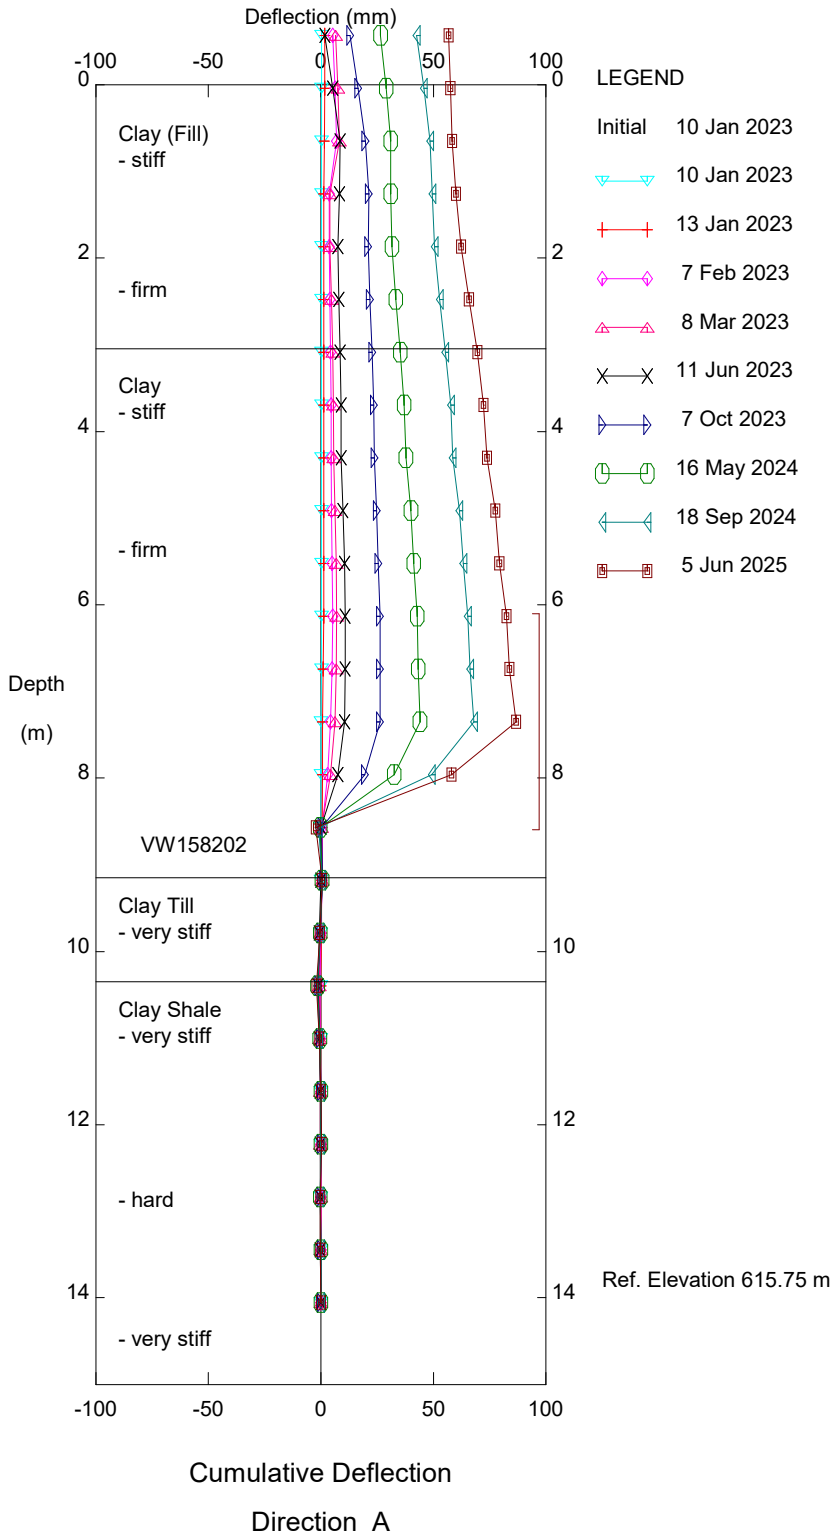
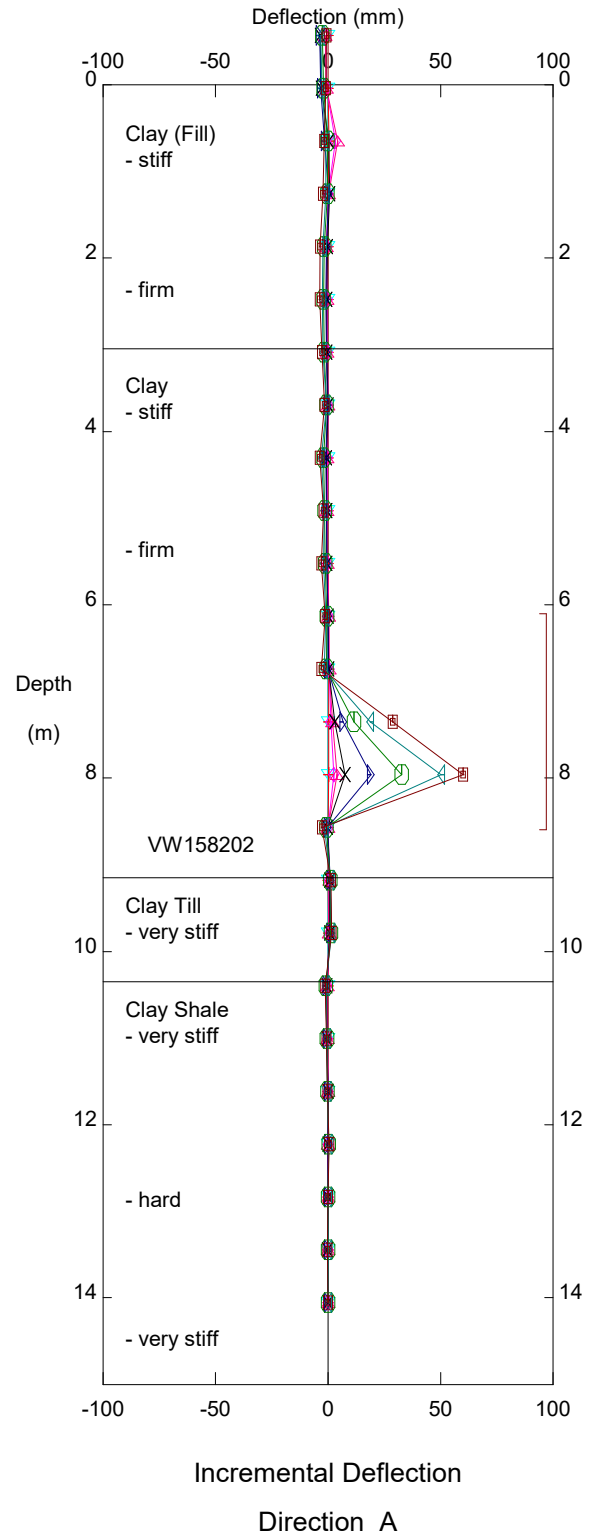
Hwy 679:06 km 8.18 Prairie Echo, Inclinator SI23-1

| Discussion | |
|---|---|
| <b>Interpretation of Monitoring Results:</b> | <p>SI23-1 showed a cumulative movement of 86.4 mm over a well defined movement zone between 6.1 m to 8.6 m depth with a rate of movement of 26.4 mm/yr since the previous readings on September 18, 2024. The movement rate has been elevated over the last four readings compared to the previous trend.</p> <p>Vibrating wire piezometer VW23-1 is located near the shear zone in SI23-1. It continues to show artesian groundwater conditions of about 3.3 m above ground surface. VW23-2 also shows artesian groundwater conditions of about 2.3 m above ground surface. VW23-1 and VW23-2 showed decreases in groundwater levels of 0.06 m and 0.02 m, respectively, compared to the September 18, 2024, readings. VW23-3 also showed artesian conditions about 2.5 m above ground surface prior to being damaged.</p> |

| <b>INSTRUMENT<br/>#</b> | <b>DATE<br/>INITIALIZED</b> | <b>TOTAL<br/>CUMULATIVE<br/>RESULTANT<br/>MOVEMENT AT<br/>NOTED DEPTH<br/>SINCE INITIAL<br/>READING<br/>(mm)</b> | <b>MAXIMUM<br/>RATE OF<br/>MOVEMENT<br/>(mm/yr)</b> | <b>CURRENT<br/>STATUS</b> | <b>DATE<br/>OF<br/>PREVIOUS<br/>READING</b> | <b>INCREMENTAL<br/>MOVEMENT<br/>SINCE<br/>PREVIOUS<br/>READING<br/>(mm)</b> | <b>RATE OF<br/>MOVEMENT<br/>(mm/yr)</b> | <b>CHANGE IN<br/>RATE OF<br/>MOVEMENT<br/>SINCE<br/>PREVIOUS<br/>READING<br/>(mm/yr)</b> |
|---|---|---|---|---|---|---|---|---|
| SI23-1 | January 10,<br>2023 | 86.4 mm over 6.1 m<br>to 8.6 m depth<br>in 172° direction | 101.7 mm/yr in<br>January 2023 | Operational | September<br>18, 2024 | 18.8 | 26.4 | -43.6 |

| Discussion | |
|---|---|
| <b>Future Work:</b> | The instruments should be read again in the fall of 2025. The movement rate in SI23-1 should be monitored to confirm if it is still elevated. Long term monitoring post-construction is recommended. |

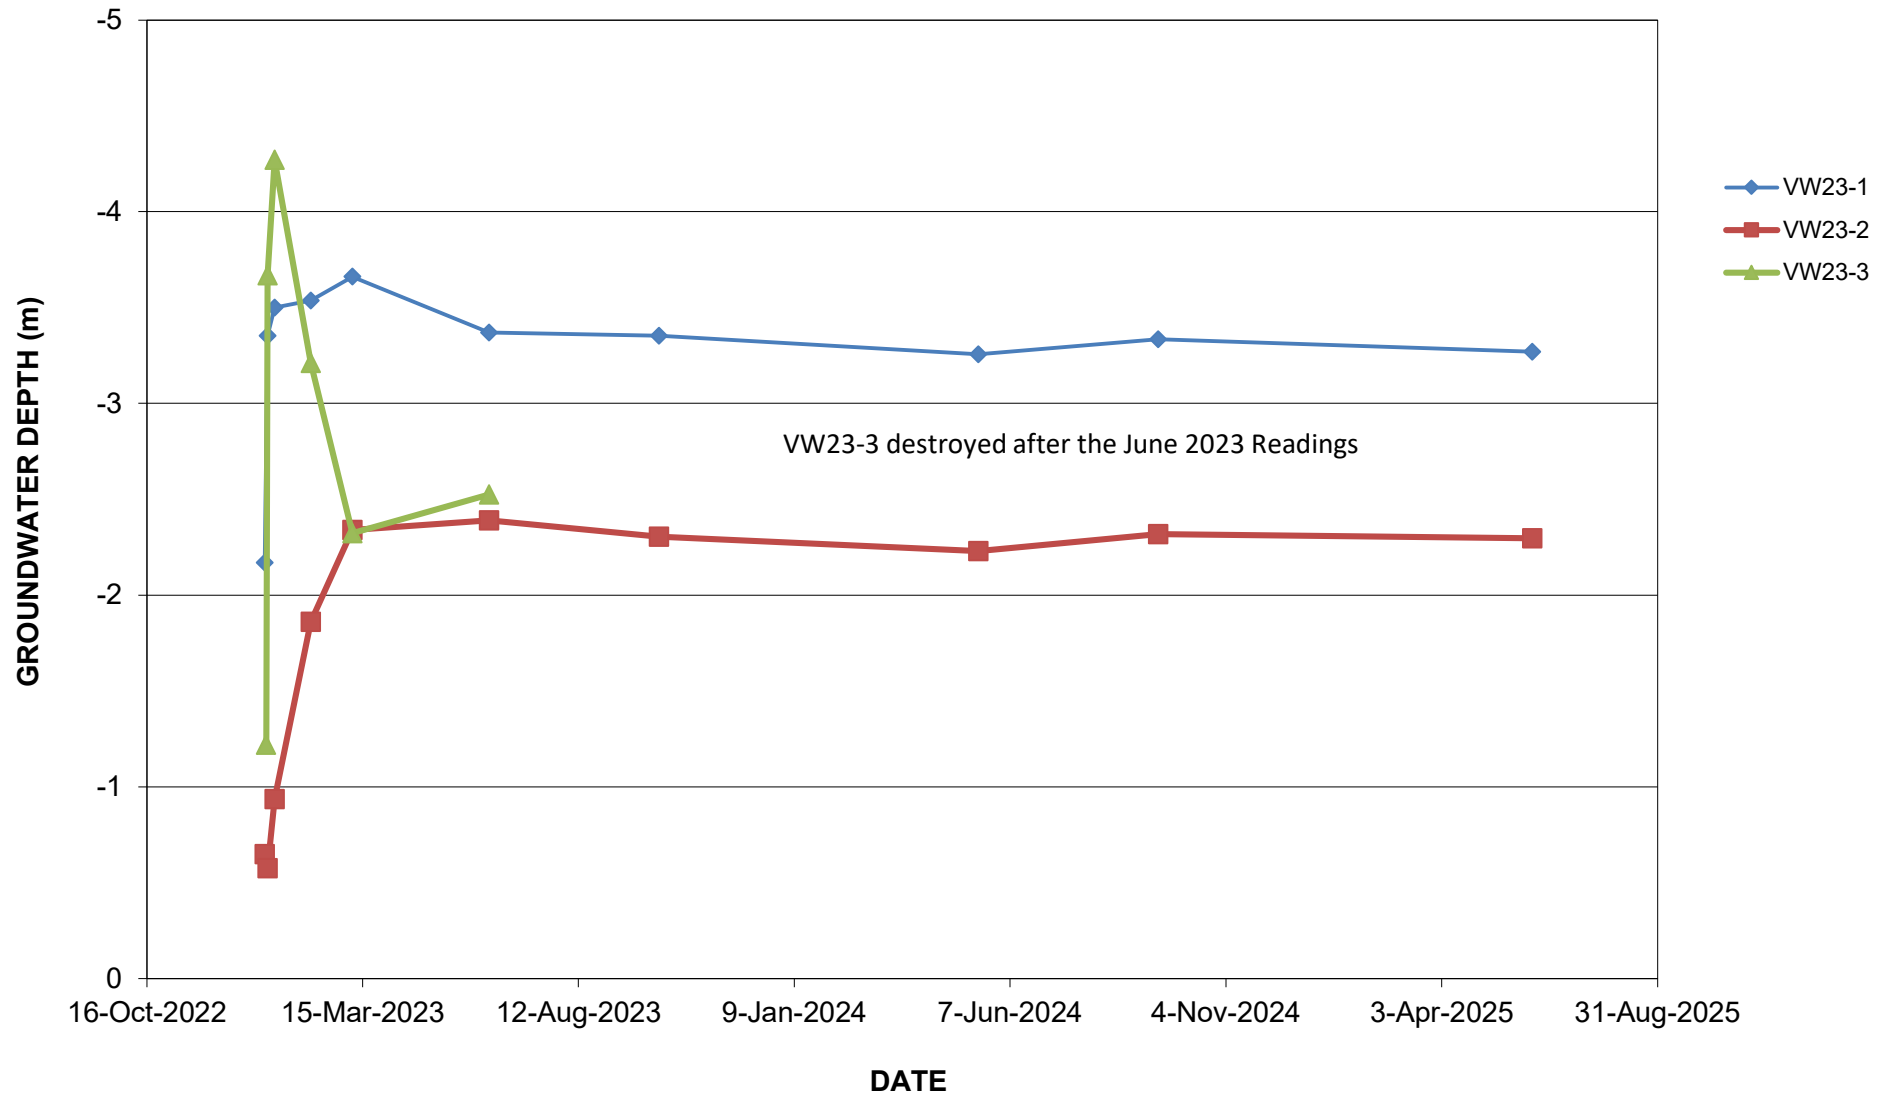
**FIGURE SH036-1**  
**PIEZOMETRIC DEPTHS FOR HWY 679:06 PRAIRIE ECHO**

| INSTRUMENT<br># | DATE<br>INITIALIZED | TIP<br>ELEV.<br>(m) | GROUND<br>ELEV.<br>(m) | CURRENT<br>STATUS | HIGHEST<br>MEASURED<br>WATER<br>ELEVATION<br>(m) | CURRENT<br>WATER<br>ELEVATION<br>(m) | PREVIOUS<br>WATER<br>ELEVATION<br>(SEPTEMBER<br>18, 2024)<br>(m) | CHANGE IN<br>WATER LEVEL<br>SINCE<br>PREVIOUS<br>READING<br>(m) |
|---|---|---|---|---|---|---|---|---|
| VW23-1<br>(158202) | January 6,<br>2023 | 606.75 | 615.75 | Operational | 619.41 on<br>March 8, 2023 | 619.02 | 619.08 | -0.06 |
| VW23-2<br>(158210) | January 6,<br>2023 | 607.44 | 613.54 | Operational | 615.93 on June<br>11, 2023 | 615.83 | 615.85 | -0.02 |
| VW23-3<br>(157856) | January 7,<br>2023 | 610.68 | 619.98 | Destroyed | 624.24 on<br>January 13,<br>2023 | N/A | 622.51 | N/A |
