**ALBERTA TRANSPORTATION
GEOHAZARD ASSESSMENT PROGRAM
PEACE REGION – PEACE-HIGH LEVEL
2017 CALL OUT**

Site Number	Location	Name	Hwy	km
	Shafstbury Trail	Shafstbury Trail North Slides	684:02	28.4
Legal Description		UTM Co-ordinates		
NW¼ 19-083-021 W5M		11U E 481381	N 6230300

Date	PF	CF	Total
Previous Inspection:				
Current Inspection:	6-June-2017	11	4	44
Road AADT:	1670		Year:	2016
Inspected By:	Rocky Wang, TRANS Ed Szmata, TRANS		Don Proudfoot, Thurber Shawn Russell, Thurber	
Report Attachments:	<input checked="" type="checkbox"/> Photographs <input checked="" type="checkbox"/> Plans <input checked="" type="checkbox"/> Maintenance Items

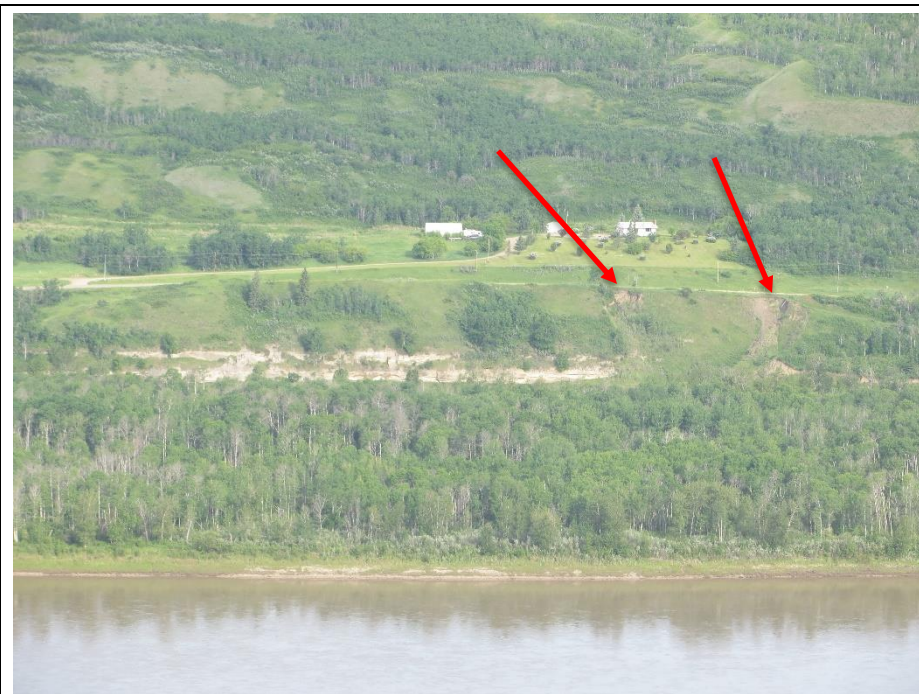
Photo 1.
Looking
West from the east
valley slope of the
Peace River towards
the two slides on Hwy
684:02.

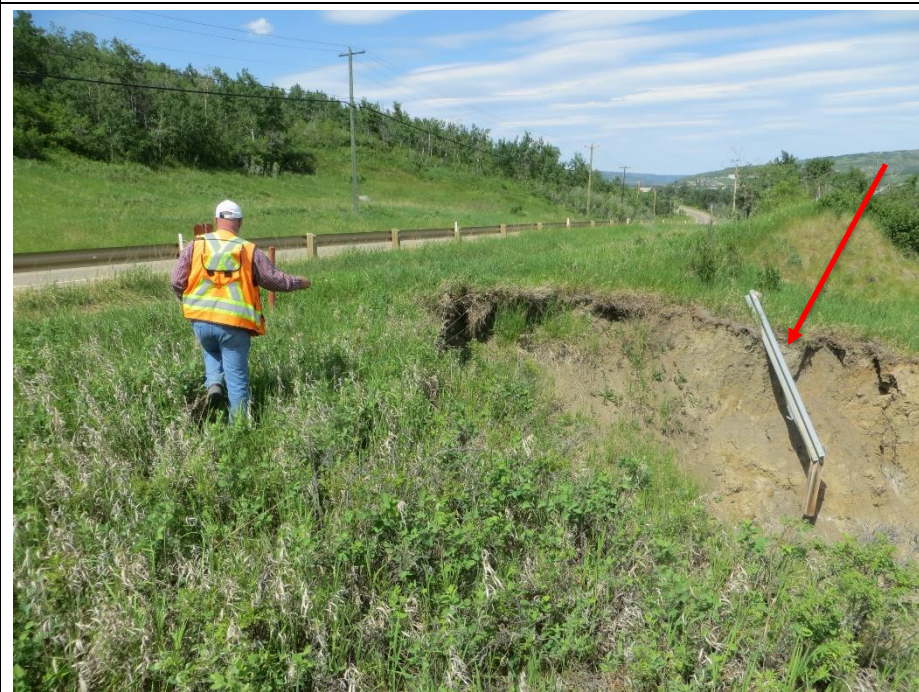
to east at the south end of Slide 1 and could possibly be affected by Slide 1 (Photos 2, 5 and 6). Thurber did not find any record of the Pipeline	
--	--	--

Photo 2.
Looking northeast
from the south side of
Slide 1. Note hanging
guardrail.

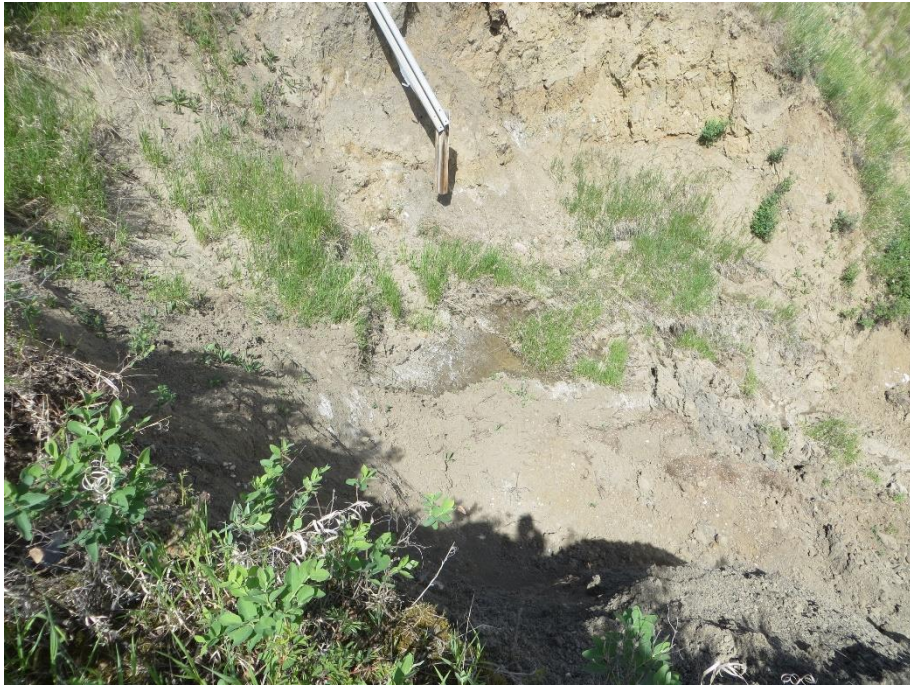
Photo 3.
Looking northeast from the south side of Slide 1 down into the slide bowl. Some slow seepage and recent mud flow can be observed in the base of the bowl.

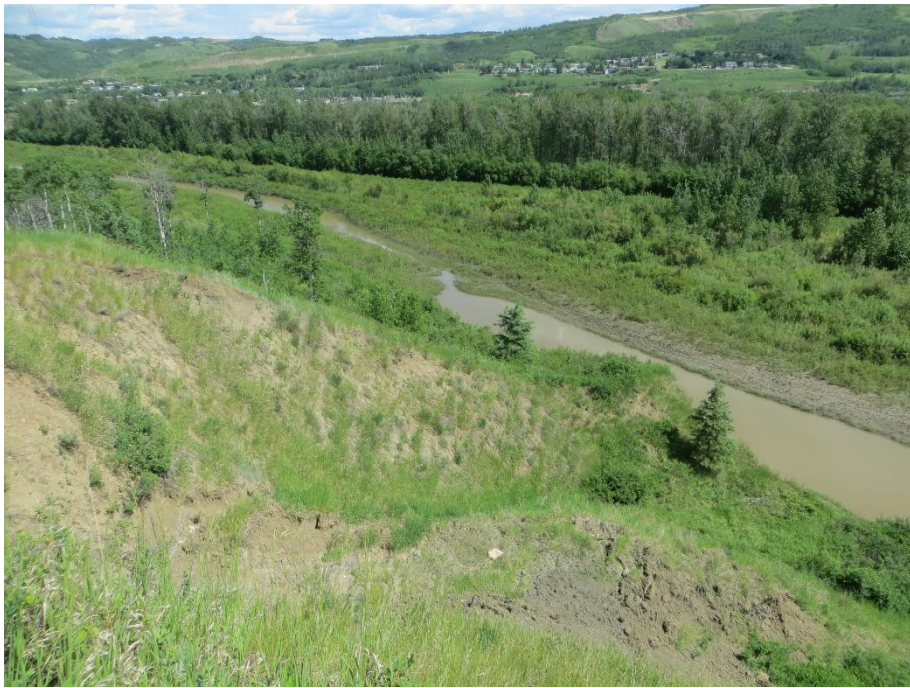
Photo 4.
Looking northeast from the south side of Slide 1. Some fresh slide debris and seepage can be seen below the till ledge is the base of the upper slide bowl.

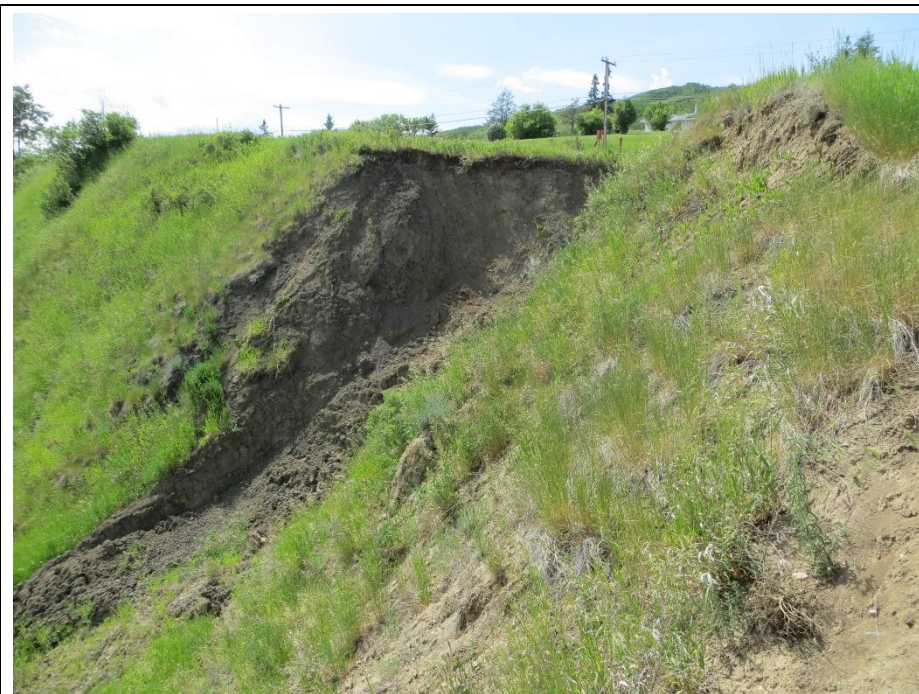
Photo 5.
Looking southwest from the north side of Slide 1. The upper layer above the till surface is actively retrogressing.

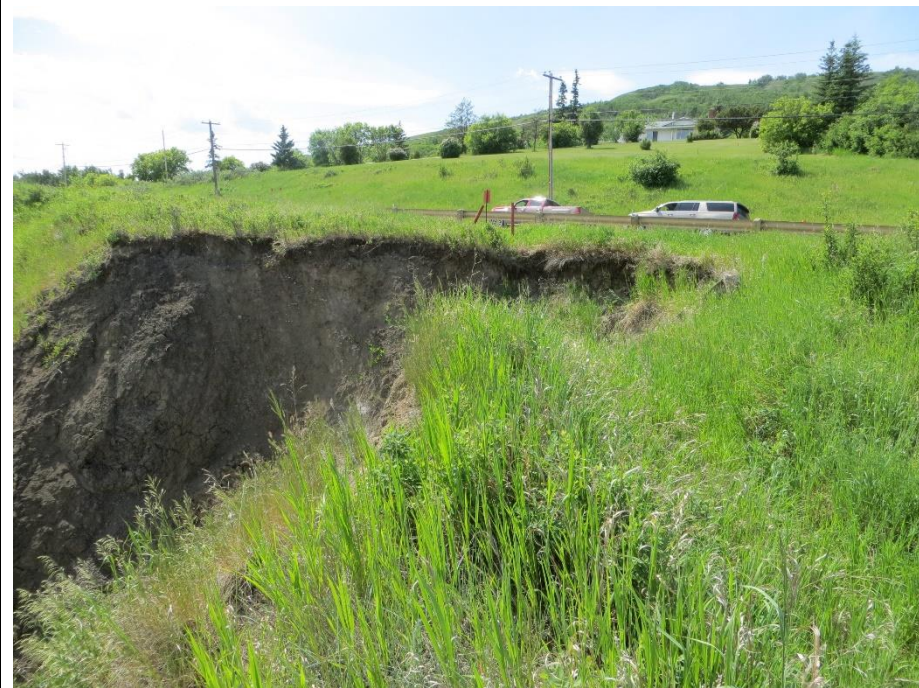
Photo 6.
Looking southwest from the north side of Slide 1. The upper layer above the till surface is actively retrogressing towards Hwy 684:02.

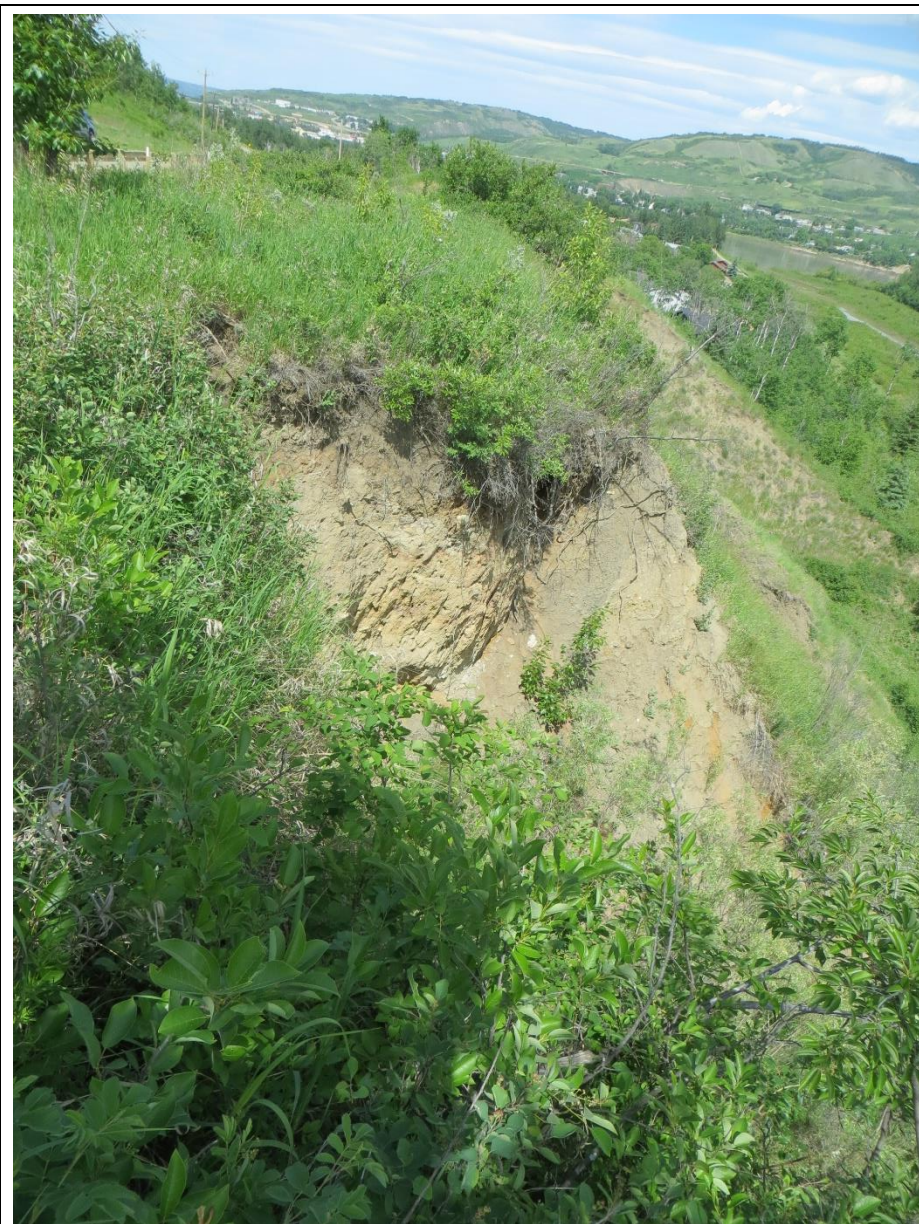
Photo 7.
Looking northeast
from the center of
Slide 2.

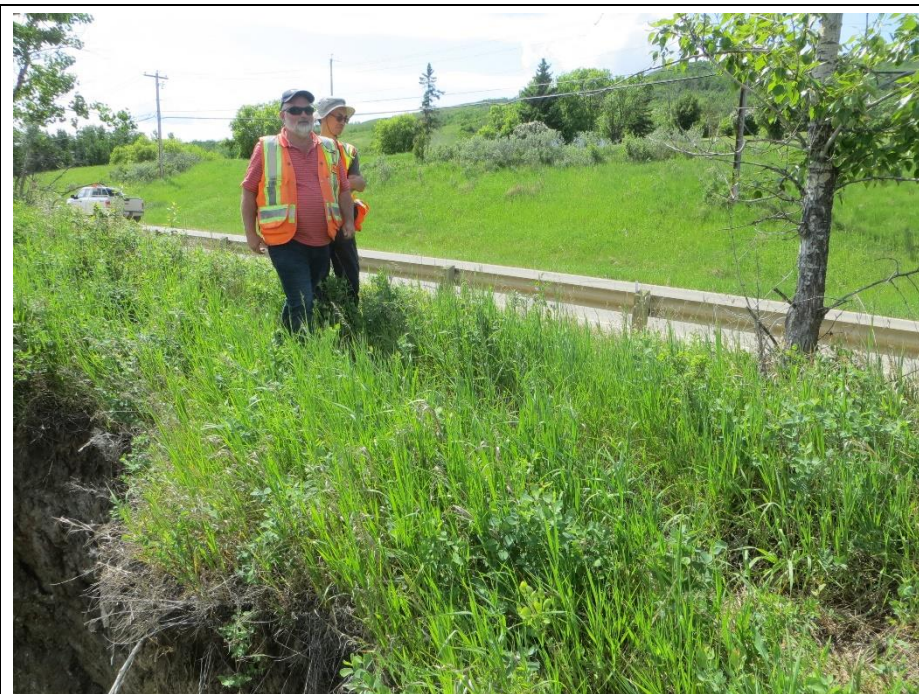
Photo 8.
Looking southwest from the north side of Slide 2. The backscarp is currently at 7.5 m from the guardrail along Hwy 684:02.

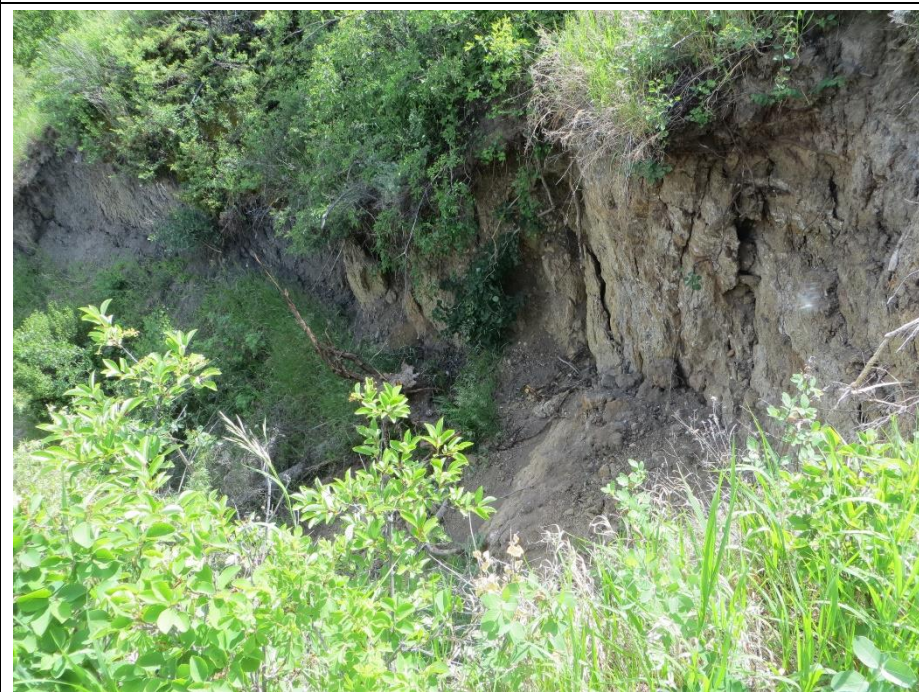
Photo 9.
Looking southeast from the center of Slide 2. The south flank of the backscarp has been recently active with fresh debris accumulating below.

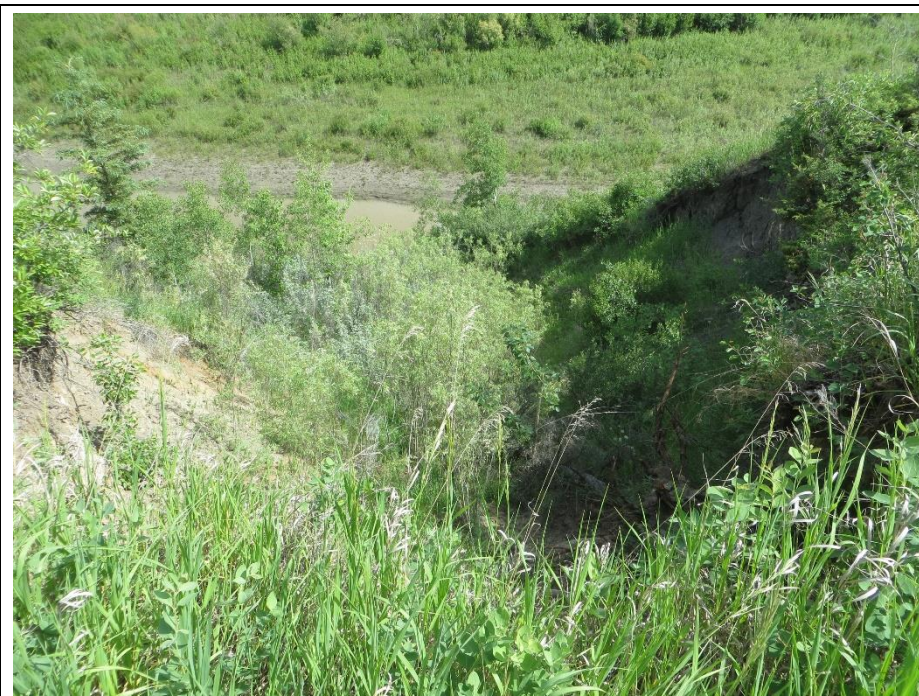
Photo 10.
Looking east along
the center of the
backscarp of Slide 2.
The backscarp is
about 14 m wide
along the crest of
valley the slope.
