**ALBERTA TRANSPORTATION
GEOHAZARD ASSESSMENT PROGRAM
PEACE REGION (PEACE RIVER DISTRICT)
2021 INSPECTION**

Site Number	Location	Name	Hwy	km
PH081	Shaftesbury Trail	Shaftesbury Trail North Slides	684:02	28.4
Legal Description		UTM Co-ordinates		
NW¼ 19-083-021 W5M		11U E 481381	N 6230300

**PH081-1: HWY 684:02, KM 28.4
SHAFTESBURY TRAIL NORTH SLIDES
2021 SITE INSPECTION PLAN**

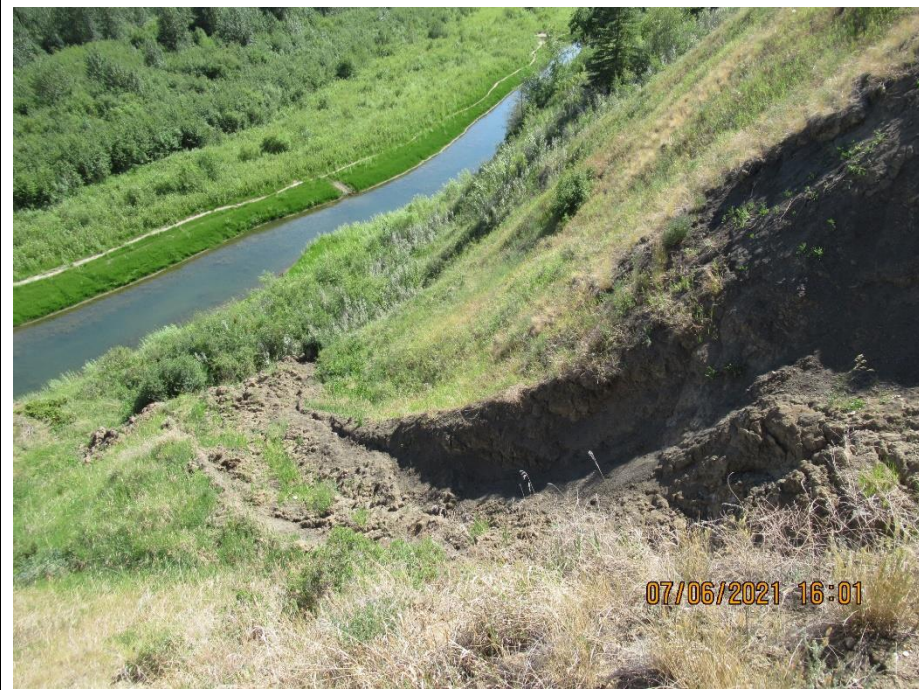
<input checked="" type="checkbox"/> Slope Movement	<p>Active slumping is occurring at the south landslides with bare backslopes (Photos 1 to 7). Slide 1 has shown some signs of ravelling and retrogression in the southern flank since 2019. The minimum offset from the headscarp to the guardrail was 3.8 m. The backscarp at Slide 2 did not appear to have significant change and there is 7.6 m offset to the guardrail which is unchanged from the 2019 inspection.</p> <p>There is a noticeable dip in the pavement and guardrail at the new slide at km 28.6. Unchanged since 2019.</p>	<input checked="" type="checkbox"/>						
<input type="checkbox"/> Erosion		<input type="checkbox"/>						
<input type="checkbox"/> Seepage		<input type="checkbox"/>						
<input type="checkbox"/> Bridge/Culvert Distress		<input type="checkbox"/>						
<input checked="" type="checkbox"/> Other	<p>There is a marked natural gas utility pipeline that appears to cross beneath the highway from west to east at the south end of Slide 1 and could possibly be affected by Slide 1. Thurber did not find any record of the pipeline</p>	<input type="checkbox"/>						
<p>Instrumentation: There are no instruments currently installed at the site.</p>								
<p>Assessment:</p> <p>Intermittent movement and retrogression is occurring at Slides 1 and 2 and the headscarps are expected to continue to move toward the highway. The newer slide at km 28.6 is causing distress in the pavement and guardrail and is located above a residential subdivision with a higher consequence of failure.</p> <p>It is possible that the landslides are caused by fluctuations in a perched groundwater table that is within the alluvial terrace soils that sit above of the harder sandy till layer, combined with softening and weathering of the very steep riverbank slope. The surface soils overlie hard bedrock at the new north landslide. If a failure occurred, the landslide could slide over the steep face of the bedrock into the back yards of the residences.</p> <p>Thurber has performed a geotechnical investigation and preliminary engineering assessment at the km 28.6 slide and the report is in progress.</p>

Photo 1.
Looking south at the downslope area below the north side of Slide 1 at the mudflow at the base of the slide.

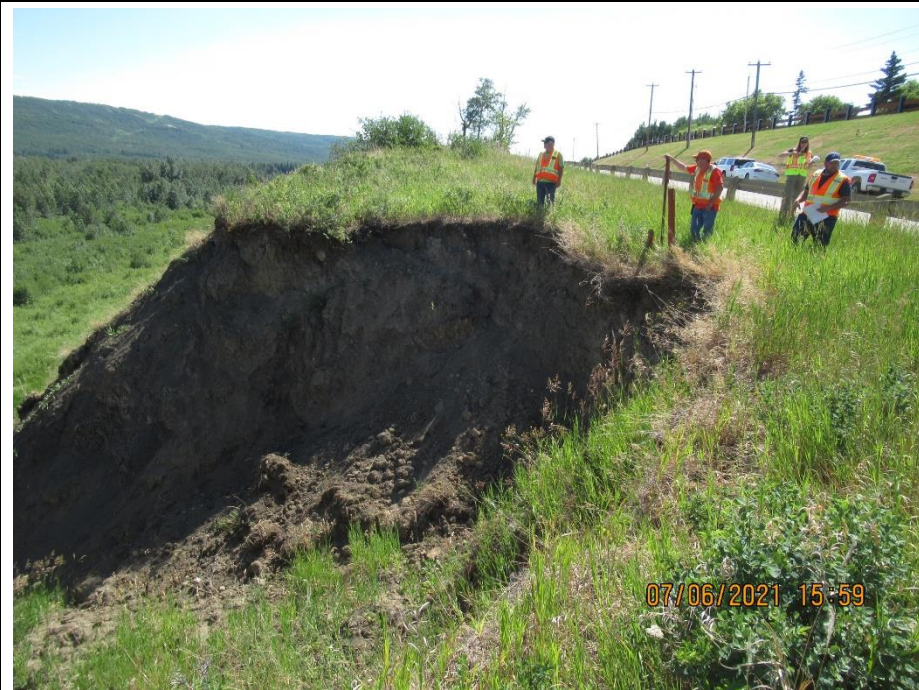
Photo 2.
Looking southwest from the north flank of Slide 1. Some retrogression of the south flank of the side has occurred since 2019. Offset to the guardrail was 3.8 m.

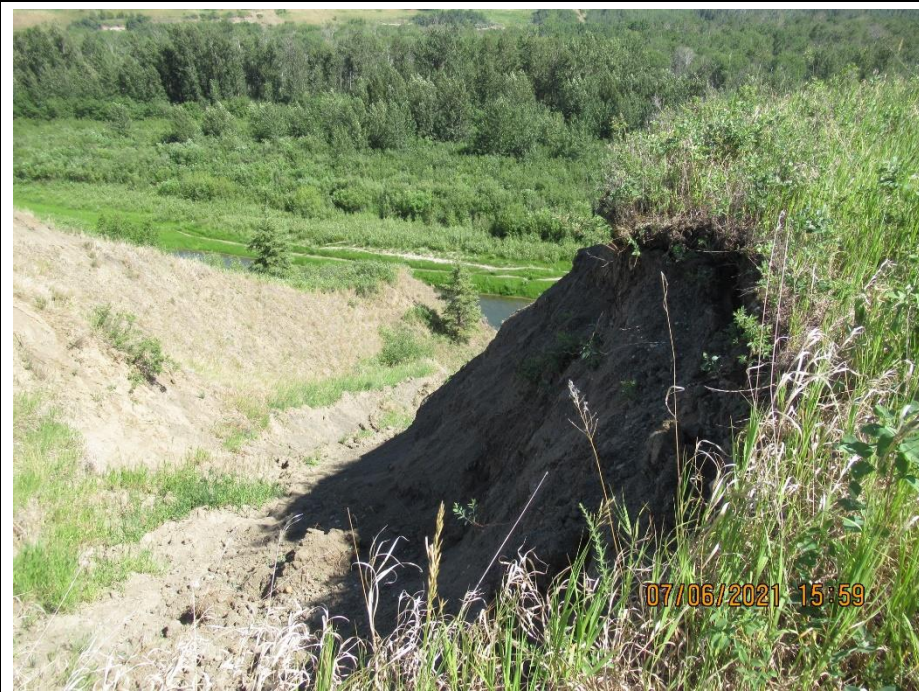
Photo 3.
Looking northeast from the south side of the backscarp of Slide 1. There has been some retrogression along the south flank.

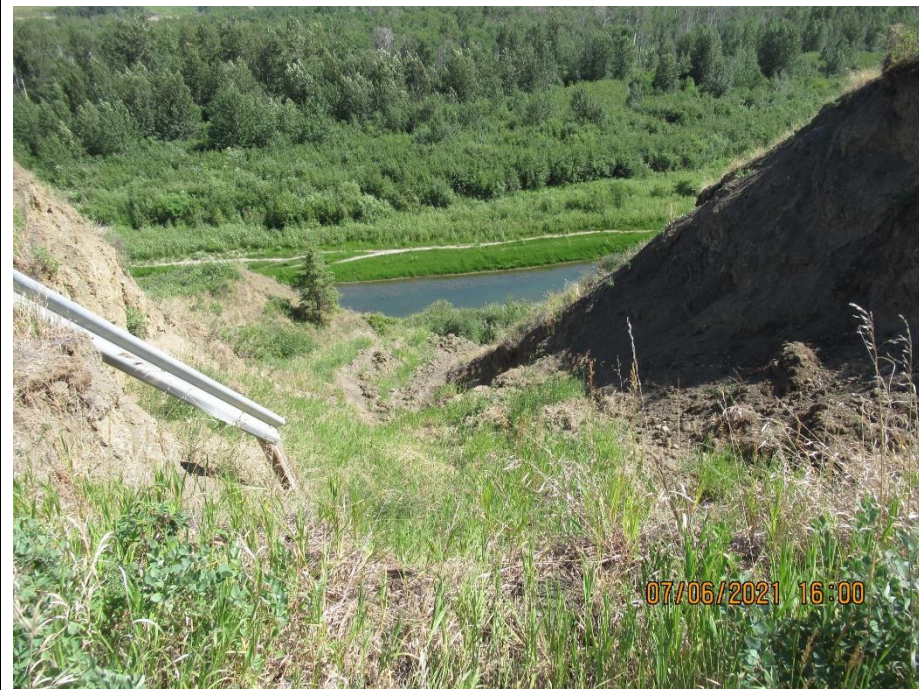
Photo 4.
Closeup view of slide debris below the backscarp of Slide 1. Increased vegetation growth on the disturbed soils relative to the 2019 condition.

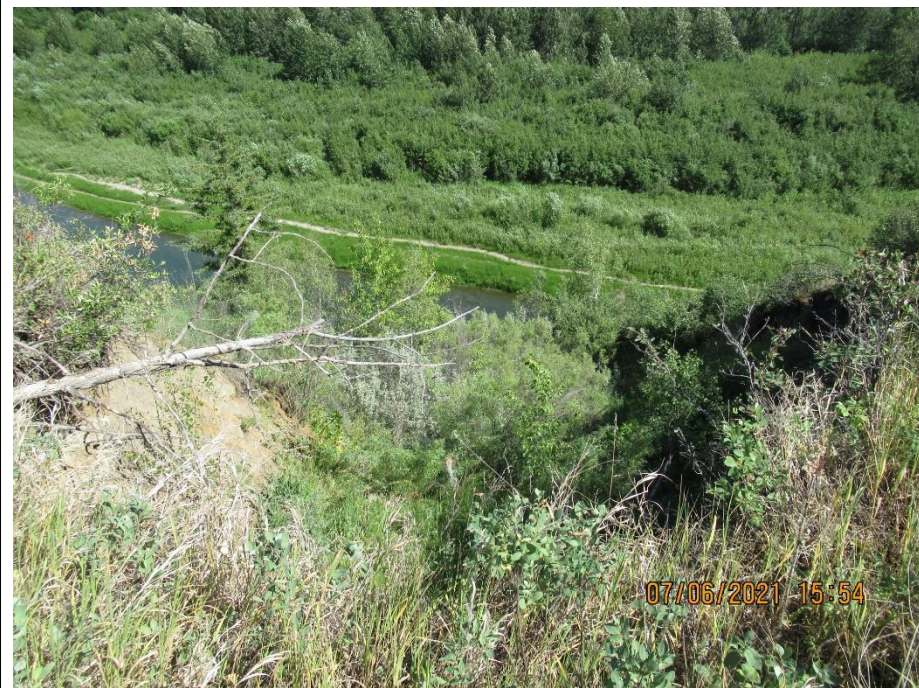
Photo 5.
Looking east from the backscarp of Slide 2. No significant change has occurred to this slide since 2019.

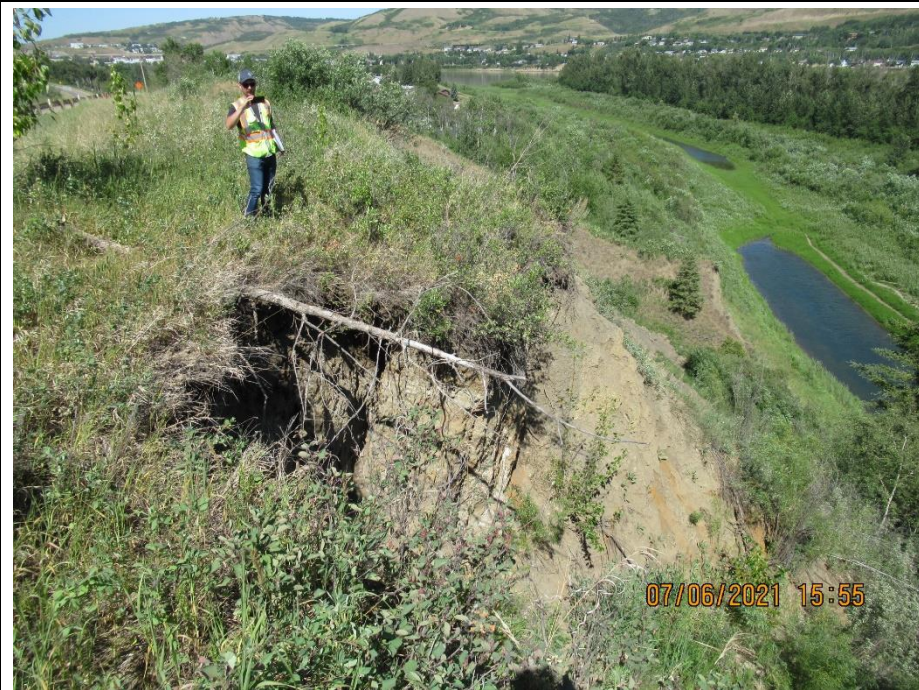
Photo 6.
Looking northeast from the south flank of Slide 2.

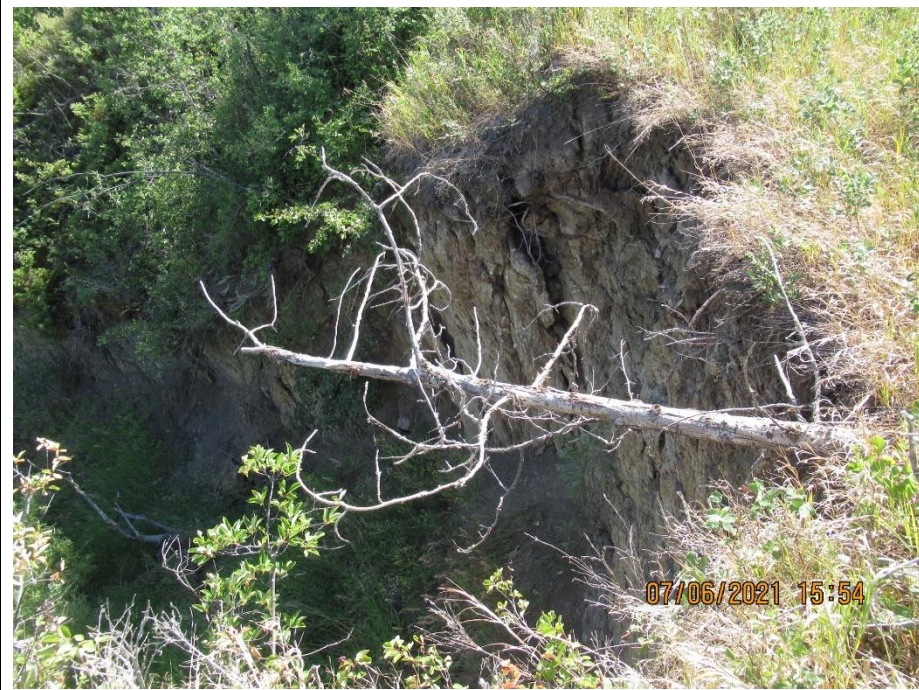
Photo 7.
Looking southeast from the backscarp of Slide 2 towards the south flank of Slide 2.

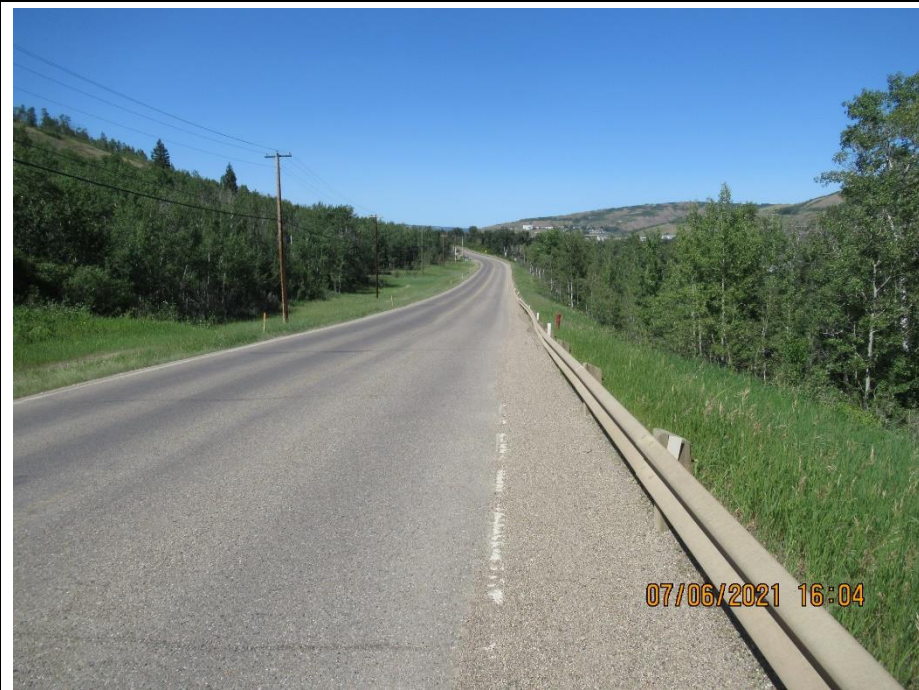
Photo 8.
Looking north towards the slide at km 28.6. Note the bow in the guardrail.

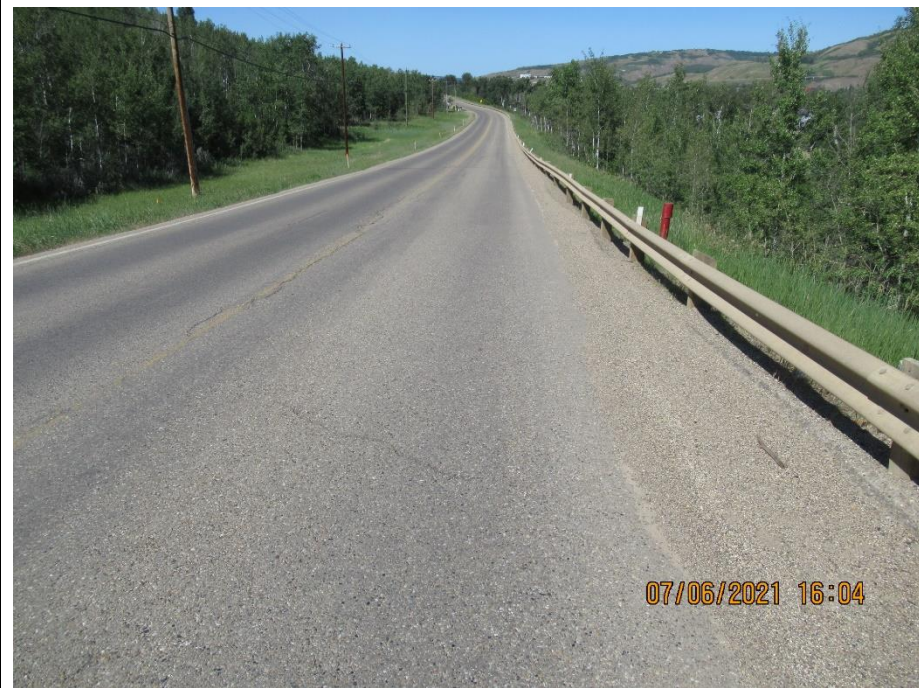
History and Date of any Remediation:	It is not known when the south landslides began to occur. The north slide appeared in 2019.	
Maintenance:	No maintenance has been recently performed at the sites to date.	
Observations:	Description	Worsened?
<input checked="" type="checkbox"/> Pavement Distress	<p>There are no signs of any cracking in the pavement structure above Slides 1 and 2.</p> <p>Cracking is more visible in the asphalt at the km 28.6 slide up to the highway centreline but otherwise had no significant expansion from the previous inspection (Photos 9 and 10).</p>	<input checked="" type="checkbox"/>

Photo 9.
Looking north at the slide at km 28.6. Tension cracks and a dip in the pavement are visible. Cracks along the median are more apparent relative to the 2019 condition.

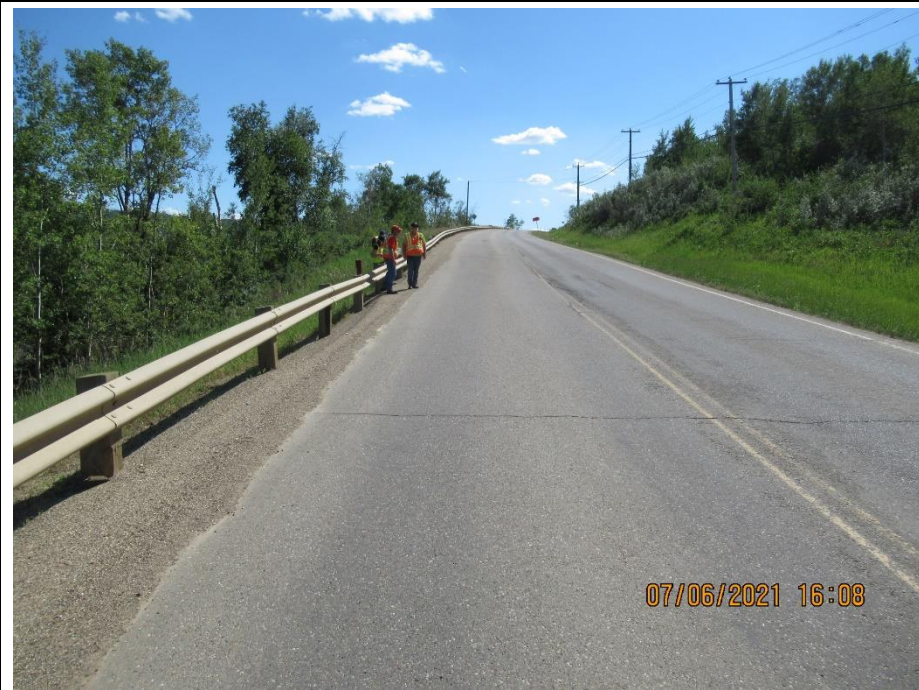
Photo 10.
Looking south at the new slide. Note the tension cracks around the road centreline.

At the north landslide, a concrete pile wall anchored into bedrock might be a good long term solution.

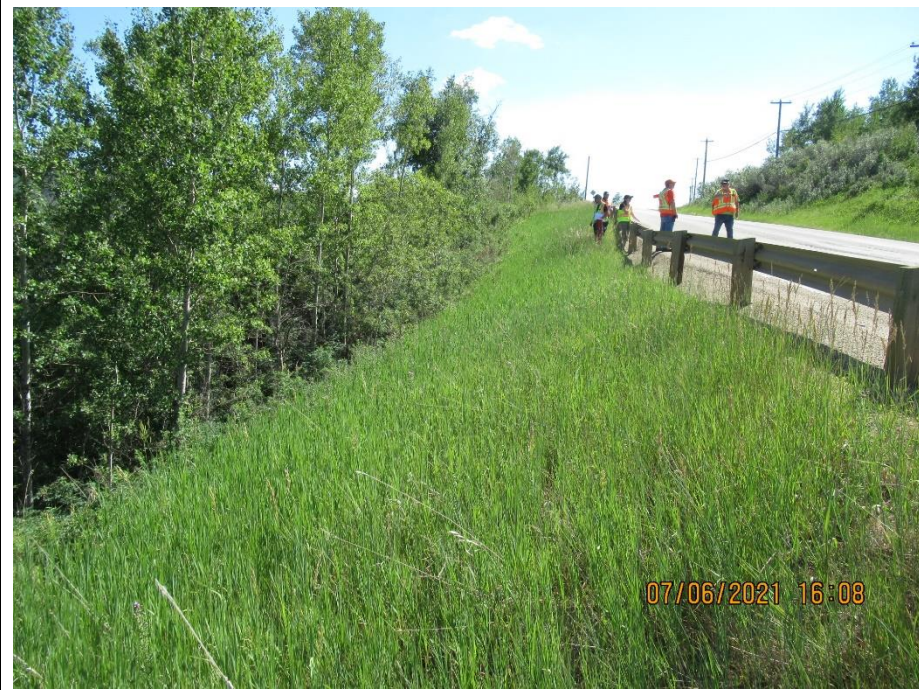
Photo 11.
Looking south at the highway side slope below the slide at km 28.6. Note the dip in the guardrail.
