**ALBERTA TRANSPORTATION  
GEOHAZARD ASSESSMENT PROGRAM  
PEACE REGION (PEACE RIVER DISTRICT)  
2022 INSPECTION**

| Site Number | Location | Name | Hwy | km |
|---|---|---|---|---|
| PH081 | Shaftesbury Trail | Shaftesbury Trail North Slides | 684:02 | 28.4 |

| | Date | Slide | PF | CF | Total |
|---|--|---|---|---|---|
| <b>Current Inspection:</b> | 26-May-2022 | South slides | 11 | 2 | 22 |

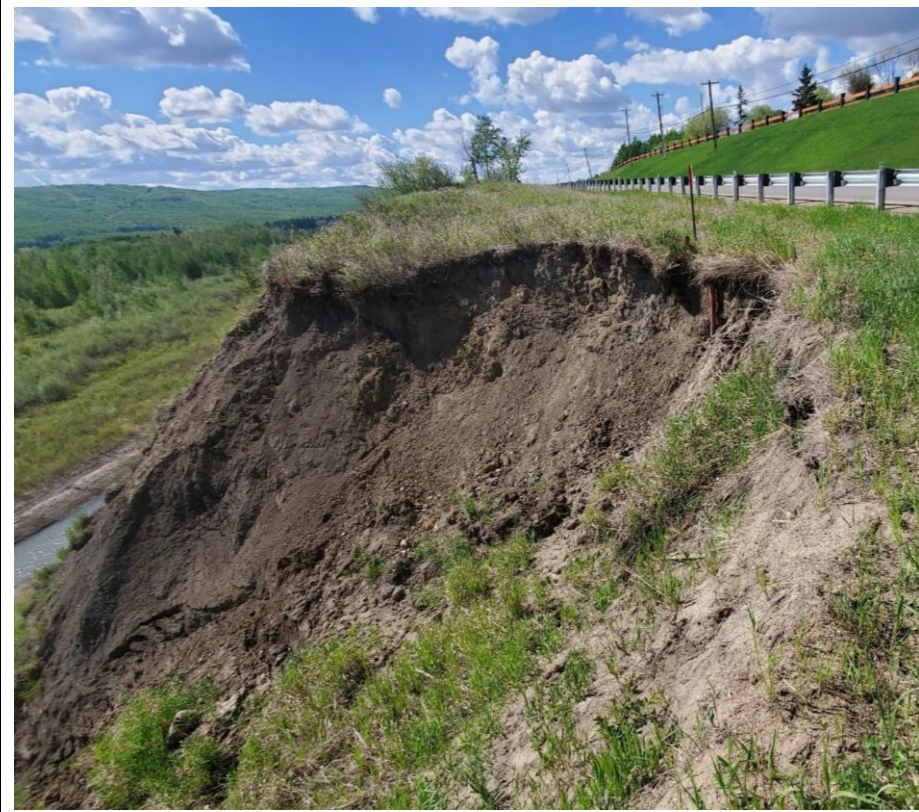
| <input checked="" type="checkbox"/> Slope Movement | Active slumping is occurring at the south landslides with bare backslopes (Photos 1 to 3). Slide 1 has shown some signs of ravelling and retrogression in the southern flank since 2021. The minimum offset from the headscarp to the guardrail was 3.4 m. The backscarp at Slide 2 did not appear to have significant change and there is 7.6 m offset to the guardrail which is unchanged from the 2021 inspection.<br><br>There is no longer a noticeable dip in the pavement and guardrail at the new slide at km 28.6 since repaving and new guardrail installation in 2021. | <input checked="" type="checkbox"/> |

**Photo 1.**  
Looking southwest from the north flank of Slide 1. Fresh soil was visible and there was minor retrogression of the south flank since 2021. Minimum offset from the main scarp to the guardrail was 3.4 m.

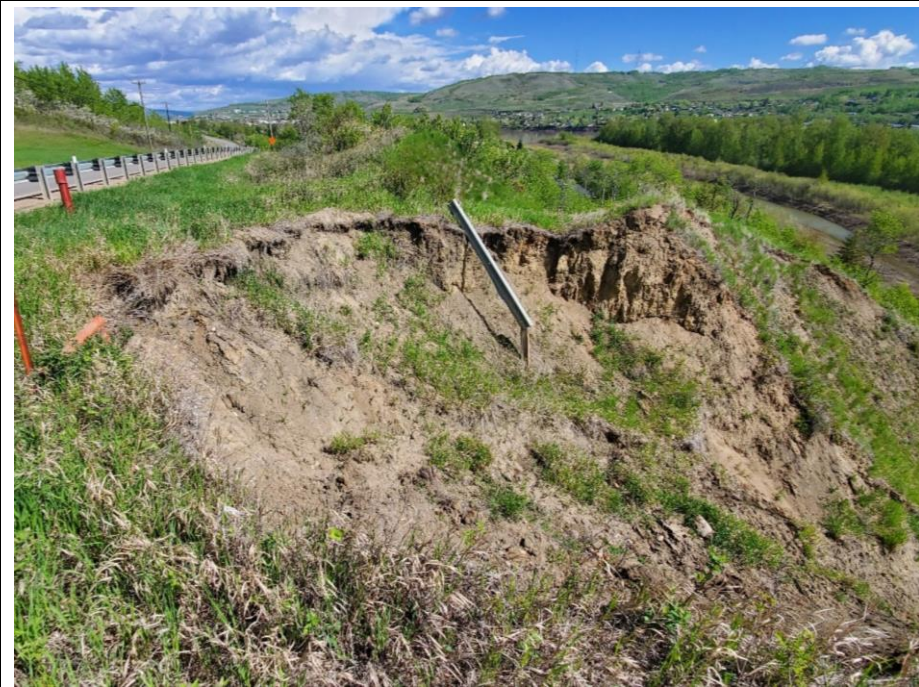
**Photo 2.**  
Looking northeast from the south side of the main scarp of Slide 1. No major retrogression was observed on the north flank relative to the 2021 condition.

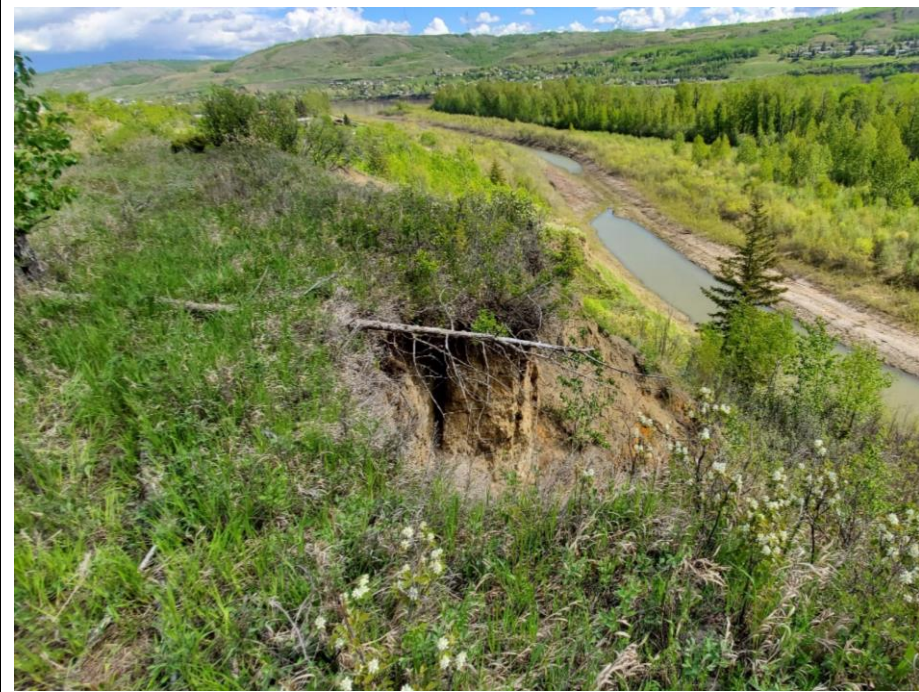
**Photo 3.**  
Looking northeast  
from the south flank  
of Slide 2.

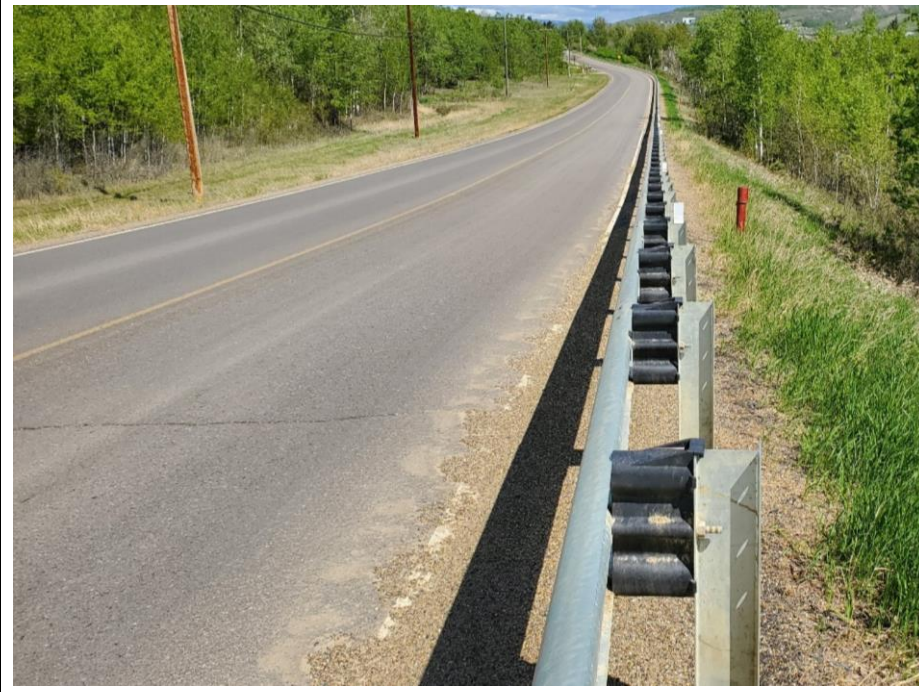
| <input checked="" type="checkbox"/> Pavement Distress | <p>There are no signs of any cracking in the pavement structure above Slides 1 and 2.</p> <p>A transverse crack was visible in the asphalt south of the km 28.6 slide across both lanes.</p> | <input checked="" type="checkbox"/> |

| | Previous tension cracks were not observed since road was repaved and no apparent expansion from the previous inspection (Photo 4). | |

**Photo 4.**  
Looking north at the  
slide at km 28.6.  
Transverse crack  
across the pavement  
is visible. No  
significant change  
relative to the 2021  
condition.

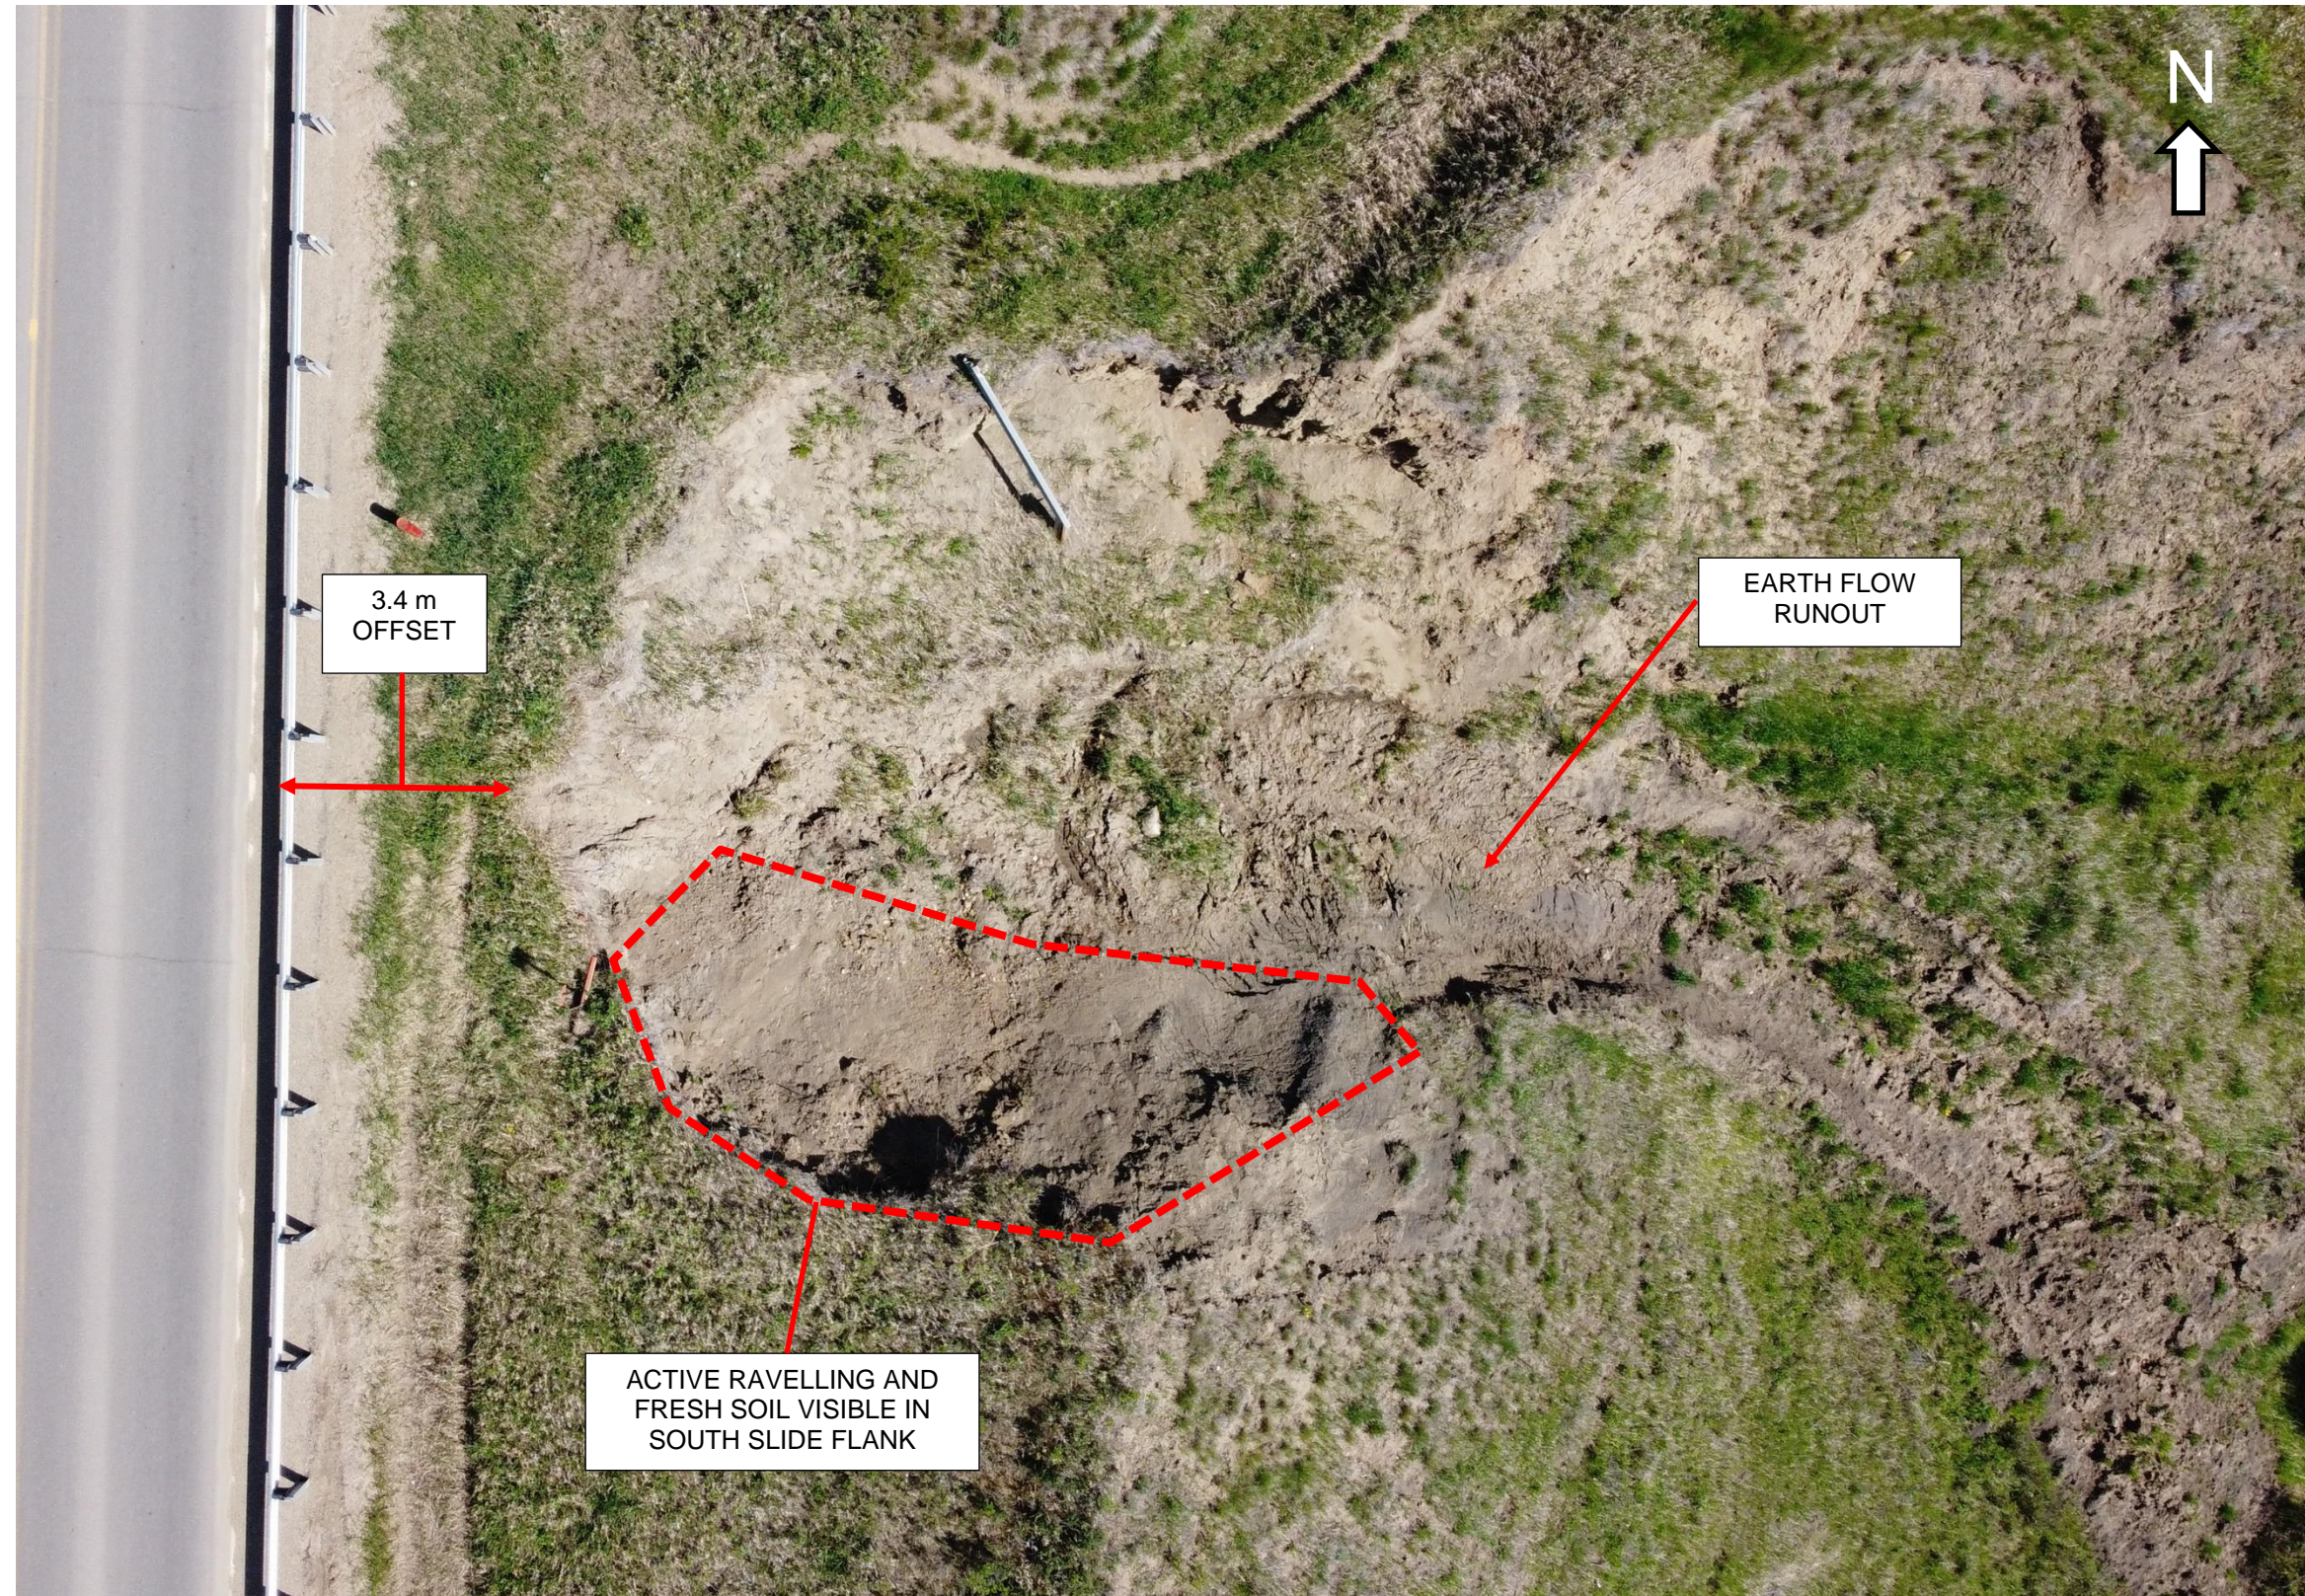
**PH081 - Drone Photo 1**  
Aerial plan view of Slide 1.

| <b>Dimensions:</b> | <p>Slide 1 is about 13 m wide, with a 3 m drop off along the backscarp which is about 3.4 m east of the NBL guardrail. (Drone Photos 1 and 2).</p> <p>Slide 2 is about 14 m wide, with a 3 m drop off along the backscarp which is about 7.6 m east of the NBL guardrail. (Drone Photos 3 and 4)</p> <p>The slide at km 28.6 is approximately 25 m wide. Tension cracking had been observed to the highway centreline.</p> | |

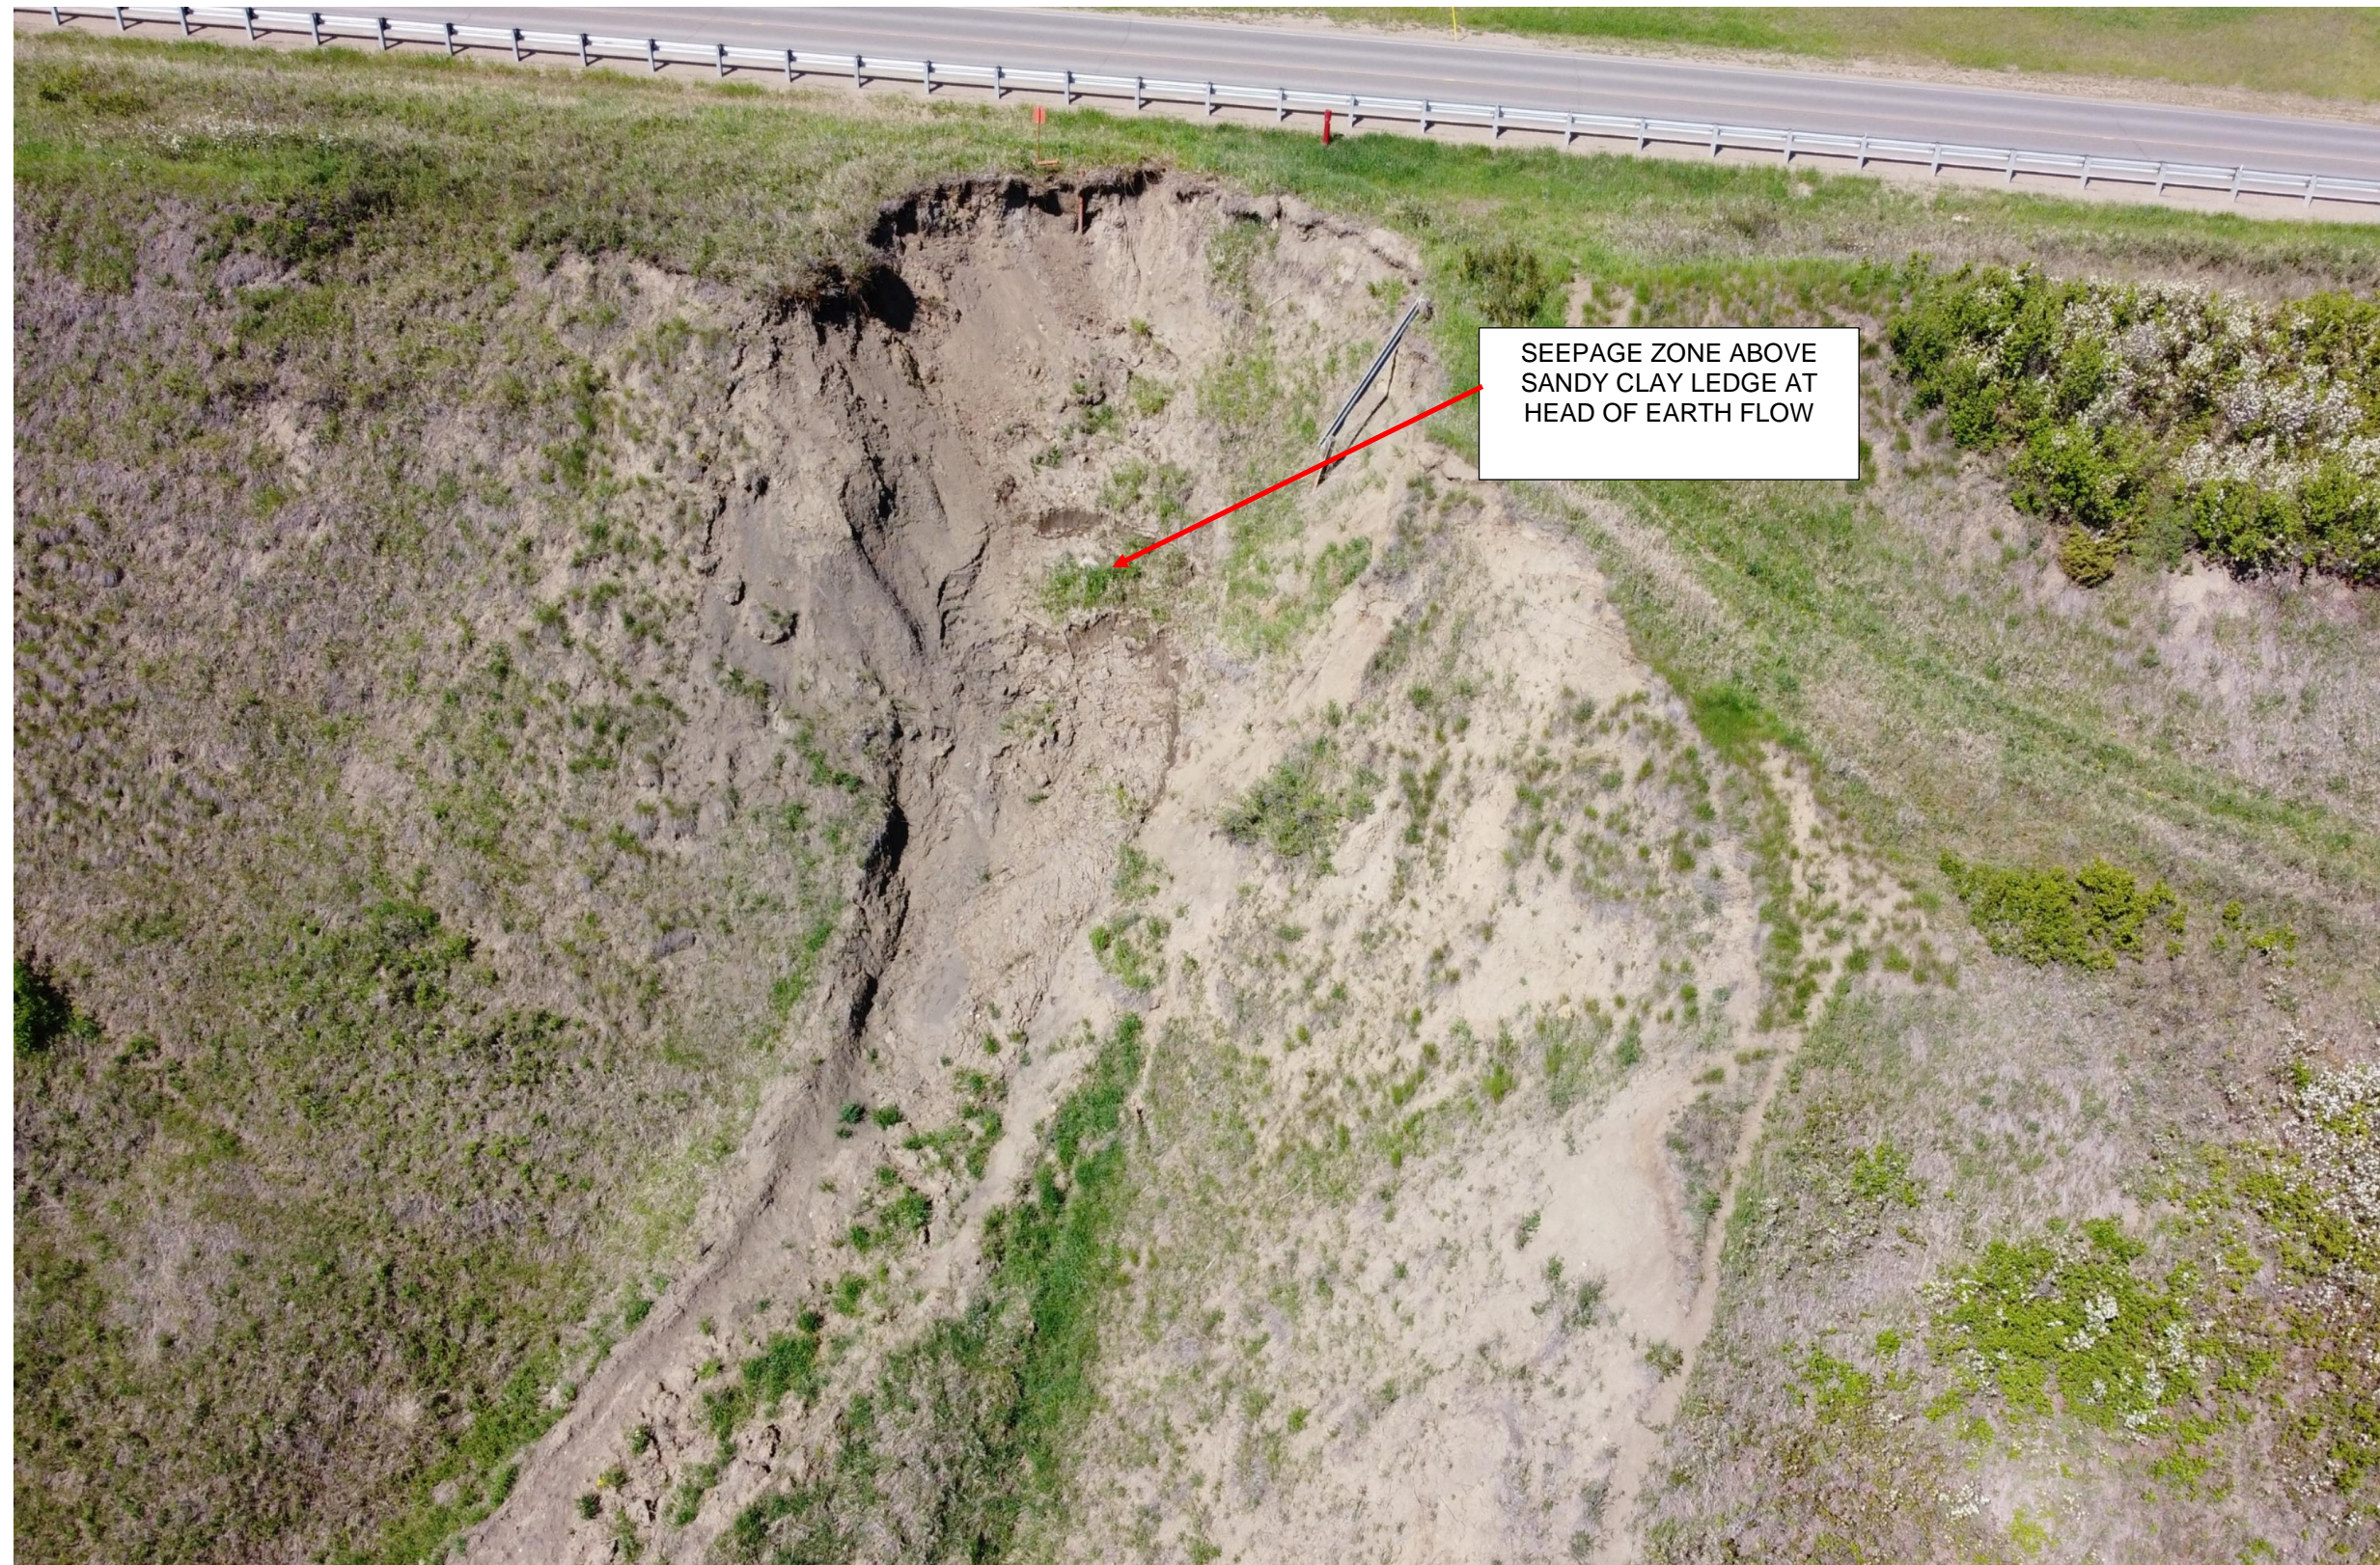
**PH081 - Drone Photo 2**  
Aerial oblique view of Slide 1 looking towards the west.

SEEPAGE ZONE ABOVE  
SANDY CLAY LEDGE AT  
HEAD OF EARTH FLOW
