**ALBERTA TRANSPORTATION AND
ECONOMIC CORRIDORS
GEOHAZARD ASSESSMENT PROGRAM
PEACE REGION (PEACE RIVER DISTRICT)
2025 INSPECTION**

Site Number	Location	Name	Hwy	km
PH081	Shaftesbury Trail	Shaftesbury Trail North Slides	684:02	28.4
Legal Description		UTM Co-ordinates (NAD 83)		
NW¼ 19-083-021 W5M		11U E 481381	N 6230300

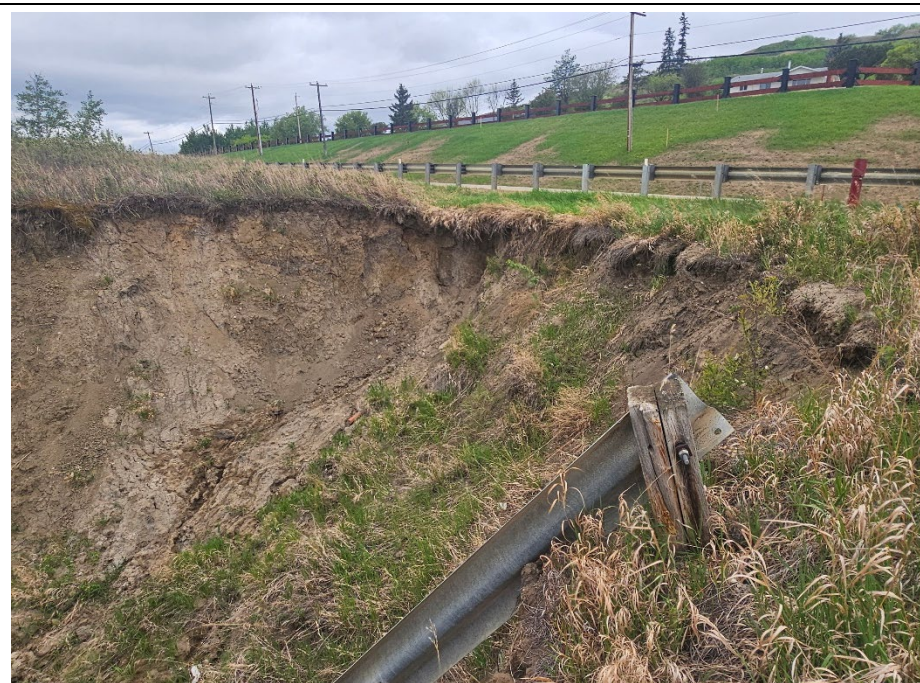
Photo 1.

Looking southwest from the north flank of Slide 1. Minor ravelling and erosion within the vertical scarp face along the south flank. No retrogression was measured at the main scarp since 2024.

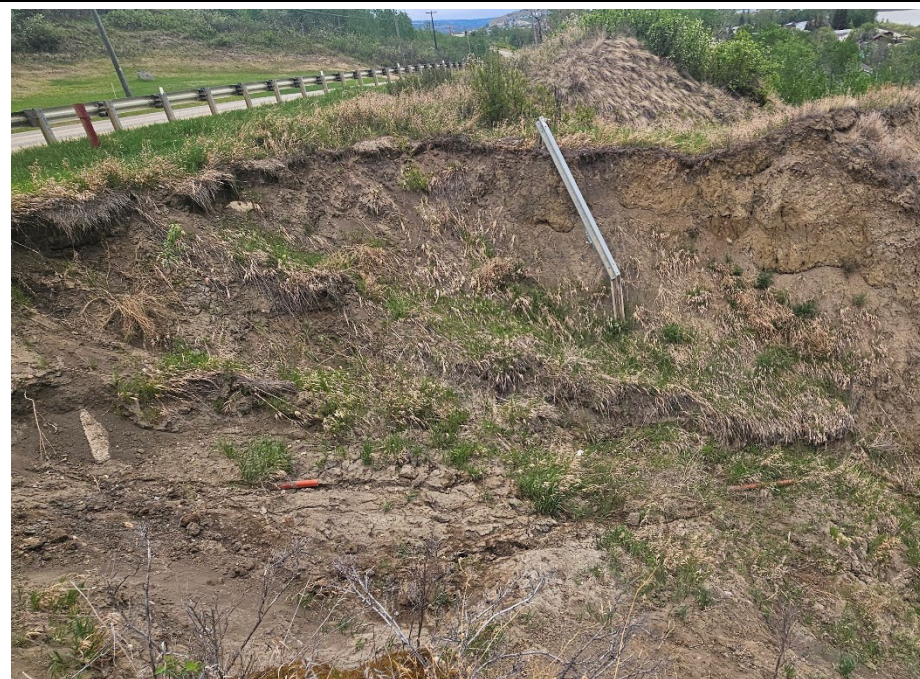
Photo 2.

Looking northeast from the south side of the main scarp of Slide 1. No visible lateral expansion of the north slide flank since 2024.

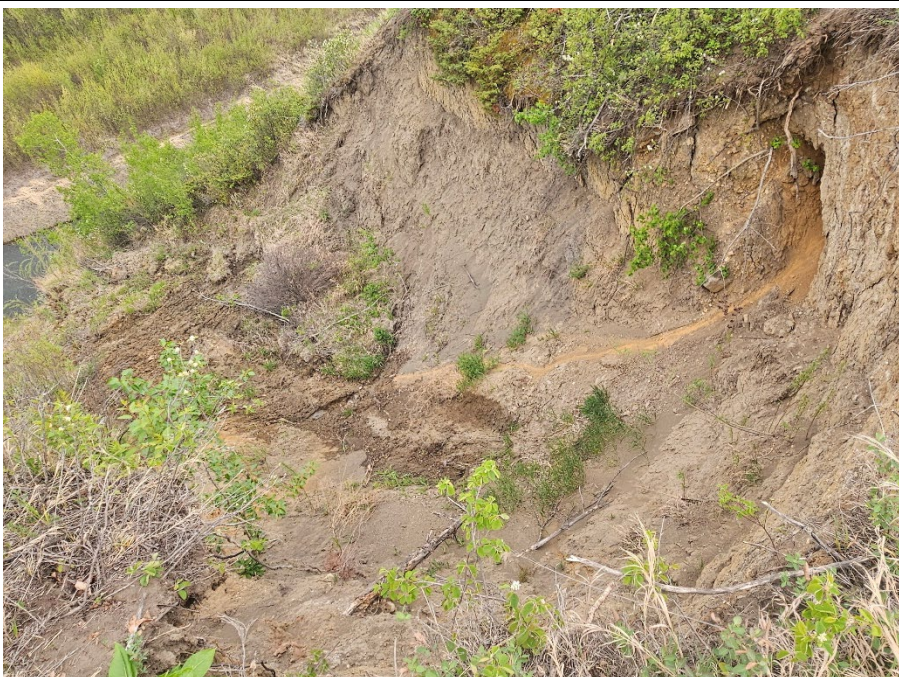
Photo 3.

Looking east and downslope from the top of the main scarp of Slide 2. Ongoing erosion within the exposed and disturbed soils but no expansion or retrogression towards the highway since 2024. Minor seepage was present near the base of the main scarp face.

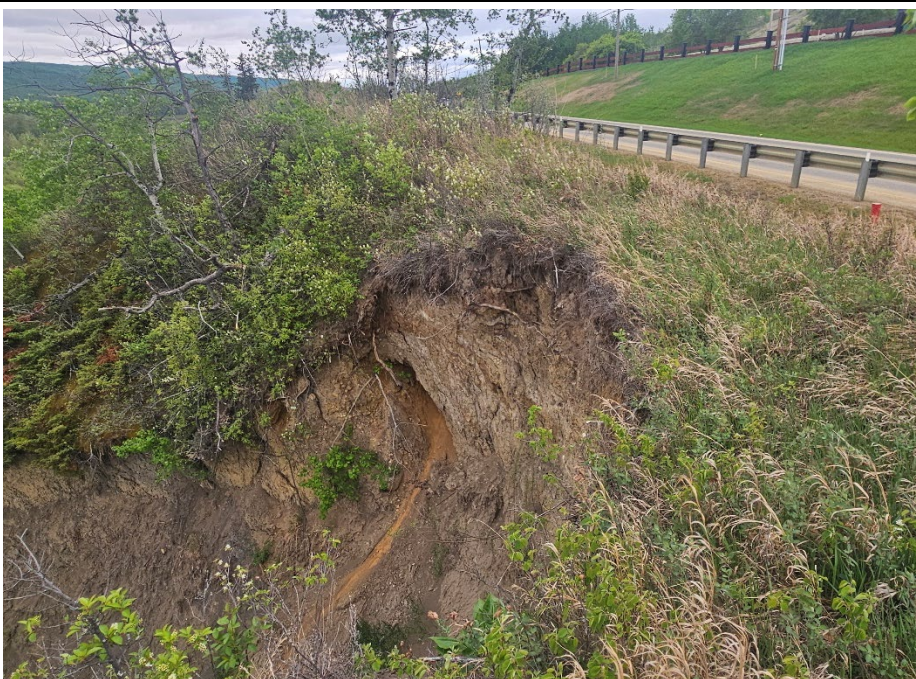
Photo 4.

View southwest towards the main scarp face of Slide 2. No additional retrogression towards the road since 2024. Offset from the scarp to the casing protector for test hole TH20-8 was 5.0 m.

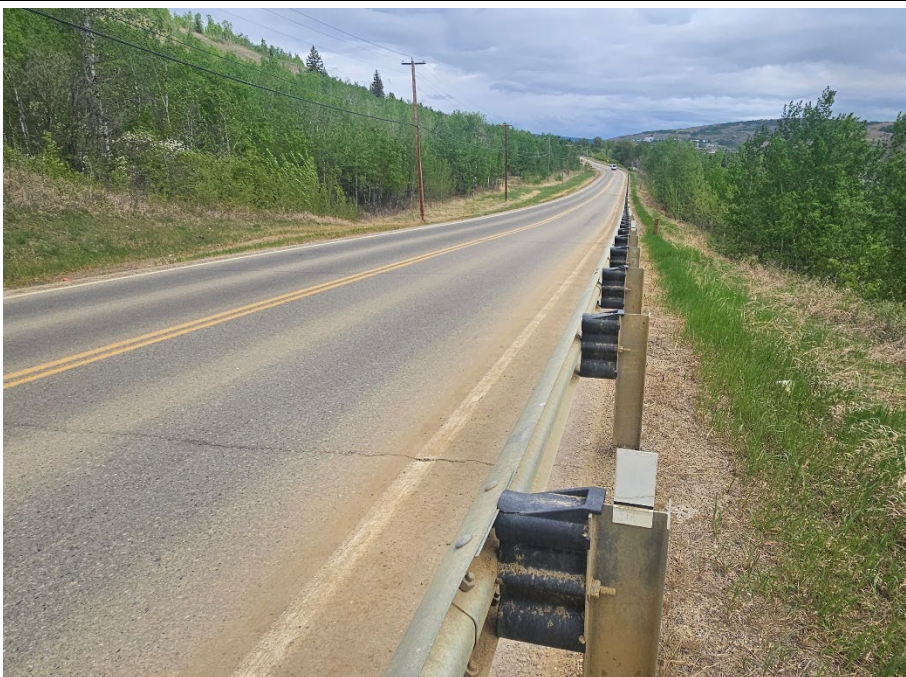
**Photo 5.**

Looking north at the slide at km 28.6. No visible changes to the slope below the road. No visible change to transverse cracks in the pavement or dip at the guardrail since 2024.

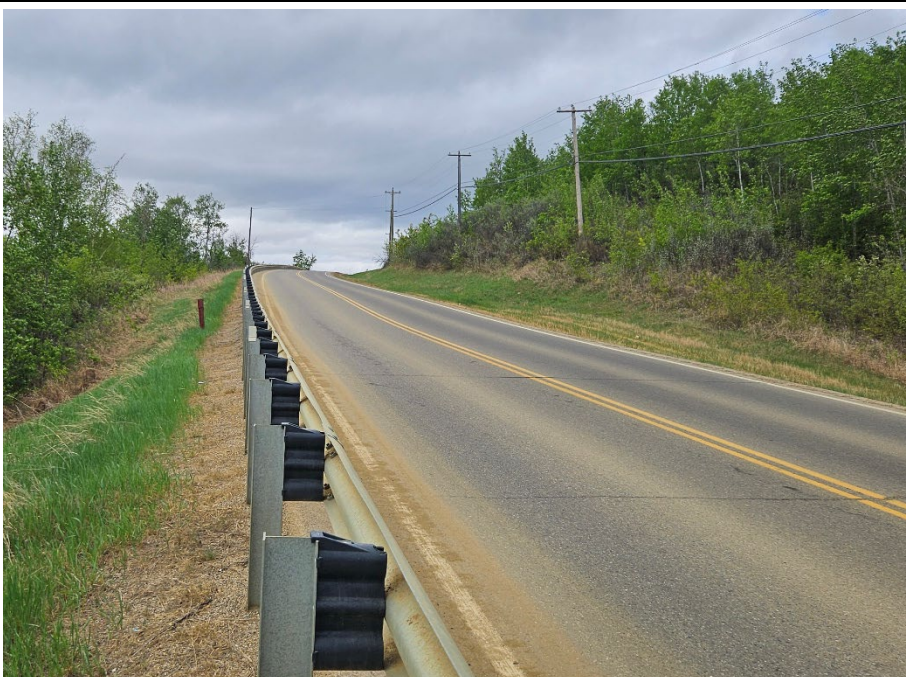
**Photo 6.**

Looking south at the slide at km 28.6. No visible changes to the road or slope since 2024.
