**ALBERTA TRANSPORTATION
GEOHAZARD ASSESSMENT PROGRAM
PEACE REGION – PEACE-HIGH LEVEL
2019 INSPECTION**

THURBER ENGINEERING LTD.

Site Number	Location	Name	Hwy	km
PH009-3	Peace River	Shaftesbury Trail - Shop Slide	Old 2:02	0.025
			684:02	30.990
Legal Description		UTM Co-ordinates		
SW¼ 31-083-21 W5M		11V E 480339	N 6232158

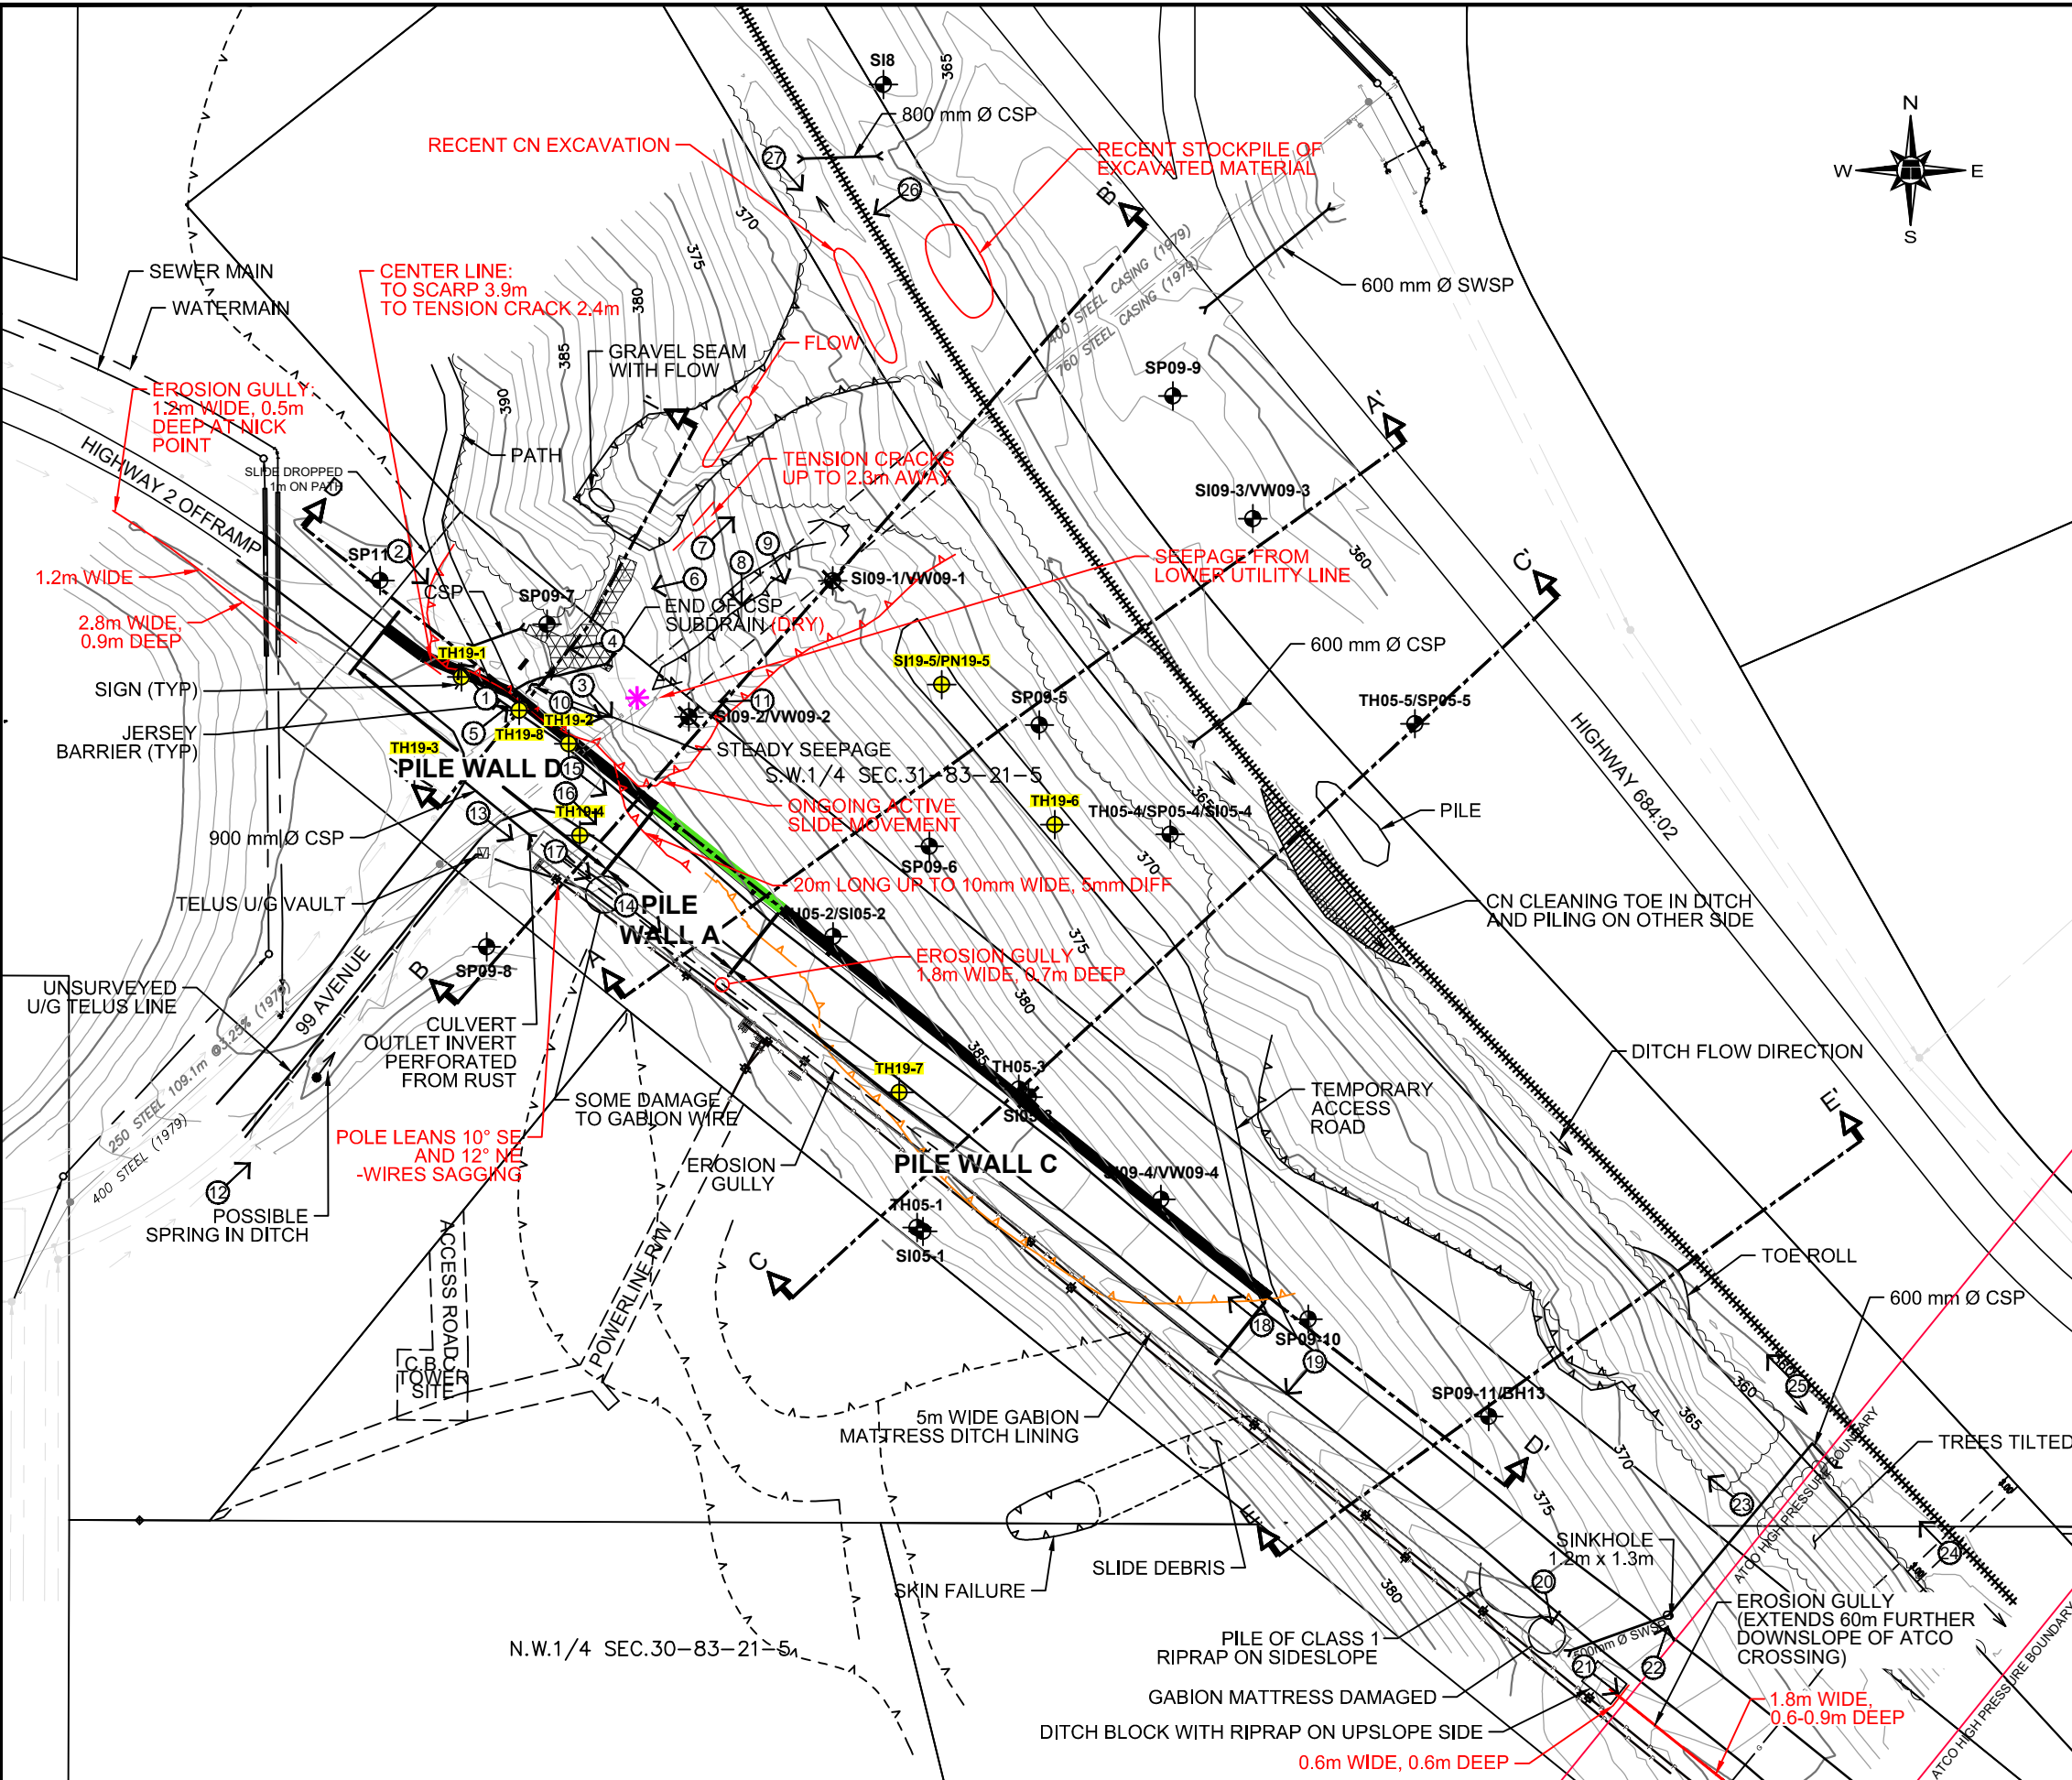
DWG No. 13351-PH009-3

1. SITE PLAN RESET IN 2019 USING SURVEY BASE PLAN. SEE HISTORICAL DRAWINGS FOR PREVIOUS SITE FEATURES AND COMMENTS.
2. MAY 2019 OBSERVATIONS SHOWN IN RED.

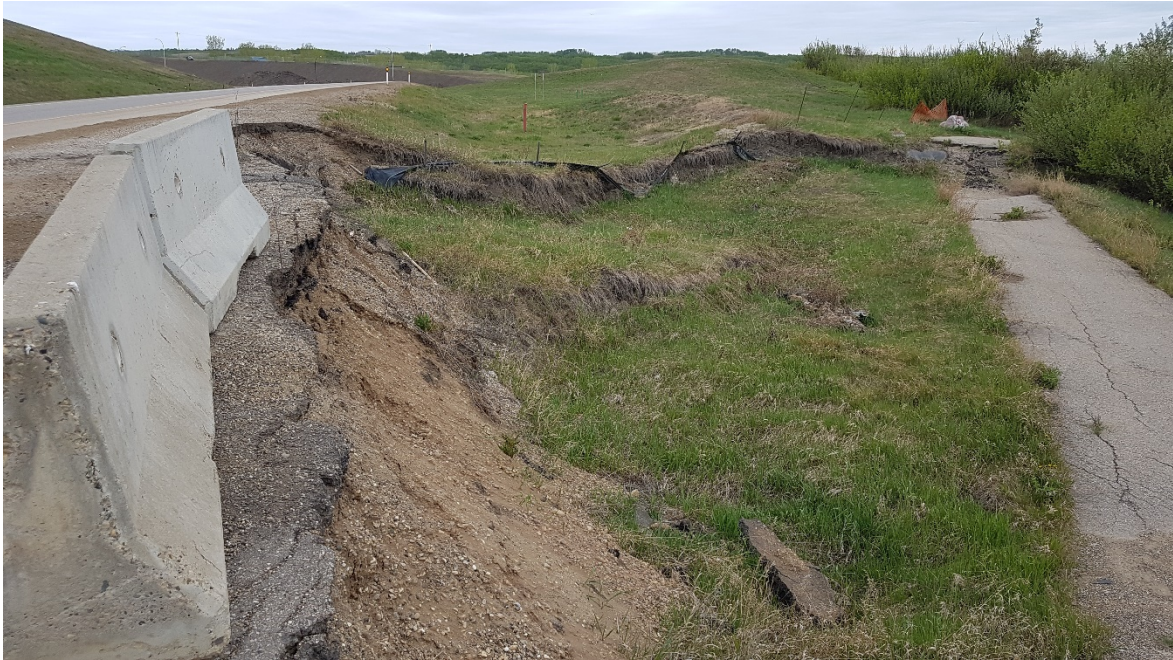
Photo 1: Looking northwest along shoulder of the Hwy 2 off-ramp on the east side of 99 Avenue intersection.

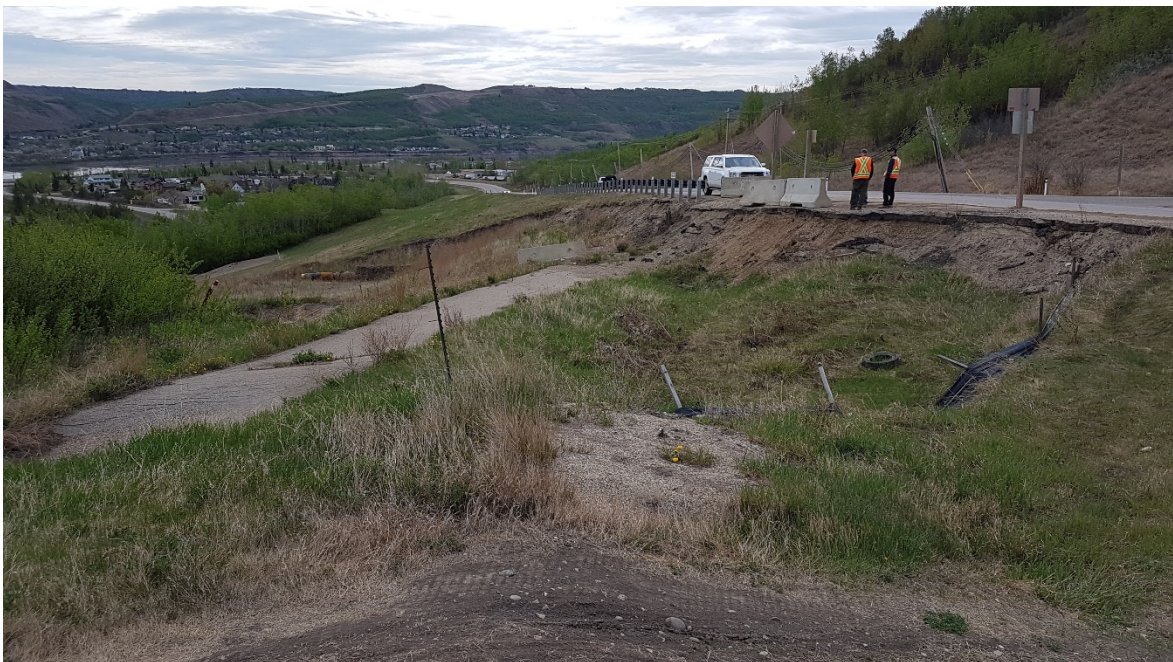
Photo 2: Looking southeast towards the backscarp along the east shoulder of the Hwy 2 off-ramp.

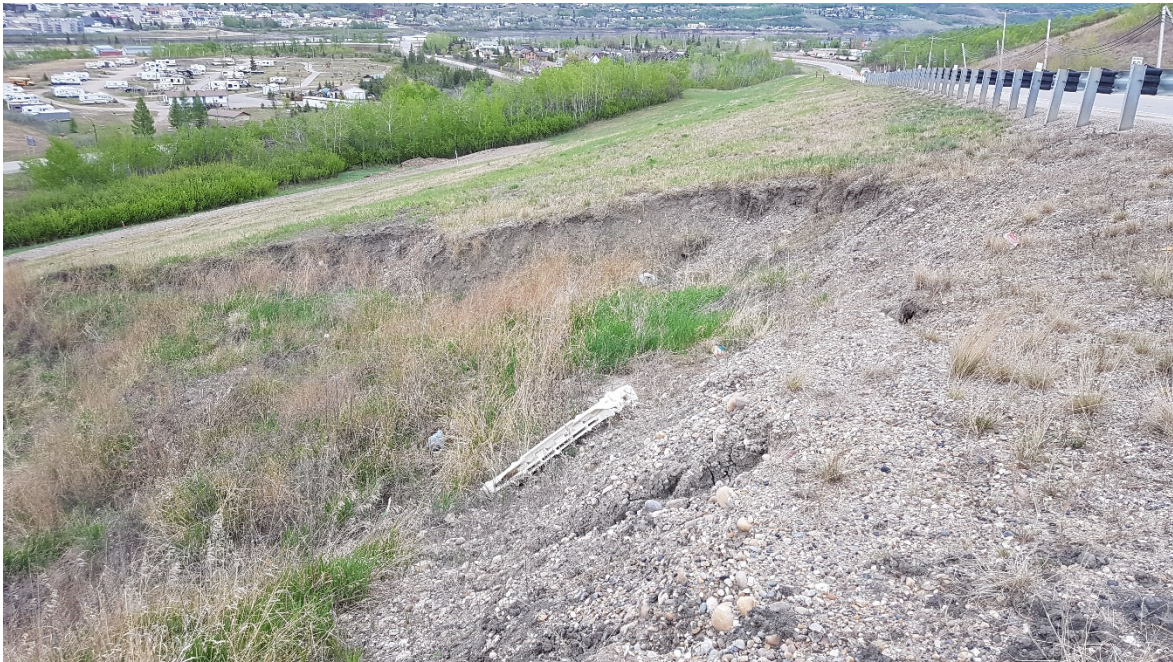
Observations:	Description	Worsened?
<input checked="" type="checkbox"/> Pavement Distress	Changes in cracking / dip at north end of slide. Cracks across regional pathway have grown. The backscarp of the slide feature along the NBL sideslope of the Hwy 2 off-ramp has retrogressed further into the roadway shoulder.	<input checked="" type="checkbox"/>
<input checked="" type="checkbox"/> Slope Movement	<p>Pavement distress and fresh cracking on the slope indicate further movement of the lower (active) slide area.</p> <p>The flow slide in the bush with a 6 m drop off at the end of the geomembrane sheets shows enlargement in the eastward direction.</p> <p>The landslide scarp noted above the rail line at the southern end of the site has a slide block with a vertical offset of about 4.5 m and a backscarp height of 1.5 m to 2 m.</p> <p>There is a dormant skin failure in the backslope below the cell phone communications tower.</p>	<input checked="" type="checkbox"/>

Photo 3: Looking southeast along the NBL shoulder of the Hwy 2 off-ramp at retrogressing backscarp.

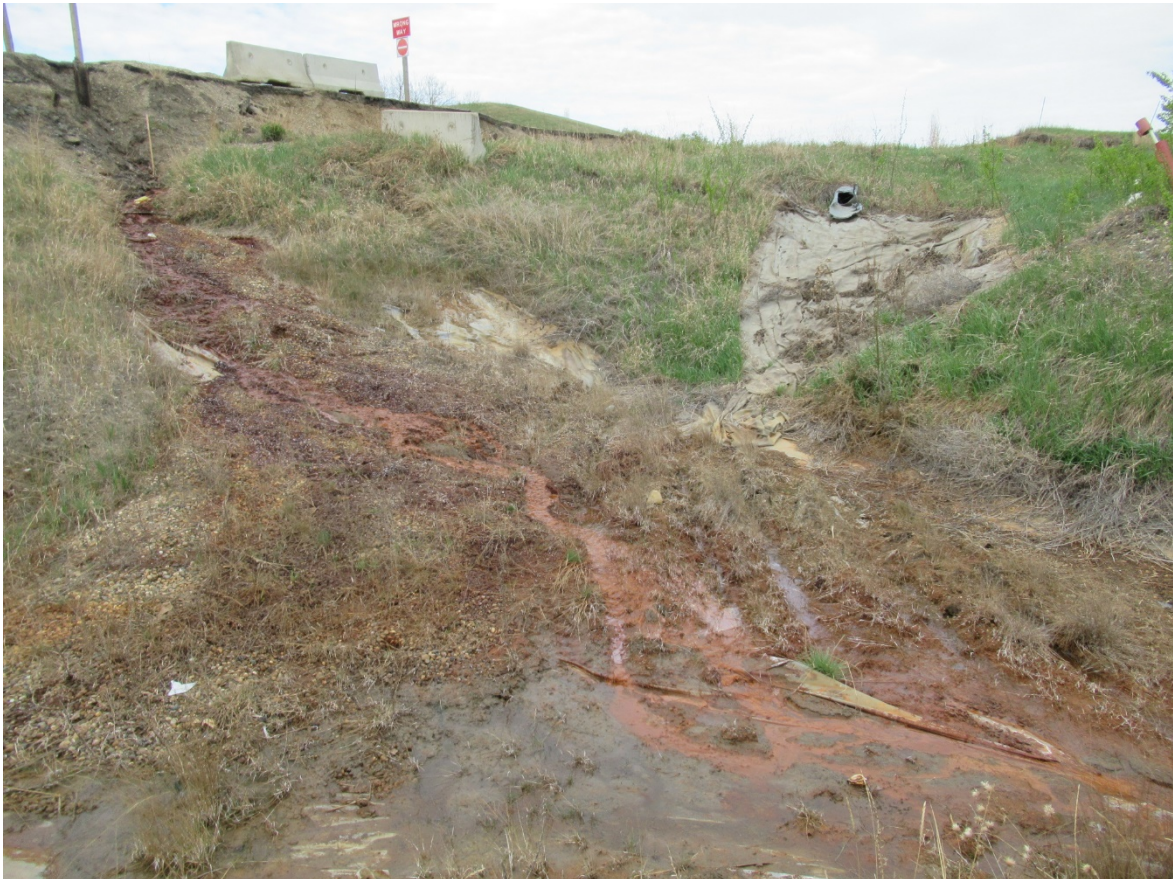
Photo 4: Looking west at springs flowing from the embankment below the Hwy 2 off-ramp at 99 Avenue.

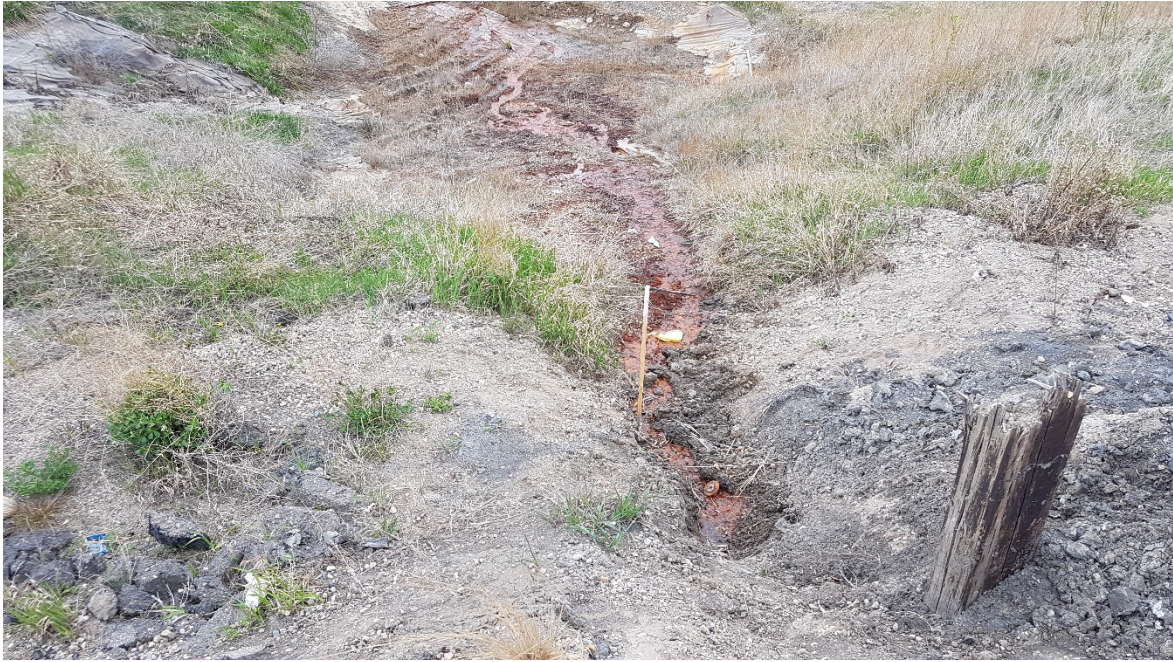
Photo 5: Looking east at seepage from gravel layer in the Hwy 2 off-ramp sideslope draining onto the geomembrane lining.

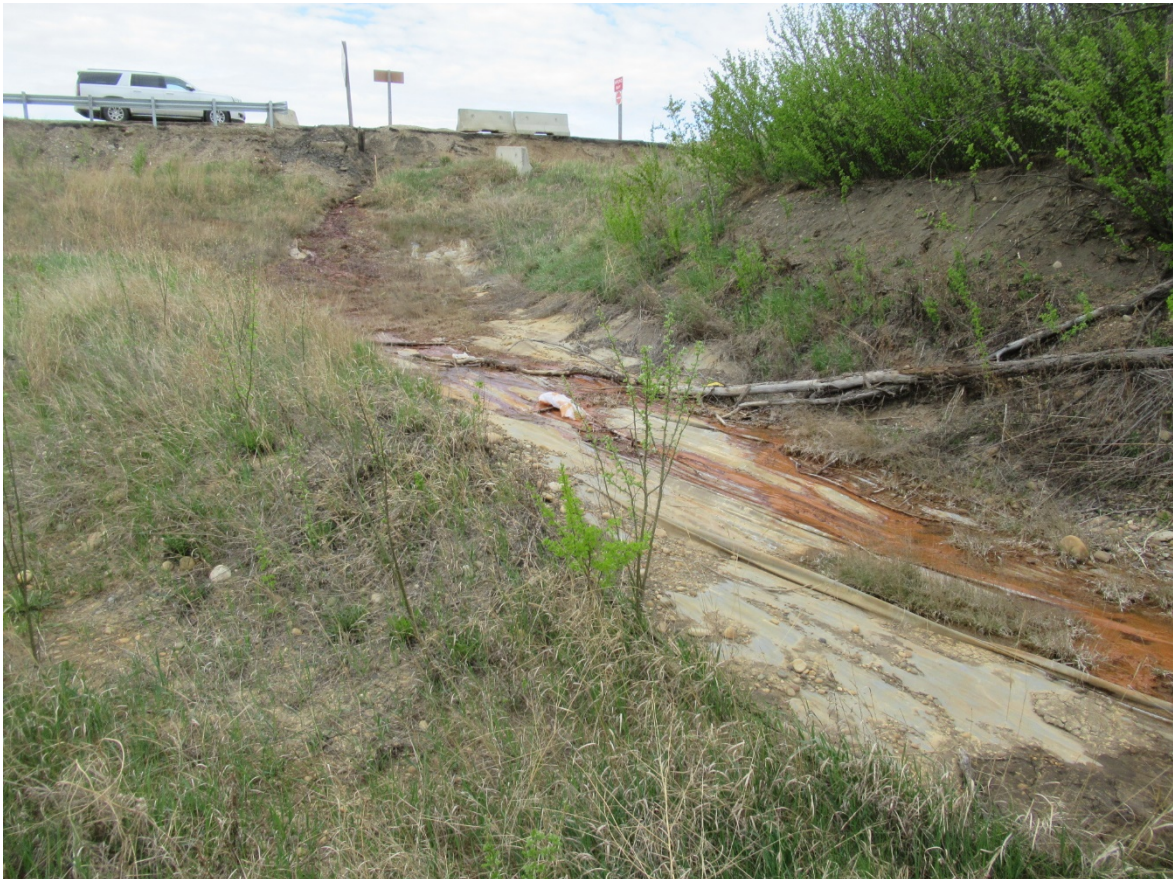
Photo 6: Looking west along the membrane installed by the Town below the 99 Avenue intersection.

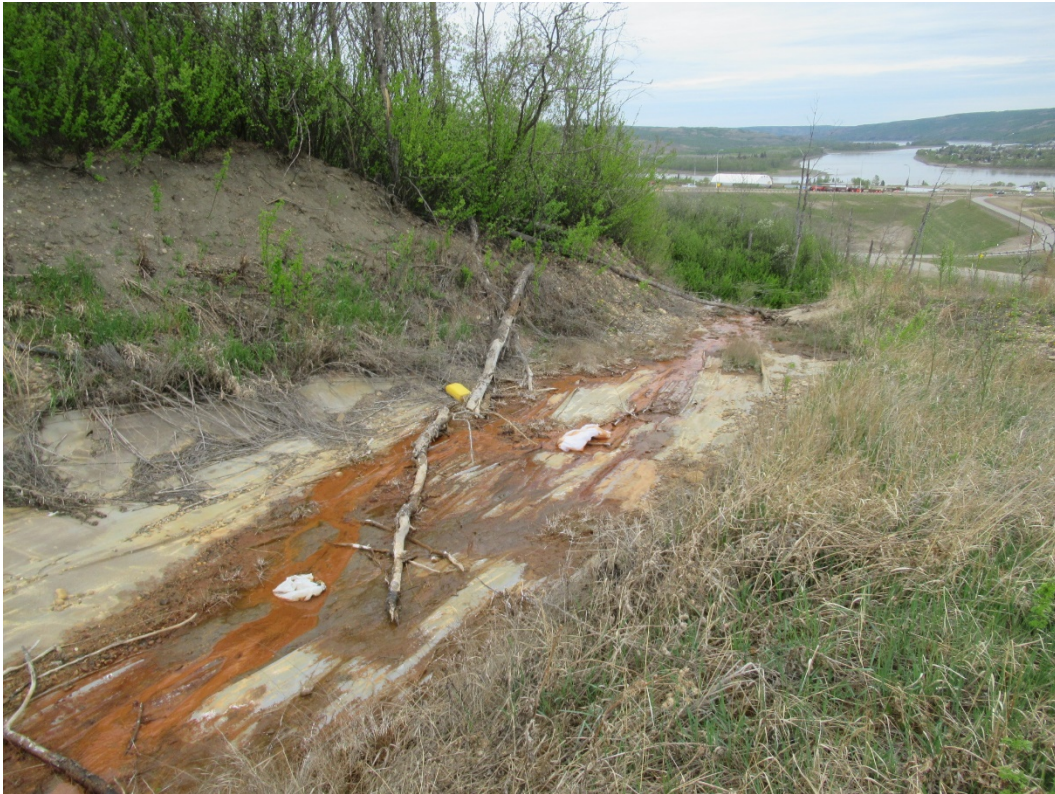
Photo 7: Looking northeast at lower portion of the geomembrance installed by the Town below the 99 Avenue intersection.

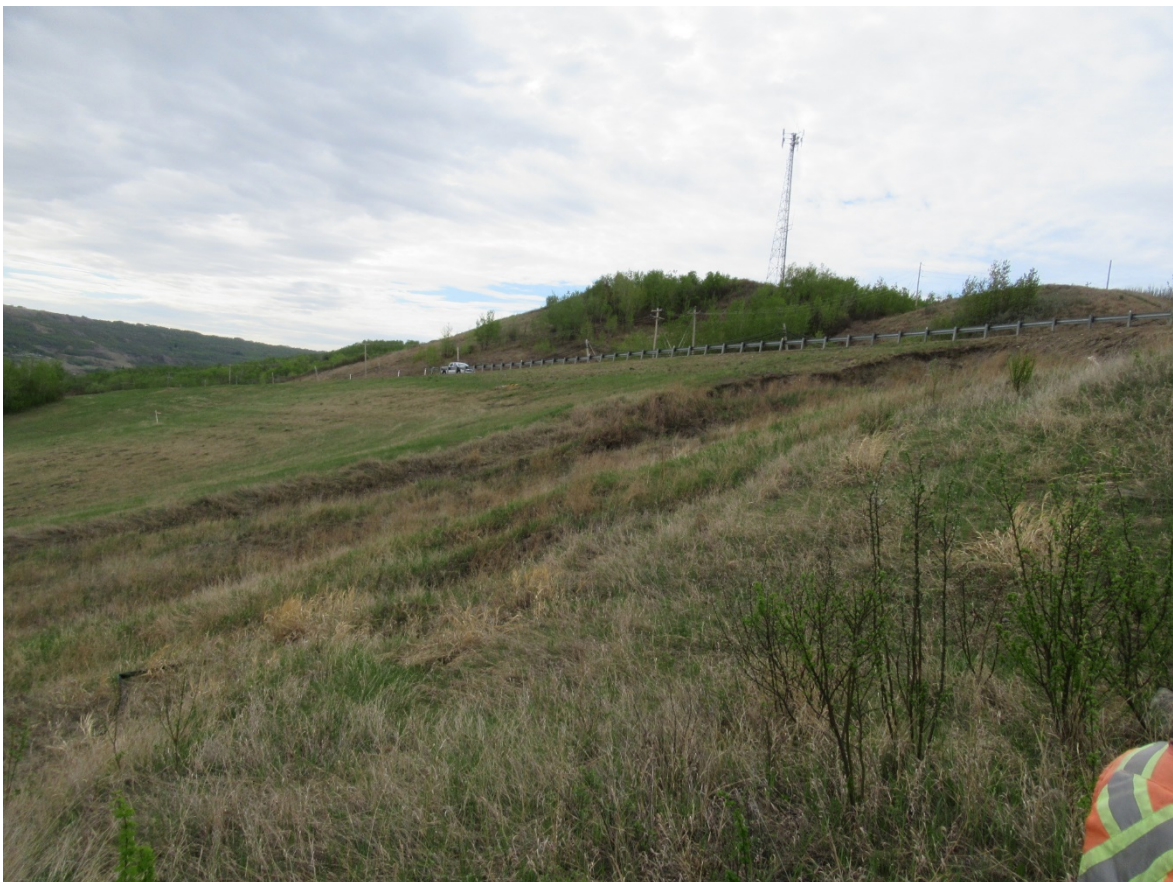
Photo 8: Looking south at backscarp of the Shop Slide below 99 Avenue intersection.

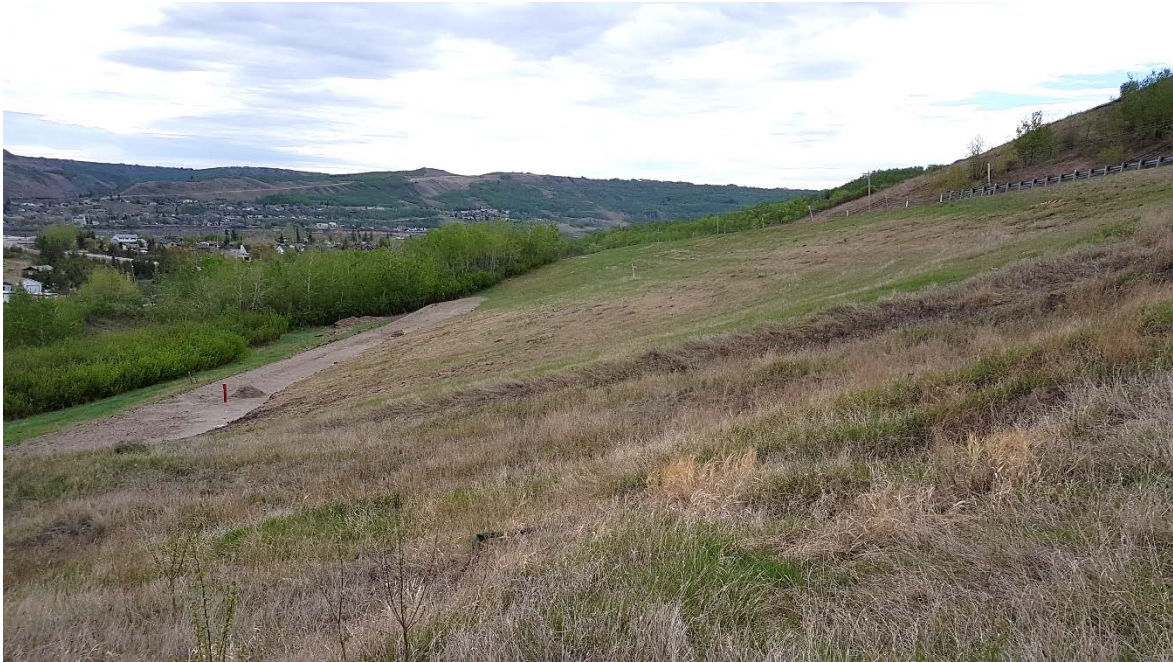
Photo 9: Looking southeast at the debris fan of the Shop Slide. New SI19-5 can be seen at left hand edge of photo on bench constructed for installation.

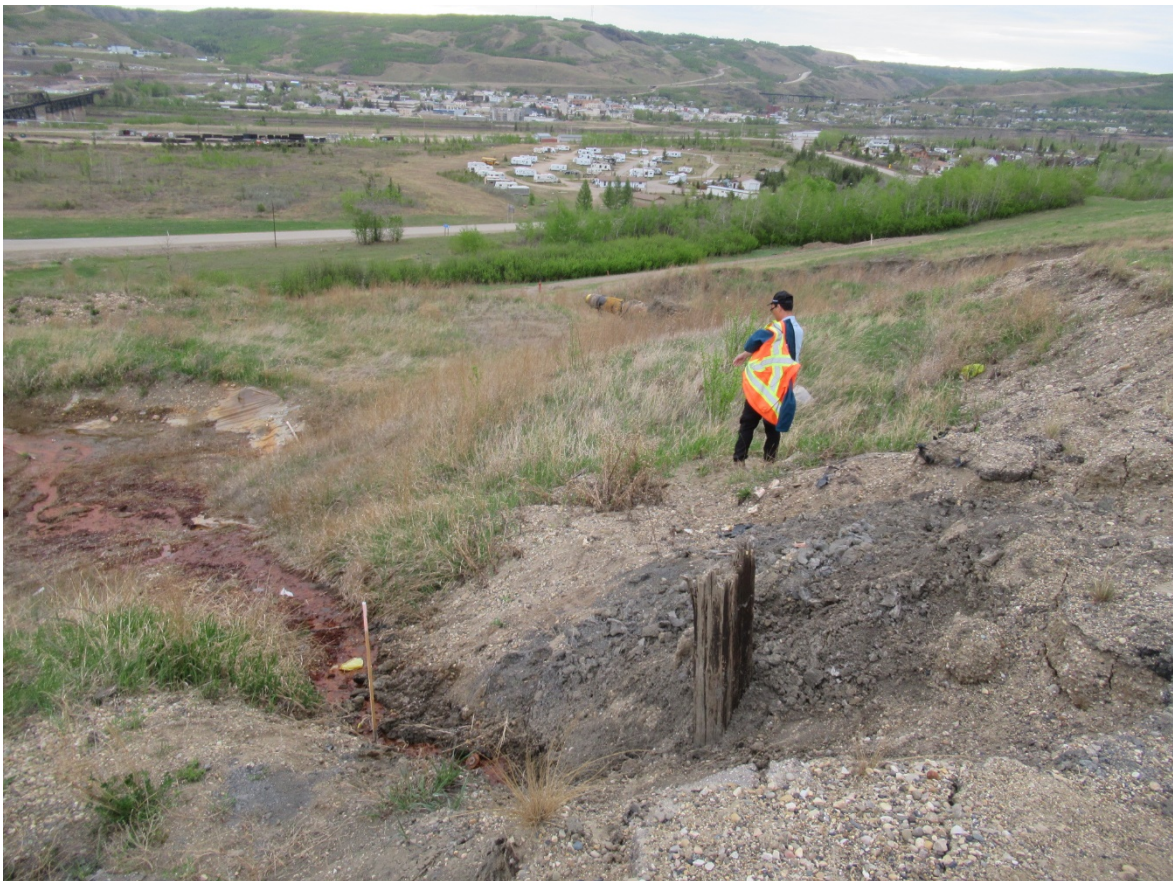
Photo 10: Looking east at the upper portion of the slide.

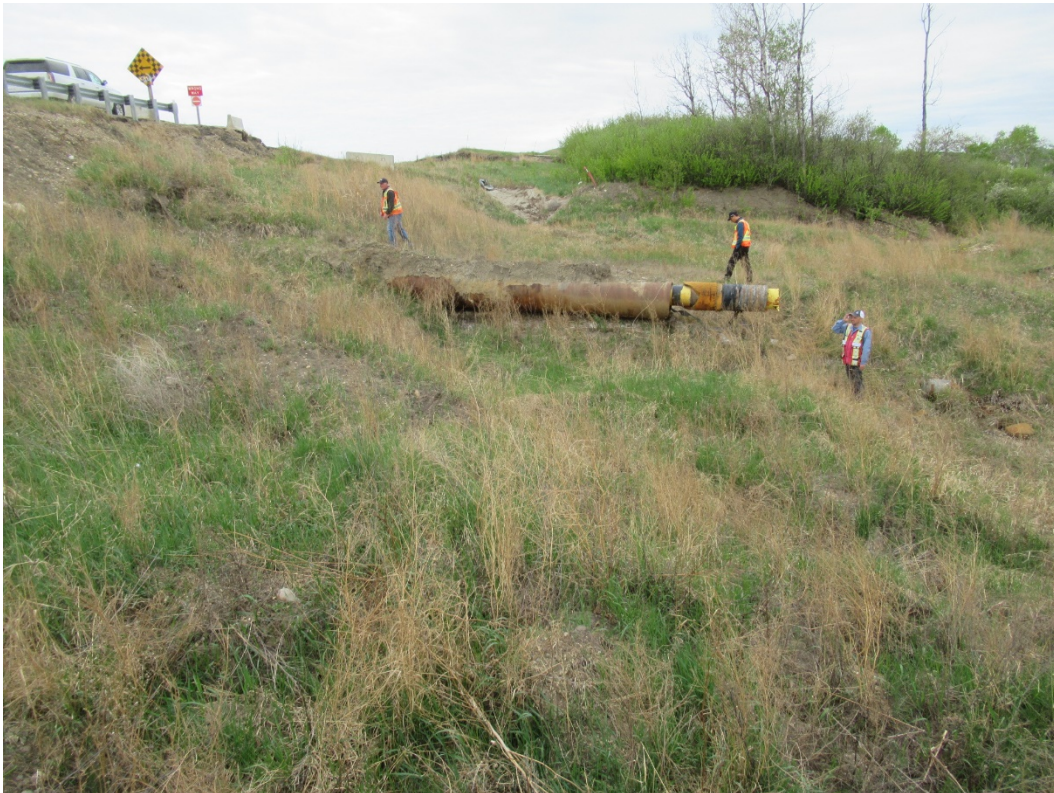
Photo 11: Looking northwest at severed and abandoned storm utility pipe. The new line was installed farther north by the Town in 2016.

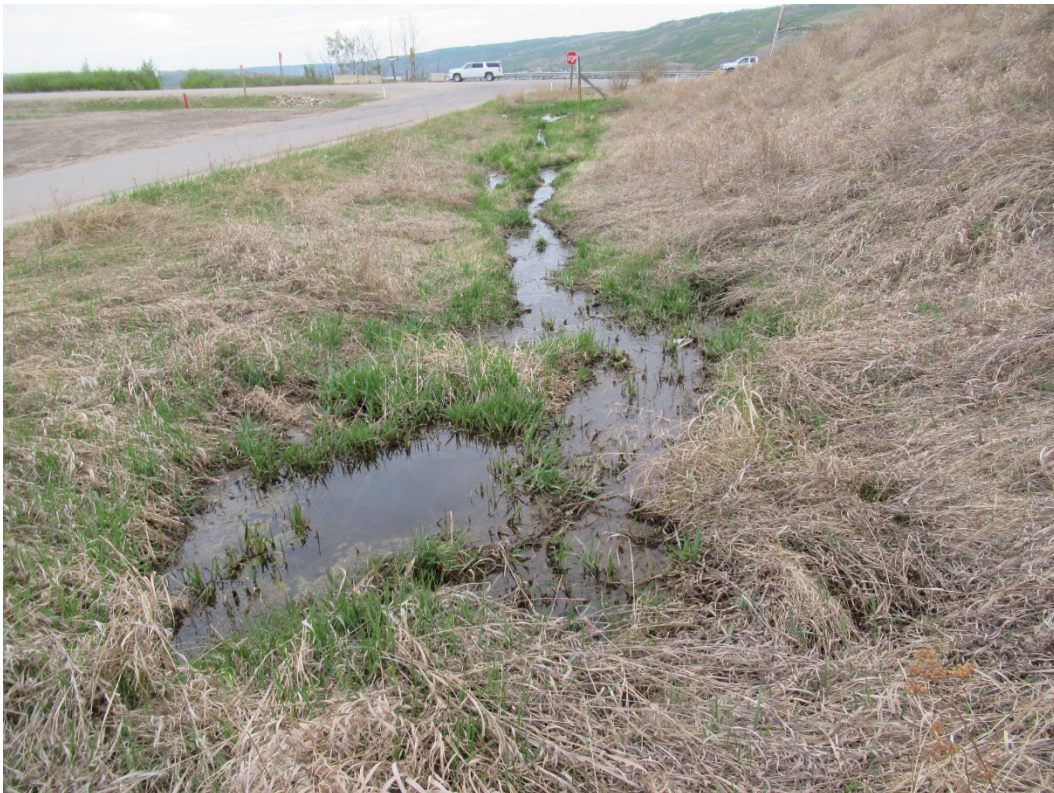
Photo 12: Looking northeast at seepage from 99 Avenue southeast ditch.

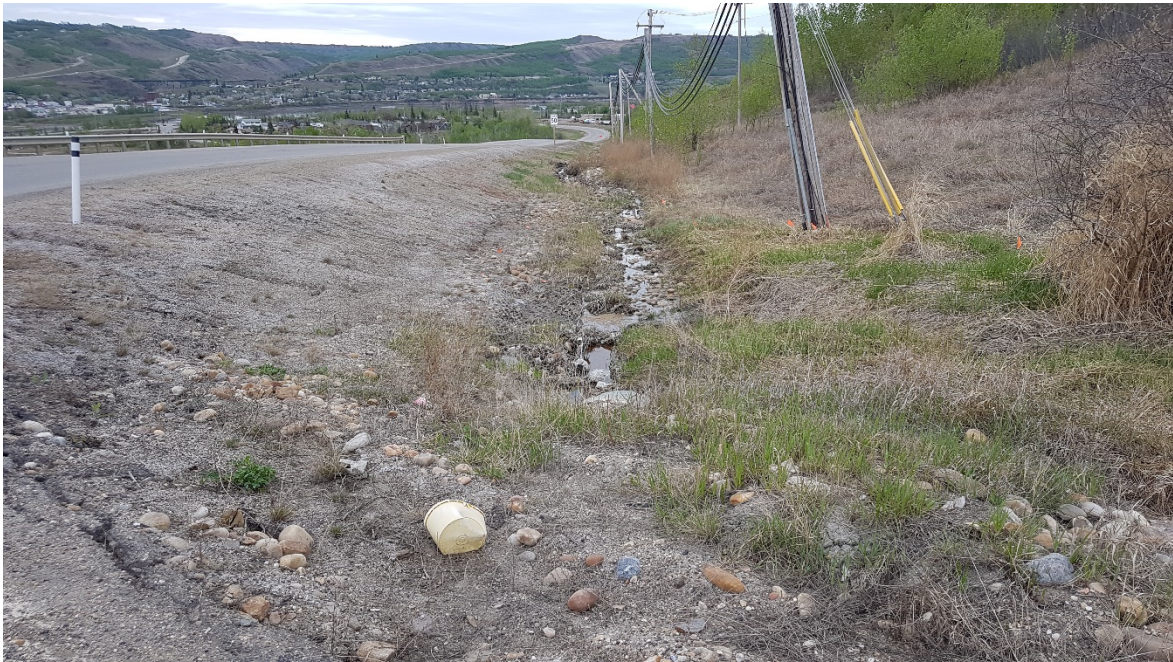
Photo 13: Looking southeast from culvert outlet at 99 Avenue. Note leaning posts and damaged gabion basket ditch lining.

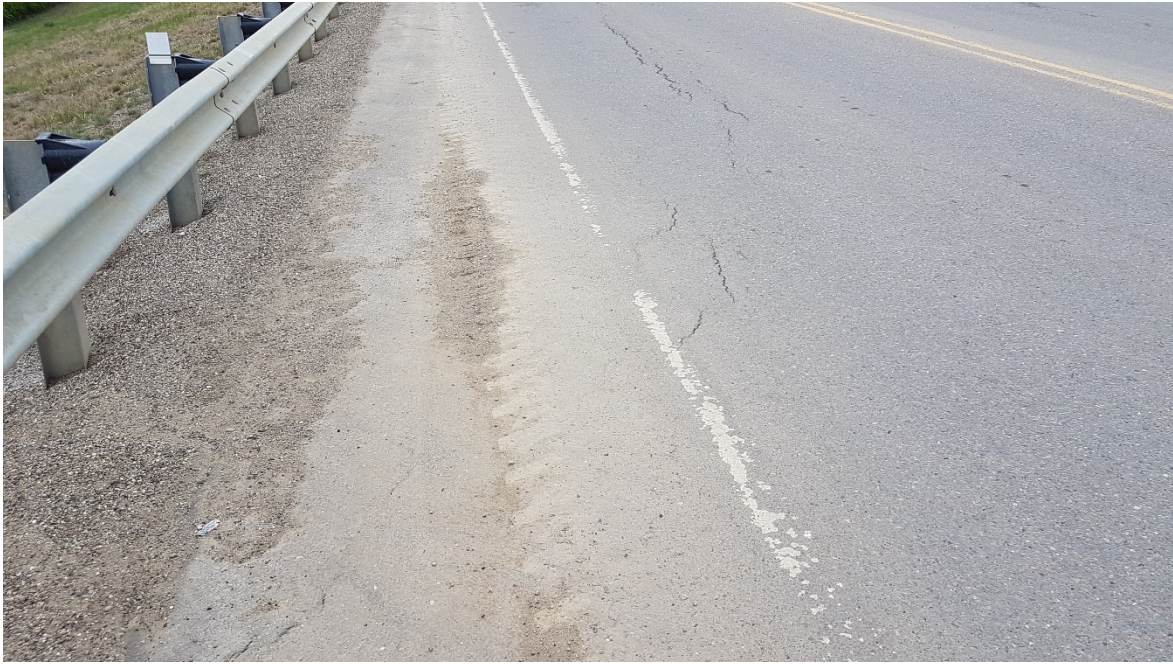
Photo 15: Cracking forming in ACP at the guardrail on the southeast side of 99 Avenue intersection. Crack is coincident with previous semi-active slide scarp.

- Road maintenance should continue as necessary to maintain a safe roadway surface and may consist of milling, patching, and crack sealing of the ACP.
- Routine inspection of the roadway to confirm that retrogression has not impacted public safety on the roadway.

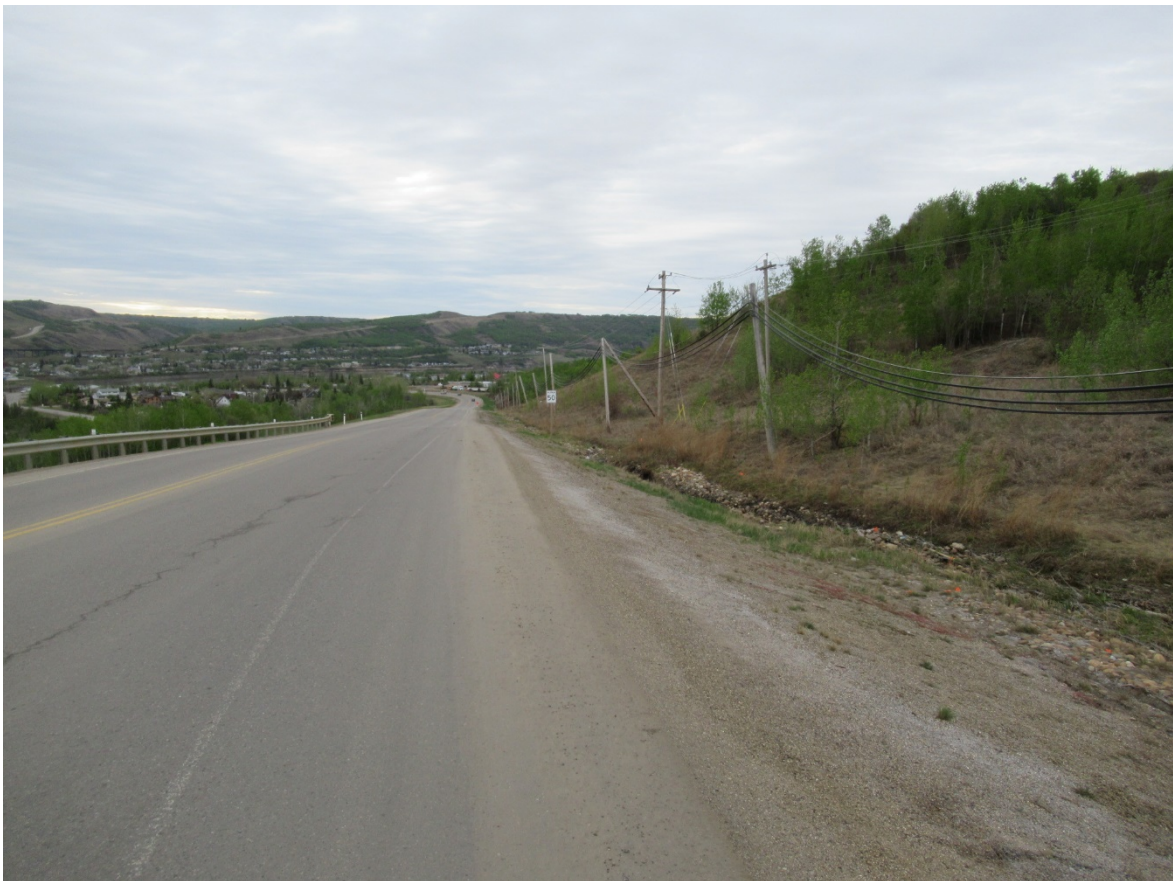
Photo 16: Looking southeast at continuation of crack from Photo 15.

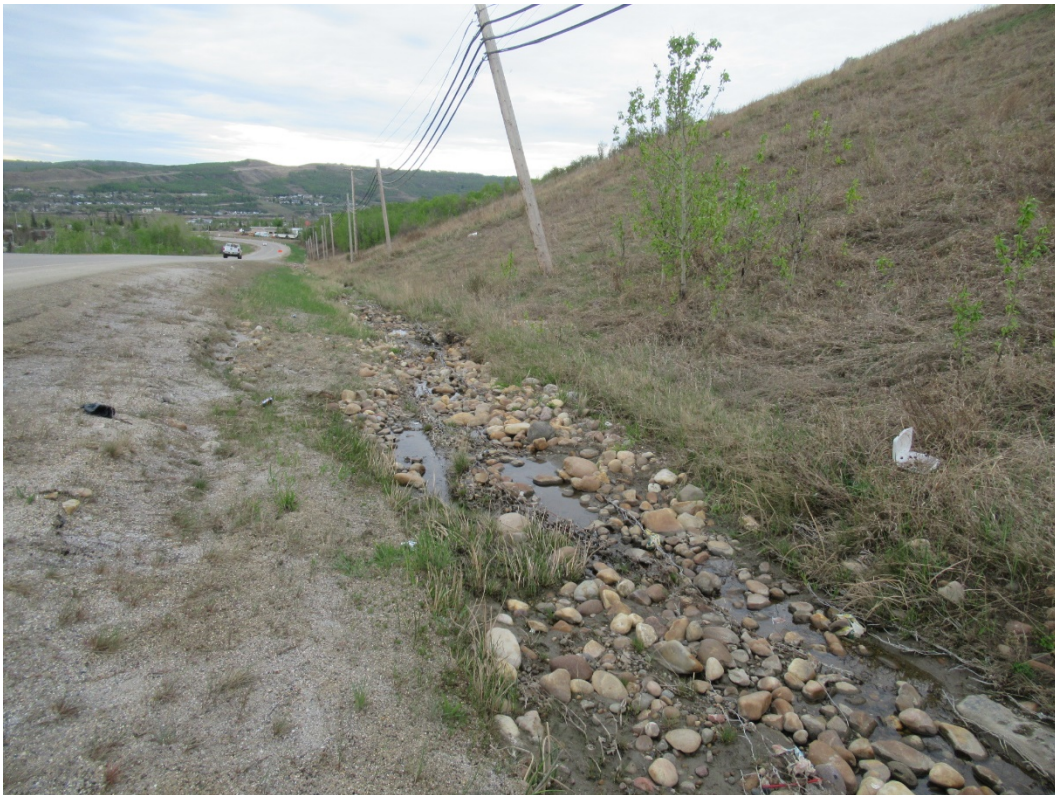
Photo 17: Looking southeast at damaged gabion basket in ditch bottom and leaning power pole

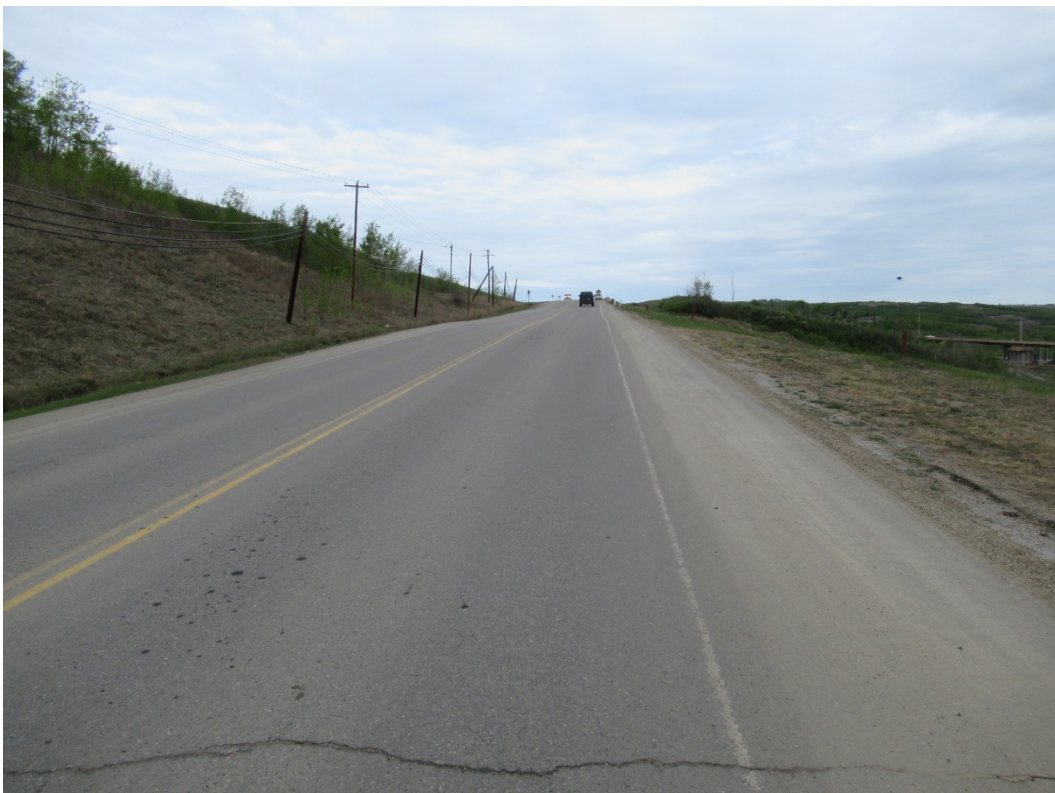
Photo 18: Looking northwest at previous scarp crack faintly visible in NBL through 2016 patch.

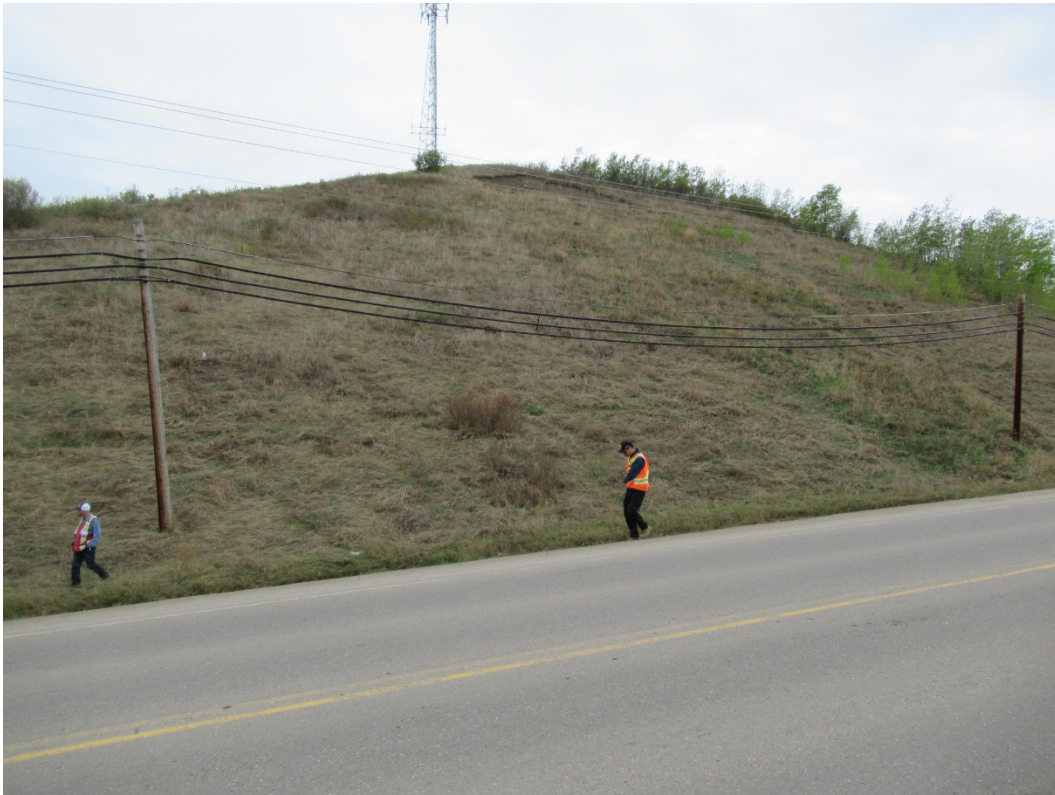
Photo 19: Looking west at skin slide in Hwy 2 backslope below communications tower.

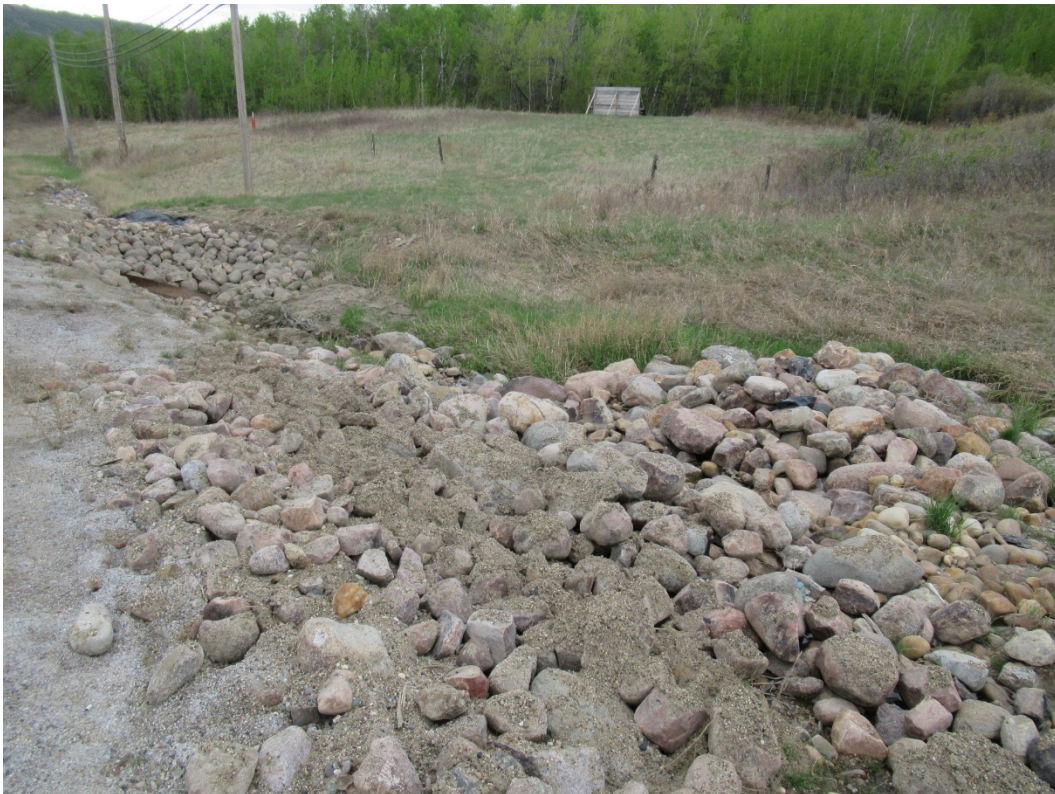
Photo 20: Looking south at riprap pile in ditch north of 500 mm SWSP centerline culvert inlet.

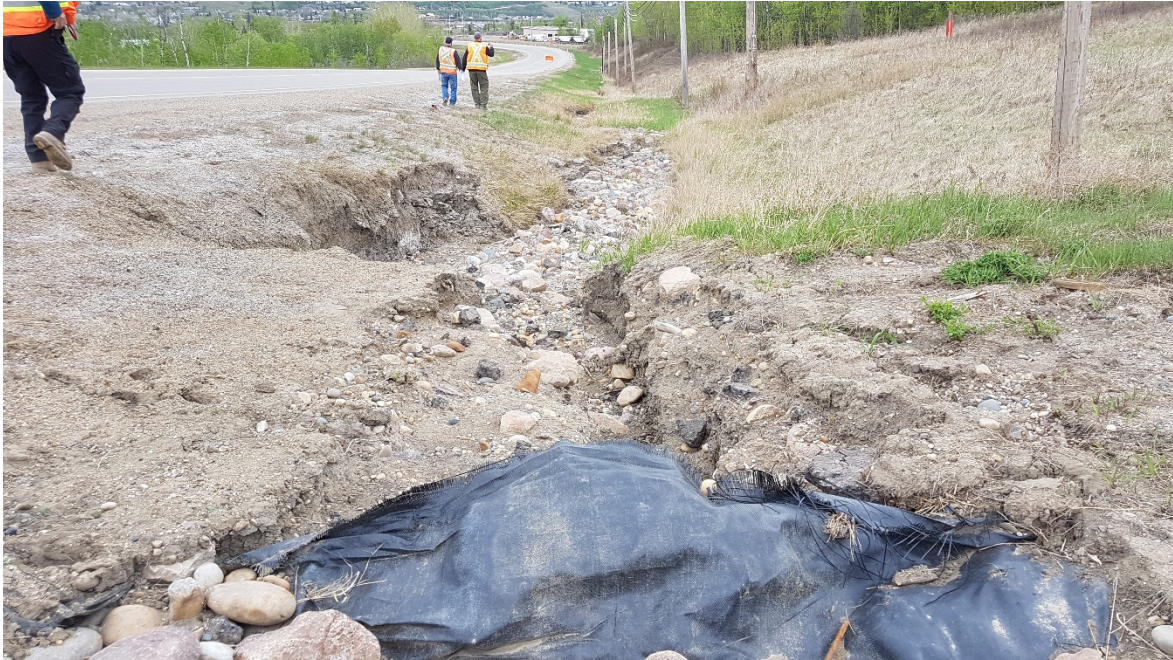
Photo 21: Looking southeast at erosion in ditch below inlet of 500 mm SWSP centerline culvert.

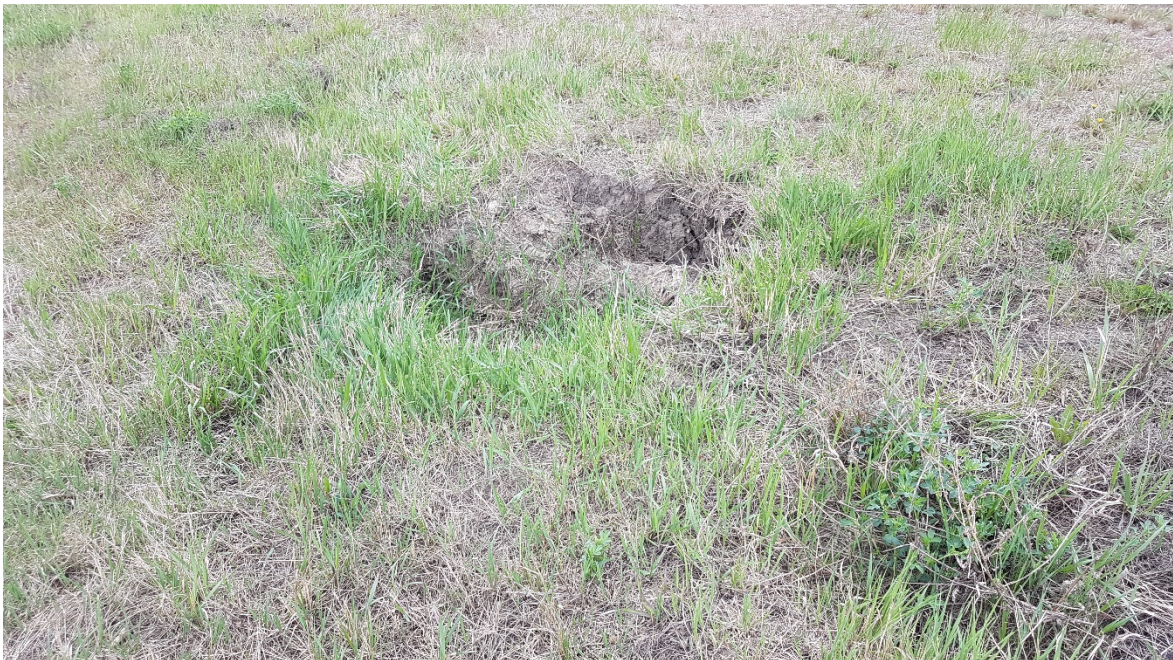
Photo 22: Looking north at a sink hole above the 500 mm SWSP centreline culvert on the sideslope of the NBL of Hwy 2 off-ramp.
