**ALBERTA TRANSPORTATION
GEOHAZARD ASSESSMENT PROGRAM
PEACE REGION – PEACE-HIGH LEVEL
2019 INSPECTION**

THURBER ENGINEERING LTD.

Site Number	Location	Name	Hwy	km
PH009-3	Peace River	Shaftesbury Trail - Shop Slide	Old 2:02	0.025
			684:02	30.990
Legal Description		UTM Co-ordinates		
SW¼ 31-083-21 W5M		11V E 480339	N 6232158

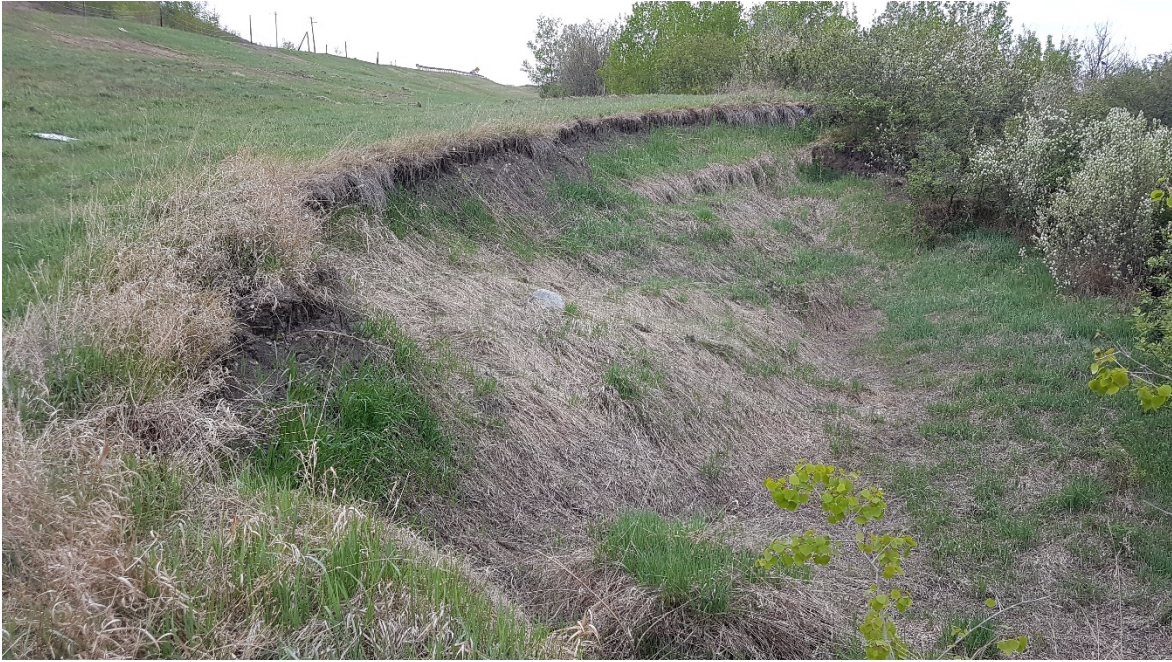
Photo 23: Looking northwest along the backscarp of the landslide downslope of the Hwy 2 off-ramp (below SP09-11).

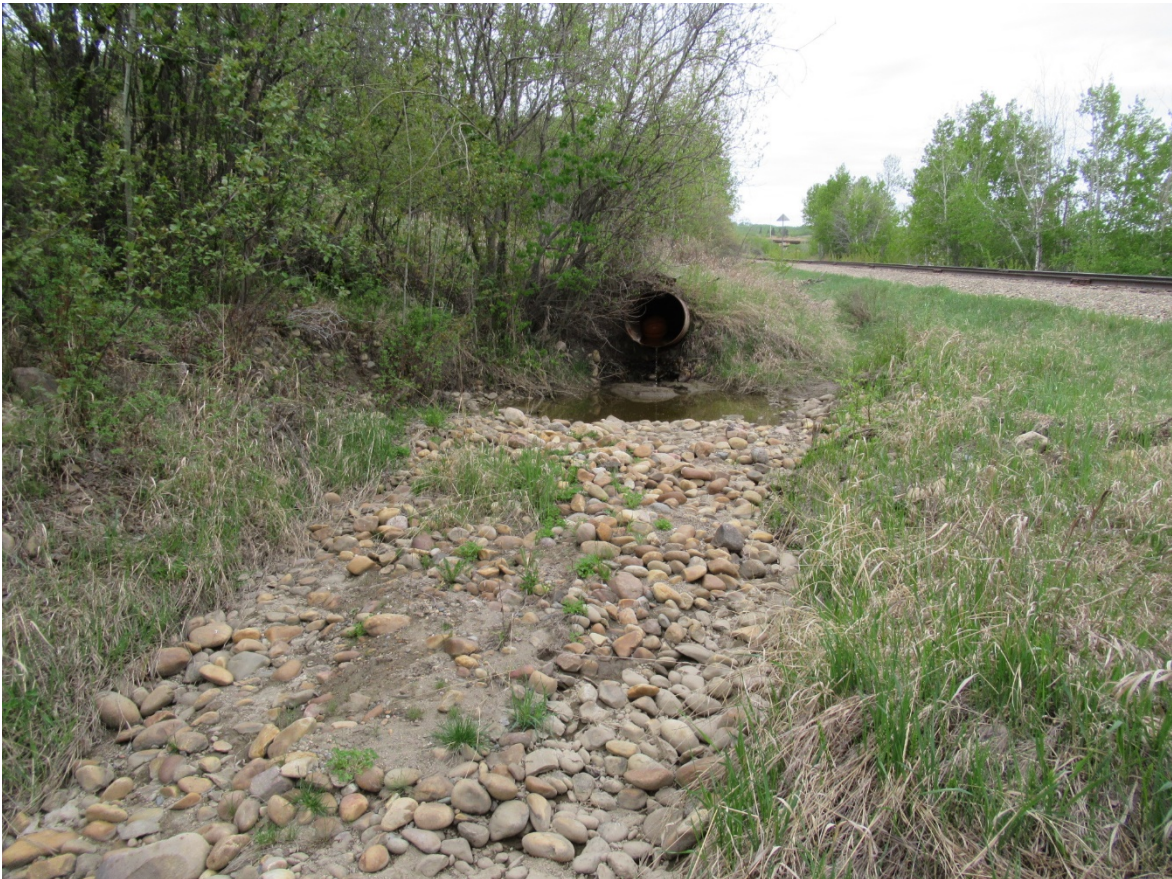
Photo 24: Looking northwest where water has previously ponded below the hanging outlet of the 600 mm CSP that connects to the 500 mm SWSP centreline culvert.

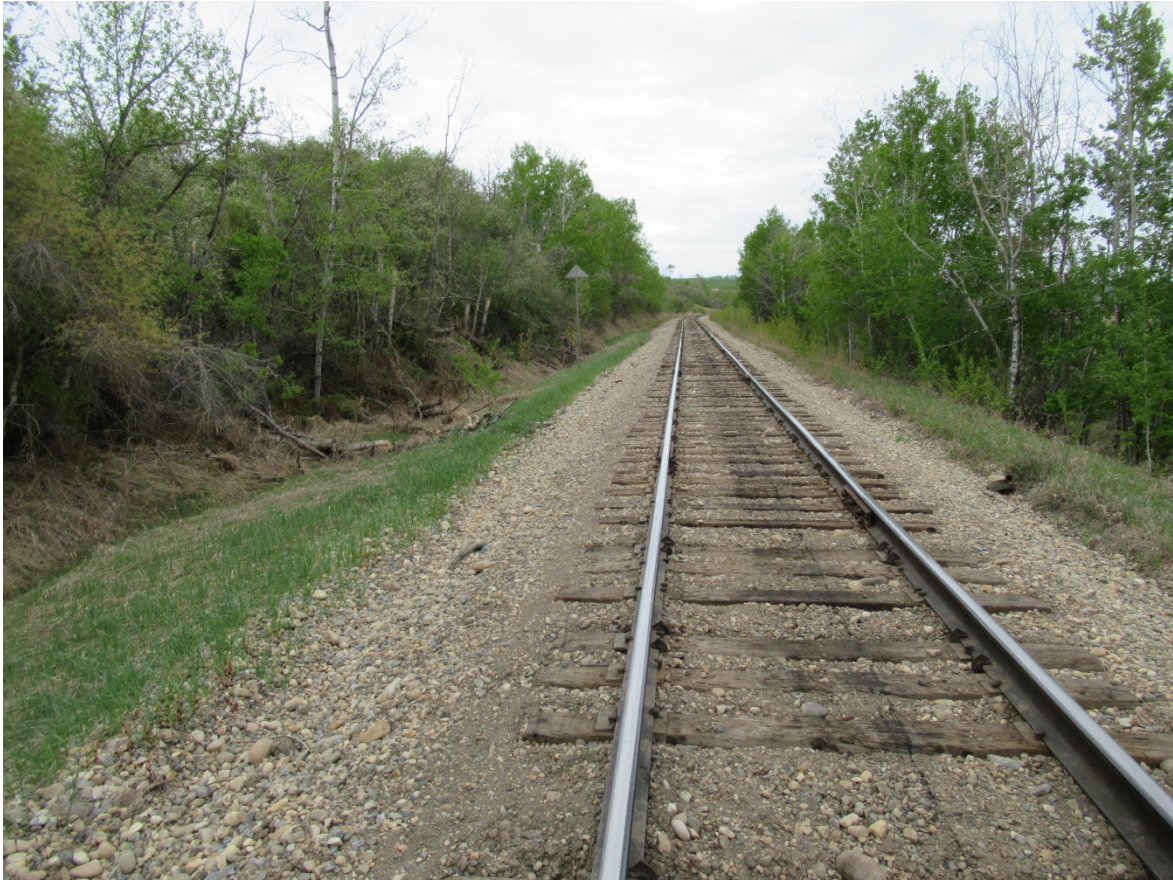
Photo 25: Looking northwest along toe bulge of the landslide below SP09-11 (Photo 23) at the west side of the CNR track.

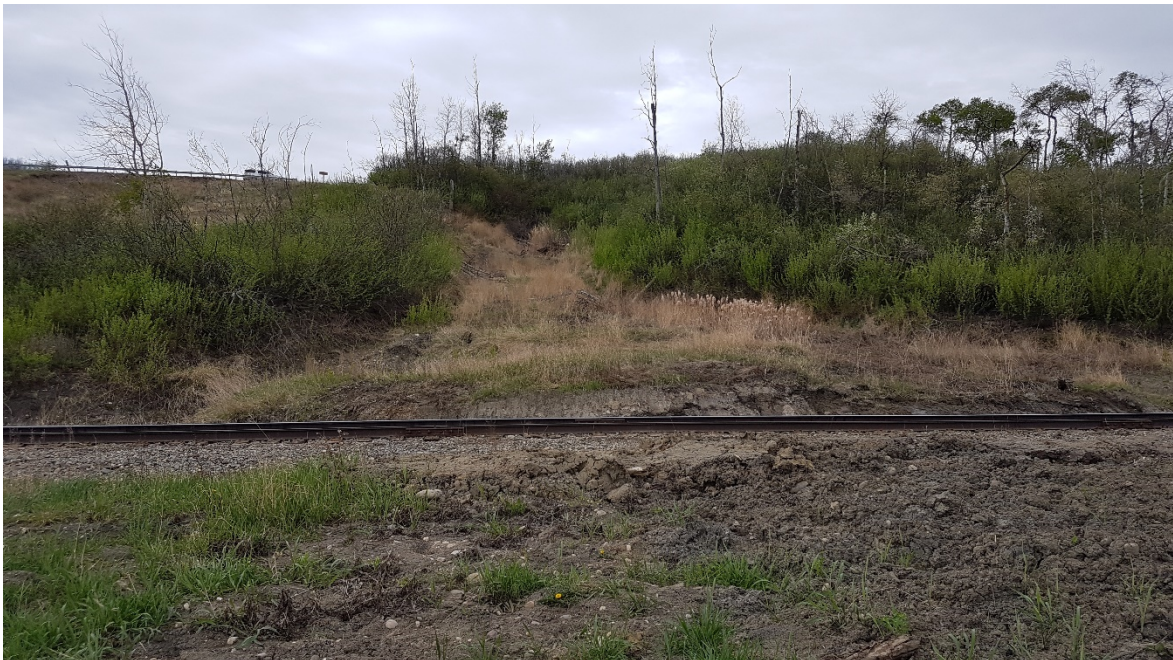
Photo 26: Looking southwest at the debris flow material immediately upslope of the CNR line. Material appears to have been recently excavated.

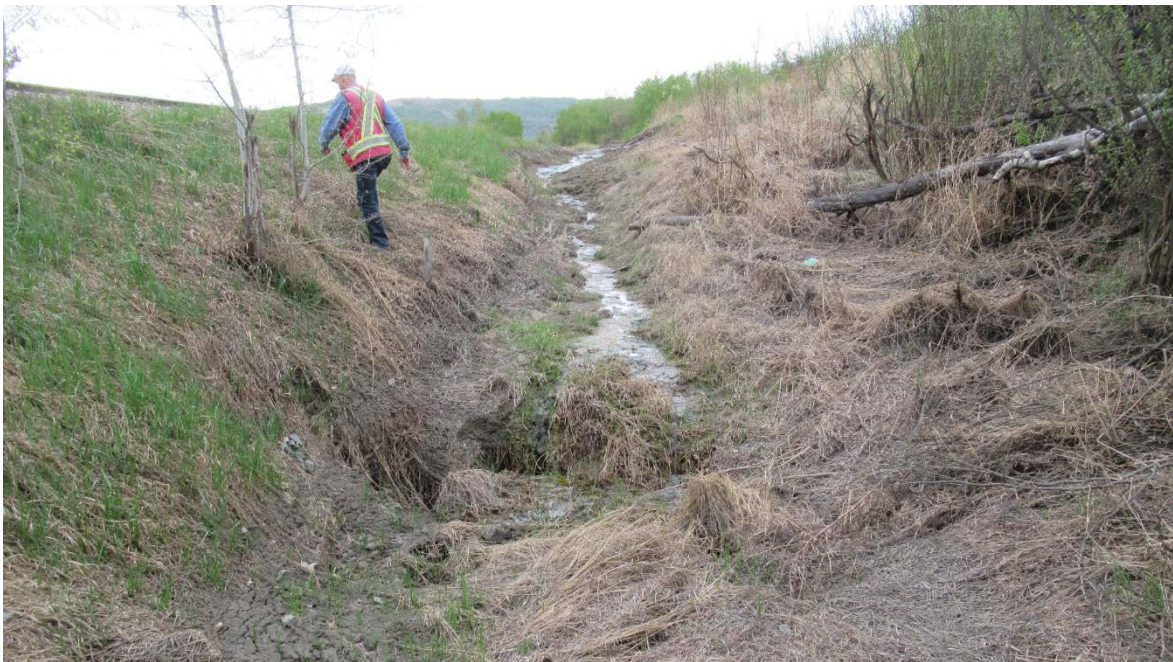
Photo 27: Looking southwest at seepage/ditch flow around debris fan flowing into nearly buried culvert below CNR tracks.
