**ALBERTA TRANSPORTATION
GEOHAZARD ASSESSMENT PROGRAM
PEACE REGION – PEACE-HIGH LEVEL
2020 INSPECTION**

THURBER ENGINEERING LTD.

| Site Number | Location | Name | Hwy | km |
|---|---|---|---|---|
| PH009-3 | Peace River | Shaftesbury Trail - Shop Slide | Old 2:02 | 0.025 |

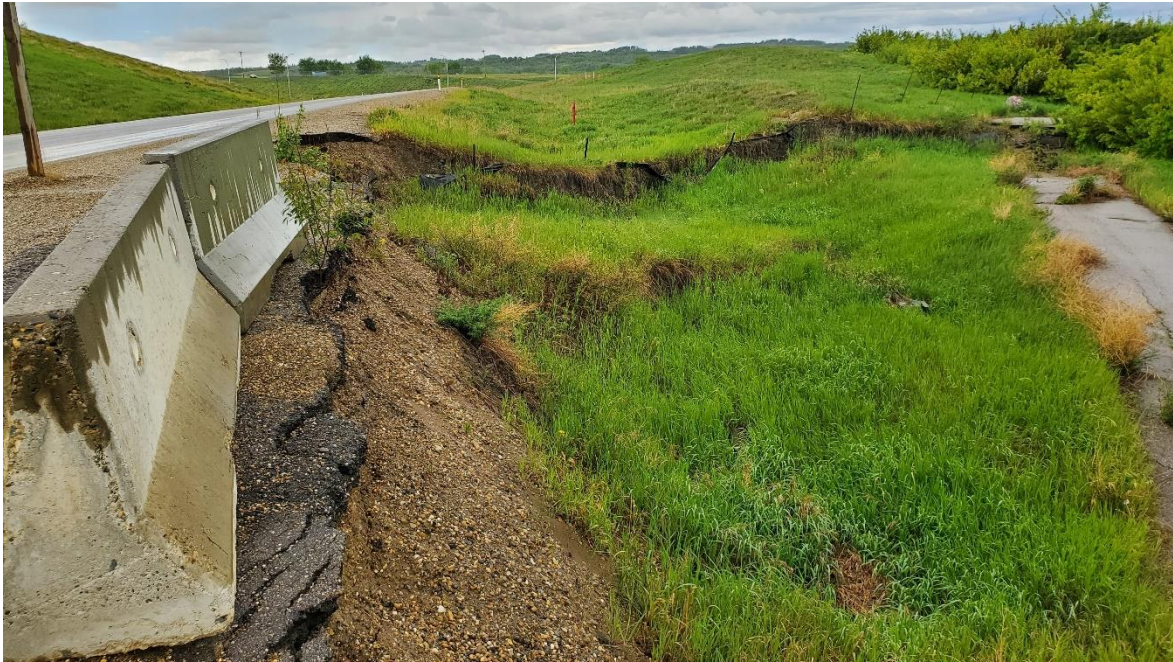
Photo 1: Looking northwest along shoulder of the Hwy 2 off-ramp on the east side of 99 Avenue intersection.

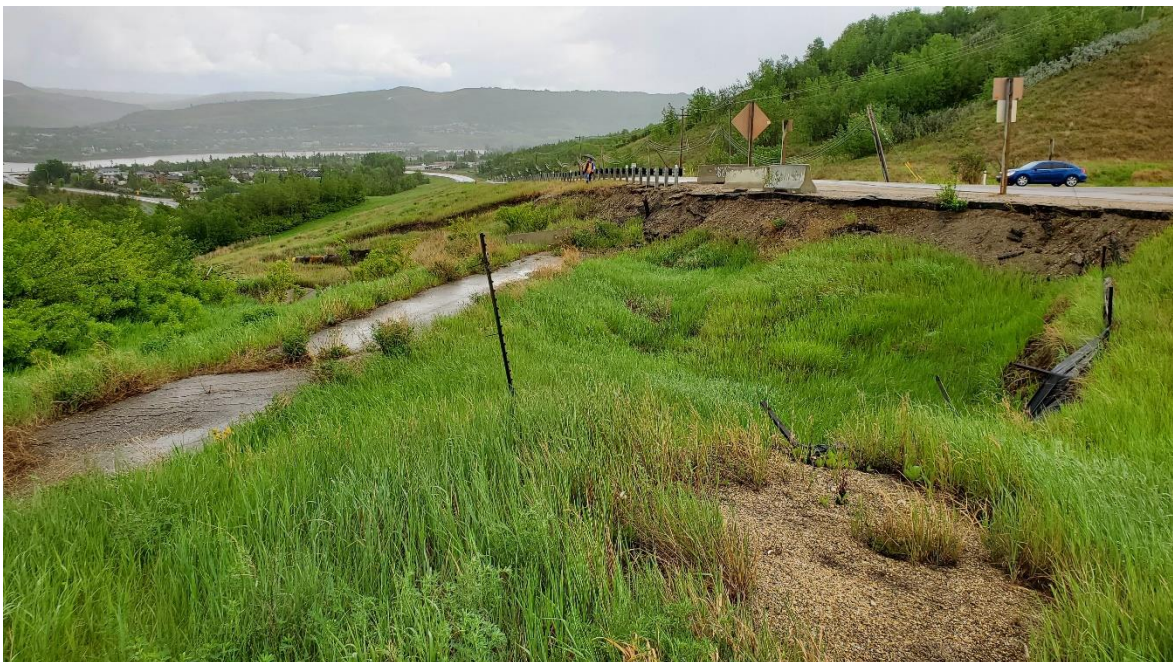
Photo 2: Looking southeast towards the backscarp along the east shoulder of the Hwy 2 off-ramp.

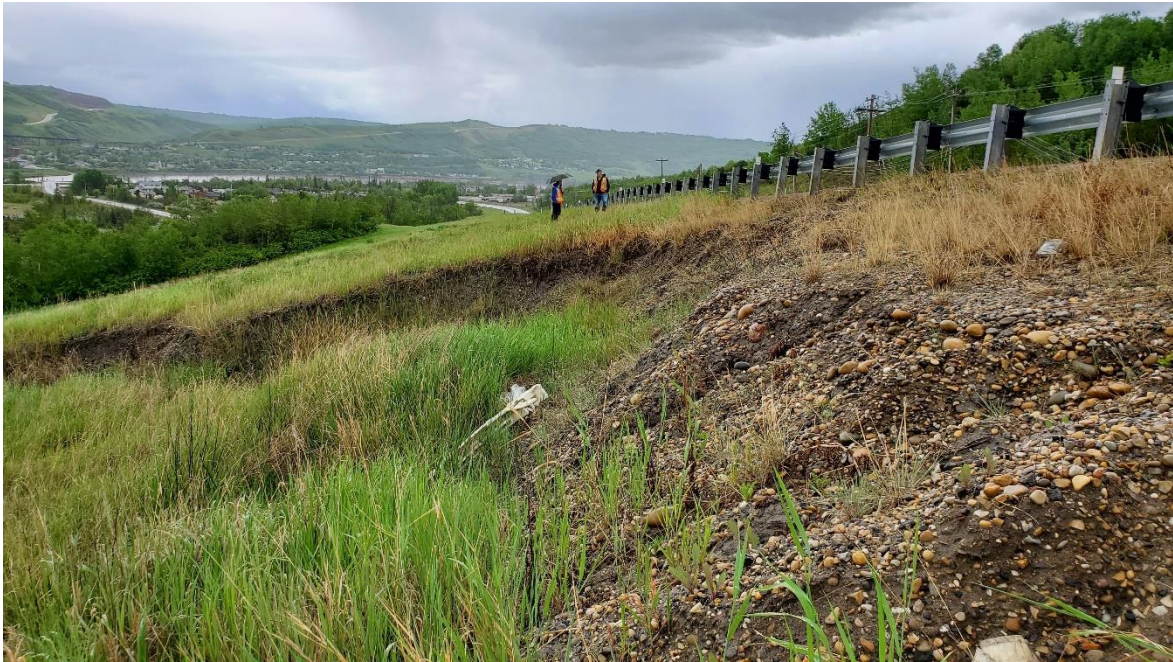
| Observations: | Description | Worsened? |
|---|---|---|
| <input checked="" type="checkbox"/> Pavement Distress | <p>Pedestrian pathway destroyed by movement. The backscarp of the slide feature along the NBL sideslope of the Hwy 2 off-ramp has retrogressed further into the roadway shoulder and cracking extends into the lane further SE.</p> | <input checked="" type="checkbox"/> |

Photo 3: Looking southeast along the NBL shoulder of the Hwy 2 off-ramp at retrogressing backscarp.

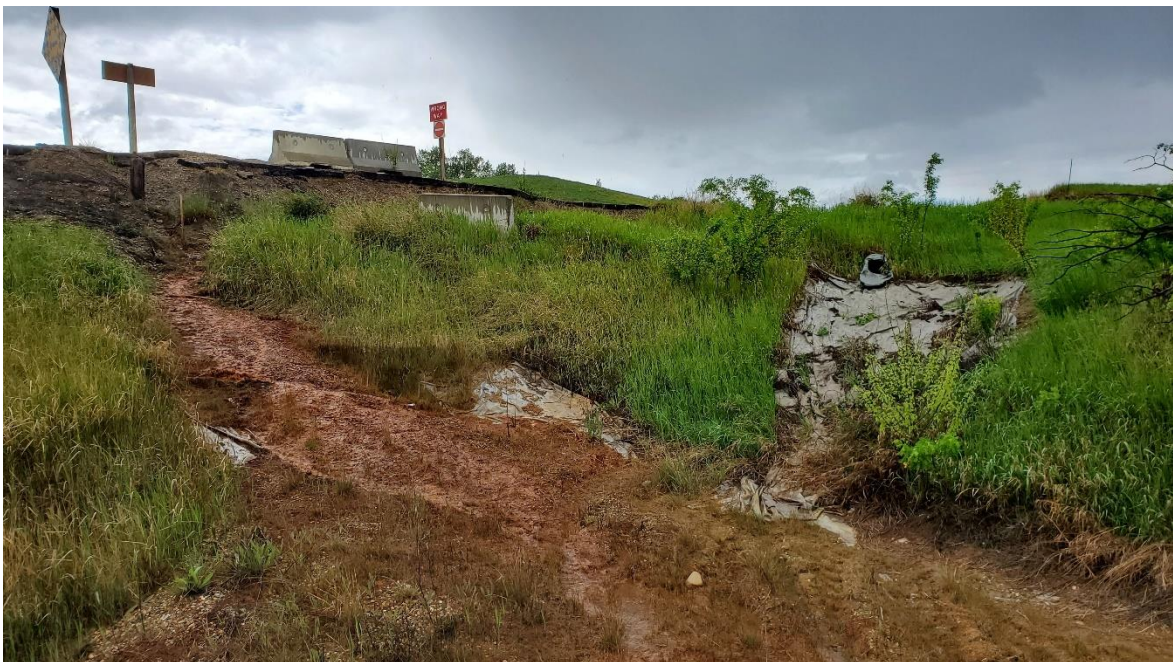
Photo 4: Looking west at springs flowing from the embankment below the Hwy 2 off-ramp at 99 Avenue.

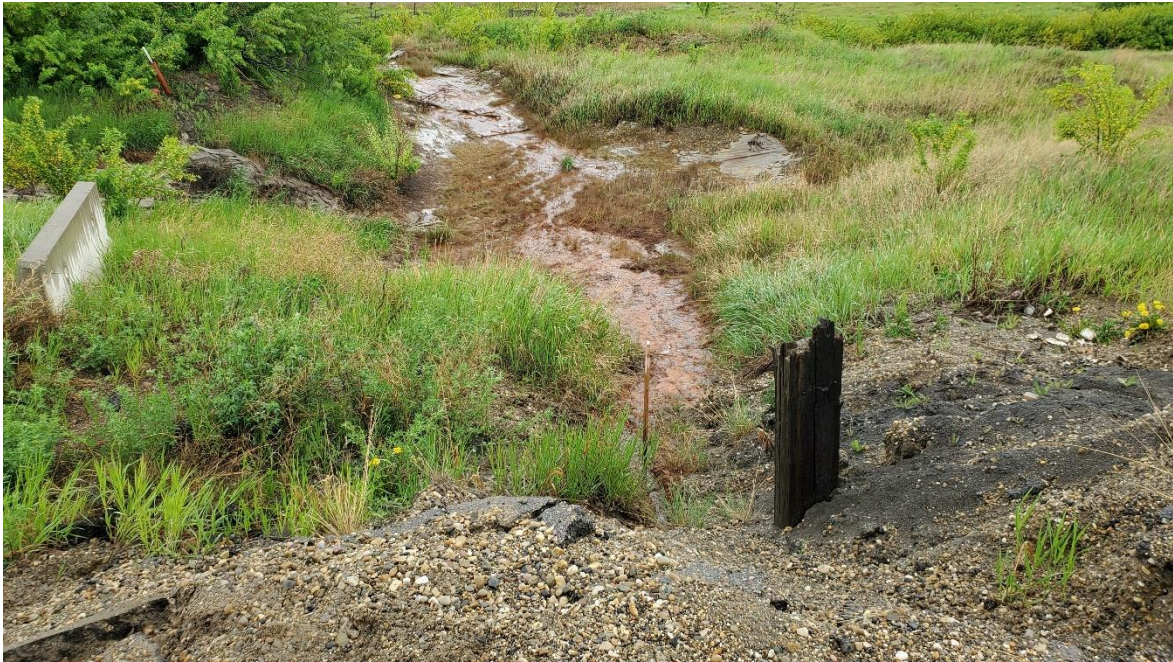
| Observations: | Description | Worsened? |
|---|---|---|
| <input checked="" type="checkbox"/> Seepage | <p>Seepage emanating from several gravel seams within the Highway 2 off-ramp embankment is shedding water over the re-graded area.</p> <p>There is a spring flowing in the southeast ditch bottom of 99 Avenue.</p> | <input type="checkbox"/> |

Photo 5: Looking east at seepage from gravel layer in the Hwy 2 off-ramp sideslope draining onto the geomembrane lining.

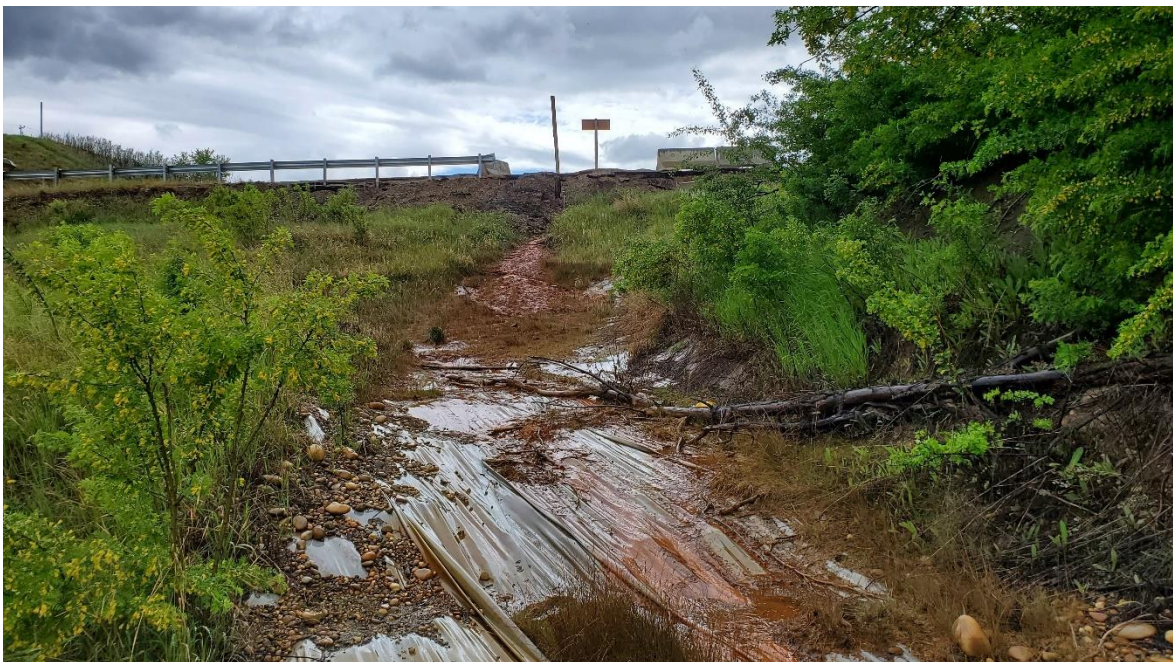
Photo 6: Looking west along the membrane installed by the Town below the 99 Avenue intersection.

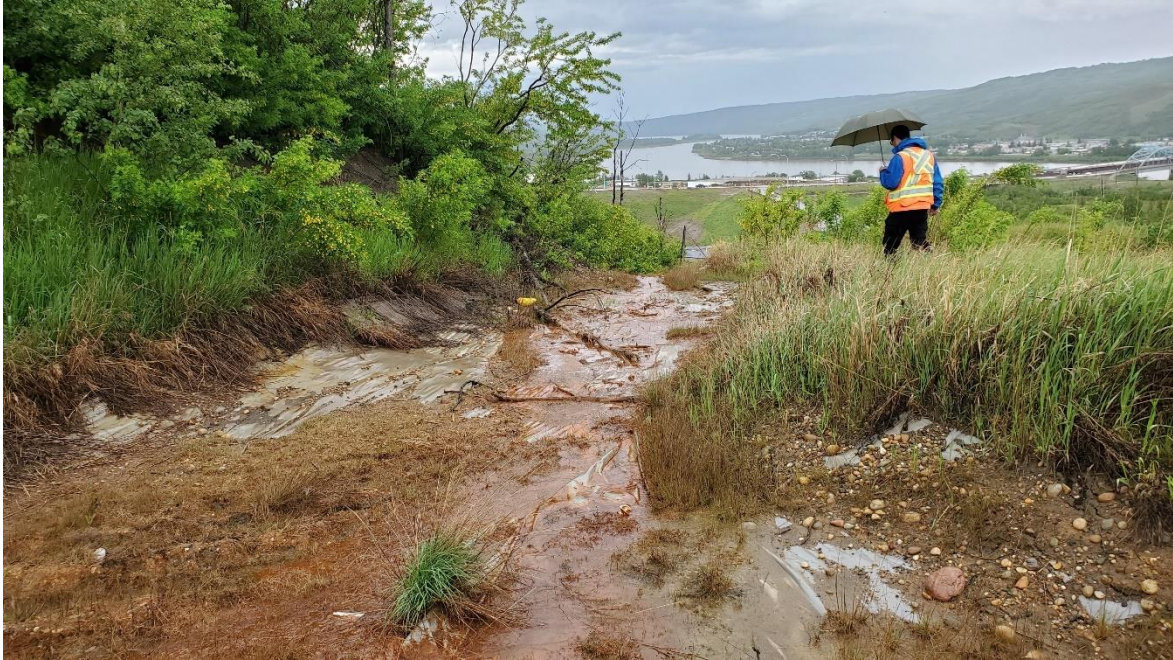
Photo 7: Looking northeast at lower portion of the geomembrane installed by the Town below the 99 Avenue intersection.

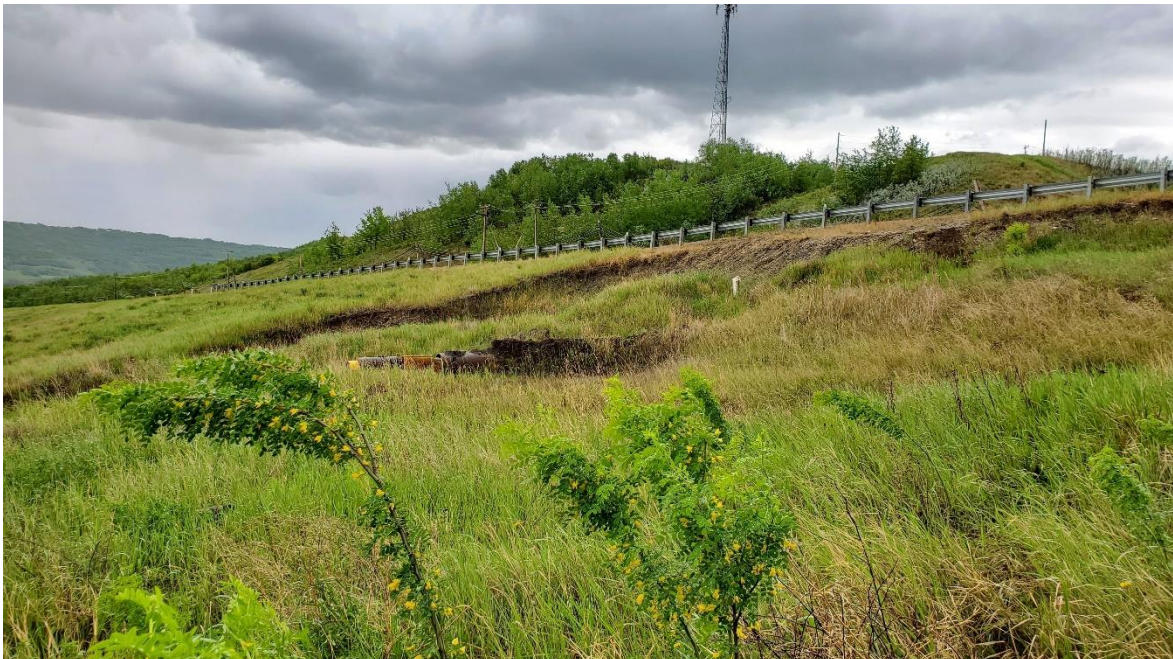
Photo 8: Looking south at backscarp of the Shop Slide below 99 Avenue intersection.

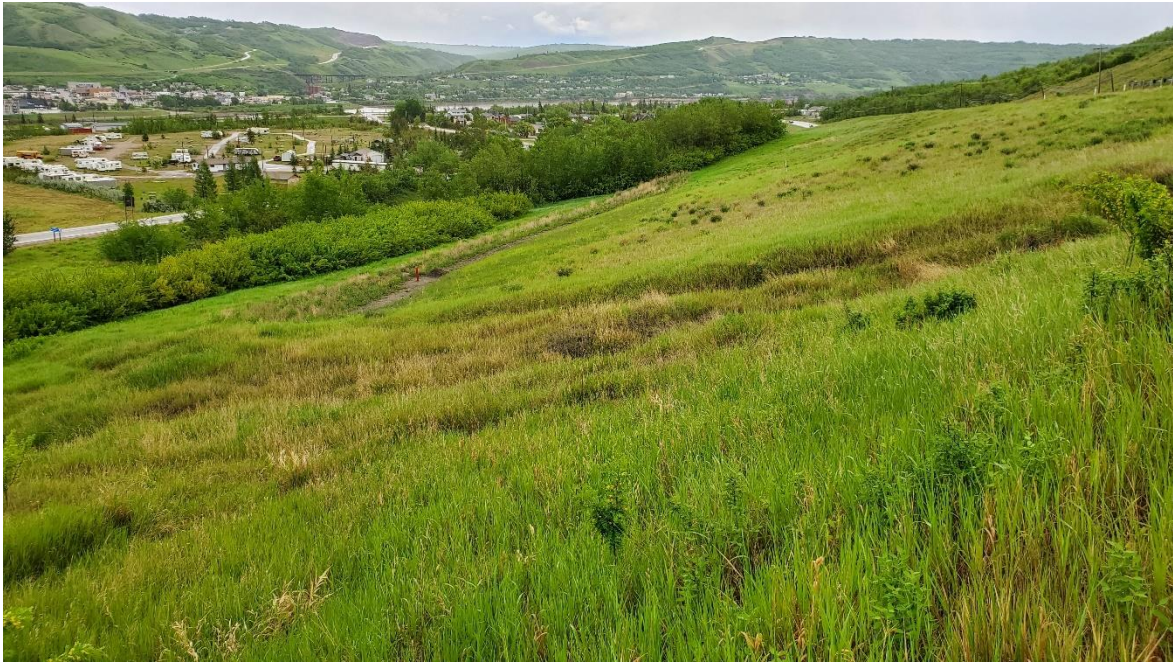
Photo 9: Looking southeast at the debris fan of the Shop Slide. New SI19-5 can be seen at left hand edge of photo on bench constructed for installation.

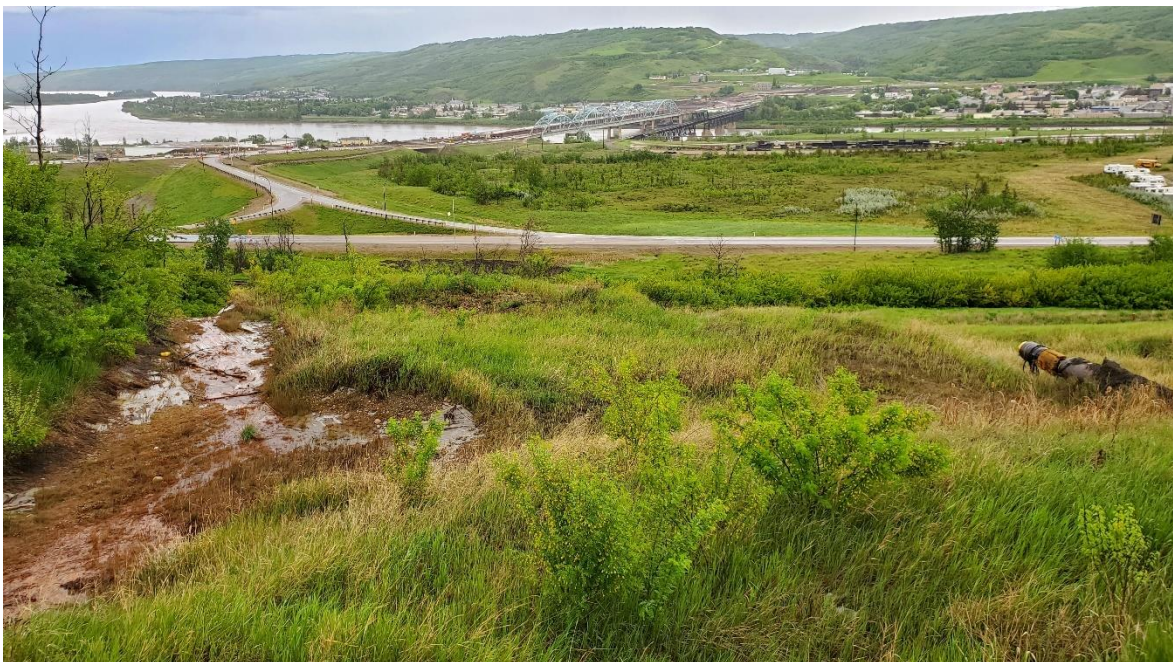
Photo 10: Looking east at the upper portion of the slide and down toward the debris fan at the toe.

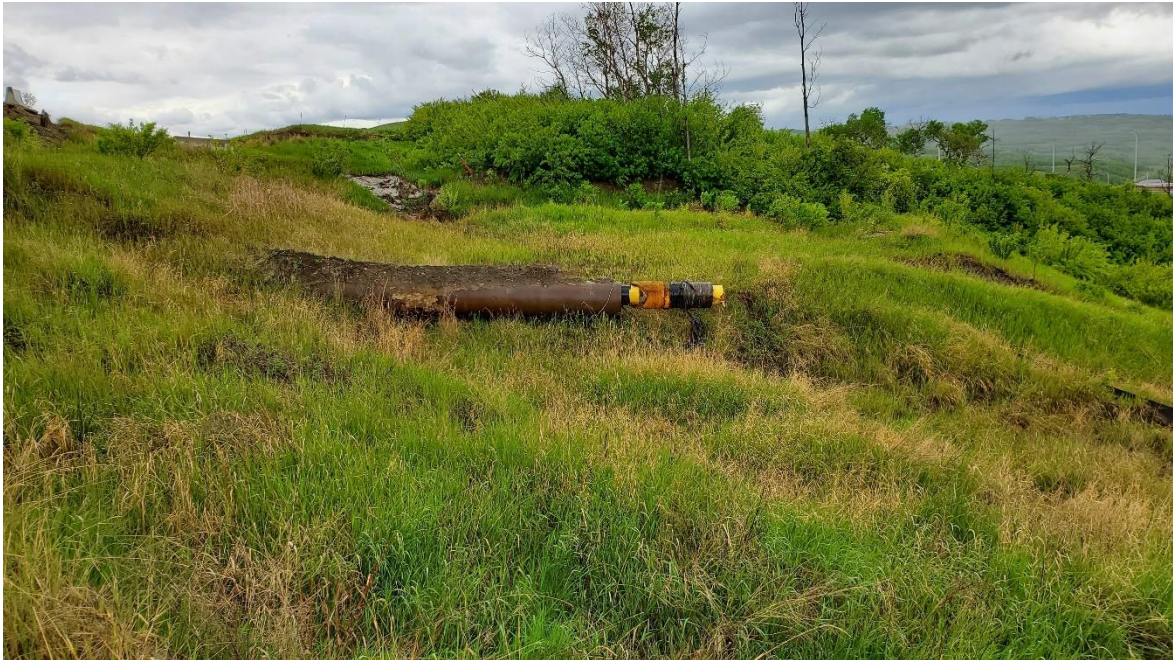
Photo 11: Looking northwest at severed and abandoned storm utility pipe. The new line was installed farther north by the Town in 2016.

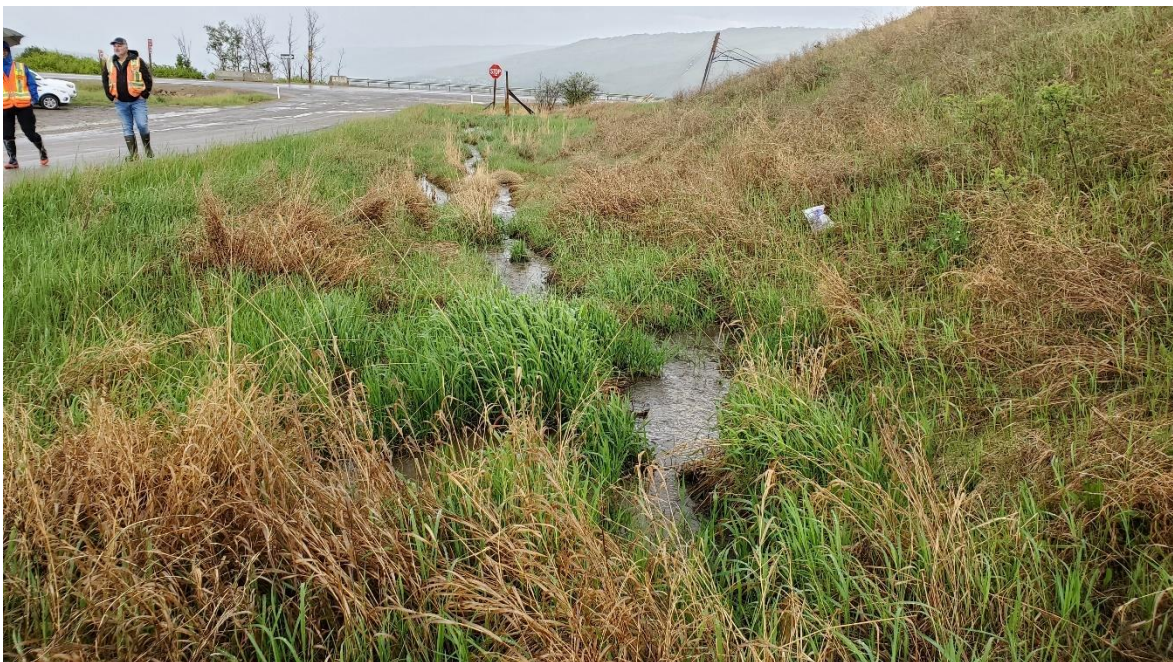
Photo 12: Looking northeast at seepage from 99 Avenue southeast ditch.

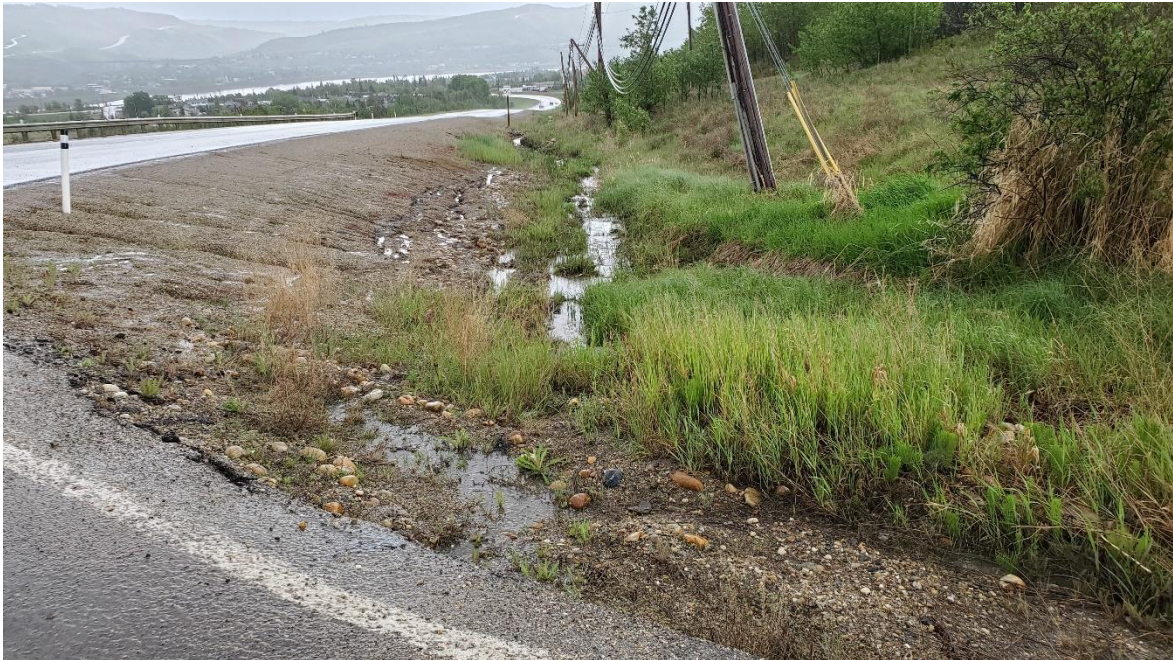
Photo 13: Looking southeast from culvert outlet at 99 Avenue. Note leaning posts and damaged gabion basket ditch lining.

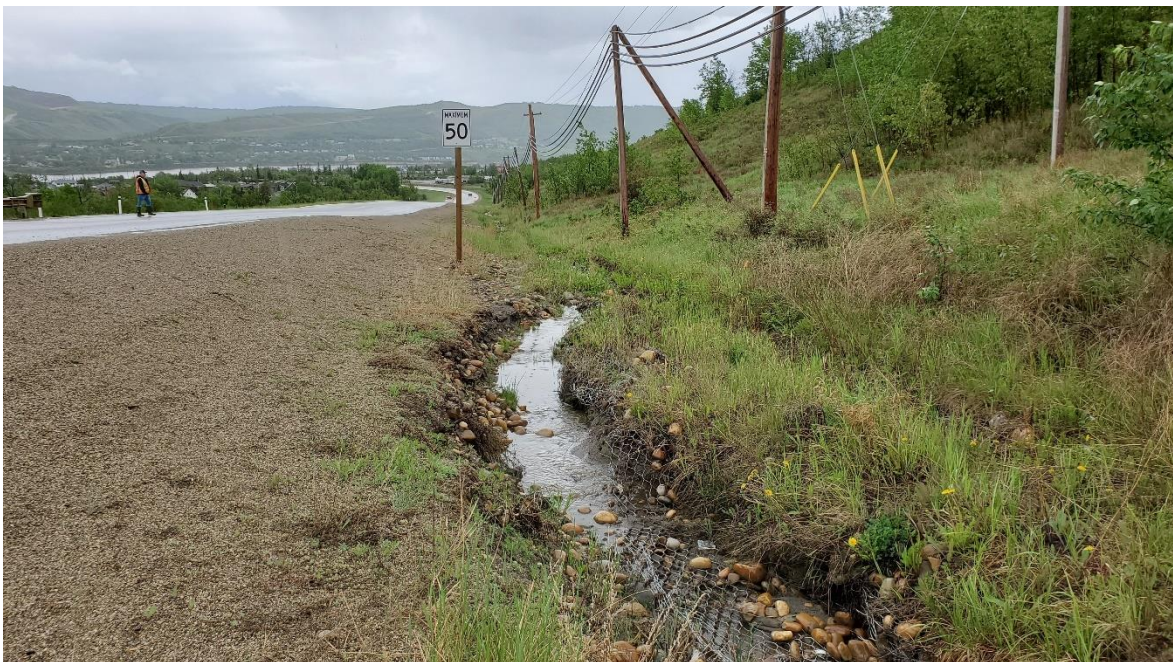
| Observations: | Description | Worsened? |
|---|---|---|
| <input checked="" type="checkbox"/> Erosion | <p>There is on-going erosion in the flow slide mass.</p> <p>The gabion mattresses in the SBL ditch of the Highway 2 off-ramp are being undermined and scours are forming along their flanks. The ditch block southeast of the 500 mm diameter SWSP centerline culvert inlet has been compromised.</p> <p>A new erosion gully has formed in the SBL ditch in the vicinity of the new water/sewer crossing.</p> | <input checked="" type="checkbox"/> |

Photo 14: Looking southeast at the scour below gabion mattress in southeast ditch of Hwy 2 off-ramp.

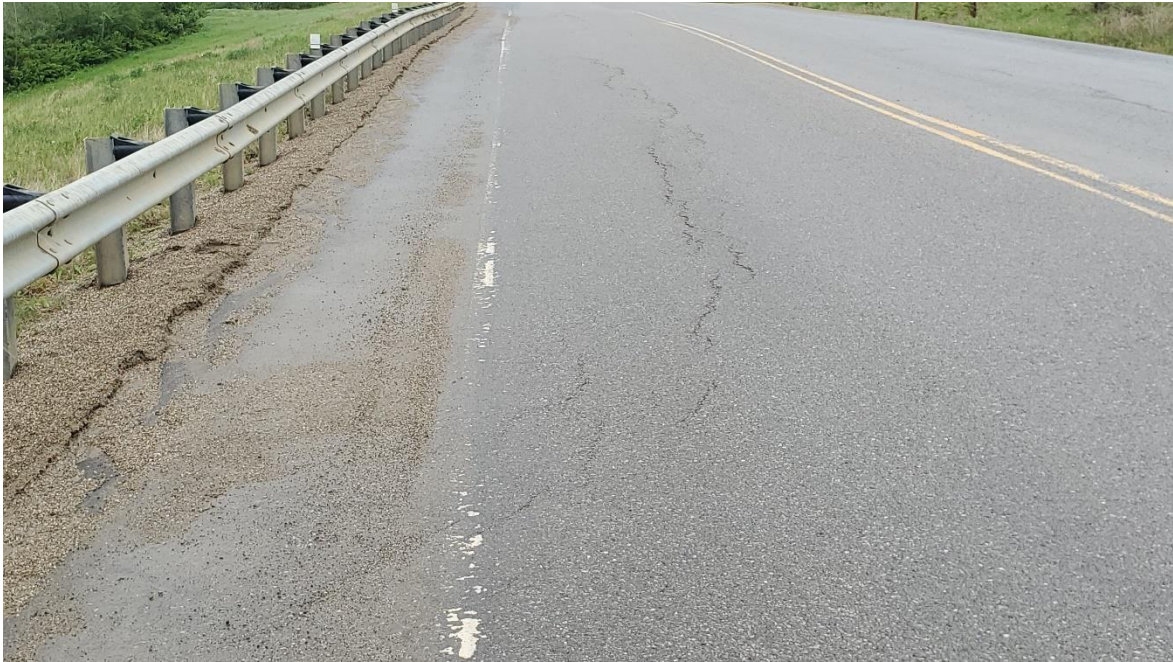
Photo 15: Cracking forming in ACP at the guardrail on the southeast side of 99 Avenue intersection. Crack is coincident with previous semi-active slide scarp. It appeared to be slightly depressed on the guardrail side of the crack.

- Road maintenance should continue as necessary to maintain a safe roadway surface and may consist of milling, patching, and crack sealing of the ACP.
- Routine inspection of the roadway to confirm that retrogression has not impacted public safety on the roadway.

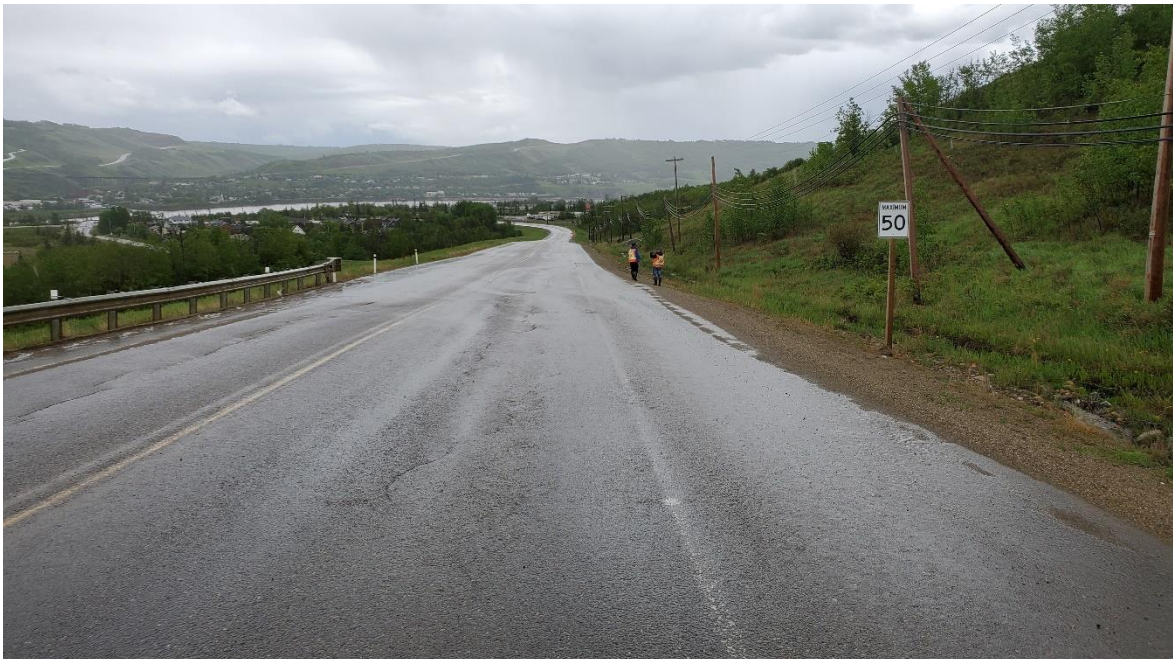
Photo 16: Looking southeast at continuation of crack from Photo 15.

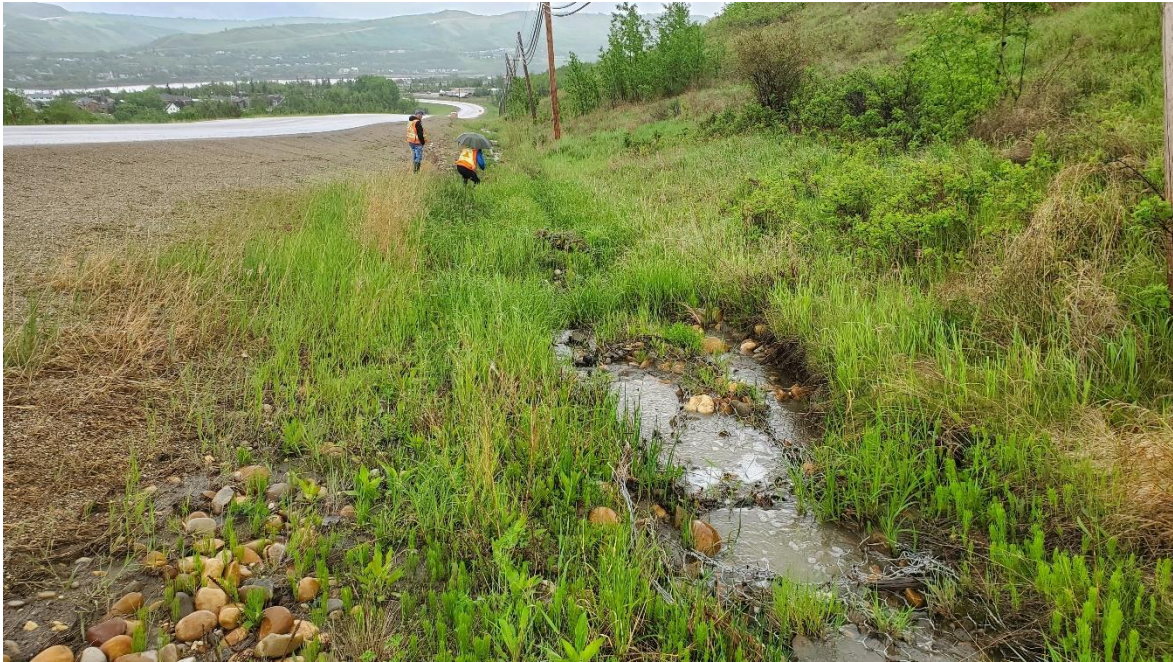
Photo 17: Looking southeast at damaged gabion basket in ditch bottom with leaning power poles in the background.

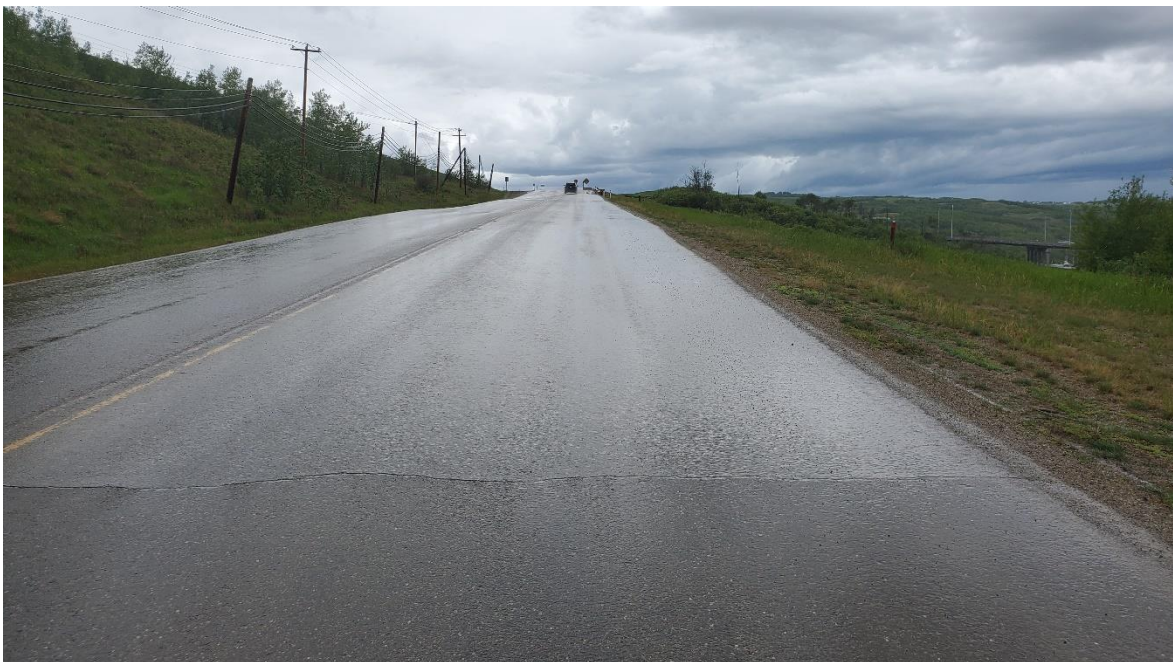
Photo 18: Looking northwest at previous scarp crack faintly visible in NBL through 2016 patch.

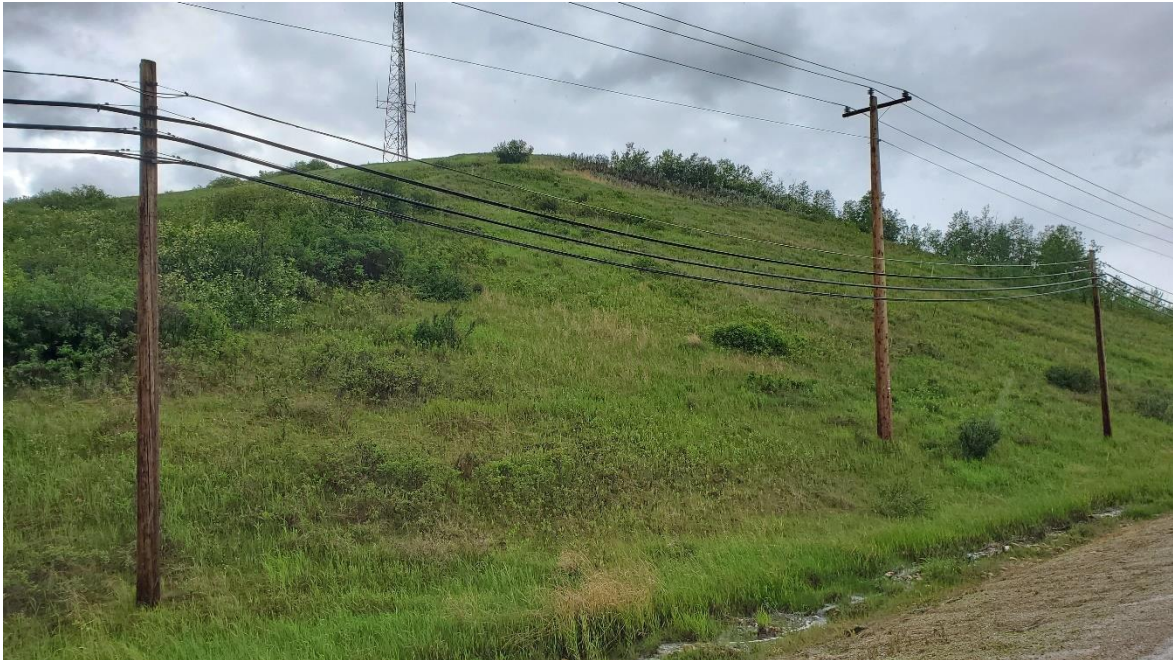
Photo 19: Looking west at shallow slide in Hwy 2 backslope below communications tower.

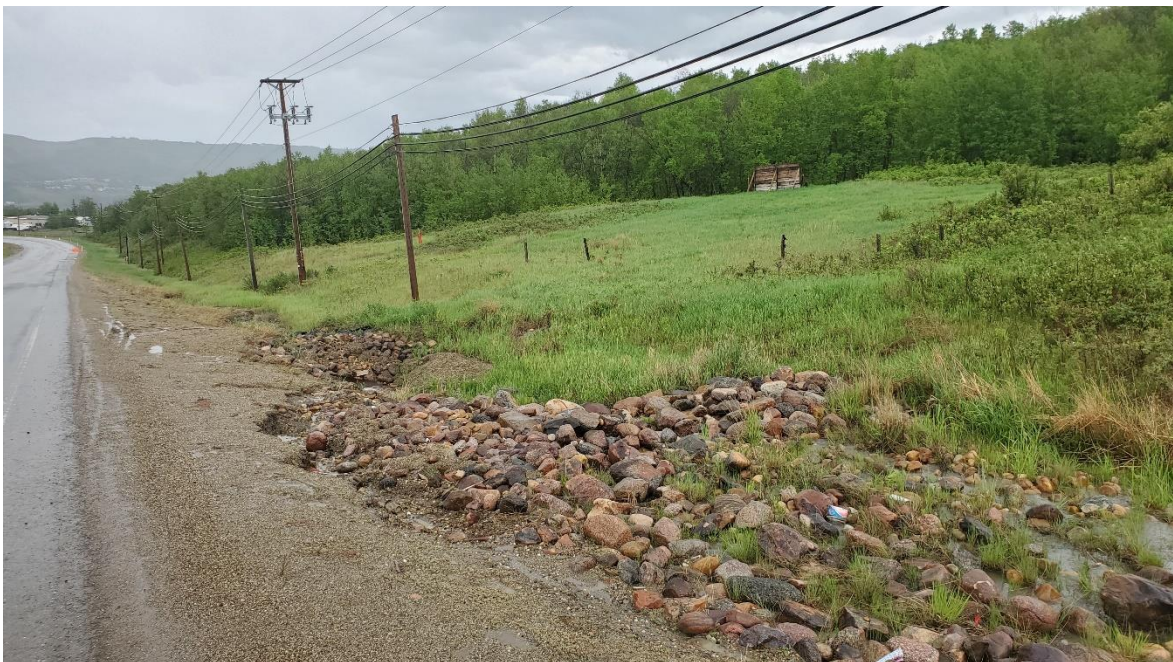
Photo 20: Looking south at riprap pile in ditch north of 500 mm SWSP centerline culvert inlet.

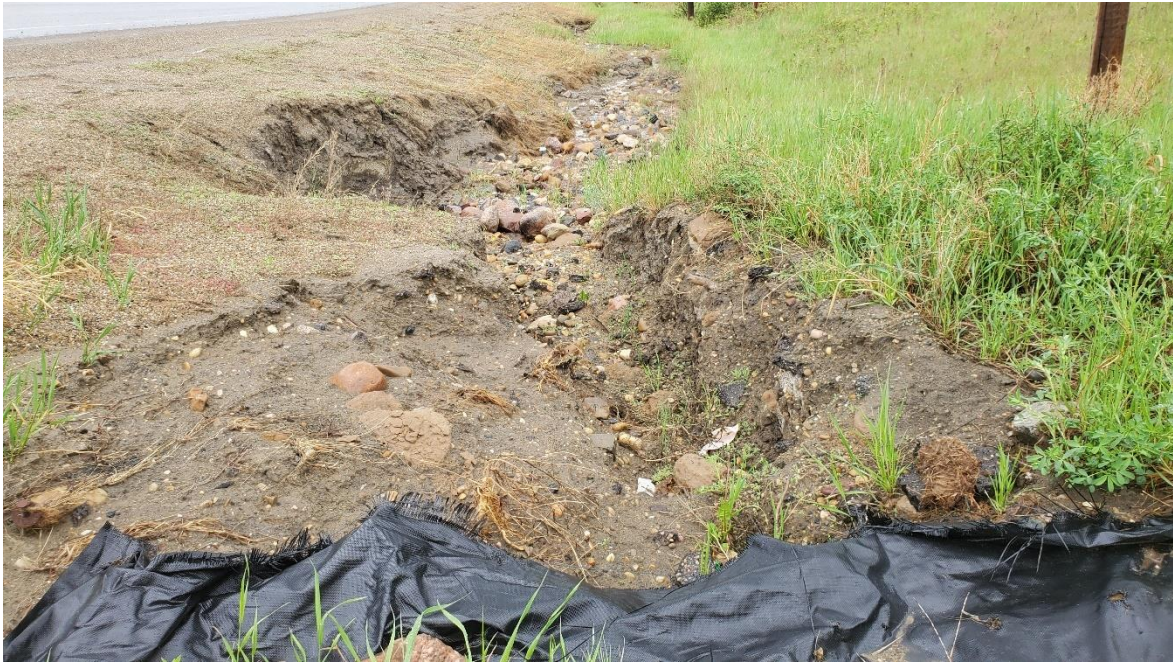
Photo 21: Looking southeast at erosion in ditch downslope inlet of 500 mm SWSP centerline culvert.

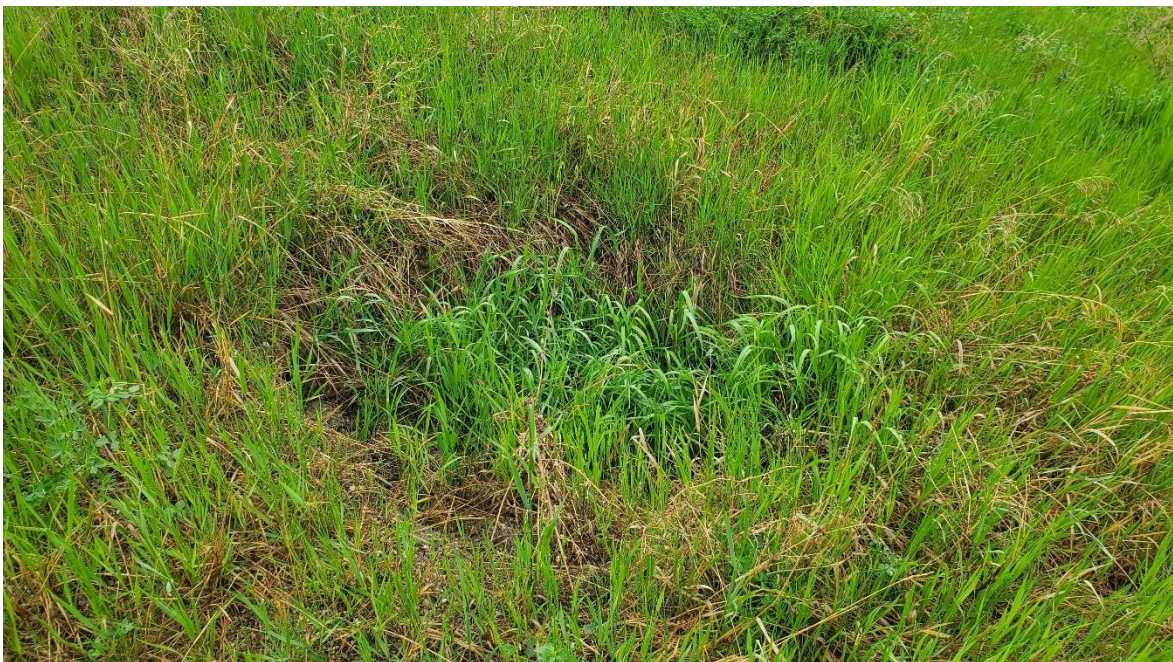
| Observations: | Description | Worsened? |
|---|---|---|
| <input checked="" type="checkbox"/> Bridge/Culvert Distress | <p>The rip rap armouring at the inlet to a 762 mm diameter centerline smooth wall steel pipe culvert has been dislodged and eroded.</p> <p>A sinkhole has formed above the buried 762 mm SWSP drain pipe connected to the centerline culvert.</p> | <input checked="" type="checkbox"/> |

Photo 22: Looking north at a sink hole above the 500 mm SWSP centreline culvert on the sideslope of the NBL of Hwy 2 off-ramp.

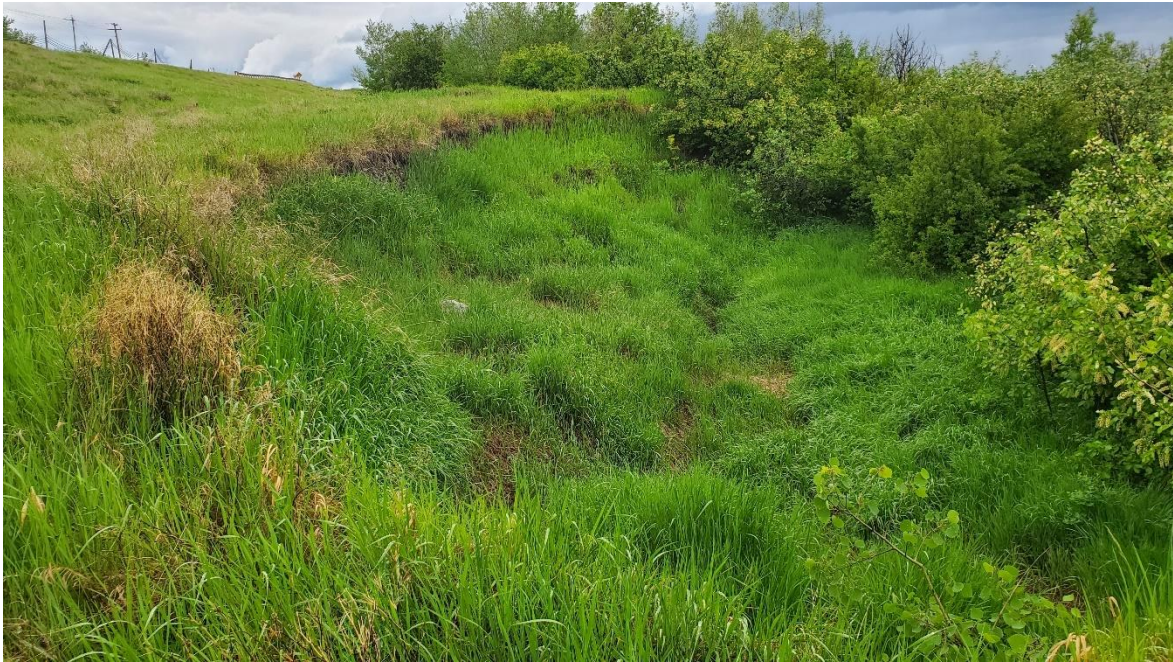
Photo 23: Looking northwest along the backscarp of the landslide downslope of the Hwy 2 off-ramp (below SP09-11).

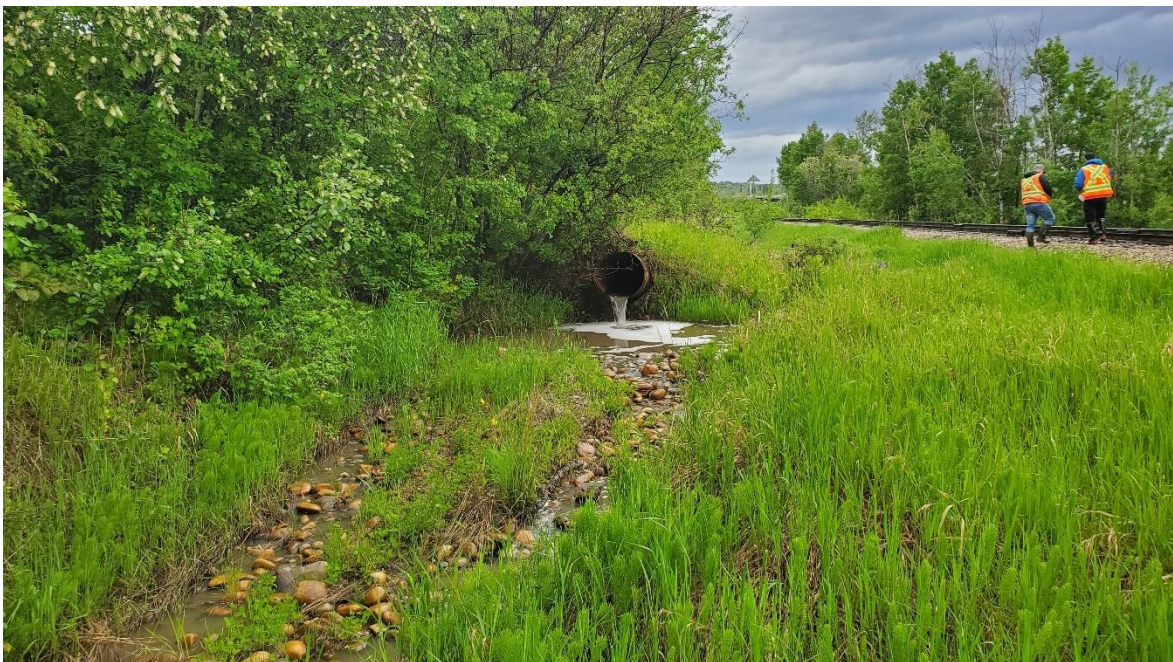
Photo 24: Looking northwest where water has previously ponded below the hanging outlet of the 600 mm CSP that connects to the 500 mm SWSP centreline culvert.

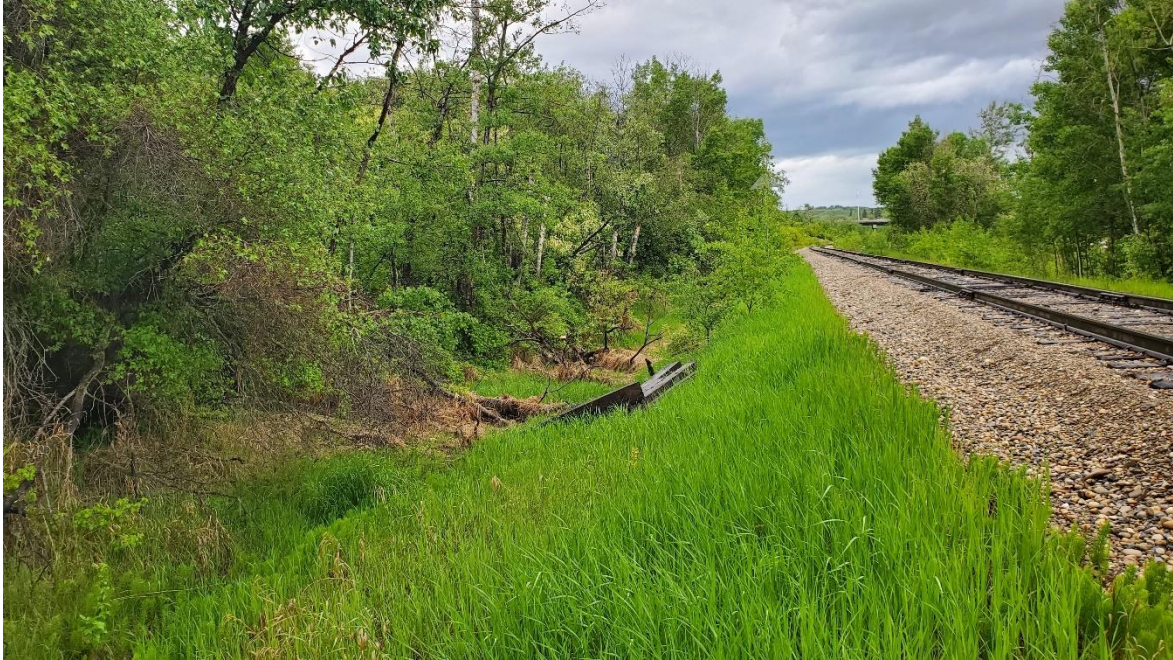
Photo 25: Looking northwest along toe bulge of the landslide below SP09-11 (Photo 23) at the west side of the CNR track.

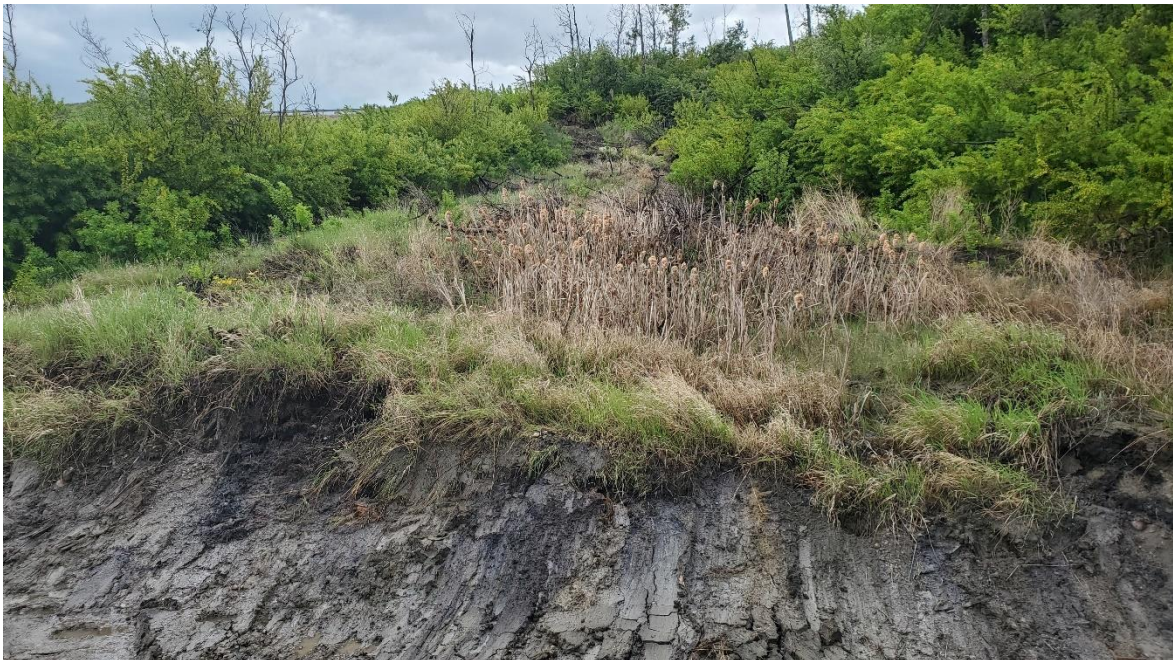
Photo 26: Looking southwest at the debris flow material immediately upslope of the CNR line. Material appears to have been recently excavated.

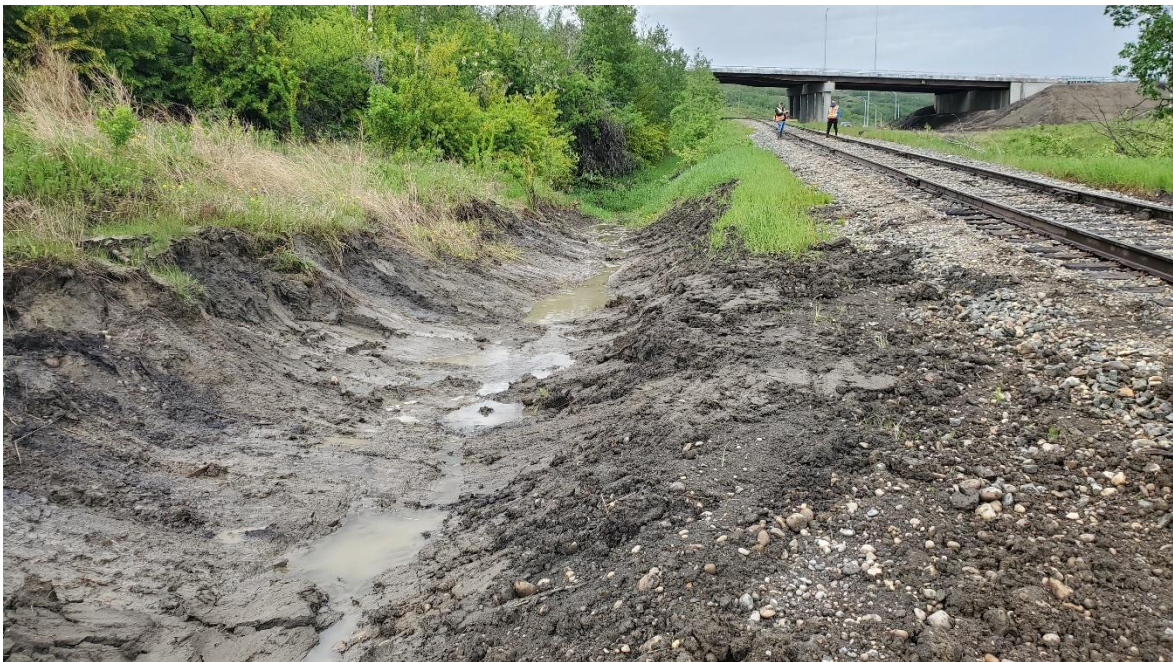
Photo 27: Looking northeast at seepage/ditch flow around debris fan flowing into nearly buried culvert below CNR tracks.
