**ALBERTA TRANSPORTATION AND
ECONOMIC CORRIDORS GRMP
PEACE REGION – (PEACE RIVER DISTRICT)
INSTRUMENTATION MONITORING - SPRING 2024**

Site Number	Location	Name	Hwy	km
PH009	Hwy 684:02 km 30.99, Town of Peace River	Shaftesbury Trail - Shop Slide	684:02	0.0-0.4
Legal Description:		UTM Co-ordinates		
4-31-83-21 W5		11U E 480321	N	6232126

Current Monitoring:	22-May-2024	Previous Monitoring	10-Oct-2023
Instruments Read By:	Mr. Niraj Regmi, G.I.T., and Mr. Nixson Mationg, of Thurber

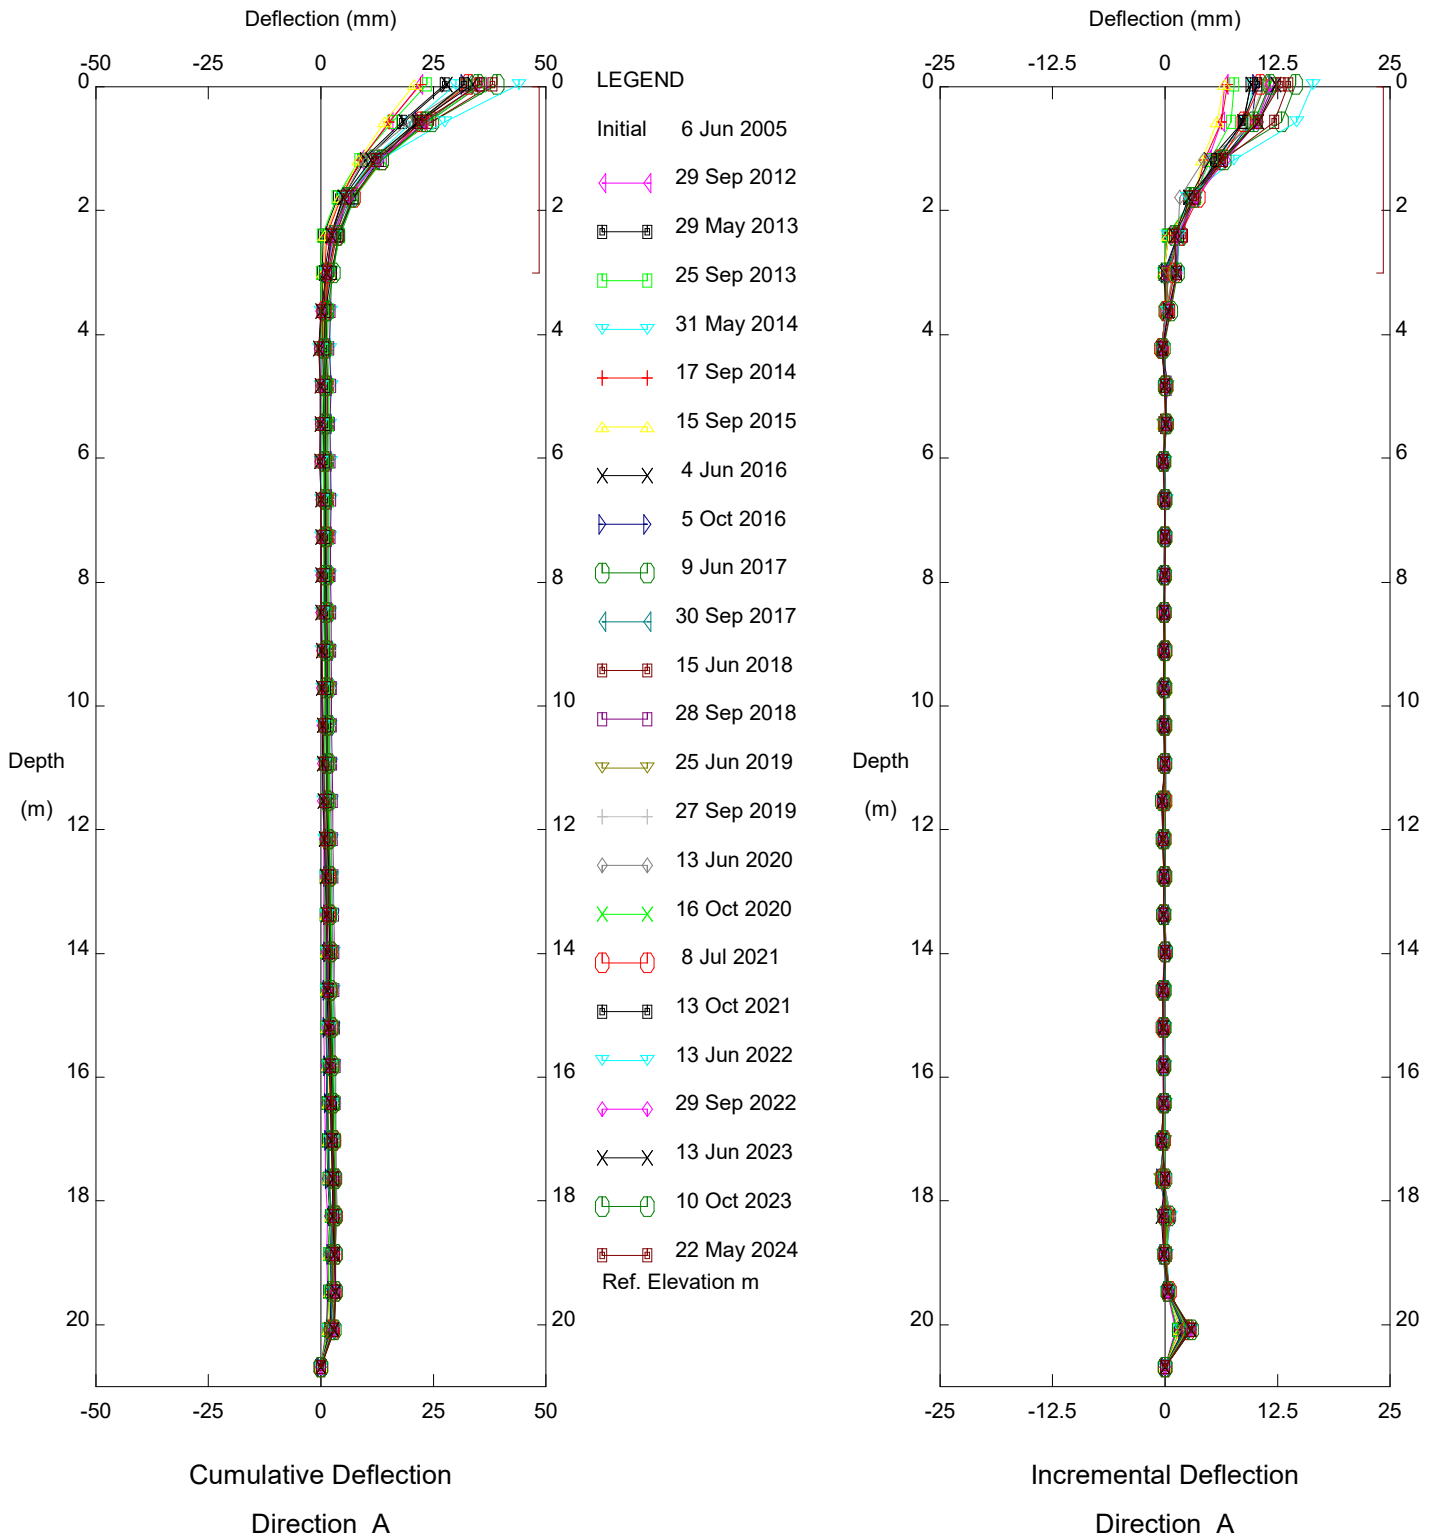
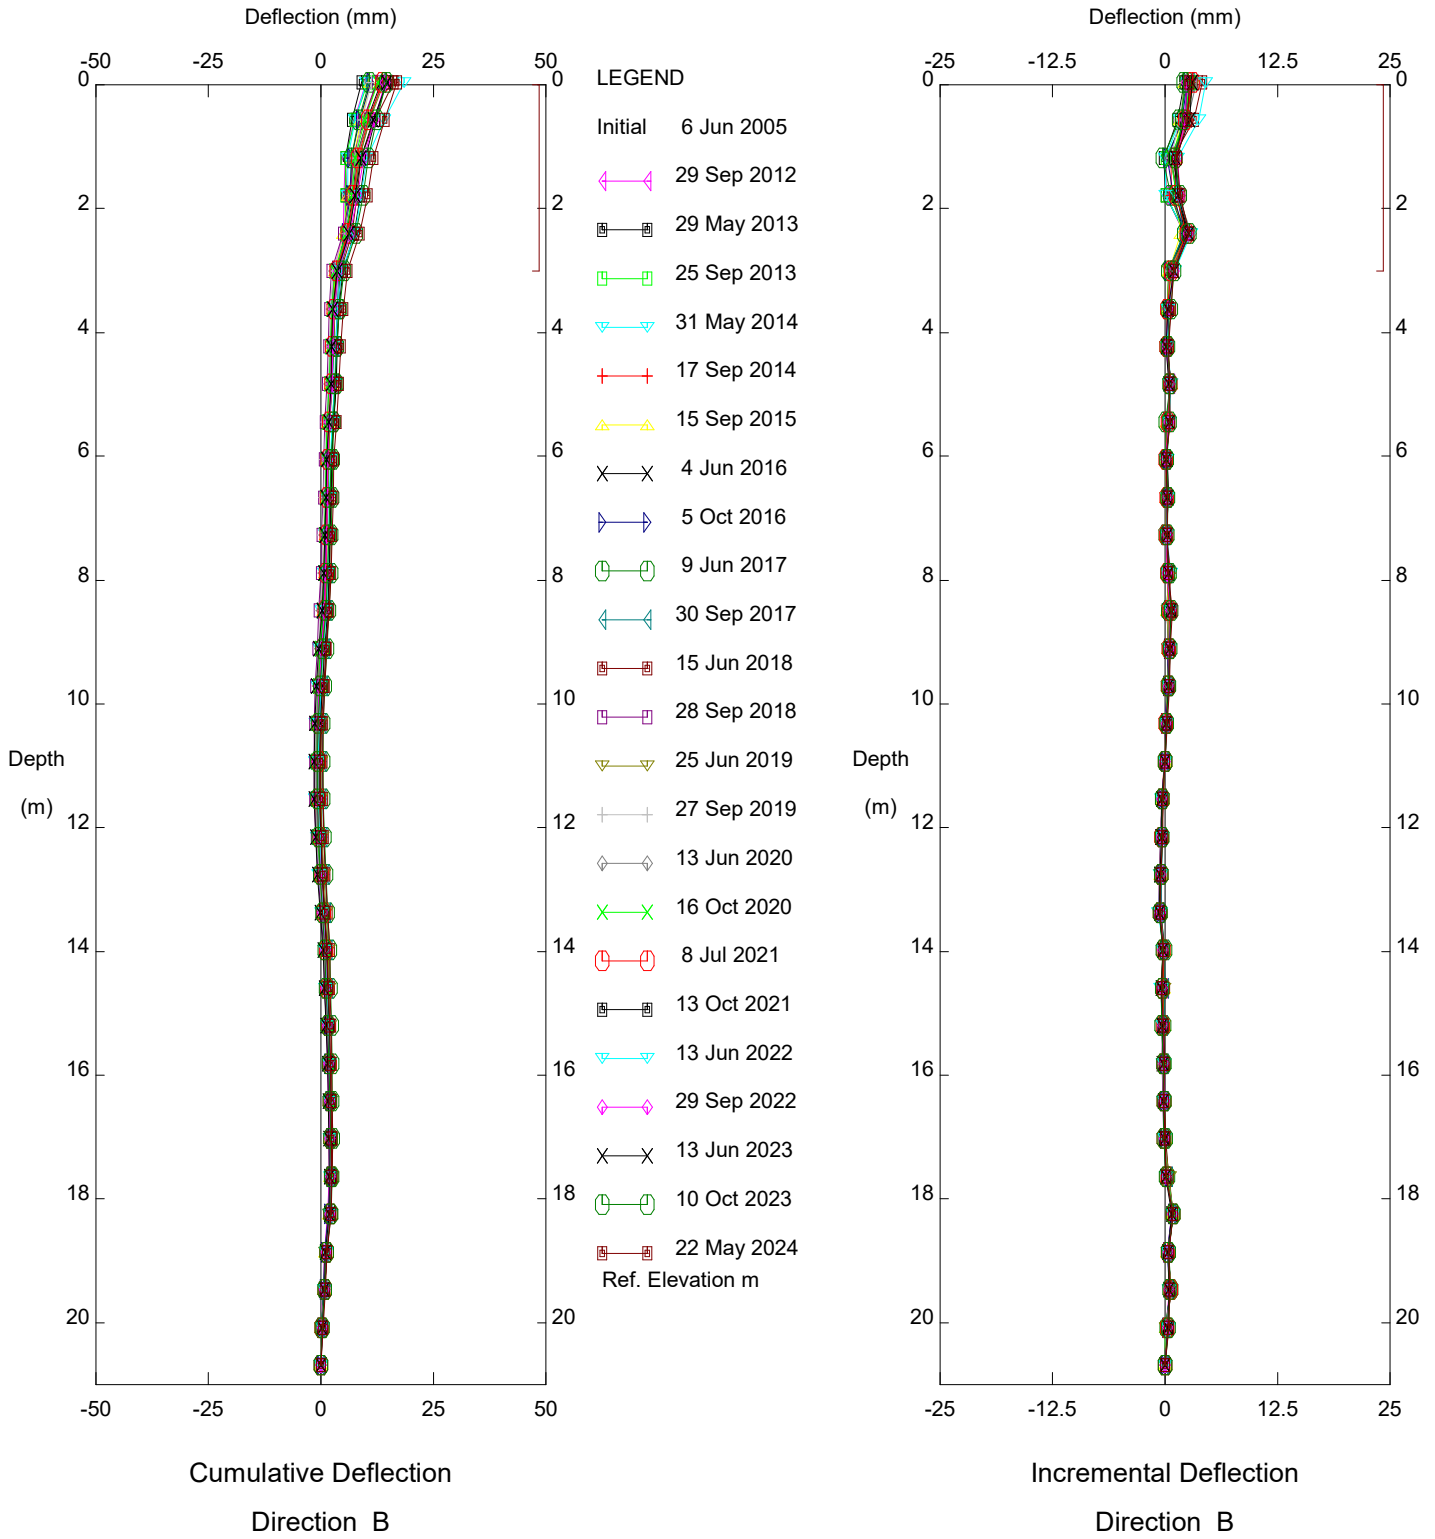
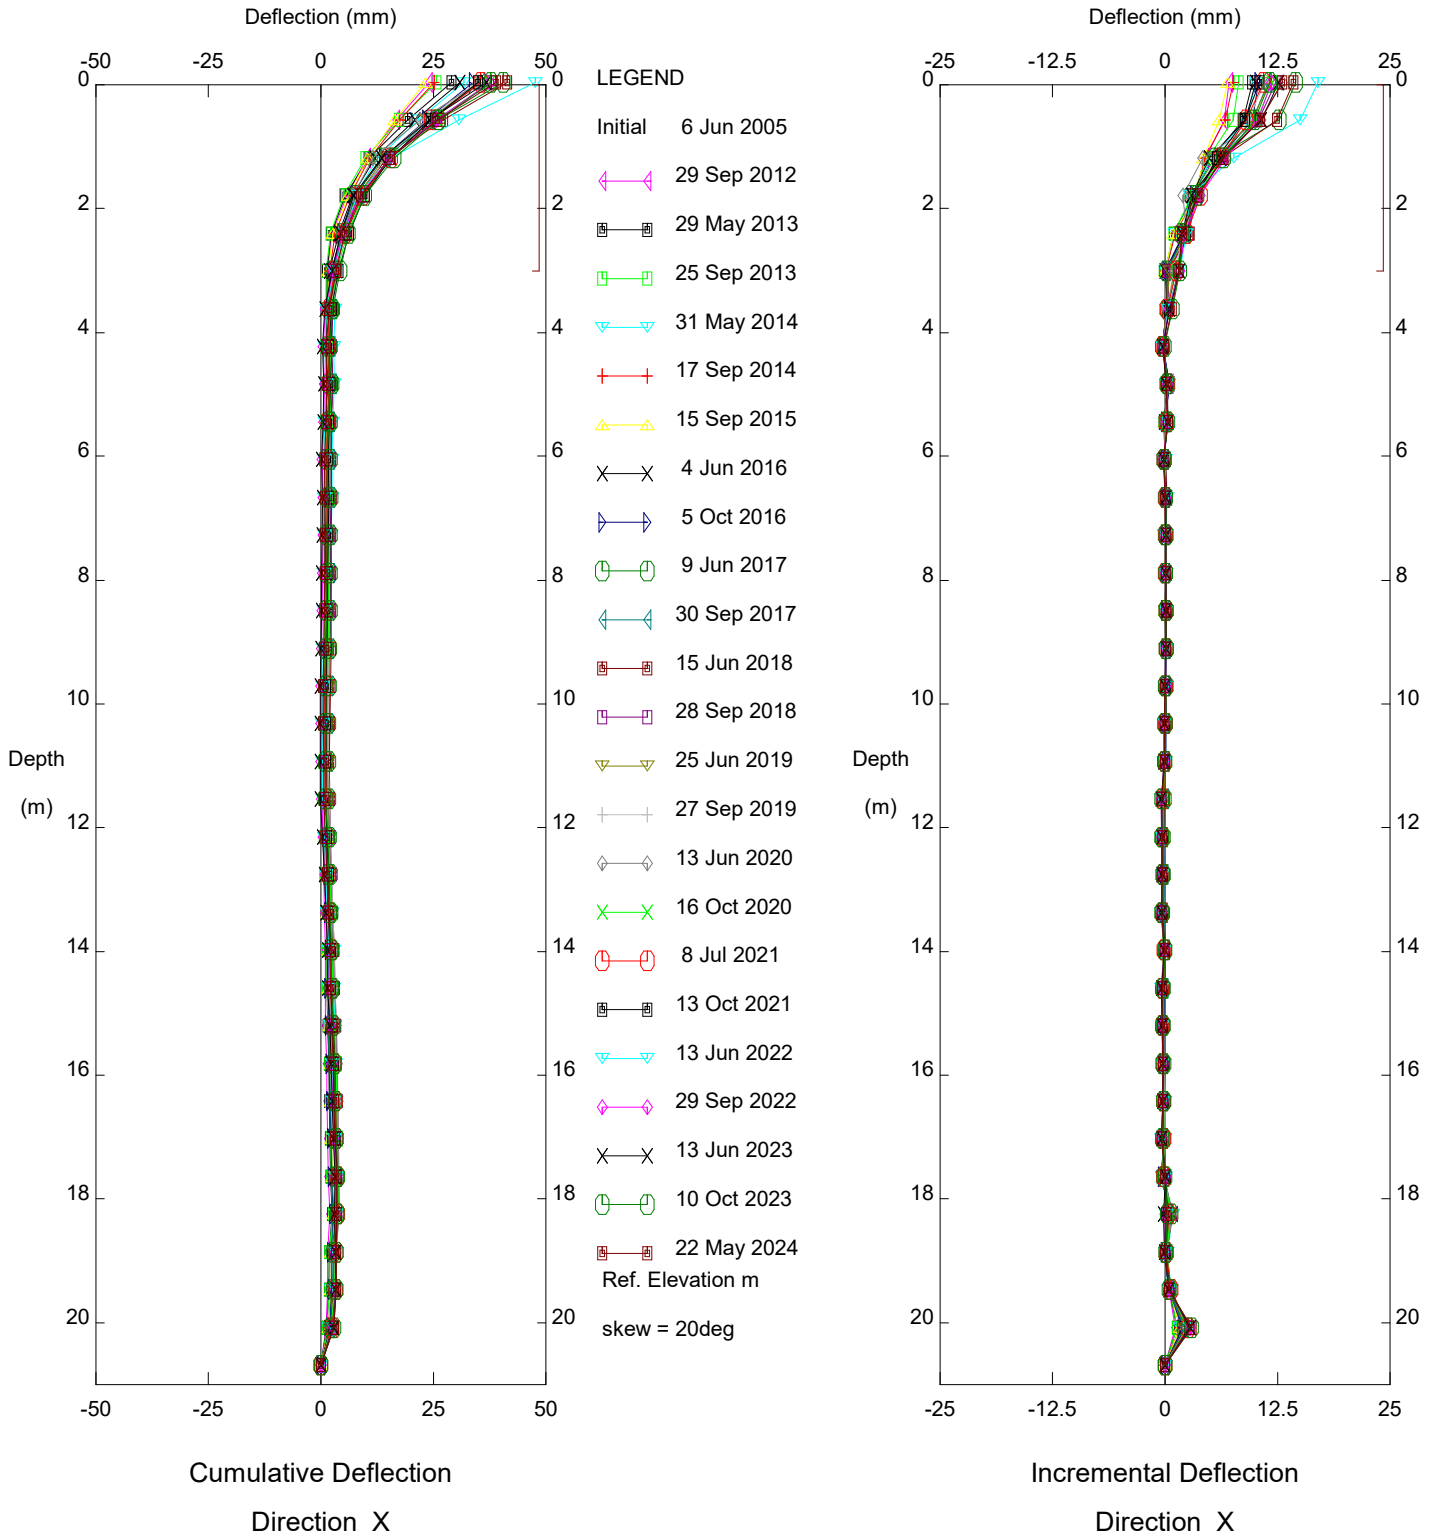
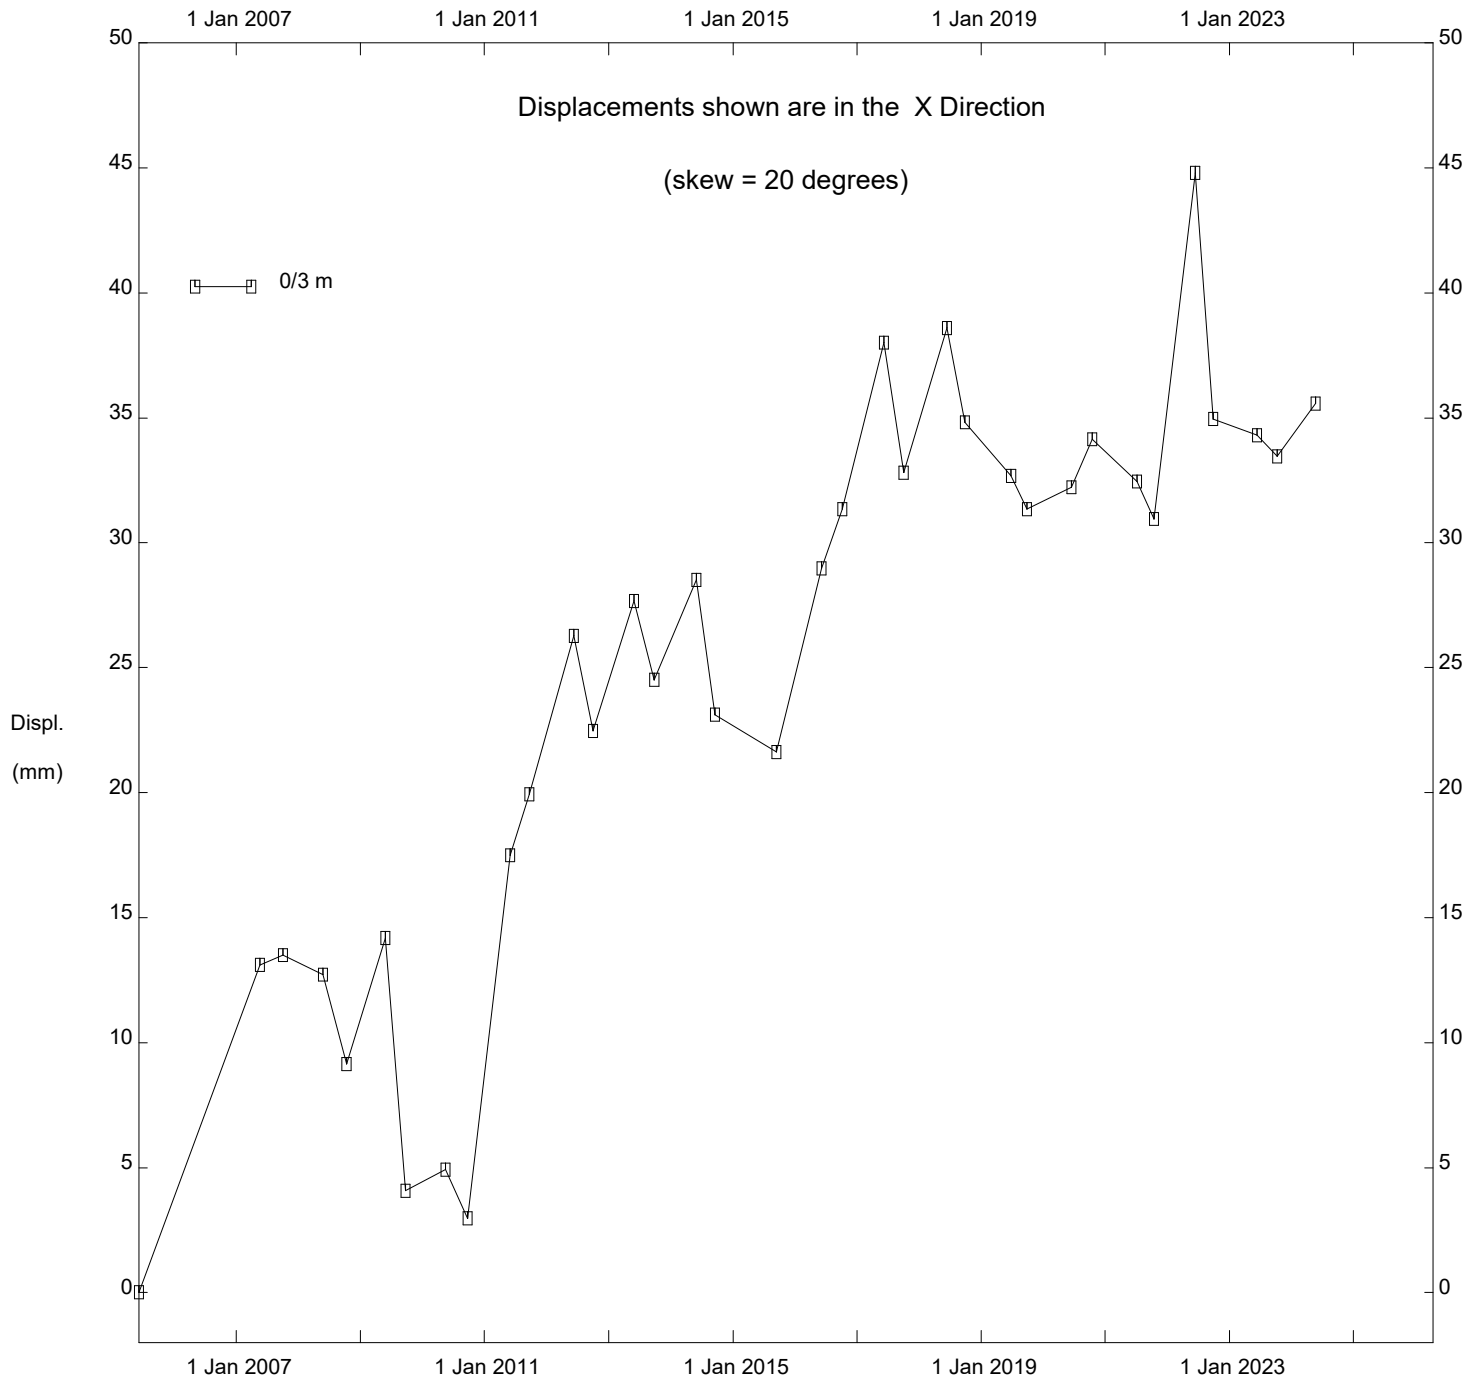
PH009 Old Hwy 2:02 Shop Slide, Inclinometer SI05-1

Discussion	
Zones of New Movement:	None
Interpretation of Monitoring Results:	<p>Slope inclinometer SI05-1 is located upslope of the highway and not within the main area of movement. It showed a rate of movement of 3.4 mm/yr over 0.0 m to 3.0 m depth since the fall of 2023 readings..</p> <p>SI09-3 is located on the east side of the rail tracks. If continues to show no discernible movement.</p> <p>SI09-4 is located immediately east of the newly installed pile wall. It showed a rate of movement of 0.2 mm/yr over 8.6 m to 10.5 m depth and 0.4 mm/yr over 8.6 m to 10.5 m depth and 11.7 m to 13.5 m depth, respectively, since the fall of 2023 readings. These movement zones were</p>

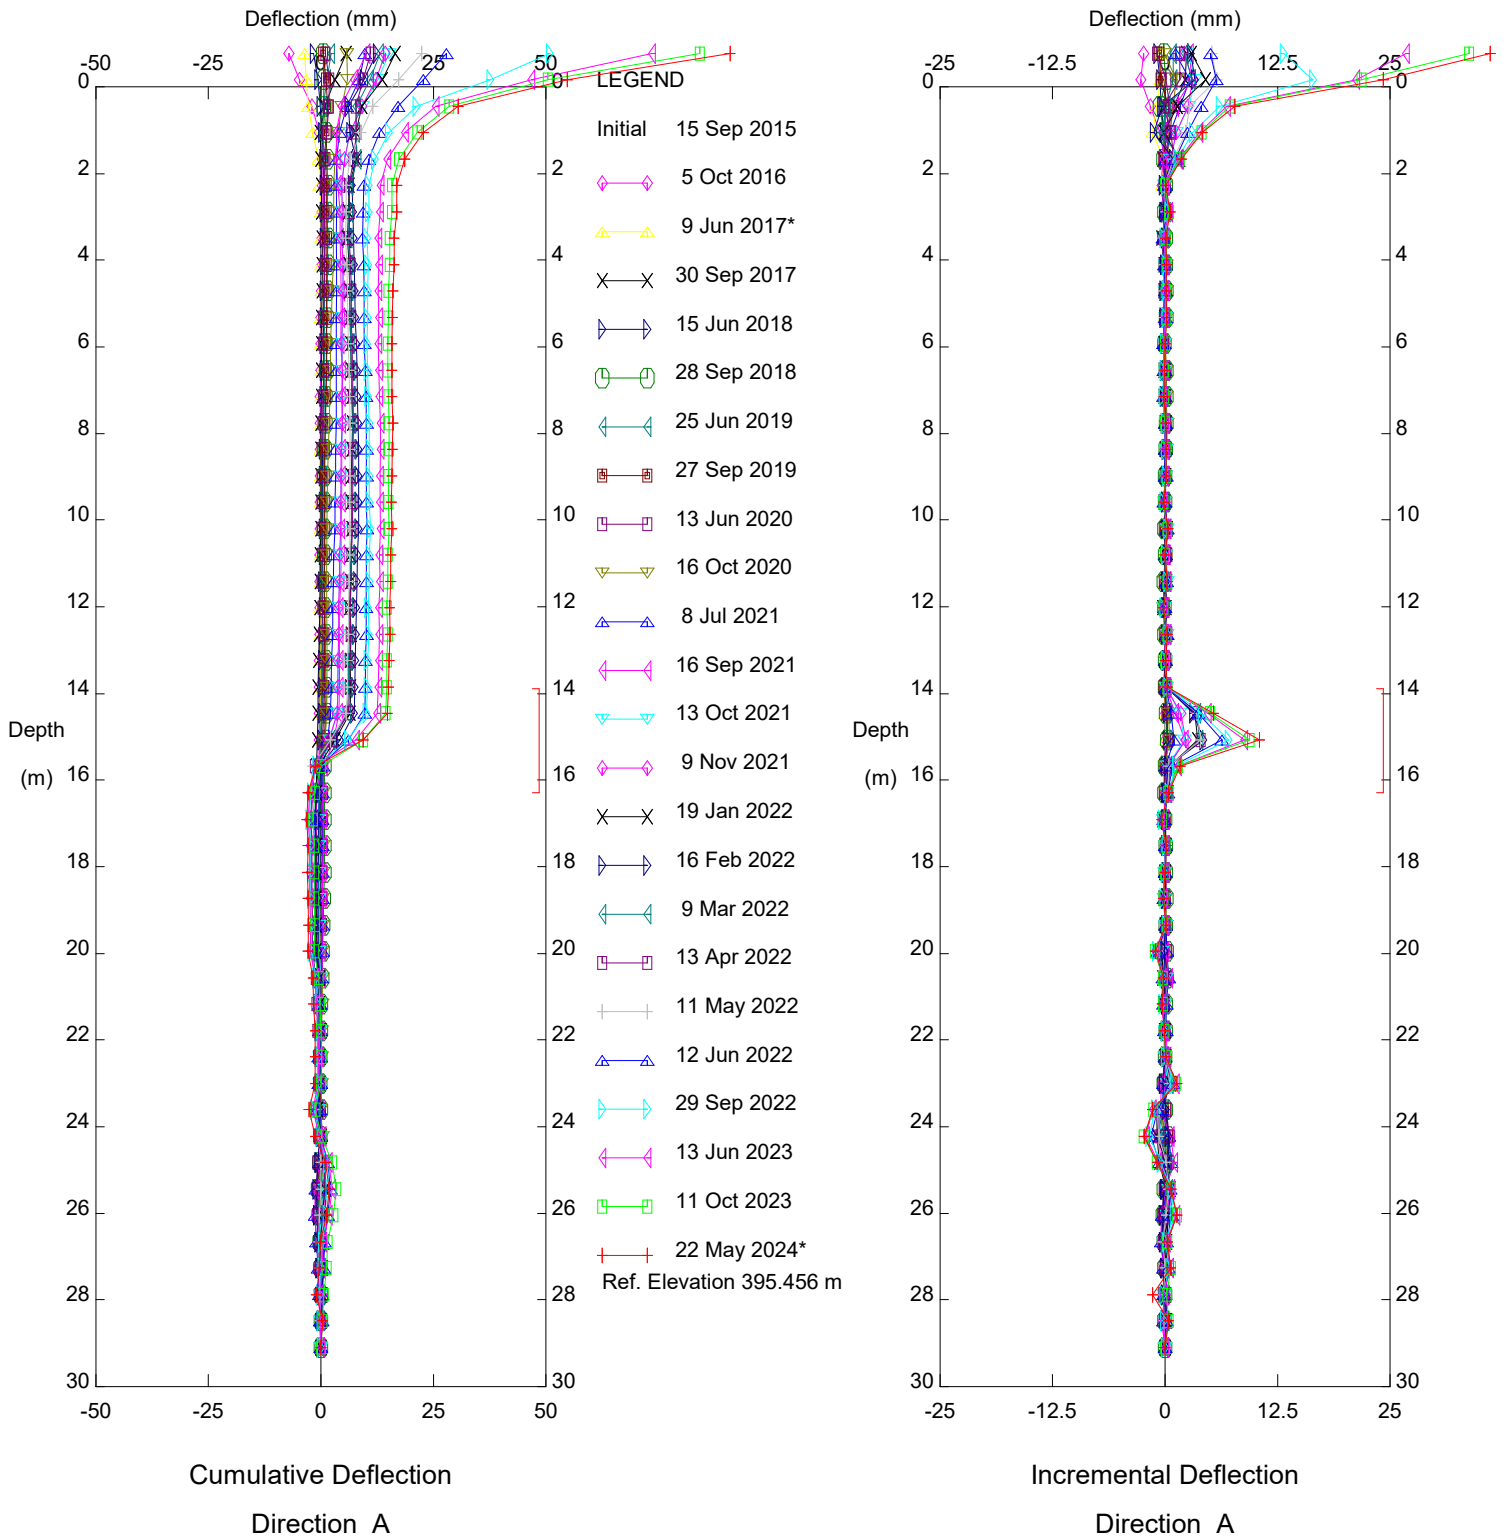
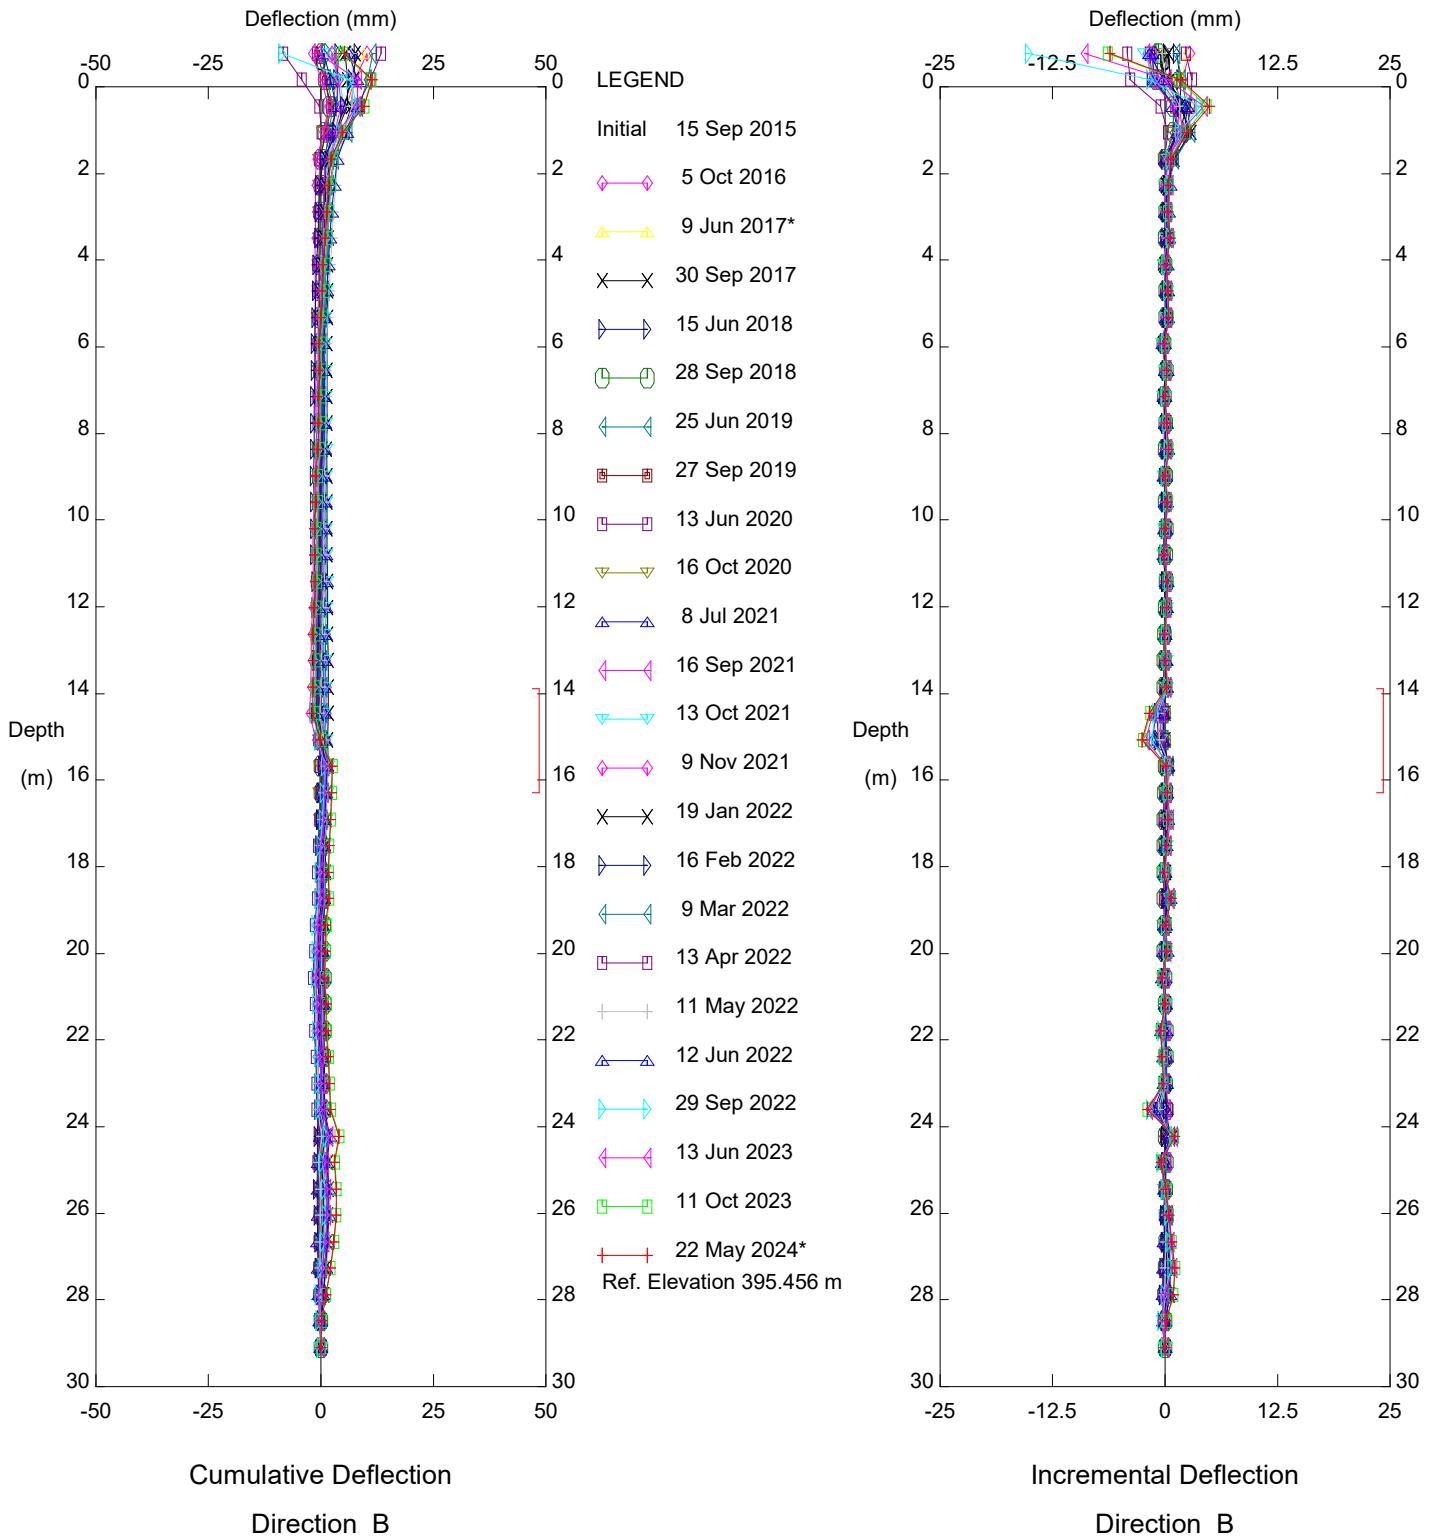
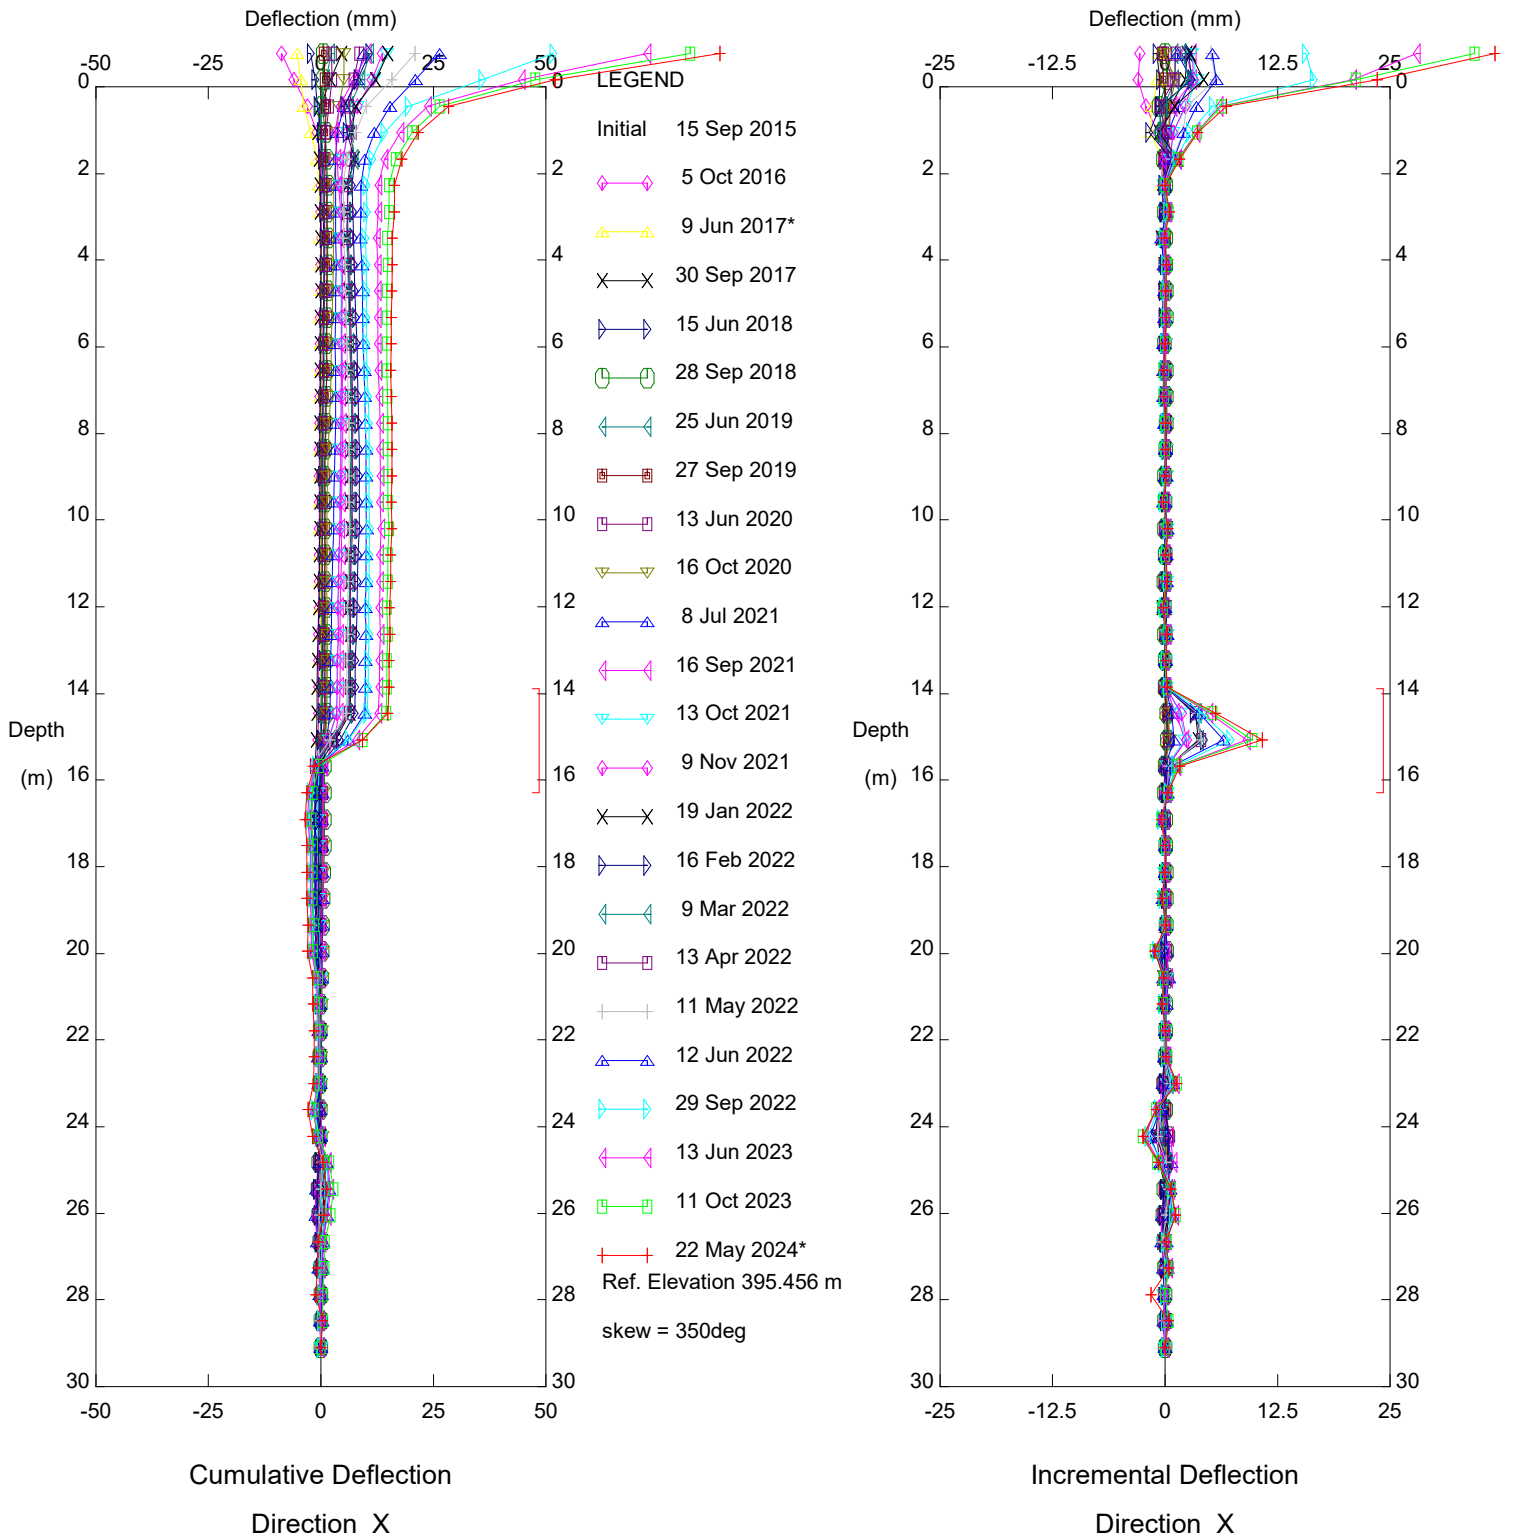
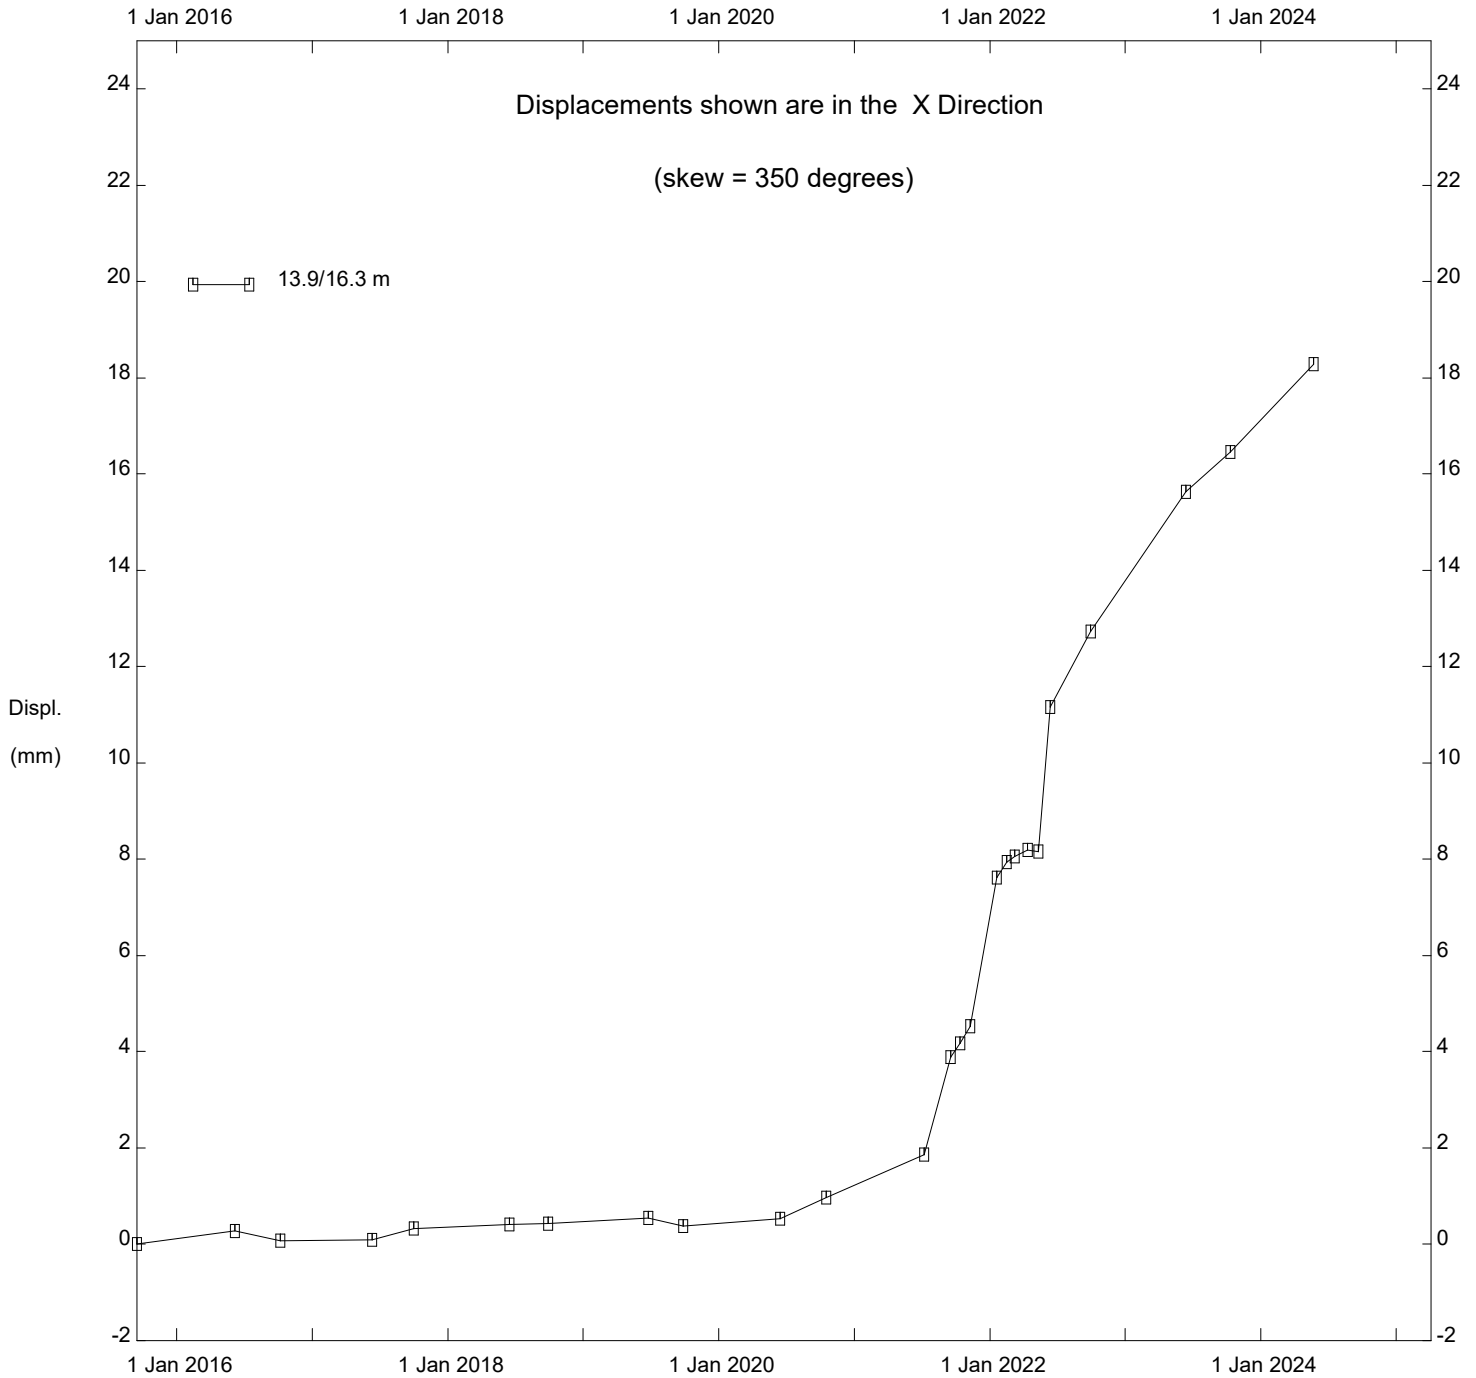
PH009 Old Hwy 2:02 Shop Slide, Inclinometer SI11-01

<p>first observed in 2021 during construction and the movement rate has been gradually levelling off with each subsequent set of readings.</p> <p>SI11-01 is located just north of the pile wall and had a rate of movement of 3.0 mm/yr over 13.9 m to 16.3 m depth. This zone was first observed soon after construction started and the maximum rate of movement of 34.3 mm/yr occurred in June 14, 2022, near the end of construction. The movement rate is still much greater than it was prior to construction, and continued inspection of this area should be done to confirm if additional stabilization measures are required.</p> <p>SI19-5 is located in the lower portion of the slide, near the centerline of the slide. It showed a rate of movement of 0.6 mm/yr over 8.2 m to 11.2 m depth and a rate of movement of less than 0.1 mm/yr over 17.9 m to 19.7 m depth. The overall movement in SI19-5 has slowed significantly since slope offloading and the completion of construction.</p> <p>It is anticipated that the concrete pile wall and associated lower slope offloading and flattening will eventually reach a new equilibrium so there should be a further reduction in the rates of movement in the inclinometers at this site..</p> <p>Surface accelerometer arrays (SAA) were installed in selected concrete piles during construction. SAA-P34 has shown an average rate of movement of 0.7 mm/yr in the downslope direction since the fall of 2023 readings, with a current pile head deflection of 7.3 mm since datalogger readings began for this instrument on May 27, 2022. SAA-P34 shows seasonal trends of greater pile deflection through winter months and a relaxation in summer months. A maximum pile head deflection of close to 10.2 mm was measured in March 2024, The gap in data noted on the plot is due to theft of the datalogger battery.</p> <p>SAA-P77 showed a rate of movement of 0.1 mm/yr since the fall of 2023 readings. SAA-P77 has shown a total pile head movement of 2.5 mm since datalogger readings began on May 27, 2022. SAA-P77 had a maximum pile head deflection of about 3.1 mm in February 2024, and began dropping before the battery was stolen. This is a smaller winter peak compared to SAA-P34.</p> <p>SAA-P113 has shown an average rate of movement of 2.1 mm/yr in the downslope direction since the fall of 2023 readings, with a total pile head deflection of 12.9 mm since datalogger readings began on May 27, 2022. The higher observed movement in SAA-P113 can be attributed to the fact that the pile wall at this location is cantilevered rather than tied-back like the other portions of the wall. The movement rate measured in the instrument has decreased since the spring of 2023 readings by 4.7 mm/yr. SAA-P113 does not show as obvious winter peaks as SAA-P34 or SAA-P77.</p> <p>The strain gauges in P34 (Figures PH009-1 and -2) show their maximum positive (tension) strain (136.1 microstrain) on the upslope pile face at 9.3 m depth, with a corresponding trend of negative (compression) strain (-215.2 microstrain) on the downslope pile face at the same depth. This seems to correspond to the observed deflection of the pile in the downslope direction noted in SAA-P34 above 9 m depth. The strains measured at this depth are plotted against time in Figure PH009-3.</p> <p>The strain gauges on the downslope side of P77 (Figure PH009-5) indicate a maximum negative strain of -138.1 microstrain at a depth of 7.1 m. P77 does not show as clear of a trend of strain in the upslope pile strain gauges (Figure PH009-4) compared to P34. The strains measured</p>

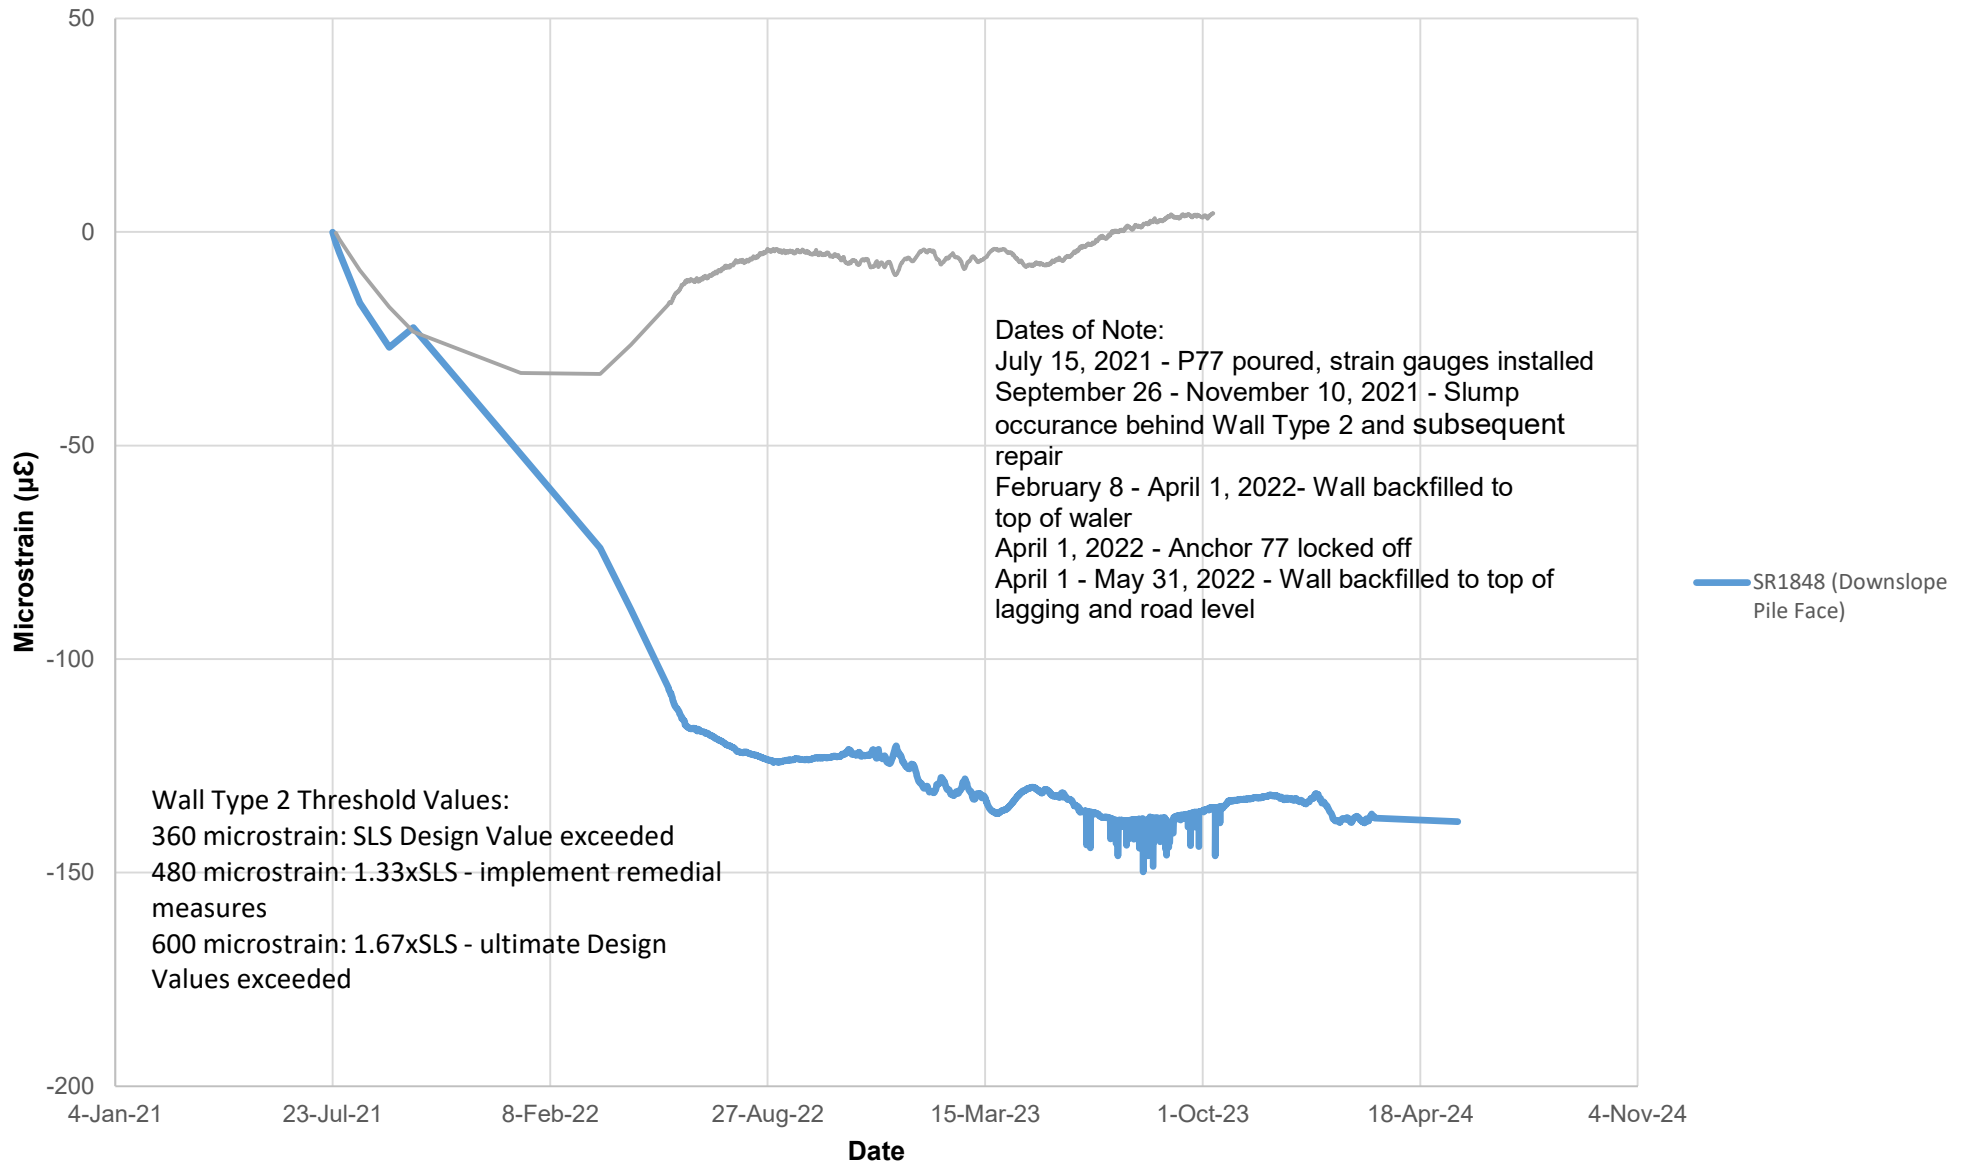
**FIGURE PH009-6: PEACE RIVER SHOP SLIDE
P77 MAXIMUM STRAIN VS TIME (7.1 m DEPTH)**

<p>at 7.1 m and 12.9 m are plotted against time in Figure PH009-6 and -7, respectively.</p> <p>The maximum negative strain for P113, of -123.6 microstrain, was measured on the downslope side at 19.0 m depth (Figure PH009-9). On the upslope side (Figure PH009-8), the maximum negative strain was -67.5 microstrain measured at a depth of 21.2 m. The depth of the main slip surface of the deep-seated landslide at this location, as indicated by former SI05-3, was at 17.5 m below original ground prior to wall construction. The strains measured at 15.3 m and 19.0 m are plotted against time in Figure PH009-10 and -11, respectively.</p> <p>The strain gauge plots are included in Appendix A.</p> <p>The load cell readings are summarized in Table PH009-4. All load cells showed an increase in measured load ranging from 8.60 kN in VC2343 (A67) to 20.78 kN in VC2340 (Anchor A19) compared to the fall of 2023 readings. Load cell VC2344 (anchor A77) showed an increase in measured load of 25.13 kN.</p> <p>Load cell VC2340 and VC2344 registered the highest maximum recorded loads of 232.51 kN and 229.90 kN, respectively, on May 22, 2024, after the battery was replaced and the datalogger was powered up for the readings. Load cells VC2341 and VC2343 registered the highest maximum recorded loads of 230.84 kN and 214.80 kN, respectively, on February 23, 2024, shortly before the batteries were stolen.</p> <p>The pattern of movements is attributed to frost pressures on the back of the wall. Load cell VC2340 (anchor A19) measured its highest load after the spring thaw in July 2023, before relaxing slightly. Load cell VC2344 (anchor A77) has continued showing an overall trend of increasing load with a smaller post-winter relaxation than seen in the other anchors. Overall, the anchor loads have risen significantly since they were locked off, and anchors A19, A34, and anchor A77 are currently above their SLS design loads but have not exceeded the 270 kN load that would remedial measures. The load cells will need to be closely monitored to see if the increased movement trend continues. The load cell readings are plotted on Figure PH009-13 in Appendix A.</p> <p>Pile head deflections measured by the SAA are within an acceptable range (below the estimated SLS Design Values, measured since anchor lock-off, of 18 mm for SAA-P34, 7 mm for SAA-P77, and 39 mm for SAA-P113). More deflection is noted in the cantilever section of the wall (SAA-P113) which would be expected. The additional deflection in SAA-P34 may be due to the deeper amount of cut as compared to the slope below SAA-P77. The March-April 2024 drop in deflection corresponds with a drop in the loads carried by some of the anchors (A34, A51, and A67 and to a lesser extent at A19) which could indicate a post-winter shifting of the slope. This will require additional readings and analysis to interpret and will be considered as part of the ongoing development of threshold criteria for this pile wall.</p> <p>Standpipe piezometers SP05-4, SP05-5 and SP09-10, and SP19-3 showed decreases in groundwater level of 1.96 m, 0.25 m, 1.16 m, and 0.67 m respectively, since the fall of 2023 readings. Standpipe piezometer SP05-1 showed an increase in groundwater level of 0.38 m, since the fall of 2023 readings. SP11-06, SP09 8, and SP09-9 continued to be dry (SP09-8 and SP09-9 have been dry since installation). The water levels measured in the standpipes have not demonstrated a trend. The results of the standpipe piezometers are summarized in Table PH009-5, and are plotted in Figure PH009-14 in Appendix A.</p>

Wall Type 2 Threshold Values:
 360 microstrain: SLS Design Value exceeded
 480 microstrain: 1.33xSLS - implement remedial measures
 600 microstrain: 1.67xSLS - ultimate Design Values exceeded
