**ALBERTA TRANSPORTATION AND
ECONOMIC CORRIDORS GRMP
PEACE REGION – (PEACE RIVER DISTRICT)
INSTRUMENTATION MONITORING - SPRING 2024**

Site Number	Location	Name	Hwy	km
PH009	Hwy 684:02 km 30.99, Town of Peace River	Shaftesbury Trail - Shop Slide	684:02	0.0-0.4
Legal Description:		UTM Co-ordinates		
4-31-83-21 W5		11U E 480321	N	6232126

Current Monitoring:	22-May-2024	Previous Monitoring	10-Oct-2023
Instruments Read By:	Mr. Niraj Regmi, G.I.T., and Mr. Nixson Mationg, of Thurber

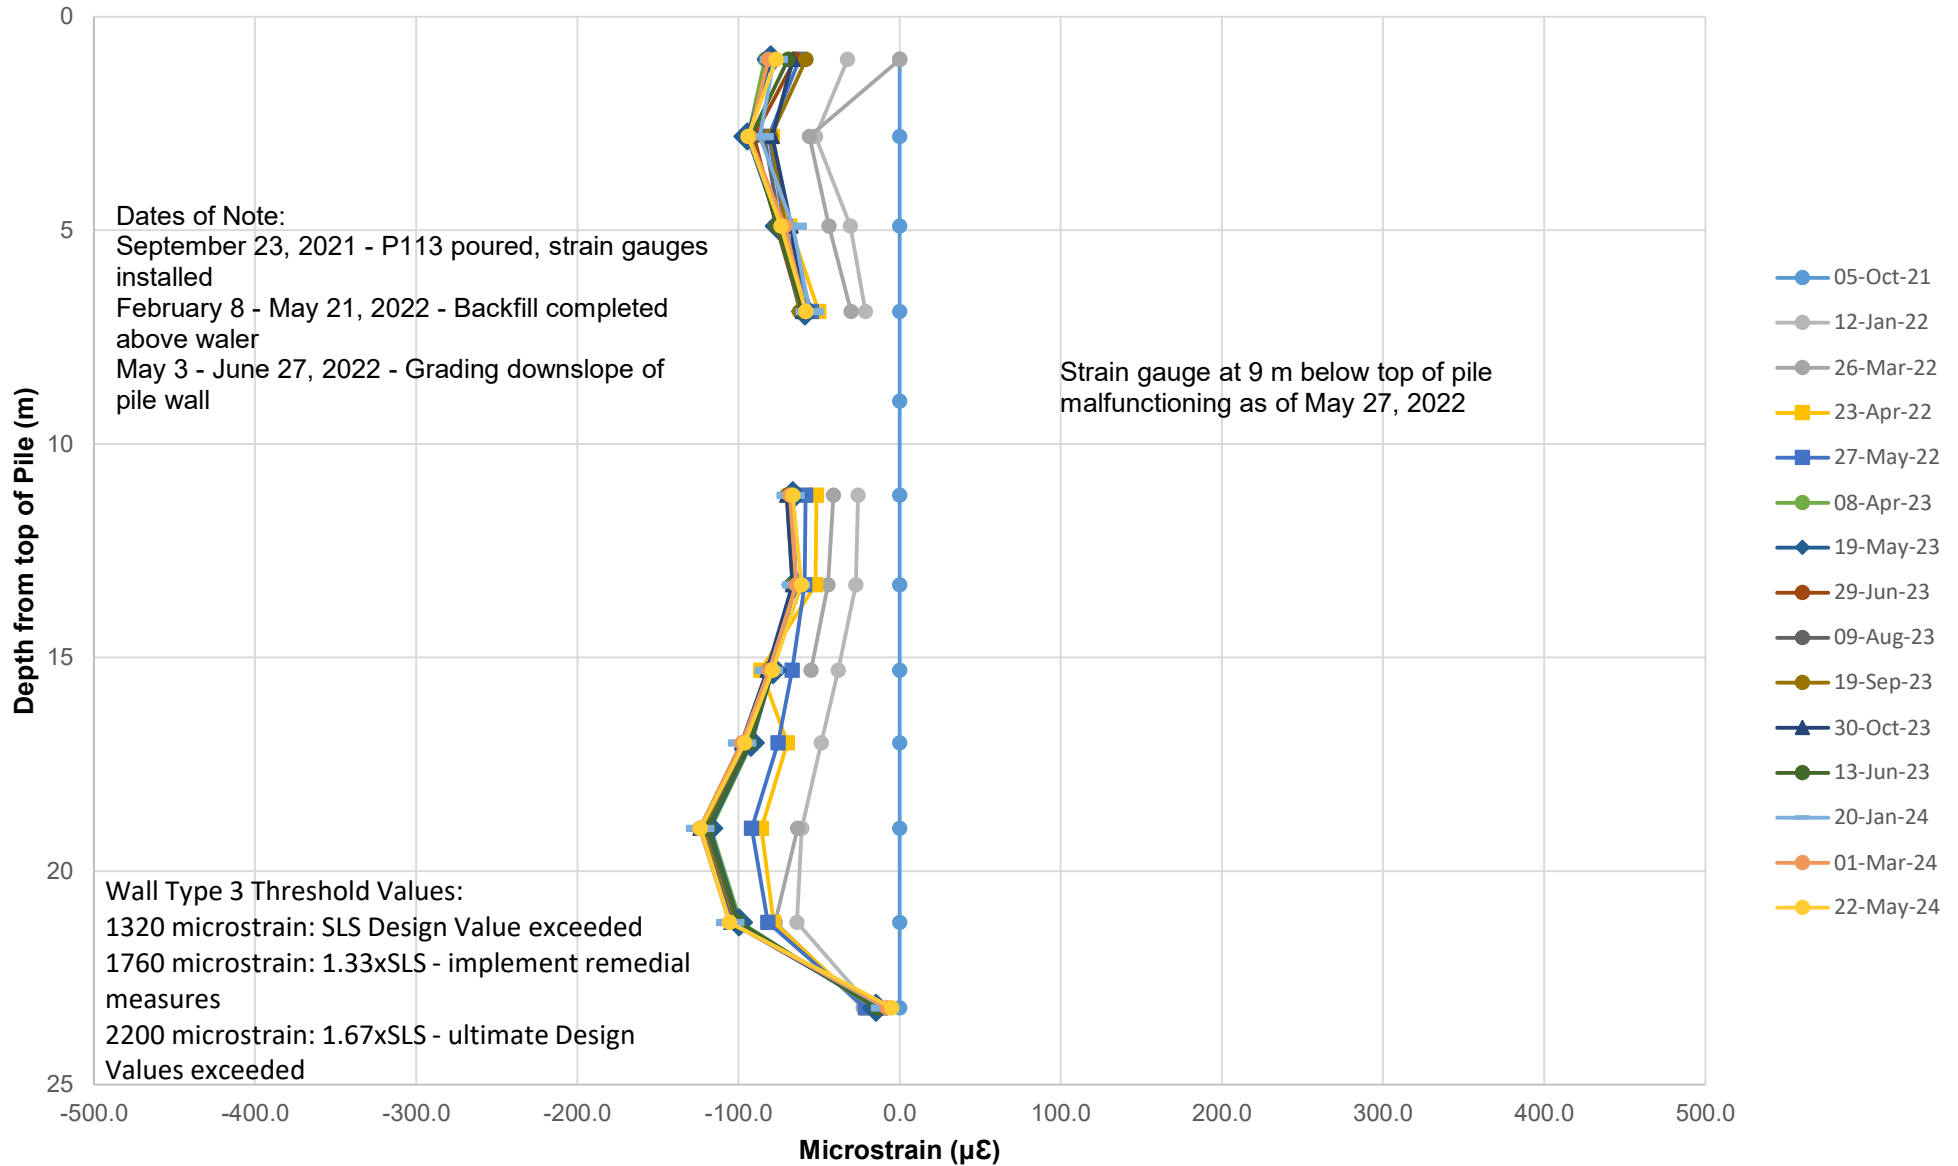
**FIGURE PH009-9: PEACE RIVER SHOP SLIDE
P113 DOWNSLOPE SIDE STRAIN GAUGE VALUES VS DEPTH**

<p>at 7.1 m and 12.9 m are plotted against time in Figure PH009-6 and -7, respectively.</p> <p>The maximum negative strain for P113, of -123.6 microstrain, was measured on the downslope side at 19.0 m depth (Figure PH009-9). On the upslope side (Figure PH009-8), the maximum negative strain was -67.5 microstrain measured at a depth of 21.2 m. The depth of the main slip surface of the deep-seated landslide at this location, as indicated by former SI05-3, was at 17.5 m below original ground prior to wall construction. The strains measured at 15.3 m and 19.0 m are plotted against time in Figure PH009-10 and -11, respectively.</p> <p>The strain gauge plots are included in Appendix A.</p> <p>The load cell readings are summarized in Table PH009-4. All load cells showed an increase in measured load ranging from 8.60 kN in VC2343 (A67) to 20.78 kN in VC2340 (Anchor A19) compared to the fall of 2023 readings. Load cell VC2344 (anchor A77) showed an increase in measured load of 25.13 kN.</p> <p>Load cell VC2340 and VC2344 registered the highest maximum recorded loads of 232.51 kN and 229.90 kN, respectively, on May 22, 2024, after the battery was replaced and the datalogger was powered up for the readings. Load cells VC2341 and VC2343 registered the highest maximum recorded loads of 230.84 kN and 214.80 kN, respectively, on February 23, 2024, shortly before the batteries were stolen.</p> <p>The pattern of movements is attributed to frost pressures on the back of the wall. Load cell VC2340 (anchor A19) measured its highest load after the spring thaw in July 2023, before relaxing slightly. Load cell VC2344 (anchor A77) has continued showing an overall trend of increasing load with a smaller post-winter relaxation than seen in the other anchors. Overall, the anchor loads have risen significantly since they were locked off, and anchors A19, A34, and anchor A77 are currently above their SLS design loads but have not exceeded the 270 kN load that would remedial measures. The load cells will need to be closely monitored to see if the increased movement trend continues. The load cell readings are plotted on Figure PH009-13 in Appendix A.</p> <p>Pile head deflections measured by the SAA are within an acceptable range (below the estimated SLS Design Values, measured since anchor lock-off, of 18 mm for SAA-P34, 7 mm for SAA-P77, and 39 mm for SAA-P113). More deflection is noted in the cantilever section of the wall (SAA-P113) which would be expected. The additional deflection in SAA-P34 may be due to the deeper amount of cut as compared to the slope below SAA-P77. The March-April 2024 drop in deflection corresponds with a drop in the loads carried by some of the anchors (A34, A51, and A67 and to a lesser extent at A19) which could indicate a post-winter shifting of the slope. This will require additional readings and analysis to interpret and will be considered as part of the ongoing development of threshold criteria for this pile wall.</p> <p>Standpipe piezometers SP05-4, SP05-5 and SP09-10, and SP19-3 showed decreases in groundwater level of 1.96 m, 0.25 m, 1.16 m, and 0.67 m respectively, since the fall of 2023 readings. Standpipe piezometer SP05-1 showed an increase in groundwater level of 0.38 m, since the fall of 2023 readings. SP11-06, SP09 8, and SP09-9 continued to be dry (SP09-8 and SP09-9 have been dry since installation). The water levels measured in the standpipes have not demonstrated a trend. The results of the standpipe piezometers are summarized in Table PH009-5, and are plotted in Figure PH009-14 in Appendix A.</p>
