**GEOHAZARD ASSESSMENT PROGRAM  
PEACE REGION – PEACE-HIGH LEVEL  
CALL-OUT INSPECTION (SEPT. 8, 2015)**

<b>Site Number</b>	<b>Location</b>	<b>Name</b>	<b>Hwy</b>	<b>km</b>
PH40	Shaftsbury	Bricks Hill Slide	684:02	53.5
<b>Legal Description</b>		<b>UTM Co-ordinates</b>		
SE¼ 21-082-23 W5M		11U E 467287	N 6219688

<b>Date</b>	<b>PF</b>	<b>CF</b>	<b>Total</b>
<b>Previous Inspection:</b>	13-Jun-2006	5	2	10
<b>Current Inspection:</b>	8-Sep-2015	11	4	44
<b>Road AADT:</b>	280		<b>Year:</b>	2014
<b>Inspected By:</b>	Ed Szmata, TRANS Jesse Kasouf, TRANS		Shawn Russell, Thurber	
<b>Report Attachments:</b>	<input checked="" type="checkbox"/> Photographs <input checked="" type="checkbox"/> Plans <input type="checkbox"/> Maintenance Items

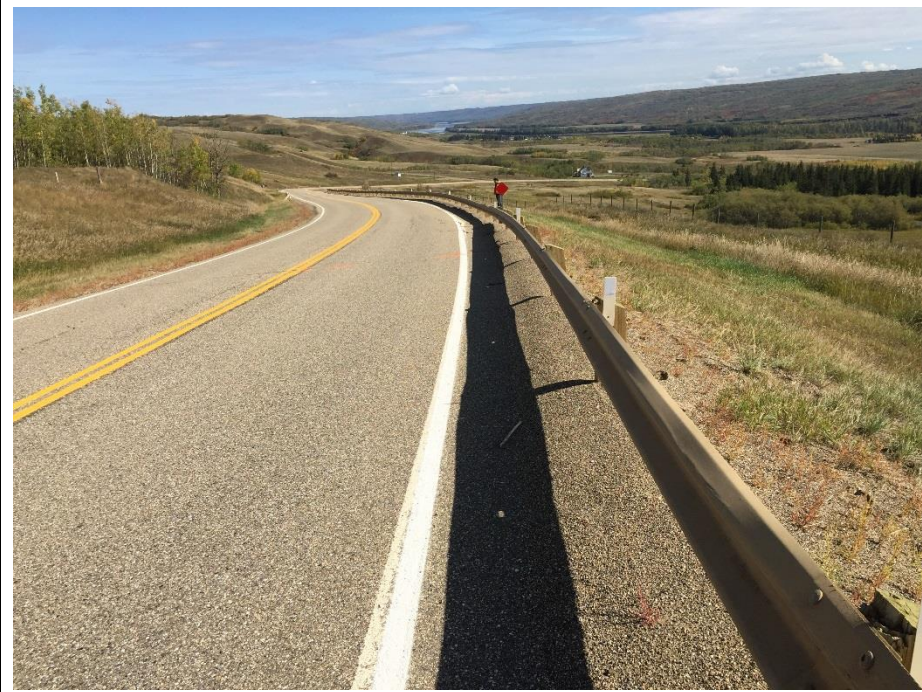
Landslide cracking in the road has occurred to the west/upslope of the previous repair from 2004, beyond the effect of the toe berm.

**Photo 1.**  
Looking NE from SBL  
shoulder towards  
new landslide cracks.

Recent landslide movement warrants that the affected southbound lane asphalt be patched in order to maintain a smooth enough surface for traffic at the current posted highway speed of 80 km/hr.

In the short term, it is recommended that the cracks in the pavement be sealed or overlain with an asphalt patch and that the area be closely monitored for future signs of movement.

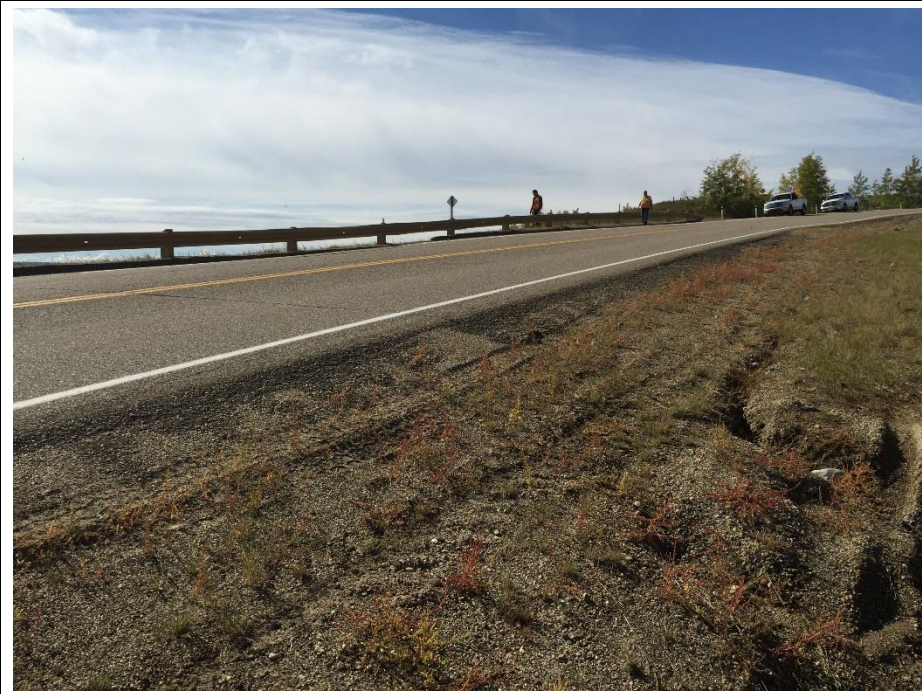
**Photo 2.**  
Looking south from  
NBL ditch towards  
new cracks. Dip in  
guardrail is also  
noticeable.

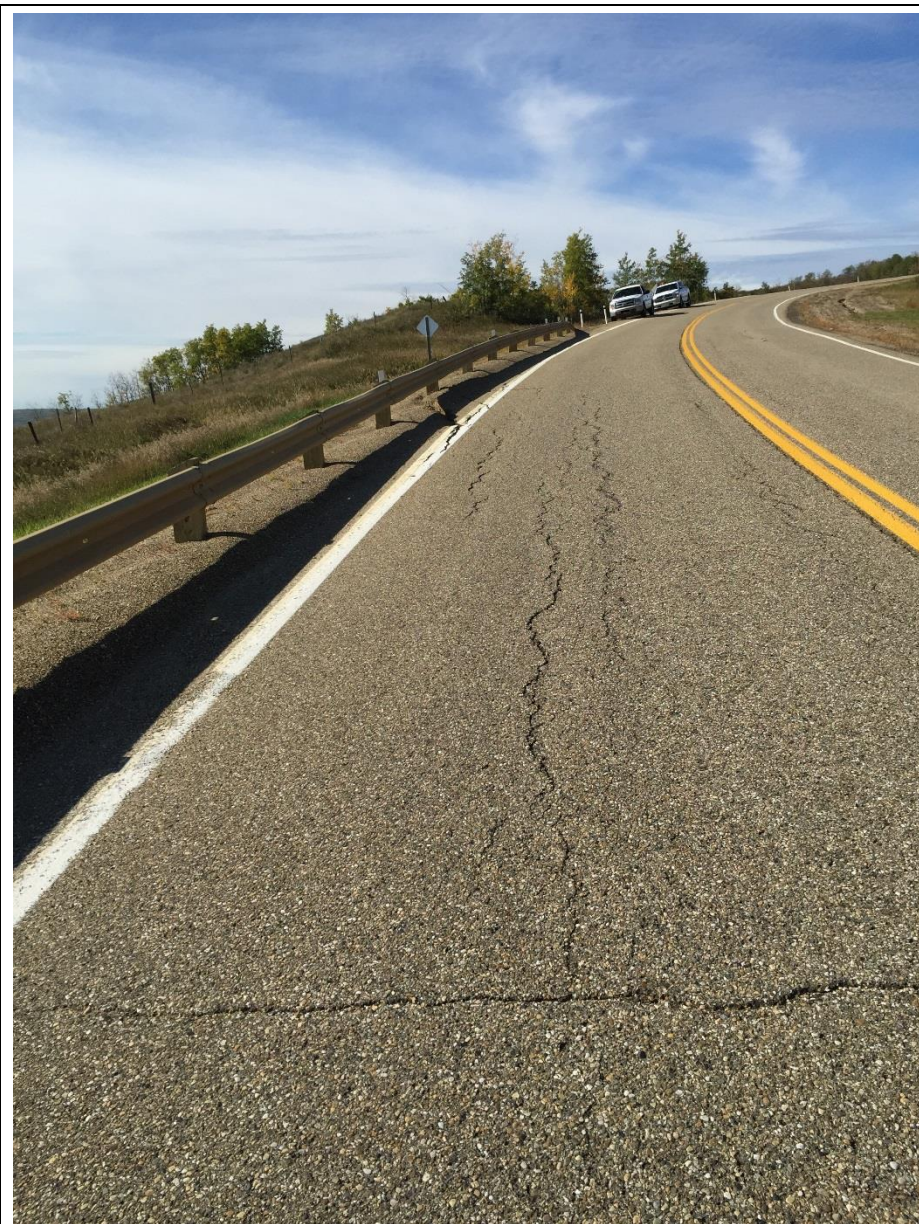
**Photo 3.**  
Looking SW at new  
cracks in SBL.

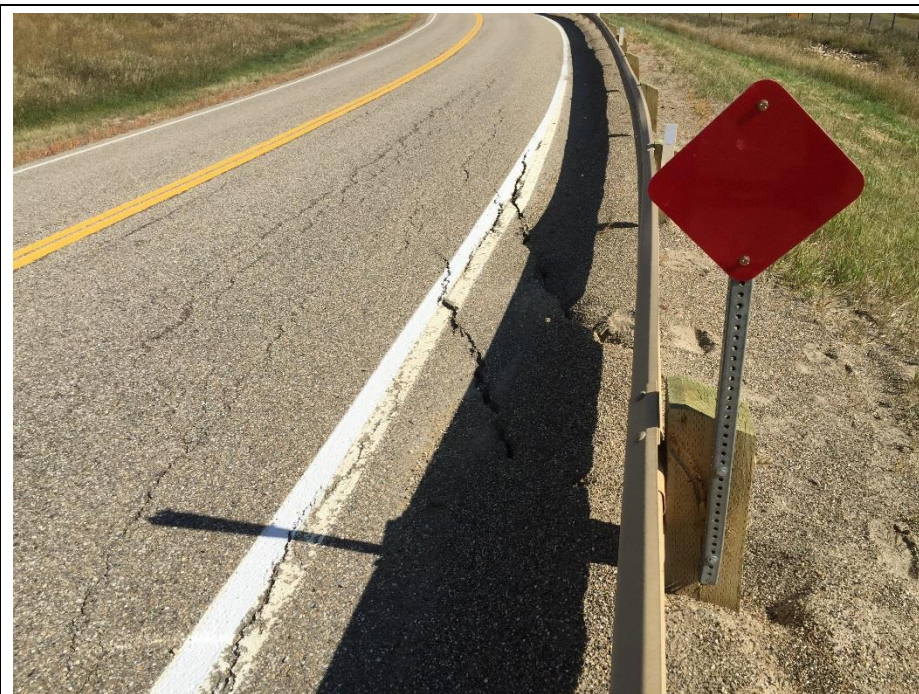
**Photo 4.**  
Looking NE at new  
cracks in SBL,  
shoulder and  
embankment  
sideslope.

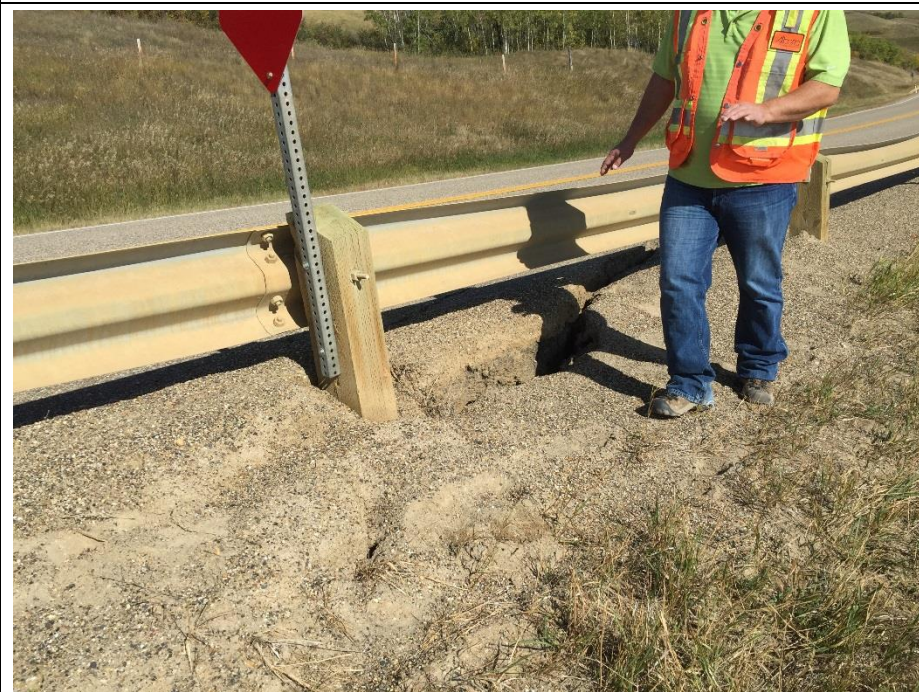
**Photo 5.**  
Looking north at  
cracks in SBL  
embankment  
sideslope. Cracks are  
open to 100 mm and  
drop is as much as  
200 mm.

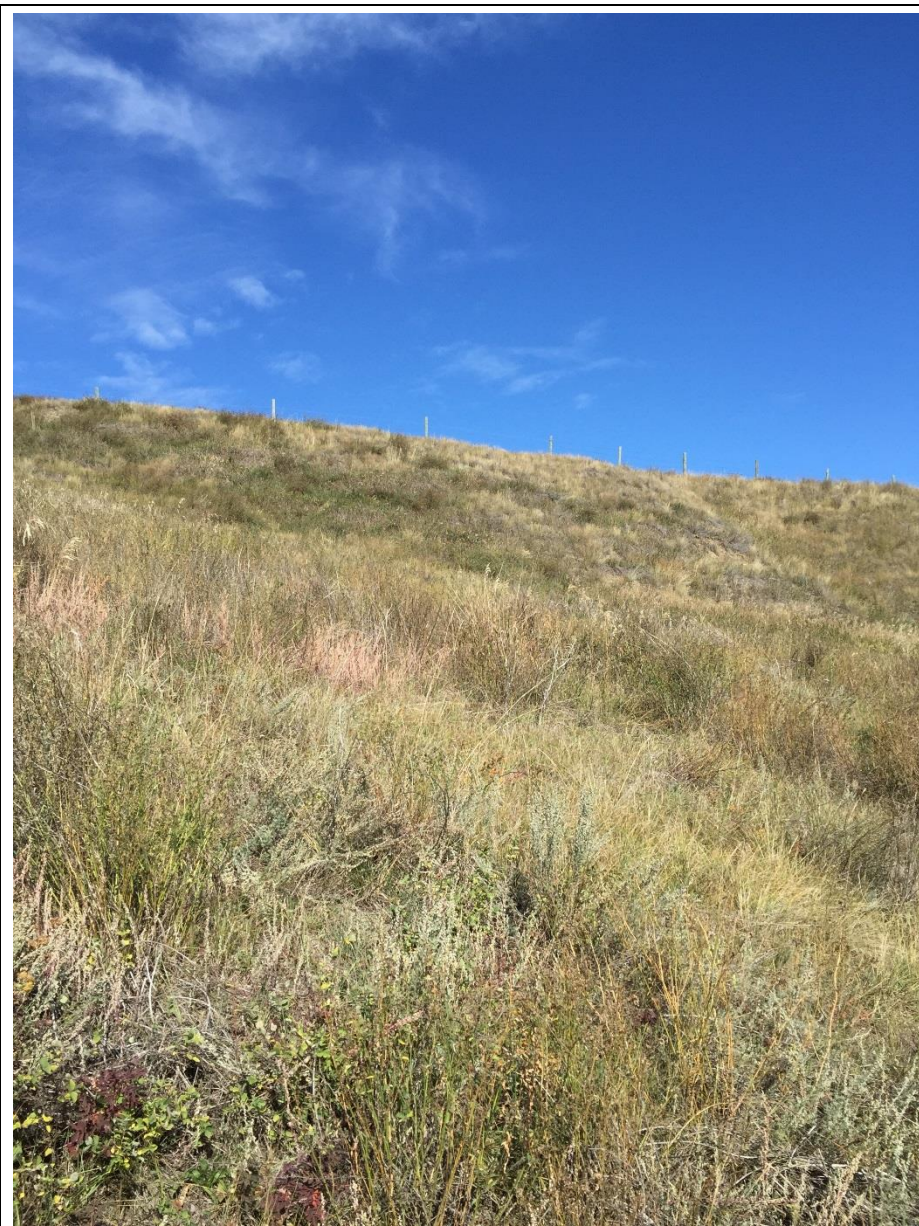
**Photo 6.**  
Looking NW upslope  
from the approximate  
center of the bulge in  
highway  
embankment  
sideslope below  
bows in guardrail and  
fence and the cracks  
in the roadway.

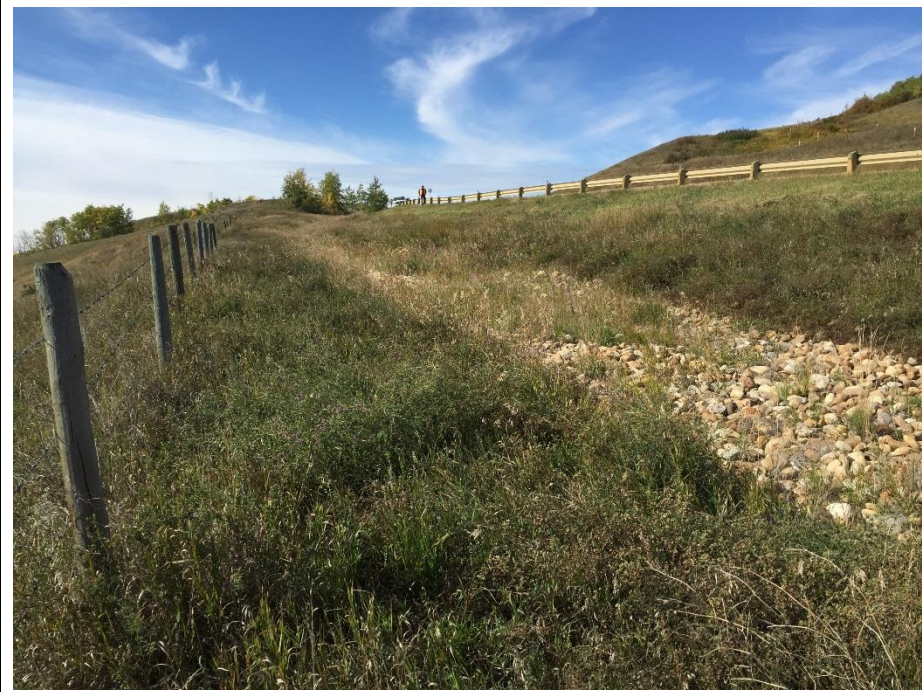
**Photo 7.**  
Looking SW along the SBL rip rap lined ditch. Bow in barbed wire fence extends 1.5 m past fence alignment. A bow in the guardrail along the SBL shoulder is also noticeable.

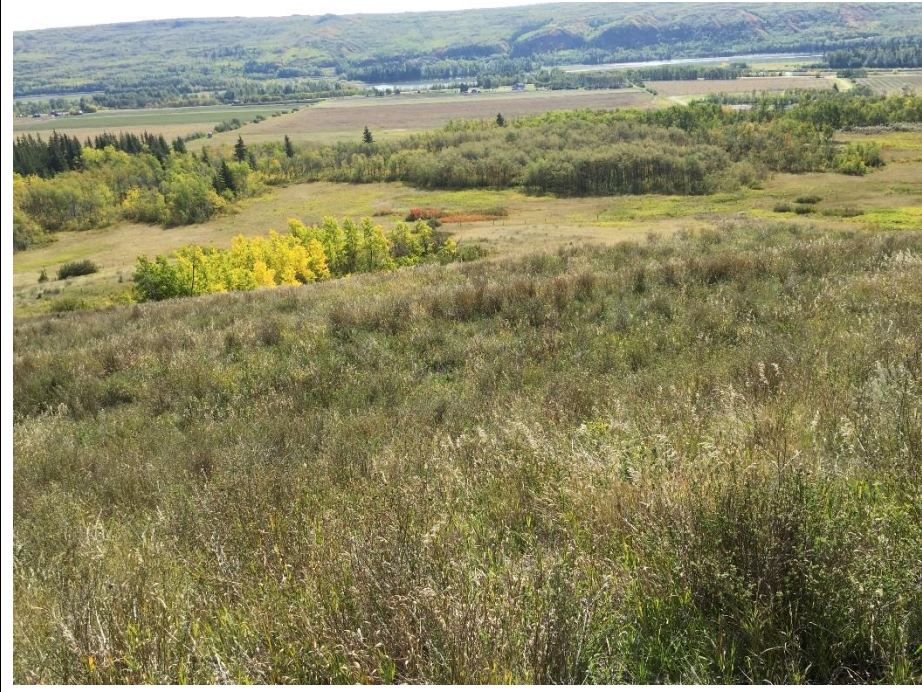
**Photo 8.**  
Looking SE from SBL ditch at toe berm constructed in 2004. No visible signs of movement or changes since last visit in June 2006.
