**ALBERTA TRANSPORTATION  
GEOHAZARD ASSESSMENT PROGRAM  
PEACE REGION – PEACE-HIGH LEVEL  
2020 INSPECTION**

Site Number	Location	Name	Hwy	km
PH009A-1	Shaftesbury	Bricks Hill Slide	684:02	9.240
Legal Description		UTM Co-ordinates		
SE¼ 21-082-23 W5M		11U E 467287	N 6219688

2020 INSPECTION PLAN

DWG No. 13351-PH009A-1

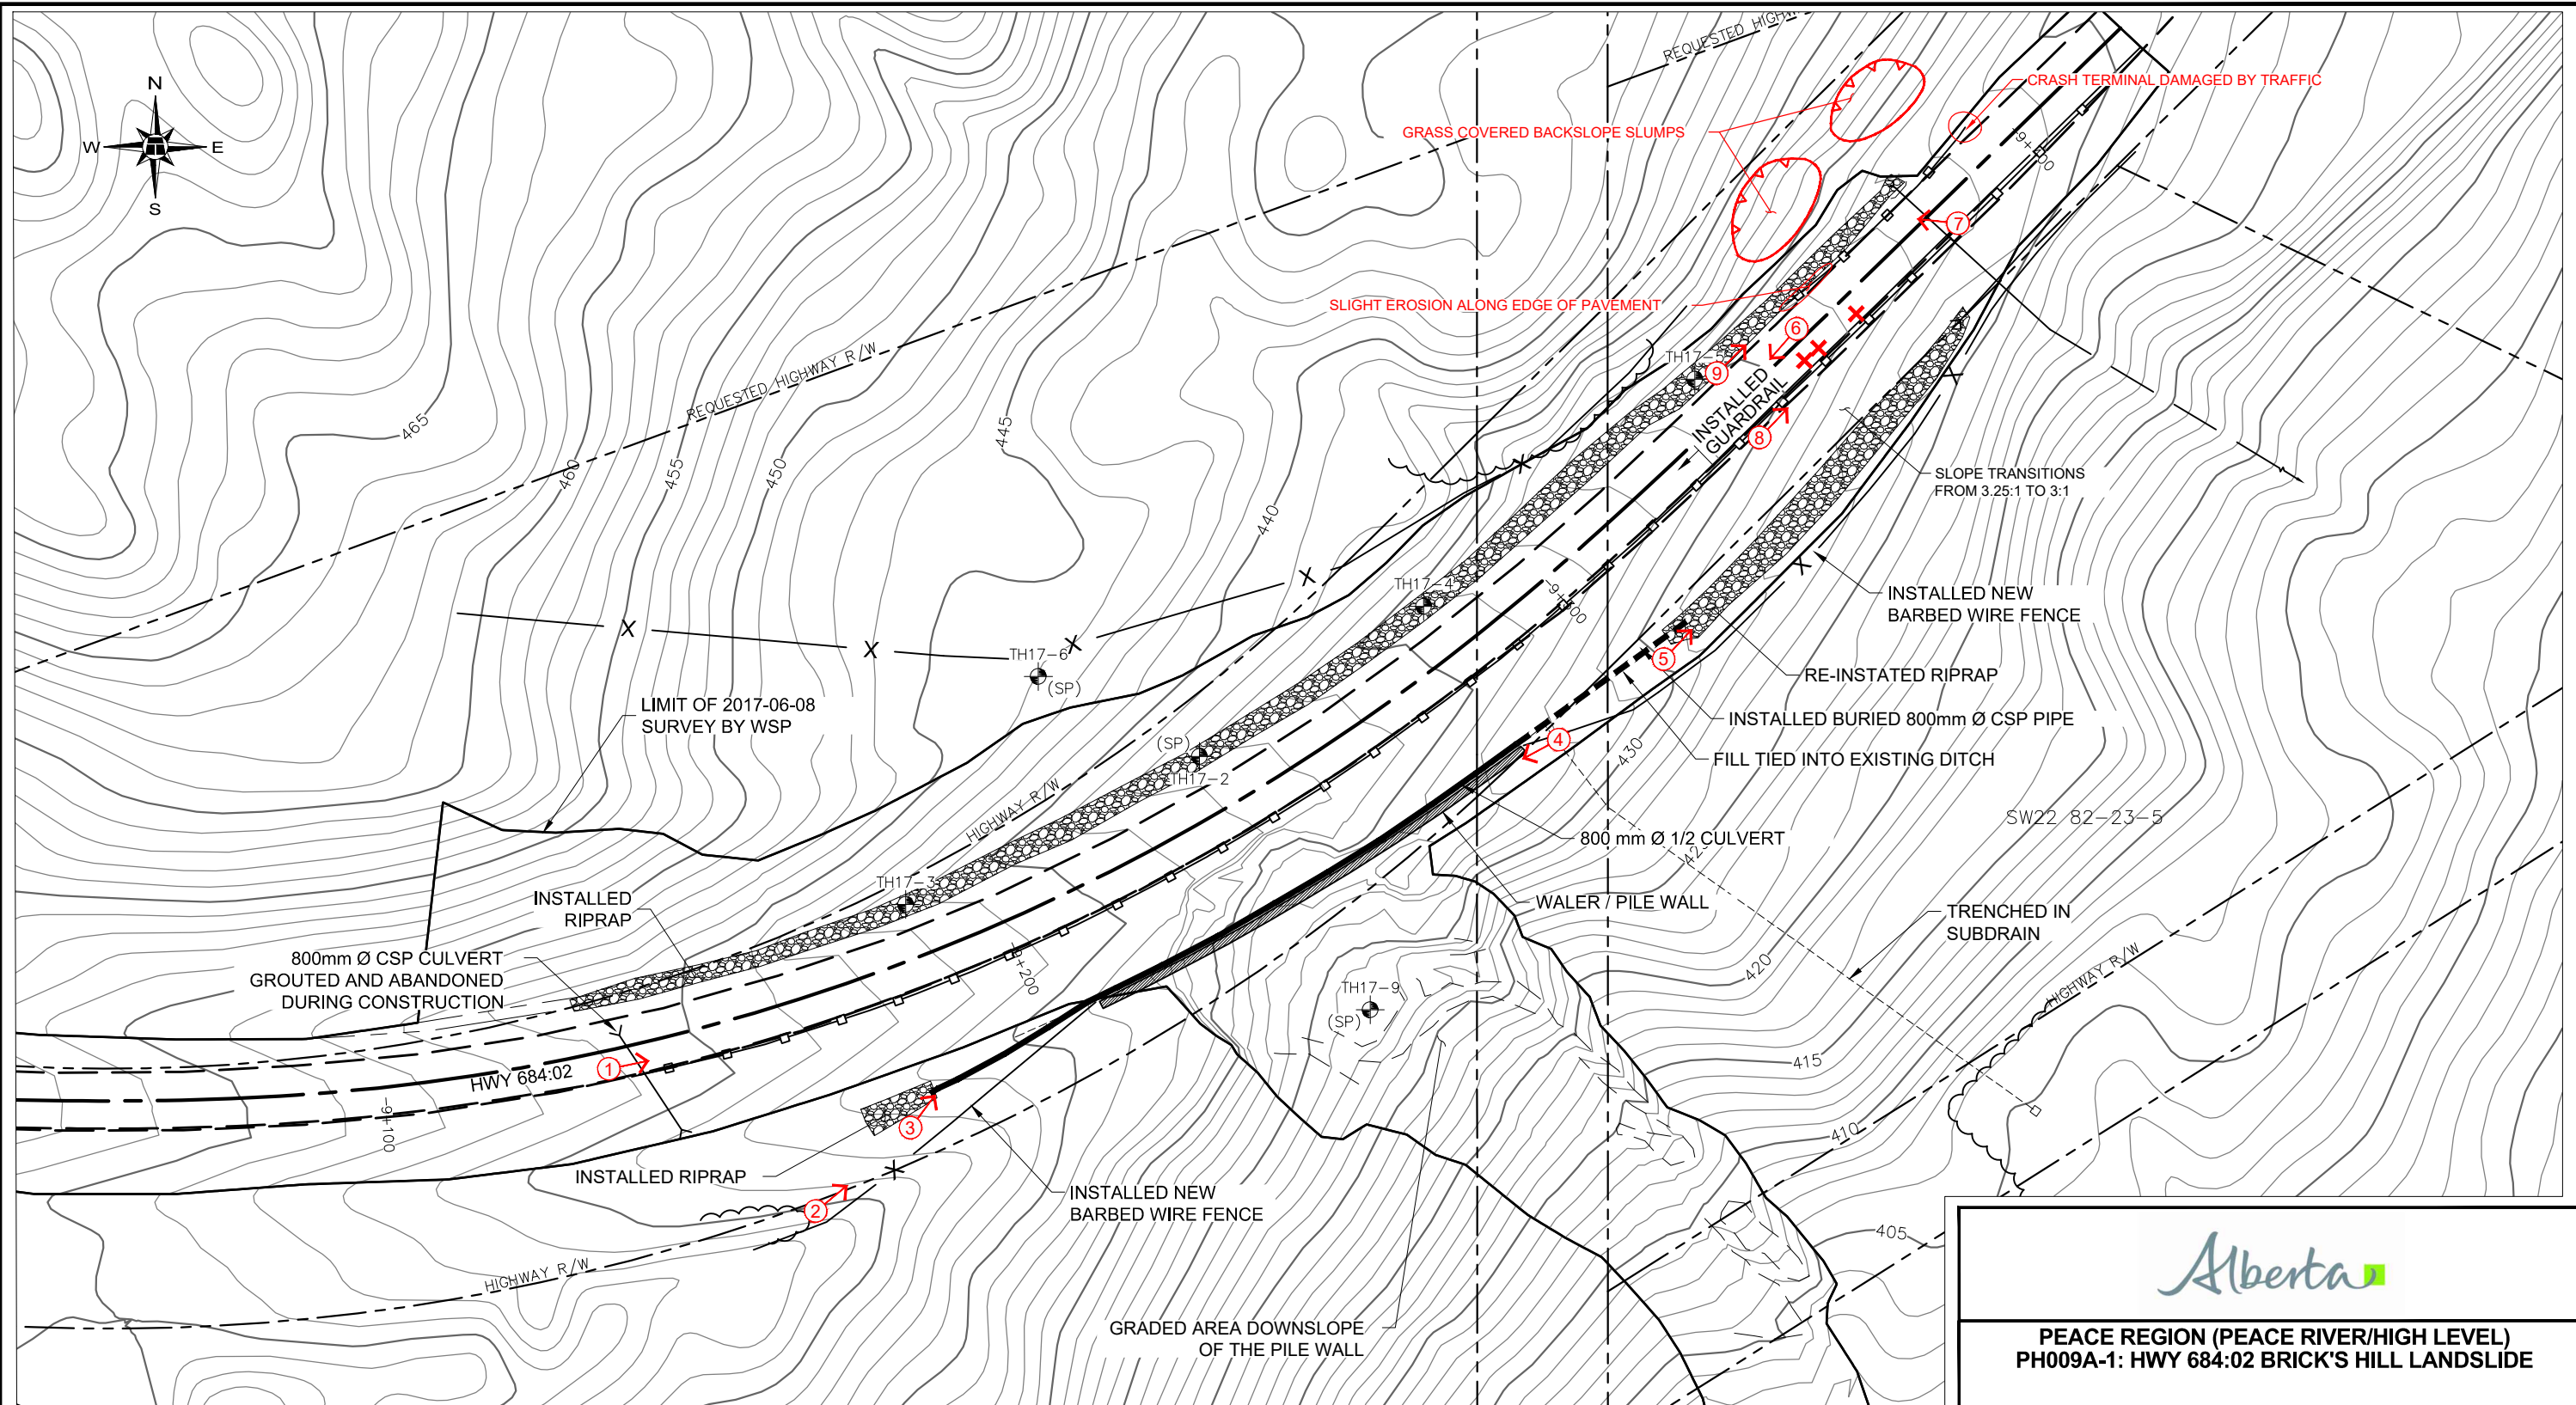
1. JUNE 11, 2020 SITE OBSERVATION SHOWN IN RED

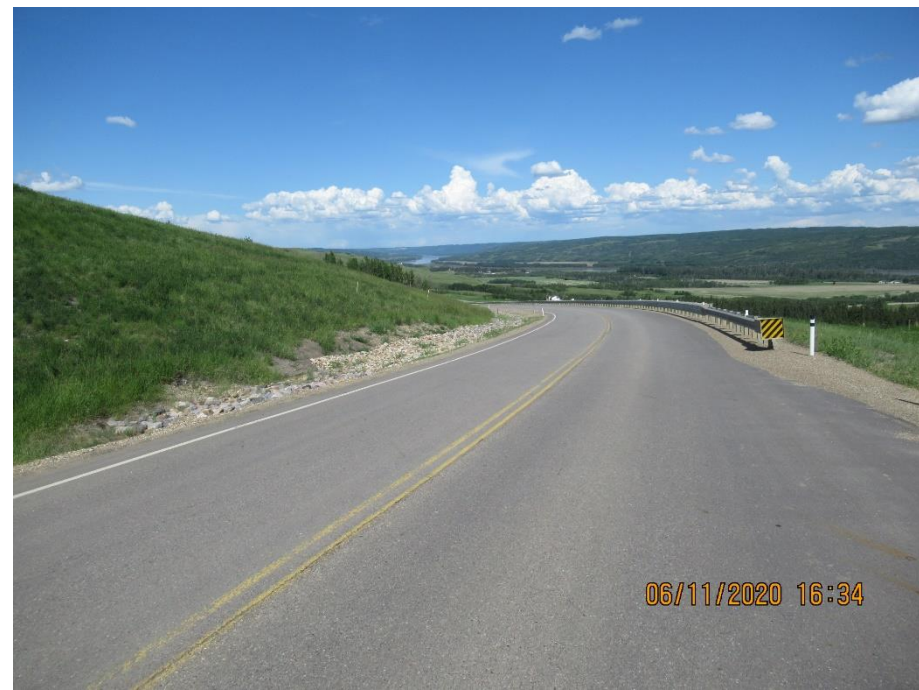
The recent remedial measures appear to be performing well to date. The rehabilitated highway surface and sideslope do not show any signs of movement and pile head deflections are well within predicted values.

**Photo 1.**  
Looking northeast at repaired highway.

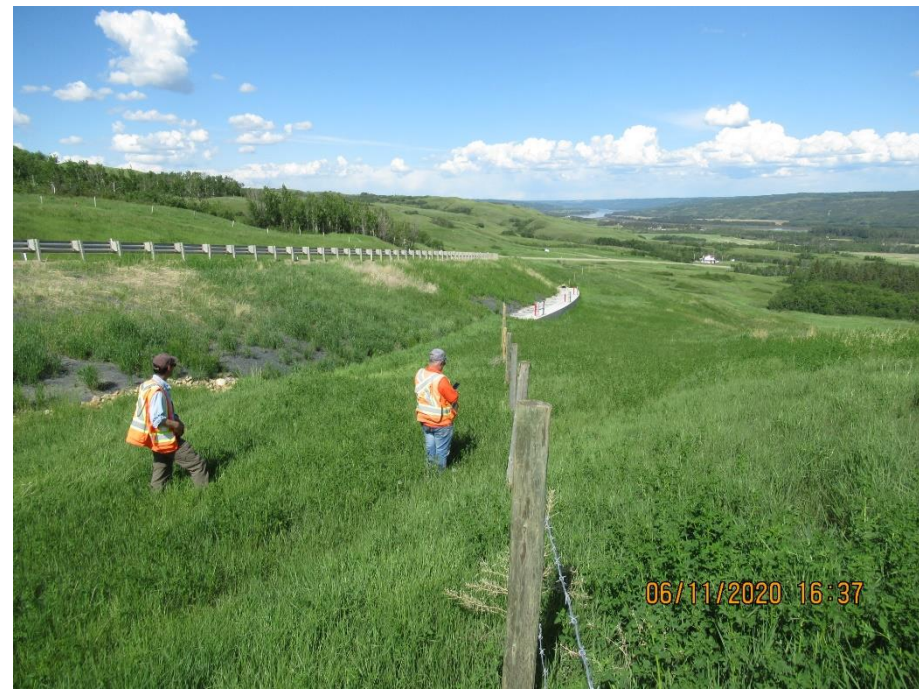
**Photo 2.**  
Looking northeast at reconstructed sideslope and pile wall.

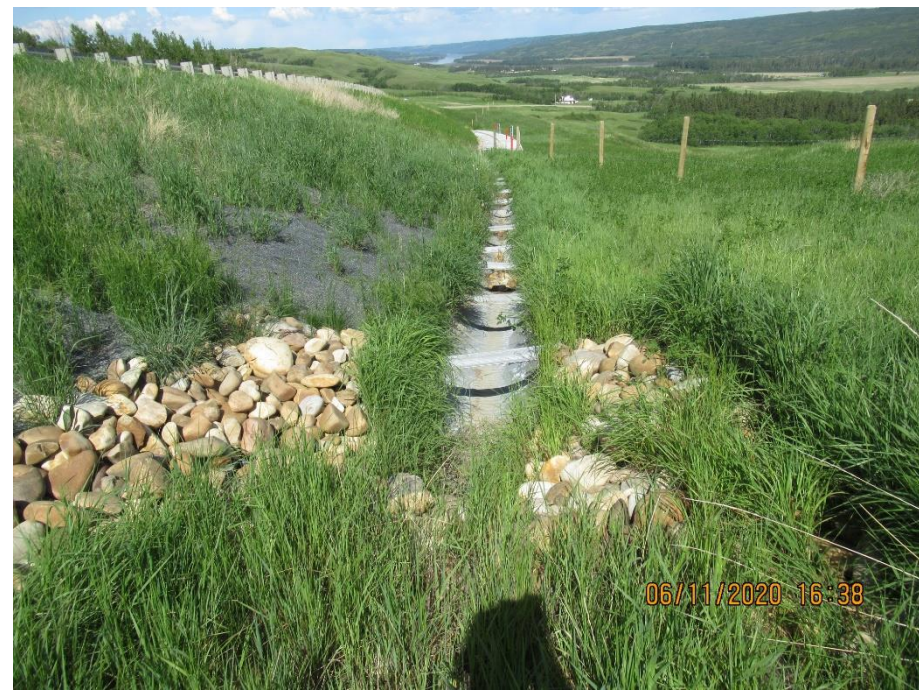
**Photo 3.**  
Looking northeast  
along the 1/2 culvert  
lined drainage south  
drainage ditch.

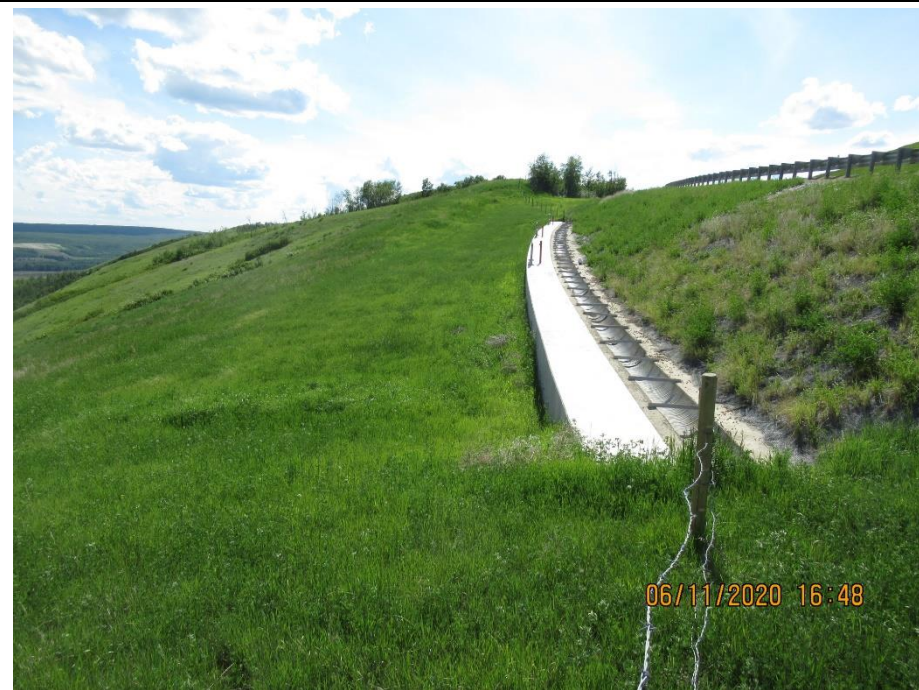
**Photo 4.**  
Looking southwest  
along the pile wall.

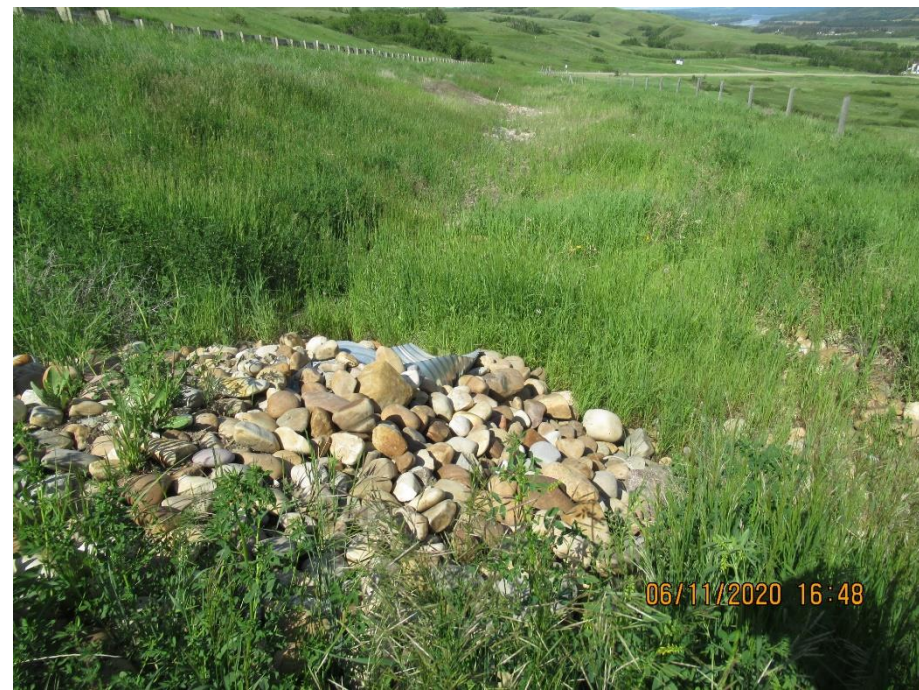
**Photo 5.**  
Looking northeast  
along the south ditch.

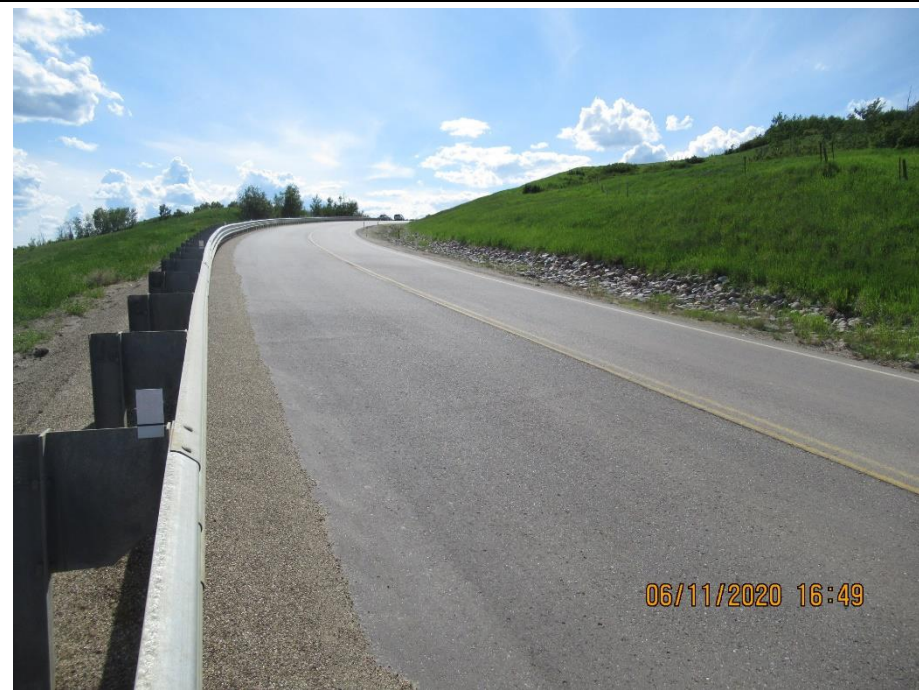
**Photo 6.**  
Looking southwest at  
the repaired highway.

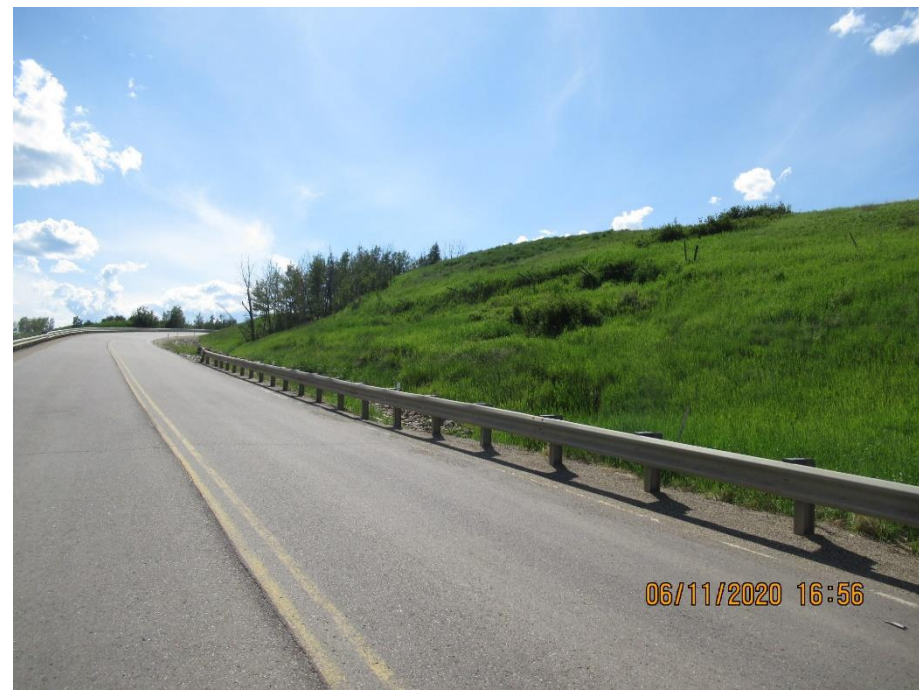
The old slumps in the backslope are grassed over and relatively dormant, likely a result of weathering and loss of cohesion in the clay soils.

**Photo 7.**  
Looking southwest at  
an old grass covered  
slump in the  
backslope.

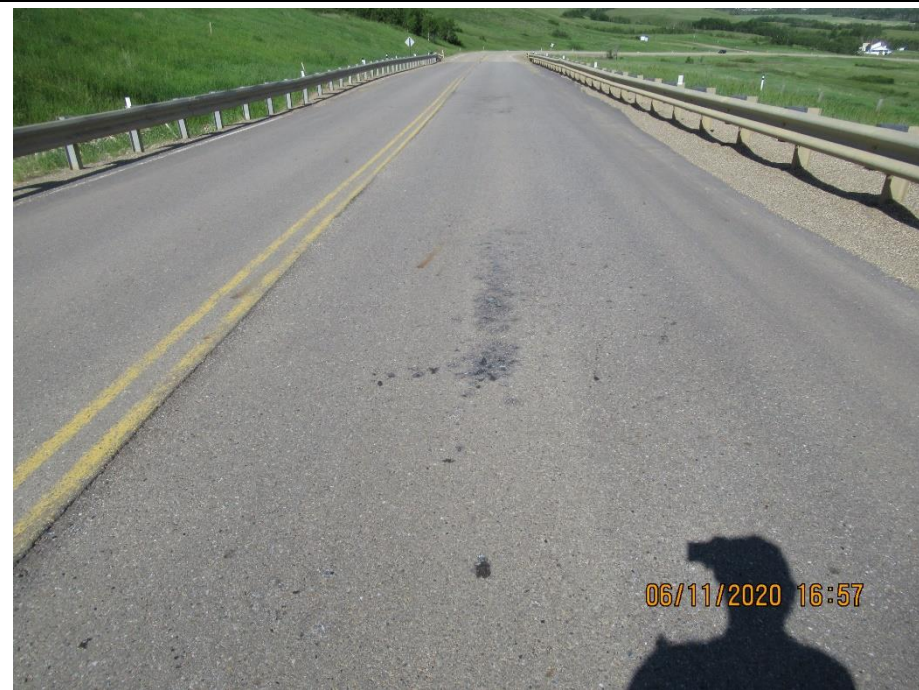
Minor seepage from the pavement edge could be due to water trapped in the GBC and should be monitored for potential development of local asphalt potholes.

**Photo 8.**  
Seepage from the  
pavement.

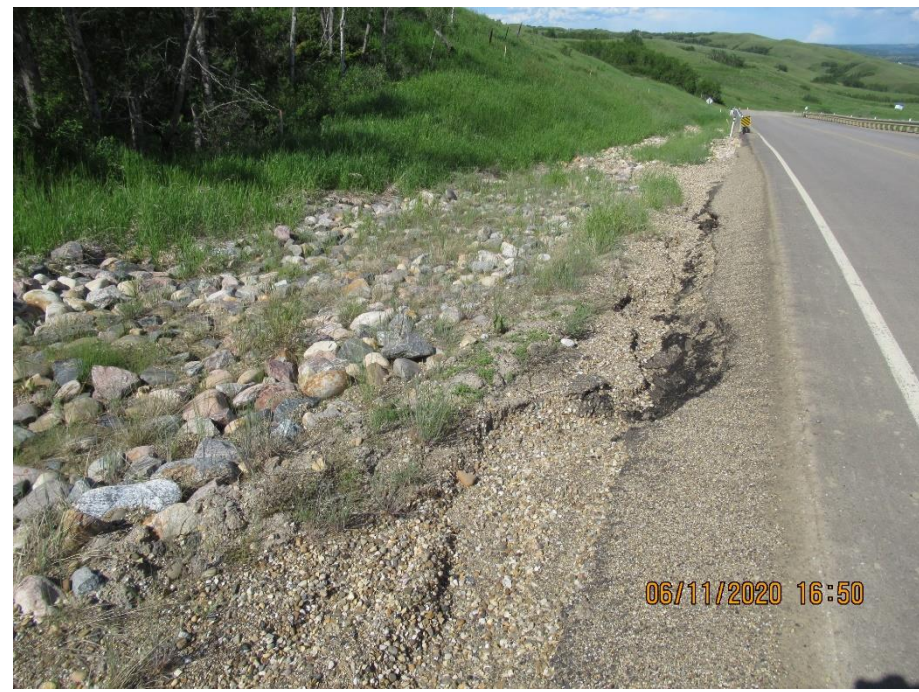
The minor erosion along the edge of pavement is considered to be due to a fast spring runoff that was channelized against the pavement by a compacted windrow of frozen snow.

**Photo 9.**  
Erosion along the  
north shoulder of the  
highway.
