**ALBERTA TRANSPORTATION  
GEOHAZARD ASSESSMENT PROGRAM  
PEACE REGION – PEACE RIVER DISTRICT  
2021 INSPECTION**

<b>Site Number</b>	<b>Location</b>	<b>Name</b>	<b>Hwy</b>	<b>km</b>
PH009A-1	Shaftesbury	Bricks Hill Slide	684:02	9.240
<b>Legal Description</b>		<b>UTM Co-ordinates</b>		
SE¼ 21-082-23 W5M		11U E 467287	N 6219688

**PEACE REGION (PEACE RIVER DISTRICT)  
PH009A-1: HWY 684:02 BRICK'S HILL LANDSLIDE**

**2021 INSPECTION PLAN**

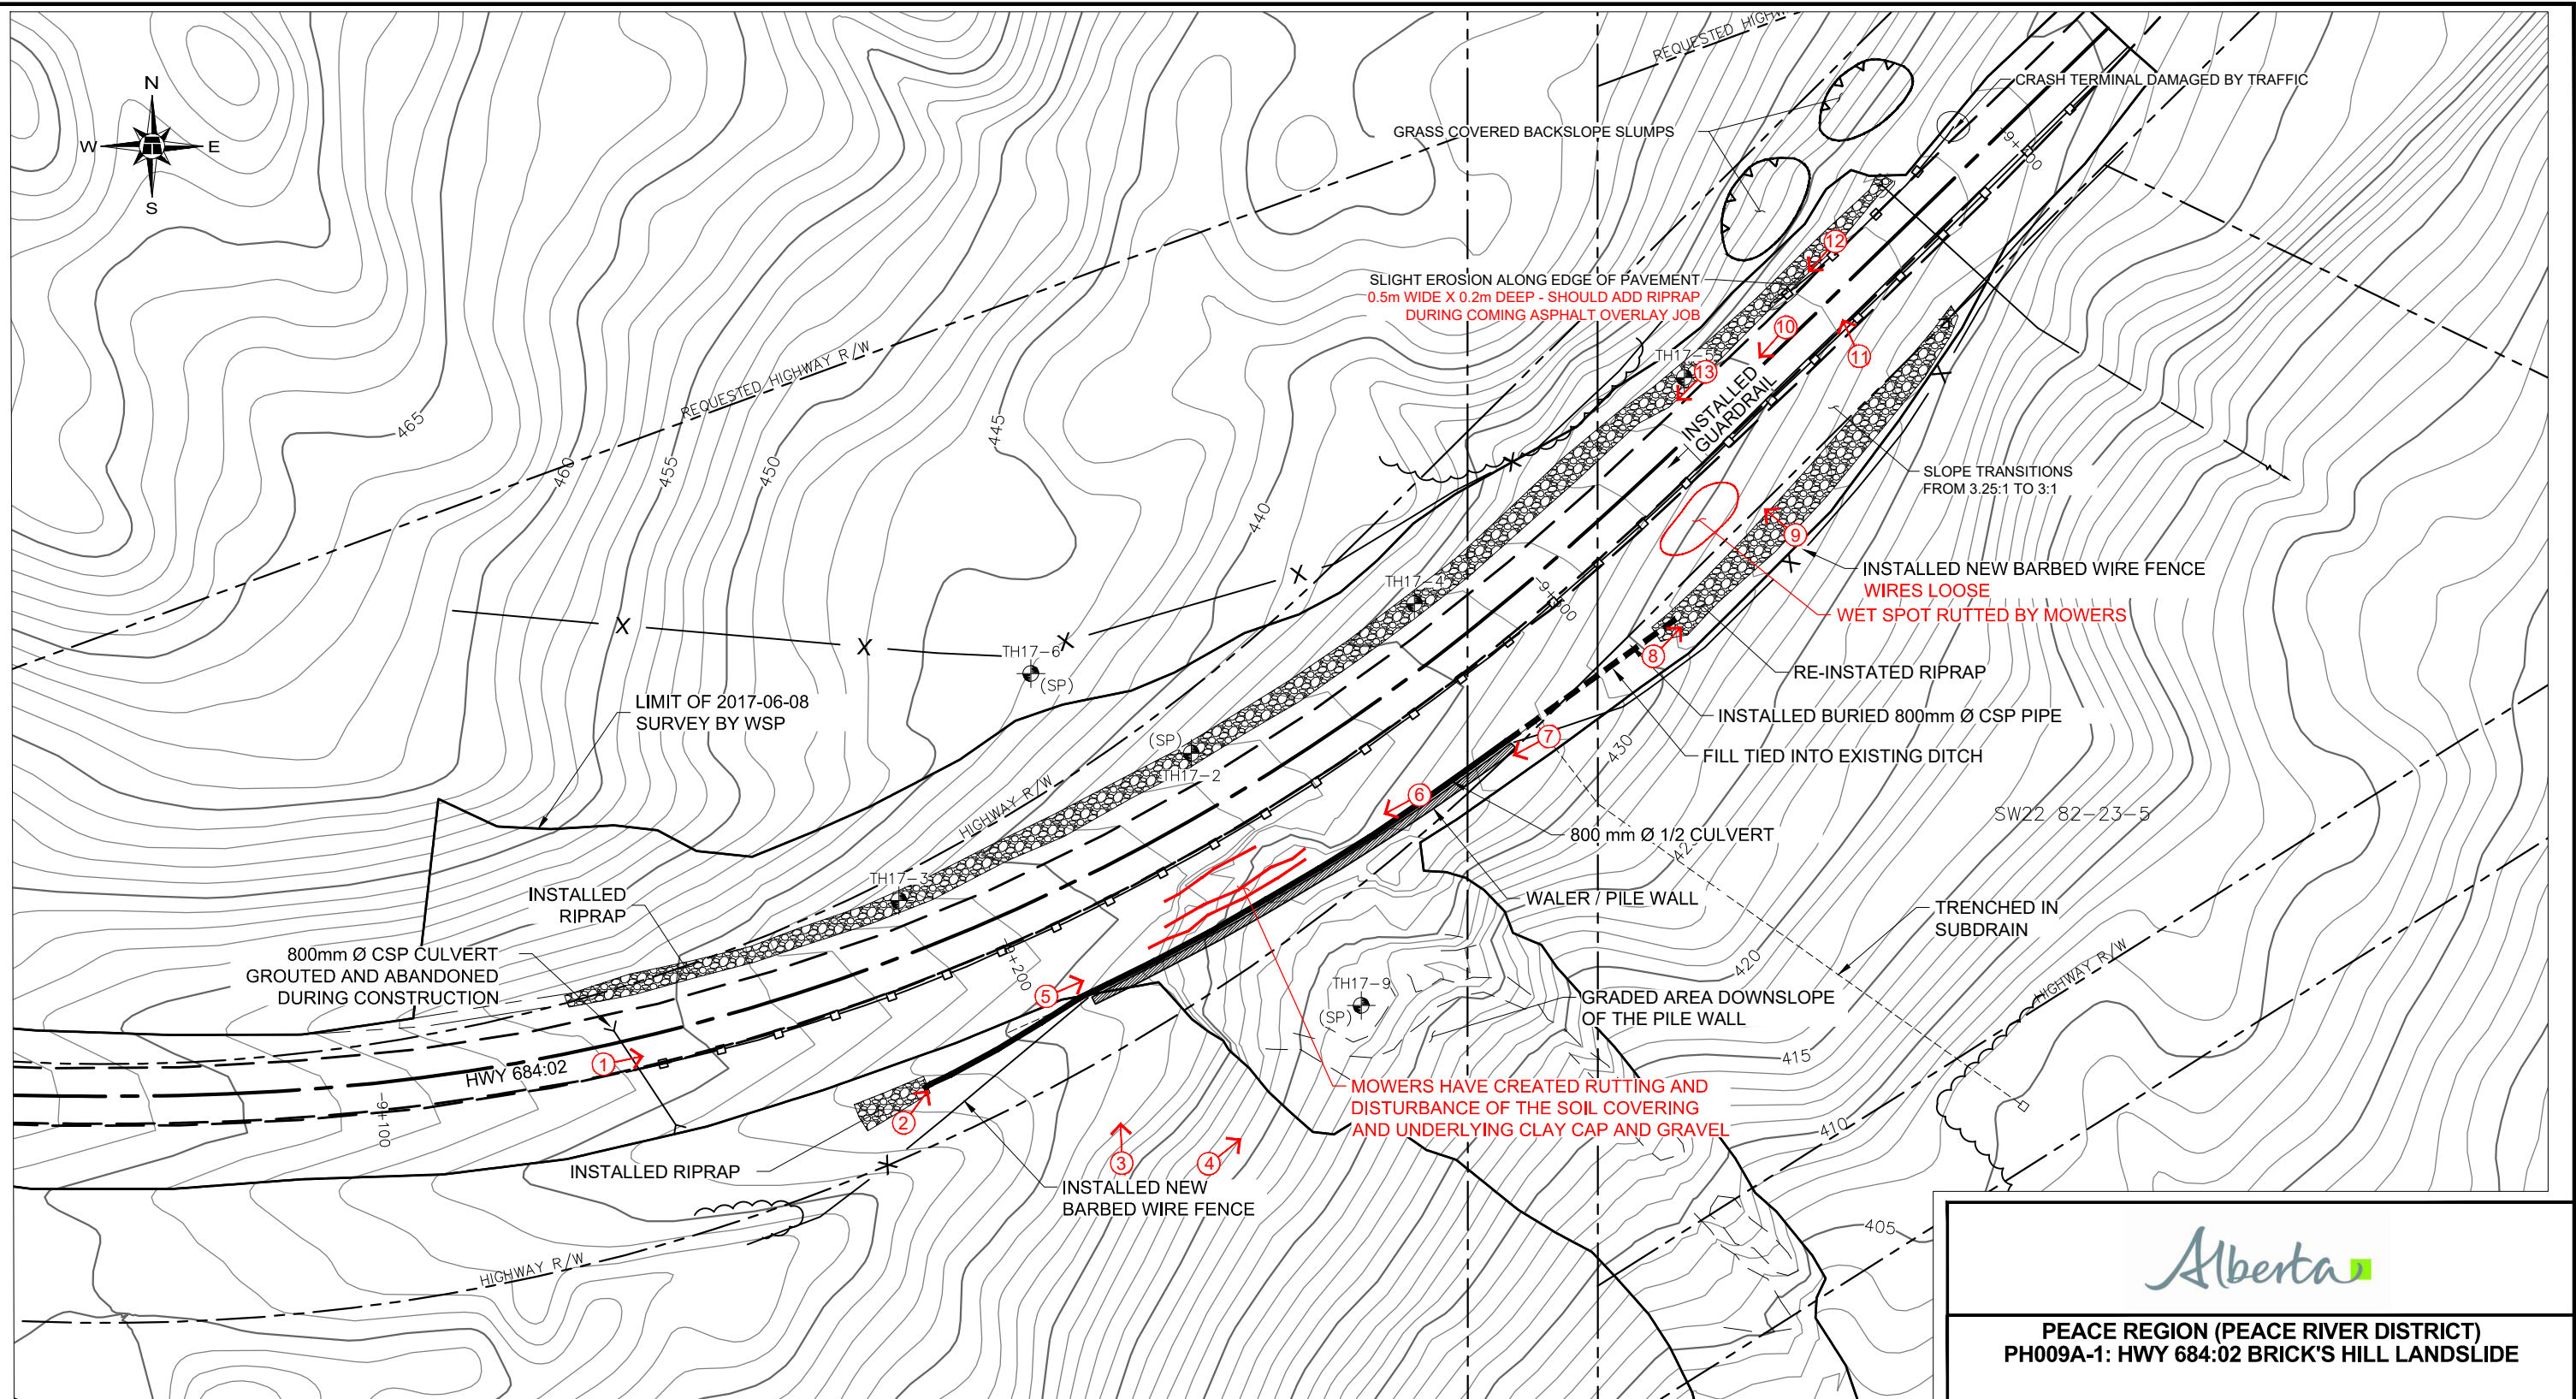
**DWG No. 32121-PH009A-1**

1. JULY 8, 2021 SITE OBSERVATION SHOWN IN RED
2. WOULD HAVE BEEN BETTER TO HAVE SET NEW GUARDRAIL ABOUT 50 mm HIGHER IN ANTICIPATION OF FUTURE OVERLAY PROJECT.

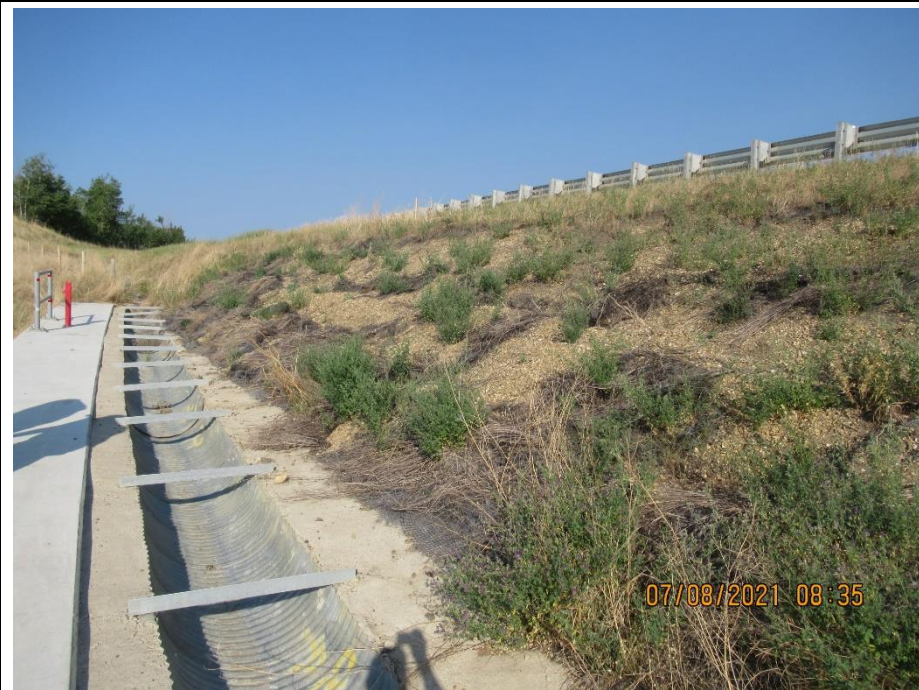
**Photo 6.**  
Looking west along  
the drainage trough  
and pile wall. Note  
the disturbance  
caused by mowers to  
the fill slope surface  
above the drain  
trough

The side slope area that was rutted by the mowers should be repaired by raking out the ruts, seeding and covering the slope with additional TRM. In the future this part of the slide repair should be mowed by hand, not with heavy tractors as the slope is steep and prone to disturbance under wheel traffic. AT suggested that "No Mowing" signs be placed on the steep sideslope above each end of the pile wall to remind the mowing crew of this.

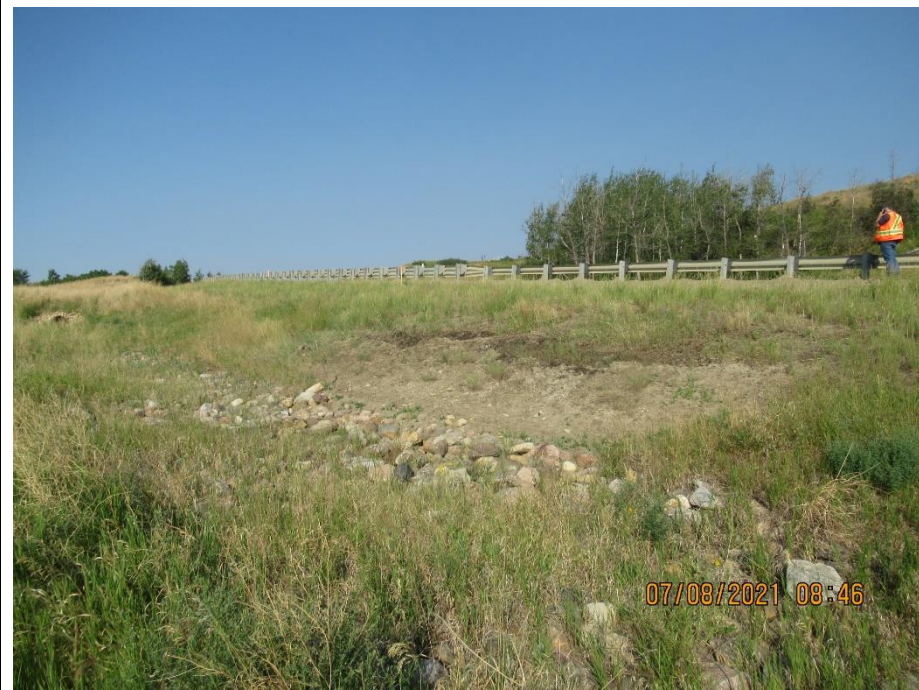
Minor seepage from the sideslope is near where some wetness was noted last year in the pavement. There might be a spring in this area.

**Photo 9.**  
Wet area in fill  
sideslope where  
mower has rutted the  
ground surface

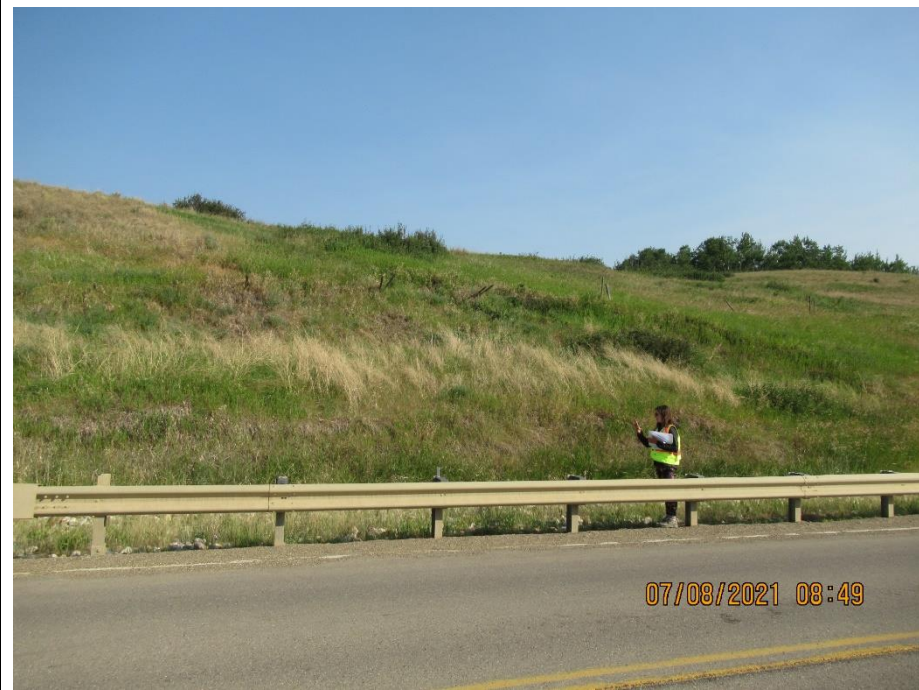
The old slumps in the backslope are grassed over and relatively dormant, likely a result of weathering and loss of cohesion in the clay soils.

**Photo 11.**  
Grass covered  
backslope slumps

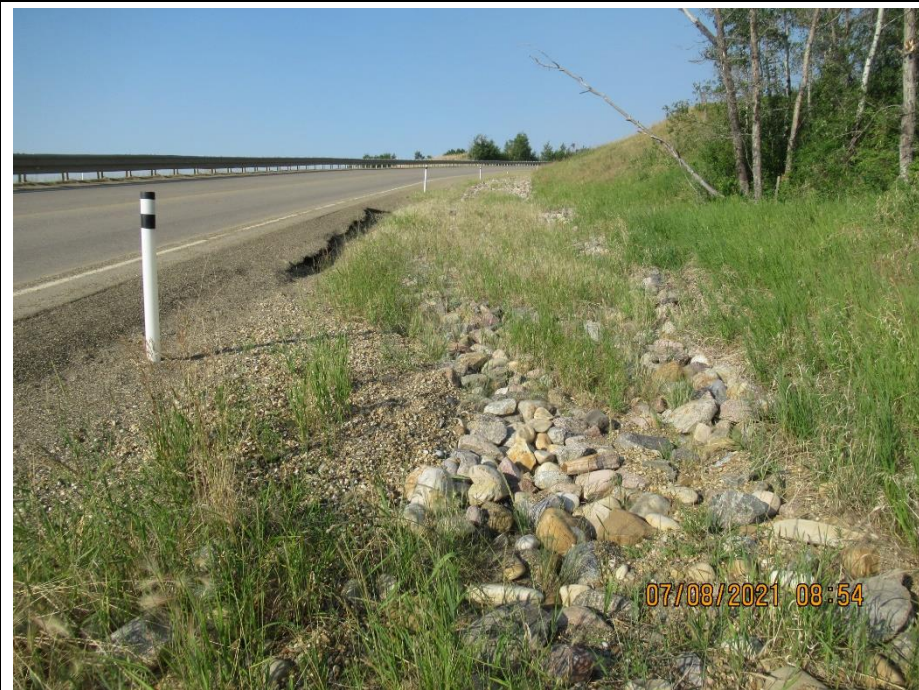
<b>Observations:</b>	<b>Description</b>	<b>Worsened?</b>
<input checked="" type="checkbox"/> Pavement Distress	A short section of the edge of the pavement had been eroded (photo 12).	<input type="checkbox"/>
<input checked="" type="checkbox"/> Slope Movement	There are two grassed over small old slumps in the backslope (photo 11).	<input type="checkbox"/>
<input checked="" type="checkbox"/> Erosion	Small section of eroded pavement edge as noted above (photo 12).	<input type="checkbox"/>
<input checked="" type="checkbox"/> Seepage	A wet sideslope area (photo 9)	<input checked="" type="checkbox"/>
<input type="checkbox"/> Bridge/Culvert Distress		<input checked="" type="checkbox"/>
<input checked="" type="checkbox"/> Other	Mowers had rutted the surface of the sideslope fill in the landslide repair area	<input type="checkbox"/>

The minor erosion along the edge of pavement is considered to be due to a fast spring runoff that was channelized against the pavement by a compacted windrow of frozen snow.

**Photo 12.**  
Looking west at  
eroded shoulder of  
road

It is understood that a pavement overlay is planned for 2021 up the Hwy 684 hill section. AT mentioned that they would include some repairs to the eroded highway shoulder using extra riprap as part of this work.
