July 28, 2022

**ALBERTA TRANSPORTATION GRMP (CON0022164)  
PEACE REGION (PEACE RIVER DISTRICT)  
INSTRUMENTATION MONITORING RESULTS – SPRING 2022**

**SITE PH009A: HWY 684:02, BRICKS HILL**

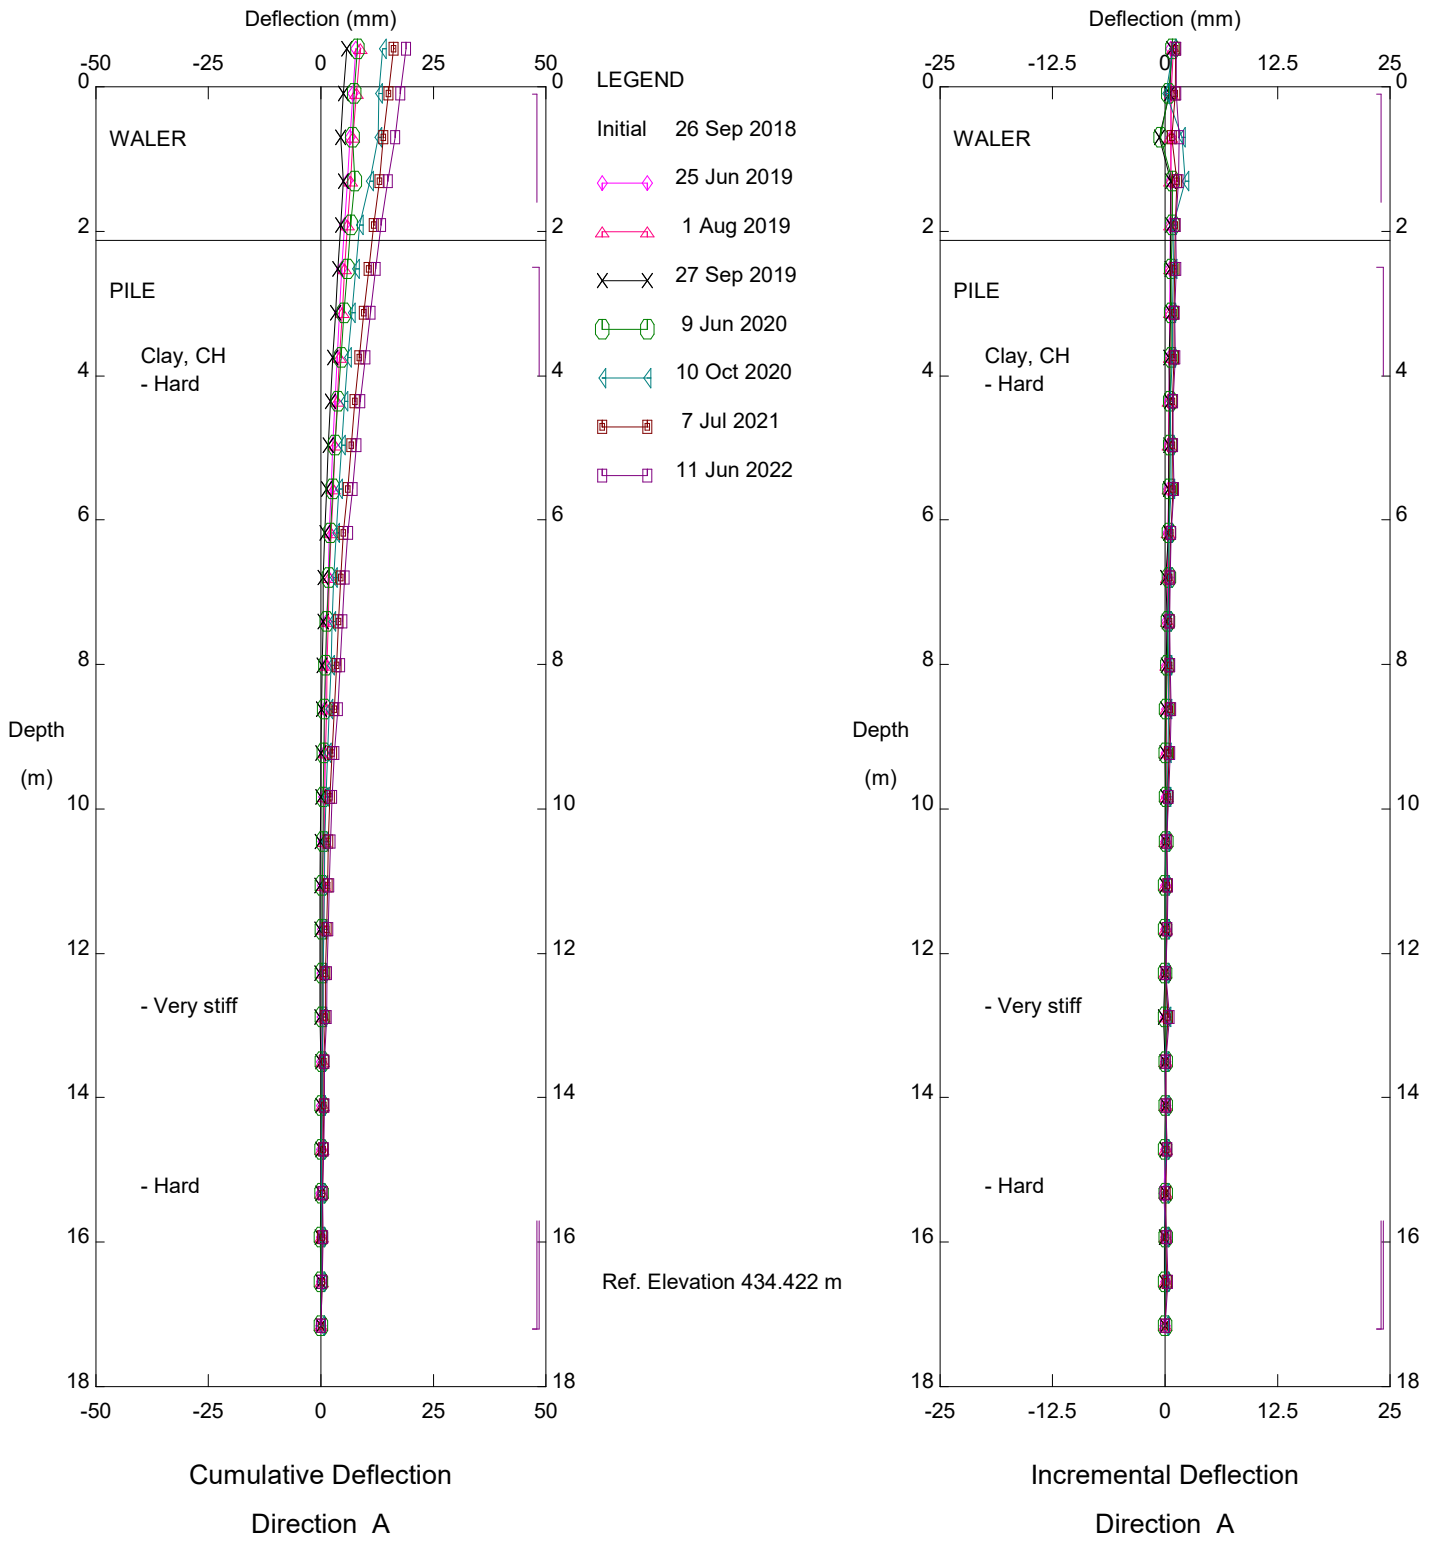
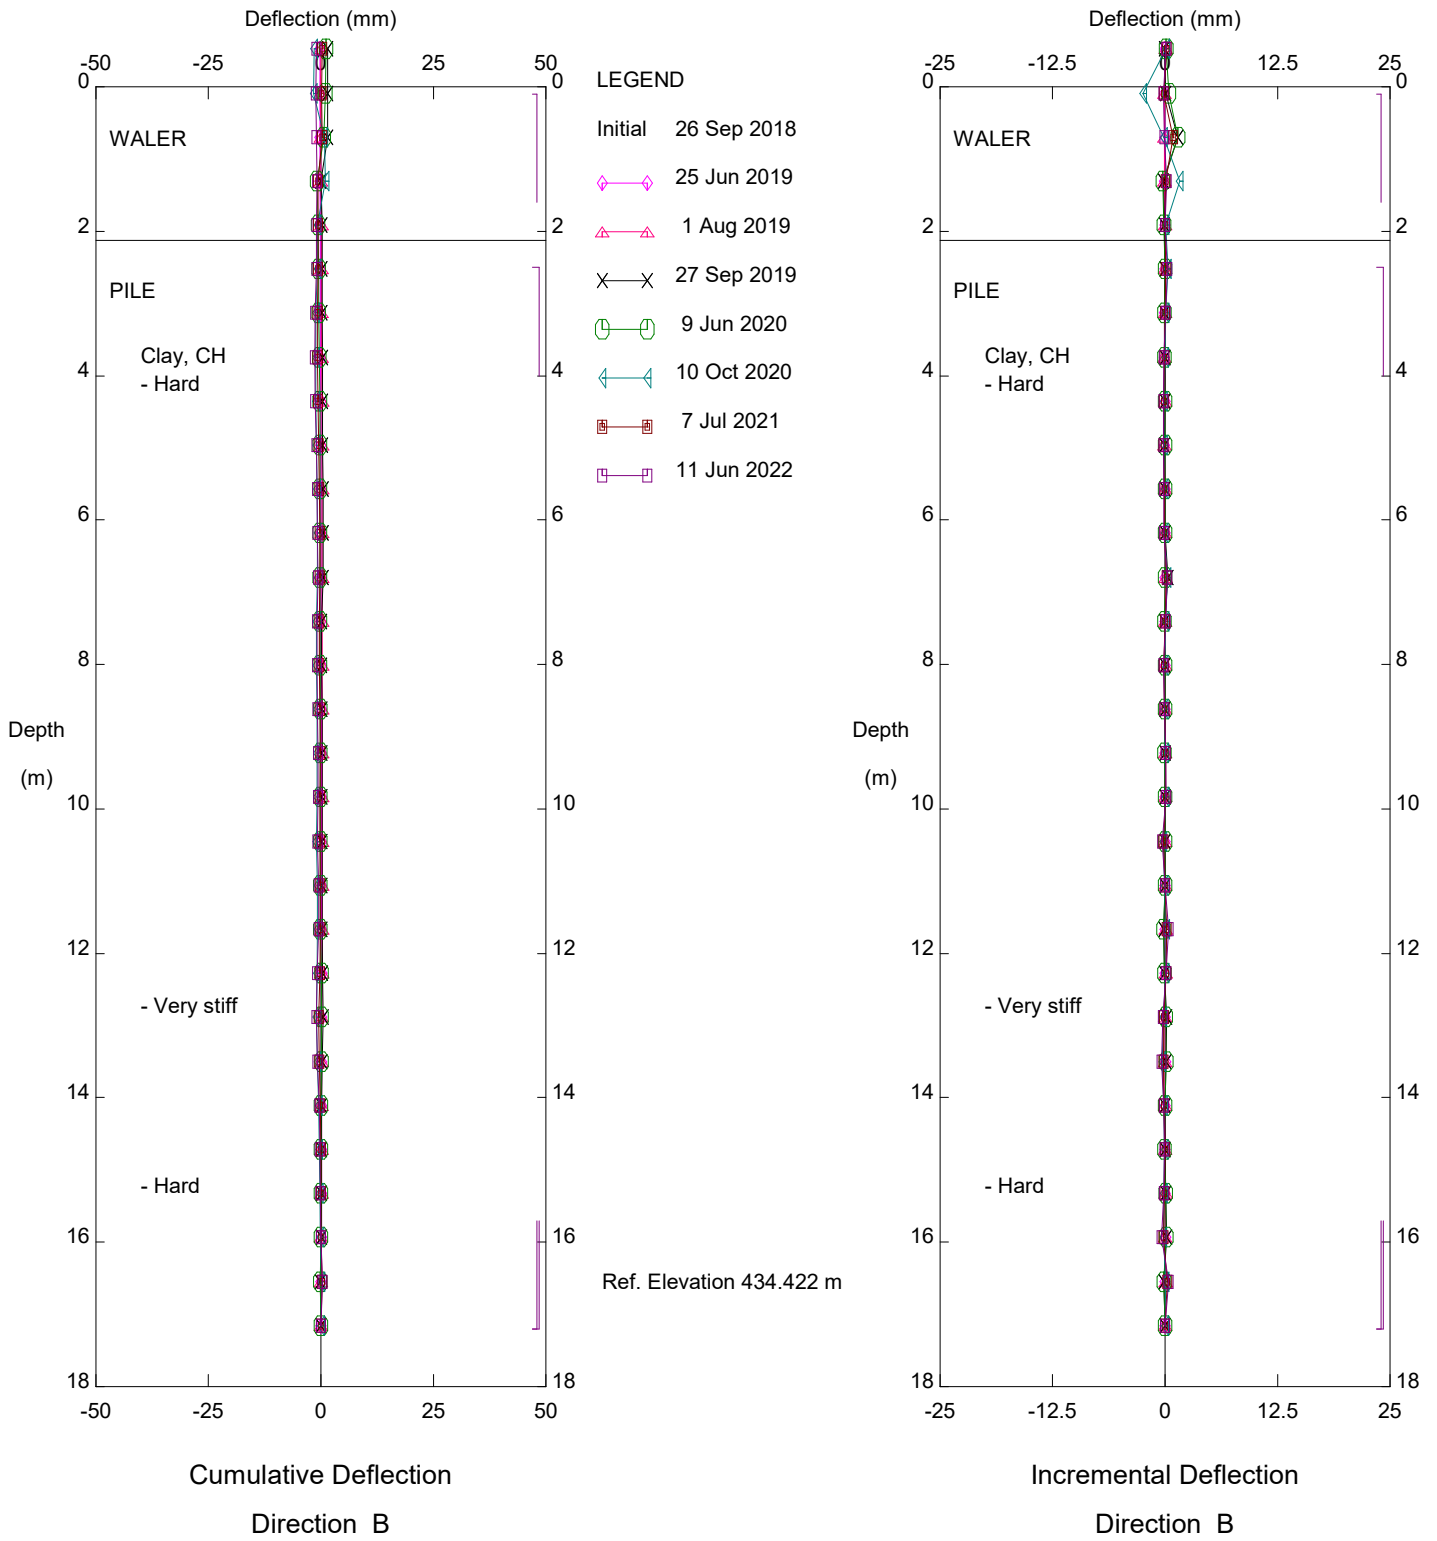
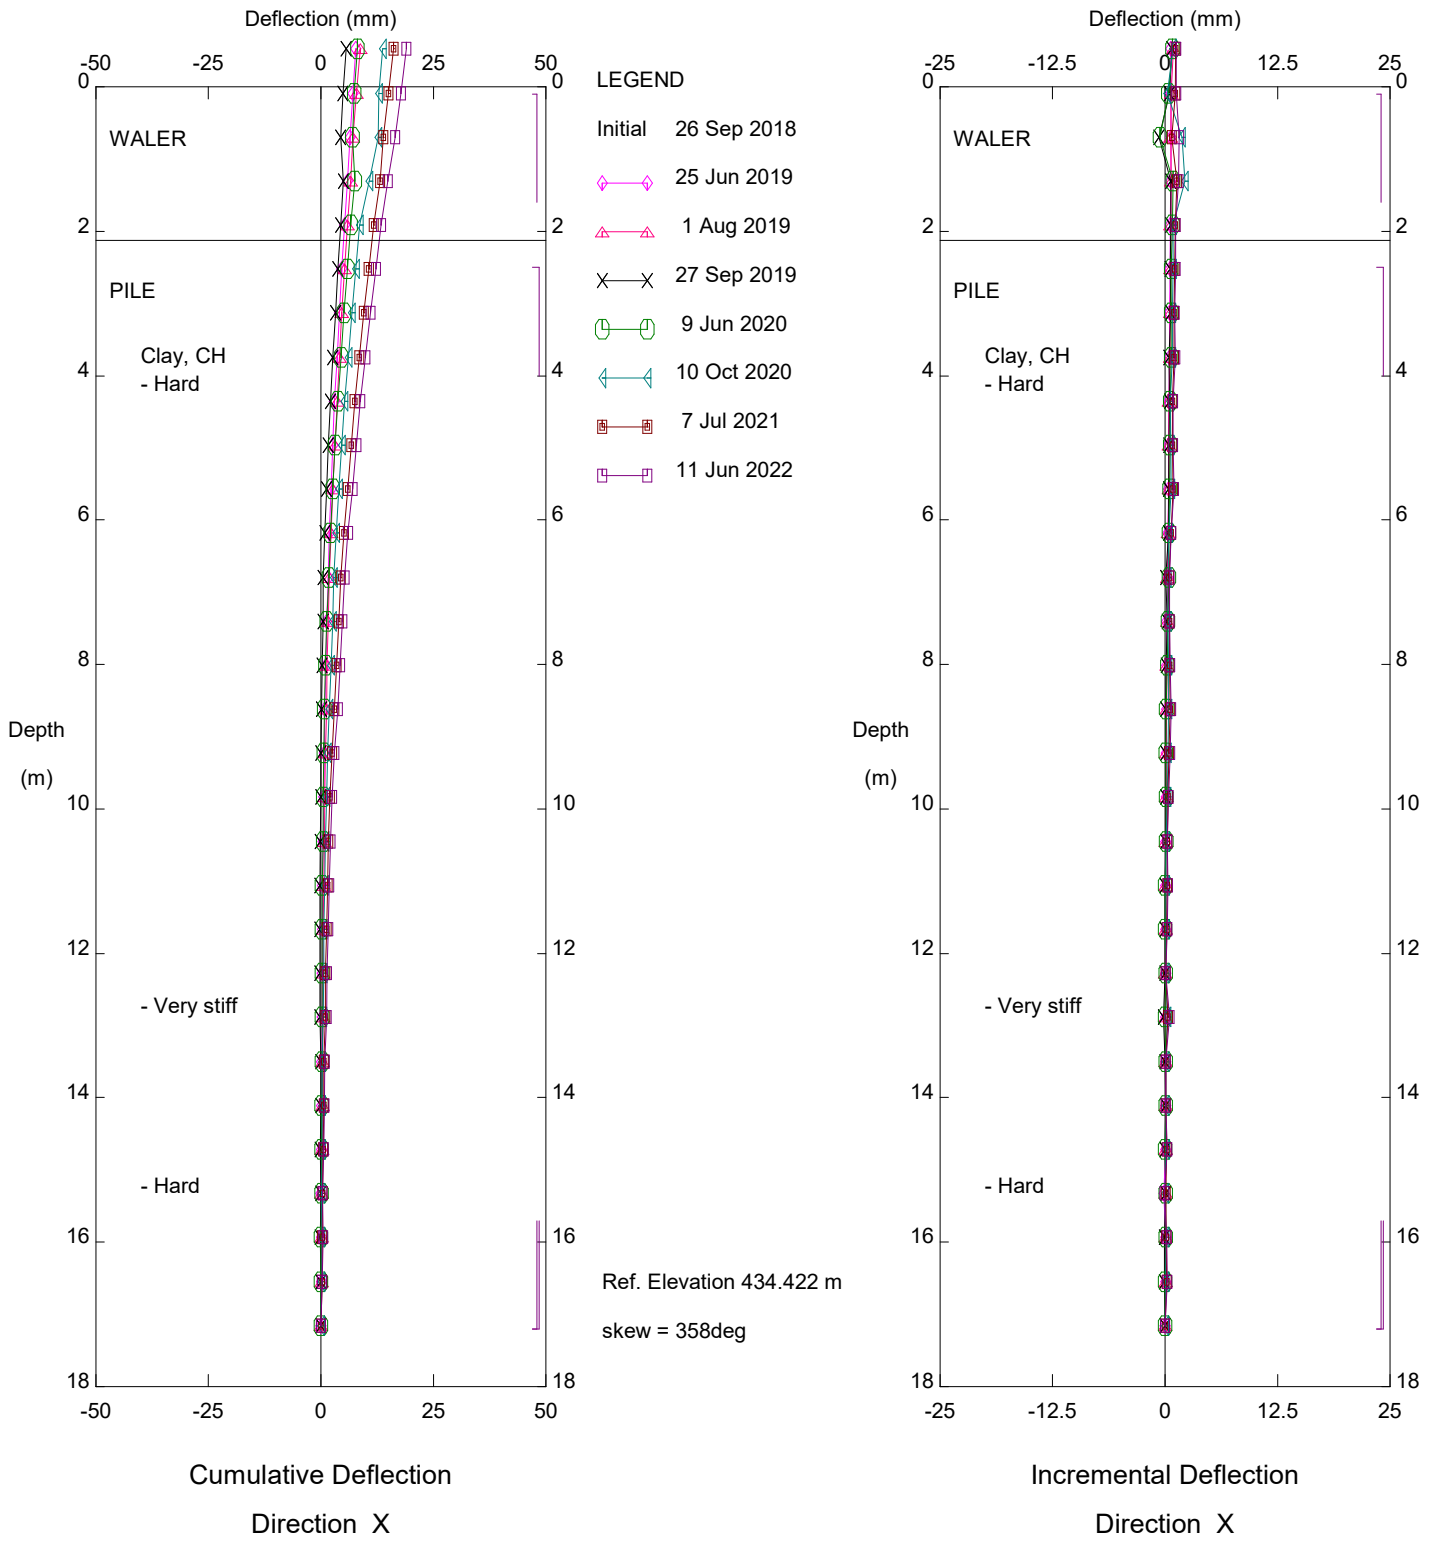
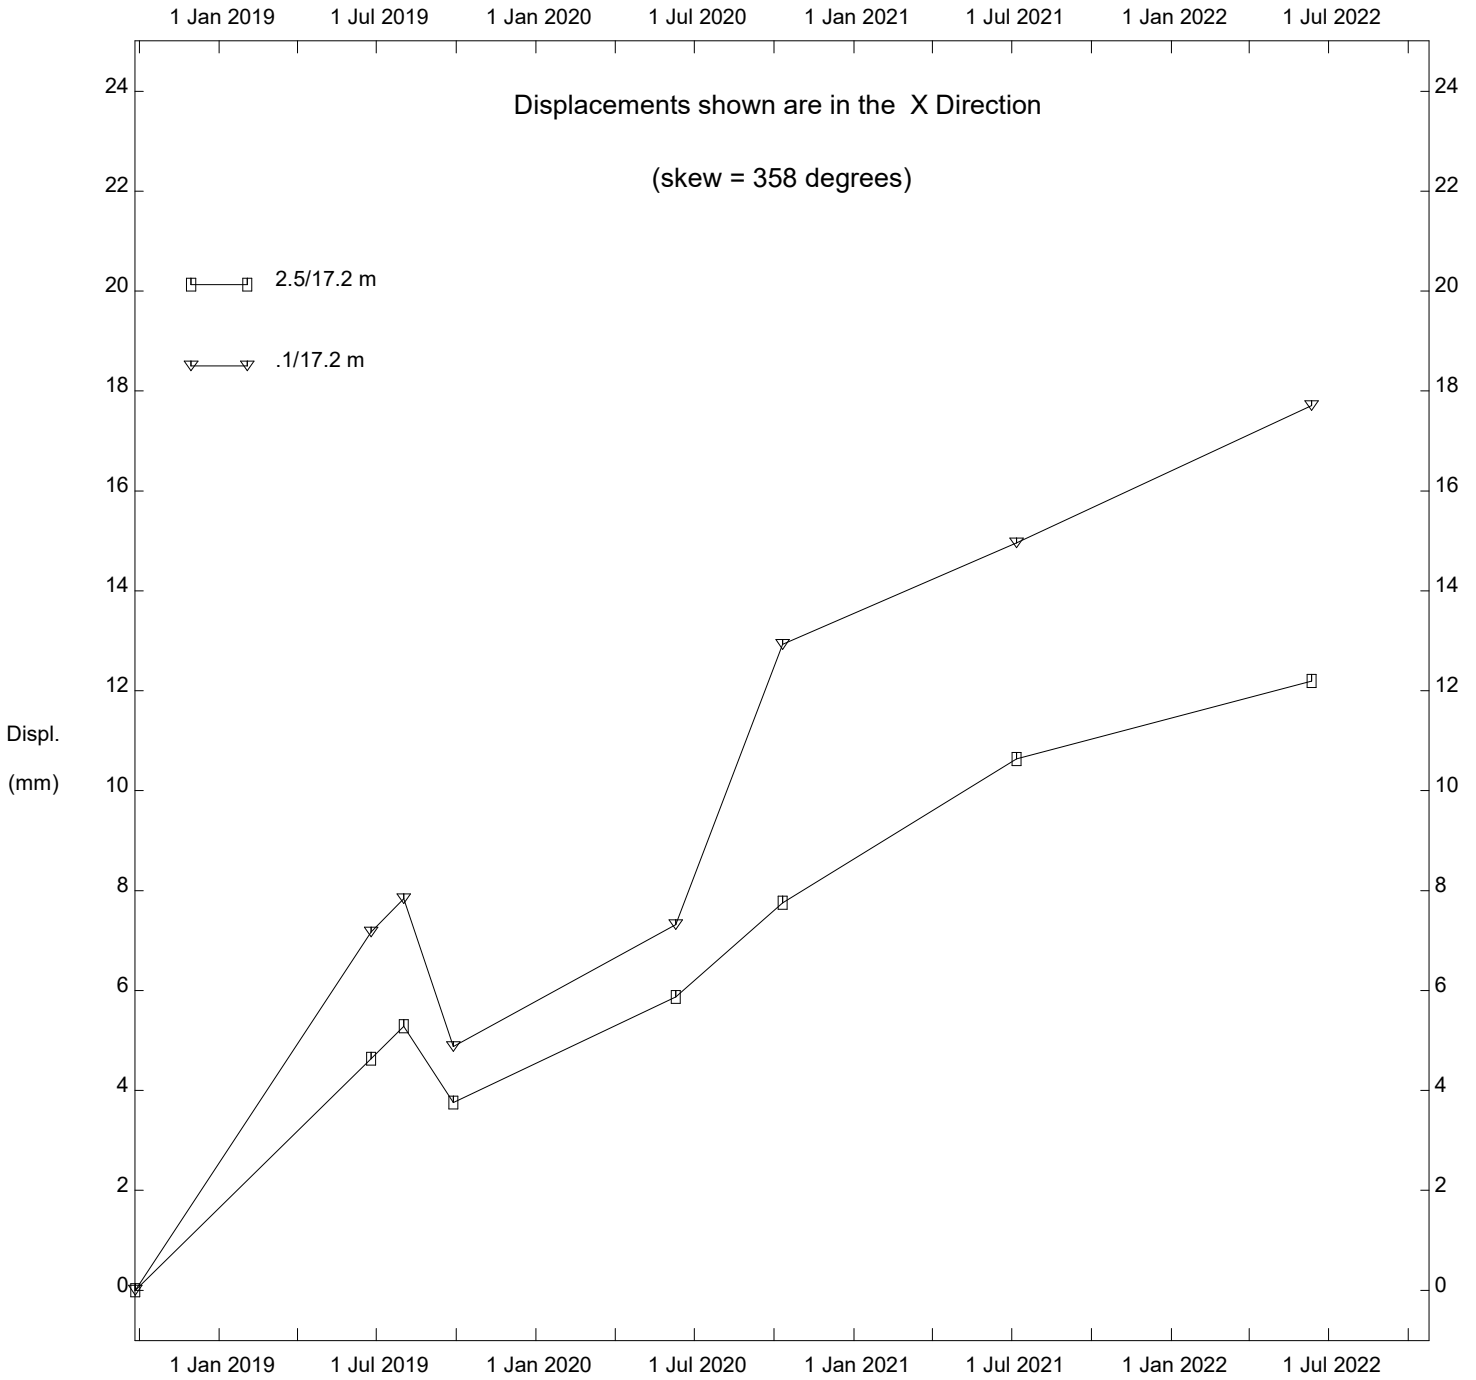
Hwy 684:02 km 9 Bricks Hill, Inclinometer SI18-P23

11.8 mm over 0.1 m to 17.1 m depth in 157° direction	5.2 mm/yr in June 2019			2.8	3.0	0.7
SI18-P23	September 26, 2018	12.2 mm over 2.5 m to 17.2 m depth in 155° direction	6.3 mm/yr in June 2019	Operational	July 7, 2021	1.6	1.7	-2.2

17.7 mm over 0.1 m to 17.2 m depth in 155° direction	16.6 mm/yr in October 2020			2.8	3.0	0.2
SI18-P40	September 26, 2018	18.2 mm over 2.3 m to 16.9 m depth in 130° direction	9.9 mm/yr in June 2019	Operational	July 7, 2021	2.4	2.6	-1.6

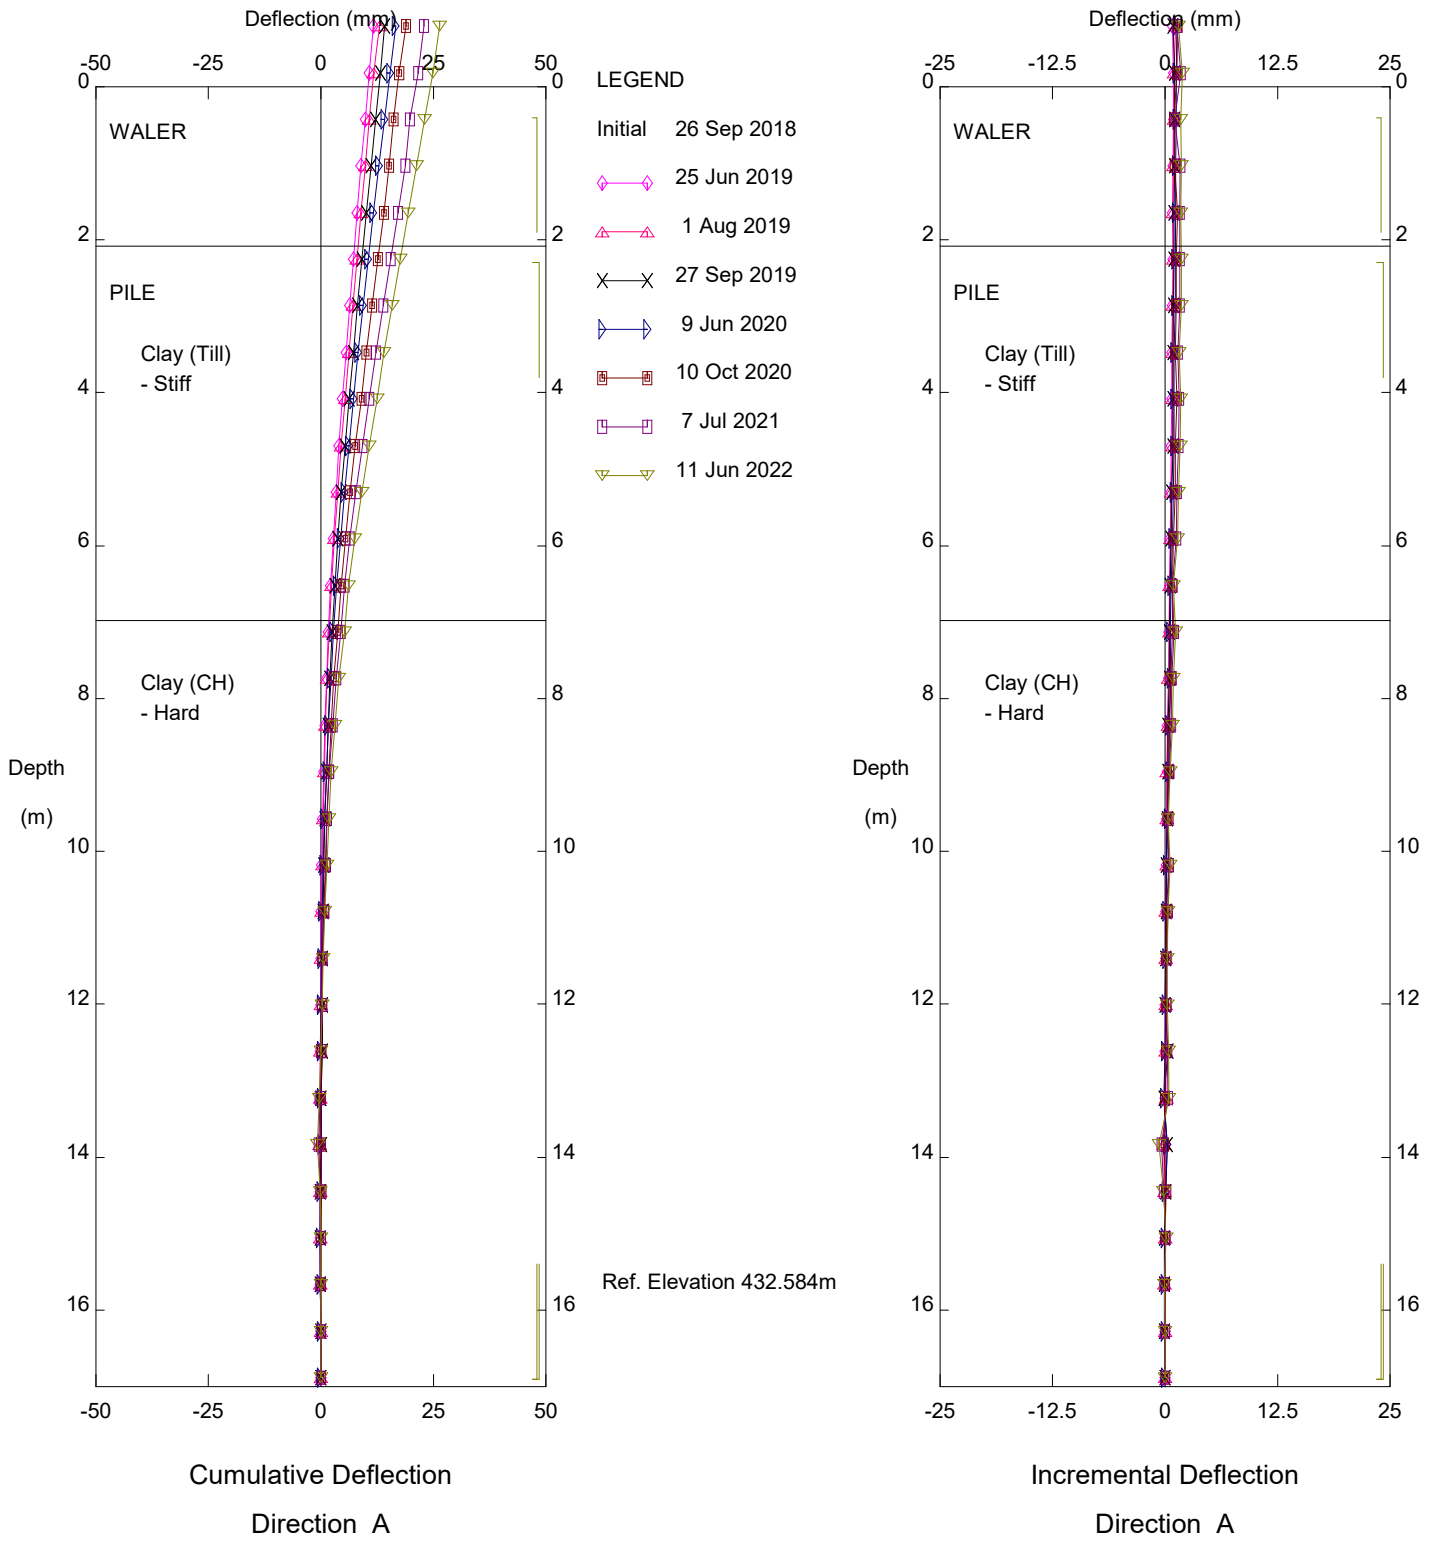
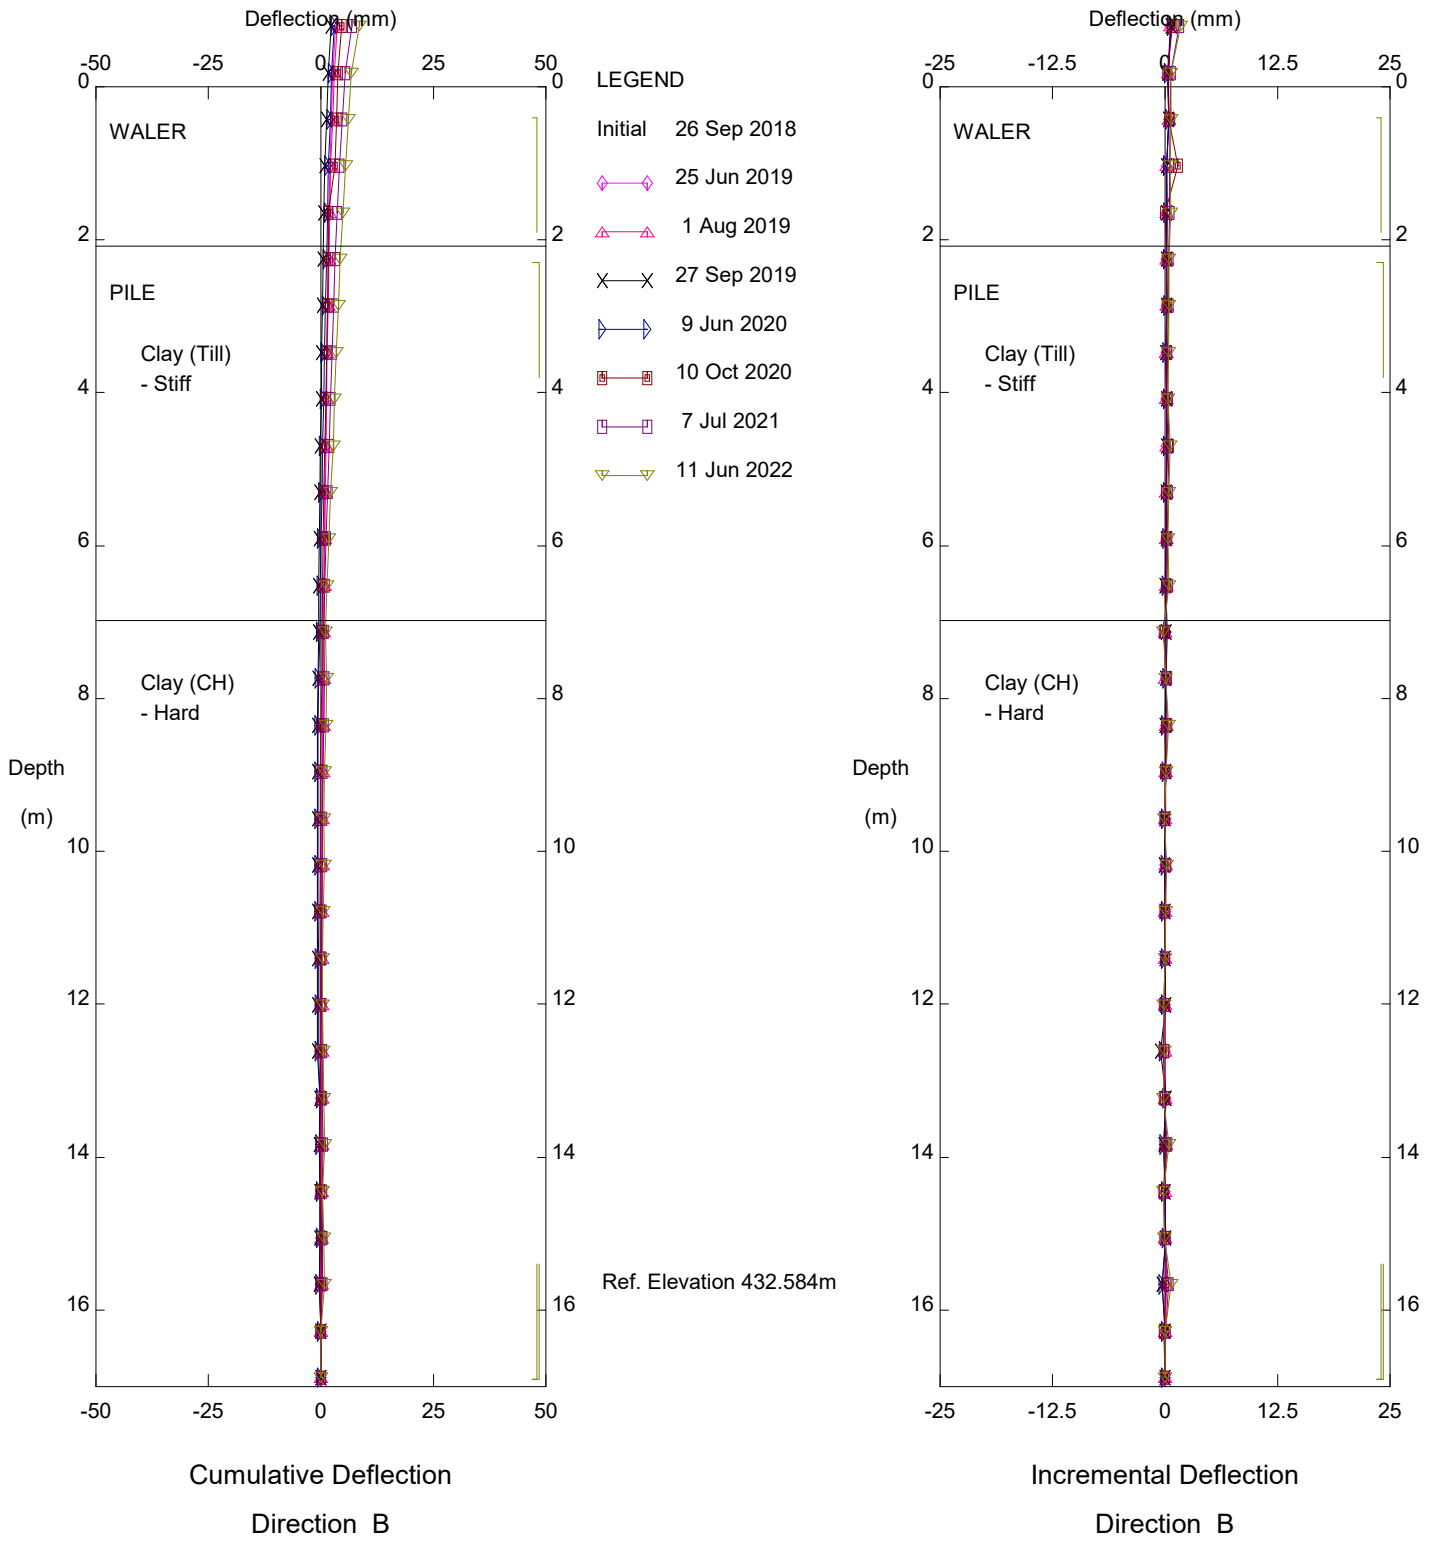
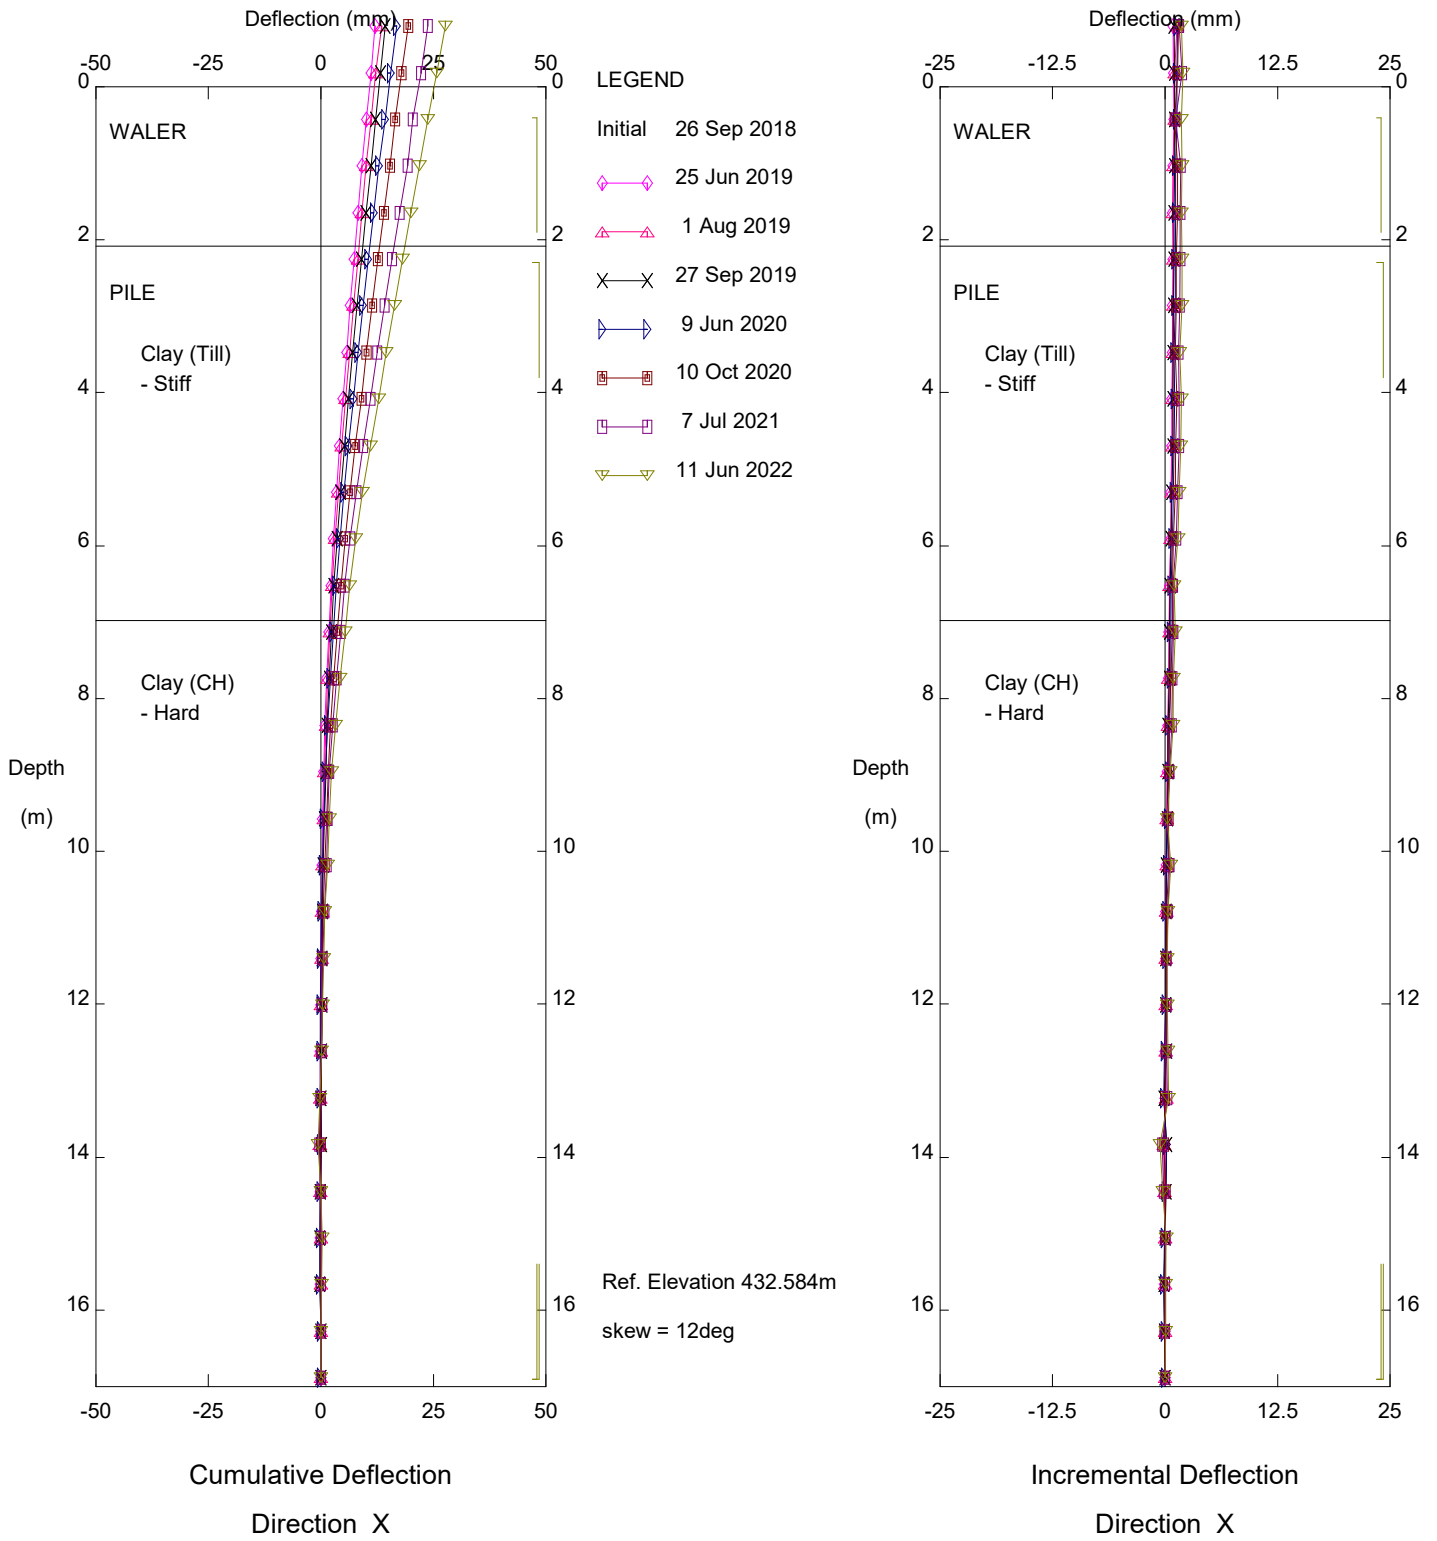
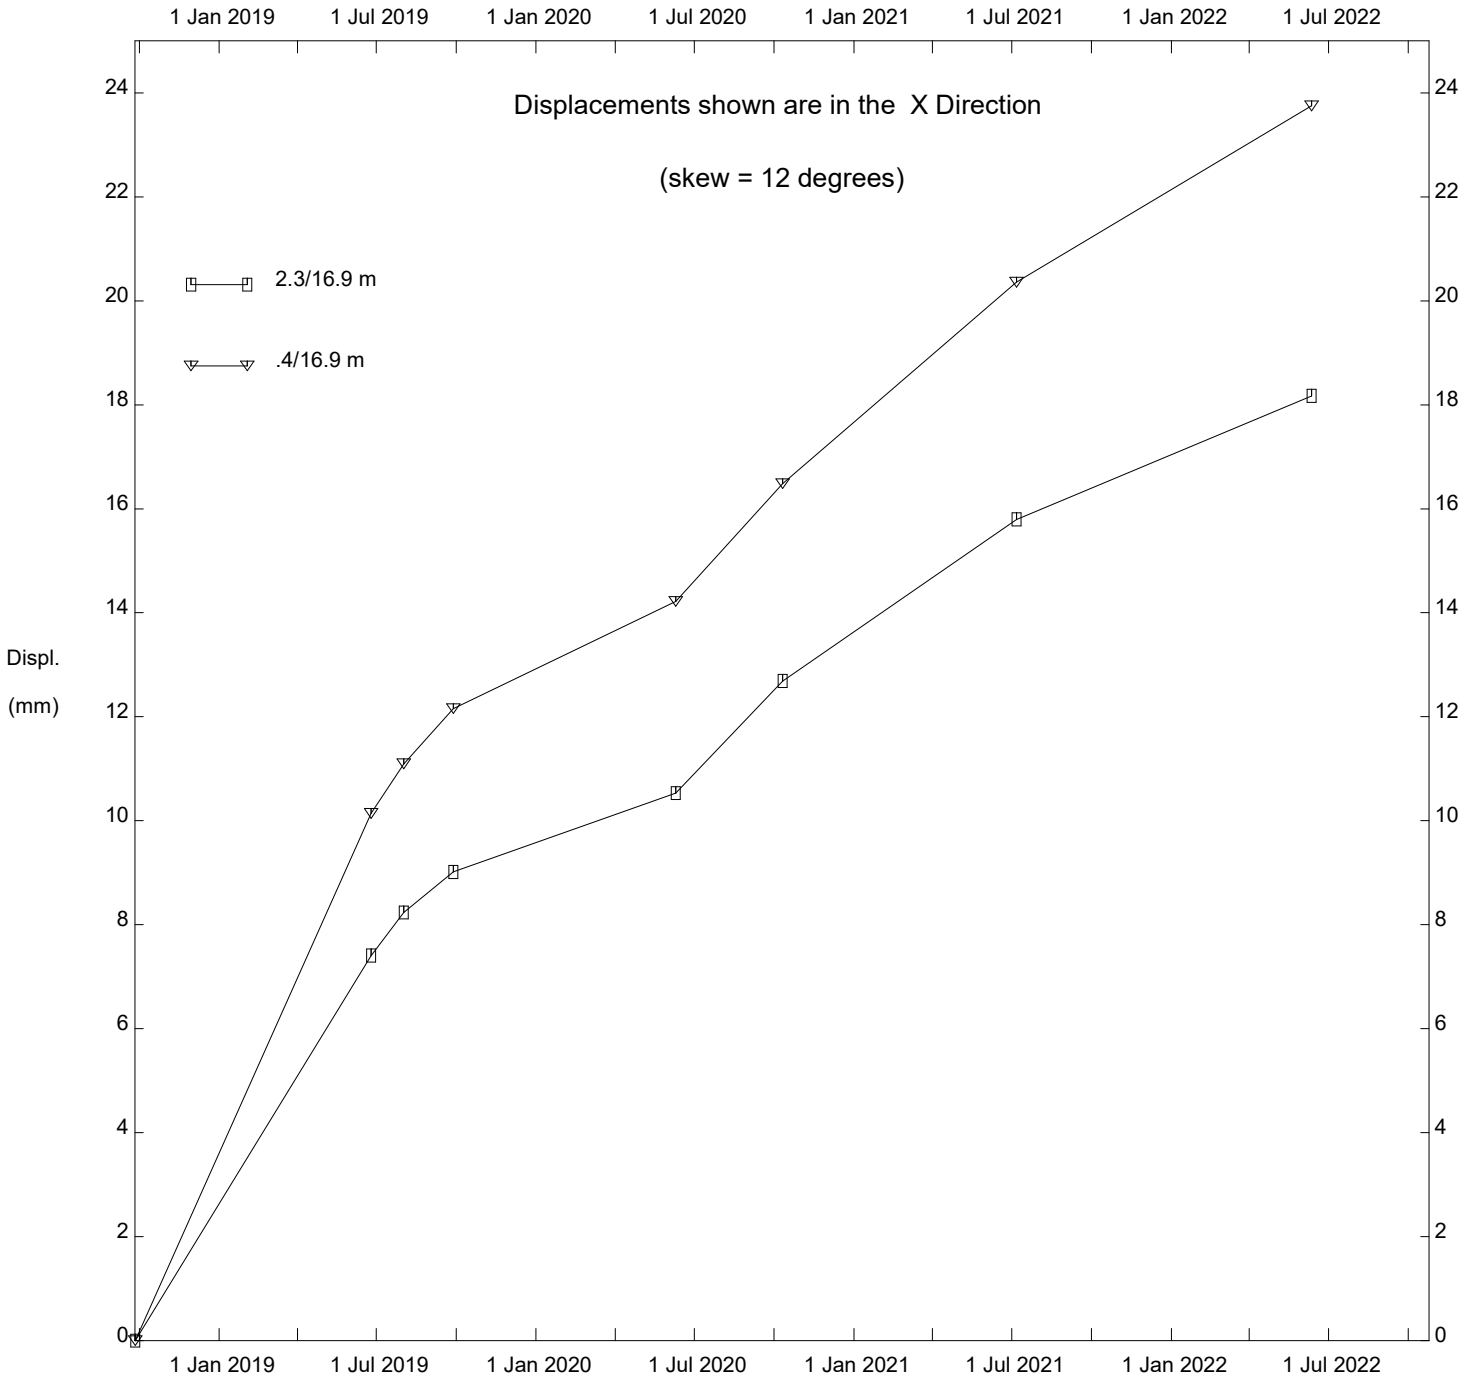
Alberta Transportation, Inclinometer SI18-P40

23.7 mm over 0.4 m to 16.9 m depth in 130° direction	13.5 mm/yr in June 2019			3.4	3.7	-1.6

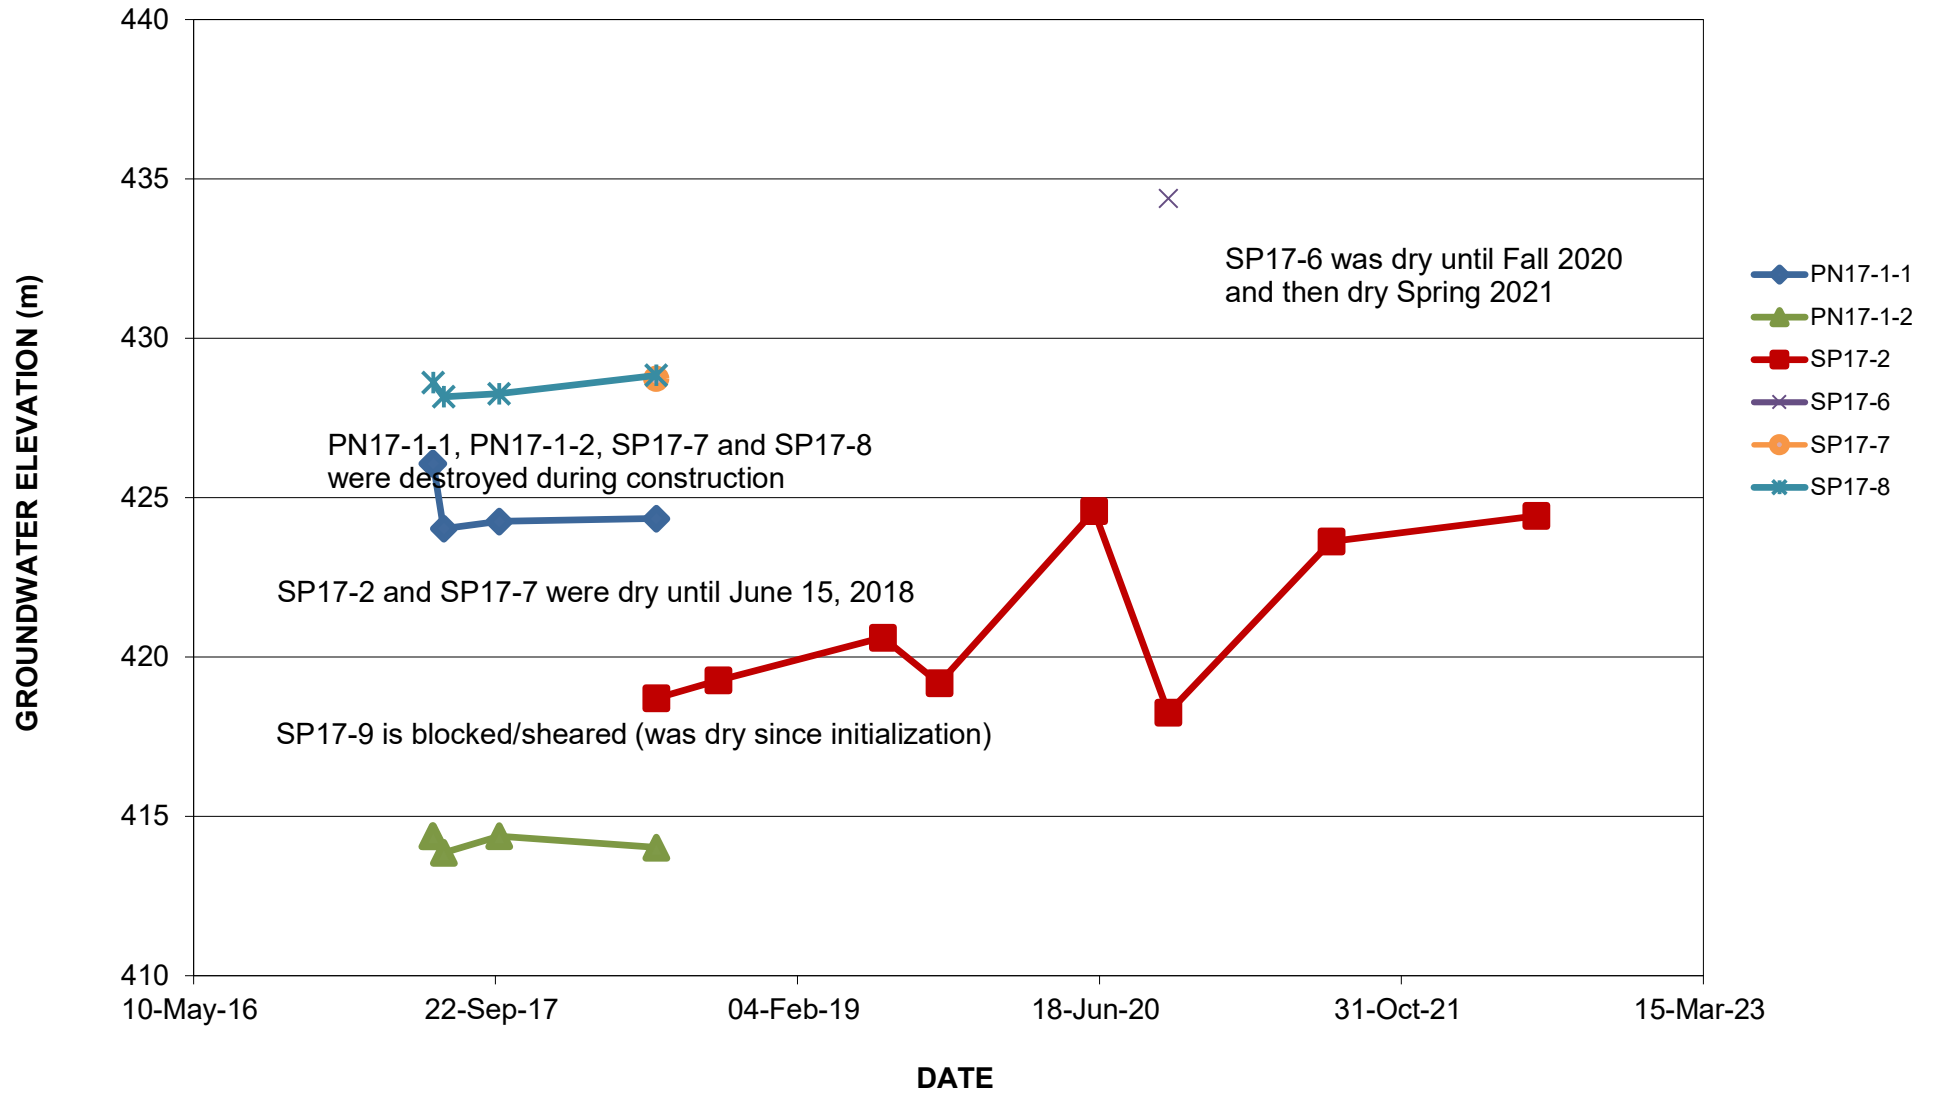
**FIGURE PH009A-1  
PIEZOMETRIC ELEVATIONS FOR HWY 684:02 BRICKS HILL**

The groundwater level increased in standpipe piezometer SP17-2 by 0.8 m since the previous reading in the spring of 2021. SP17-6 was dry. The standpipe piezometer readings are summarized in Table PH009A-3. The pneumatic and standpipe piezometer readings are plotted on Figure PH009A-1 (by elevation) and PH009A-2 (by depth) in Appendix A.
