ALBERTA TRANSPORTATION AND
ECONOMIC CORRIDORS
GEOHAZARD ASSESSMENT PROGRAM
PEACE REGION (PEACE RIVER DISTRICT)
2025 INSPECTION

Site Number	Location	Name	Hwy	km
PH093-1	Brick's Hill/Shaftesbury Trail	The Big Eddie	684:02	8.86-8.98
Legal Description		UTM Co-ordinates		
NW24/SW25-91-23-W5M		11 E 467,076	N	6,219,660

PH093: BIG EDDIE: HWY 684:02 KM 8.86 TO KM 8.98
2025 SITE INSPECTION PLAN

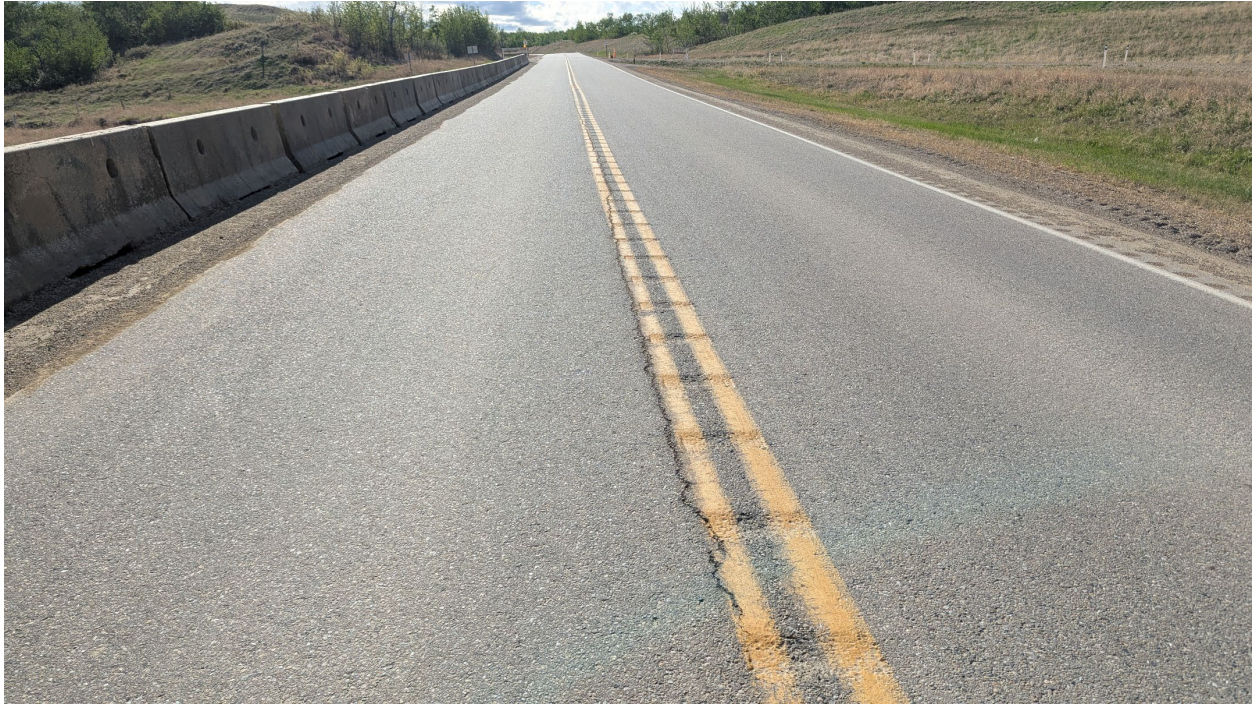
Photo 1: Looking west along as-yet uncracked highway surface. Centerline crack may be between mats from last paving/overlay.

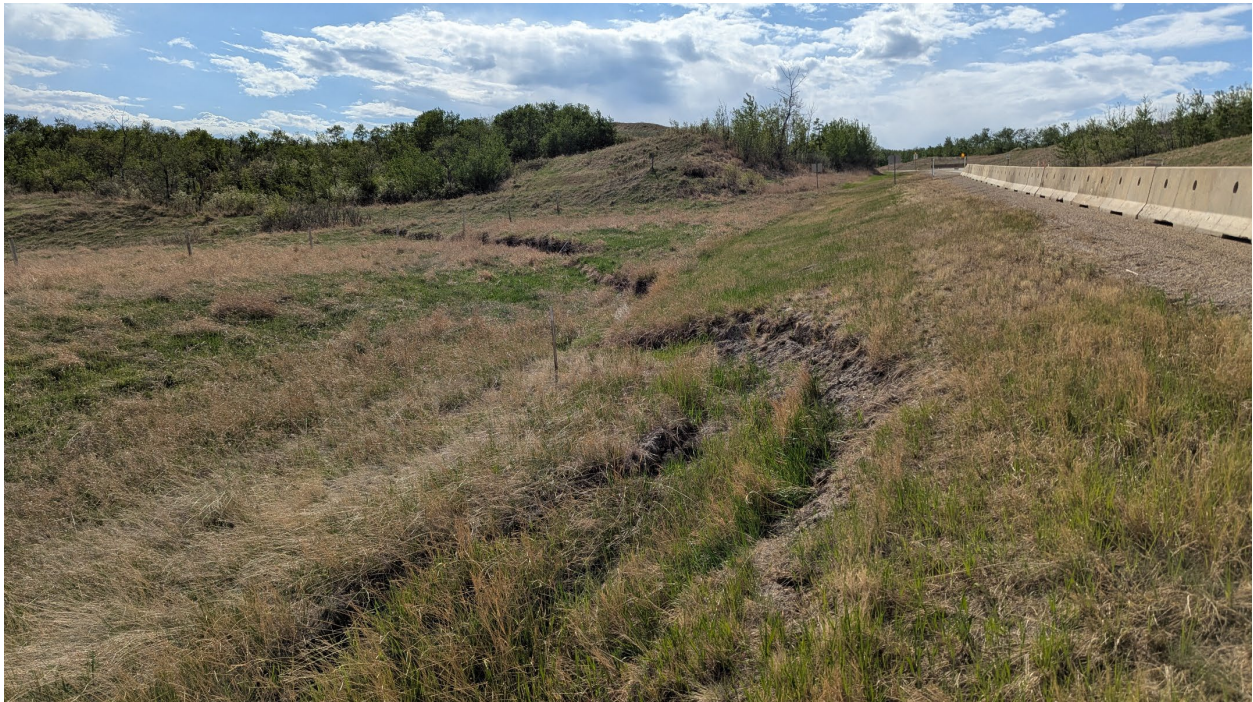
<input checked="" type="checkbox"/> Slope Movement	Tension crack arcs along south highway sideslope and continues to drop and widen. The headscarp is slowly retrogressing and may rapidly retrogress as water infiltrates the cracks.	<input checked="" type="checkbox"/>
<input checked="" type="checkbox"/> Erosion	Ongoing seepage and weathering causing upper slide blocks to erode.	<input checked="" type="checkbox"/>
<input checked="" type="checkbox"/> Seepage	There are damp areas on the west flank. The location of previously installed subdrains is not known. Seepage from the headscarp observed in 2025.	<input checked="" type="checkbox"/>
<input checked="" type="checkbox"/> Bridge/Culvert	Outlet of 900 mm CSP on west side is mostly obstructed. Temporary detour has diverted ditch flow to the east along the north side of the highway.	<input type="checkbox"/>
<input type="checkbox"/> Other		<input type="checkbox"/>

Photo 2: Looking southwest along main tension crack at the highway sideslope with measuring transect stakes in foreground.

- Routine monitoring to determine if tension cracking has started within the pavement. If this occurs, then traffic should be shifted onto the temporary detour.

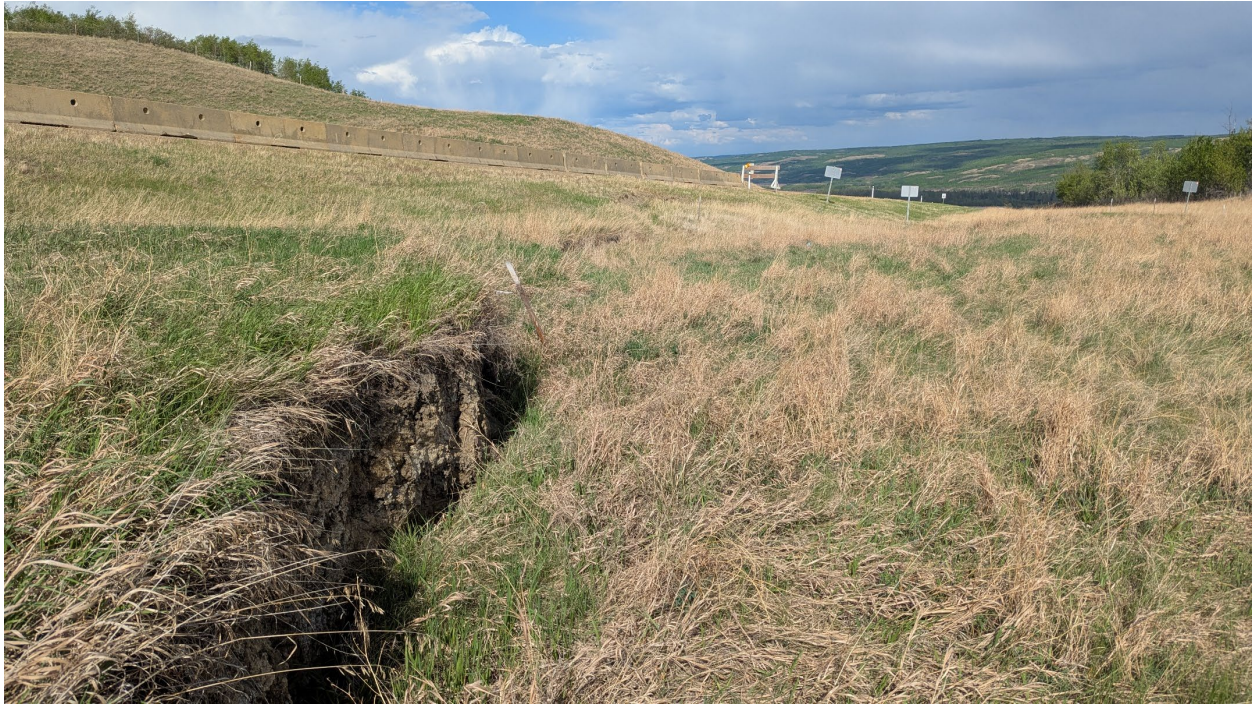
Photo 3: Looking southeast along the rest of the main tension crack at the highway sideslope.

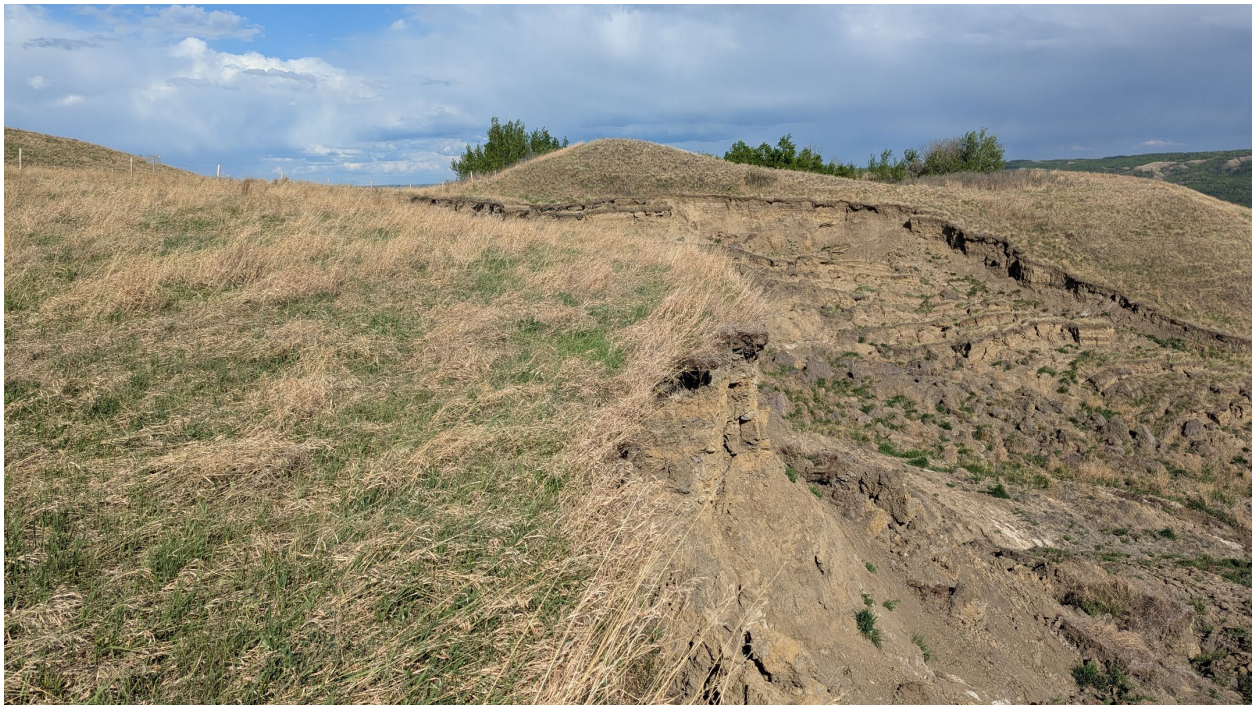
It is expected that the slow movements between the headscarp and the highway will continue until there is a sudden, brittle failure and the next block slides or topples out. This may be triggered by high rainfall raising the groundwater table and lubricating the slip surfaces or by steady erosion of the slide material below the headscarp leading to further destabilization of the overall slope.

Photo 4: Looking east along the main headscarp where the portion is regressing towards the highway.

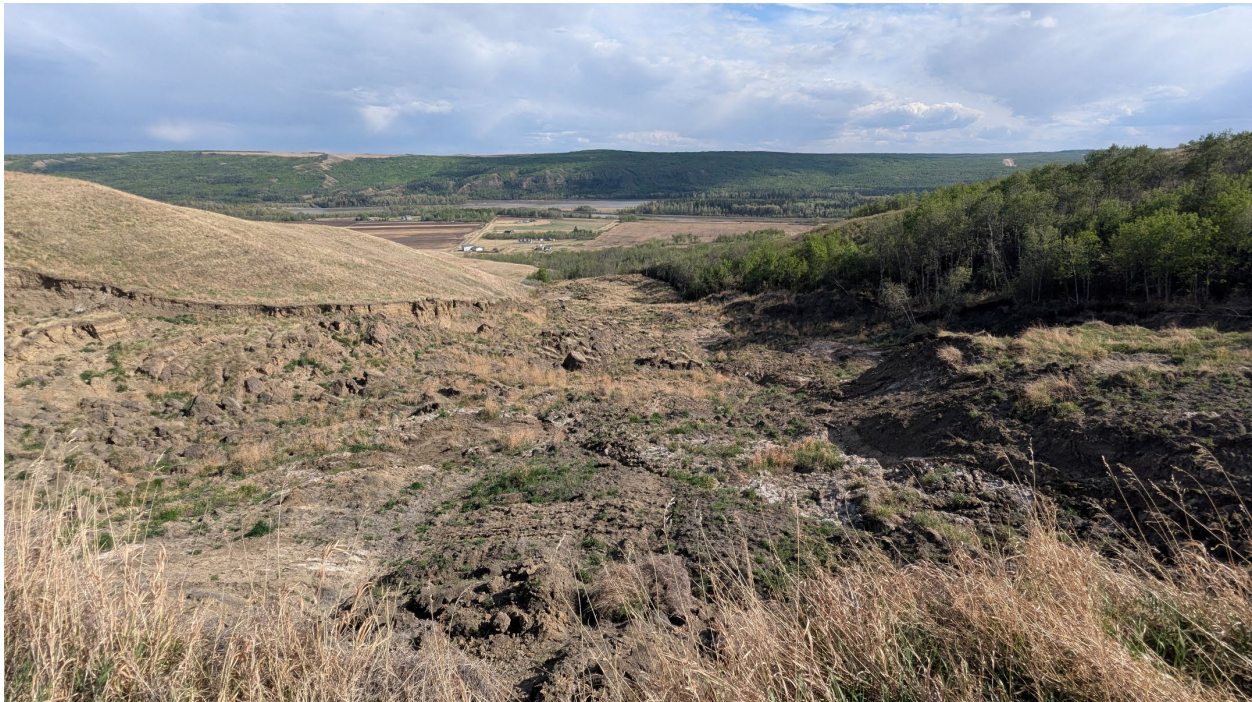
Photo 5: Looking south down the axis of the landslide mass. Vegetation is starting to grow.

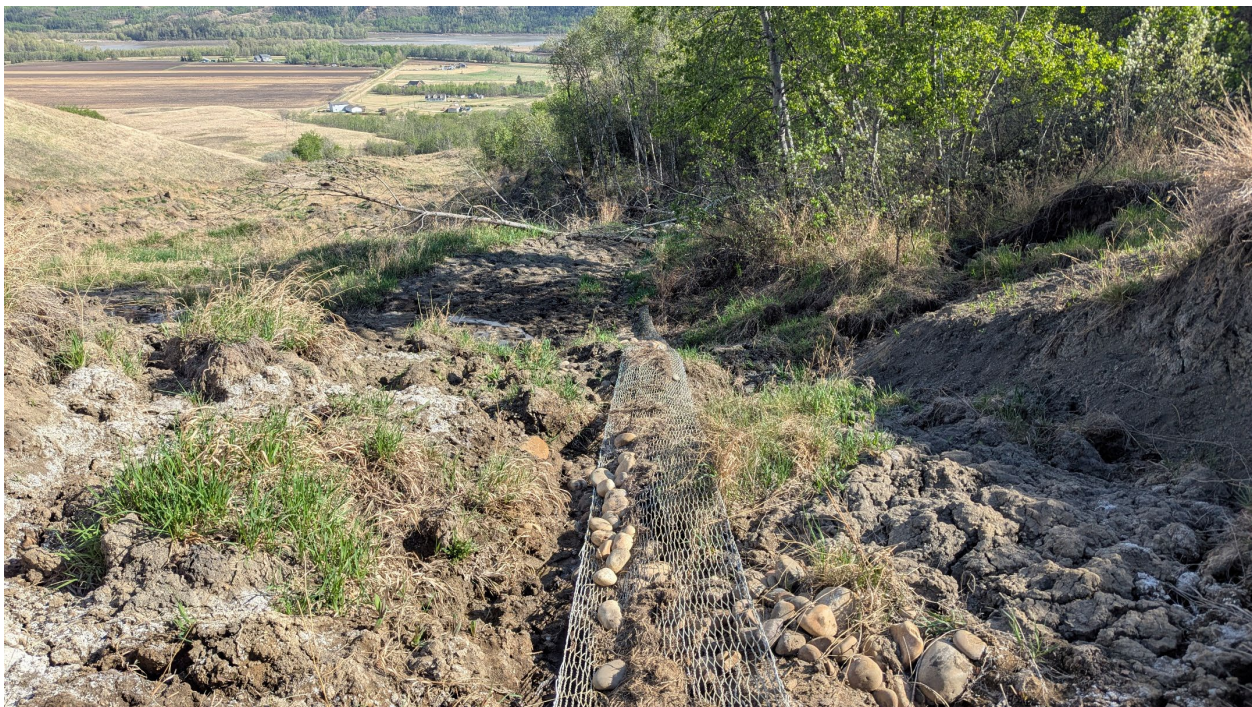
Photo 6: Stretching gabion mattress along the west flank of the landslide.

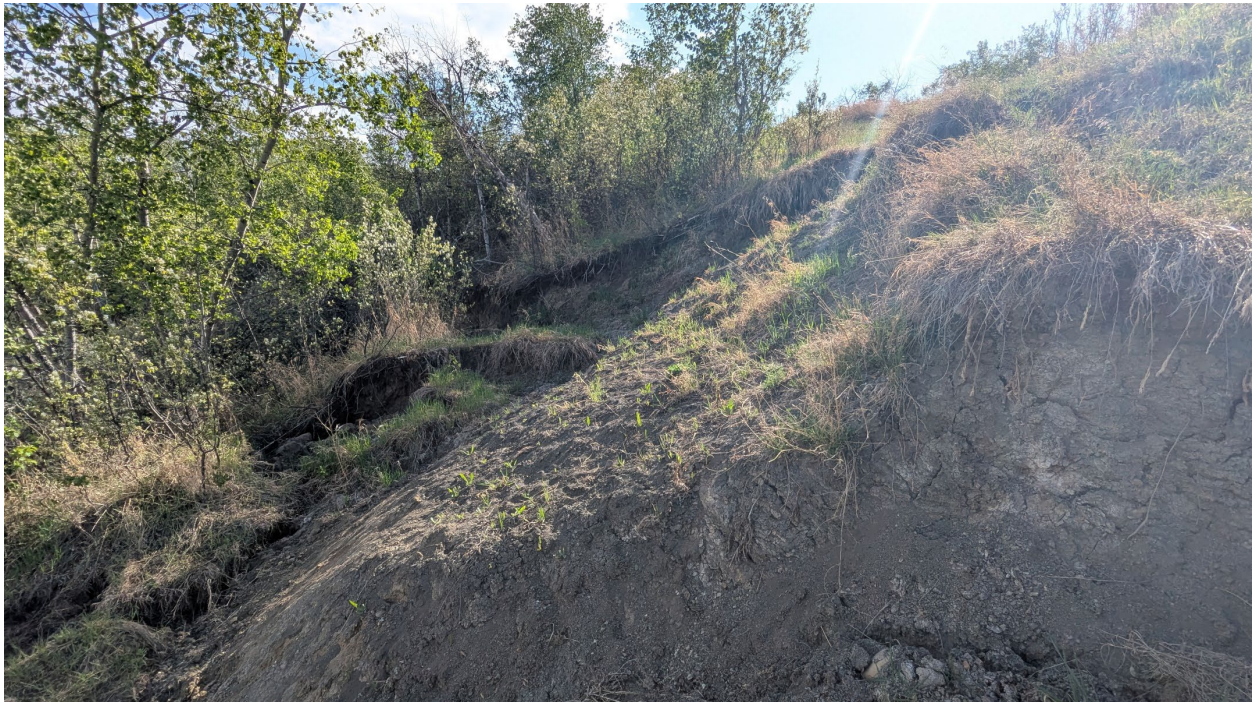
Photo 7: Additional scarps just beyond the west flank of the landslide. This is starting to move in 2025.

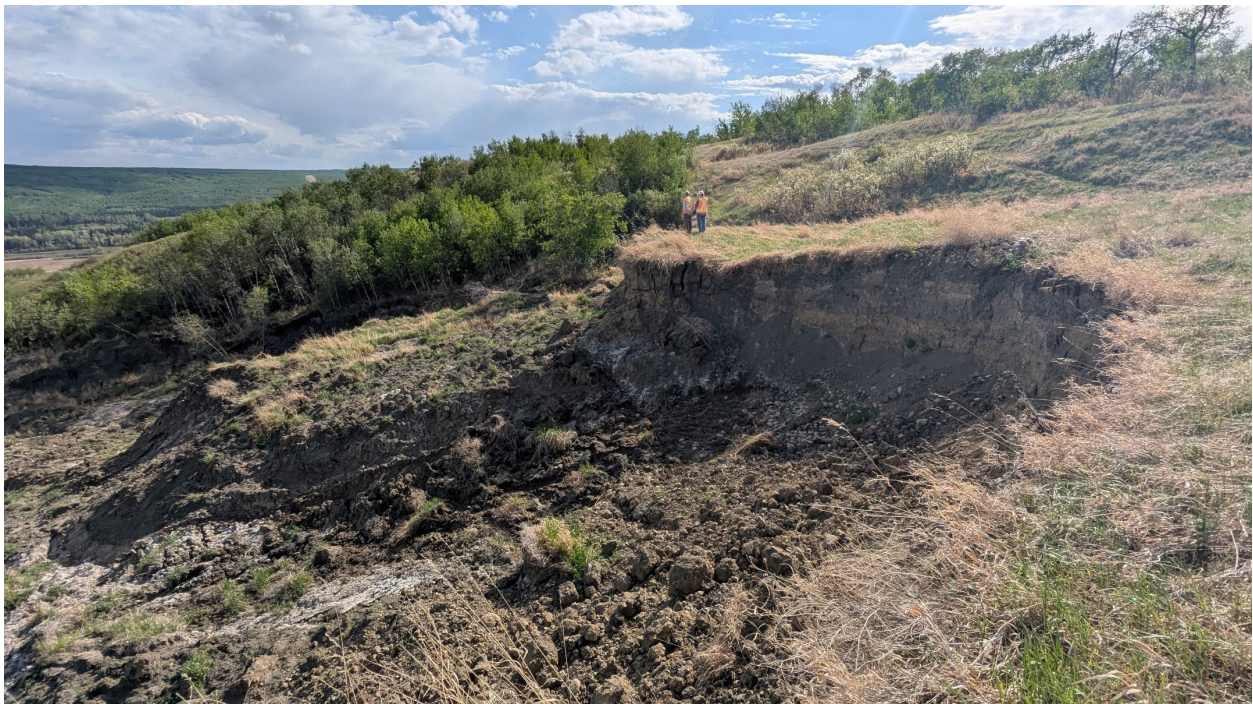
Photo 8: Looking east across the main landslide scarp.

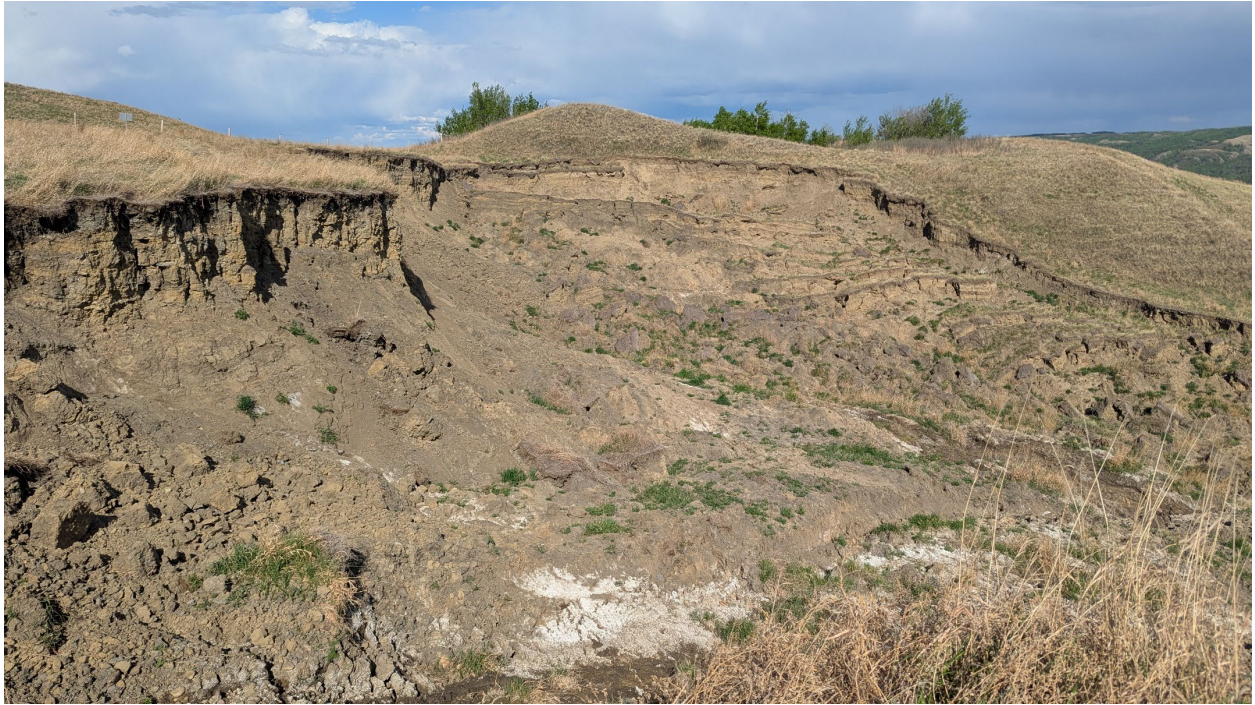
Photo 9: Toppling blocks at the face of the main headscarp.

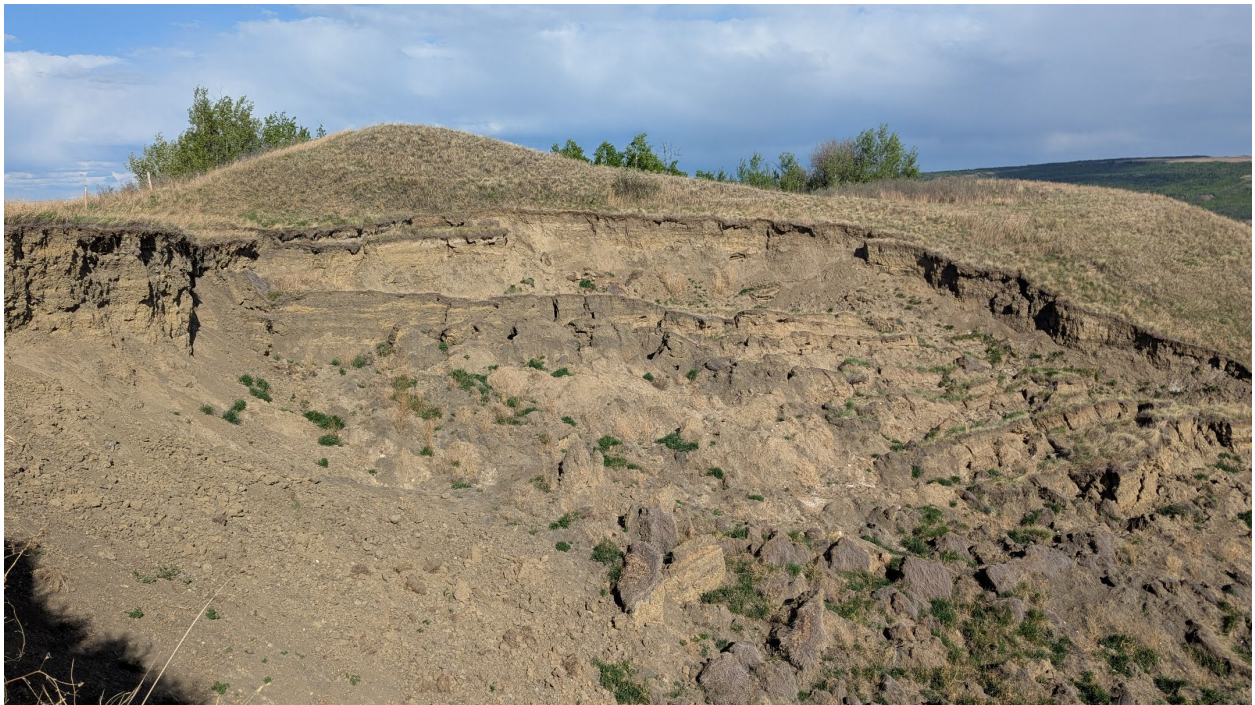
Photo 10: Looking east along face of the main headscarp.

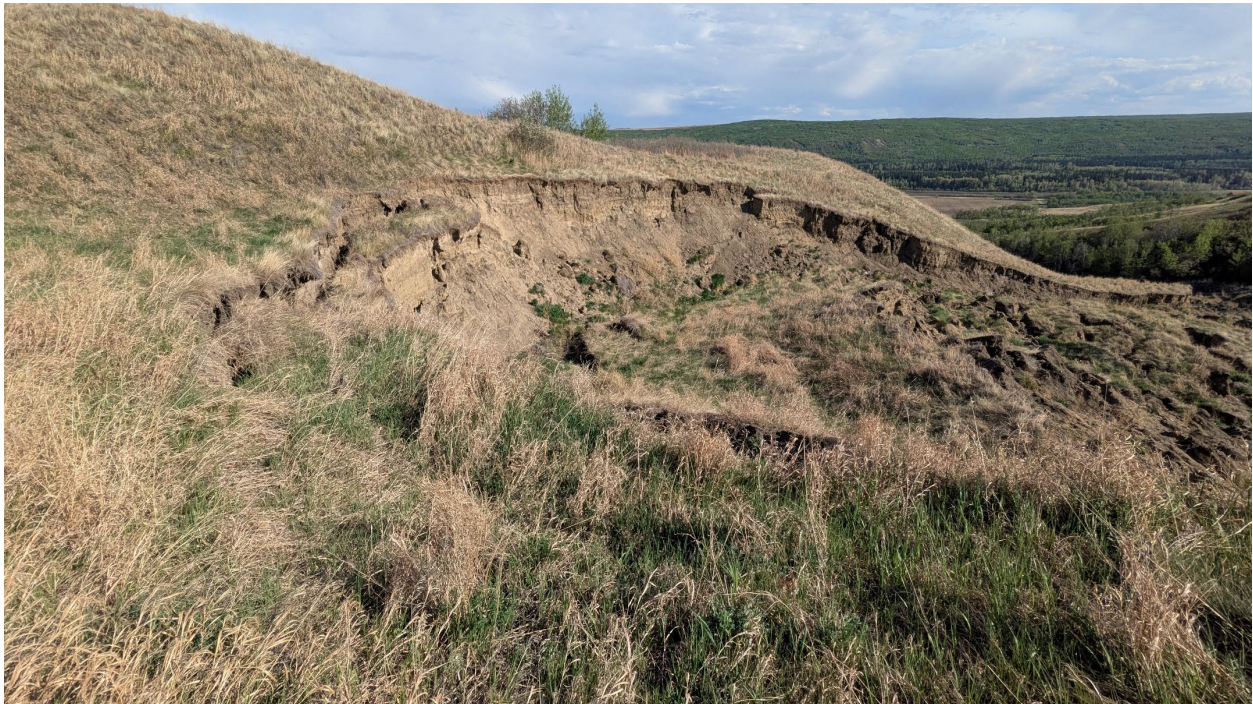
Photo 11: Looking southeast at the east flank of the main landslide.

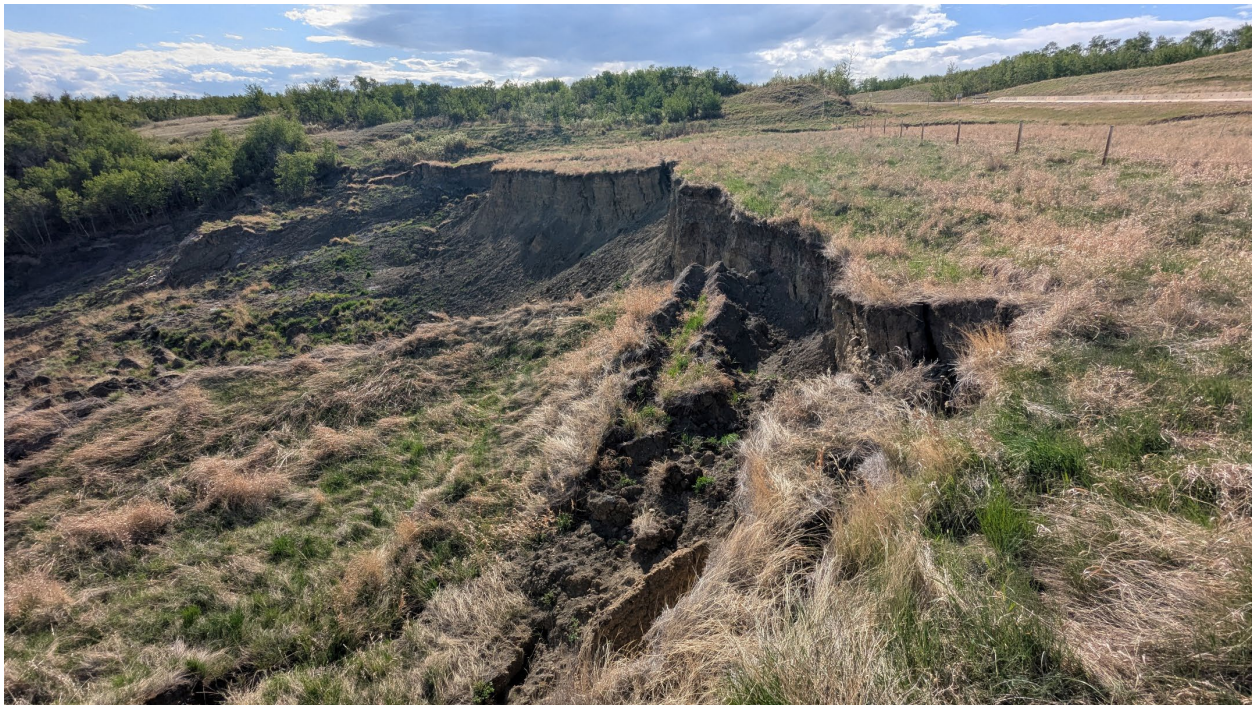
Photo 12: Looking west at the main landslide headscarp.
