**ALBERTA TRANSPORTATION AND
ECONOMIC CORRIDORS GRMP
PEACE REGION – (PEACE RIVER DISTRICT)
INSTRUMENTATION MONITORING - SPRING 2025**

Site Number	Location	Name	Hwy	km
PH009-3	Hwy 684:02 km 30.99, Town of Peace River	Shaftesbury Trail - Shop Slide	684:02	30.9-31.1
			Old 2:02	0.0-0.4
Legal Description:		UTM Co-ordinates		
4-31-83-21 W5		11V E 480321	N	6232126

Current Monitoring:	8-June-2025	Previous Monitoring	19 & 20-Sep-2024
Instruments Read By:	Mr. Niraj Regmi, G.I.T., and Mr. Godfred Etiendem, of Thurber

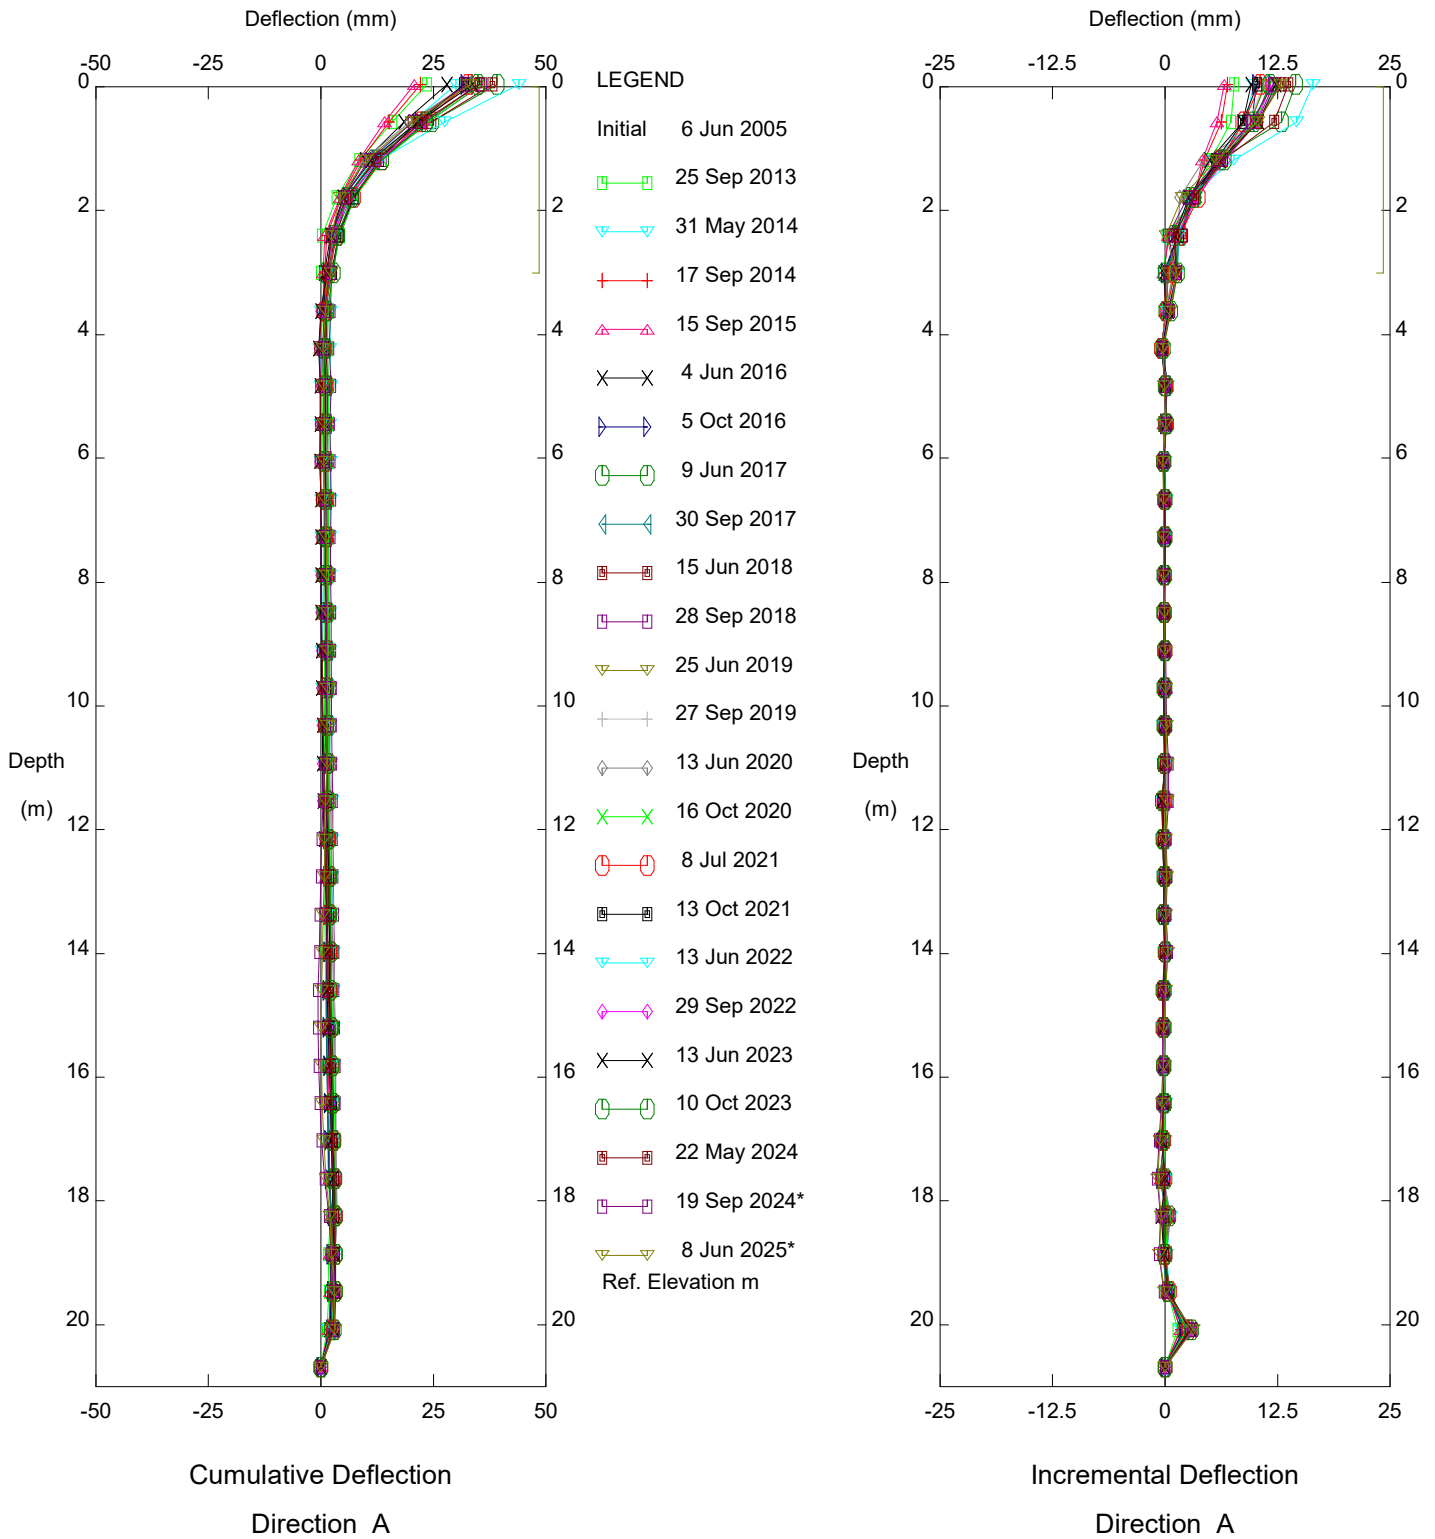
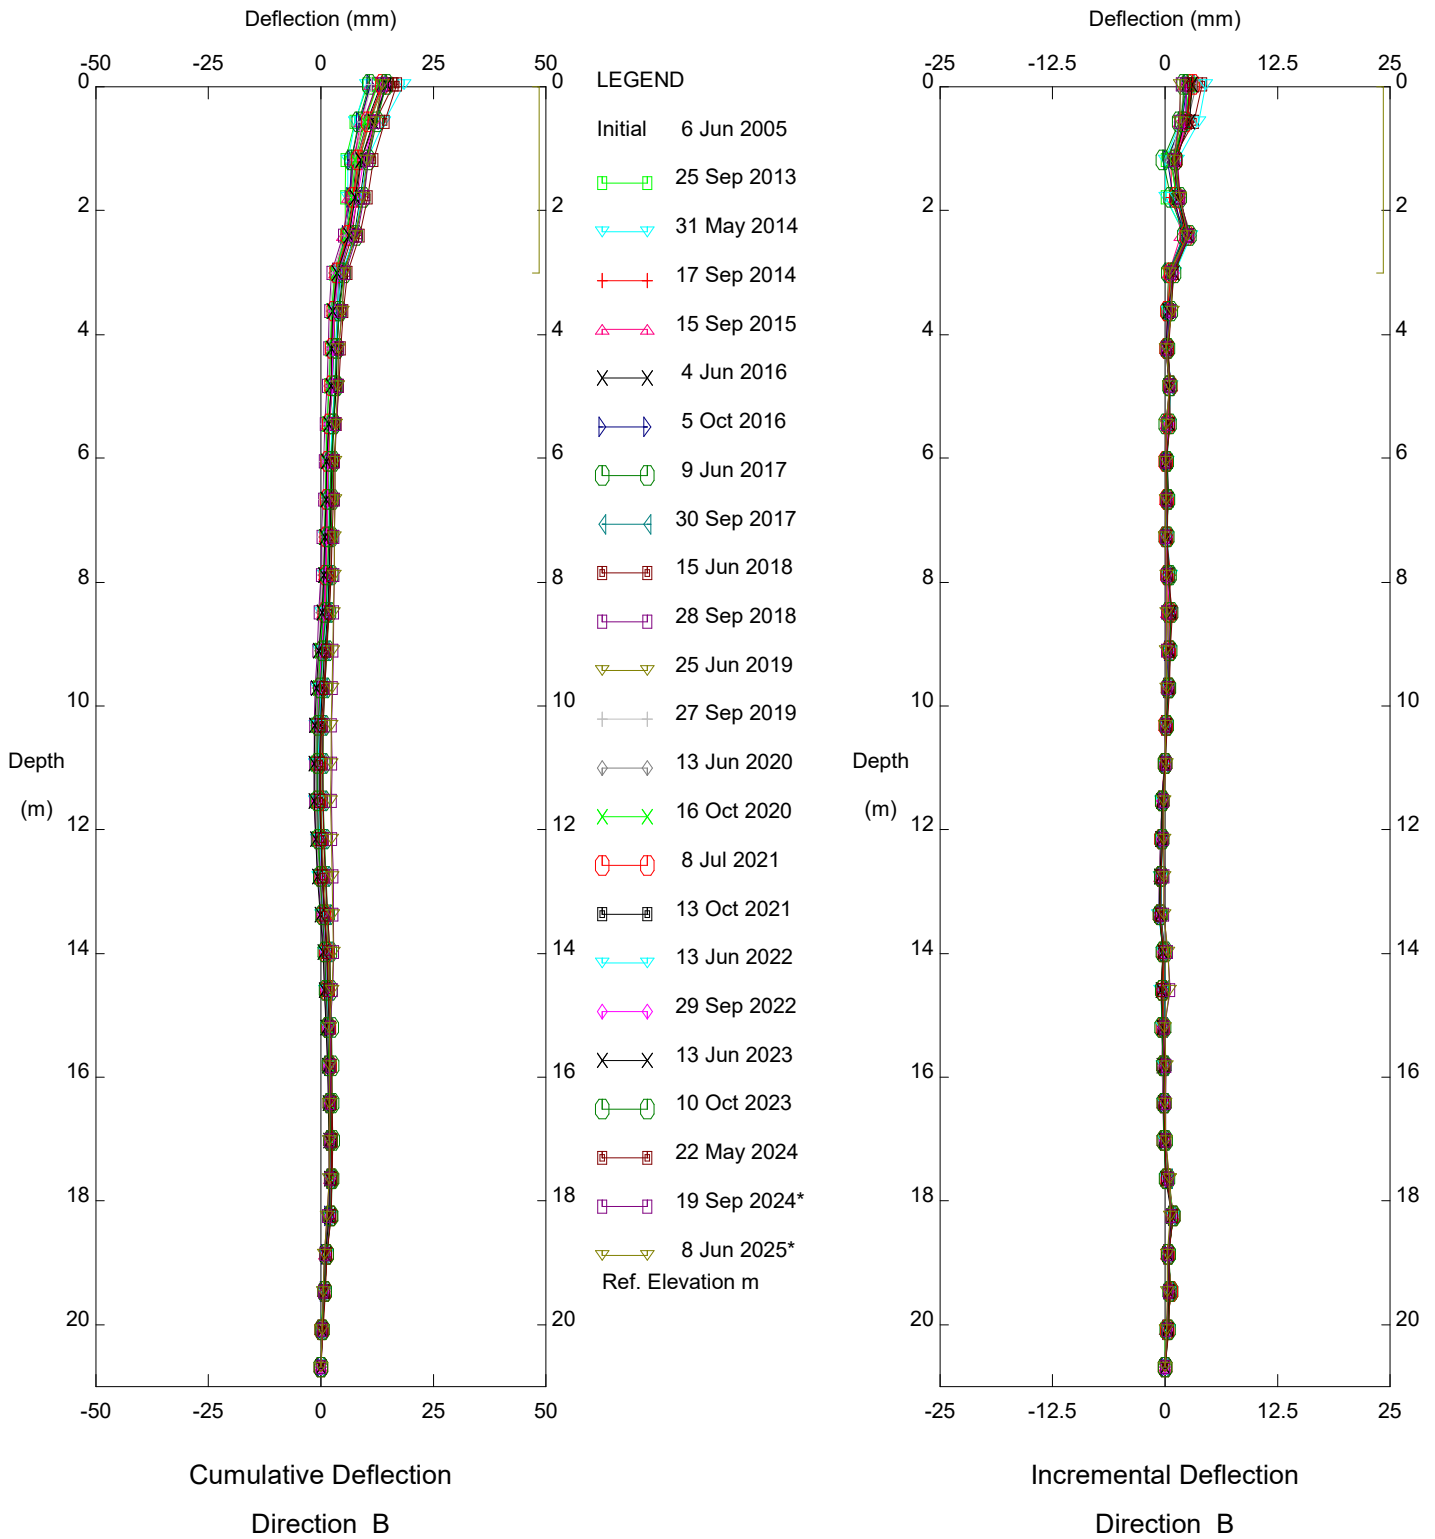
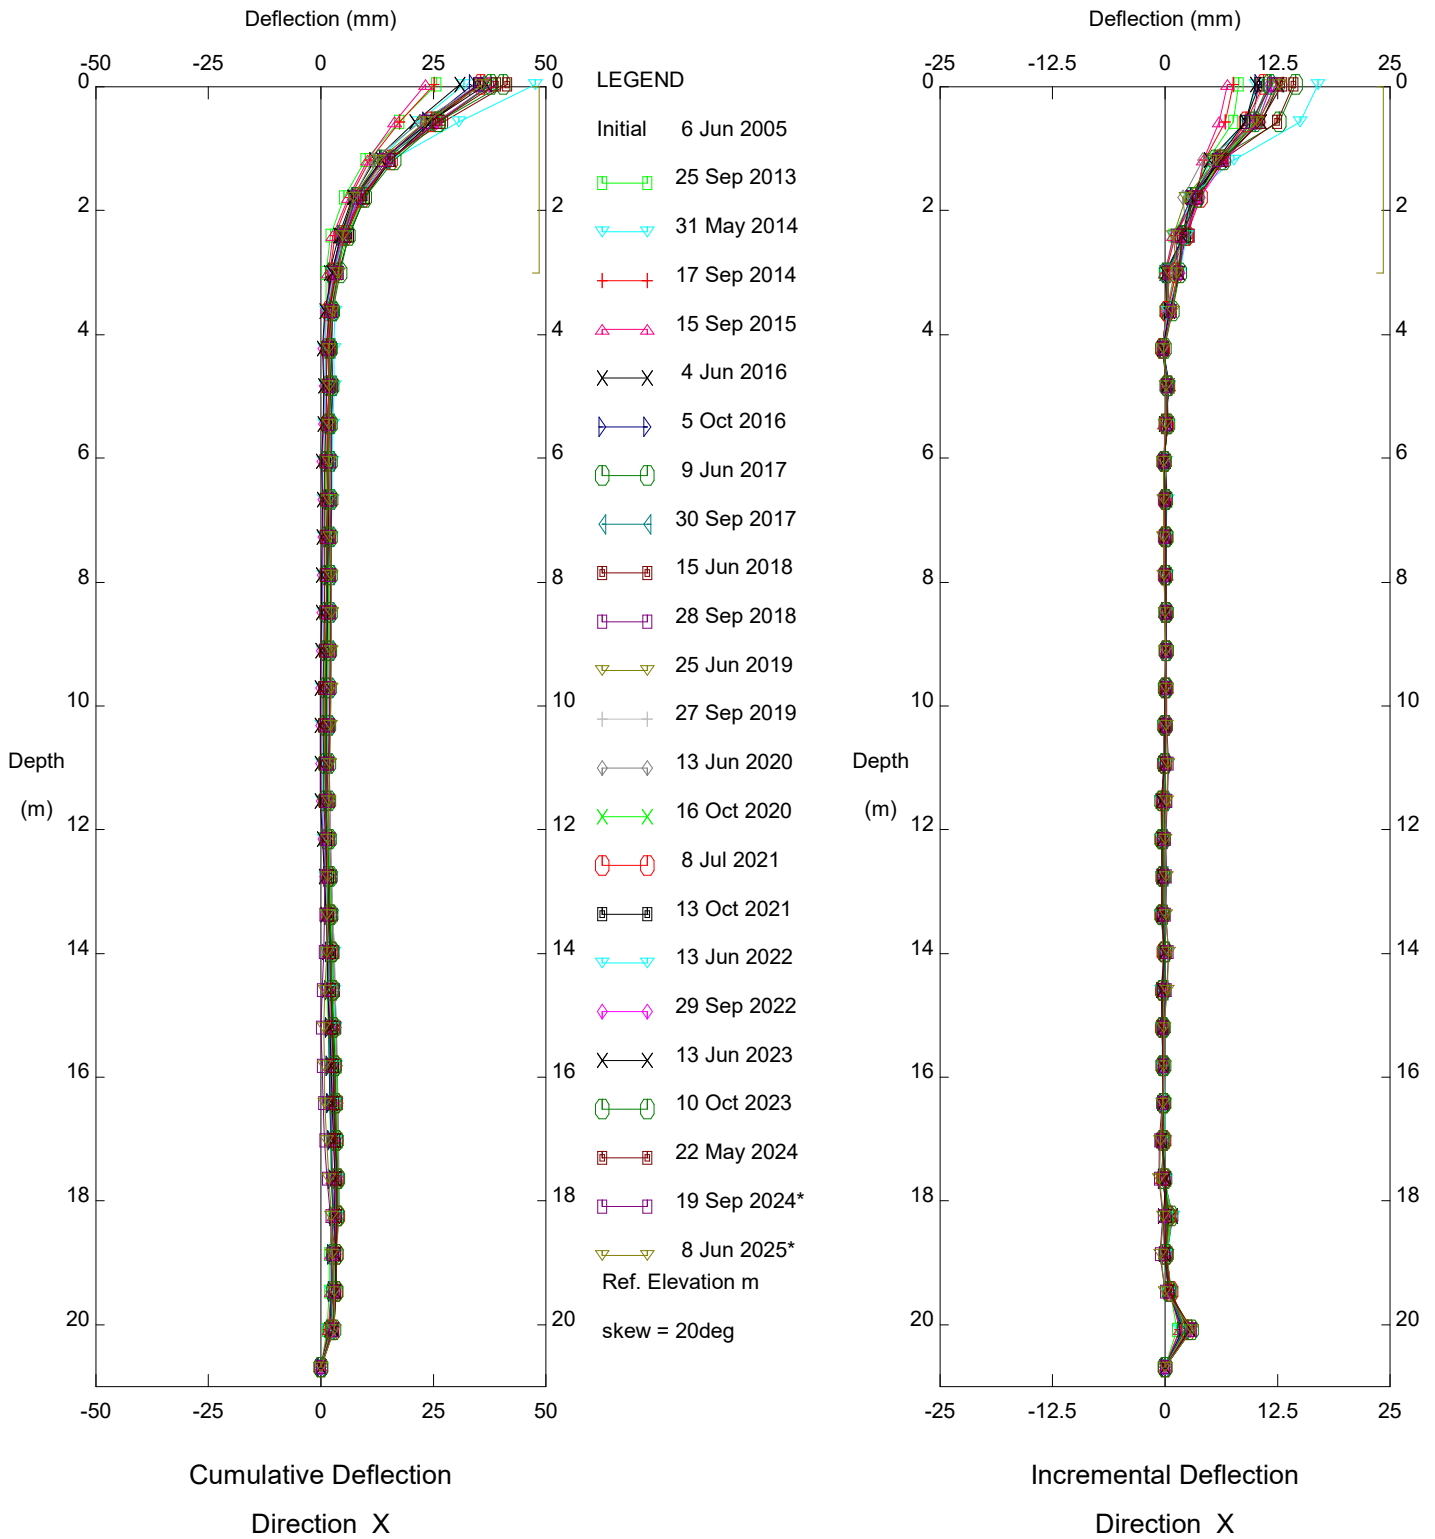
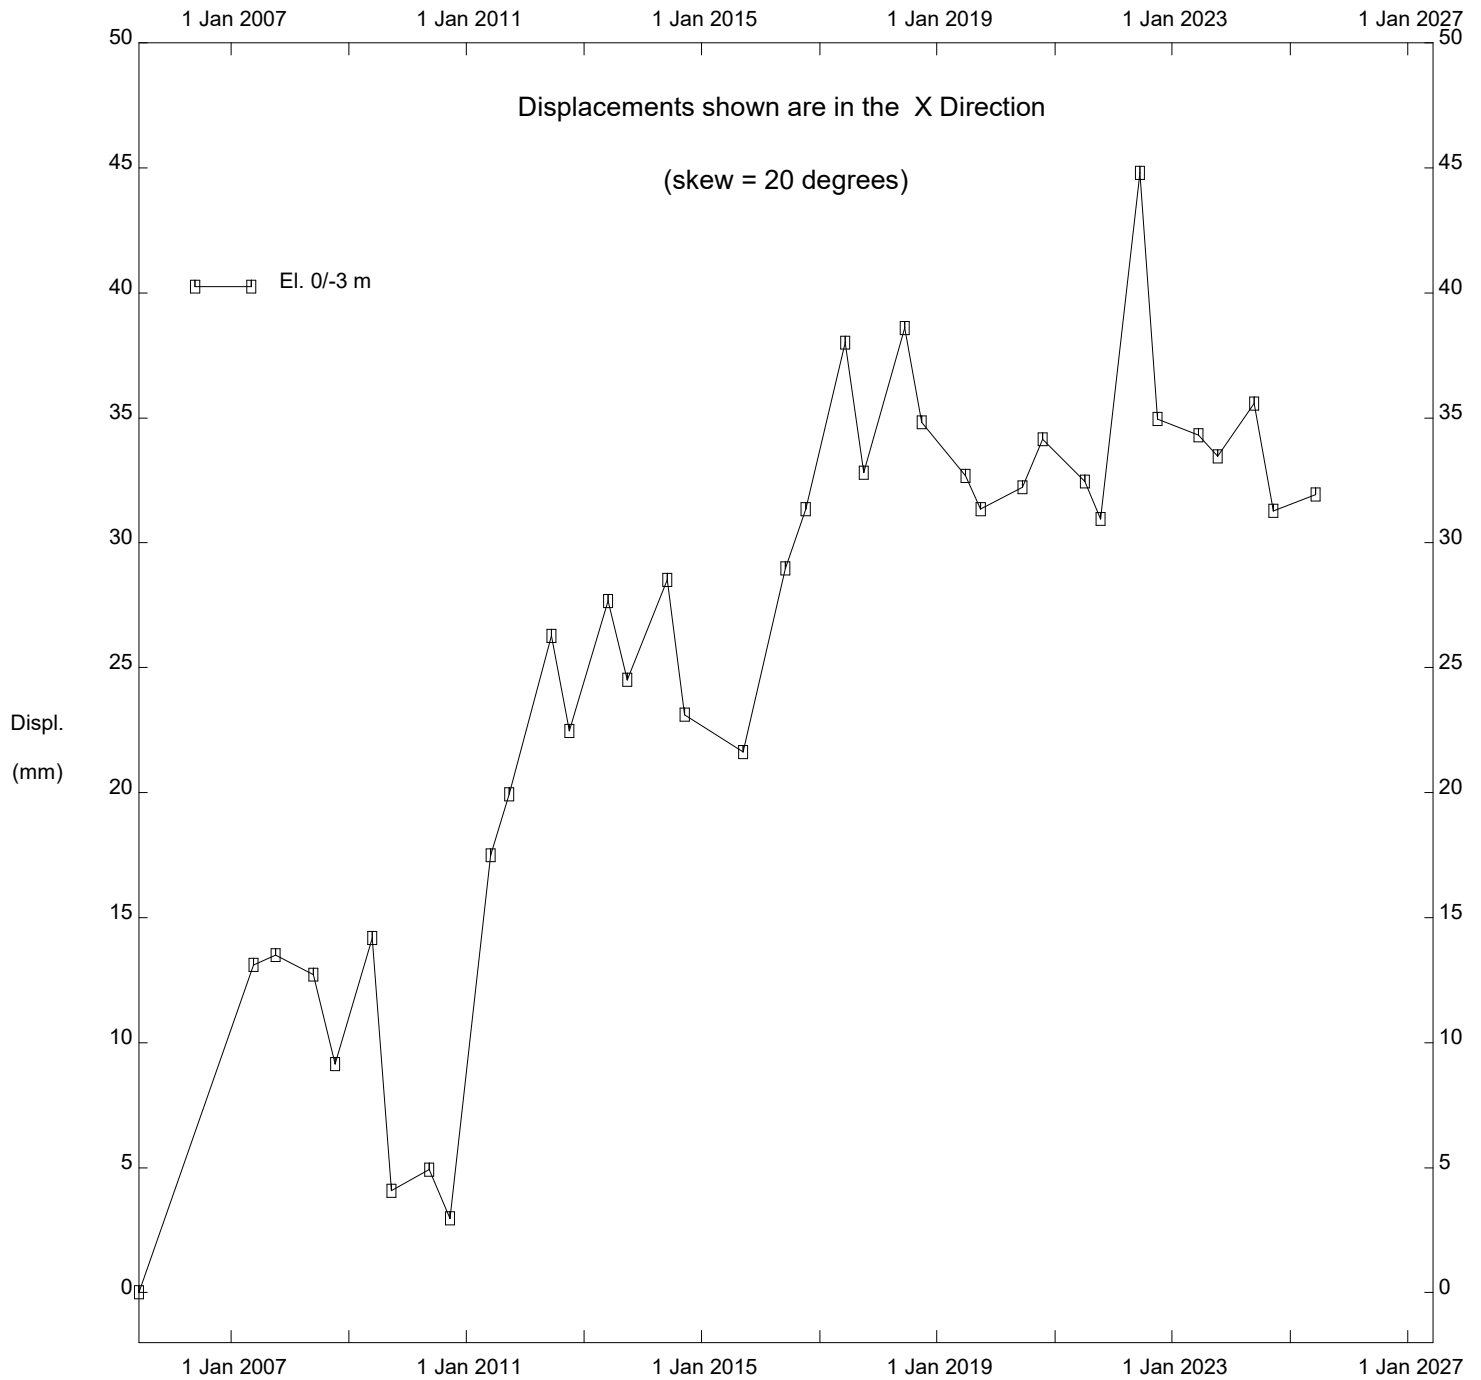
PH009 Old Hwy 2:02 Shop Slide, Inclinometer SI05-1

Discussion	
Zones of New Movement:	None
Interpretation of Monitoring Results:	<p>SLOPE INDICATORS</p> <p>Slope inclinometer SI05-1 is located upslope of the highway and not within the main area of movement. It showed a rate of movement of 0.9 mm/yr over 0.0 m to 3.0 m depth since the fall of 2024 readings.</p>

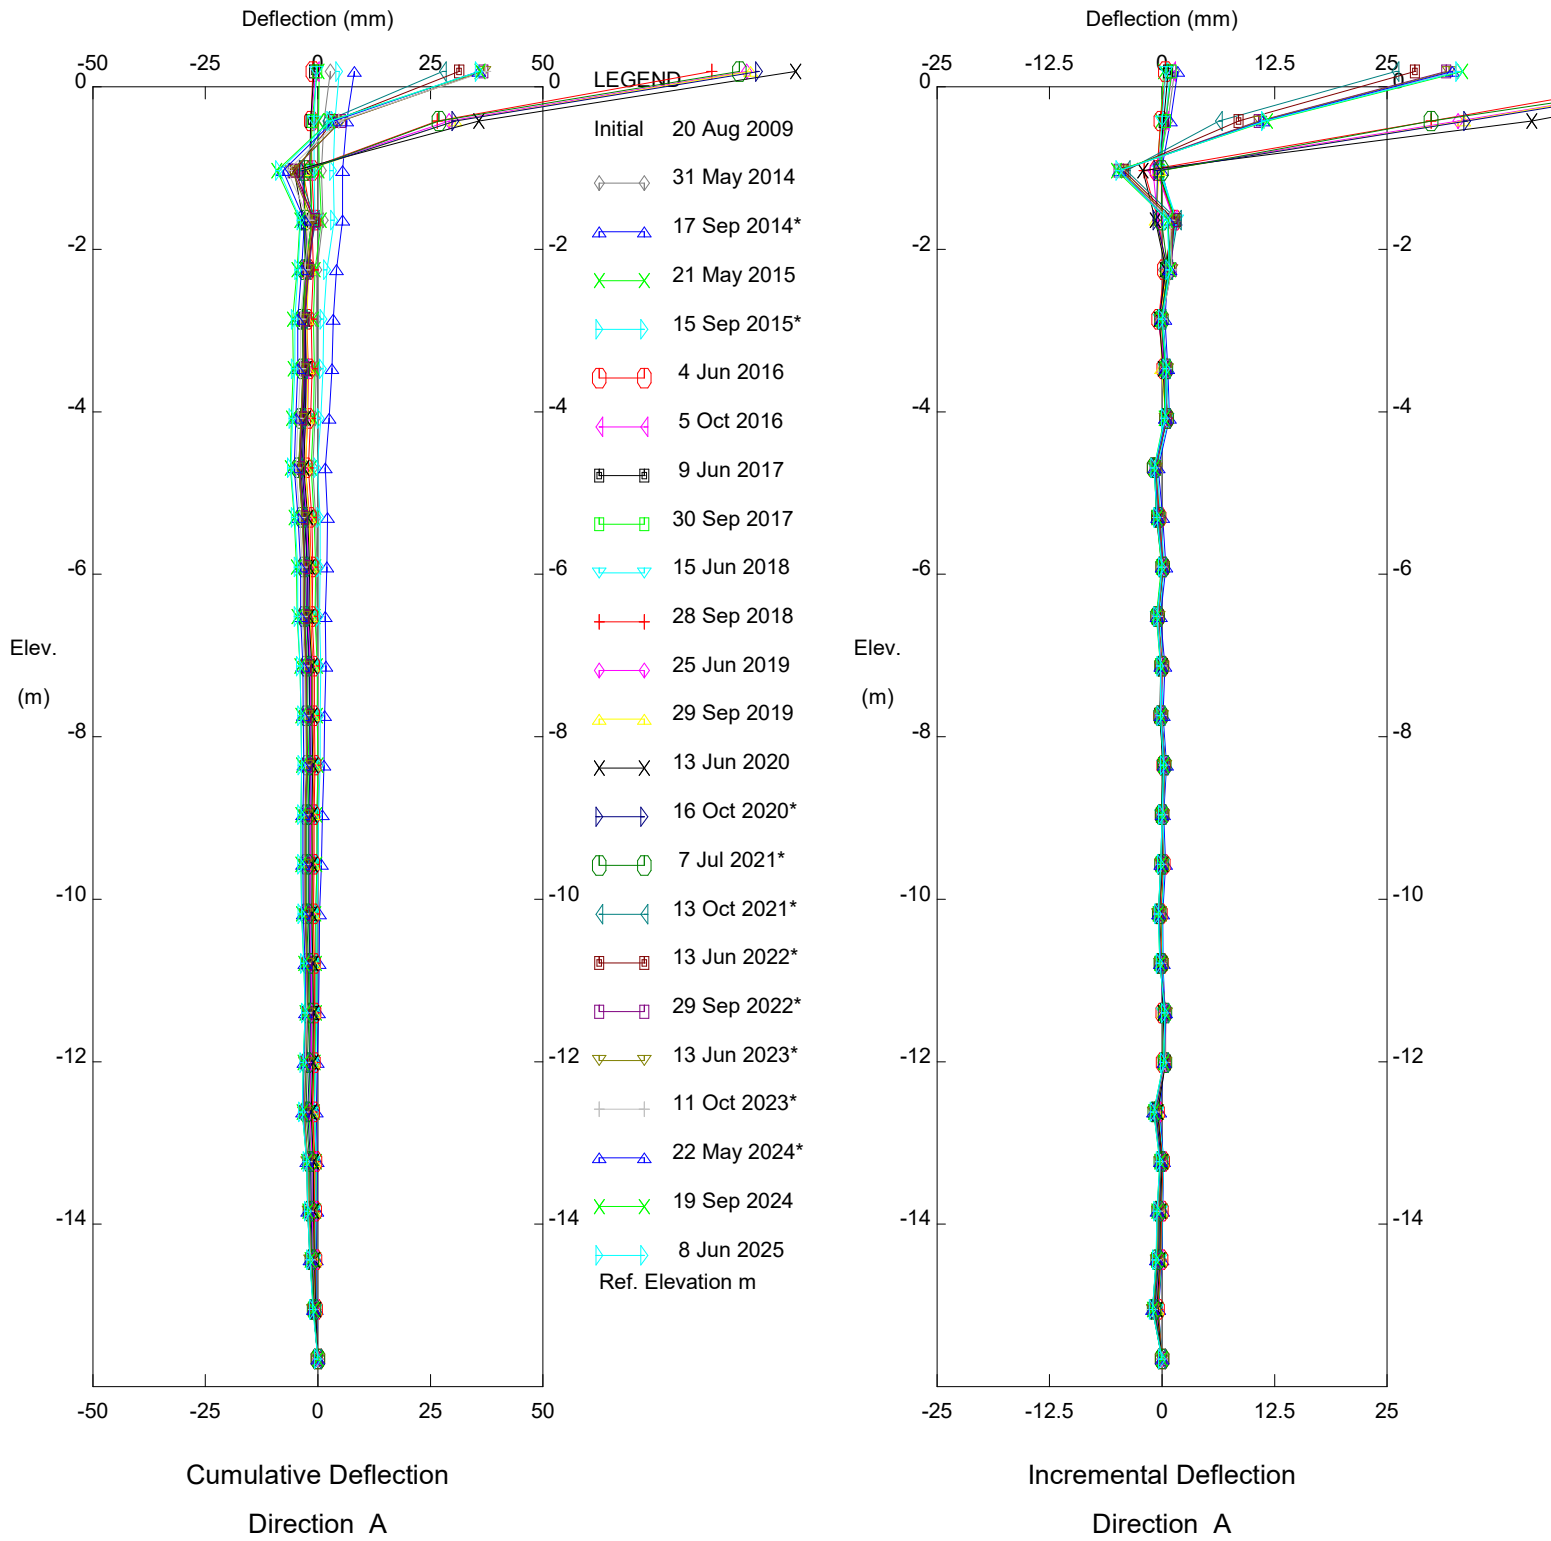
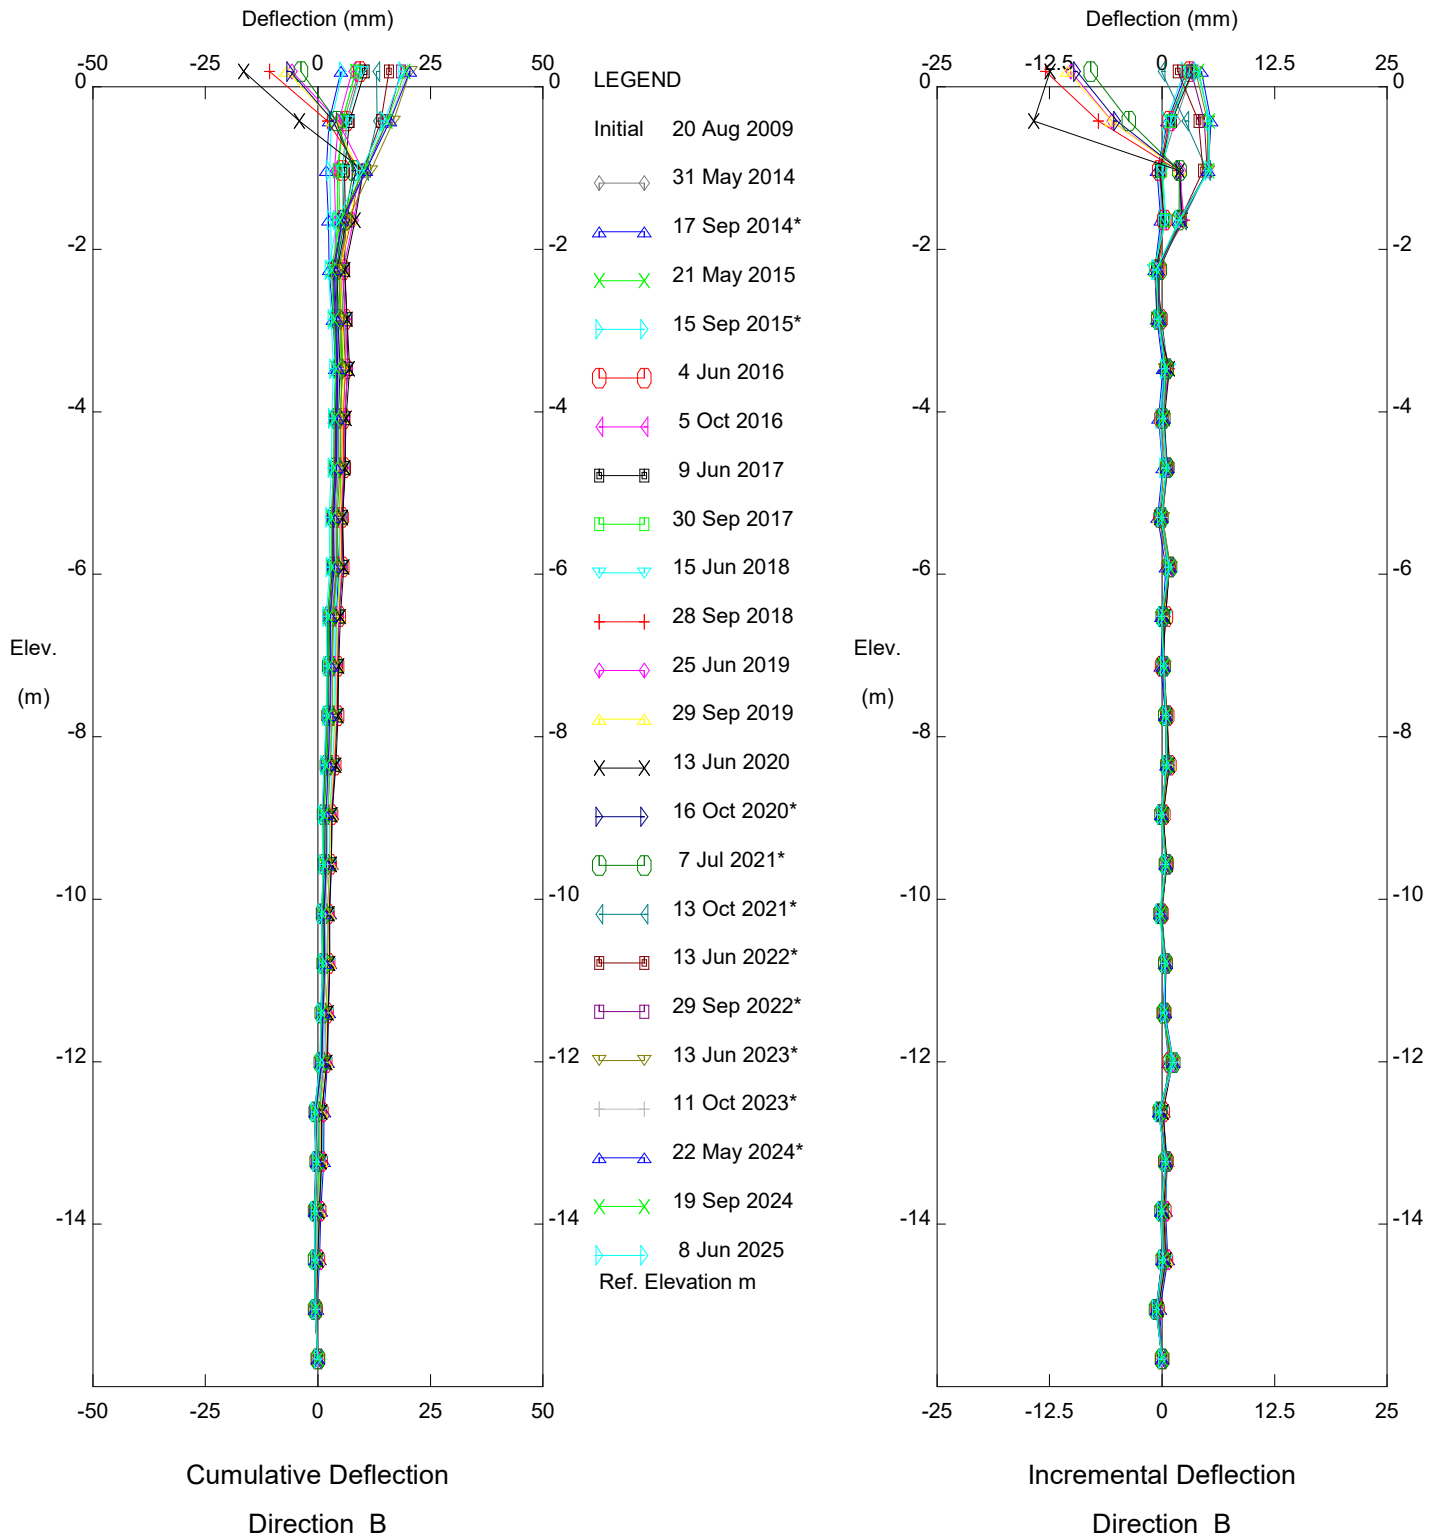
PH009 Old Hwy 2:02 Shop Slide, Inclinometer SI09-3

<p>SI09-3 is located on the east side of the rail tracks. It continues to show no discernible movement.</p> <p>SI09-4 is located immediately east (downslope) of the newly installed pile wall. It showed no discernible movement over 8.6 m to 10.5 m depth and a rate of movement of 0.2 mm/yr over 11.7 m to 13.5 m depth, respectively, since the fall of 2024 readings. These movement zones were first observed in 2021 during construction, and the movement rates have been gradually decreasing since.</p> <p>SI11-01 is located about 7 m north of the north end of the pile wall and developed a movement zone between 13.9 m to 16.3 m depth shortly after construction started and the maximum rate of movement of 34.3 mm/yr occurred in June 14, 2022, near the end of construction. The rate of movement observed over this depth since the fall of 2024 readings was 4.6 mm/yr. This zone of movement shows no signs of slowing despite the installation of the pile wall and offloading of the slope below. There was no discernible movement over the previously perceived new movement zone between 23.0 m and 25.4 m depth, indicating that the erroneous readings likely caused it. The displacement plot for this zone is included for completeness, where it can be seen that there has not been a historically coherent pattern in this zone, and it will no longer be tracked.</p> <p>SI19-5 is located in the lower central portion of the slide. It showed a rate of movement of 0.2 mm/yr over 8.2 m to 11.2 m depth and a rate of movement of 0.2 mm/yr over 17.9 m to 19.7 m depth. The overall movement in SI19-5 has slowed significantly since slope offloading and the completion of construction.</p> <p>It is anticipated that the landslide movements are now constrained by the concrete pile wall and associated lower slope offloading and flattening. A new equilibrium is becoming established and movement rates have reduced with the exception of SI11-01. .</p> <p>SAA</p> <p>Surface accelerometer arrays (SAA) were installed in three concrete piles during construction. SAA-P34 has shown an average rate of movement of 0.4 mm/yr in the downslope direction since the fall of 2024 readings, with a current pile head deflection of 8.3 mm since datalogger readings began for this instrument on May 27, 2022. SAA-P34 shows seasonal trends of greater pile deflection through winter months and a relaxation in summer months in response to the seasonal behaviour of anchors. The maximum pile head deflection of 12.0 mm was measured in March 2025.</p> <p>SAA-P77 showed a rate of movement of 0.3 mm/yr since the fall of 2024 readings. SAA-P77 has shown a total pile head movement of 3.9 mm since datalogger readings began on May 27, 2022. The maximum pile head deflection of 5.0 mm was measured in March 2025. . The seasonal movement trend at SAA-P77 is less pronounced compared to SAA-P34, which is due to the lower height of the wall at this location (roughly 3 m compared to 6 m to 7 m at P34).</p> <p>SAA-P113 has shown an average rate of movement of 2.1 mm/yr in the downslope direction since the fall of 2024 readings, with a total pile head deflection of 17.4 mm since datalogger readings began on May 27, 2022. The higher observed movement in SAA-P113 can be attributed to the fact that the pile wall at this location is cantilevered rather than tied-back like the other portions of the wall. The movement rate measured in the instrument has decreased since the fall of 2024 readings by 4.3 mm/yr. SAA-P113 does not show clear seasonal movement trends as SAA-P34 or SAA-P77 since there are no anchors in this portion of the wall.</p>
