**ALBERTA TRANSPORTATION AND
ECONOMIC CORRIDORS GRMP
PEACE REGION – (PEACE RIVER DISTRICT)
INSTRUMENTATION MONITORING - SPRING 2025**

Site Number	Location	Name	Hwy	km
PH009-3	Hwy 684:02 km 30.99, Town of Peace River	Shaftesbury Trail - Shop Slide	684:02	30.9-31.1
			Old 2:02	0.0-0.4
Legal Description:		UTM Co-ordinates		
4-31-83-21 W5		11V E 480321	N	6232126

Current Monitoring:	8-June-2025	Previous Monitoring	19 & 20-Sep-2024
Instruments Read By:	Mr. Niraj Regmi, G.I.T., and Mr. Godfred Etiendem, of Thurber

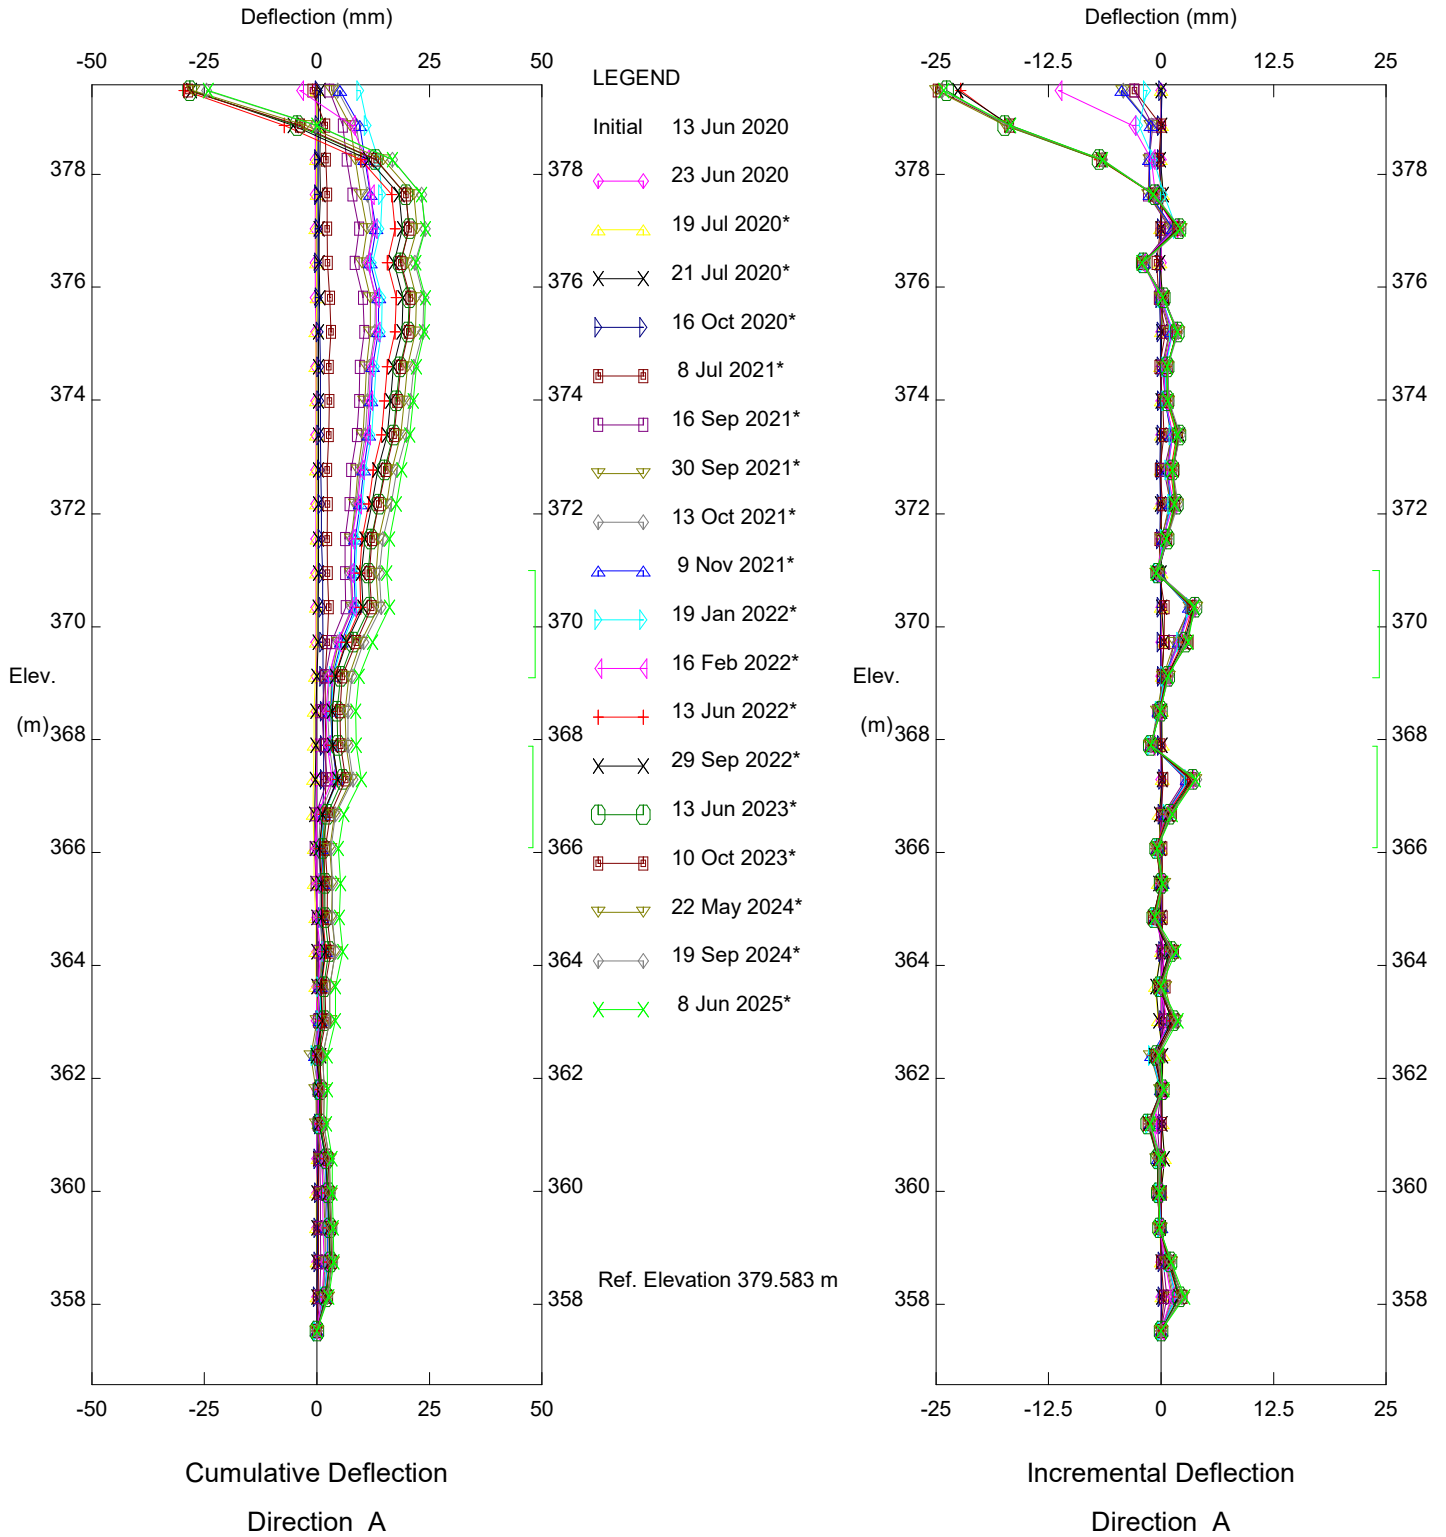
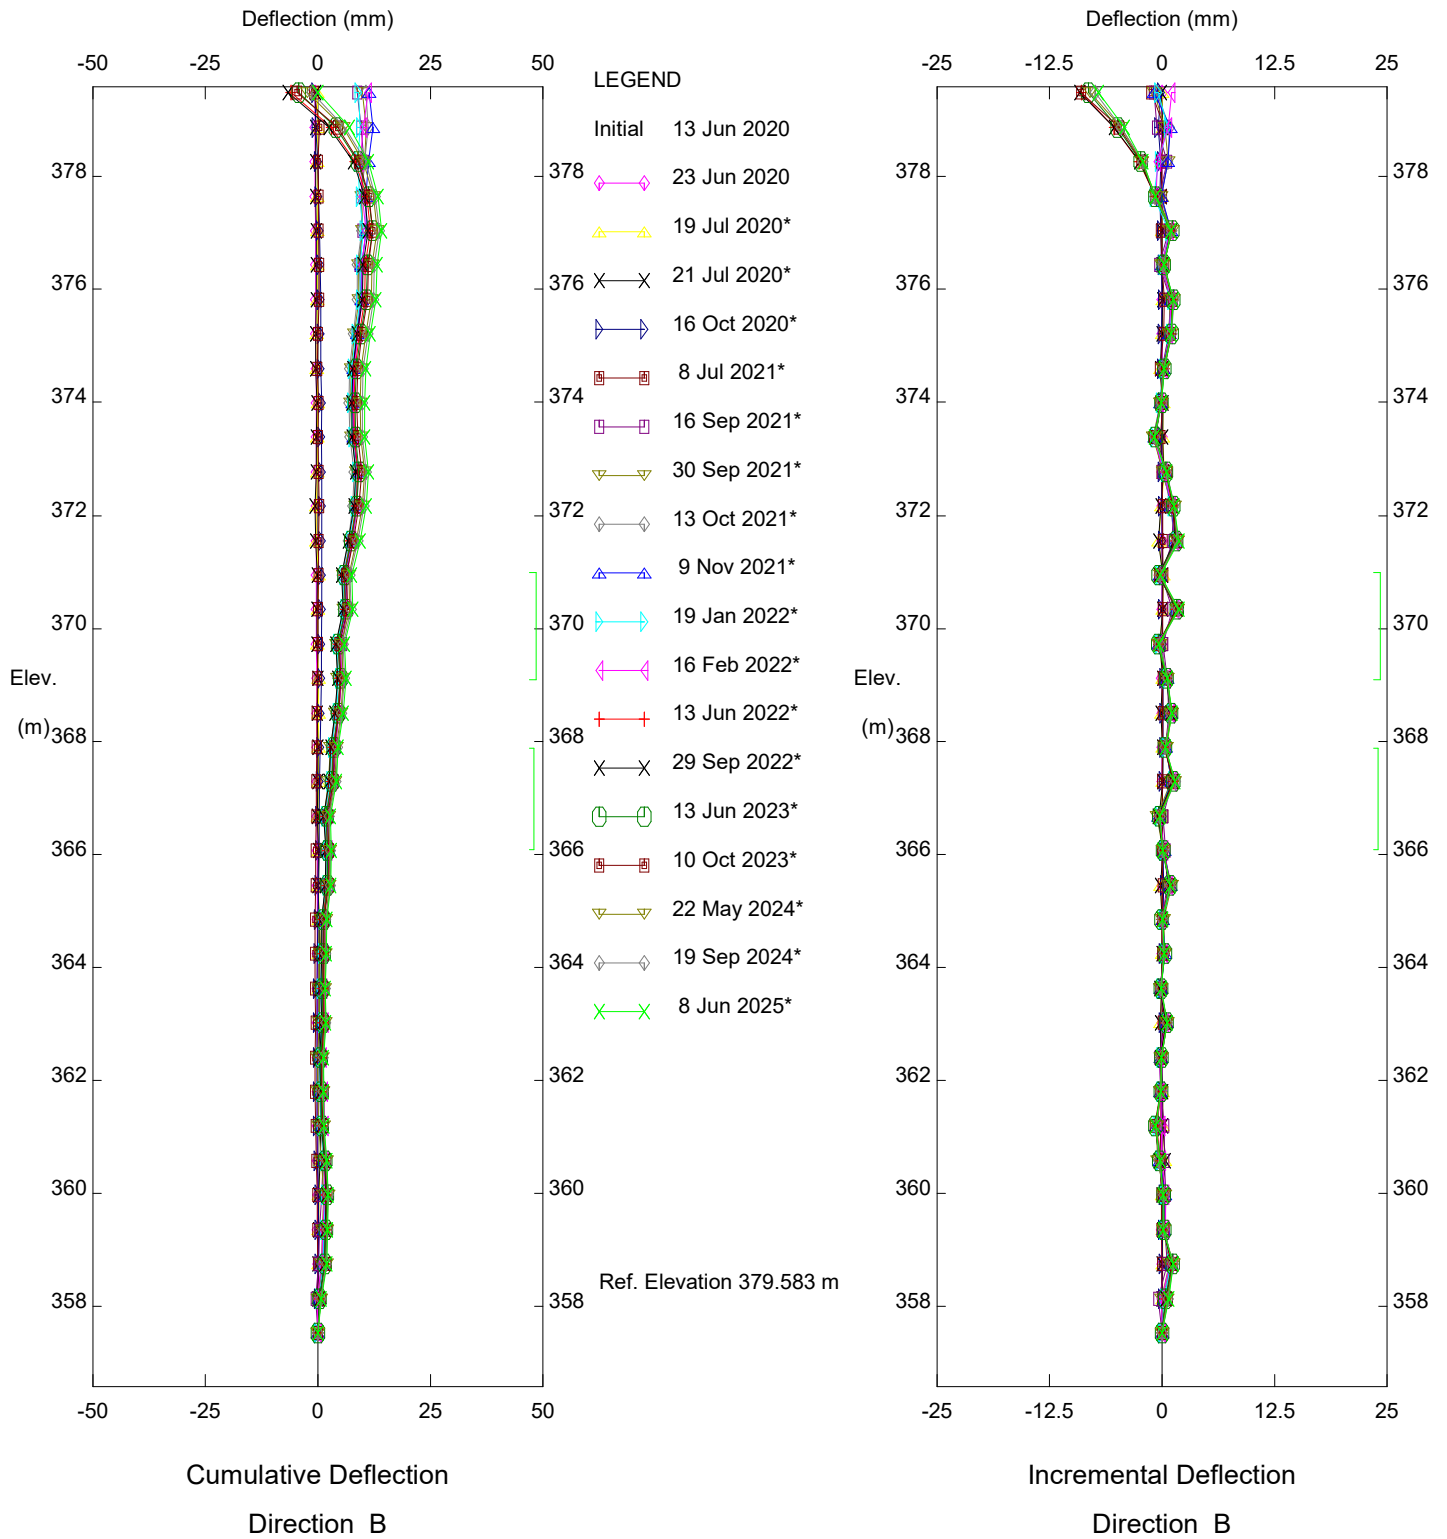
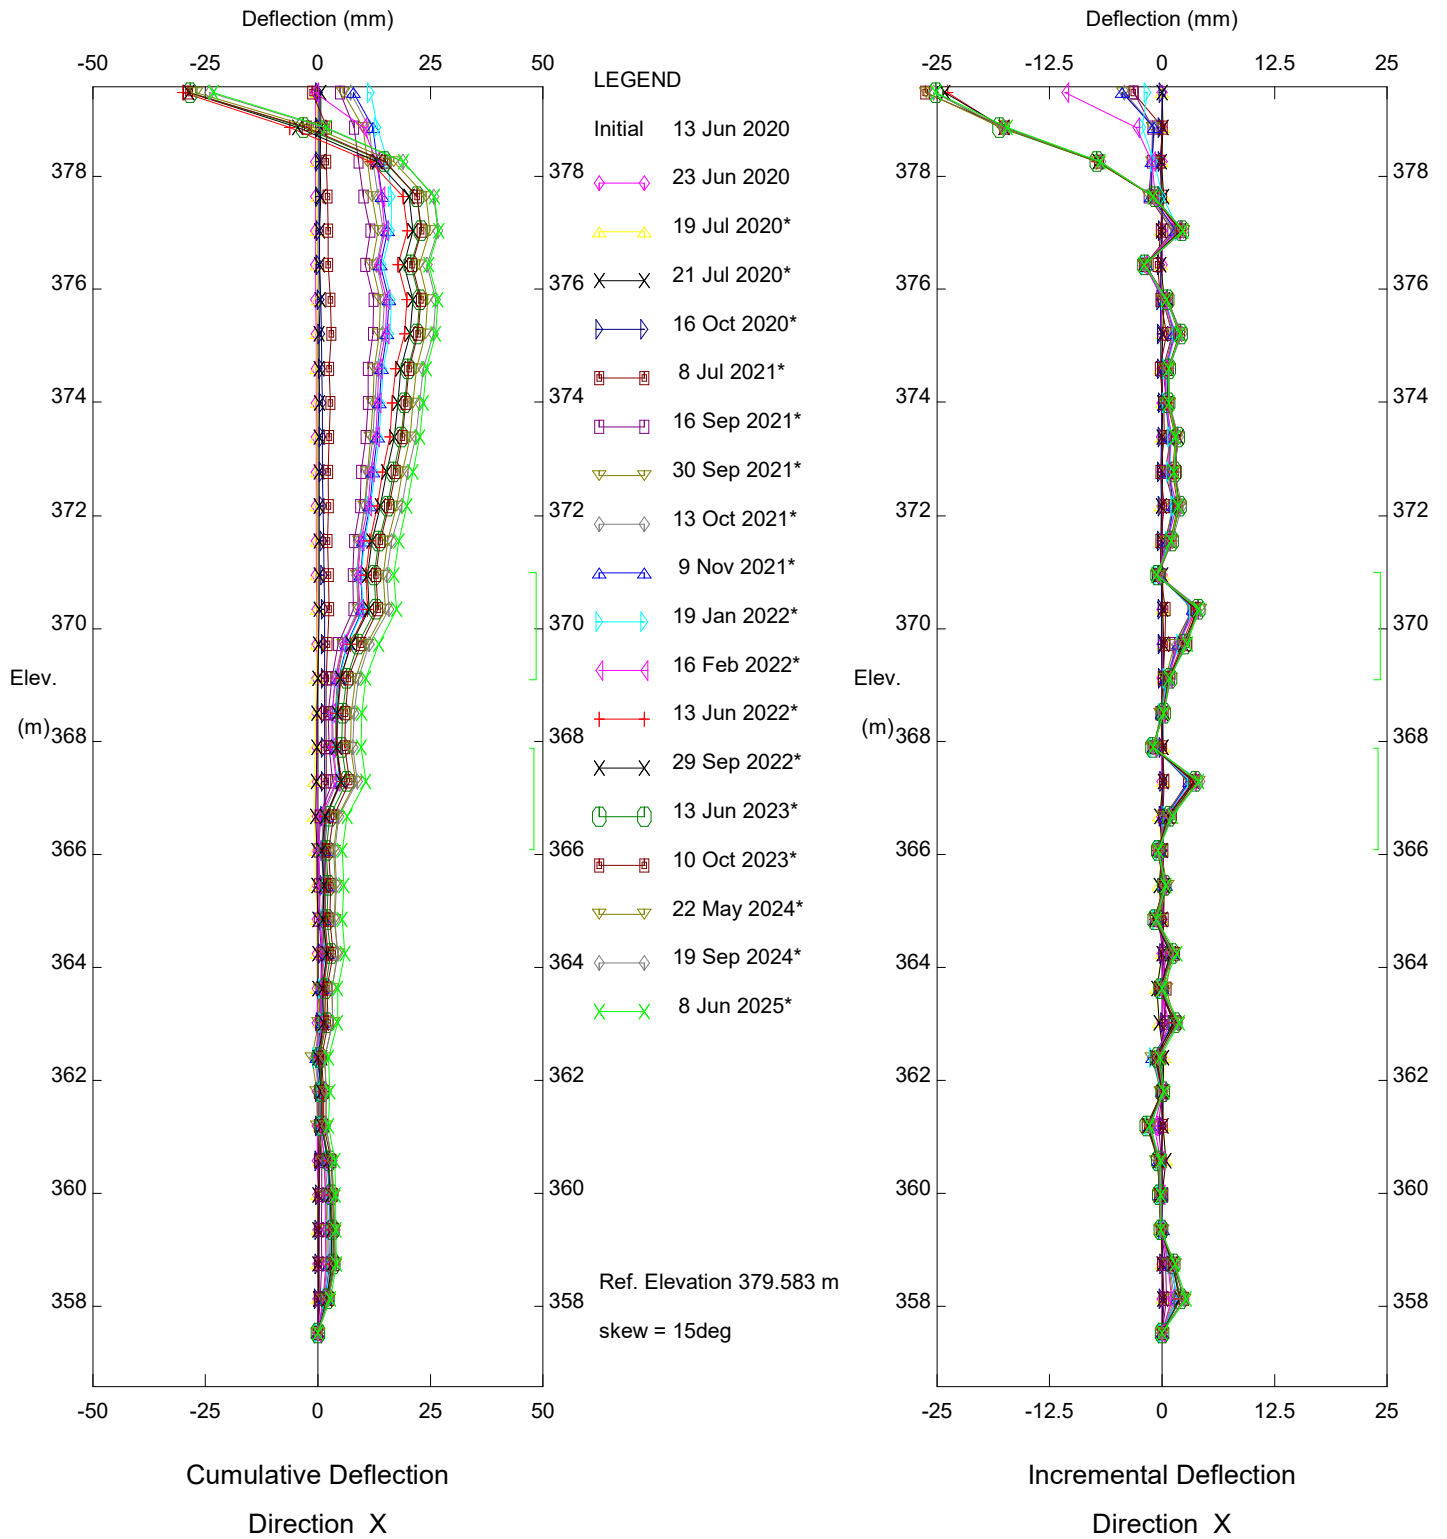
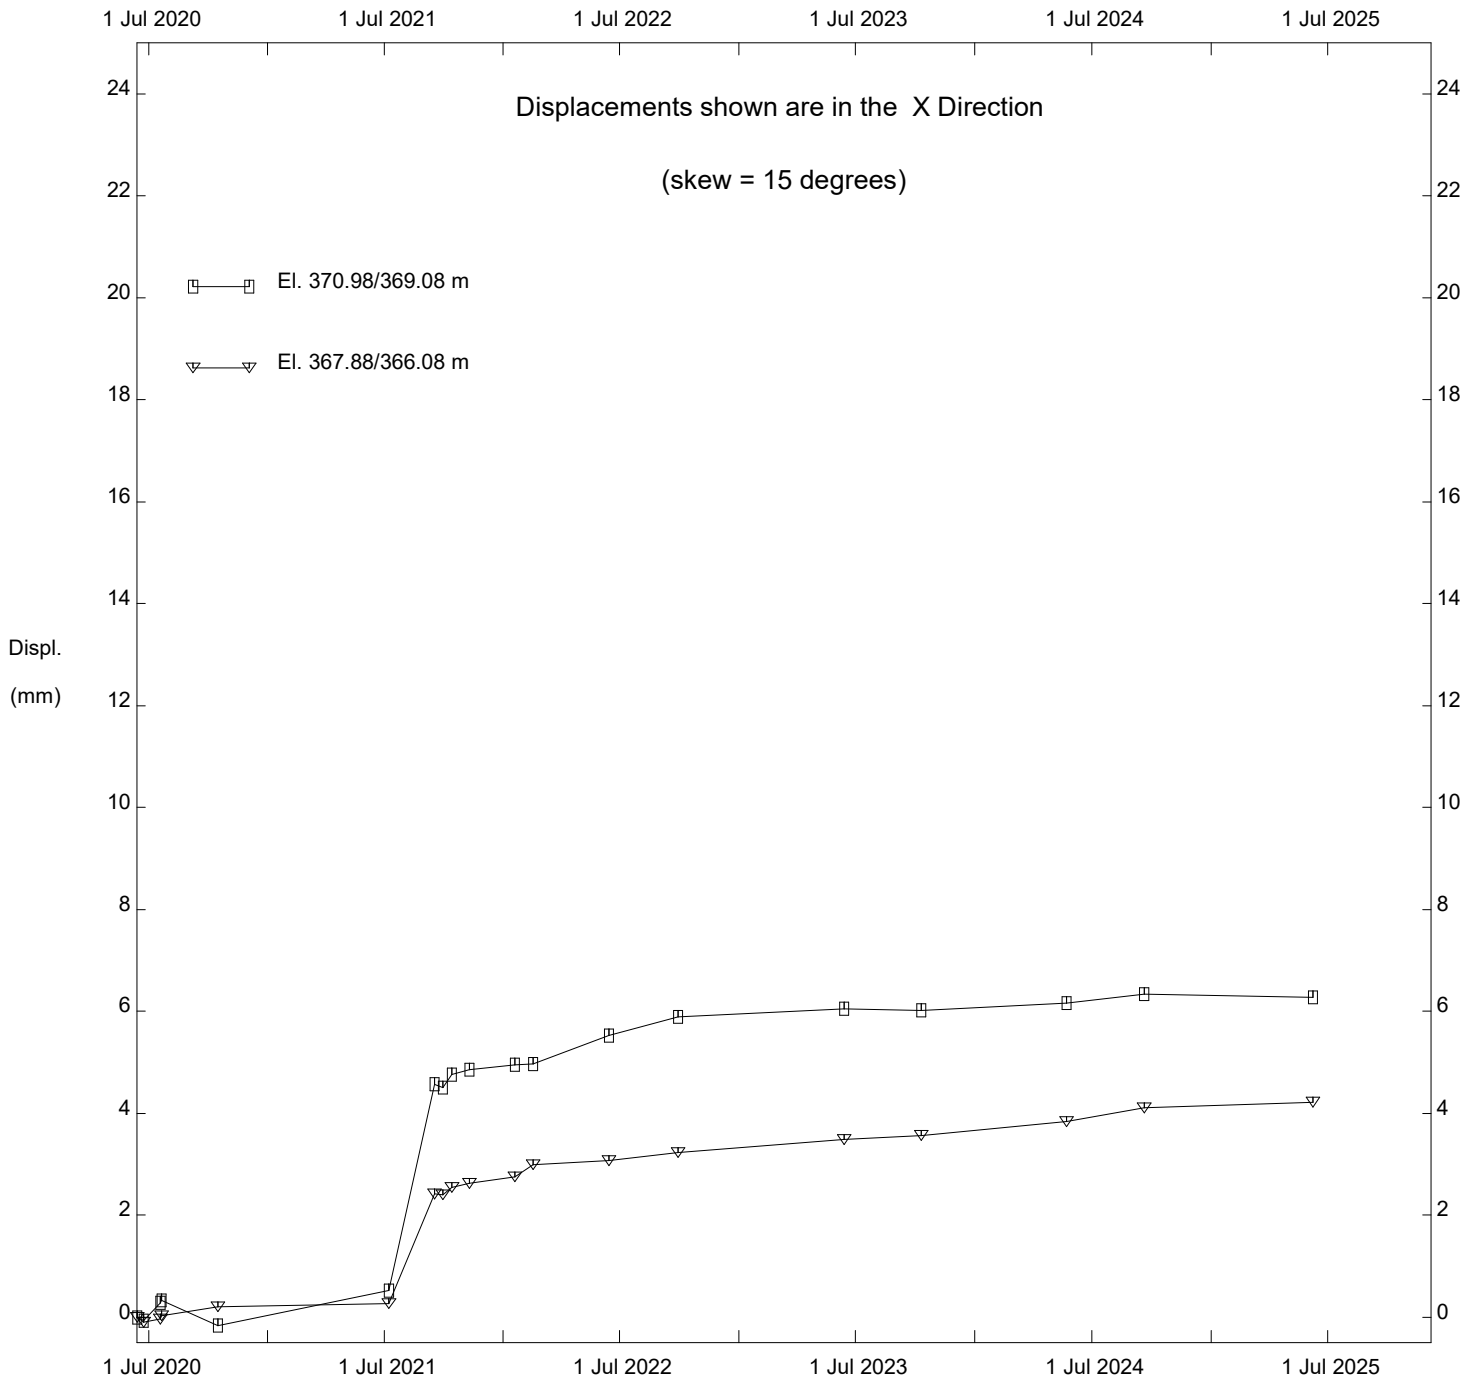
PH009 Old Hwy 2:02 Shop Slide, Inclinometer SI09-4

<p>SI09-3 is located on the east side of the rail tracks. It continues to show no discernible movement.</p> <p>SI09-4 is located immediately east (downslope) of the newly installed pile wall. It showed no discernible movement over 8.6 m to 10.5 m depth and a rate of movement of 0.2 mm/yr over 11.7 m to 13.5 m depth, respectively, since the fall of 2024 readings. These movement zones were first observed in 2021 during construction, and the movement rates have been gradually decreasing since.</p> <p>SI11-01 is located about 7 m north of the north end of the pile wall and developed a movement zone between 13.9 m to 16.3 m depth shortly after construction started and the maximum rate of movement of 34.3 mm/yr occurred in June 14, 2022, near the end of construction. The rate of movement observed over this depth since the fall of 2024 readings was 4.6 mm/yr. This zone of movement shows no signs of slowing despite the installation of the pile wall and offloading of the slope below. There was no discernible movement over the previously perceived new movement zone between 23.0 m and 25.4 m depth, indicating that the erroneous readings likely caused it. The displacement plot for this zone is included for completeness, where it can be seen that there has not been a historically coherent pattern in this zone, and it will no longer be tracked.</p> <p>SI19-5 is located in the lower central portion of the slide. It showed a rate of movement of 0.2 mm/yr over 8.2 m to 11.2 m depth and a rate of movement of 0.2 mm/yr over 17.9 m to 19.7 m depth. The overall movement in SI19-5 has slowed significantly since slope offloading and the completion of construction.</p> <p>It is anticipated that the landslide movements are now constrained by the concrete pile wall and associated lower slope offloading and flattening. A new equilibrium is becoming established and movement rates have reduced with the exception of SI11-01. .</p> <p>SAA</p> <p>Surface accelerometer arrays (SAA) were installed in three concrete piles during construction. SAA-P34 has shown an average rate of movement of 0.4 mm/yr in the downslope direction since the fall of 2024 readings, with a current pile head deflection of 8.3 mm since datalogger readings began for this instrument on May 27, 2022. SAA-P34 shows seasonal trends of greater pile deflection through winter months and a relaxation in summer months in response to the seasonal behaviour of anchors. The maximum pile head deflection of 12.0 mm was measured in March 2025.</p> <p>SAA-P77 showed a rate of movement of 0.3 mm/yr since the fall of 2024 readings. SAA-P77 has shown a total pile head movement of 3.9 mm since datalogger readings began on May 27, 2022. The maximum pile head deflection of 5.0 mm was measured in March 2025. . The seasonal movement trend at SAA-P77 is less pronounced compared to SAA-P34, which is due to the lower height of the wall at this location (roughly 3 m compared to 6 m to 7 m at P34).</p> <p>SAA-P113 has shown an average rate of movement of 2.1 mm/yr in the downslope direction since the fall of 2024 readings, with a total pile head deflection of 17.4 mm since datalogger readings began on May 27, 2022. The higher observed movement in SAA-P113 can be attributed to the fact that the pile wall at this location is cantilevered rather than tied-back like the other portions of the wall. The movement rate measured in the instrument has decreased since the fall of 2024 readings by 4.3 mm/yr. SAA-P113 does not show clear seasonal movement trends as SAA-P34 or SAA-P77 since there are no anchors in this portion of the wall.</p>

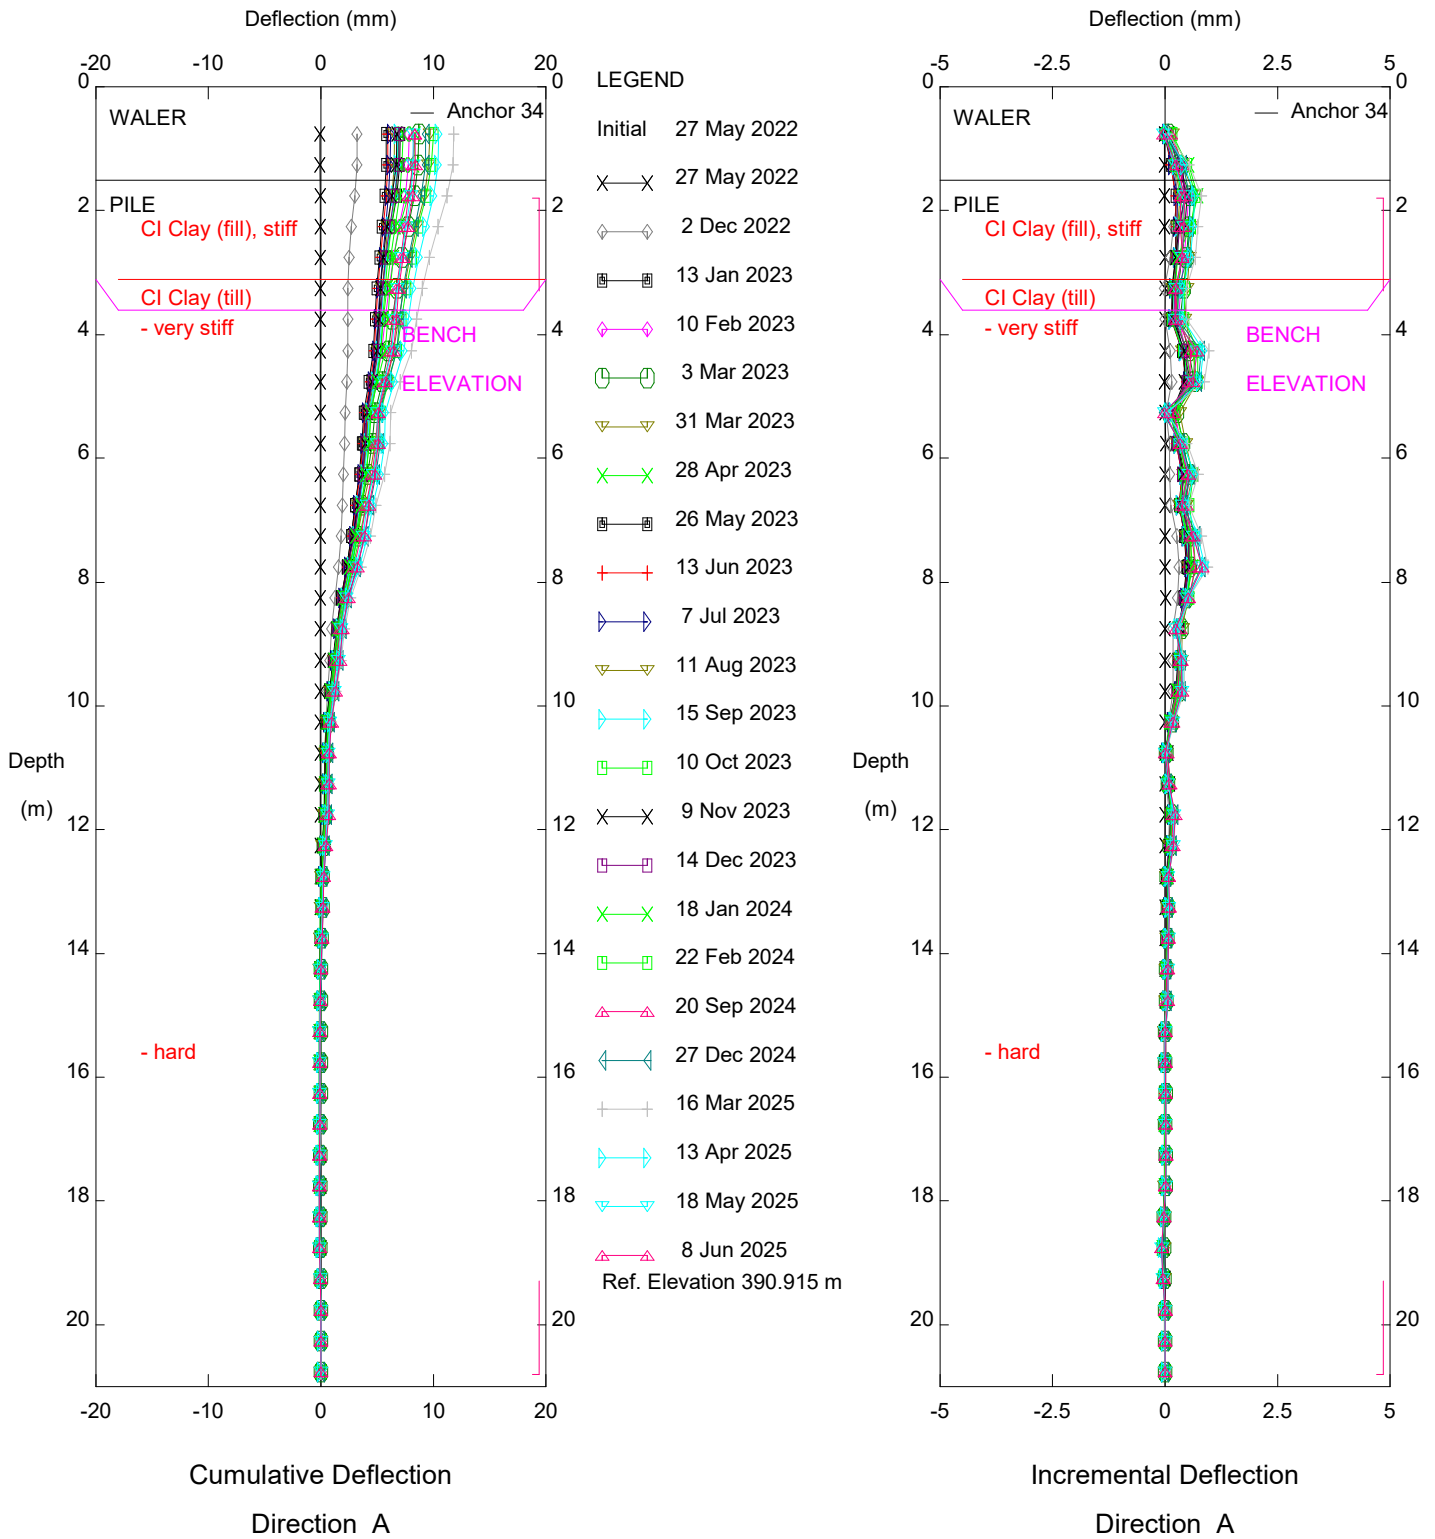
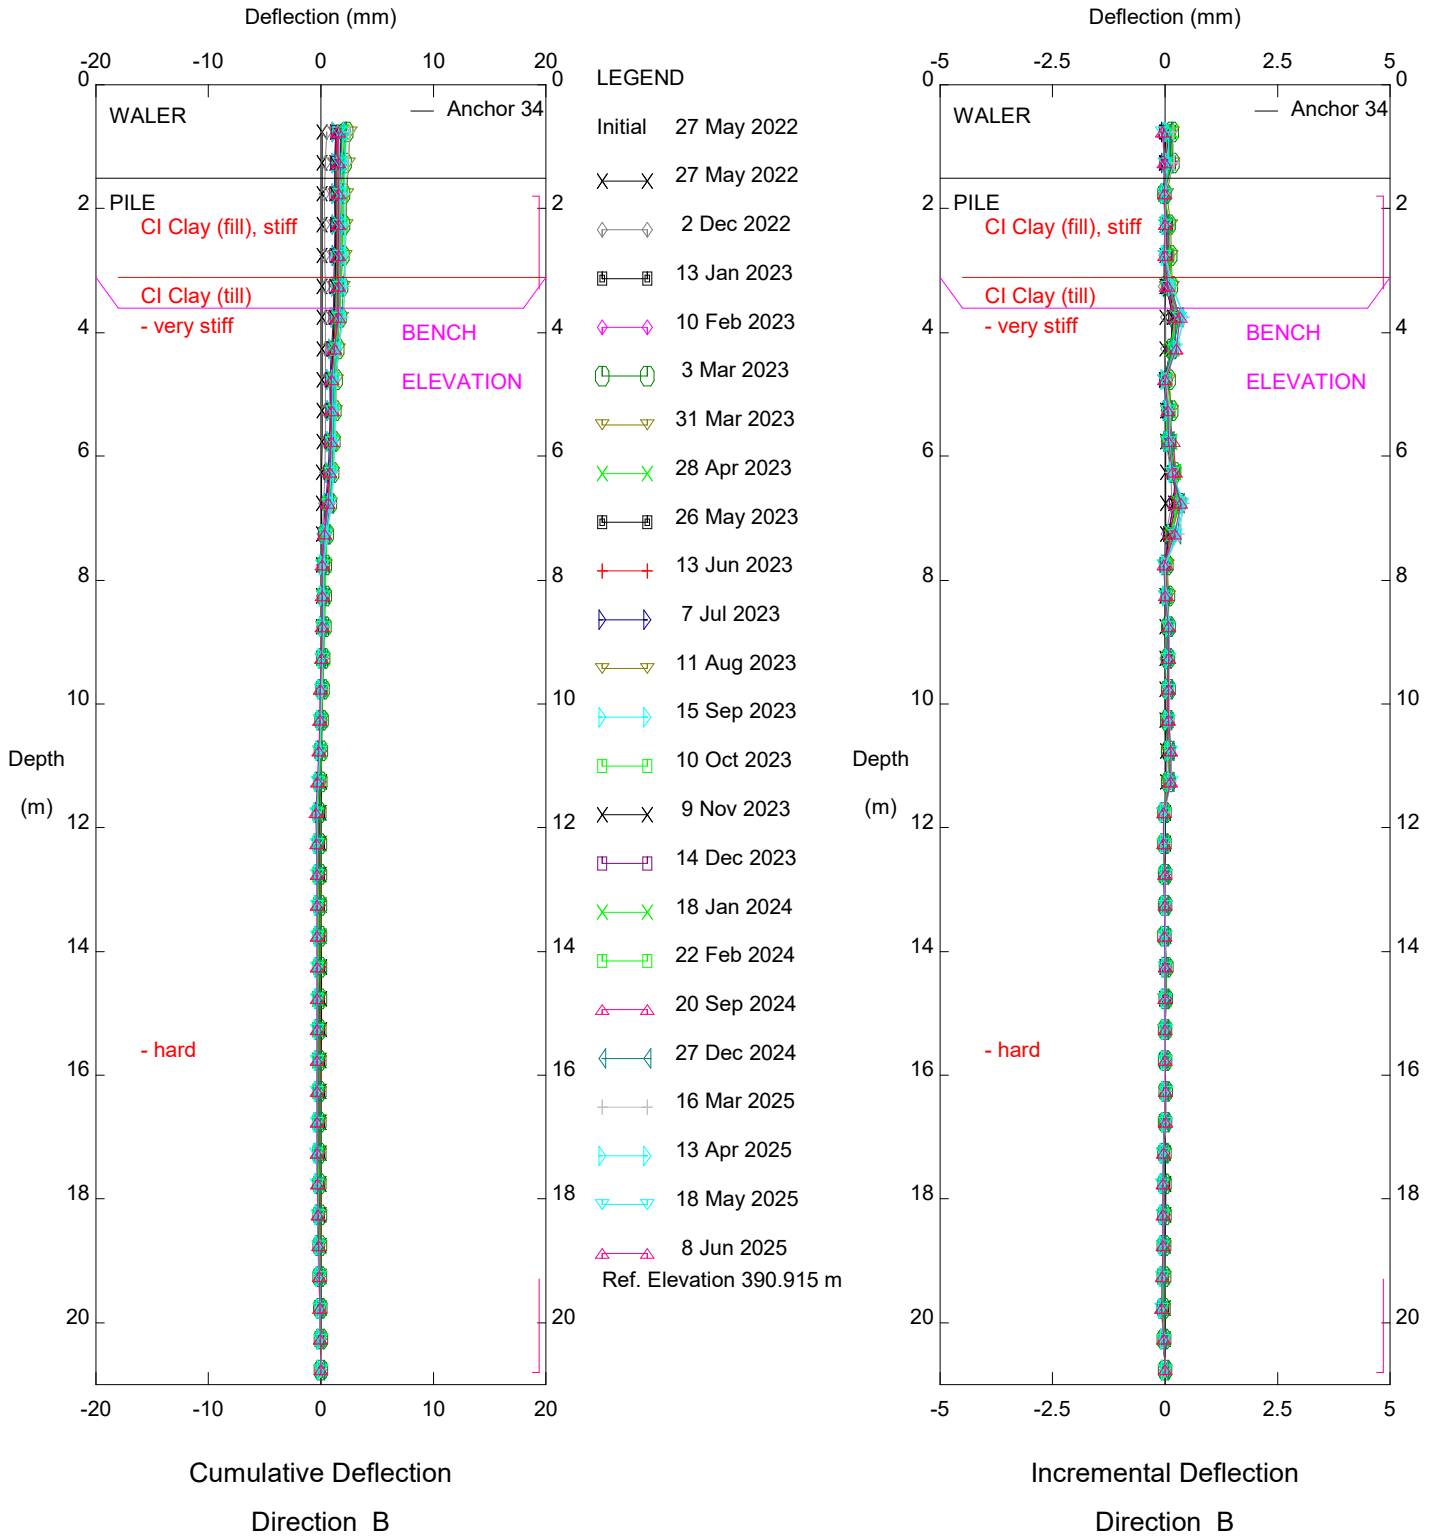
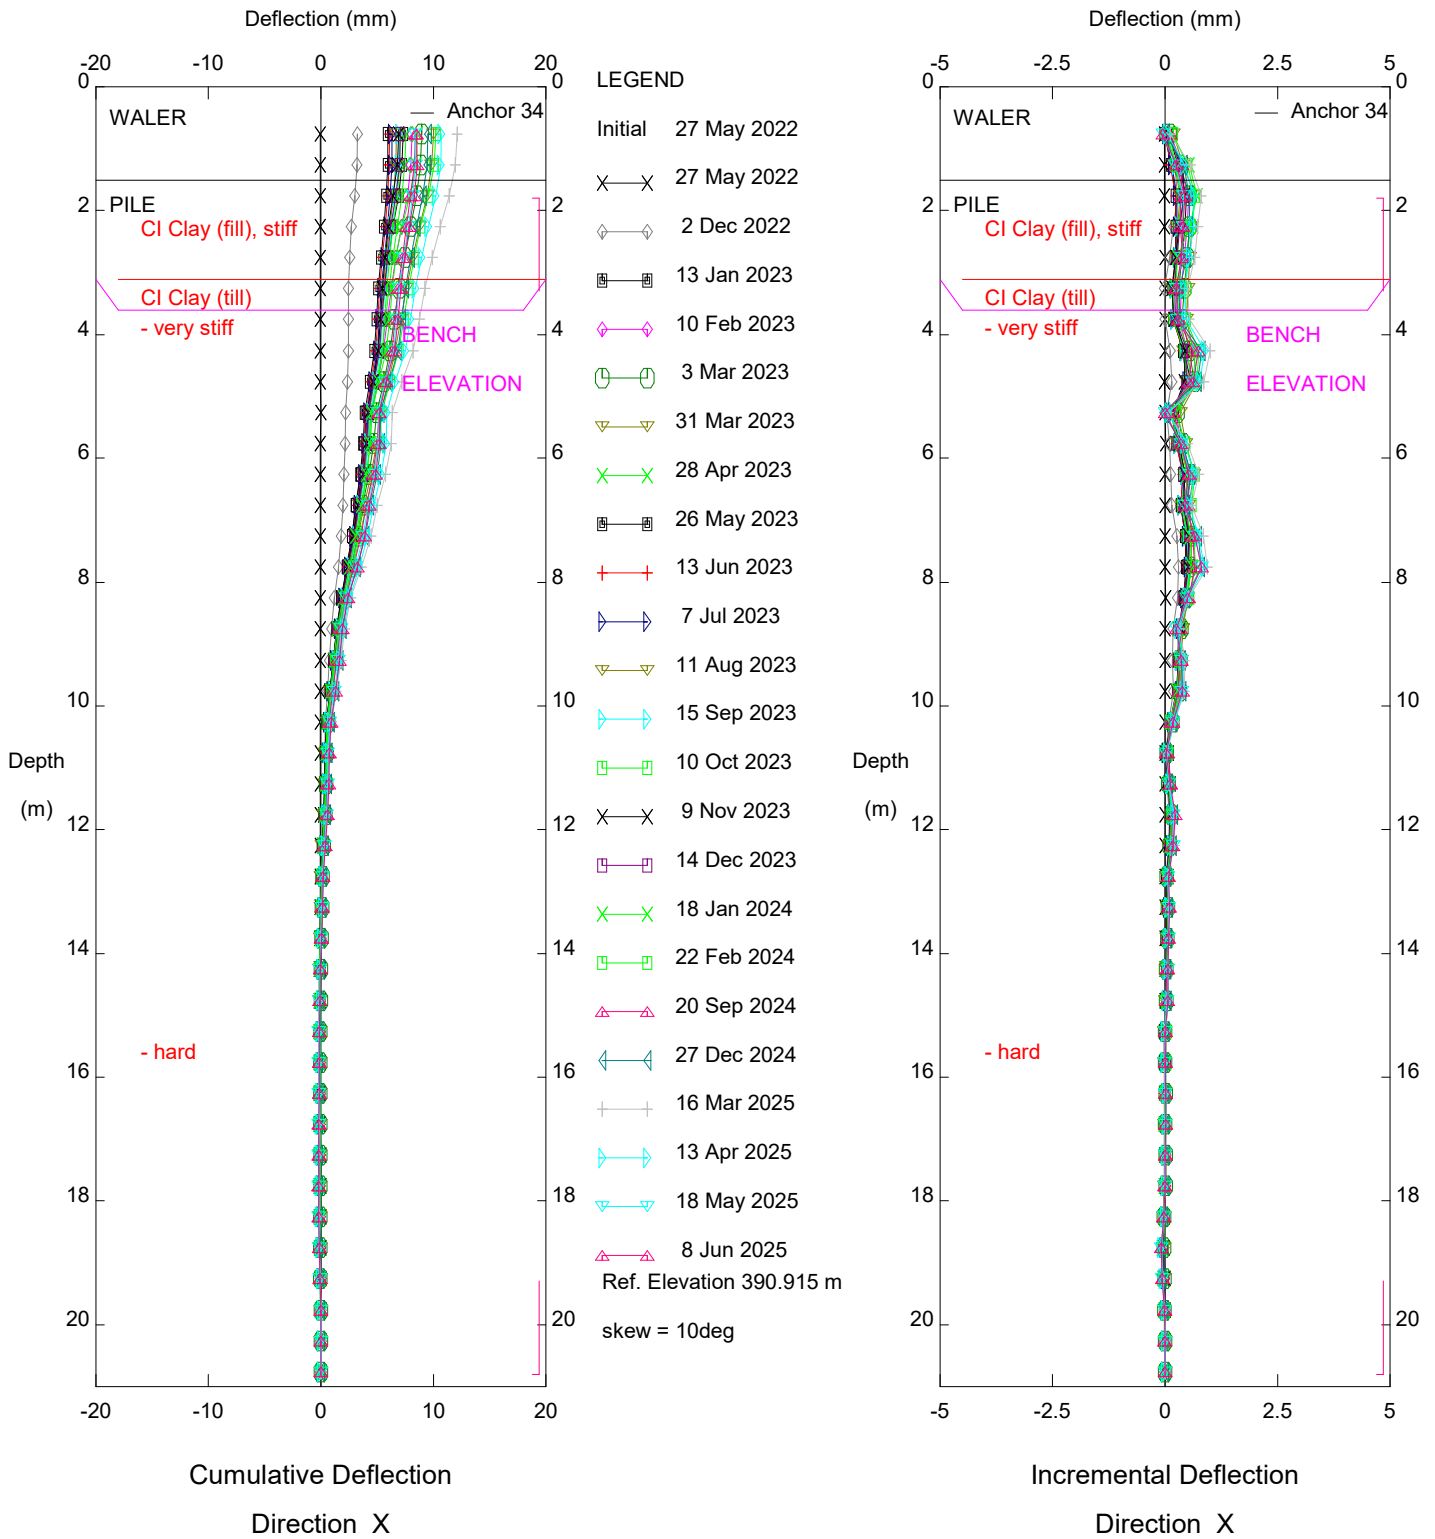
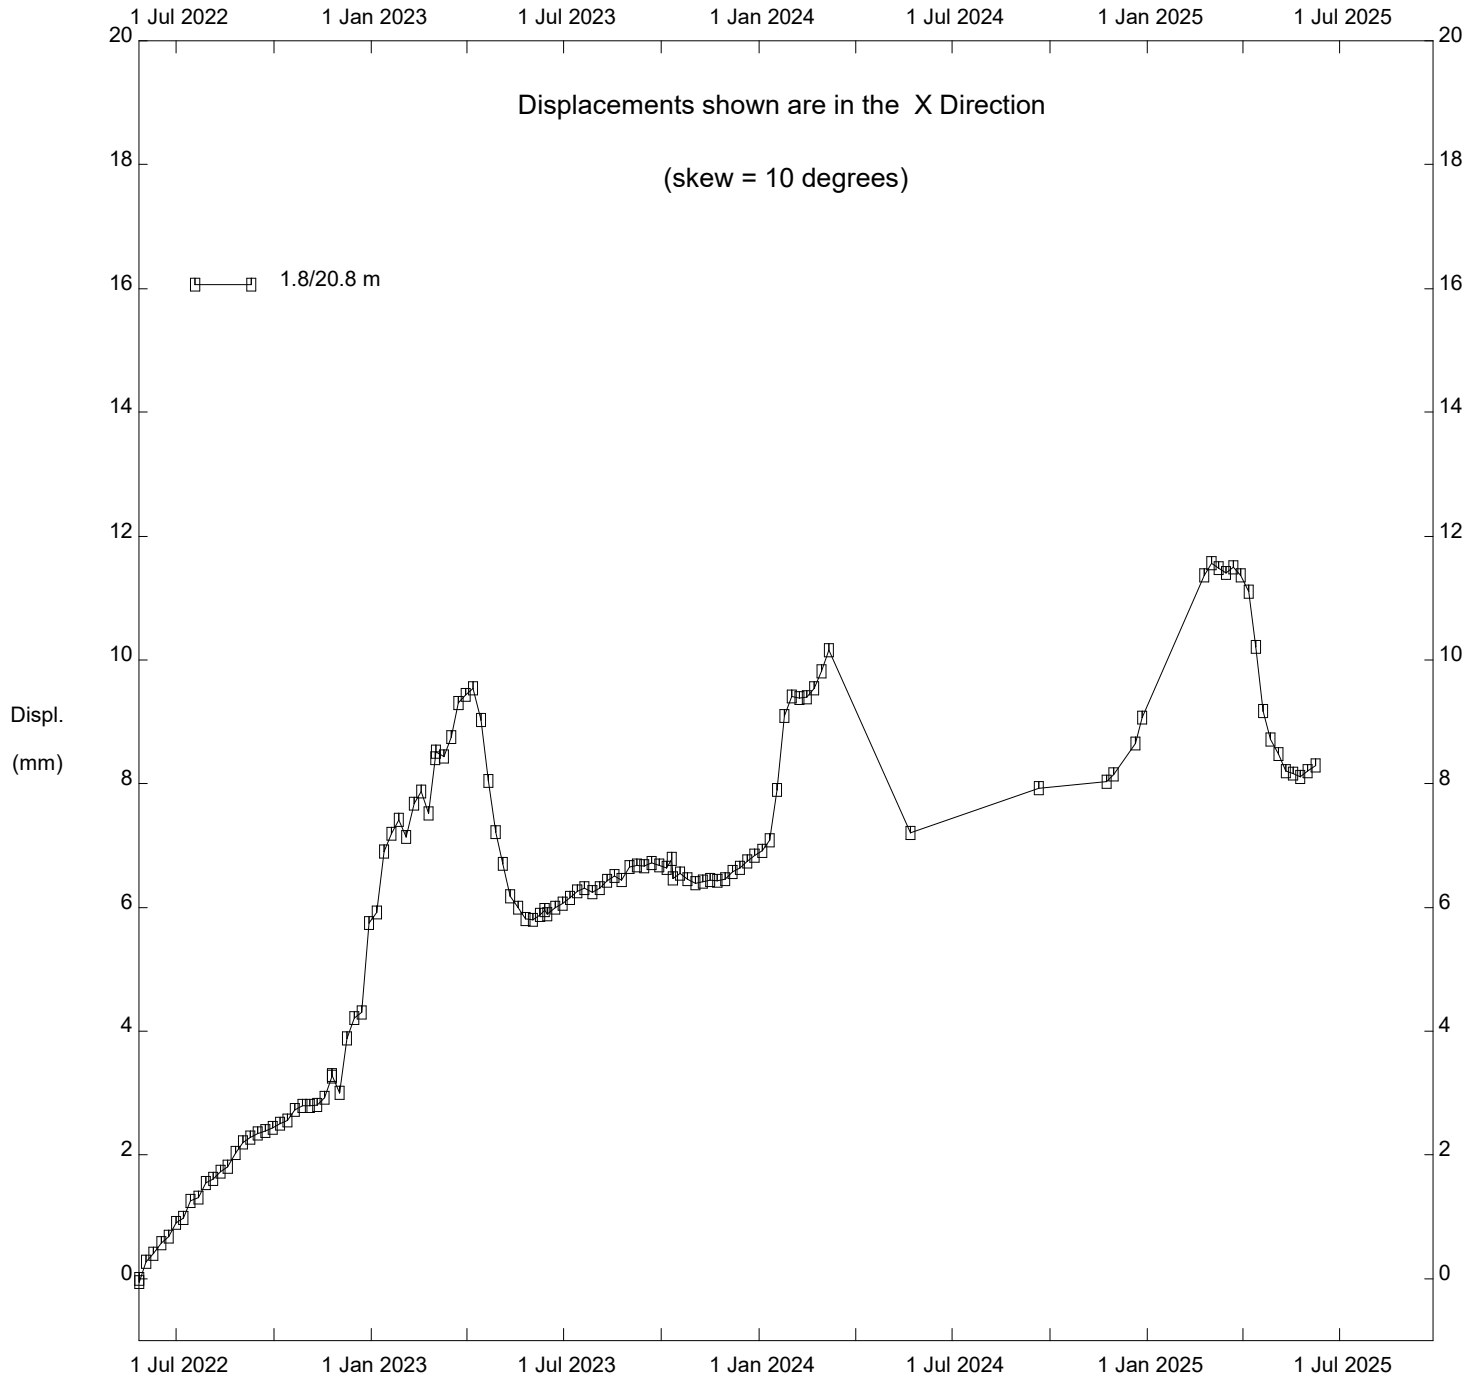
Shop Slide Type 1 Wall Section, Inclinometer SAA-P34

Pile head deflections measured by the SAA are within an acceptable range (below the estimated SLS Design Values, measured since anchor lock-off: of 18 mm for SAA-P34, 7 mm for SAA-P77, and 39 mm for SAA-P113). More deflection is noted, as expected, in the cantilever section of

<p>the wall (SAA-P113). The additional deflection in SAA-P34 may be due to the deeper amount of cut as compared to the slope below SAA-P77. This will require additional readings and analysis to interpret and will be considered as part of the ongoing development of threshold criteria for this pile wall.</p> <p>PIEZOMETERS</p> <p>Standpipe piezometers SP05-1, SP05-4, SP09-10, and SP019-3 showed decreases in groundwater level of 0.17 m, 0.07 m, 1.03 m, and 0.43 m respectively, since the fall of 2024 readings. Standpipe piezometer SP05-5 showed an increase in groundwater level of 0.03 m, since the fall of 2024 readings. SP11-06, SP09 8, and SP09-9 continued to be dry (SP09-8 and SP09-9 have been dry since installation). The water levels measured in the standpipes have not demonstrated a trend. The results of the standpipe piezometers are summarized in Table PH009-5, and are plotted in Figure PH009-11 in Appendix A. Historical standpipe piezometer readings are presented in Figure PH009-12.</p> <p>VW09-4 showed a slight decrease in ground water level of 0.13 m since the fall of 2024 readings; the groundwater levels have been trending downward since 2012. VW09-3 has been dry since August 2009. The vibrating wire piezometer results are summarized in Table PH009-6, and are plotted in Figure PH009-13 in Appendix A.</p> <p>Pneumatic piezometer PN15-5A showed a decrease in groundwater level of 0.01 m since the previous reading in fall of 2024. PN19-5B showed an increase in groundwater level of 0.13 m since the fall of 2024 readings and has had a slight increasing trend overall since installation (February 2019). Pneumatic piezometer results are summarized in Table PH009-7, and are plotted in Figure PH009-14 in Appendix A.</p>
