**ALBERTA TRANSPORTATION AND
ECONOMIC CORRIDORS GRMP
PEACE REGION – (PEACE RIVER DISTRICT)
INSTRUMENTATION MONITORING - SPRING 2025**

Site Number	Location	Name	Hwy	km
PH009-3	Hwy 684:02 km 30.99, Town of Peace River	Shaftesbury Trail - Shop Slide	684:02	30.9-31.1
			Old 2:02	0.0-0.4
Legal Description:		UTM Co-ordinates		
4-31-83-21 W5		11V E 480321	N	6232126

Current Monitoring:	8-June-2025	Previous Monitoring	19 & 20-Sep-2024
Instruments Read By:	Mr. Niraj Regmi, G.I.T., and Mr. Godfred Etiendem, of Thurber

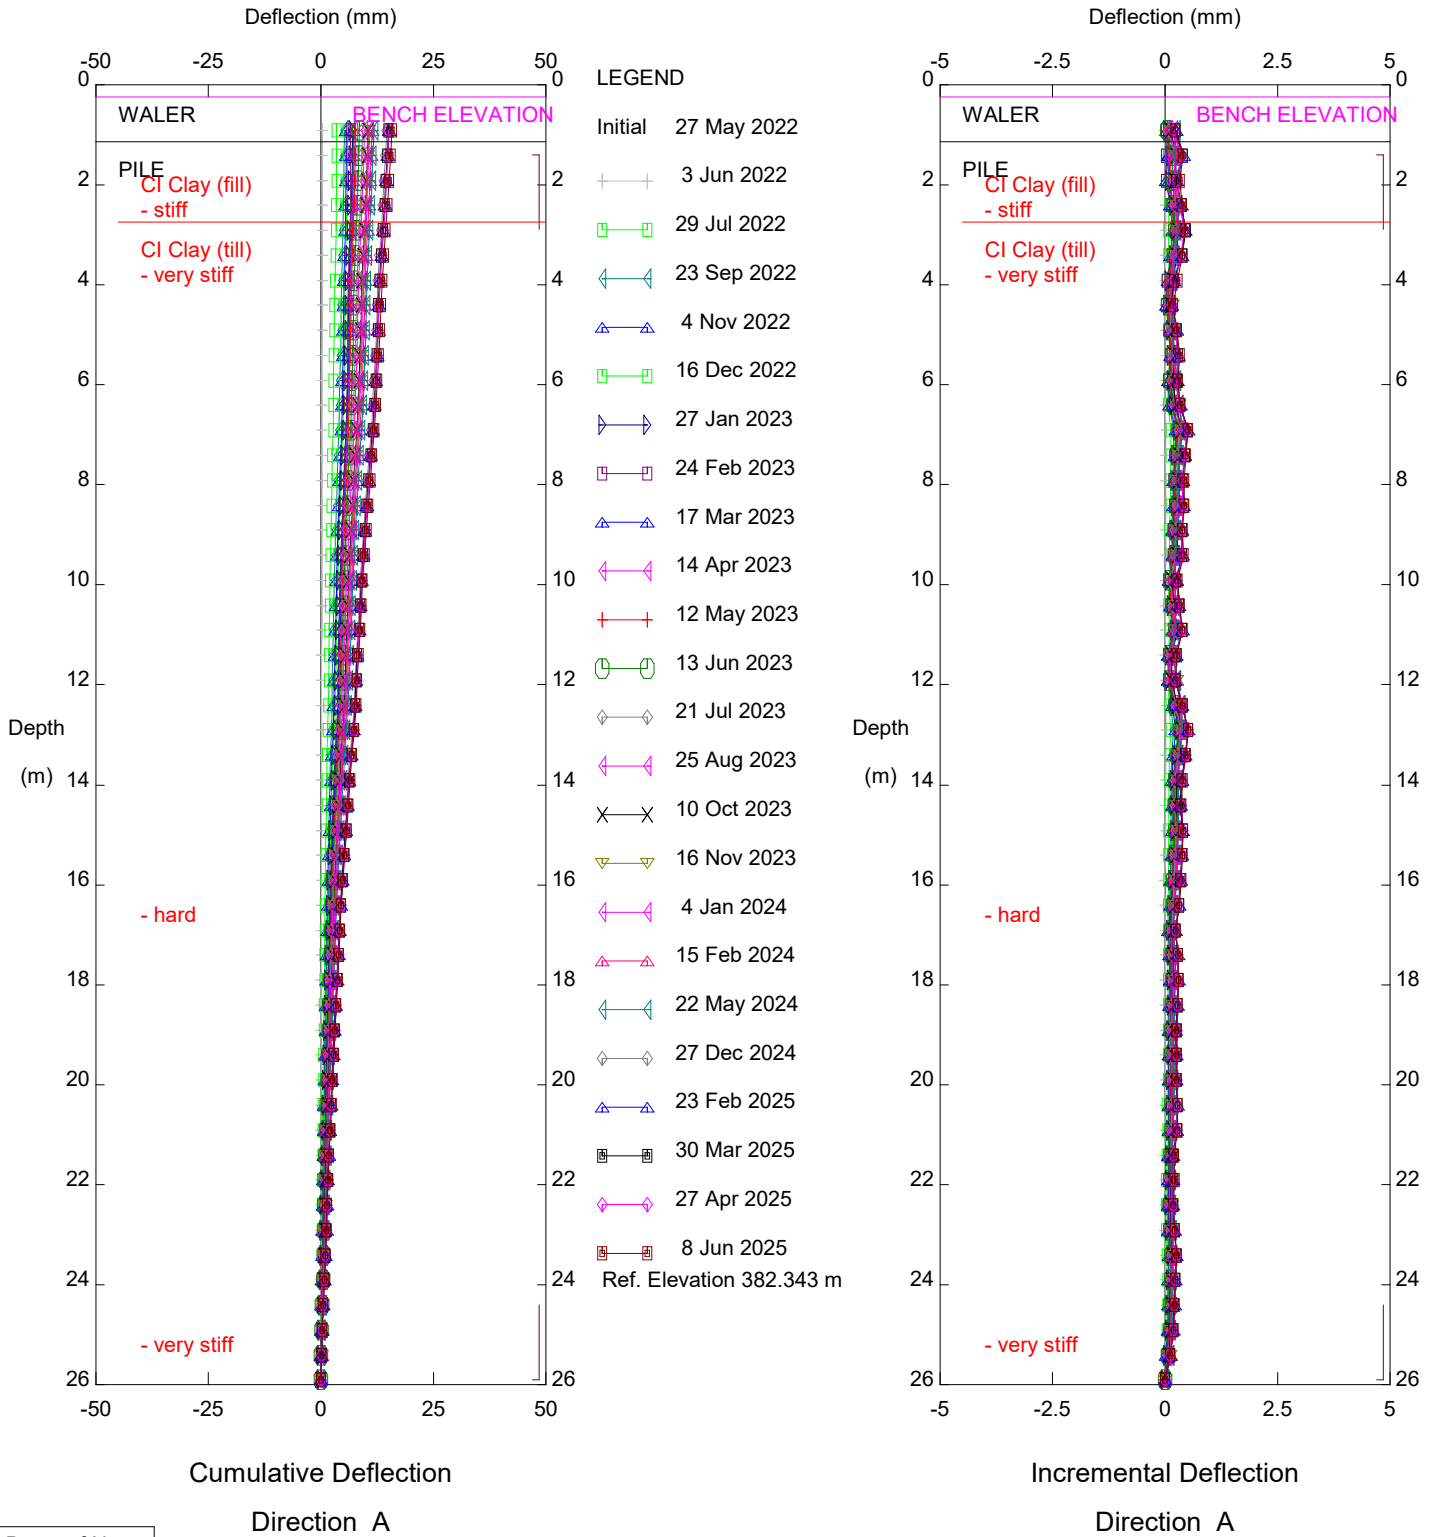
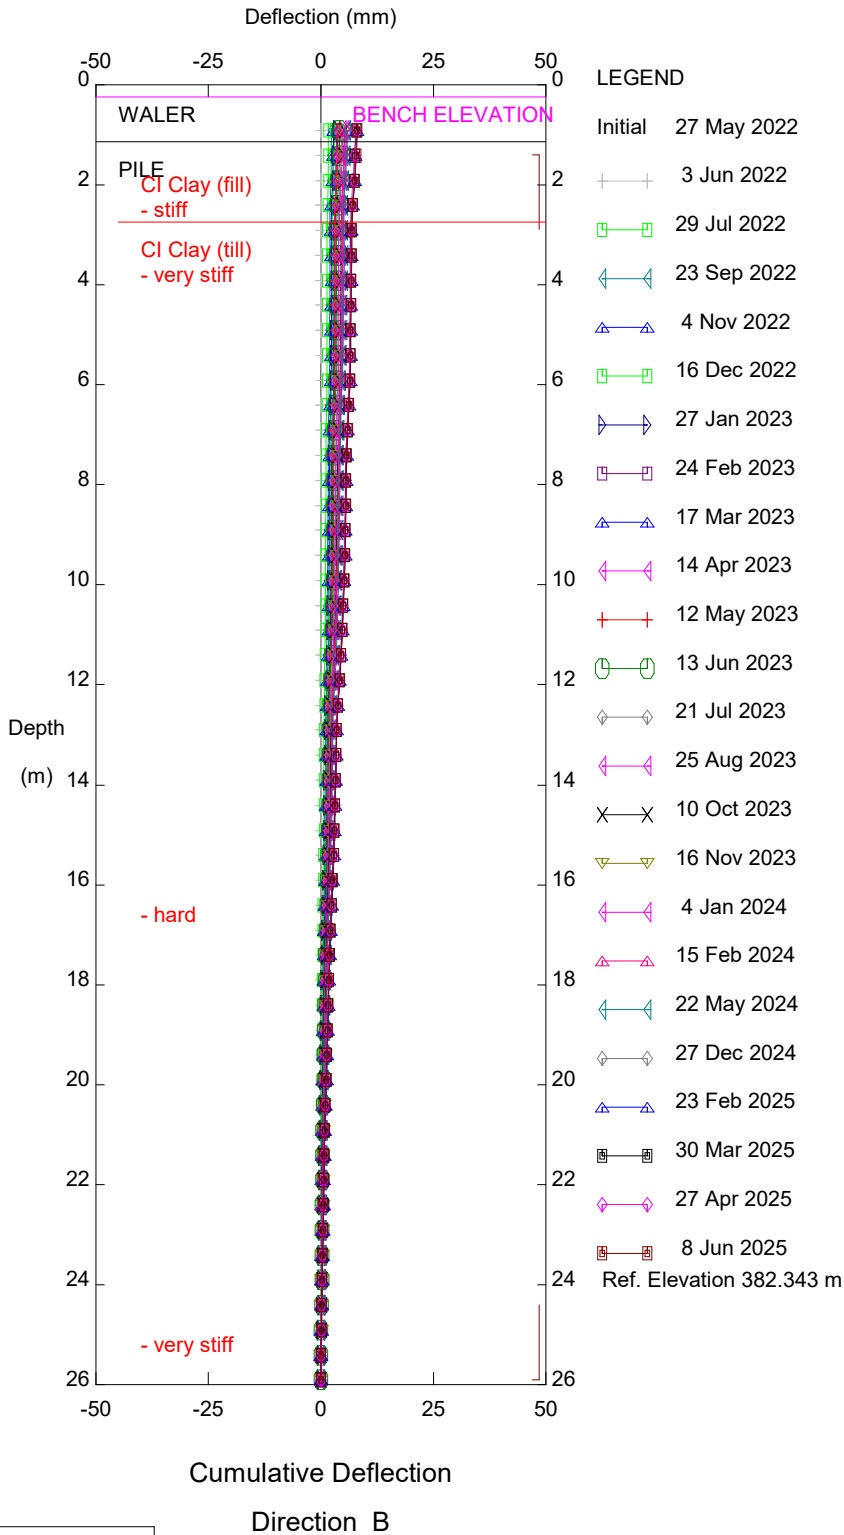
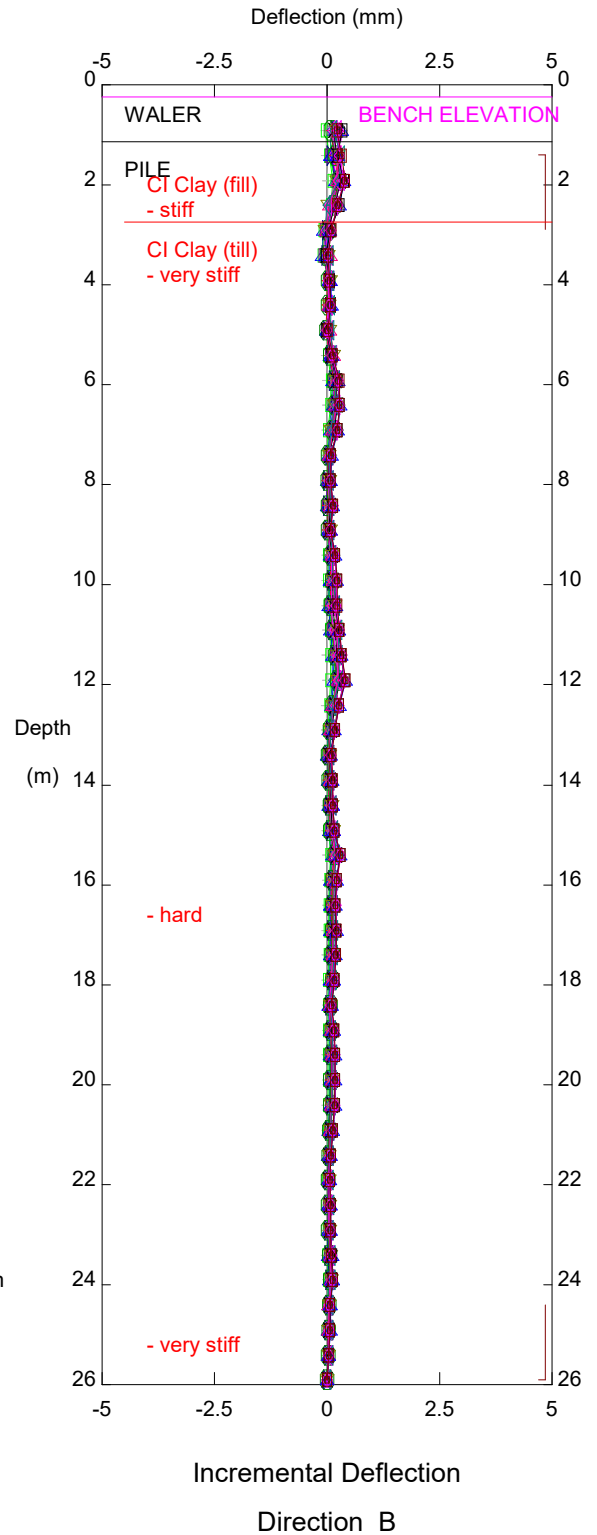
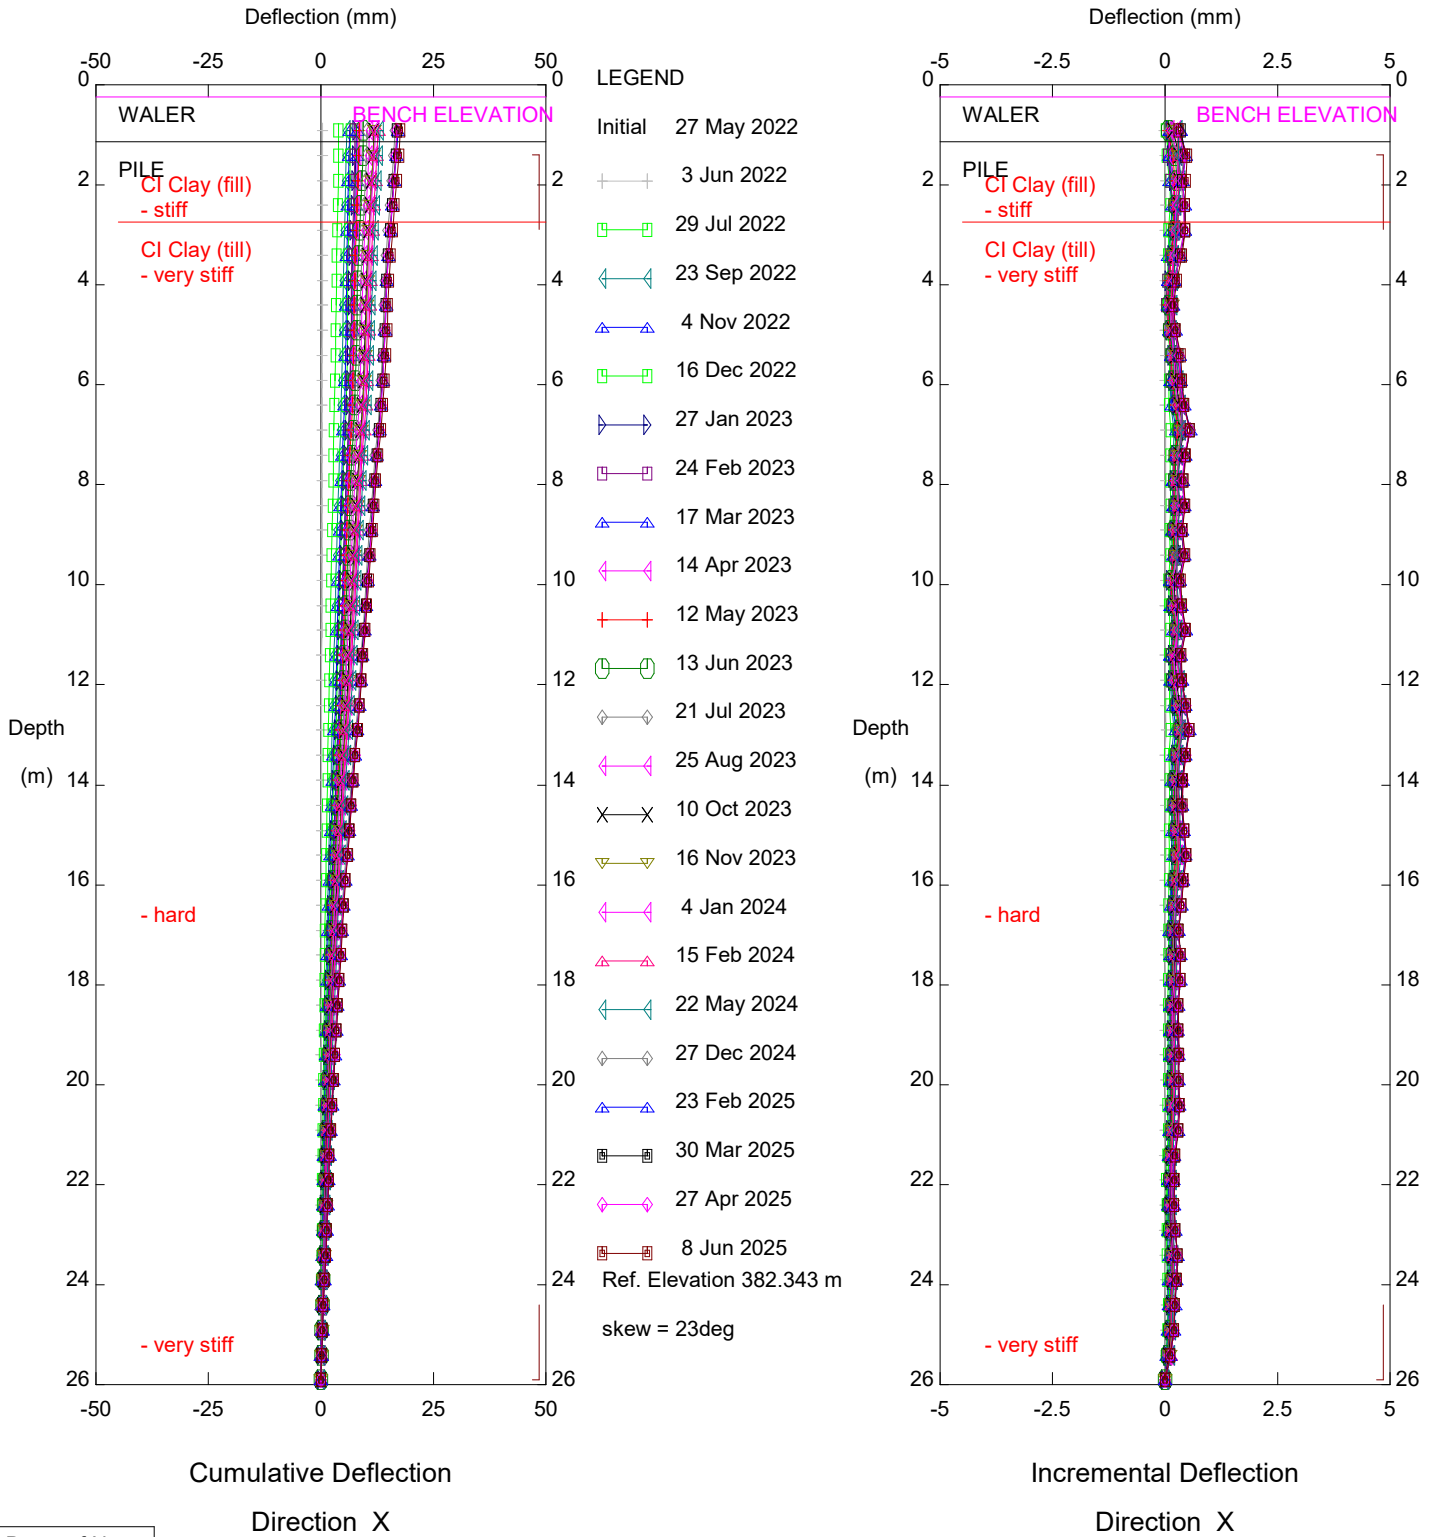
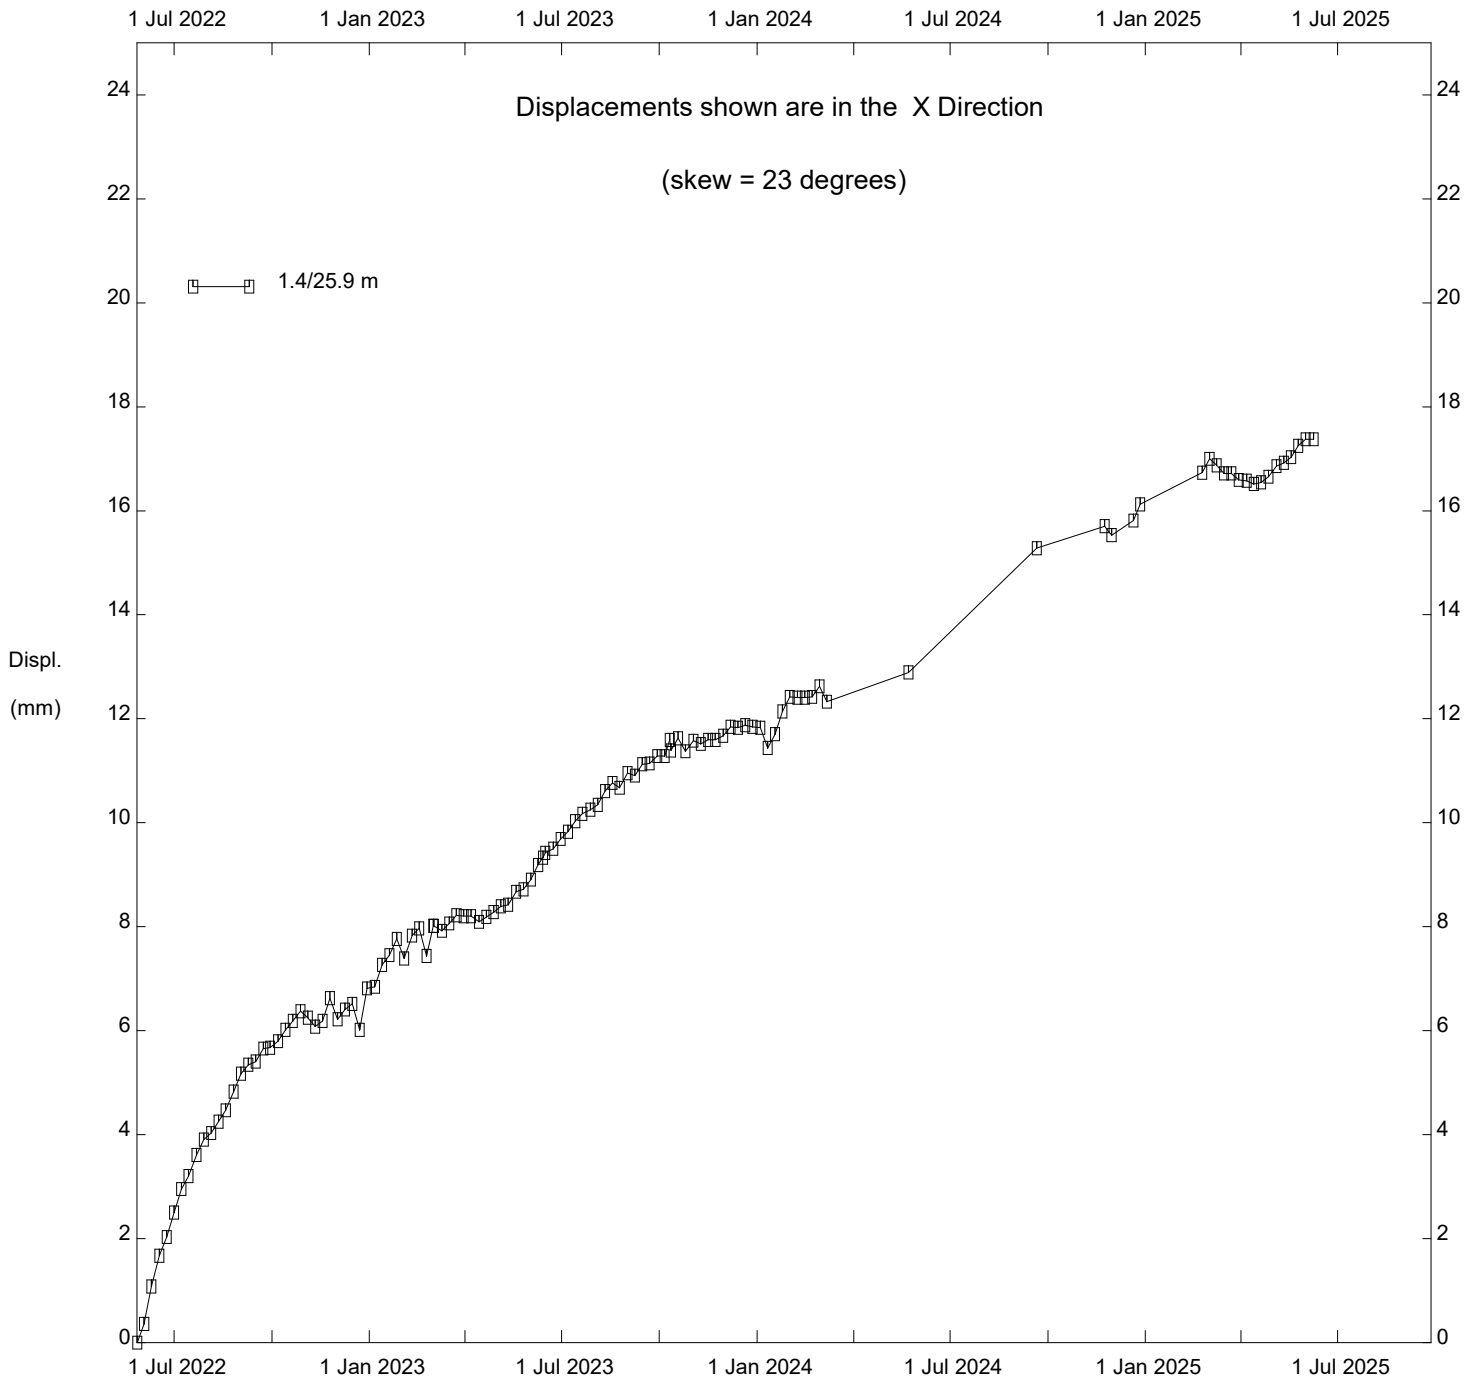
Shop Slide Wall Type 3, Inclinator SAA-P113

Pile head deflections measured by the SAA are within an acceptable range (below the estimated SLS Design Values, measured since anchor lock-off: of 18 mm for SAA-P34, 7 mm for SAA-P77, and 39 mm for SAA-P113). More deflection is noted, as expected, in the cantilever section of

<p>the wall (SAA-P113). The additional deflection in SAA-P34 may be due to the deeper amount of cut as compared to the slope below SAA-P77. This will require additional readings and analysis to interpret and will be considered as part of the ongoing development of threshold criteria for this pile wall.</p> <p>PIEZOMETERS</p> <p>Standpipe piezometers SP05-1, SP05-4, SP09-10, and SP019-3 showed decreases in groundwater level of 0.17 m, 0.07 m, 1.03 m, and 0.43 m respectively, since the fall of 2024 readings. Standpipe piezometer SP05-5 showed an increase in groundwater level of 0.03 m, since the fall of 2024 readings. SP11-06, SP09 8, and SP09-9 continued to be dry (SP09-8 and SP09-9 have been dry since installation). The water levels measured in the standpipes have not demonstrated a trend. The results of the standpipe piezometers are summarized in Table PH009-5, and are plotted in Figure PH009-11 in Appendix A. Historical standpipe piezometer readings are presented in Figure PH009-12.</p> <p>VW09-4 showed a slight decrease in ground water level of 0.13 m since the fall of 2024 readings; the groundwater levels have been trending downward since 2012. VW09-3 has been dry since August 2009. The vibrating wire piezometer results are summarized in Table PH009-6, and are plotted in Figure PH009-13 in Appendix A.</p> <p>Pneumatic piezometer PN15-5A showed a decrease in groundwater level of 0.01 m since the previous reading in fall of 2024. PN19-5B showed an increase in groundwater level of 0.13 m since the fall of 2024 readings and has had a slight increasing trend overall since installation (February 2019). Pneumatic piezometer results are summarized in Table PH009-7, and are plotted in Figure PH009-14 in Appendix A.</p>

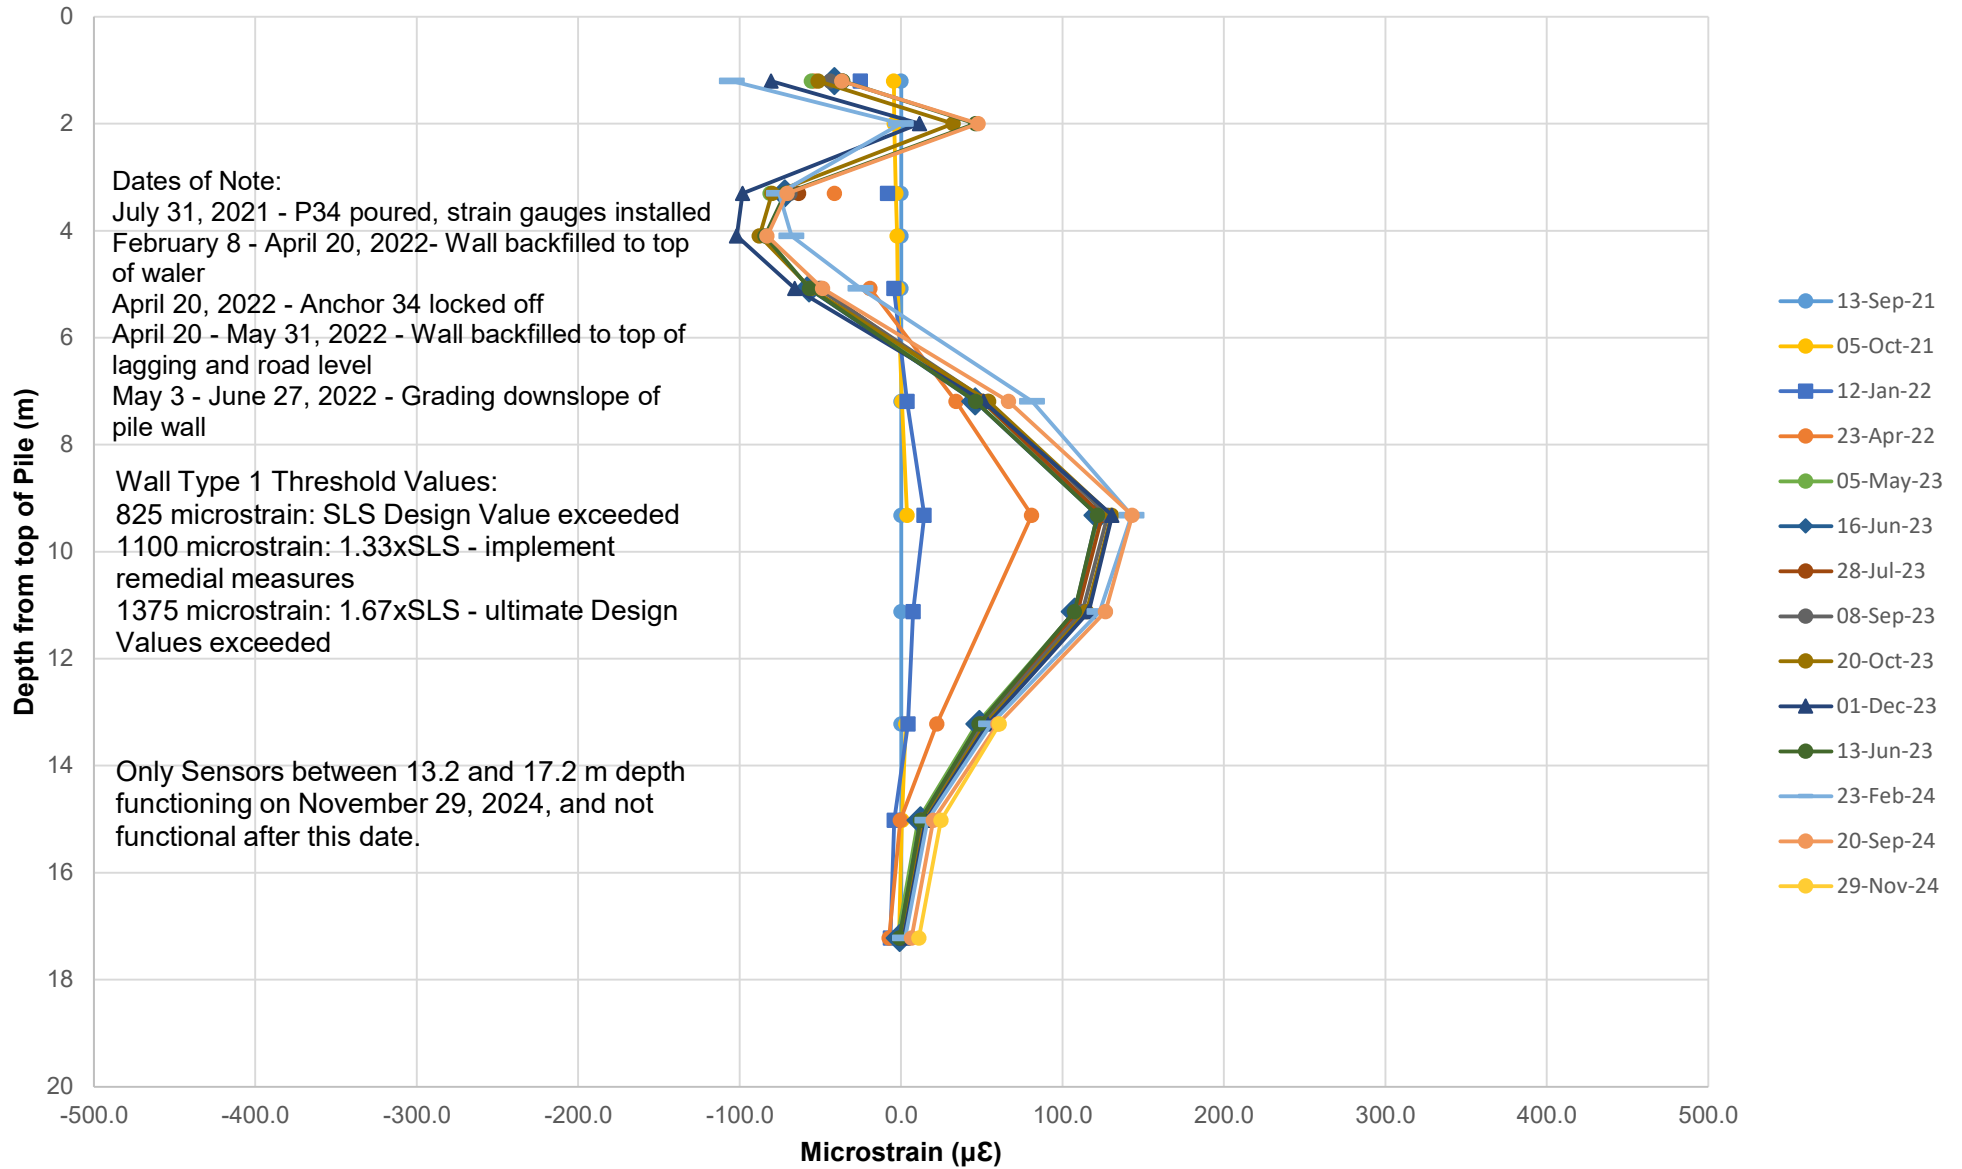
**FIGURE PH009-1: PEACE RIVER SHOP SLIDE
P34 UPSLOPE SIDE STRAIN GAUGE VALUES VS DEPTH**

On November 29, 2024, The functioning strain gauges in P34 (Figures PH009-1 and -2) showed minor changes in strain, ranging from a increase in positive (tension) strain of 0.8 microstrain on the upslope pile face at 13.2 m depth, to an increase in positive (tension) strain of 4.6 microstrain on the upslope face at 17.2 m depth. The strains measured at 13.2 m depth are plotted against time in Figure PH009-3.

The datalogger system should be reviewed in the fall of 2025 to re-enable readings of the strain gauges.

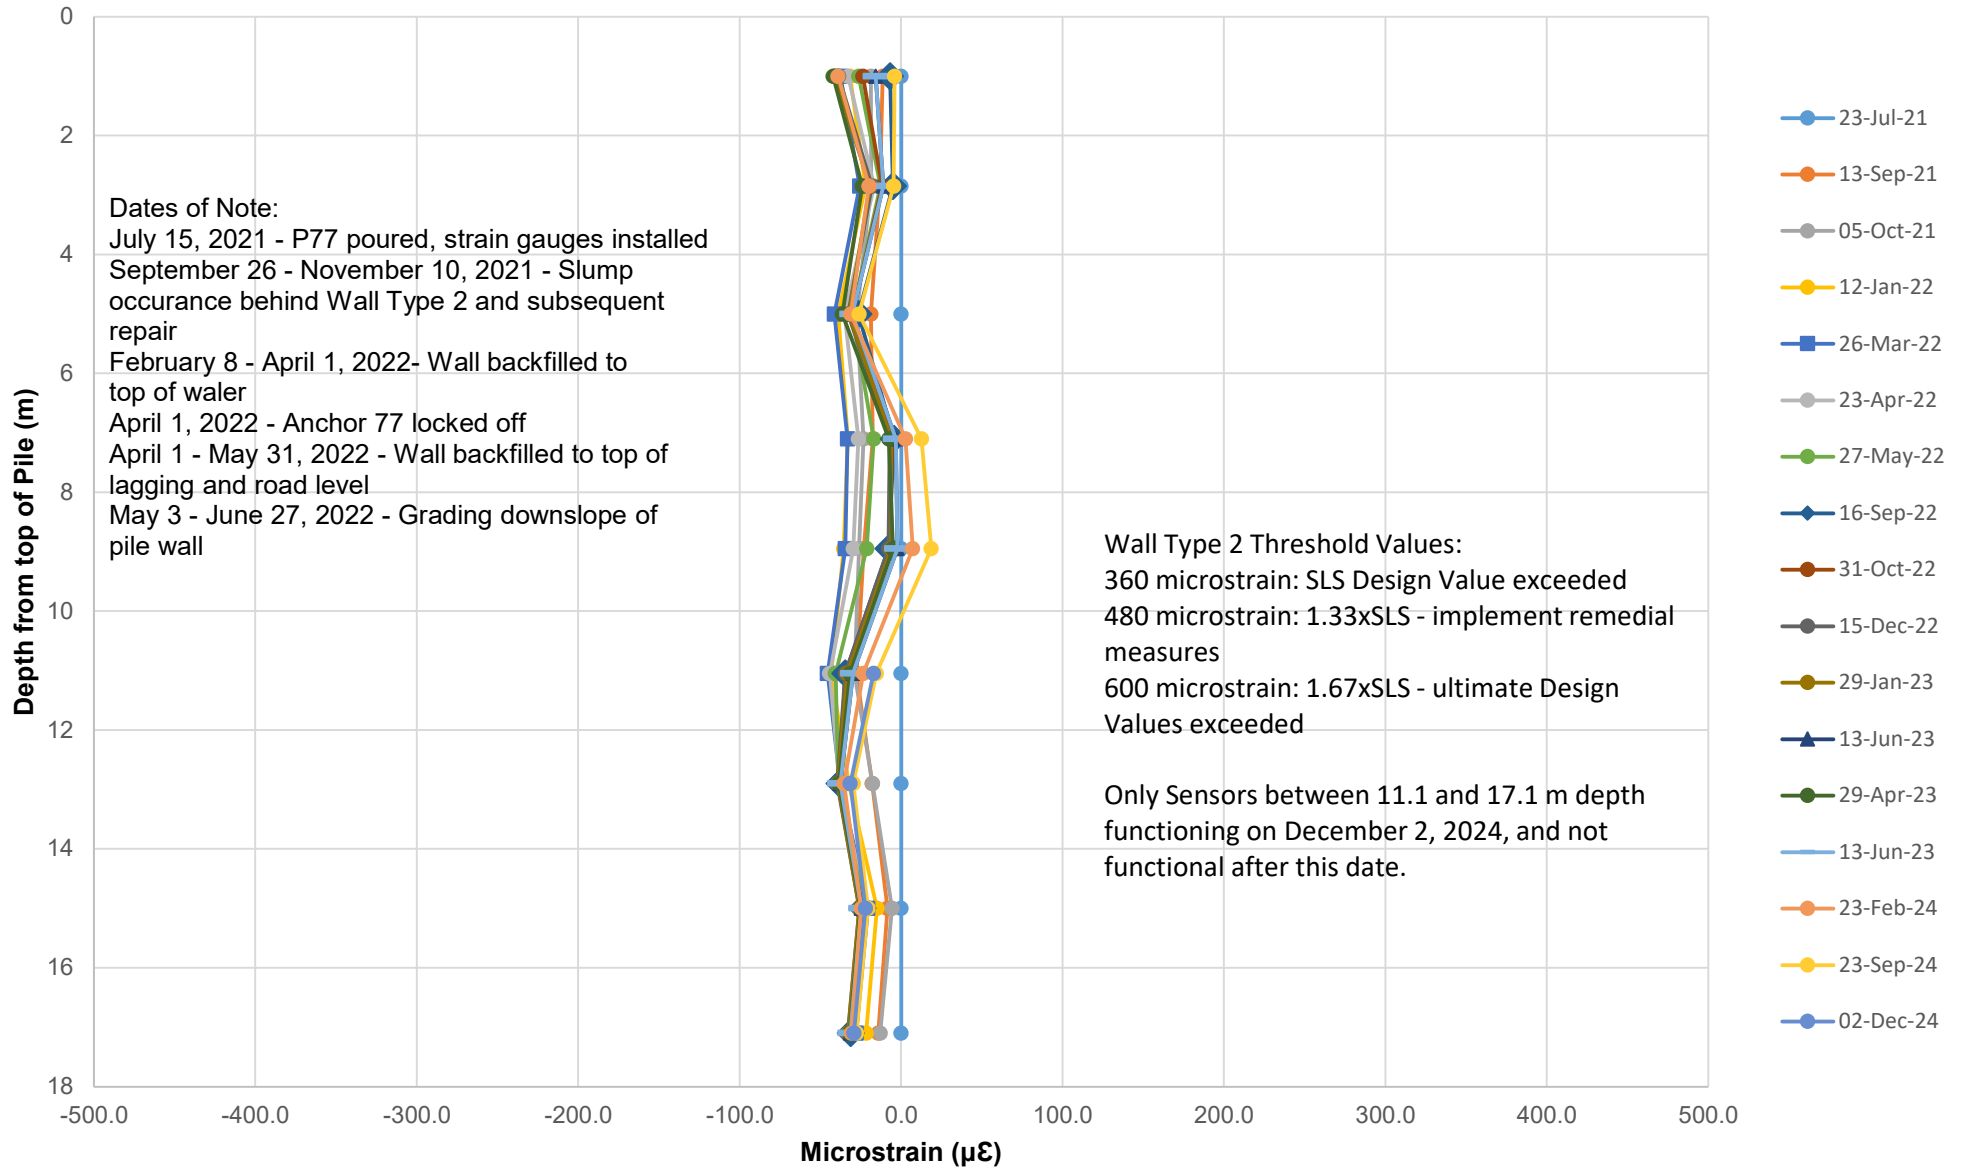
**FIGURE PH009-4: PEACE RIVER SHOP SLIDE
P77 UPSLOPE SIDE STRAIN GAUGE VALUES VS DEPTH**

On December 2, 2024, The functioning strain gauges in P77 (Figures PH009-4 and -5) showed minor changes in strain, ranging from an increase in negative (compression) strain of 1.1 microstrain on the downslope pile face at 15.0 m depth, to an increase in negative (compression) strain of 2.5 microstrain on the downslope face at 12.9 m depth. The strains measured at 11.1 m depth and 12.9 m depth are plotted against time in Figures PH009-6 and PH009-7, respectively.

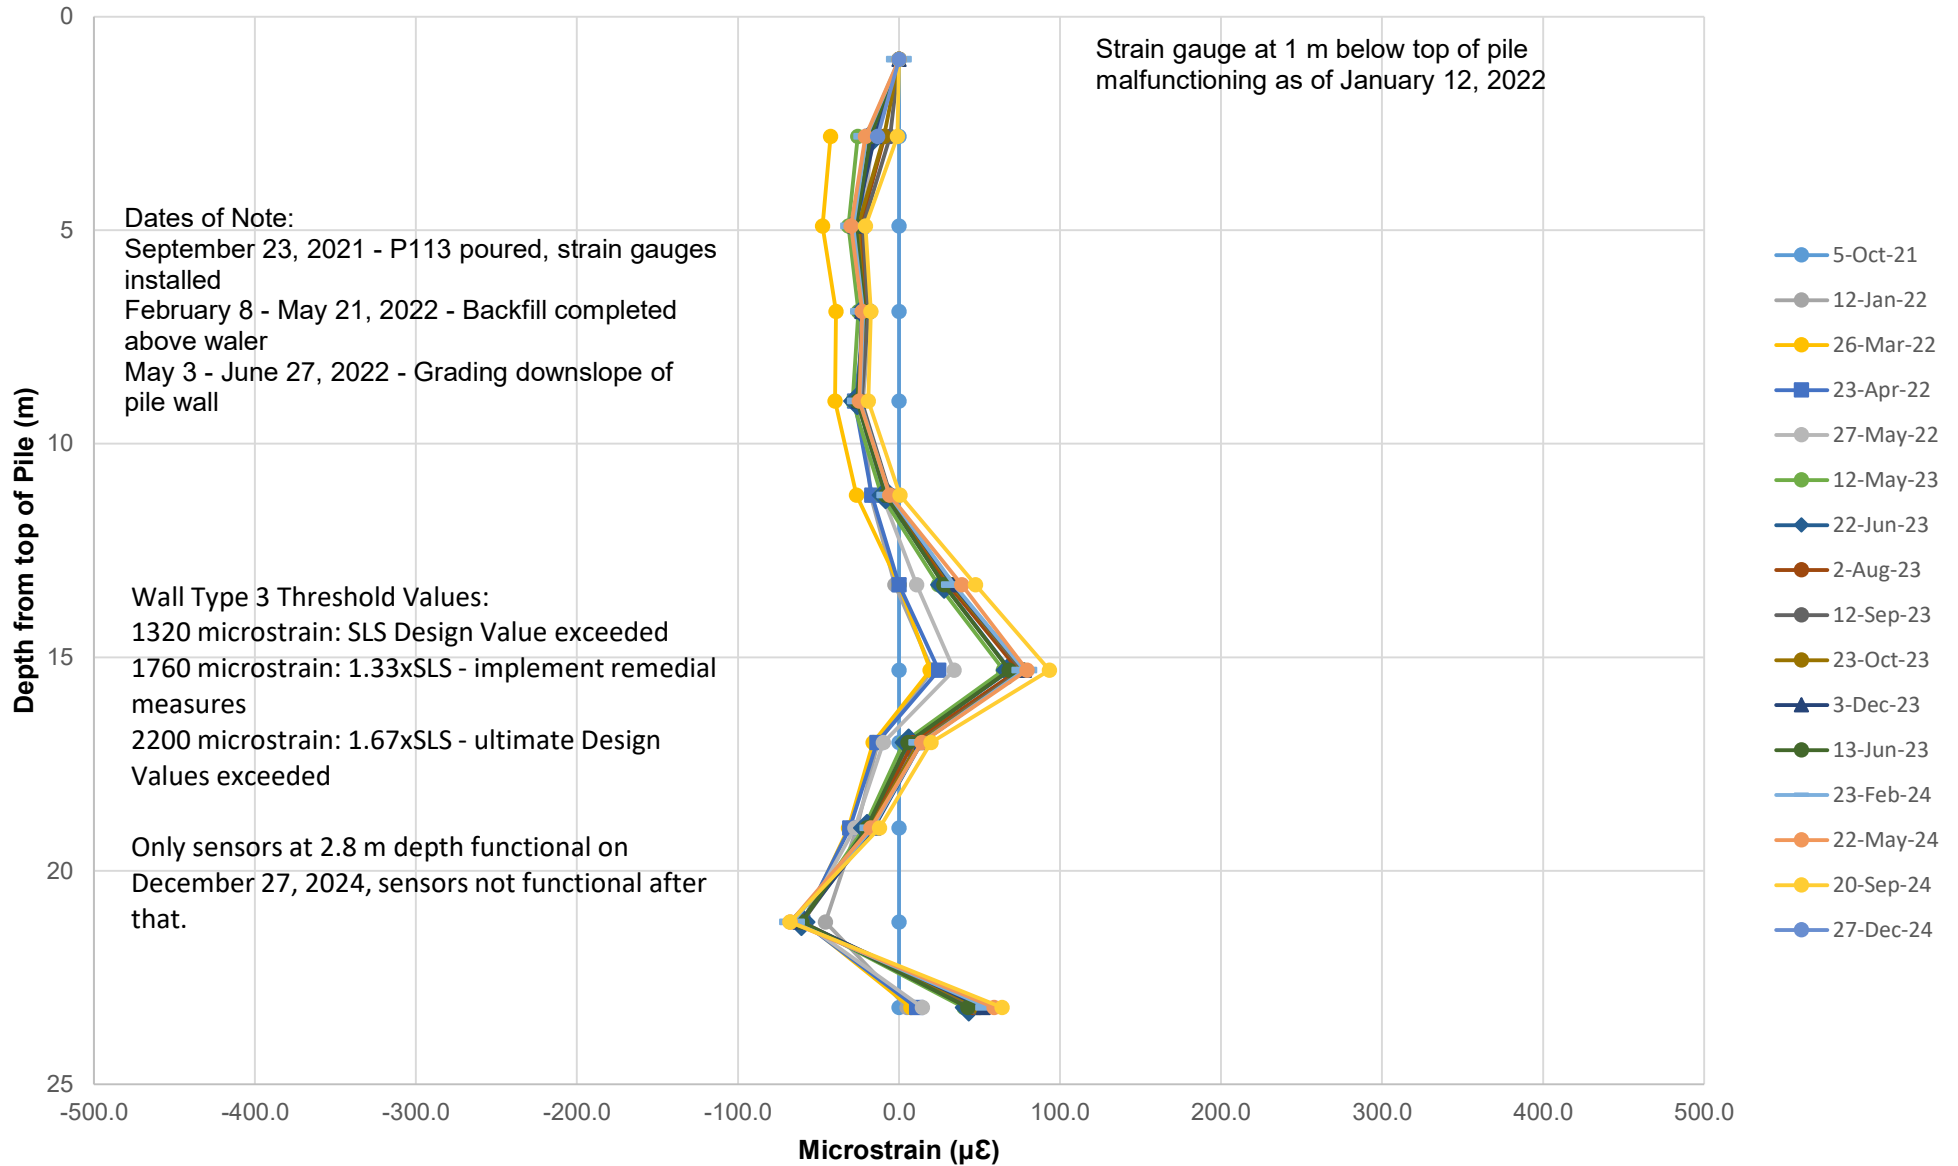
**FIGURE PH009-8: PEACE RIVER SHOP SLIDE
P113 UPSLOPE SIDE STRAIN GAUGE VALUES VS DEPTH**

On December 27, 2024, only the strain gauges at 2.8 m depth in P113 were functioning (Figures PH009-8 and -9). The upslope strain gauge showed an increase in negative (compression) strain of 12.4 microstrain, and the downslope strain gauge showed an increase in negative (compression) strain of 6.0 microstrain.

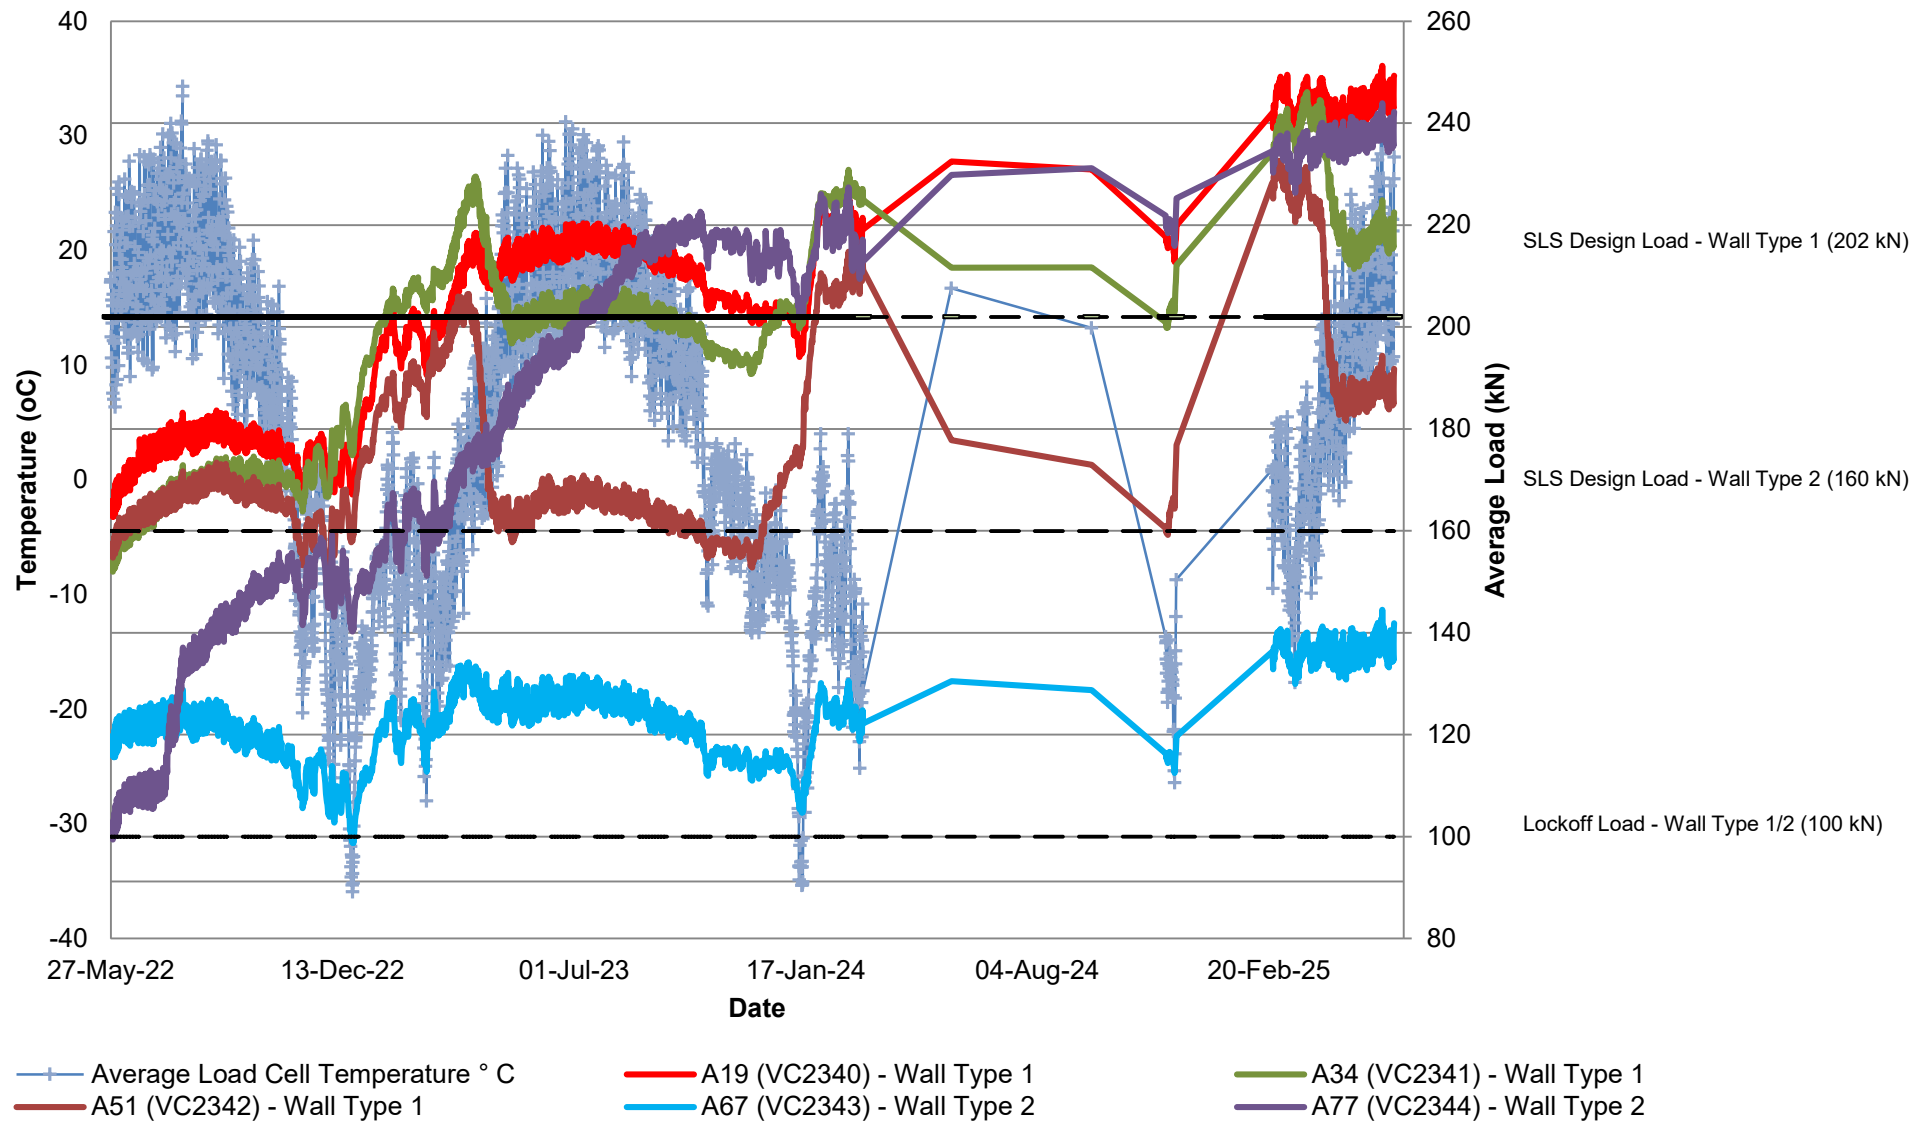
**FIGURE PH009-10
OLD HWY 2:02 SHOP SLIDE LOAD CELL READINGS**

The load cell readings are summarized in Table PH009-4. The anchors showed increases in measured load ranging from an increase of 10.80 kN in Anchor A34 (Load Cell VC2341) to an increase of 18.43 kN in Anchor A19 (Load Cell VC2340), compared to the fall of 2024 readings.

All of the anchors registered maximum recorded loads between March 2, 2025, and May 29, 2025.

The pattern of movements is attributed to frost pressures on the back of the wall. The load cells generally show a pattern of highest loads in the winter months, before relaxing slightly into the spring and summer months. Anchors A67(Load Cell VC2343) and A77 (Load Cell VC2344) have continued showing an overall trend of increasing load with a smaller post-winter relaxation than seen in the other anchors. Overall, the anchor loads have risen significantly since they were locked off, and Anchors A19, A34, and A77 are currently above their SLS design loads but have not exceeded the 270 kN load that would require remedial measures. The load cells will need to be closely monitored to see if the increased movement trend continues. The load cell readings are plotted on Figure PH009-10 in Appendix A.
