ALBERTA TRANSPORTATION AND  
ECONOMIC CORRIDORS  
GEOHAZARD ASSESSMENT PROGRAM  
PEACE REGION (PEACE RIVER DISTRICT)  
2025 INSPECTION

Site Number	Location	Name	Hwy	km
PH009-3	Town of Peace River	Shaftesbury Trail – Shop Slide	Old 2:02	0.025
			684:02*	30.990
Legal Description		UTM Co-ordinates		
SW31-083-21 W5M		11V E 480339	N 6232158

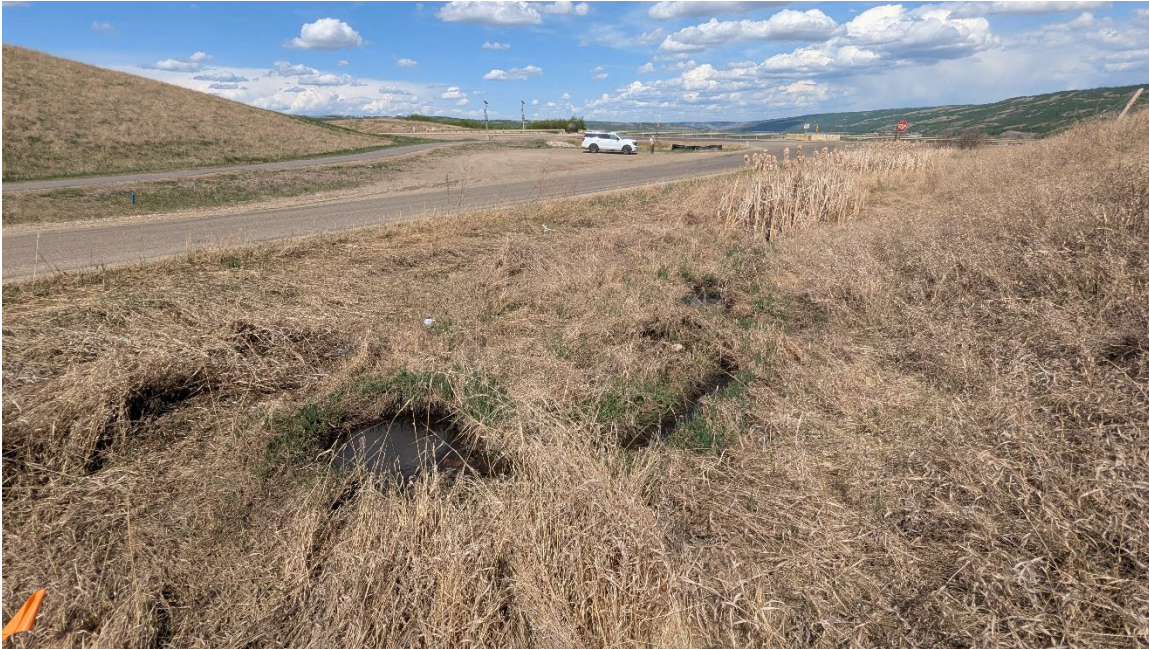
**Photo 1A: Looking north at spring along 99 Avenue and new pedestrian pathway constructed by the Town.**

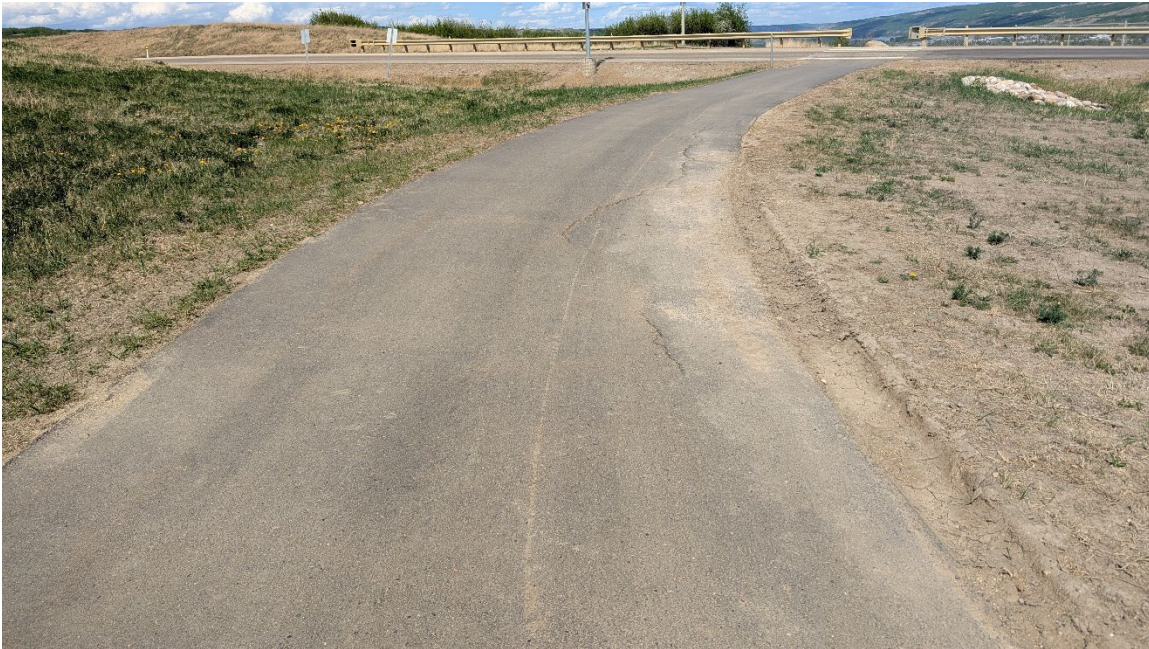
**Photo 1B: Looking north at crack in new pedestrian pathway.**

- Road maintenance such as crack sealing of the ACP to limit infiltration.
- Routine inspection to confirm that the sinkhole has stabilized.
- Repair of the multiplexers to ensure ongoing readings of the instrumentation can be taken. Conduit connections may need to be upgraded and additional desiccant added to limit further degradation of the electronic connections.

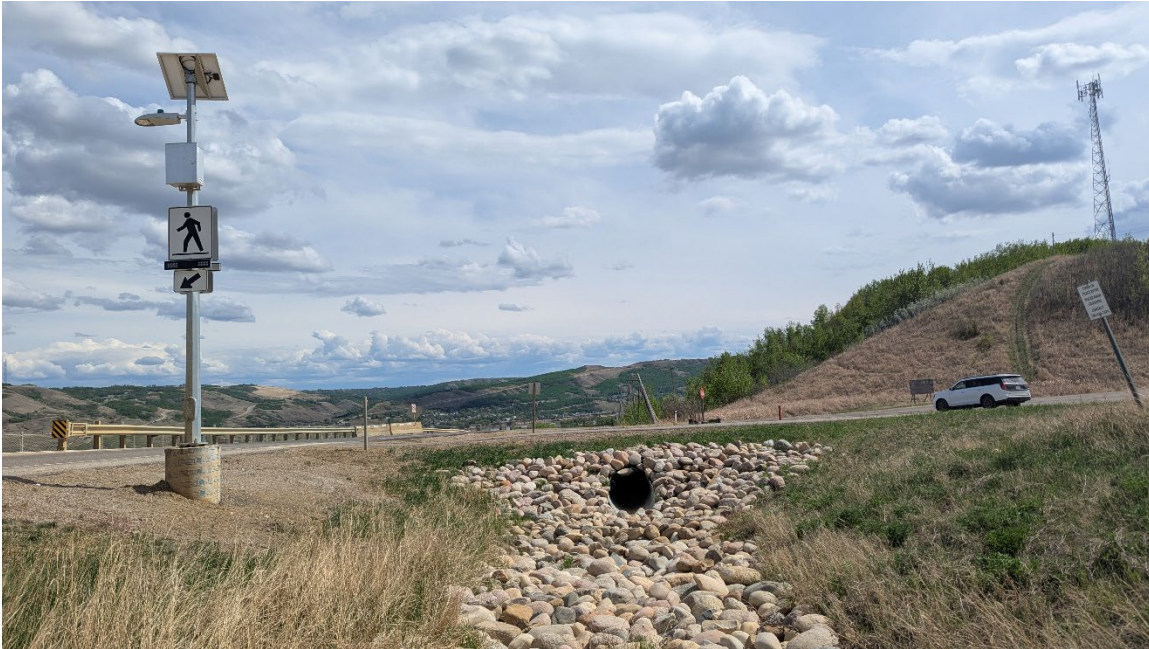
**Photo 2: Looking southeast at new culvert and crossing lights installed by Town at pedestrian pathway.**

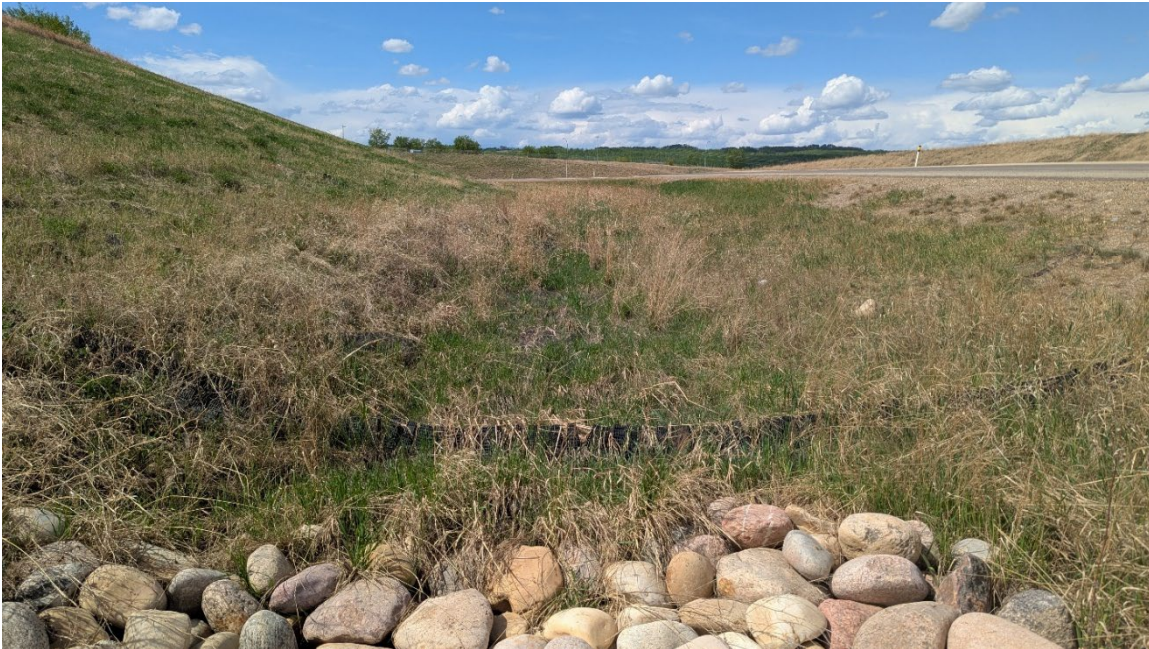
**Photo 3 – Looking northwest at repaired ditch along Hwy 2 off-ramp.**

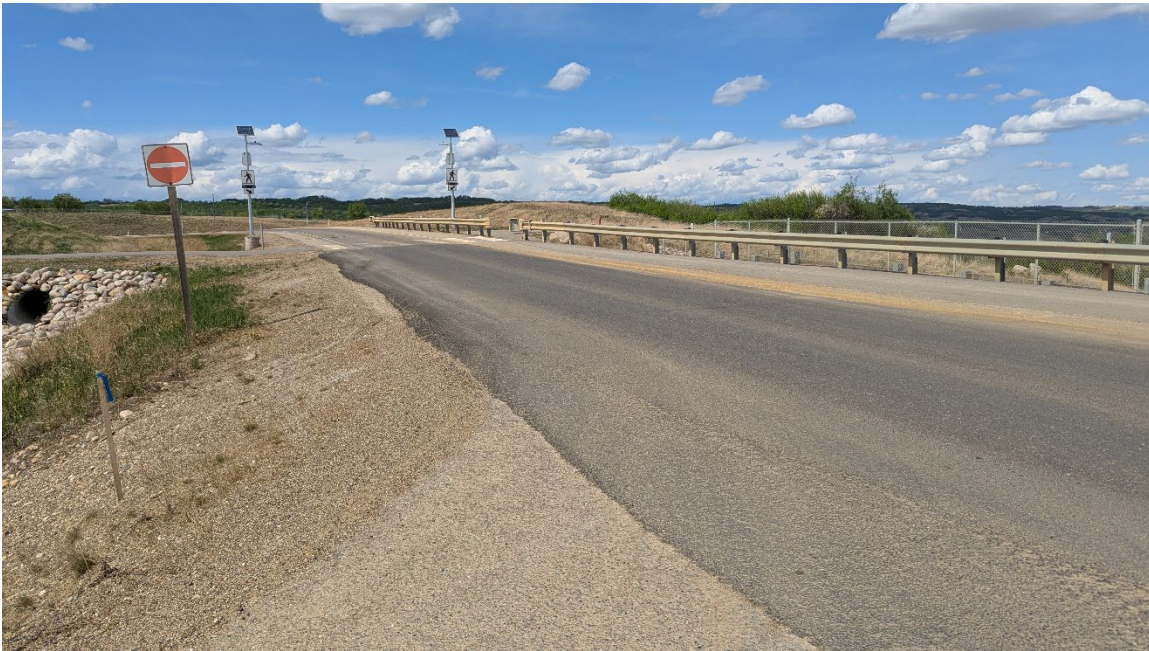
Observations:	Description	Worsened?
<input checked="" type="checkbox"/> Pavement Distress	The sinkhole near the NW end of the wall (due to subsidence over a tieback anchor) that formed in 2023 was patched again in Spring 2024 and overlaid in 2025.	<input type="checkbox"/>
<input checked="" type="checkbox"/> Slope Movement	Pavement cracks and unevenness SE of 99 Ave indicating ongoing creep movement of the deeper landslide as the slide block engages the new pile wall. There was new movement at the scarp east of the wall ("CN Slide") just beyond the highway ROW.	<input checked="" type="checkbox"/>
<input checked="" type="checkbox"/> Erosion	Most of the re-lined SW ditch is stable except for one area where the rock appears to have been disturbed by the power line company contractor which was no worse in 2025. However, a shallow erosion gully has formed along the top of the riprap SE of the 99 Ave intersection. A shallow erosion gully is forming beyond the south-most pile wall riprap drainage basin (not worse in 2025).	<input checked="" type="checkbox"/>

**Photo 4 – Looking northwest at overlay over location of patched sinkhole in Hwy 2 off-ramp surface northwest of 99 Avenue intersection. Pedestrian pathway crossing is in the background.**

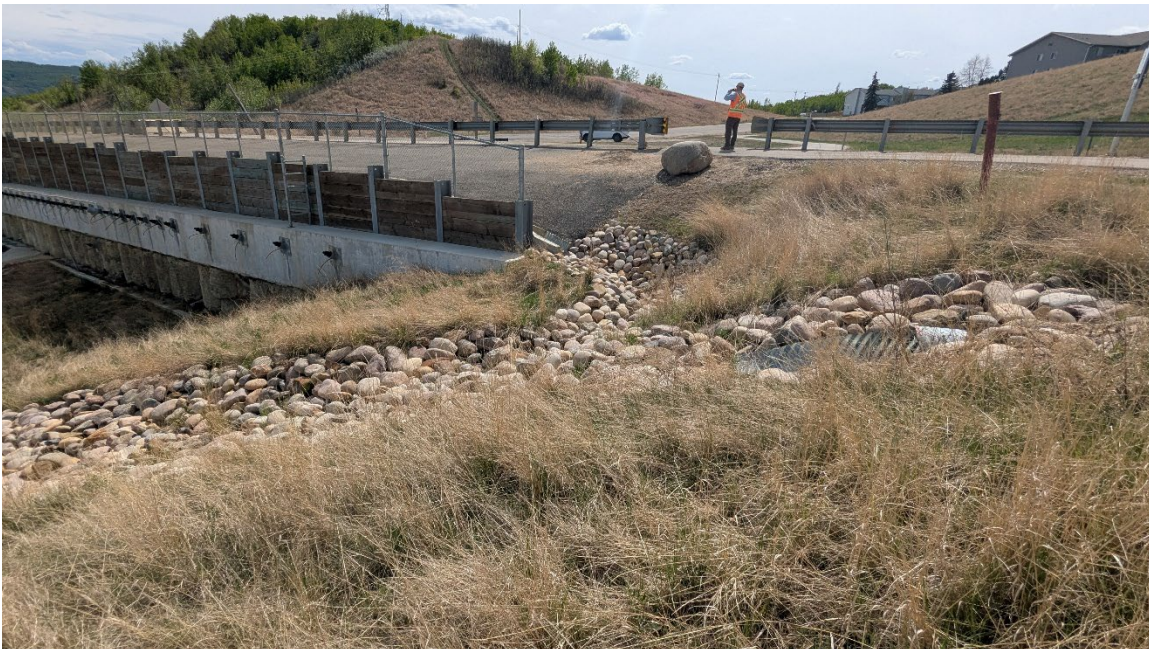
Pile Wall Inclinometers	SI09-4 is located immediately downslope of the pile wall, near the SE end, and developed two movement zones (9.6 m and 12.6 m depth) during construction but both have stabilized since. SI11-01 at the NW end of the wall developed a zone at about 15.1 m depth during construction, likely related to a temporary excavation immediately below the location, and though the rate of movement has subsided (5 mm/yr down from a peak of 34 mm/yr), it has not stopped; however, there no surface expression of this movement yet (just over 20 mm cumulative now).
Downslope Inclinometers	SI 19-5, located mid-slope below the wall, has zones at 9.7 m and at 18.8 m that have both plateaued since construction completed and are slightly creeping (0.2 mm/year). SI09-3 is located on the far side of the tracks and has not shown movement.
Standpipe Piezometers	SP09-8, SP09-9, and SP11-06: dry since installation. SP05-4, SP05-5, and SP09-10: no obvious pattern. SP05-1, SP19-3: steadily decreasing over the last four years.

**Photo 5: Looking south at NW end of wall just below SI11-01 which continues to move even after construction is completed.**

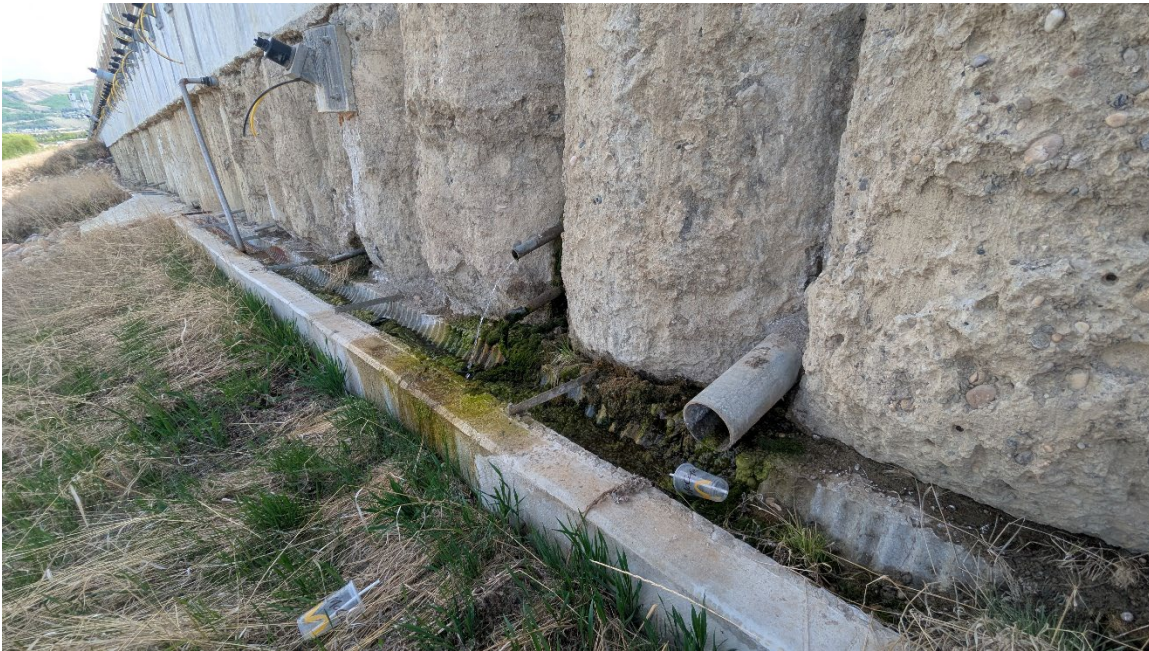
<input checked="" type="checkbox"/> Seepage	The spring along the southeast ditch of 99 Avenue continues to flow. The existing subdrain brought through the pile wall continues to flow. Slow and steady seepage was noted from other subdrains installed during construction.	<input type="checkbox"/>
<input checked="" type="checkbox"/> Bridge/Culvert	The previous sinkhole above the elbow of the buried 762 mm SWSP drainpipe has been successfully repaired. The Town finished installing a culvert in the ditch to connect the pedestrian path to the subdivision SW of the site.	<input checked="" type="checkbox"/>
<input checked="" type="checkbox"/> Other	The datalogger enclosure was broken into and the batteries stolen (now replaced). Thermal expansion and contraction appear to have disconnected some conduit connections. These were repaired in Fall 2024; however, moisture and rodent activity have caused some issues with multiplexer connections that are still being investigated.	<input checked="" type="checkbox"/>

**Photo 6: Accumulating sediment and moss growth around the active subdrains. Those on the far side of the apron are dry.**

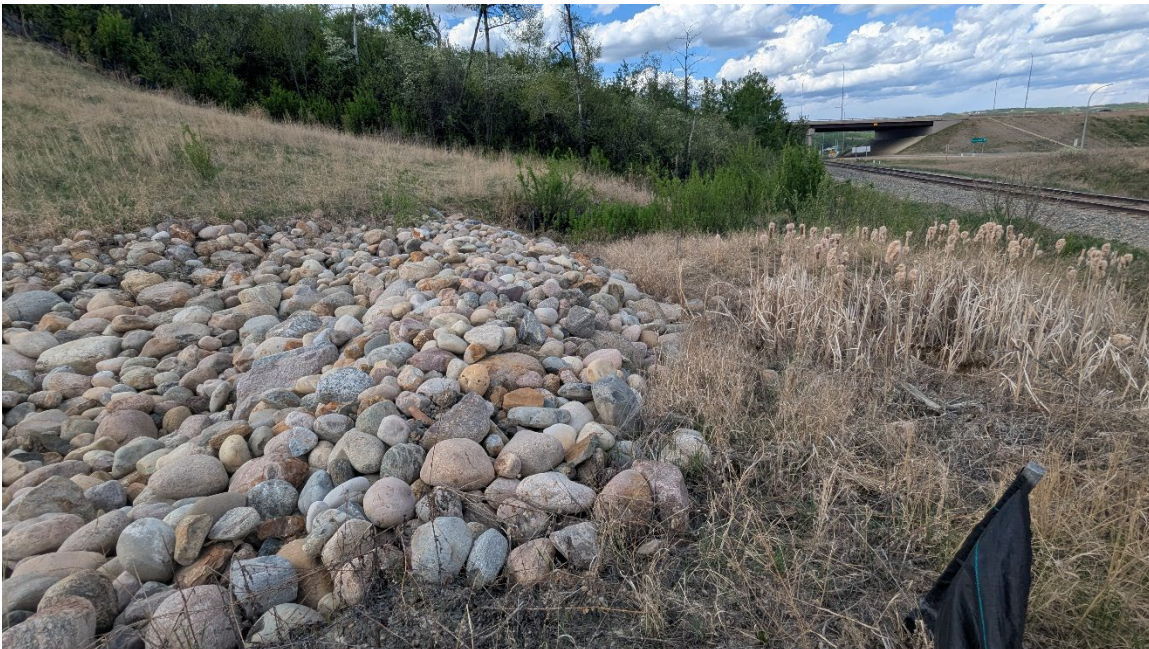
**Photo 7: Looking north at bottom of the main riprap channel at the edge of the CN ROW.**

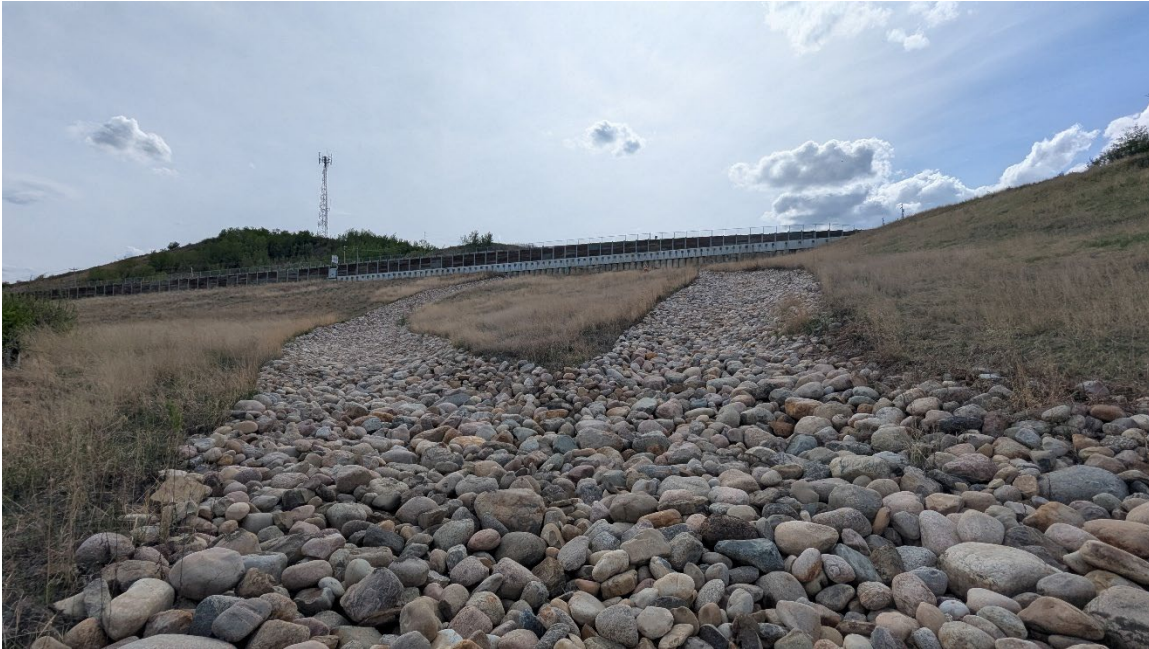
**Photo 8: Looking southwest back up at the wall along the regraded slope and riprap drainage channels.**

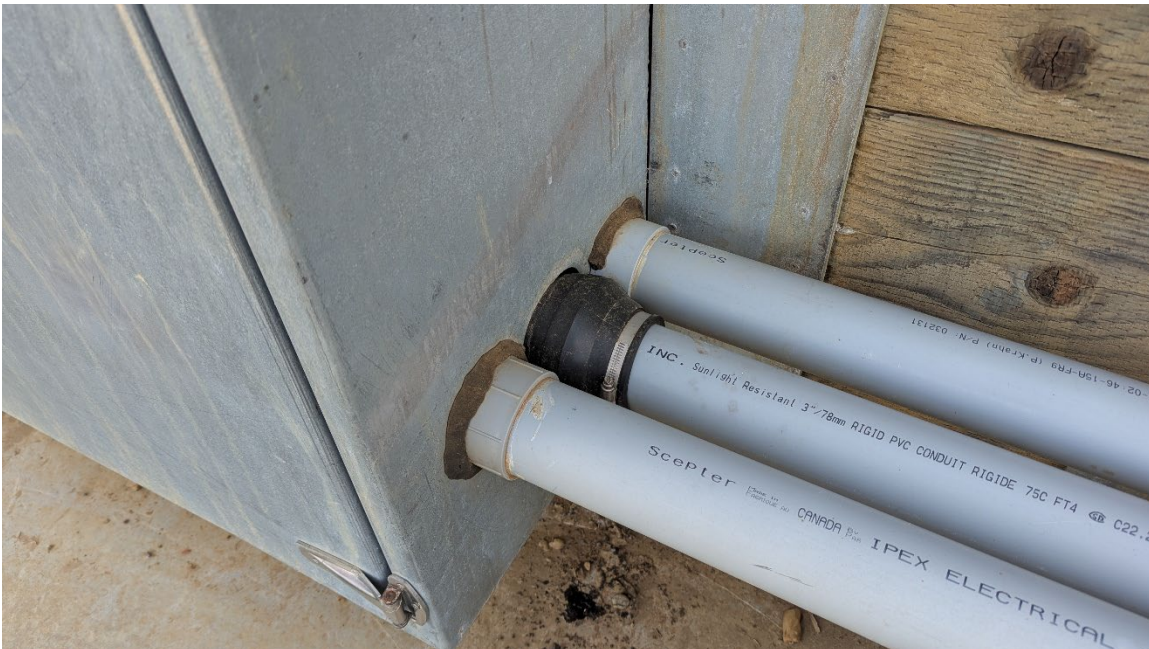
**Photo 9: Thermal expansion/contraction had detached this conduit from the side of the data enclosure. It has been partially repaired with a rubber boot. More work is recommended to make this more weather-tight.**

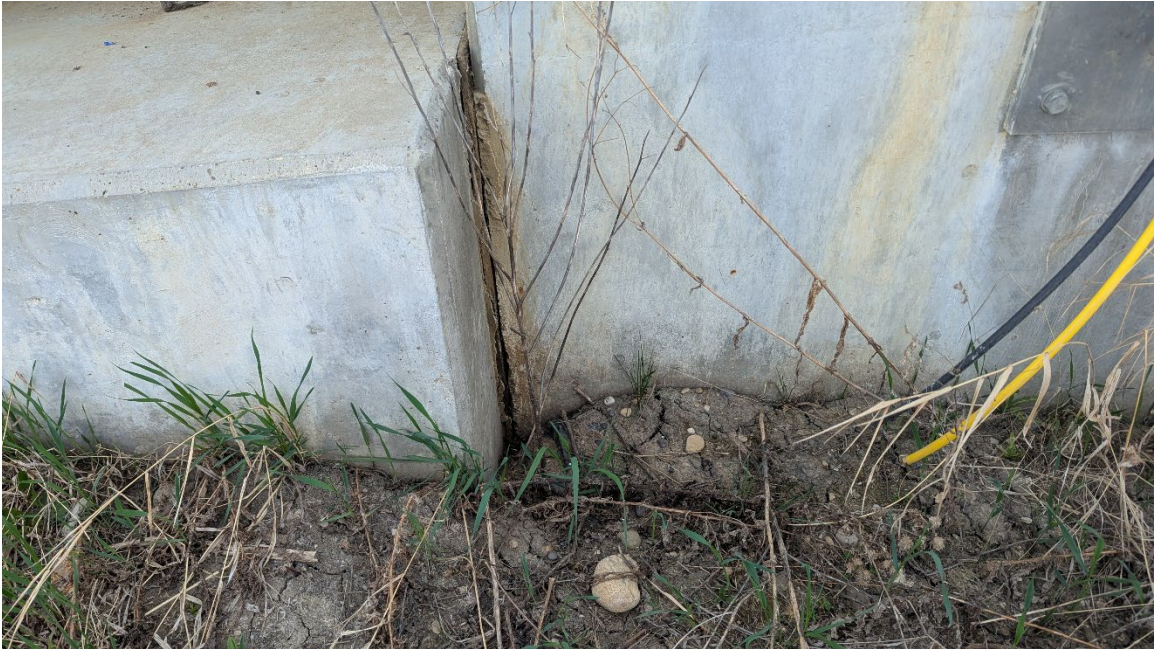
**Photo 10: Small void or settlement at the junction between Wall Types 2 and 3. It hasn't gotten worse since 2024.**

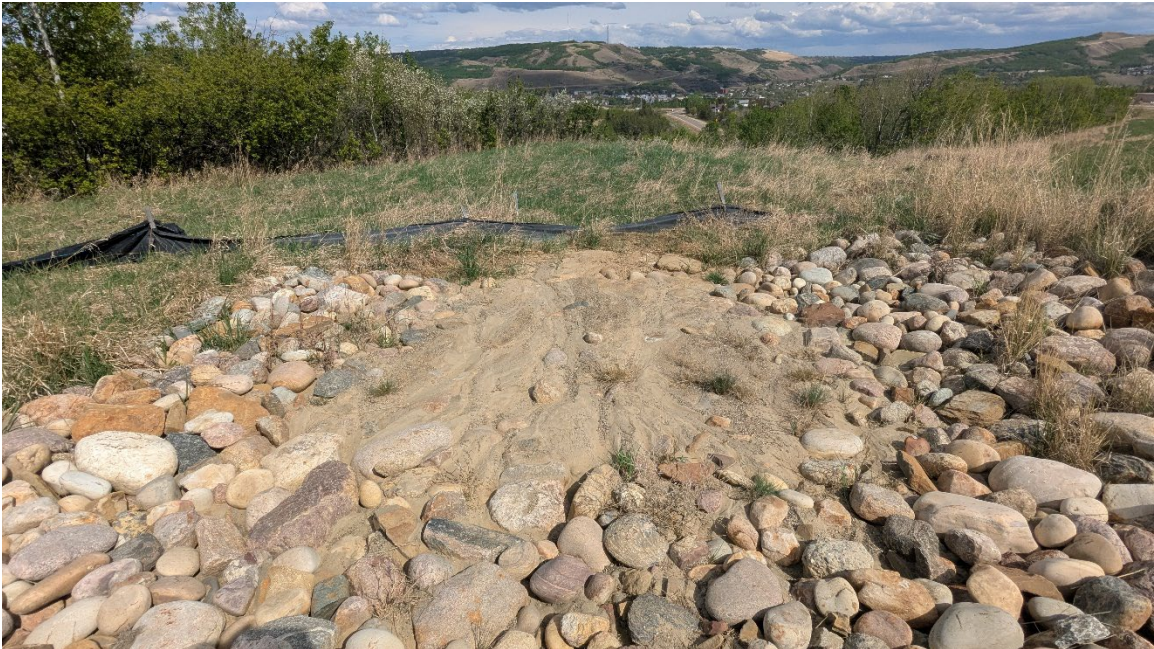
**Photo 11: Looking southeast at accumulating sediment in the riprap dissipation bowl. The shallow gully forming beyond the silt fence has started to vegetate and stabilize.**

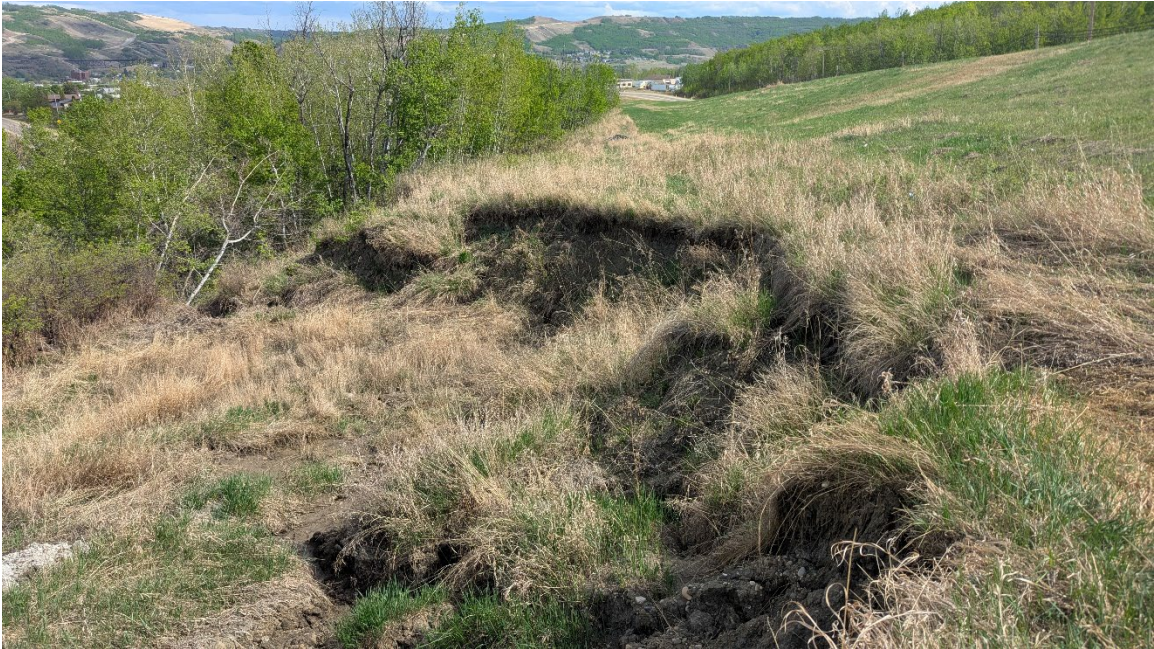
**Photo 12: Looking southeast at the active scarp just beyond the edge of the highway ROW.**

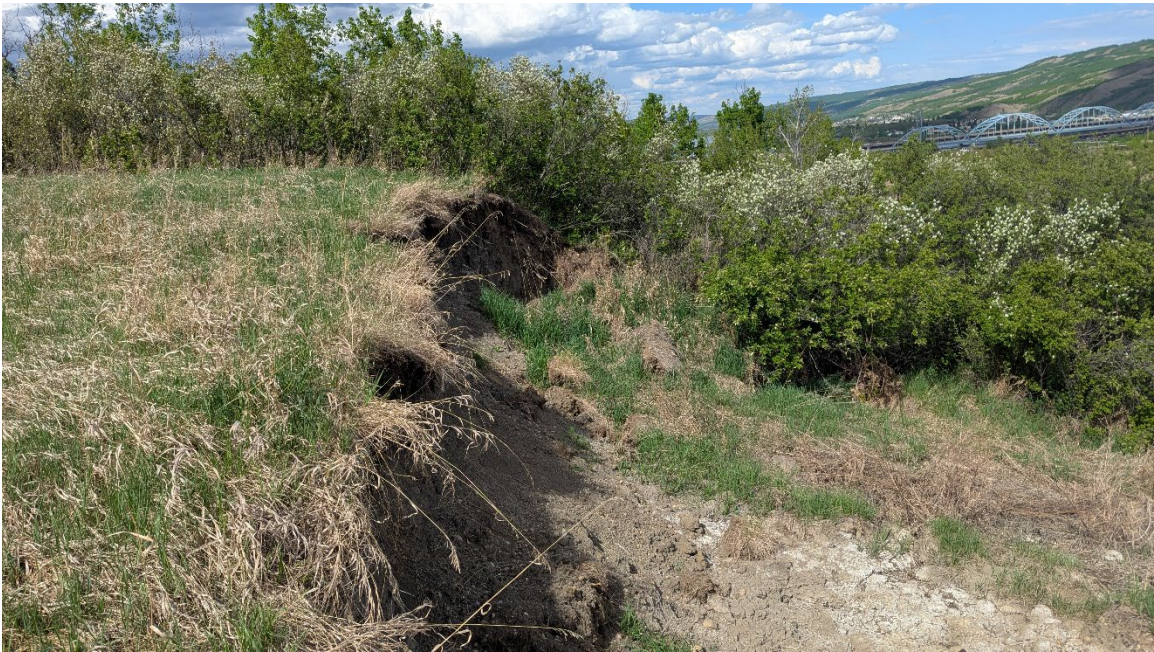
**Photo 13: Looking north at the recent movement on the northwest flank of the active scarp. The CN rail line is located downslope of this landslide. The scarp has not retrogressed but the soil mass below has moved further downward.**

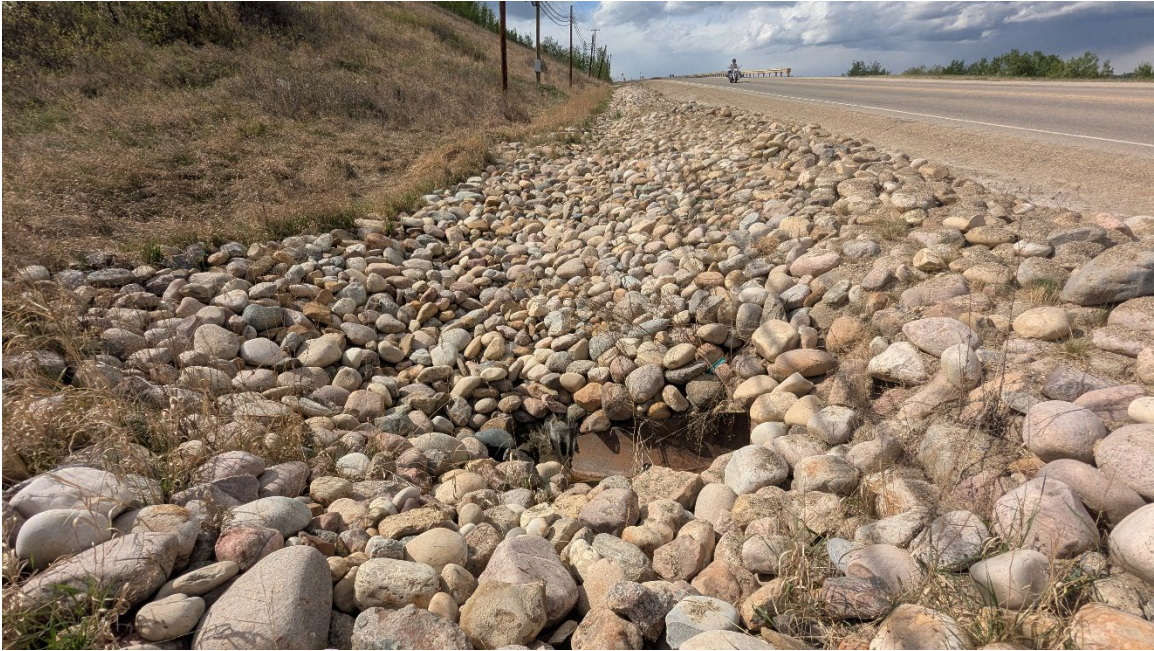
**Photo 14: Looking northwest along the re-lined upslope ditch where 2024 construction activity had disturbed the riprap diverting flow out of the channel.**

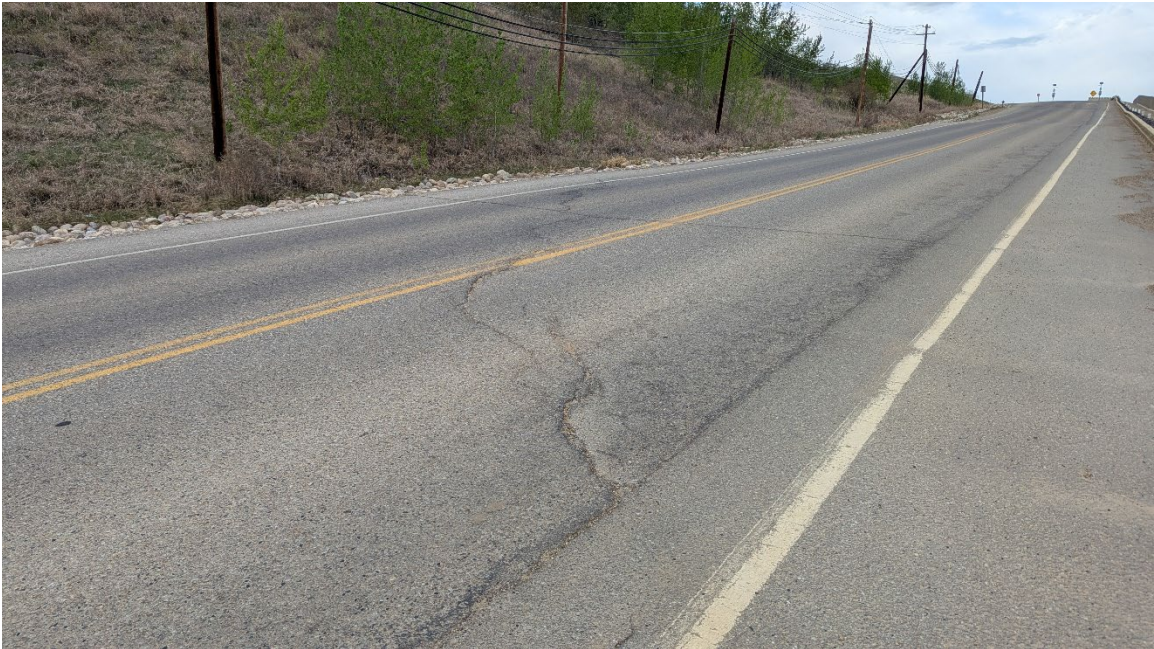
**Photo 15: Looking west at the historical deep-seated crack location at the SE end of the pile wall. There was no significant change from 2024.**

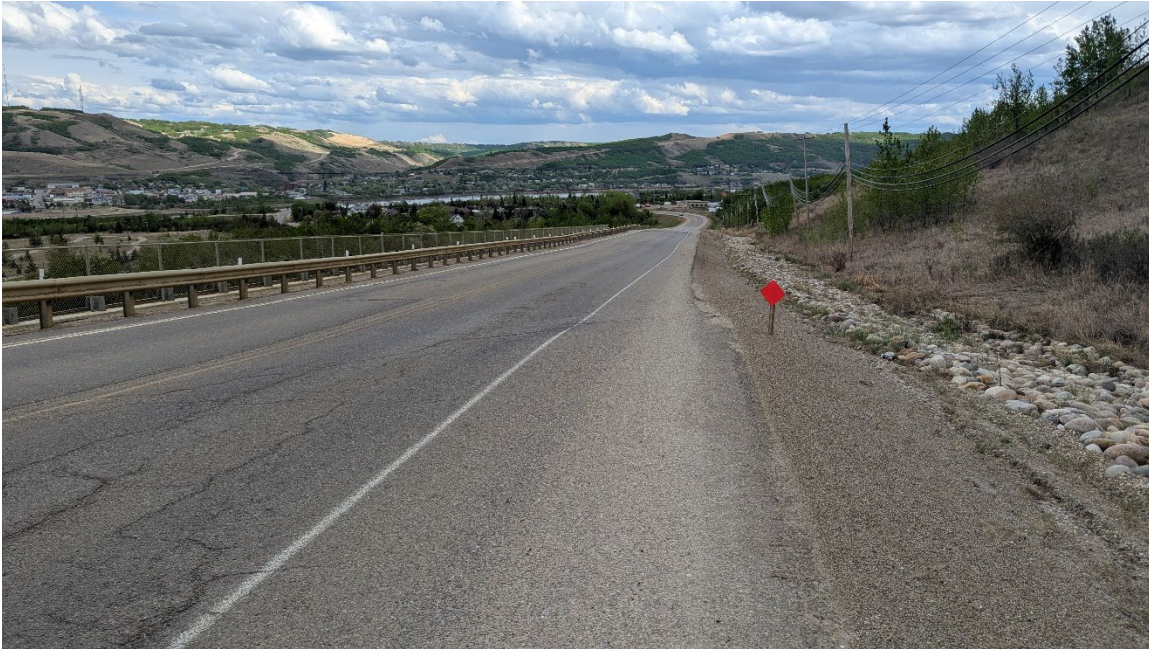
**Photo 16: Looking southeast at the dips in the roadway surface and the shallow gully forming at the top of the riprap in the right ditch.**

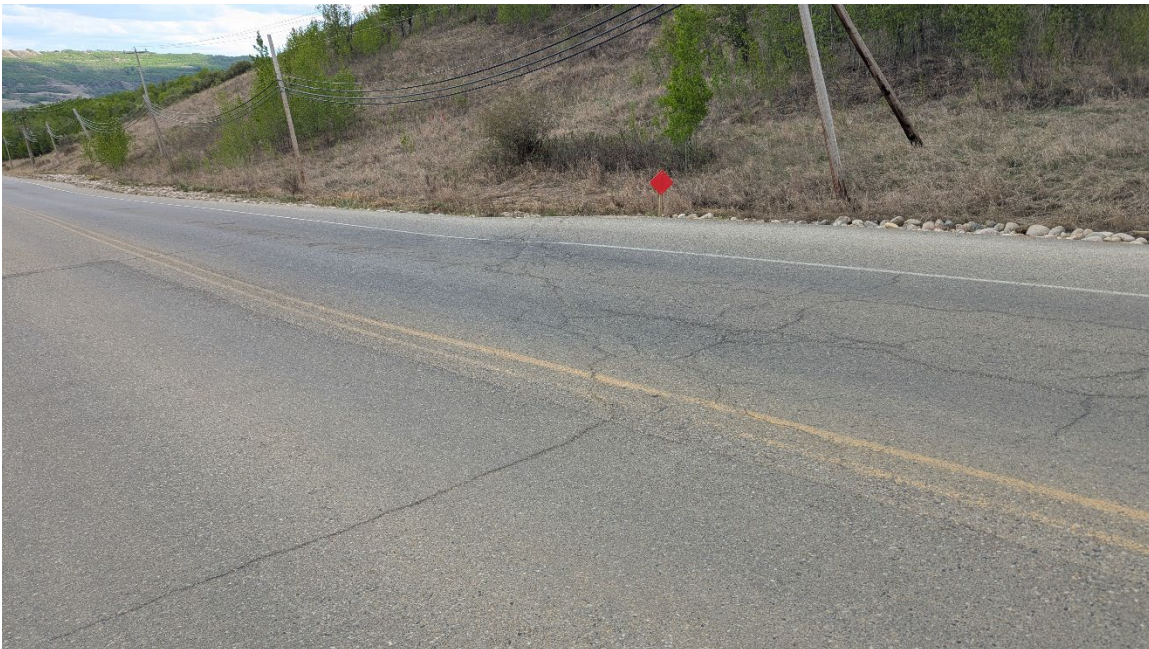
**Photo 17: Looking south at the cracks coincident with the northwest flank of the deep-seated landslide.**
