September 11, 2017

File: 13351

**GEOHAZARD ASSESSMENT PROGRAM  
CALL-OUT INSPECTION  
HWY 688:02 km 15.42 MCKINNEY CREEK**

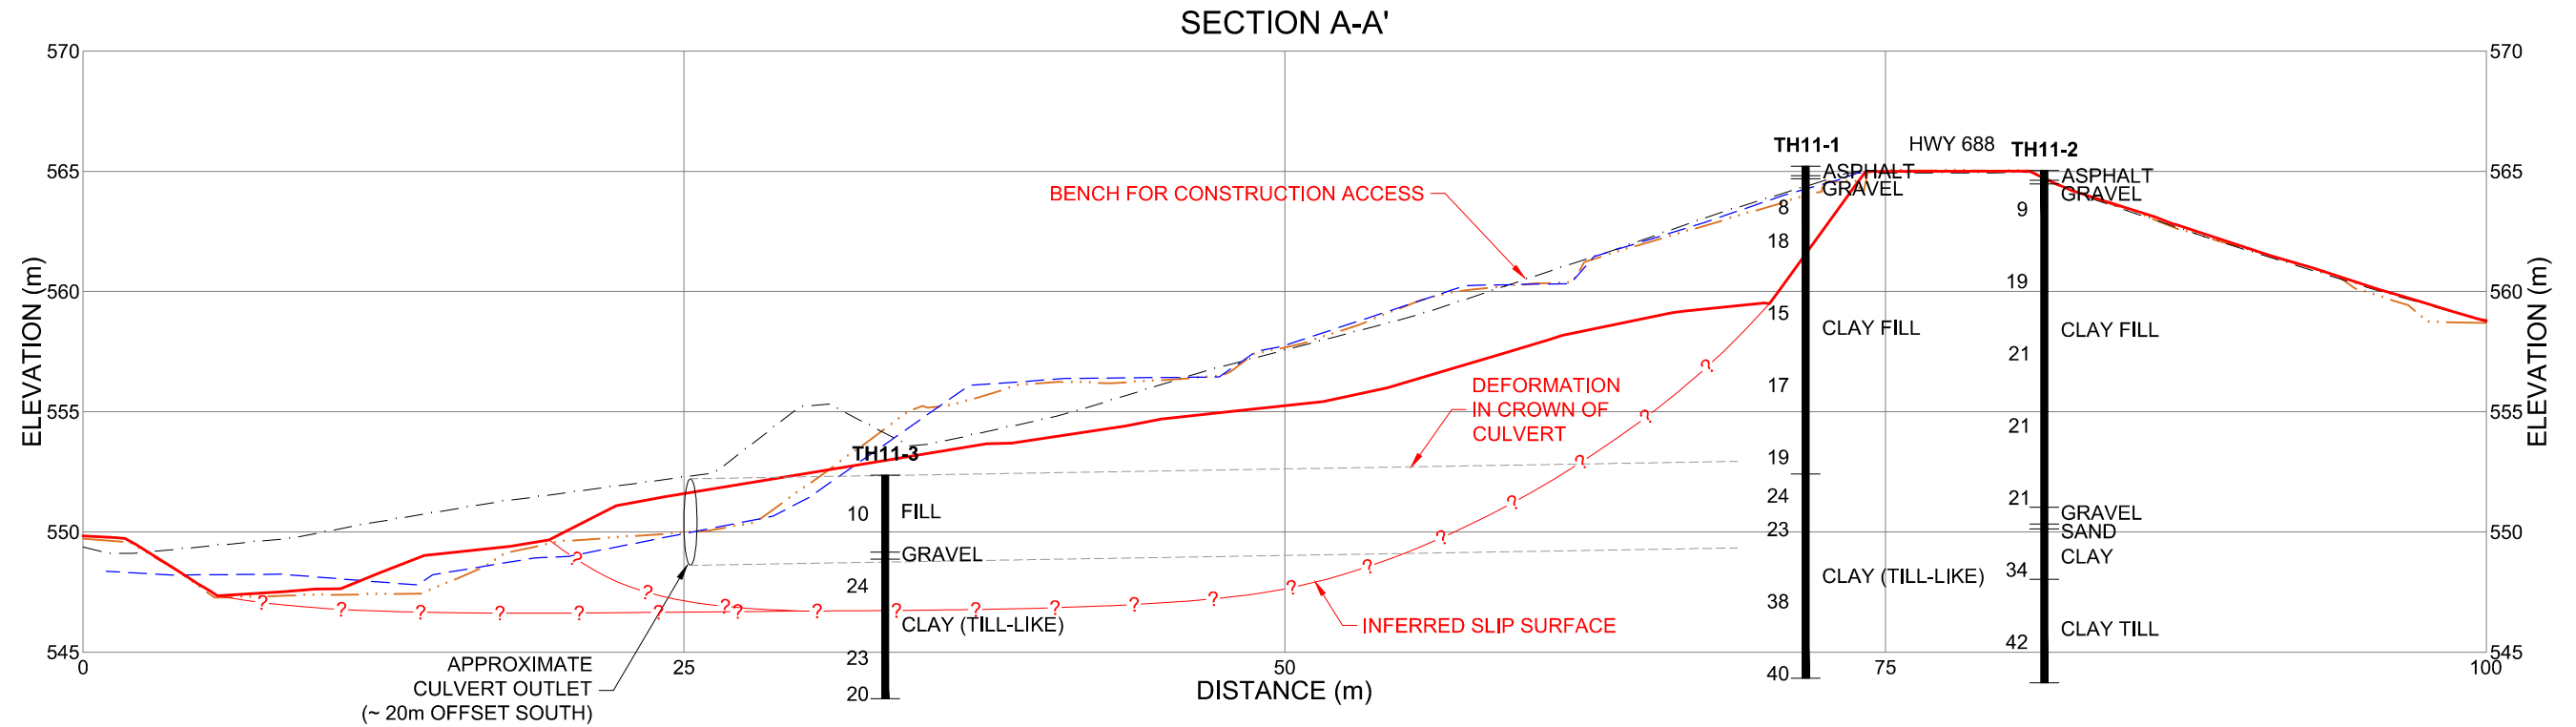
**FIGURE 2**

Based on the test holes from the previous Hoggan Engineering investigation and the topographic survey by WSP, we have plotted the inferred stratigraphic conditions and slip surface of the landslide on Figure 2. Based on this information, we believe that the slip surface extends down through the high plastic clay fill into the upper native soils but likely does not extend deep down into the hard native till material.

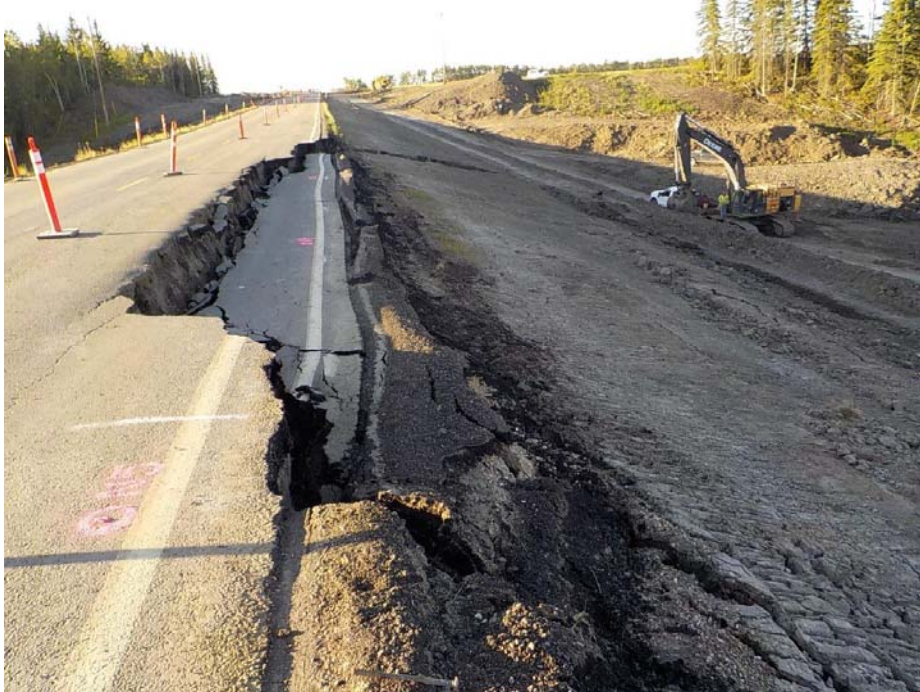
Photo 1: Looking south at west side shortly after movement commenced (by others, Sept. 1, 2017).

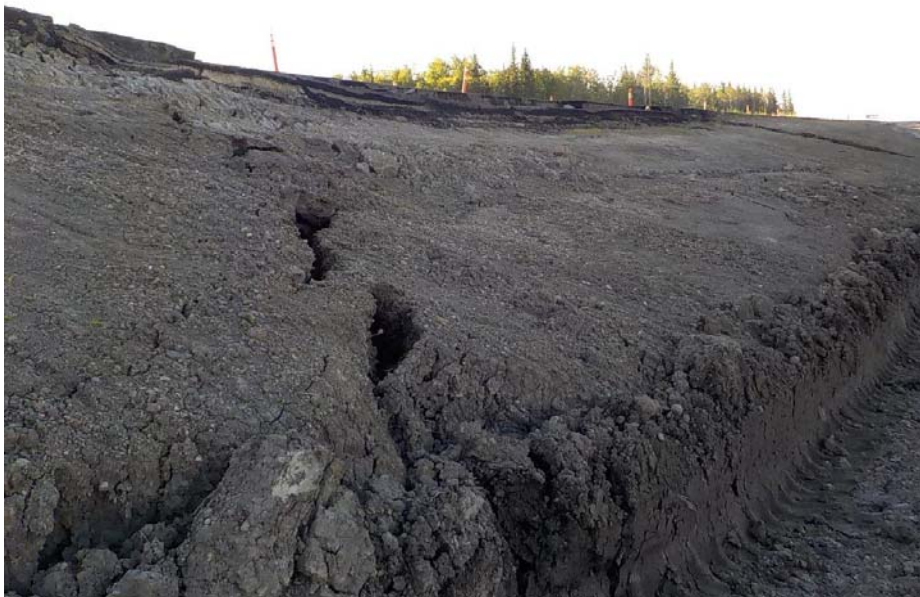
Photo 2: Looking south at north edge of cracking shortly after slide initiated (by others, Sept. 1, 2017)

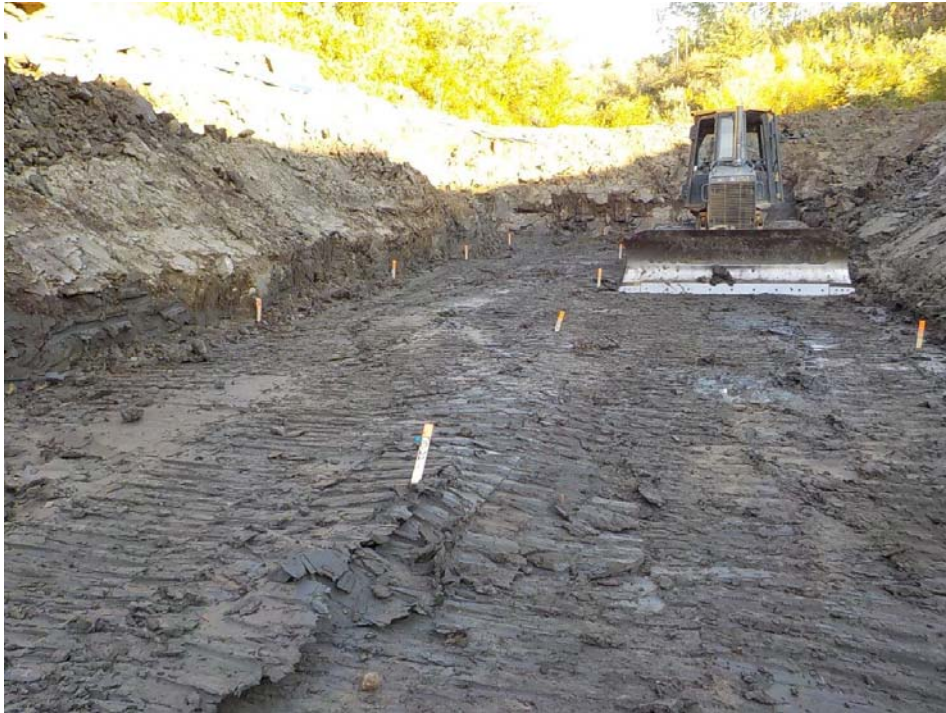
Photo 3: Start of heave in base of culvert extension excavation. Note cracks and leaning grade stake in the foreground (by others, Sept 1, 2017)

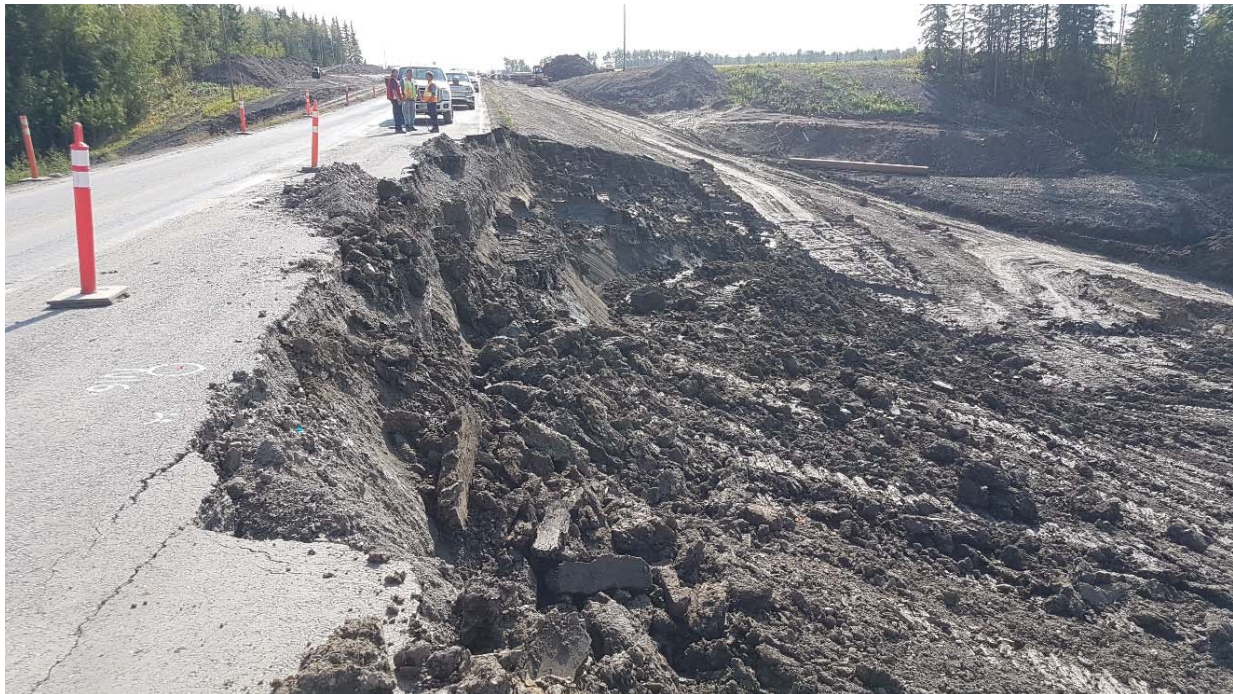
Photo 4: Looking south at west slide. Note that there has been excavation and fill placement in the slide bowl in efforts to reduce movement rates.

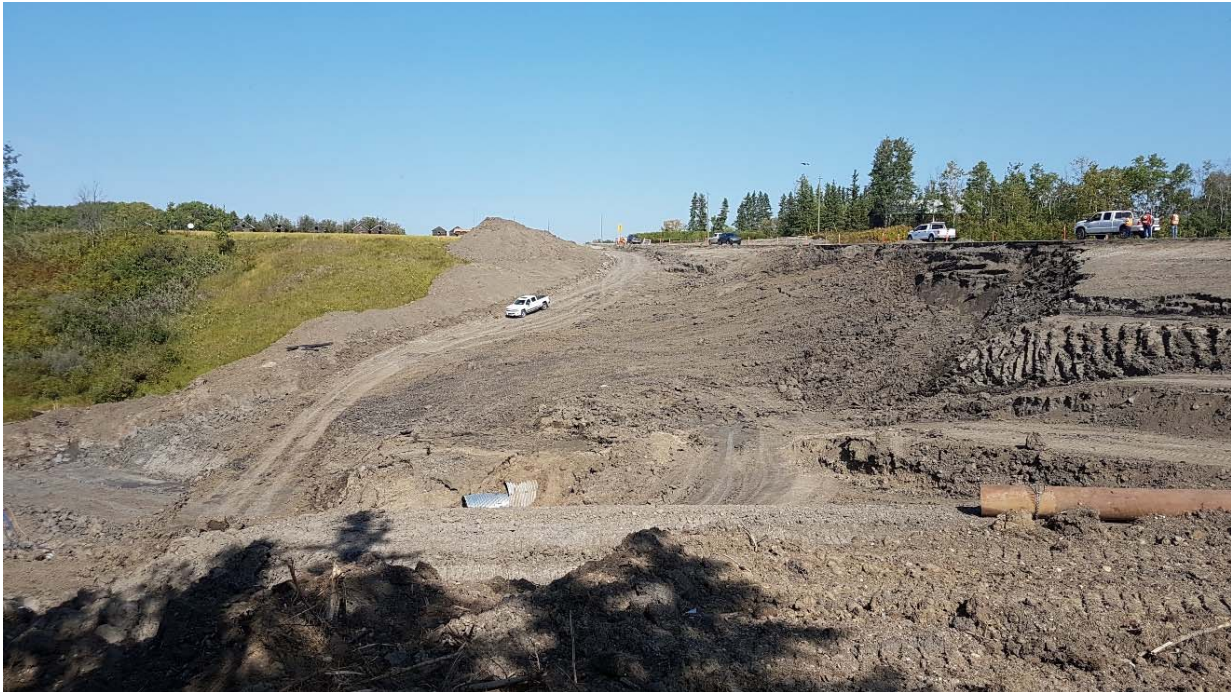
Photo 5: Looking northeast at west slide. It is recommended that topsoil stockpiles on the north slope be removed.

It was also recommended on site by Thurber that stockpiles on or close to the west embankment and creek valley slopes be moved away. In particular, the large stockpile located on the north slope should be moved as soon as practical as the 2013 call-out identified slumping along that portion of the creek valley.

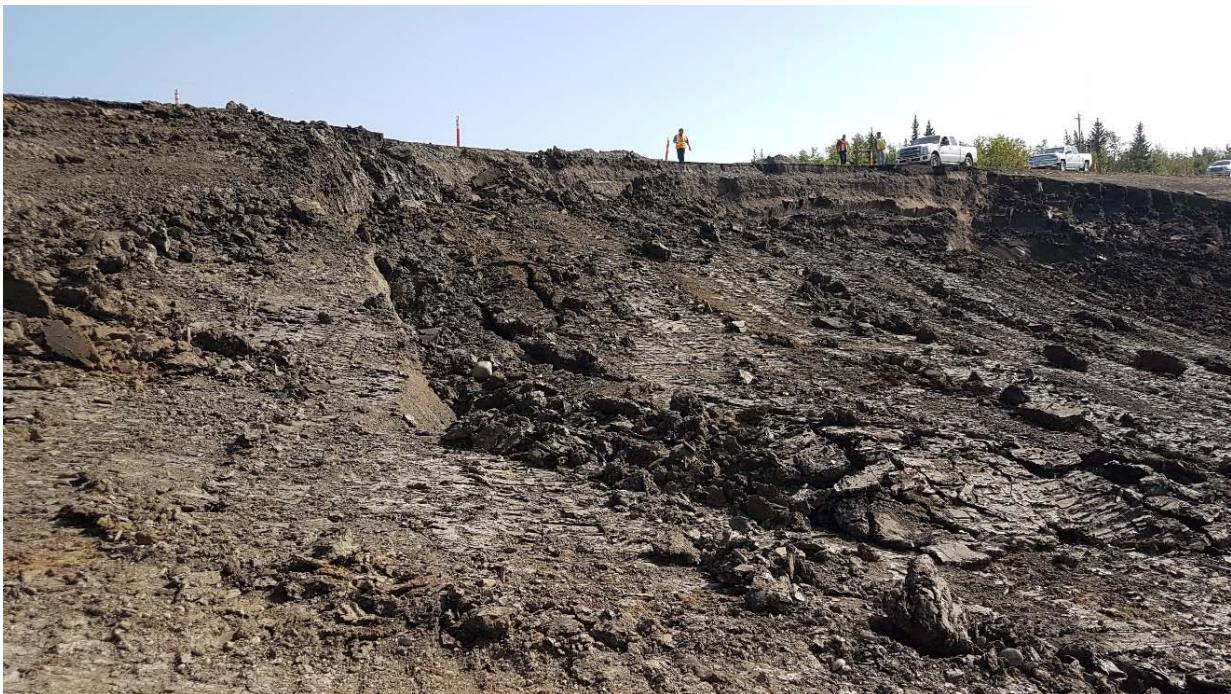
Photo 6: Looking southeast at west edge of slide.

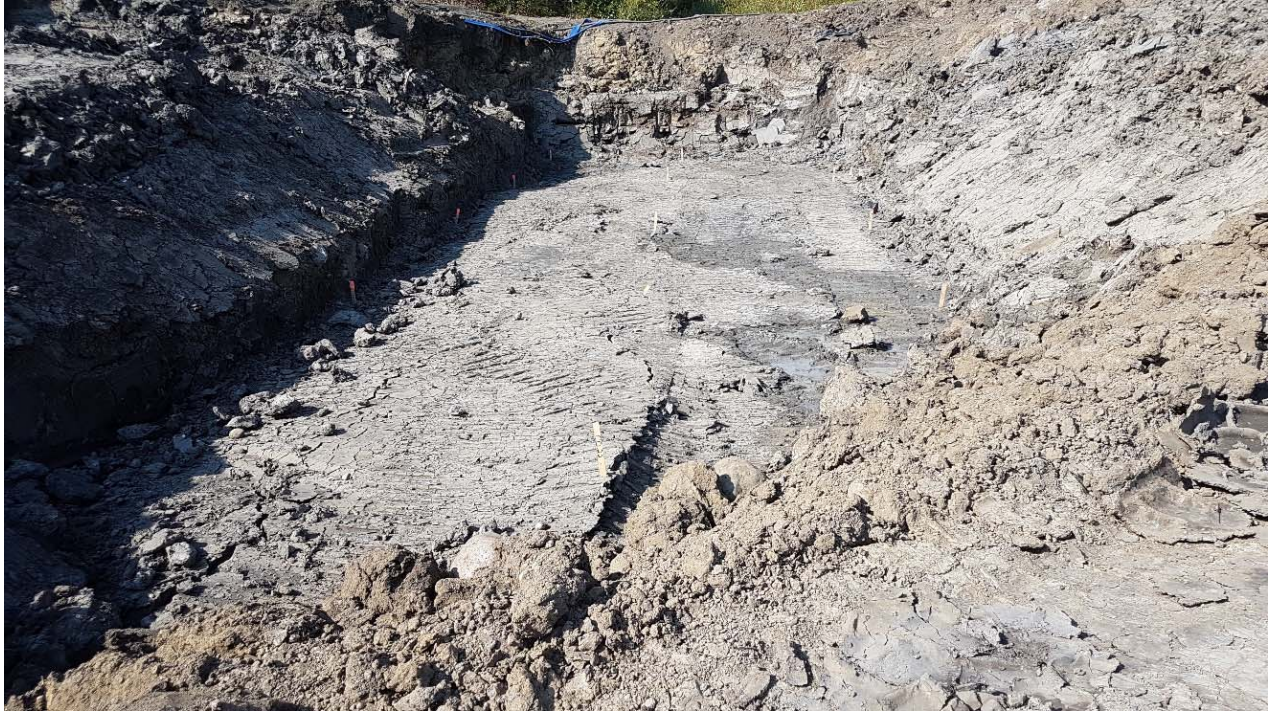
Photo 7: Looking at basal heave in west culvert extension excavation.

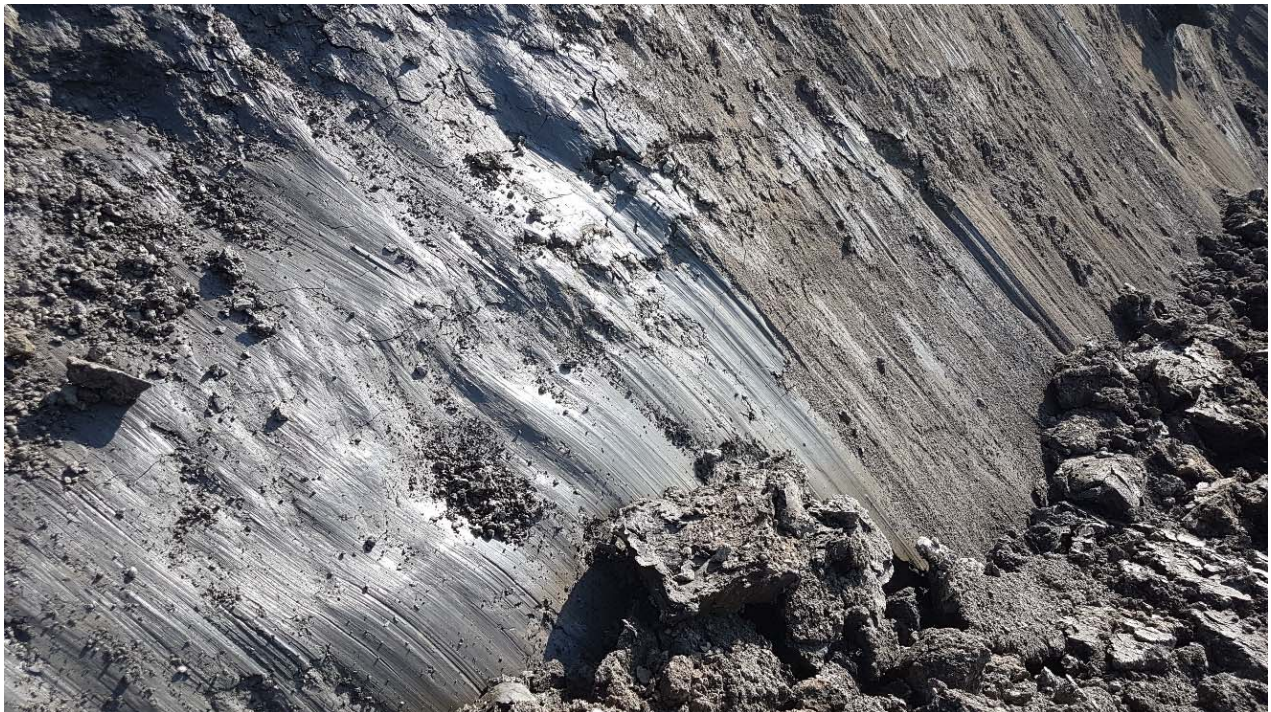
Photo 8: Slickensides on face of scarp.

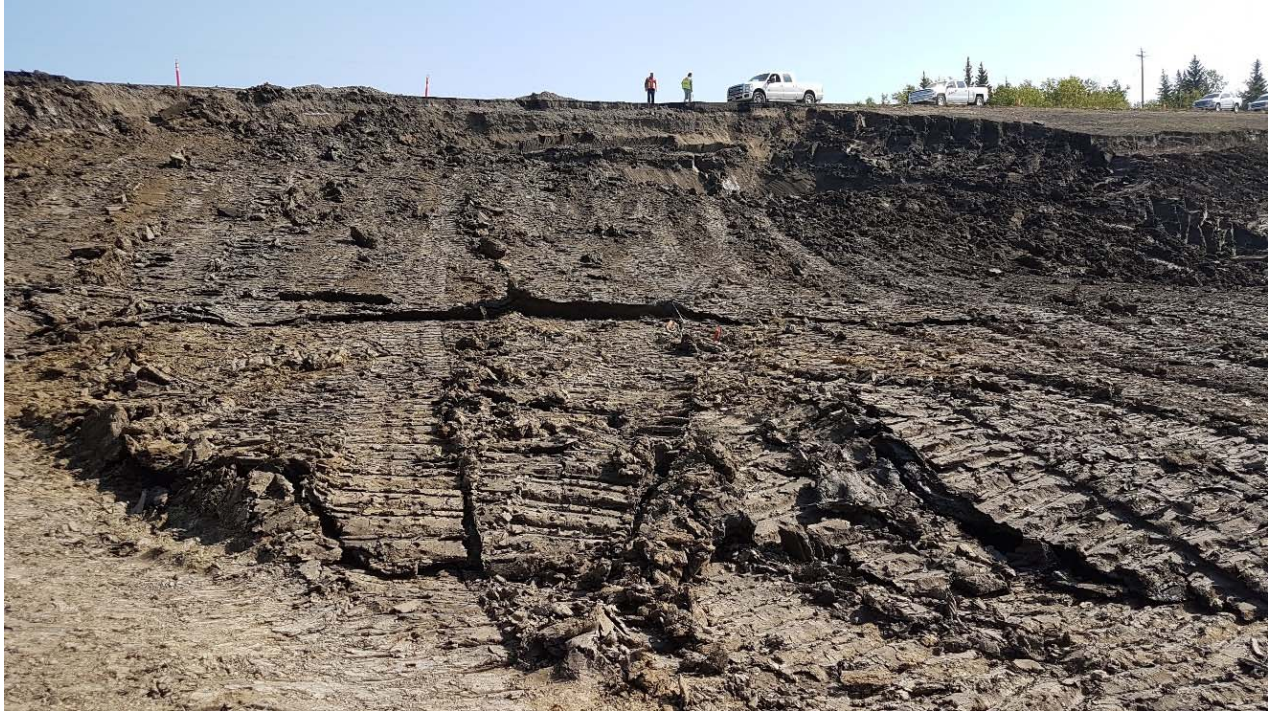
Photo 9: Looking east at toe roll material from upper portion of the slide.

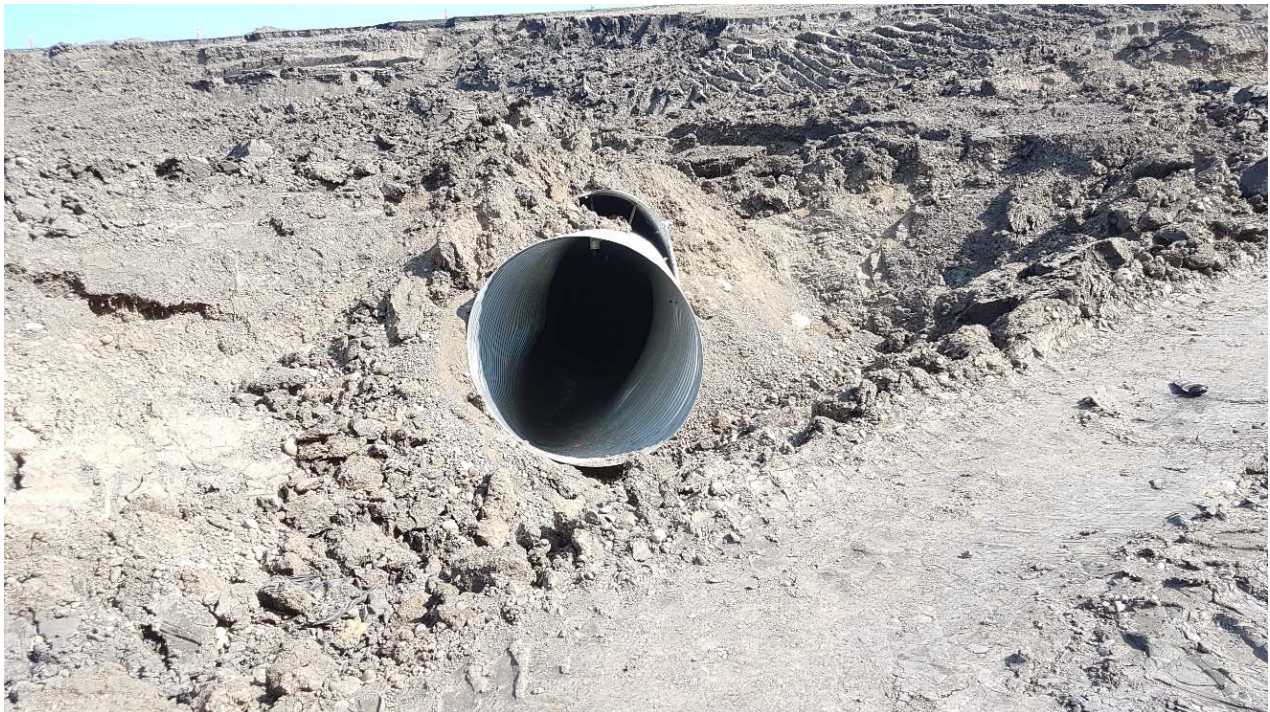
Photo 10: Looking east at deformed liner of the culvert extension.

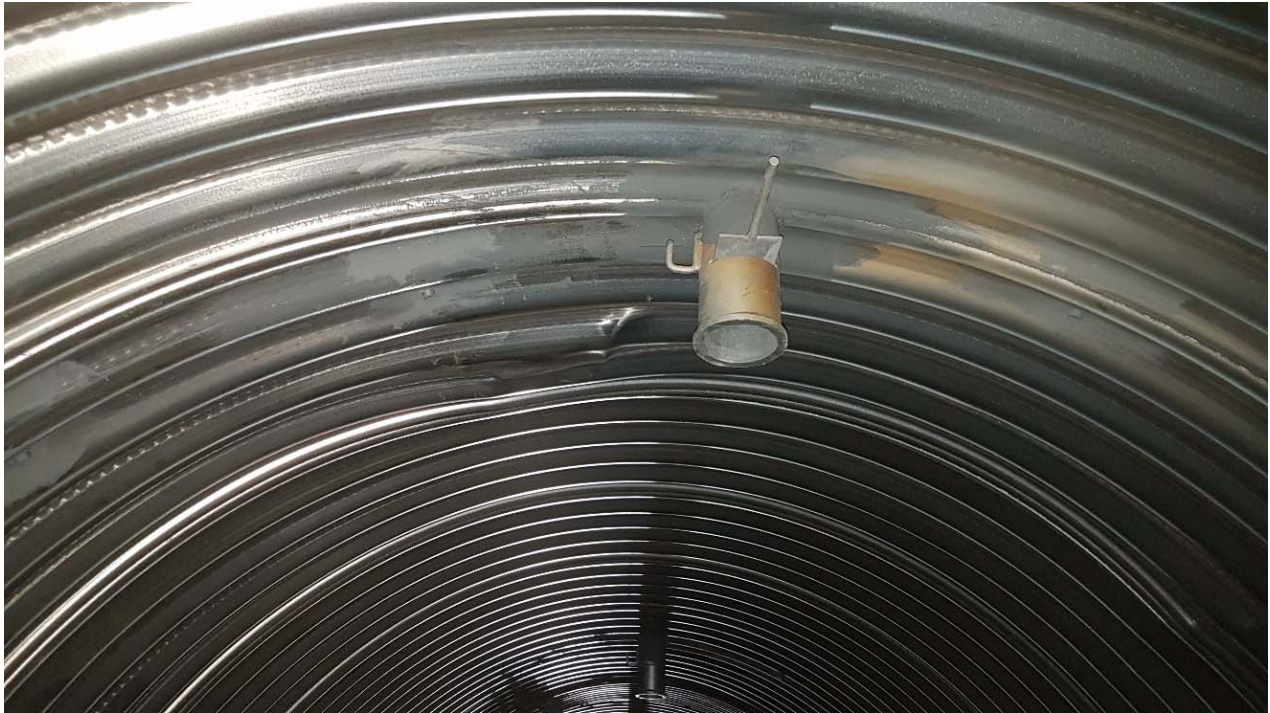
Photo 11: Deflection in roof of culvert liner approximately 30 m from the current outlet.

Note that the damage observed in the roof of the culvert will need to be assessed by others for structural integrity. AT has recommended against entering the portion of the culvert below the slide mass for safety reasons; however, once the short-term measures have been implemented to slow the slide movement, this should be reviewed as additional measurements to determine if the culvert is continuing to deflect will likely be necessary to assess how much repair or replacement may be required. In addition, sizing of a replacement culvert will need to be done by others.

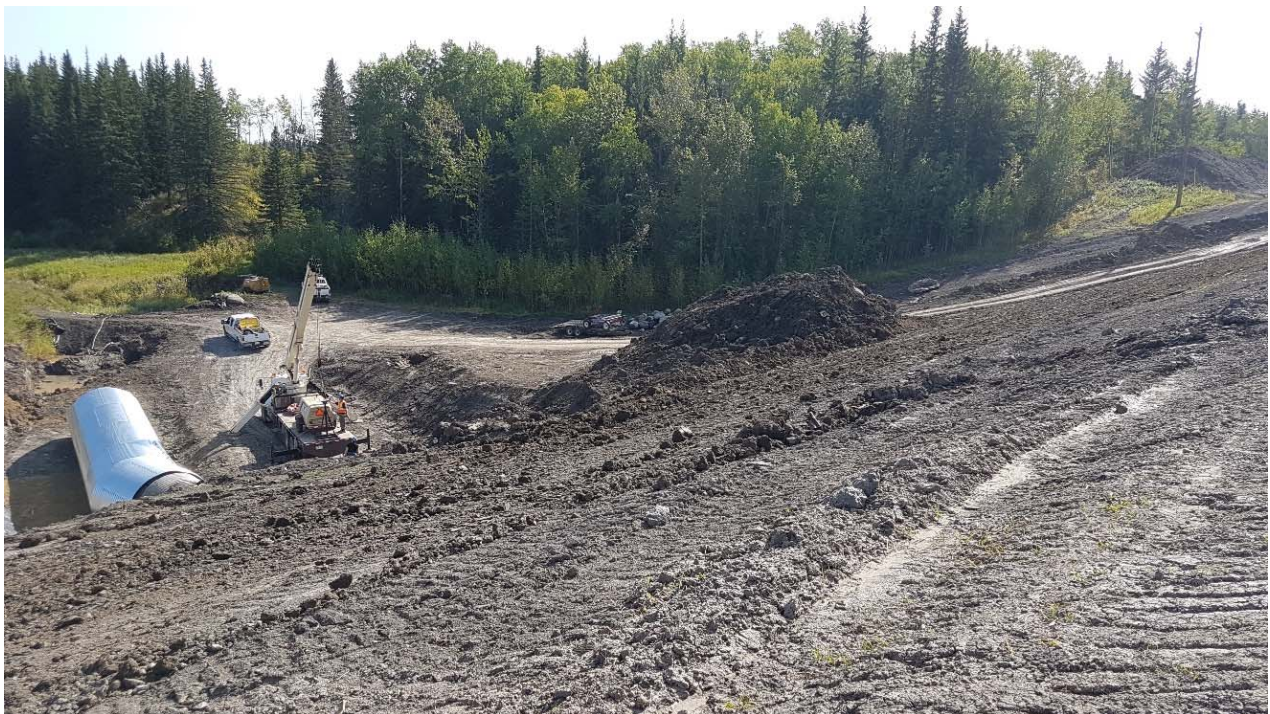
Photo 12: Looking southeast at east culvert extension. It was recommended to remove the stockpile of material located south of the excavation.

It was recommended that the east culvert excavation be backfilled as soon as possible and that, in the interim, the stockpile adjacent to the excavation be reduced in height with material moved downslope to provide a buttress. It was recommended to WSP that additional monitoring points be established on the east slope to identify if movement is continuing on that side of the embankment. Establishing and monitoring of survey points along both sides should be maintained after the sag curve has been constructed to provide warning of potential movements. The frequency of monitoring should be at least daily initially which can be reduced if movement is not observed.

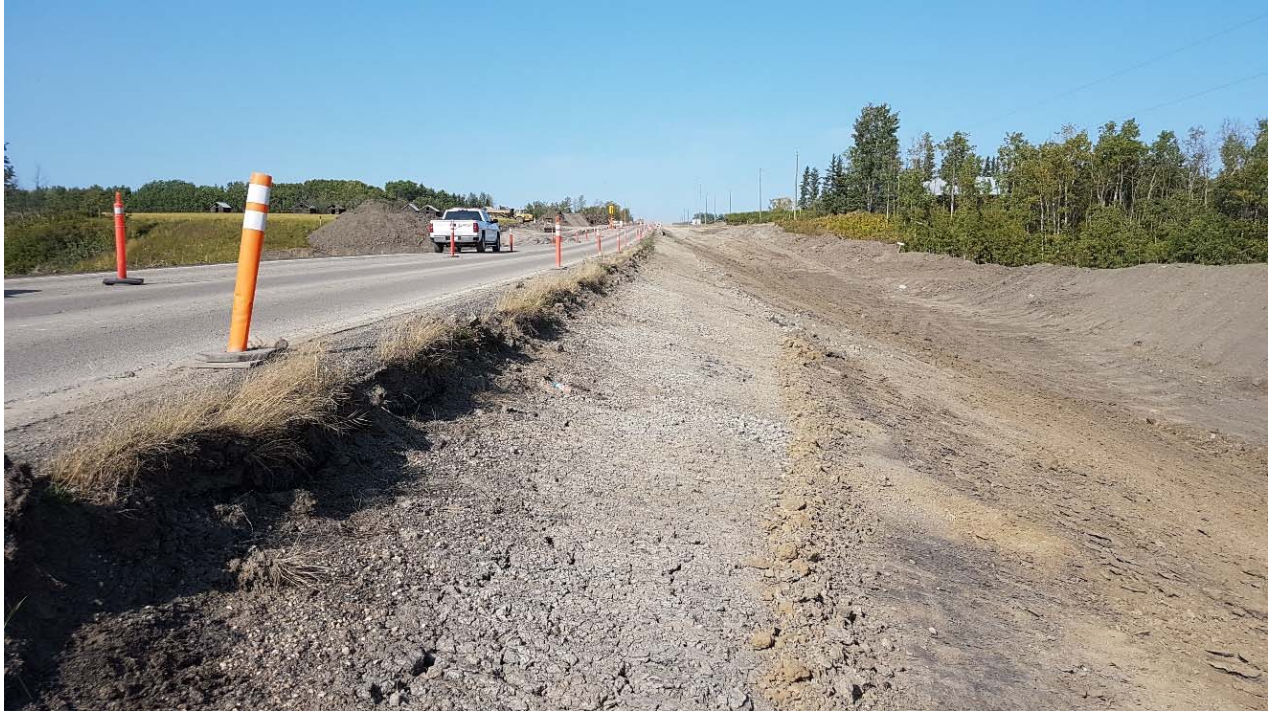
An inspection of the east sideslope identified a potential slide bowl forming coincident with the area where movement had been seen in 2013. WSP observed that there appeared to be move gravel exposed below the asphalt than had been present after topsoil stripping and guardrail removal. Repeated surveys of a few points along the embankment indicated minor vertical movements less than 100 mm overall. A survey of the highway centerline a day or two before this call-out inspection did not show a significant difference between the original survey taken during design indicating that the highway surface is not subsiding except at the west slide.

Photo 13: Looking north at stripped east sideslope above culvert extension excavation.
