**ALBERTA TRANSPORTATION AND
ECONOMIC CORRIDORS
GEOHAZARD ASSESSMENT PROGRAM
PEACE REGION (PEACE RIVER DISTRICT)
2025 INSPECTION**

Site Number	Location	Name	Hwy	km
PH080	North of St. Isidore	McKinney Creek	688:02	15.42
Legal Description		UTM Co-ordinates		
NW15/NE16/SE21/SW22-084-20-W5M		11U E 461,782	N	6,308,097

PH080: MCKINNEY CREEK CULVERT SLIDE
HWY 688:02 km 15.42 BF72477
2025 SITE INSPECTION PLAN

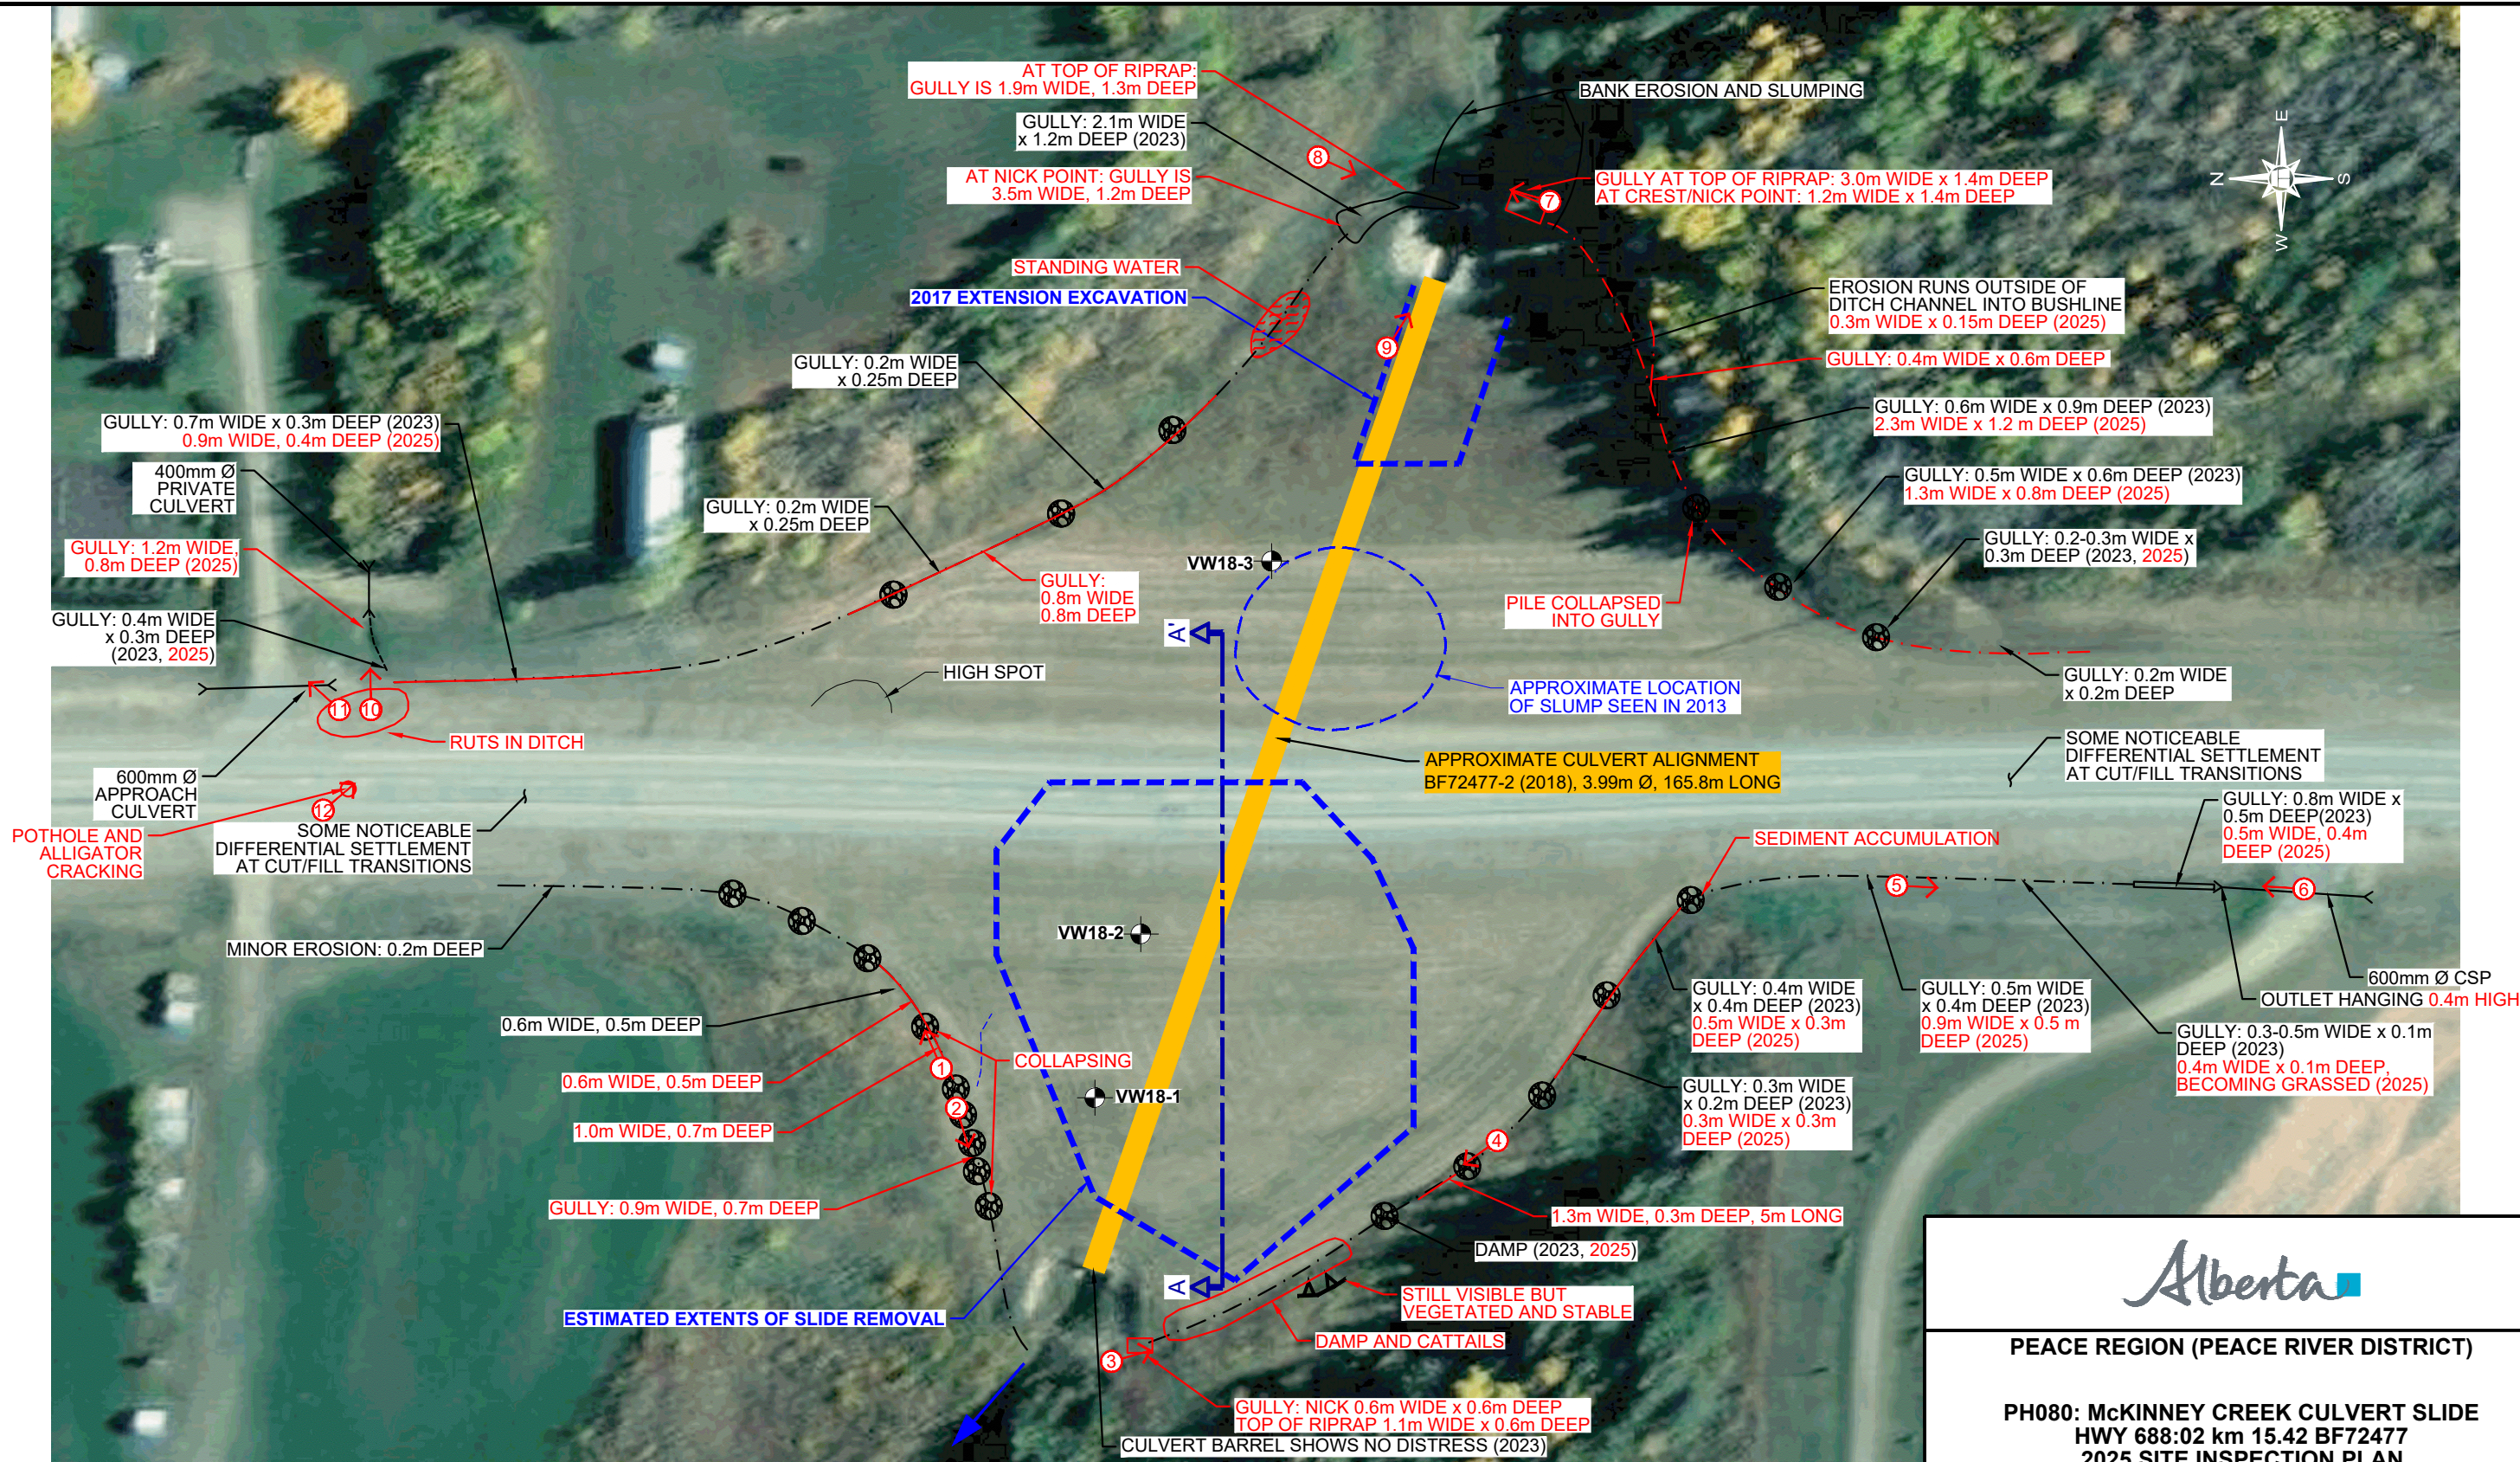
DWG No. 32121-PH080-1

The significant erosion gullies forming at all of the fill interfaces in all quadrants of the embankment noted in 2023 have gotten worse as of 2025. In three of the quadrants, clusters of riprap had been placed in the ditch (these were redrawn in 2025). However, the domed shape of these clusters have served to push flow around both sides concentrating flow on the downstream side resulting in downcutting beside these clusters and the formation of gullies immediately downslope. The growth of the gullies has caused several of the rock clusters to collapse. In the SE quadrant, the erosion has caused the main flow to detour outside of the channel into the bush.

Significant gullies have formed at the inlet (east end) on both sides of the bank just upstream of the riprap treatment which have eroded noticeably since 2023. A new gully developed at the west end since 2023 at the edge of the outlet riprap apron.

- The ditches in all four quadrants should be reconstructed: remove the existing riprap clusters, regrade the ditches in a trapezoidal shape, line flat sections of the ditches with TRM, and steep sections of the ditch with riprap or gabion mattress. If the gradient requires it, riprap or gabion basket check dams should also be installed.
- Extend the bridge culvert inlet riprap apron further upstream. Reshape the ditches such that flow discharges in a controlled manner on to these aprons at the inlet and outlet.
- Use compacted fill or grout, along with ditch reshaping and erosion protection, to repair the hanging outlet at the southwest approach.

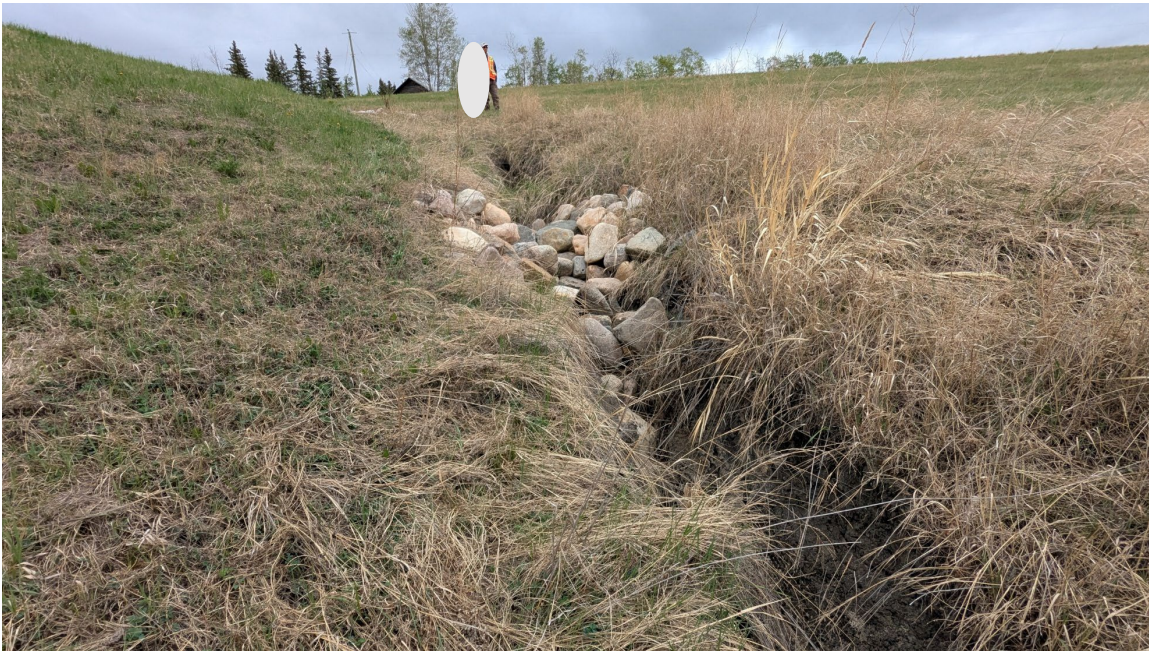
Photo 1 – Looking east at erosion at collapsed riprap clusters in NW quadrant ditch.

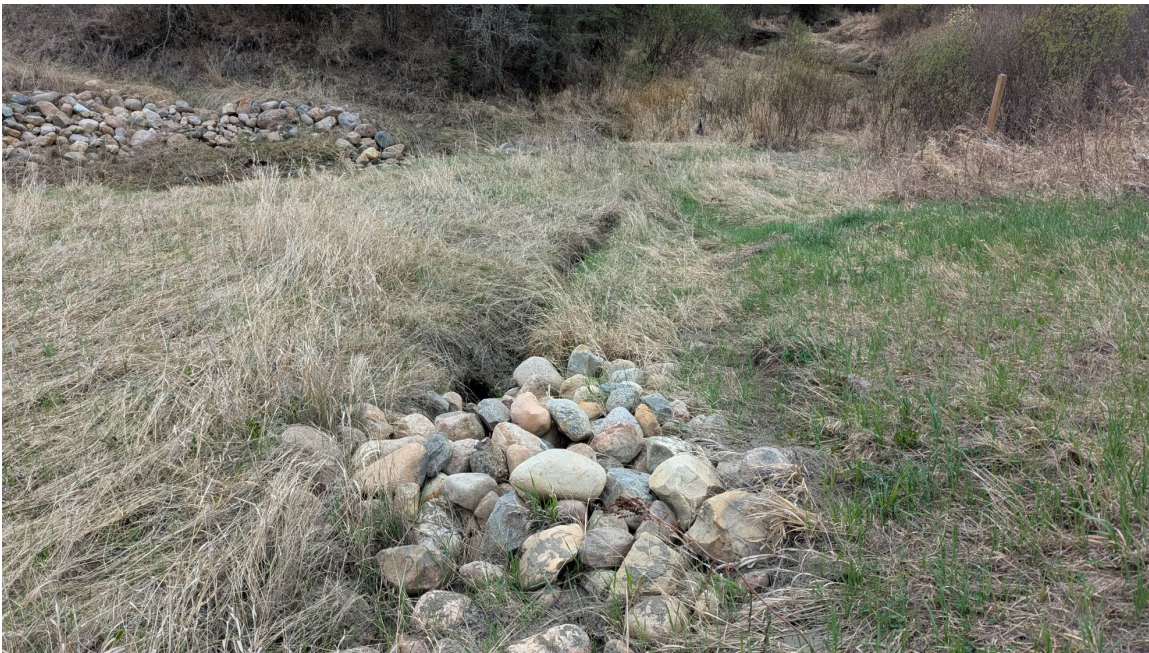
Photo 2 – Looking west at a riprap cluster and erosion gully in lower half of NW quadrant ditch.

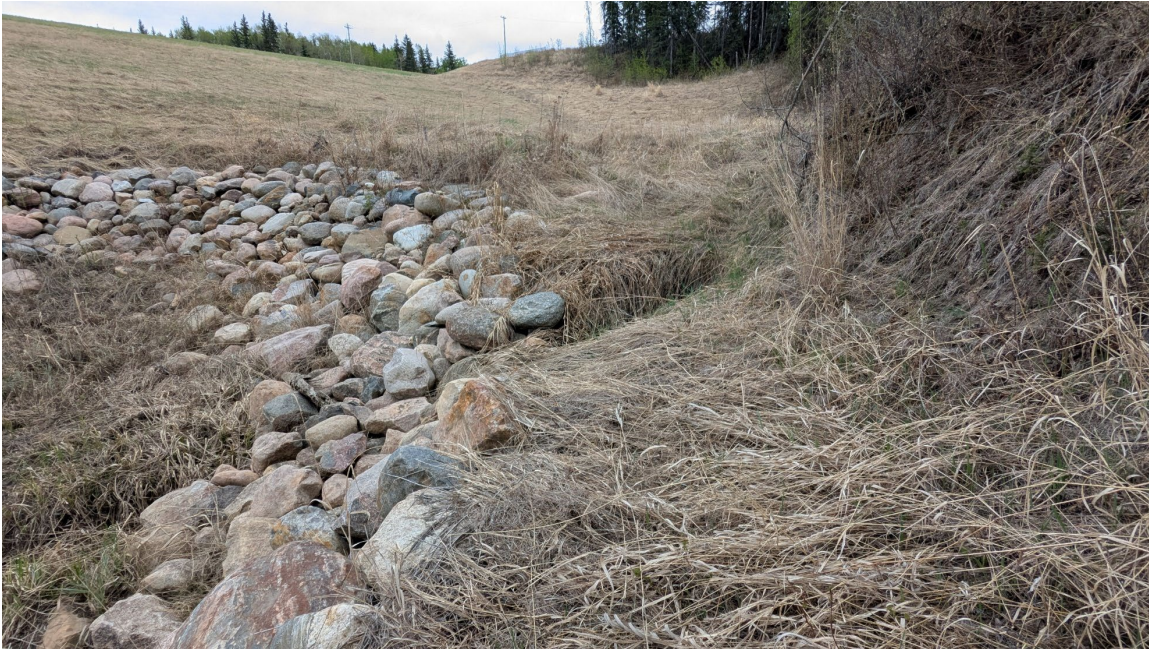
Photo 3 – Looking SE at new erosion gully cutting through the edge of the outlet riprap apron.

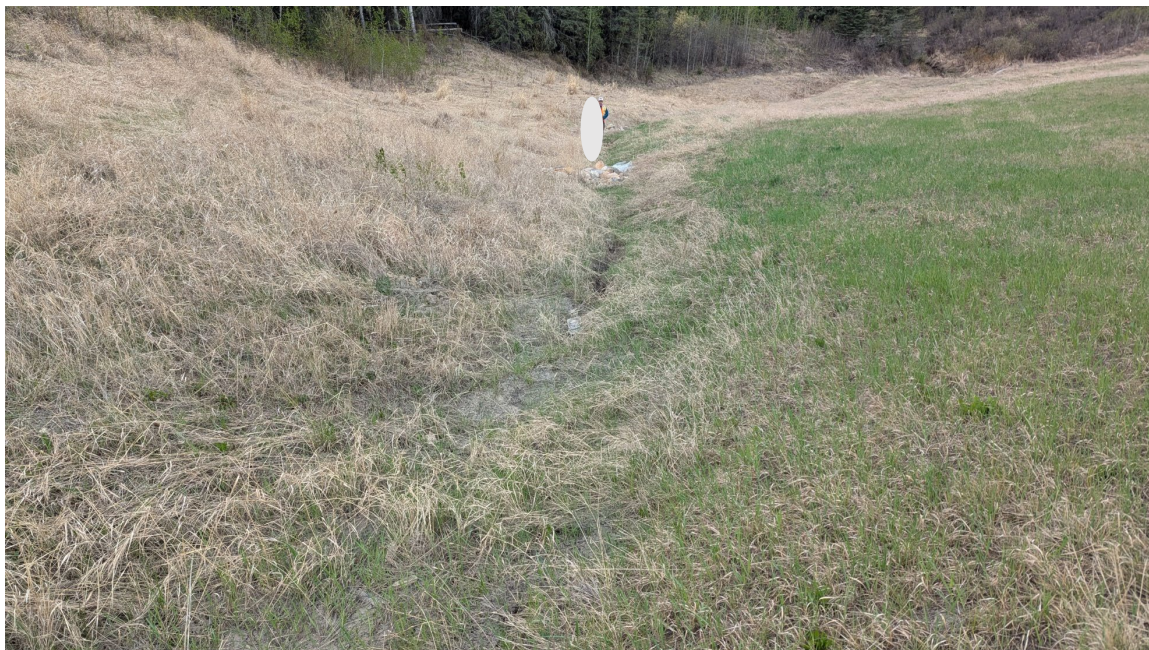
Photo 4 – Looking west at erosion gully forming in SW quadrant ditch.

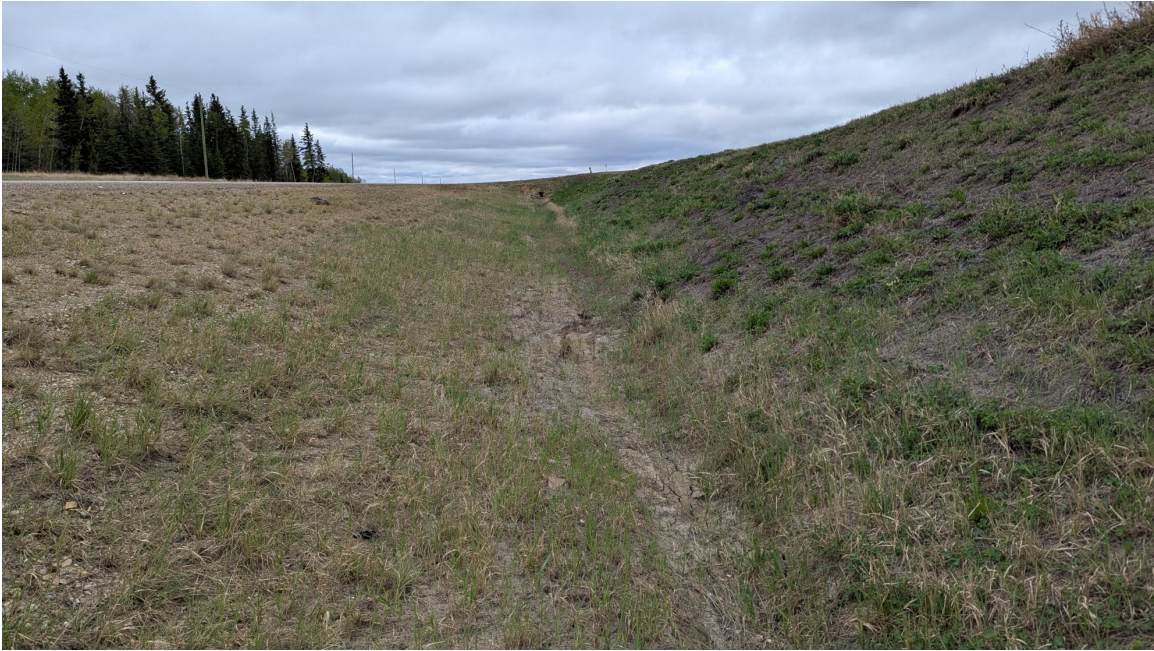
Photo 5 – Looking south at eroding west ditch. Vegetation growth has improved slightly since 2023.

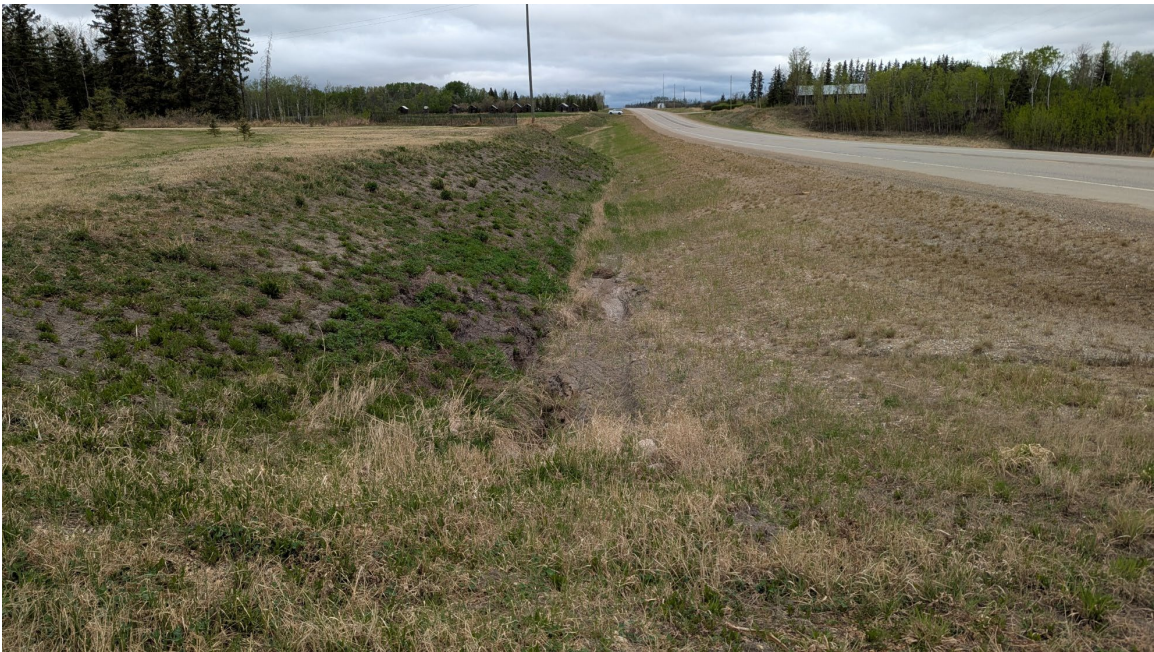
Photo 6 – Looking north at erosion gully forming below the outlet of an approach culvert in the west ditch south of the bridge culvert. Vegetation is becoming established. Also note dip in the highway over the bridge culvert.

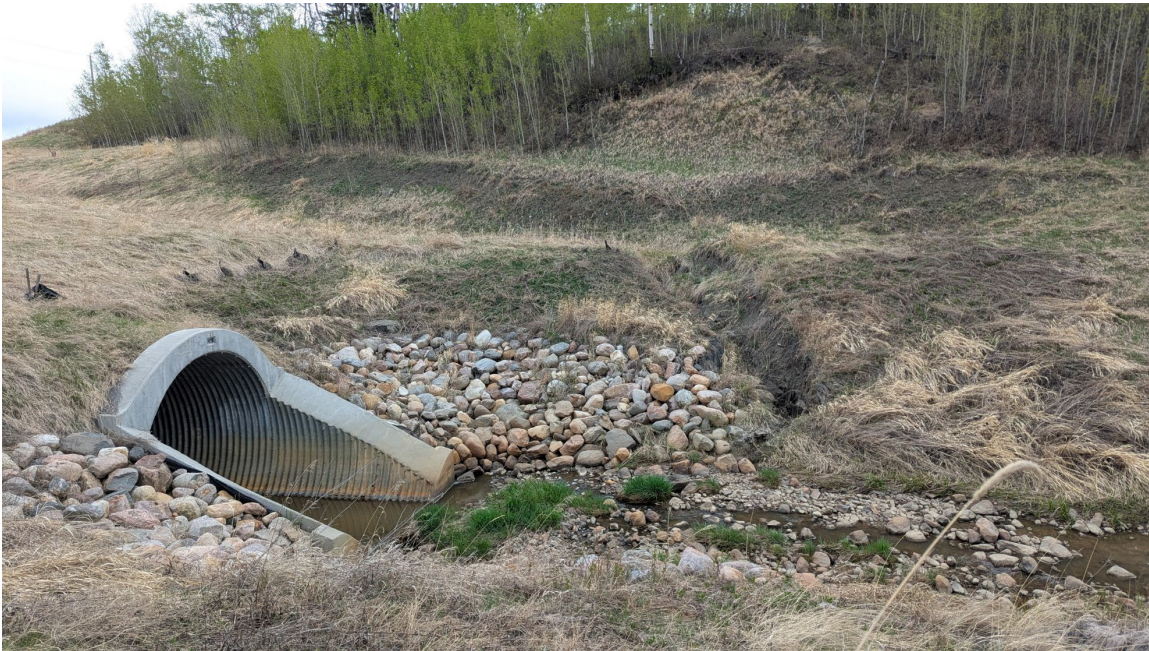
Photo 7 – Looking north at erosion gully on the north side of the culvert inlet which is starting to undermine the riprap apron.

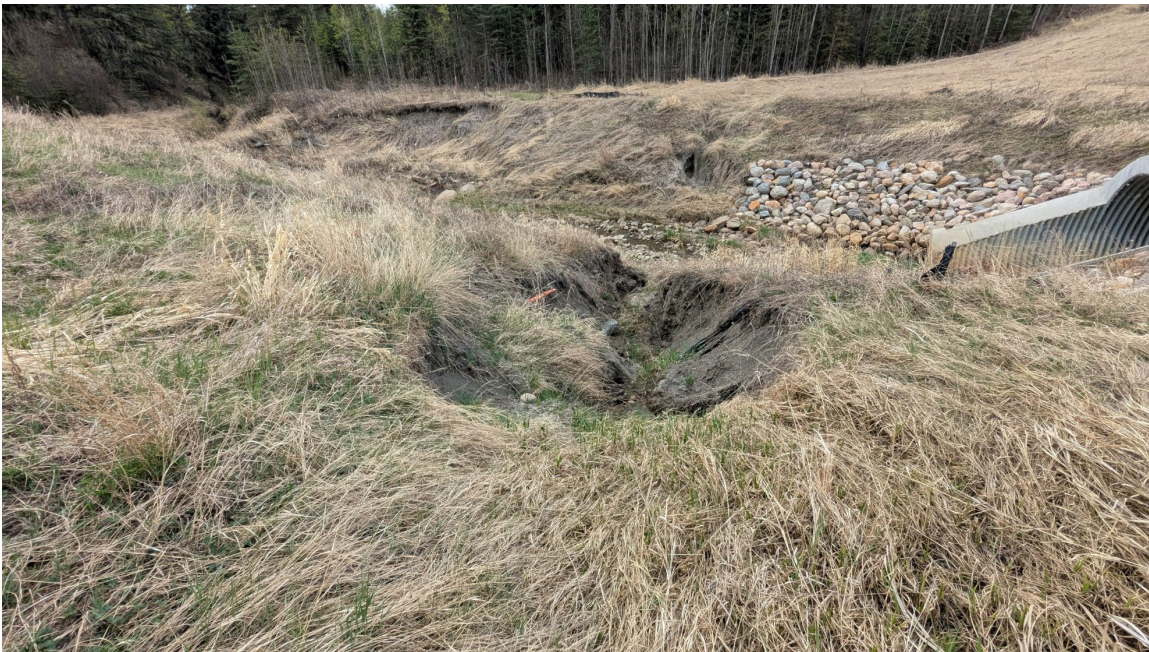
Photo 8 – Looking south at the north erosion gully (far side of Photo 6) and south erosion gully (far side of this photo) at the culvert inlet.

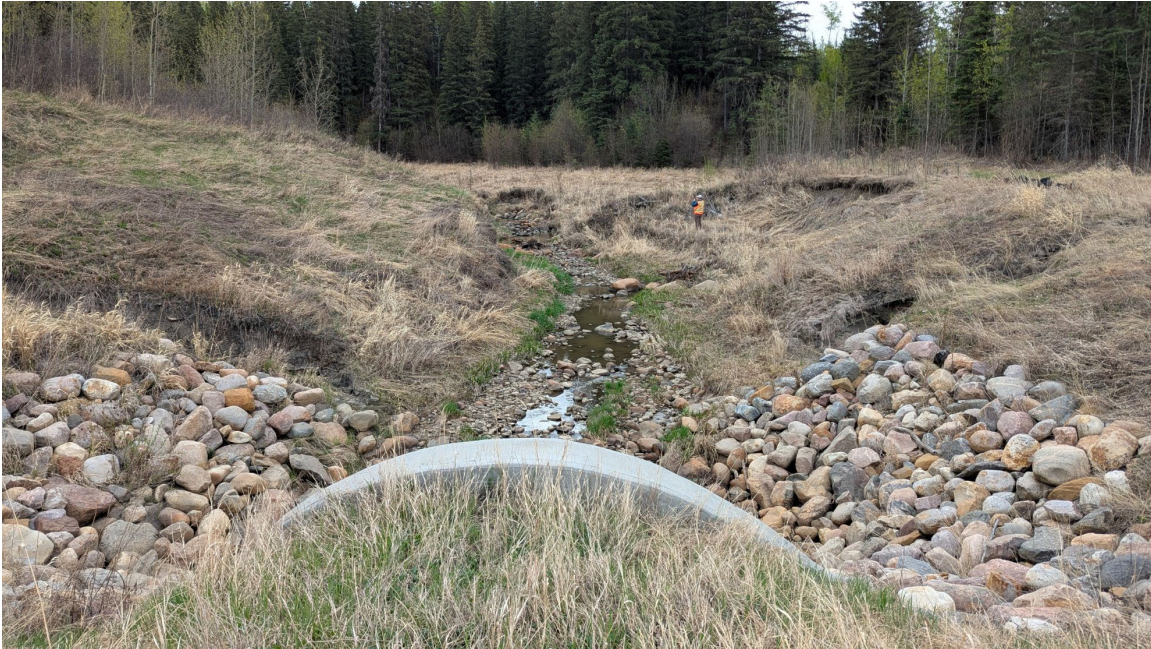
Photo 9 – Looking east at slumping forming upstream of the culvert inlet.

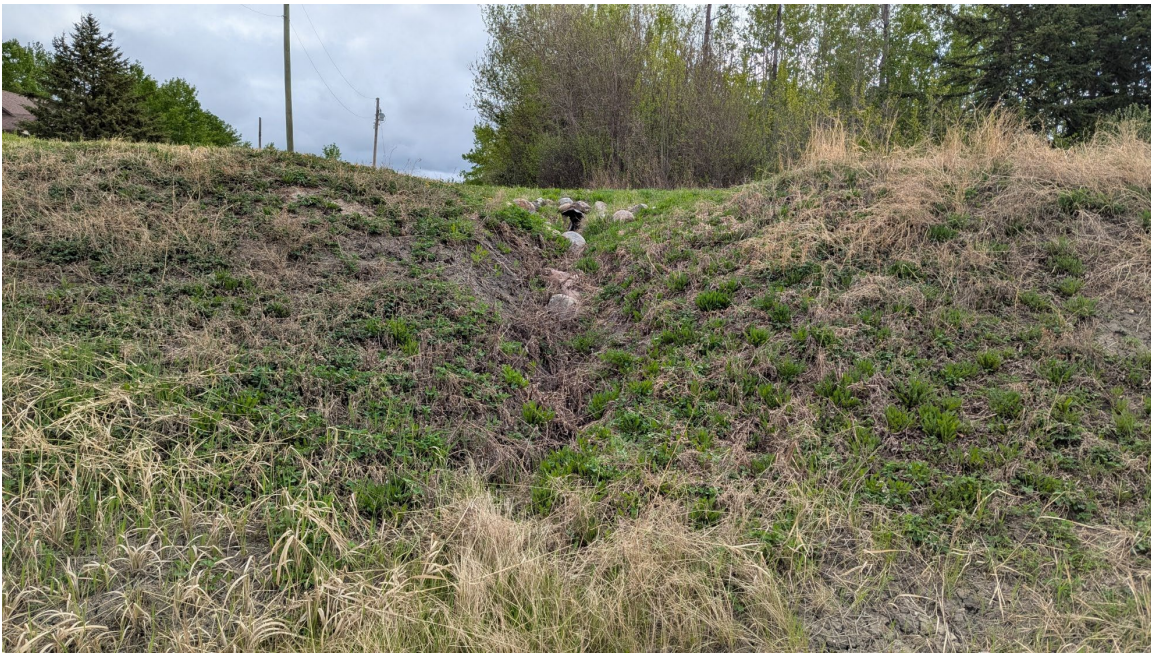
Photo 10 – Looking east at erosion gully forming below private landowner culvert on the east side of the ditch north of bridge culvert.

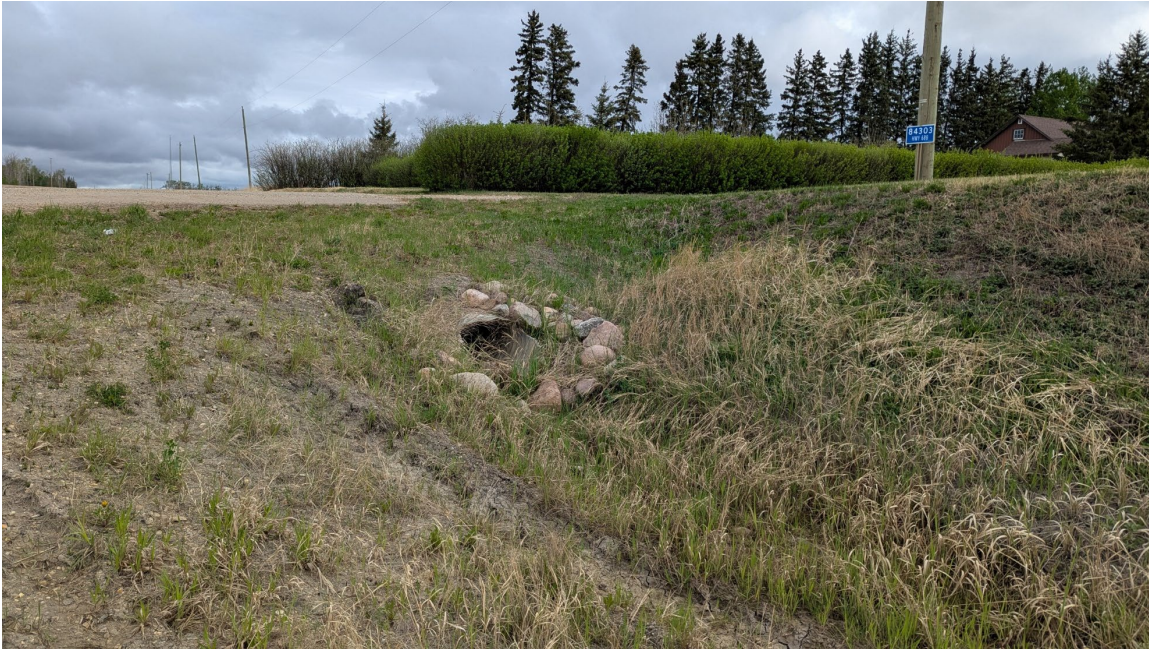
Photo 11 – Looking northeast at a gully starting to form below an approach culvert near Photo 9.

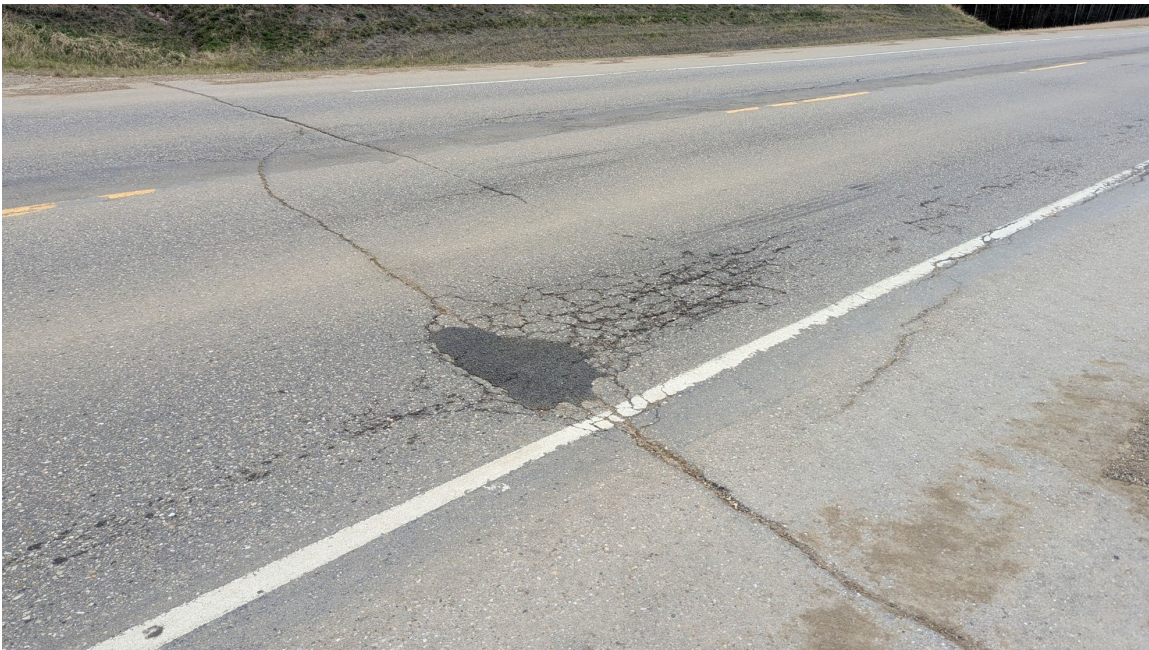
In 2023, there were no signs of slope movement on the embankment or highway surface. The observations made in 2025 also confirm that the embankment appears to be stable although the pavement appears to be deteriorating with alligator cracking and potholes being to form at the north transition. Some pavement raveling was also noted. The gullies in the upland ditches outside of the crossing had grown slightly but vegetation appears to be taking hold. Some new rutting was observed.

Photo 12 – Pothole and alligator cracking at north end near farm approach.
