| Site Number | Location | Name | Hwy | km |
|---|---|---|---|---|
| PH080 | Hwy 688:02 C1 15.4 | McKinney Creek Slide | 688:02 | Km 15.4 |

**ALBERTA TRANSPORTATION AND ECONOMIC CORRIDORS GRMP (CON0022164)  
PEACE REGION (PEACE RIVER DISTRICT)  
INSTRUMENTATION MONITORING RESULTS**

**SPRING 2025**

**SITE PH080: HWY 688:02 McKINNEY CREEK SLIDE (KM 15.4) - BF72477**

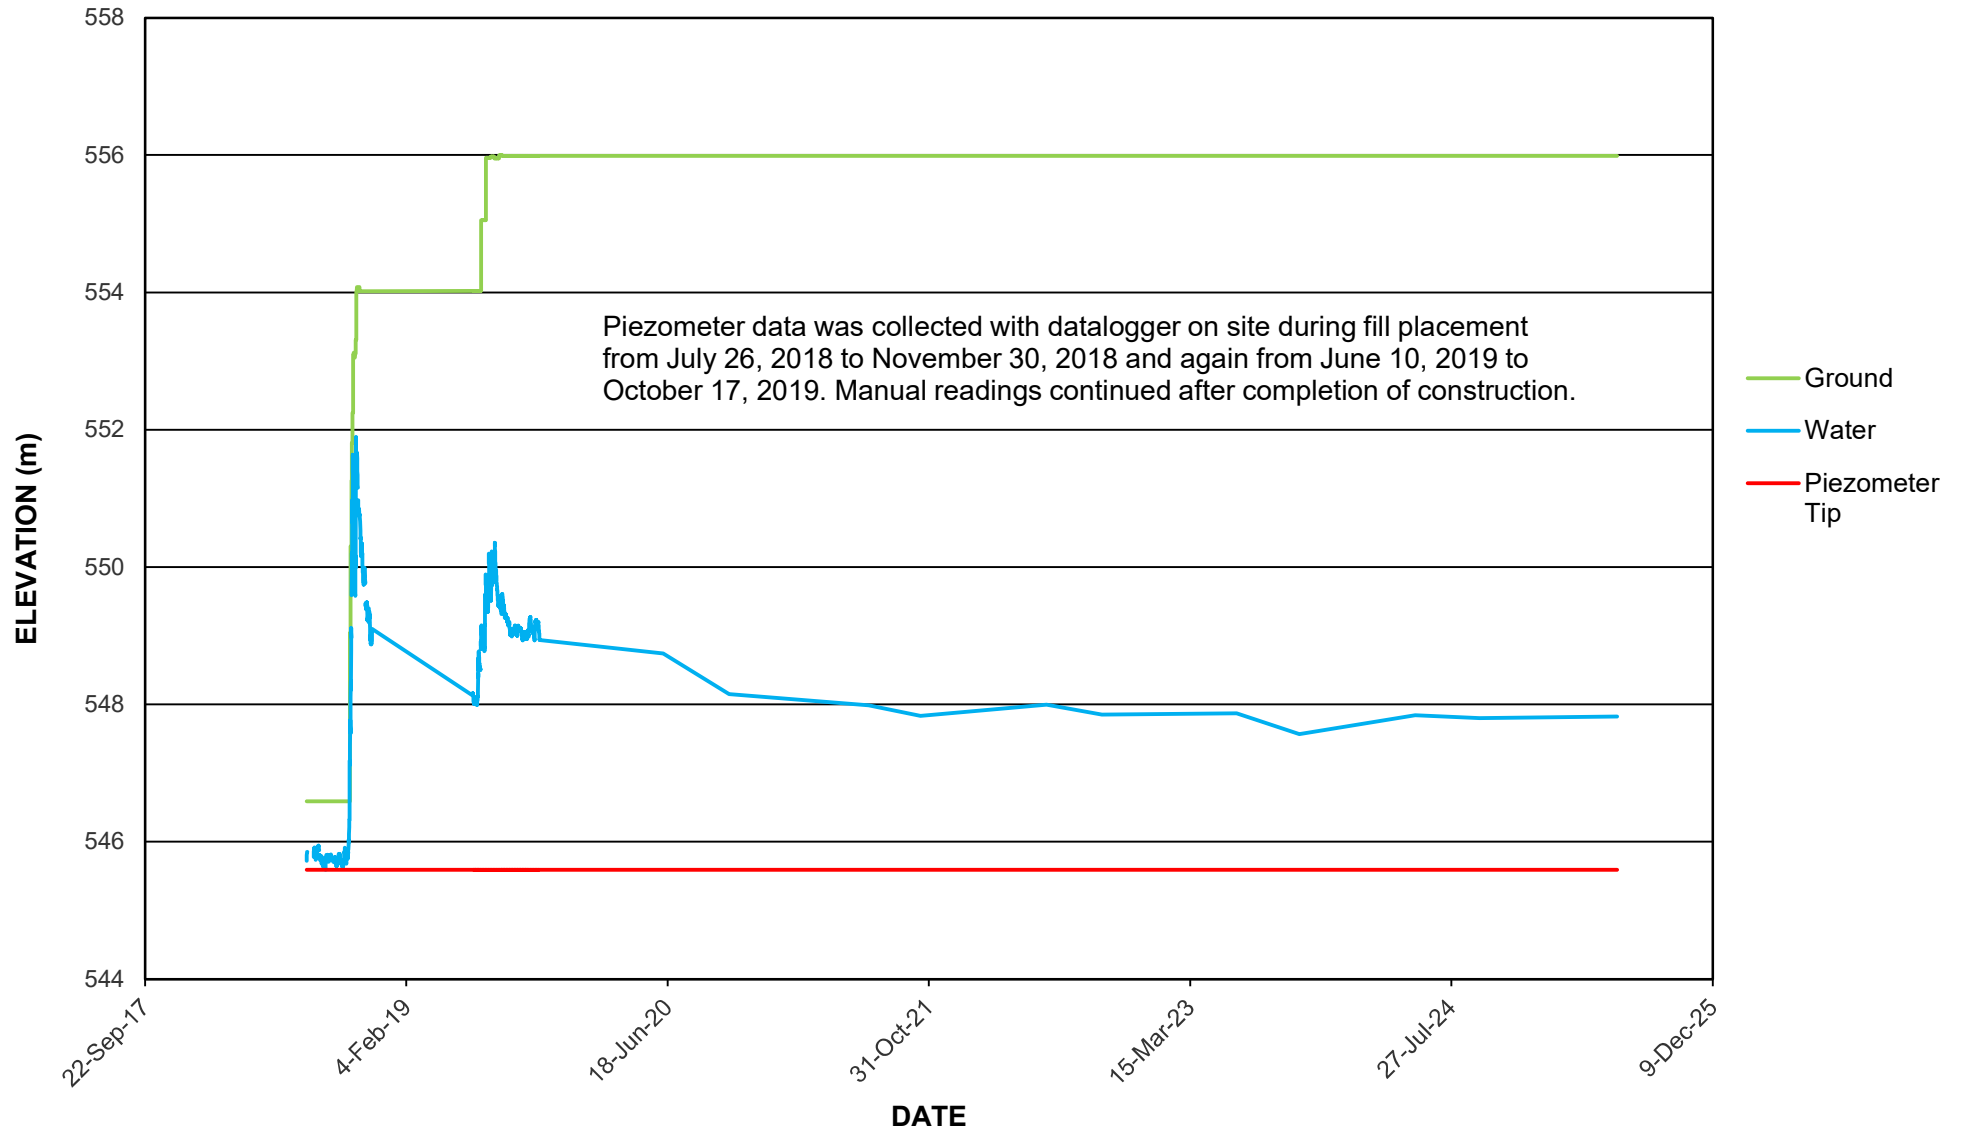
**FIGURE PH080-1**  
**HWY 688:02 McKINNEY CREEK CULVERT SLIDE - VW18-1**  
**(WEST SIDE OF CULVERT)**

| Discussion | |
|---|---|
| <b>Interpretation of Monitoring Results:</b> | <p>Vibrating wire piezometer VW18-1 showed an increase in groundwater level of 0.02 m since the fall of 2024 readings. VW18-2 and VW18-3 showed a decrease in groundwater level of 0.72 m and 0.44 m, respectively, since the fall of 2024 readings. VW18-1, VW18-2 and VW18-3 showed a prior trend of diminishing groundwater levels since the completion of construction. The groundwater levels at VW18-1, VW18-2 and VW18-3 locations appear to have levelled out with some seasonal variations. The piezometers had all previously shown their highest groundwater levels during construction as fill was placed at their respective locations.</p> <p>Figures PH080-1, PH080-2 and PH080-3 show the response of each of the piezometers relative to fill height during construction as well as the subsequent decrease in pore water pressure. Figure PH080-4 shows a combined plot of the groundwater elevations of all three vibrating wire piezometers.</p> |

| INSTRUMENT | DATE INITIALIZED | TIP Elevation (m) | CURRENT STATUS | MAXIMUM GROUNDWATER ELEVATION (M) | CURRENT GROUNDWATER ELEVATION (m) | PREVIOUS GROUNDWATER ELEVATION (m) | CHANGE IN WATER LEVEL SINCE PREVIOUS READING (m) |
|---|---|---|---|---|---|---|---|
| VW18-1 (VW47342) | July 26, 2018 | 545.59 | Operational | 551.90 on October 30, 2018 | 547.82 | 547.80 | 0.02 |

| Discussion | |
|---|---|
| <b>Future Work:</b> | <p>These piezometers were installed to monitor pore water pressure responses during fill placement of the culvert replacement project in 2019. The piezometers all show stable water levels that are well below peaks reached during construction. These instruments have served their purpose, and it suggested to remove them from the instrumentation monitoring program.</p> |

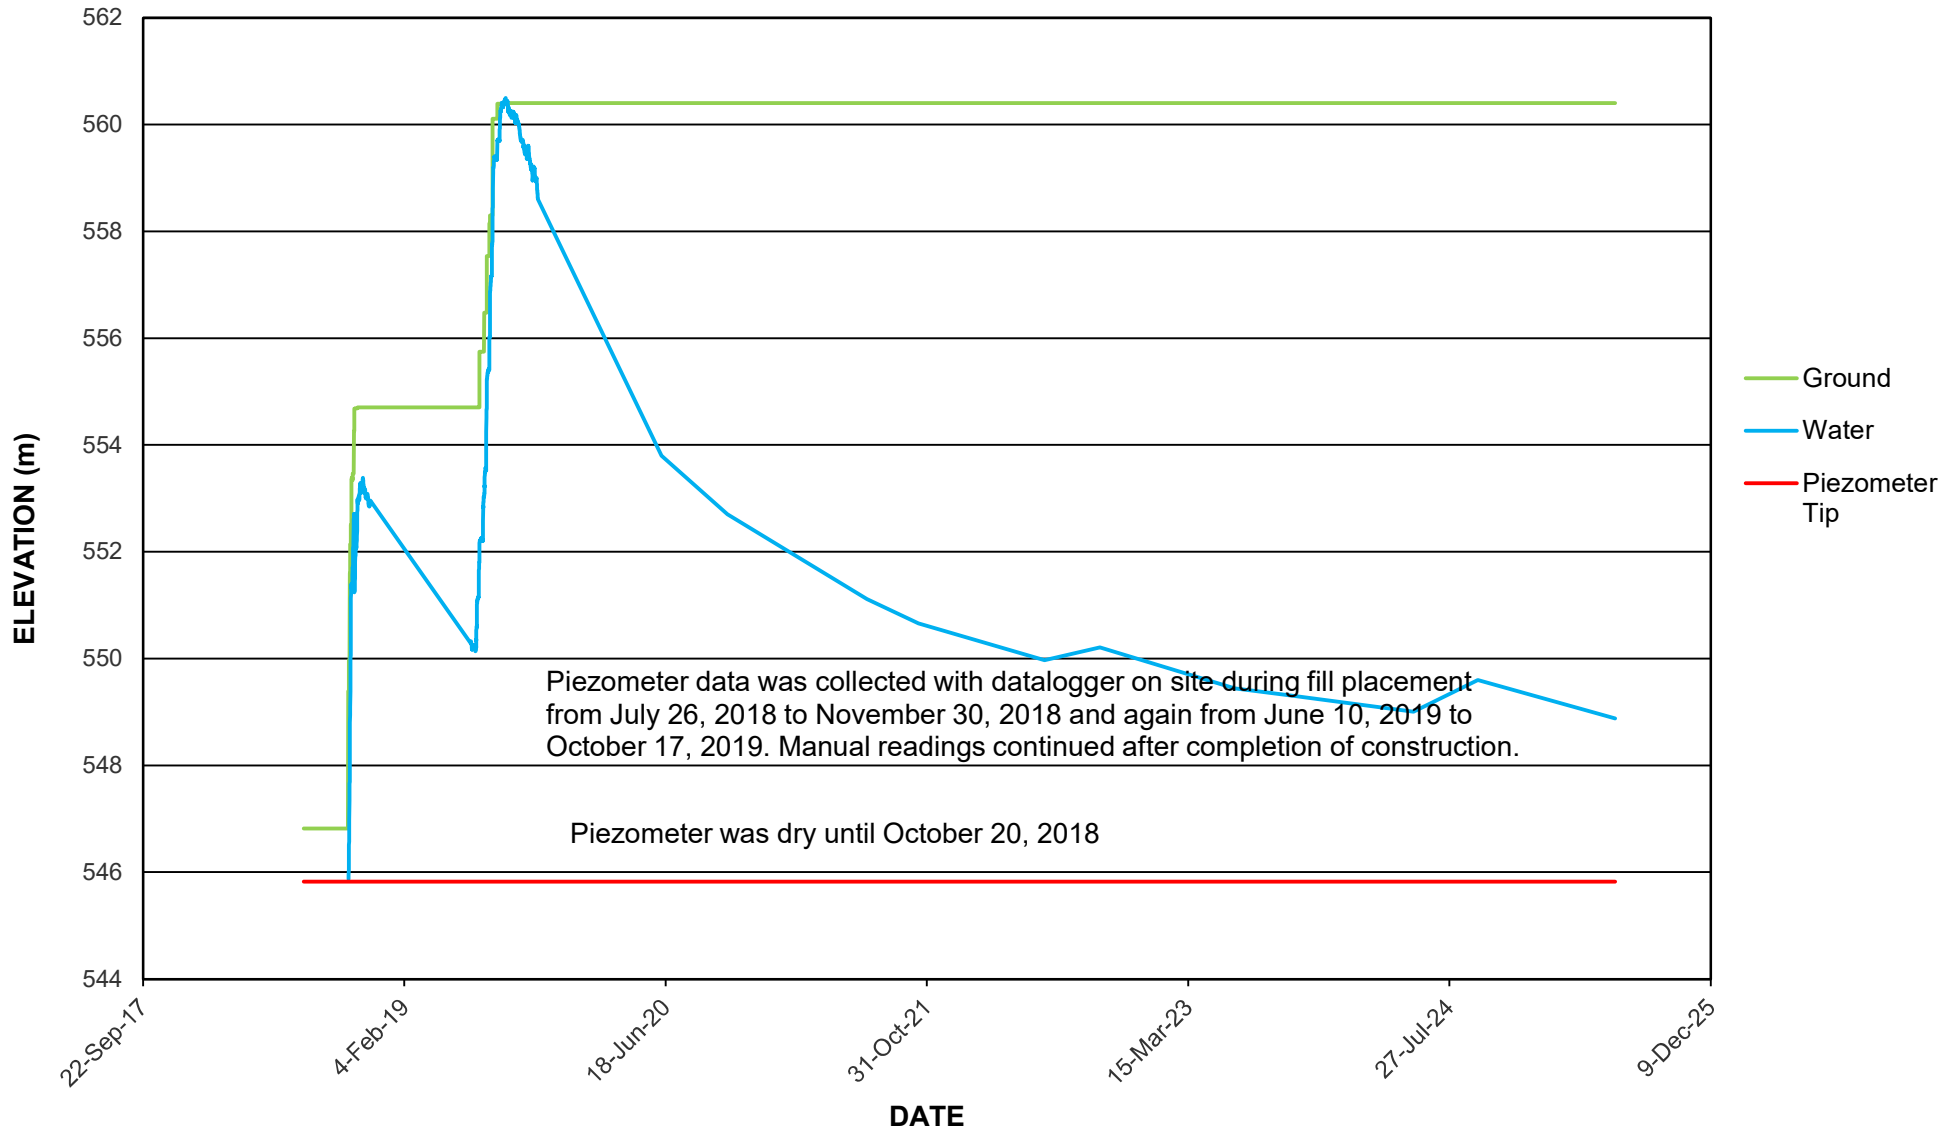
**FIGURE PH080-2**  
**HWY 688:02 McKINNEY CREEK CULVERT SLIDE - VW18-2**  
**(CENTER OF CULVERT)**

| INSTRUMENT | DATE INITIALIZED | TIP Elevation (m) | CURRENT STATUS | MAXIMUM GROUNDWATER ELEVATION (M) | CURRENT GROUNDWATER ELEVATION (m) | PREVIOUS GROUNDWATER ELEVATION (m) | CHANGE IN WATER LEVEL SINCE PREVIOUS READING (m) |
|---|---|---|---|---|---|---|---|
| VW18-2 (VW47343) | July 26, 2018 | 545.82 | Operational | 560.50 on August 16, 2019 | 548.88 | 549.60 | -0.72 |

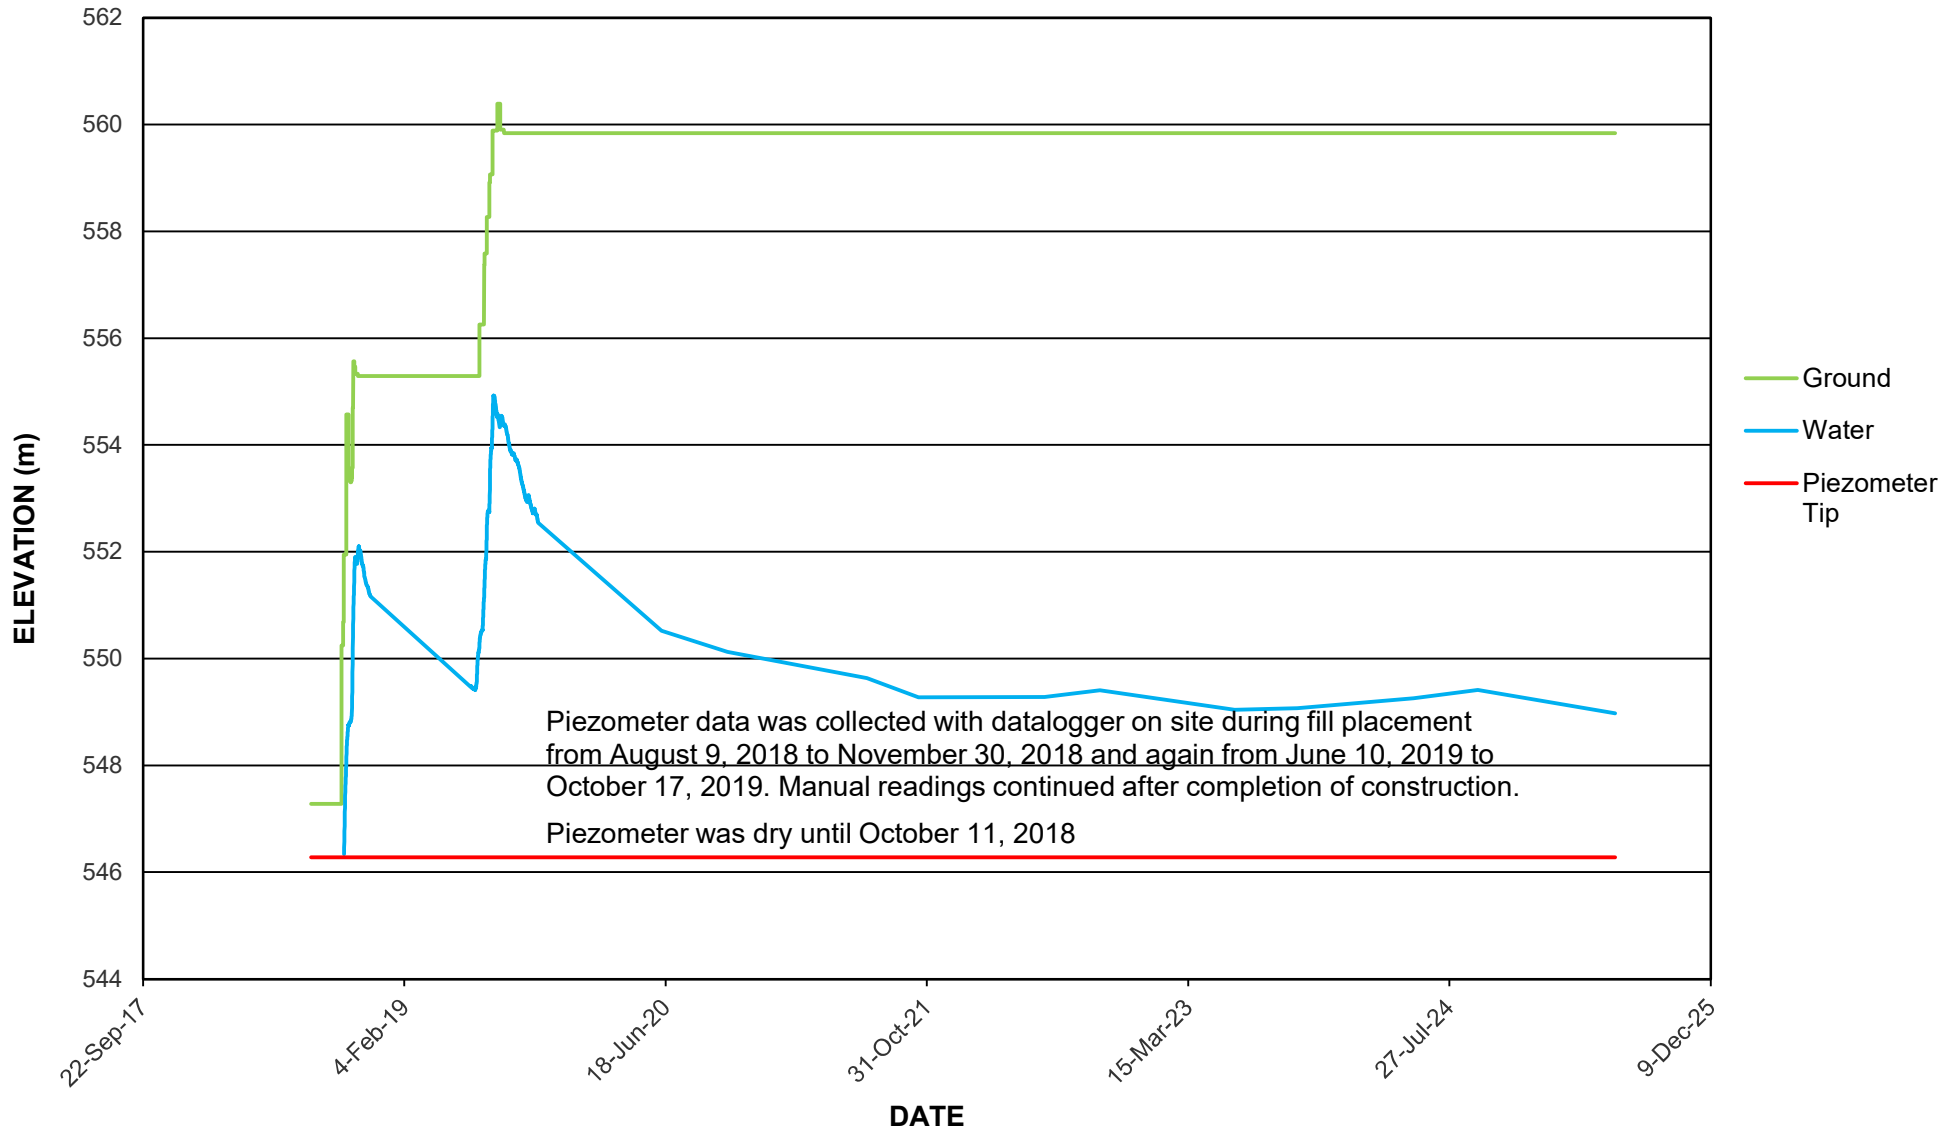
**FIGURE PH080-3**  
**HWY 688:02 McKINNEY CREEK CULVERT SLIDE - VW18-3**  
**(EAST SIDE OF CULVERT)**

| INSTRUMENT | DATE INITIALIZED | TIP Elevation (m) | CURRENT STATUS | MAXIMUM GROUNDWATER ELEVATION (M) | CURRENT GROUNDWATER ELEVATION (m) | PREVIOUS GROUNDWATER ELEVATION (m) | CHANGE IN WATER LEVEL SINCE PREVIOUS READING (m) |
|---|---|---|---|---|---|---|---|
| VW18-3 (VW45176) | August 8, 2018 | 559.84 | Operational | 554.93 on July 24, 2019 | 548.97 | 549.41 | -0.44 |
