**ALBERTA TRANSPORTATION  
GEOHAZARD ASSESSMENT PROGRAM  
PEACE REGION – HIGH LEVEL  
2019 CALLOUT**

<b>Site Number</b>	<b>Location</b>	<b>Name</b>	<b>Hwy</b>	<b>km</b>
691-2-1	Manning, Alberta		691:02	0.06
<b>Legal Description</b>		<b>UTM Co-ordinates</b>		
South Abutment: NE21-091-23-W5M		11U E 461,782	N	6,308,097

<b>Primary Site Issue:</b>	Landslide affecting the side slope of Hwy 691	
<b>Dimensions:</b>	The active slide is about 36 m wide parallel to the highway and 20 long in the downslope direction. Tension cracks extend an additional 15 m to the east. The slope is about 11 m high at the slide location. The bare backslope of the slide is inclined at 32 degrees and the side slopes outside the slide are inclined at 28 degrees to the horizontal.	
<b>Date of Remediation:</b>	None to date	
<b>Maintenance:</b>	Warning signs and barricades have been placed at the site	
<b>Observations:</b>	<b>Description</b>	<b>Worsened?</b>
<input checked="" type="checkbox"/> Pavement Distress	Tension cracks located 0.5 to 0.8 m into the pavement from the guardrail	<input type="checkbox"/>
<input checked="" type="checkbox"/> Slope Movement	There was a massive sudden movement/failure in the slope

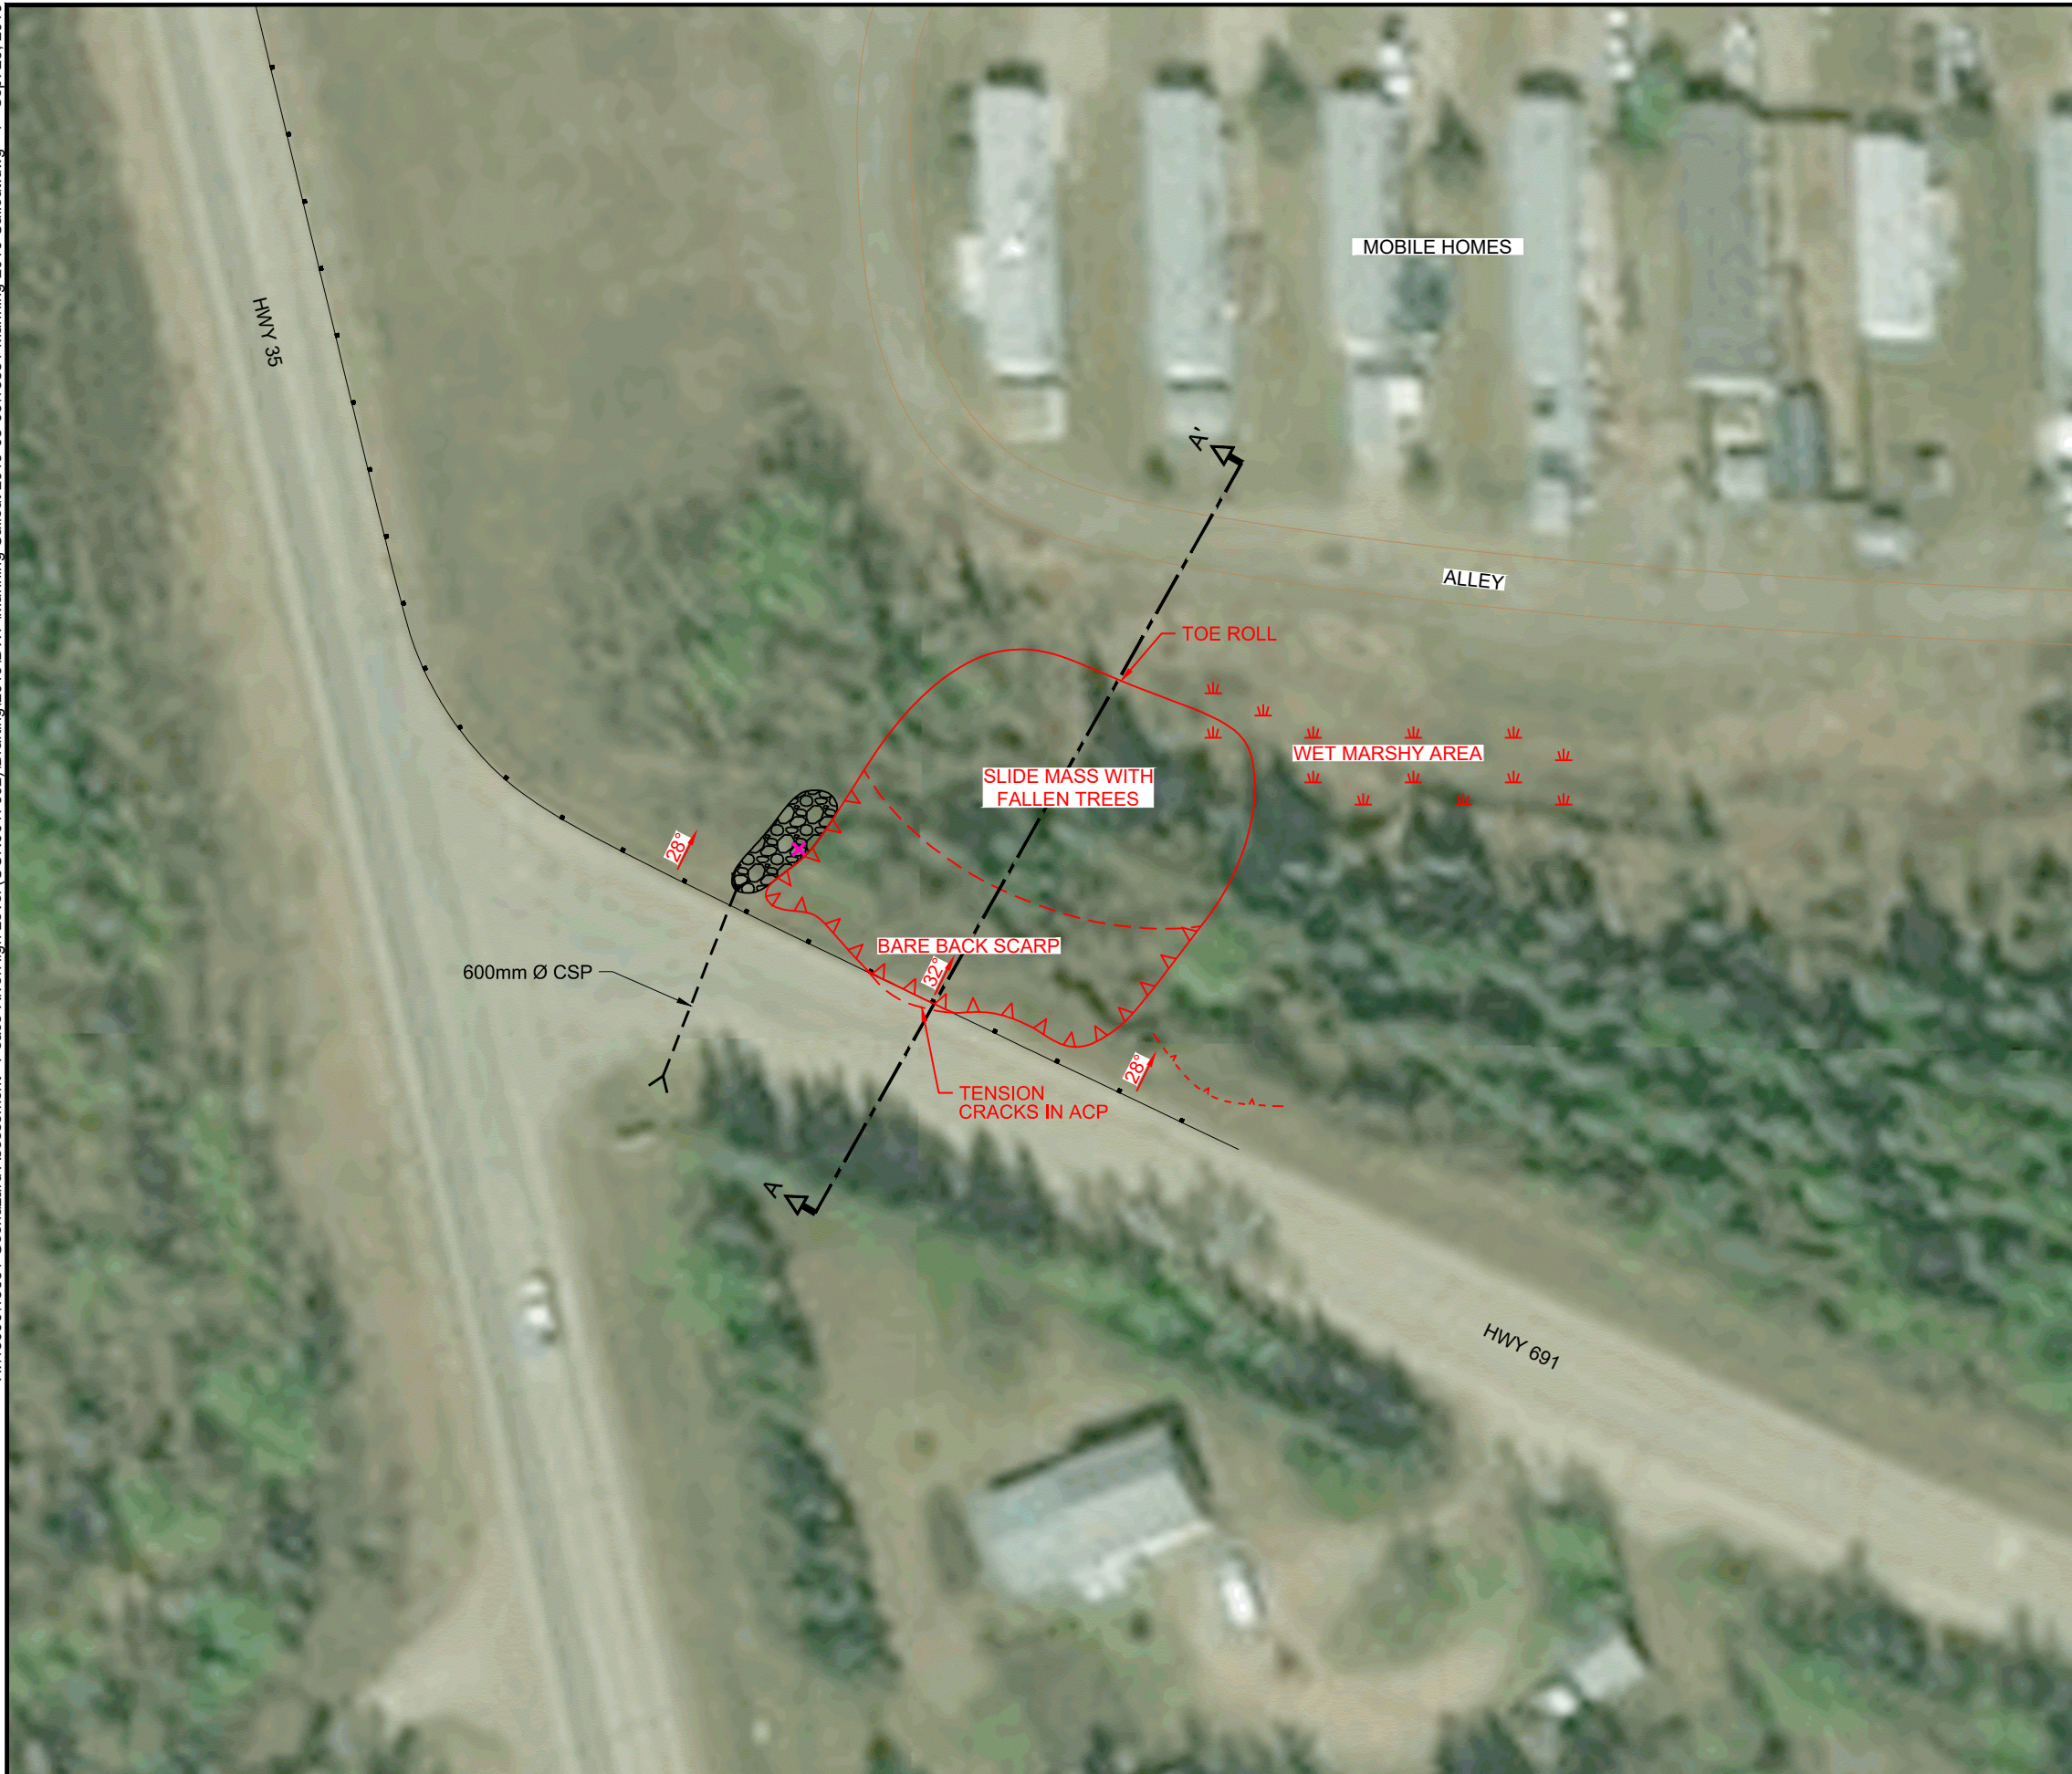
**FIGURE 1**

**SITE PLAN**

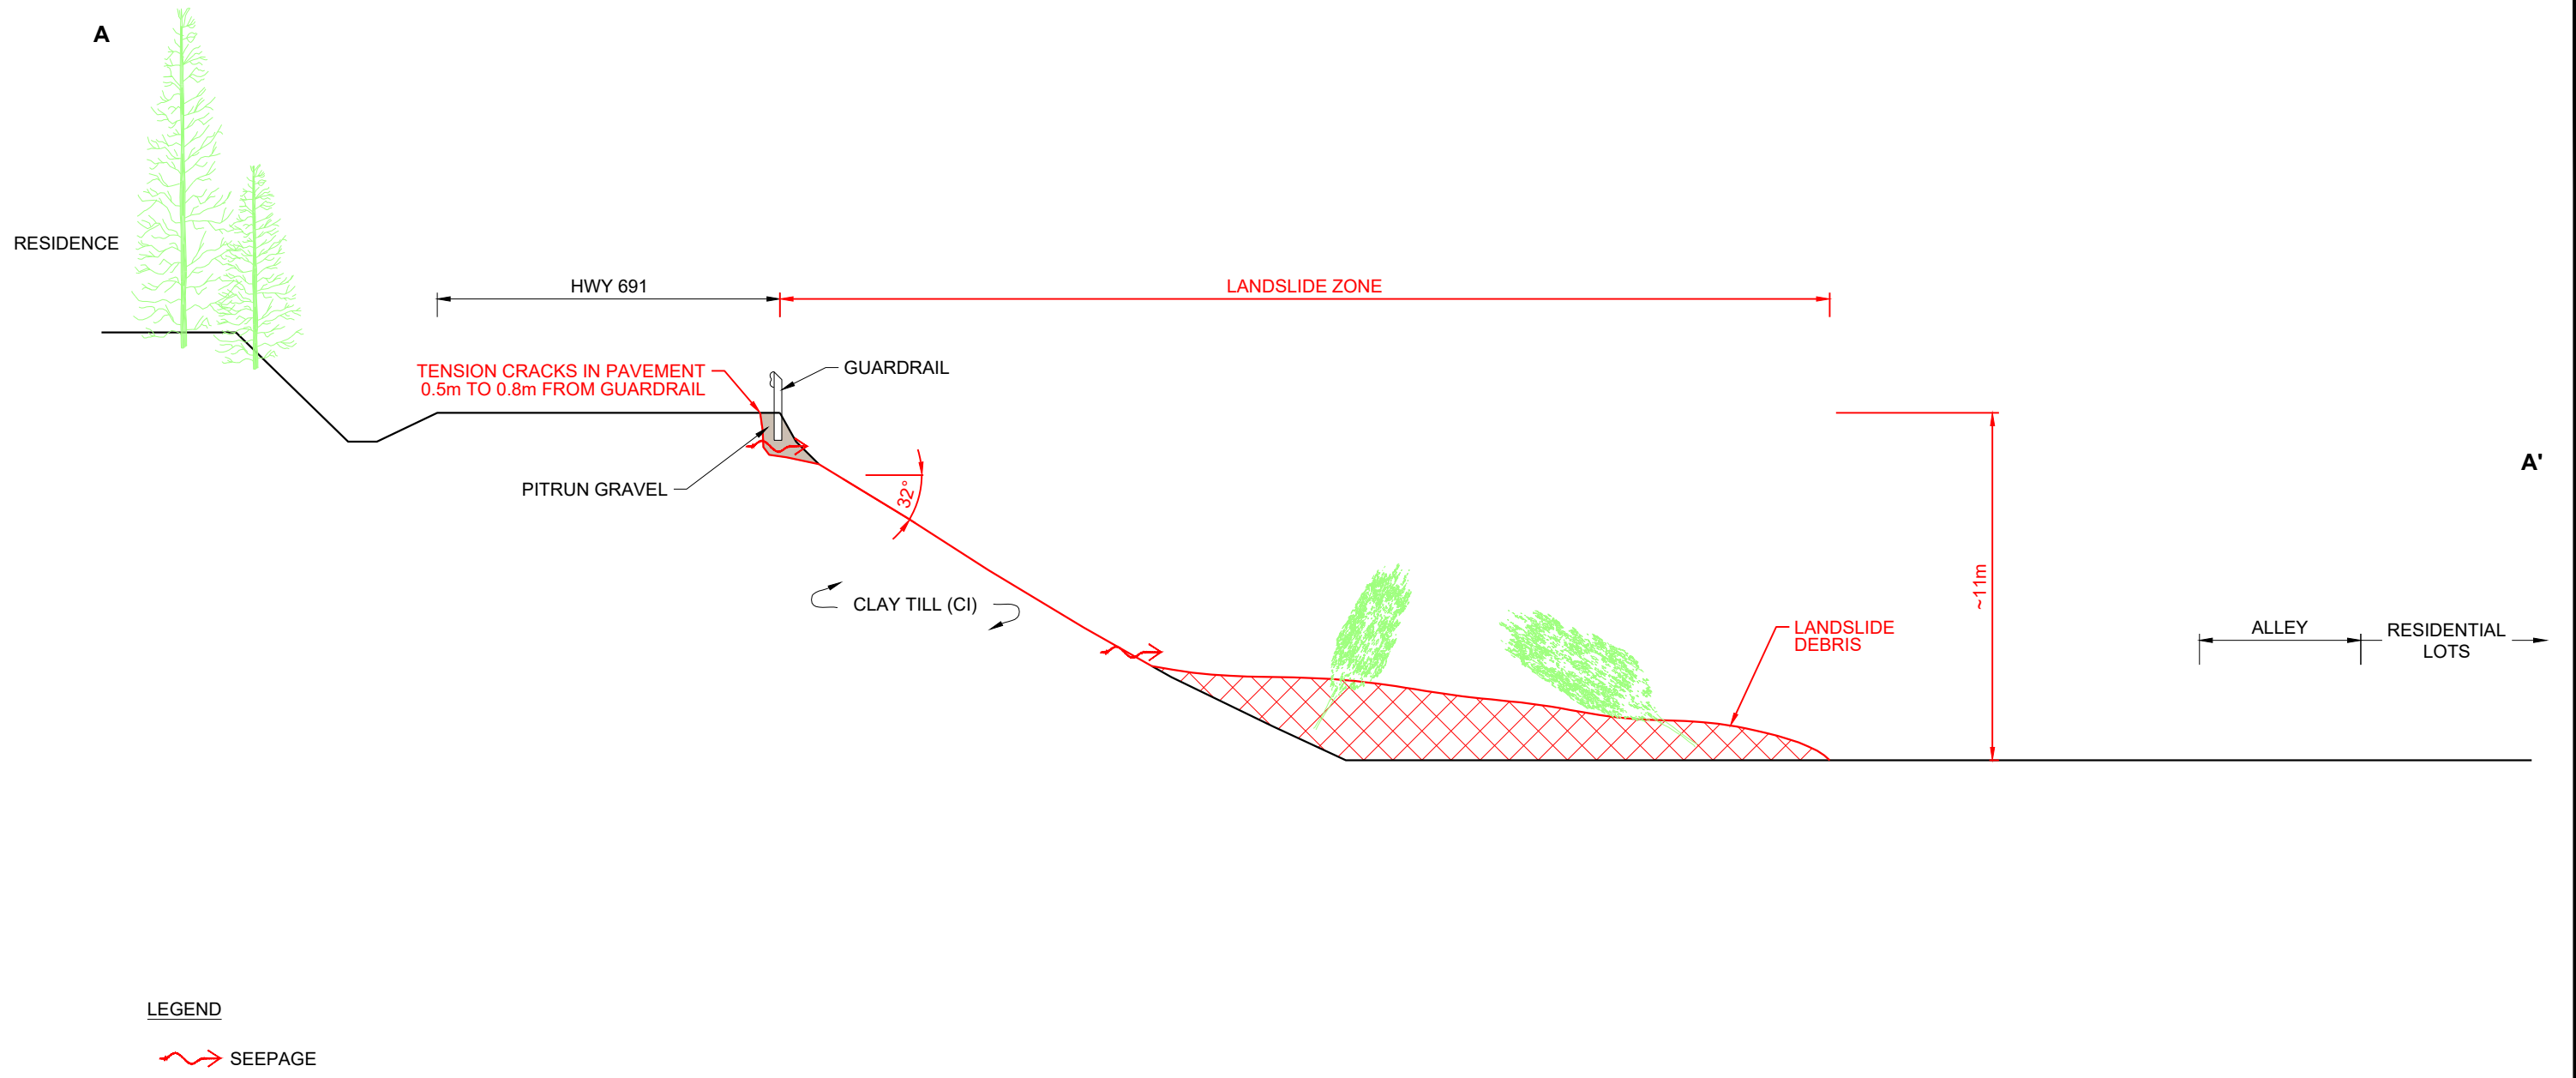
FIGURE 2

SECTION A-A'

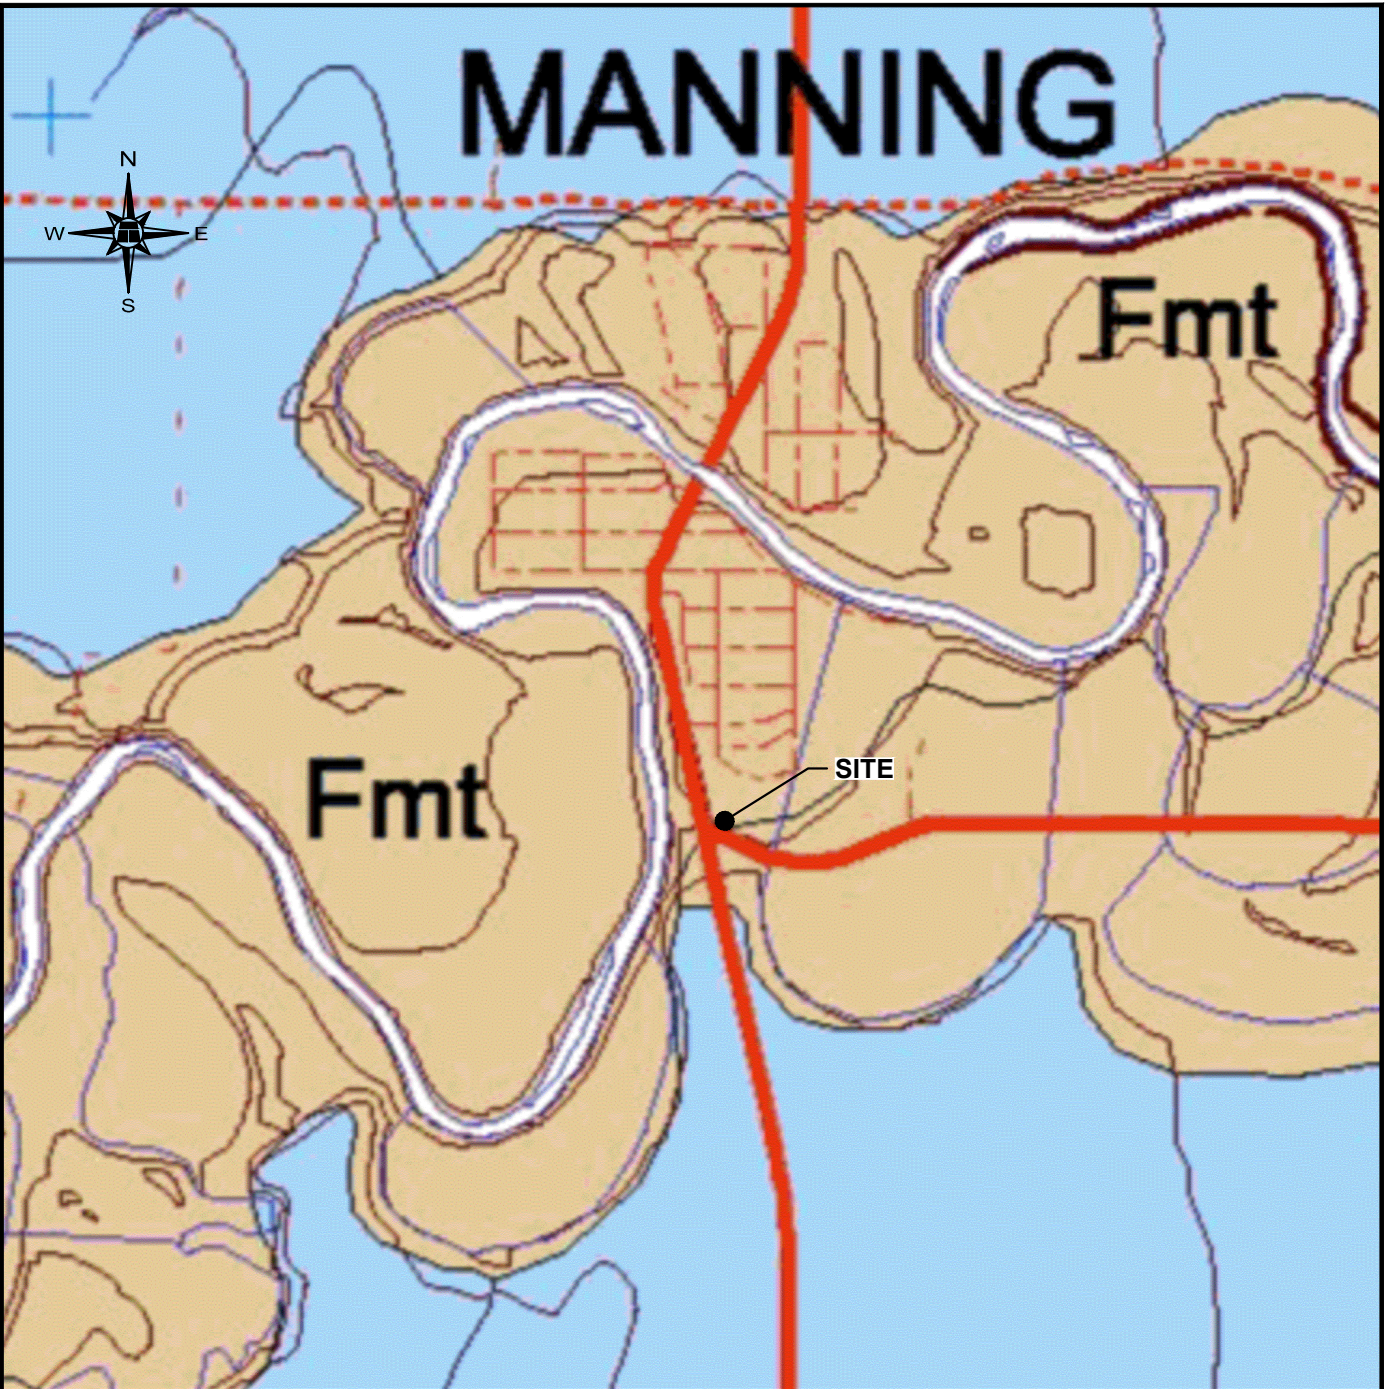
**FIGURE 3**

**SURFICIAL GEOLOGY MAP**

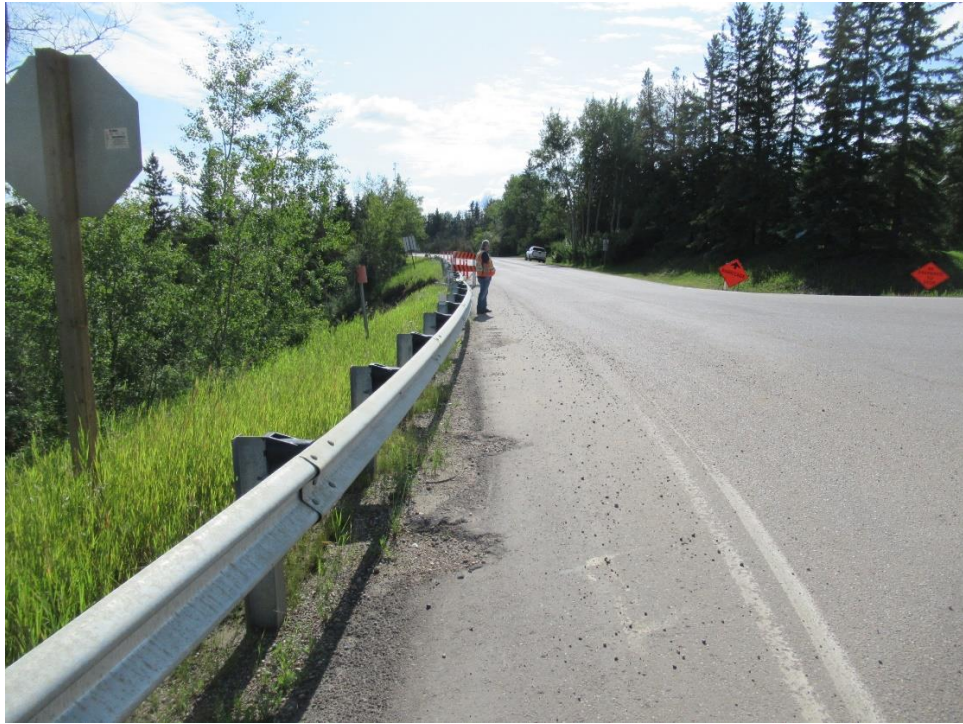
Photo 1, Looking East along Hwy. 691 toward the landslide.

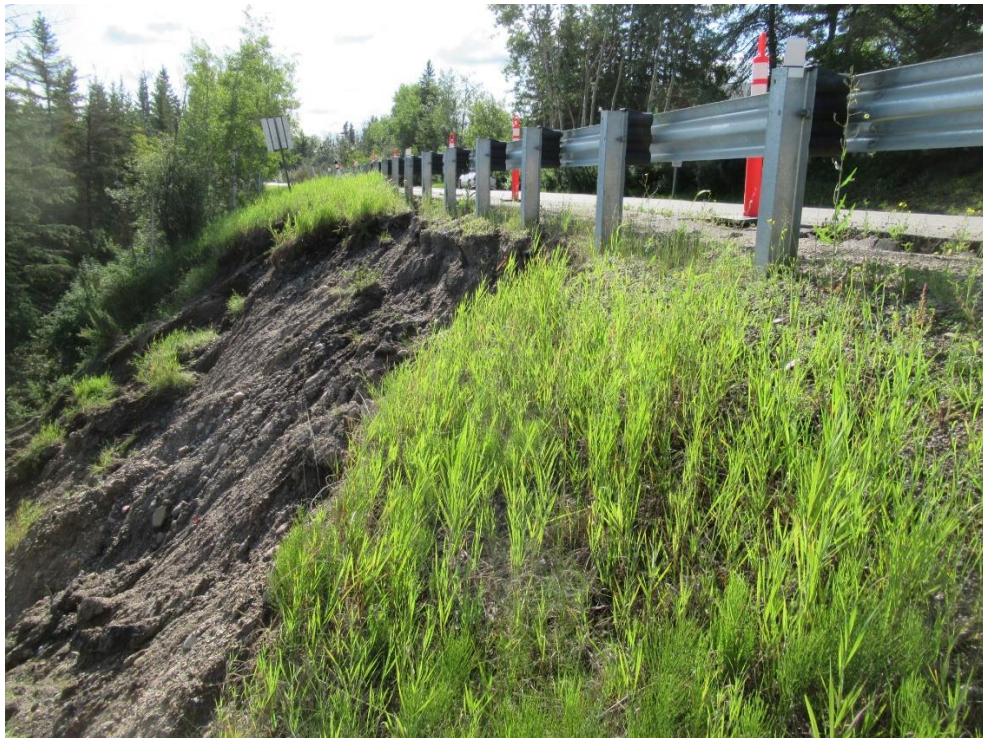
Photo 2, Backscarp of landslide is at the guardrail along Hwy. 691.

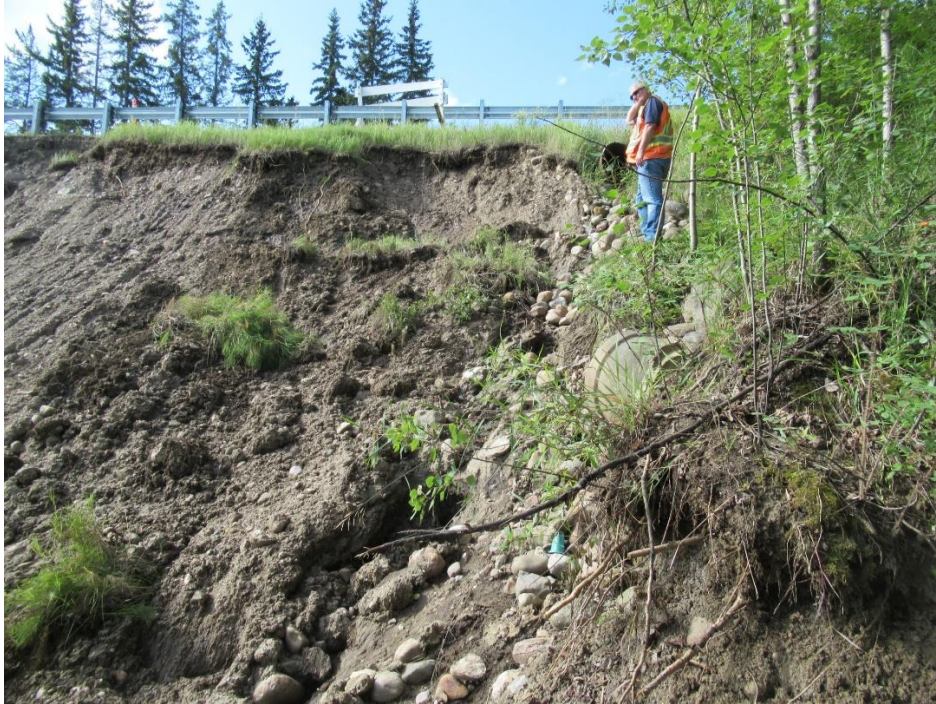
Photo 3, A 600 mm dia. C.S.P. outlets at the west flank of the slide. A 600 mm dia. Concrete pipe is located at the flank further down the slope.

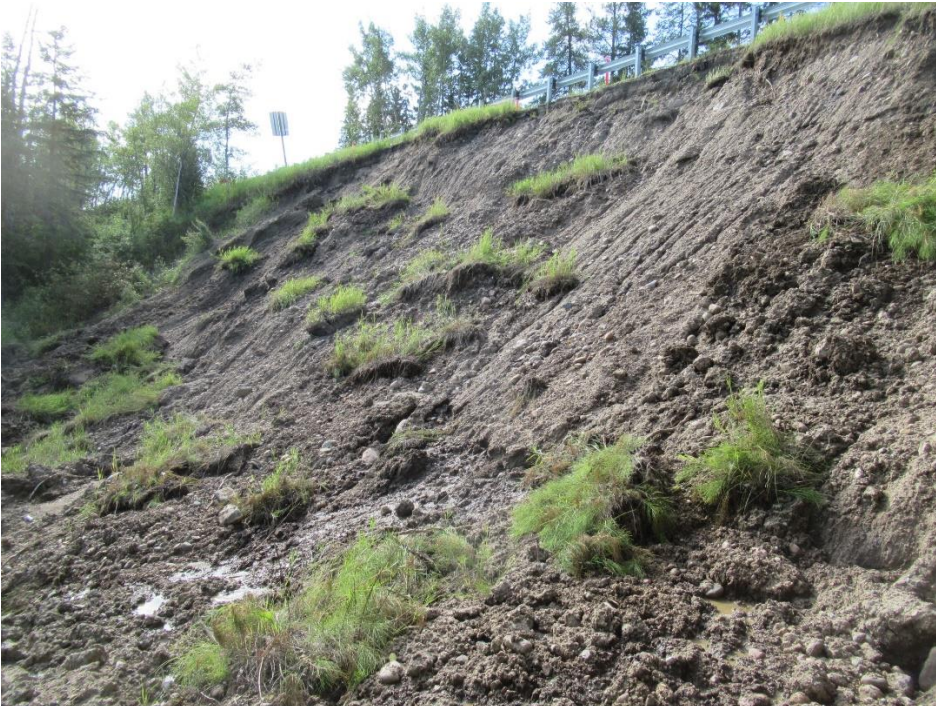
<input checked="" type="checkbox"/> Erosion	There are signs of erosion rills in the bare backslope of the landslide	<input type="checkbox"/>
<input checked="" type="checkbox"/> Seepage	Seepage was noted coming out of the top of the bare backslope from a pit run gravel layer under the pavement as well as lower in the slope from the till	<input type="checkbox"/>
<input checked="" type="checkbox"/> Bridge/Culvert Distress	The outlet of a 600 mm dia. C.S.P. centreline culvert drains onto the west flank of the slide from the intersecting ditches of Hwy. 691 and Hwy.35. The downstream riprap apron of the culvert has been disturbed by the slide movement. The outlet of a 600 mm dia. concrete pipe is also present lower on the west flank of the slide but the inlet of this pipe and where it drains from are unknown	<input type="checkbox"/>

Photo 4, Seepage coming from the till in the backscarp at the slide mass.

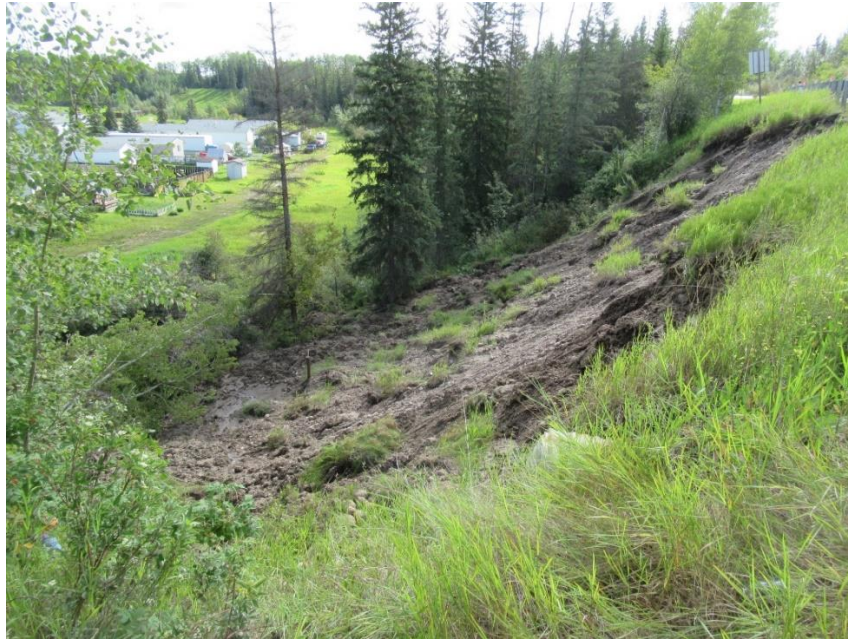
Photo 5, Looking east at the failed slope. The culvert outlet is in the forefront.

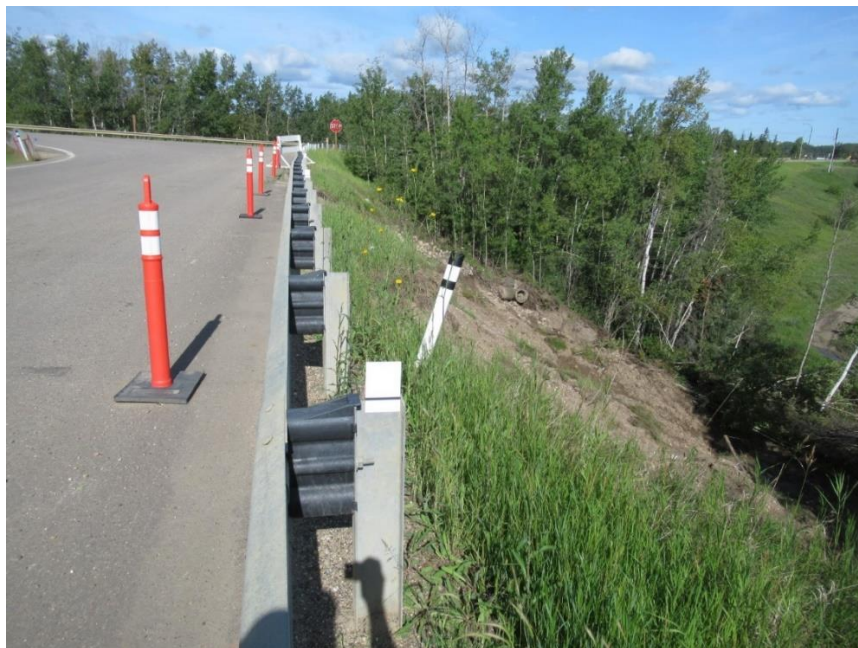
Photo 6, Looking west along Hwy. 691 at the landslide.

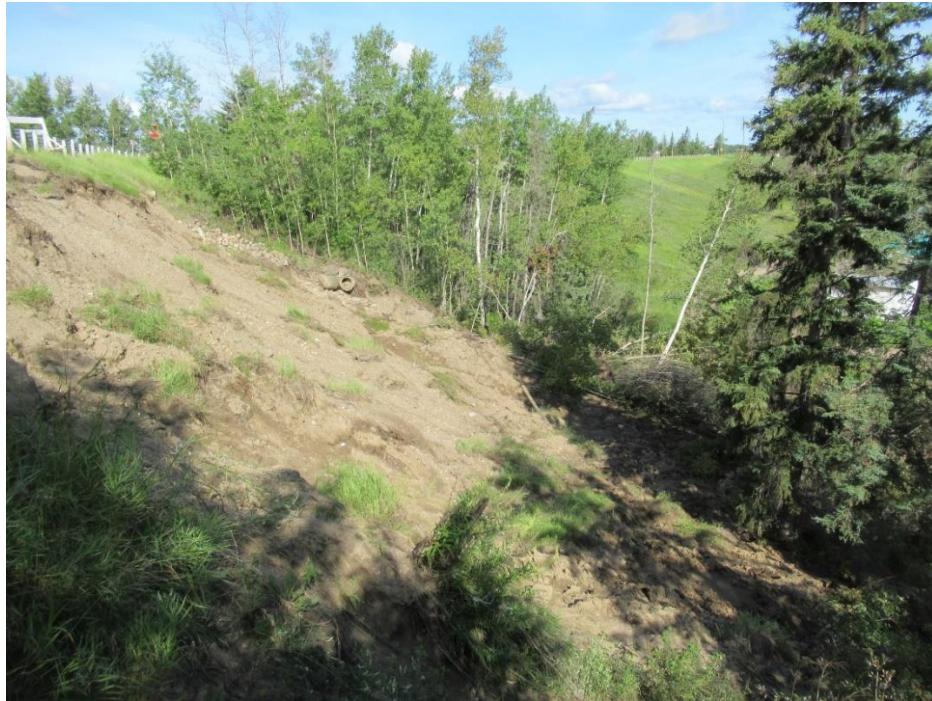
Photo 7, Looking west at the failed slope with slide mass and fallen/tilted trees at toe.

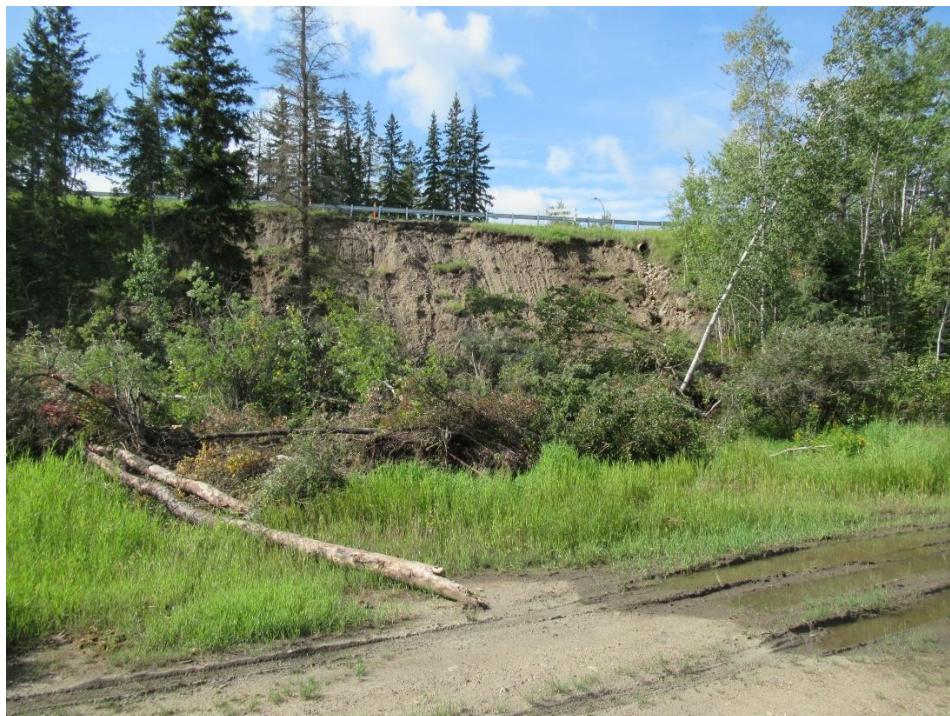
Photo 8, Looking south at the failed slope from the alley behind the mobile homes

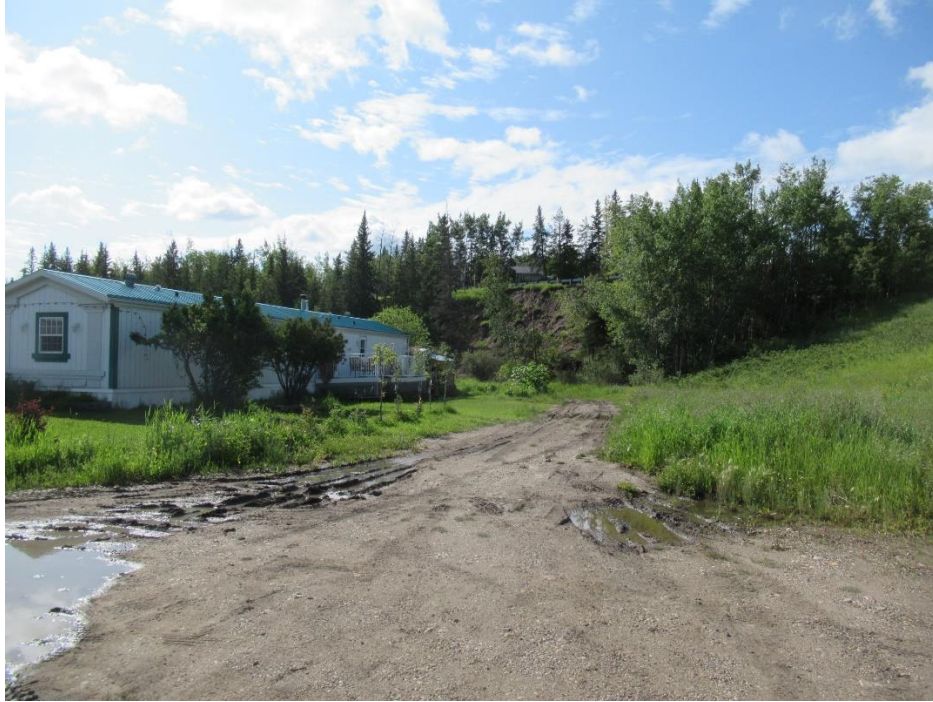
Photo 9, Looking south at the failed slope from the north end of the alley.
