**ALBERTA TRANSPORTATION
GEOHAZARD ASSESSMENT PROGRAM
PEACE REGION – HIGH LEVEL
2020 INSPECTION REPORT**

Site Number	Location	Name	Hwy	km
PH086	Manning, Alberta	Pinewood Estates	691:02	0.06
Legal Description		UTM Co-ordinates		
South Abutment: NE21-091-23-W5M		11U E 461,782	N	6,308,097

**PH086-1: HWY 691:02 PINWOOD ESTATES
2020 GEOHAZARD ASSESSMENT**

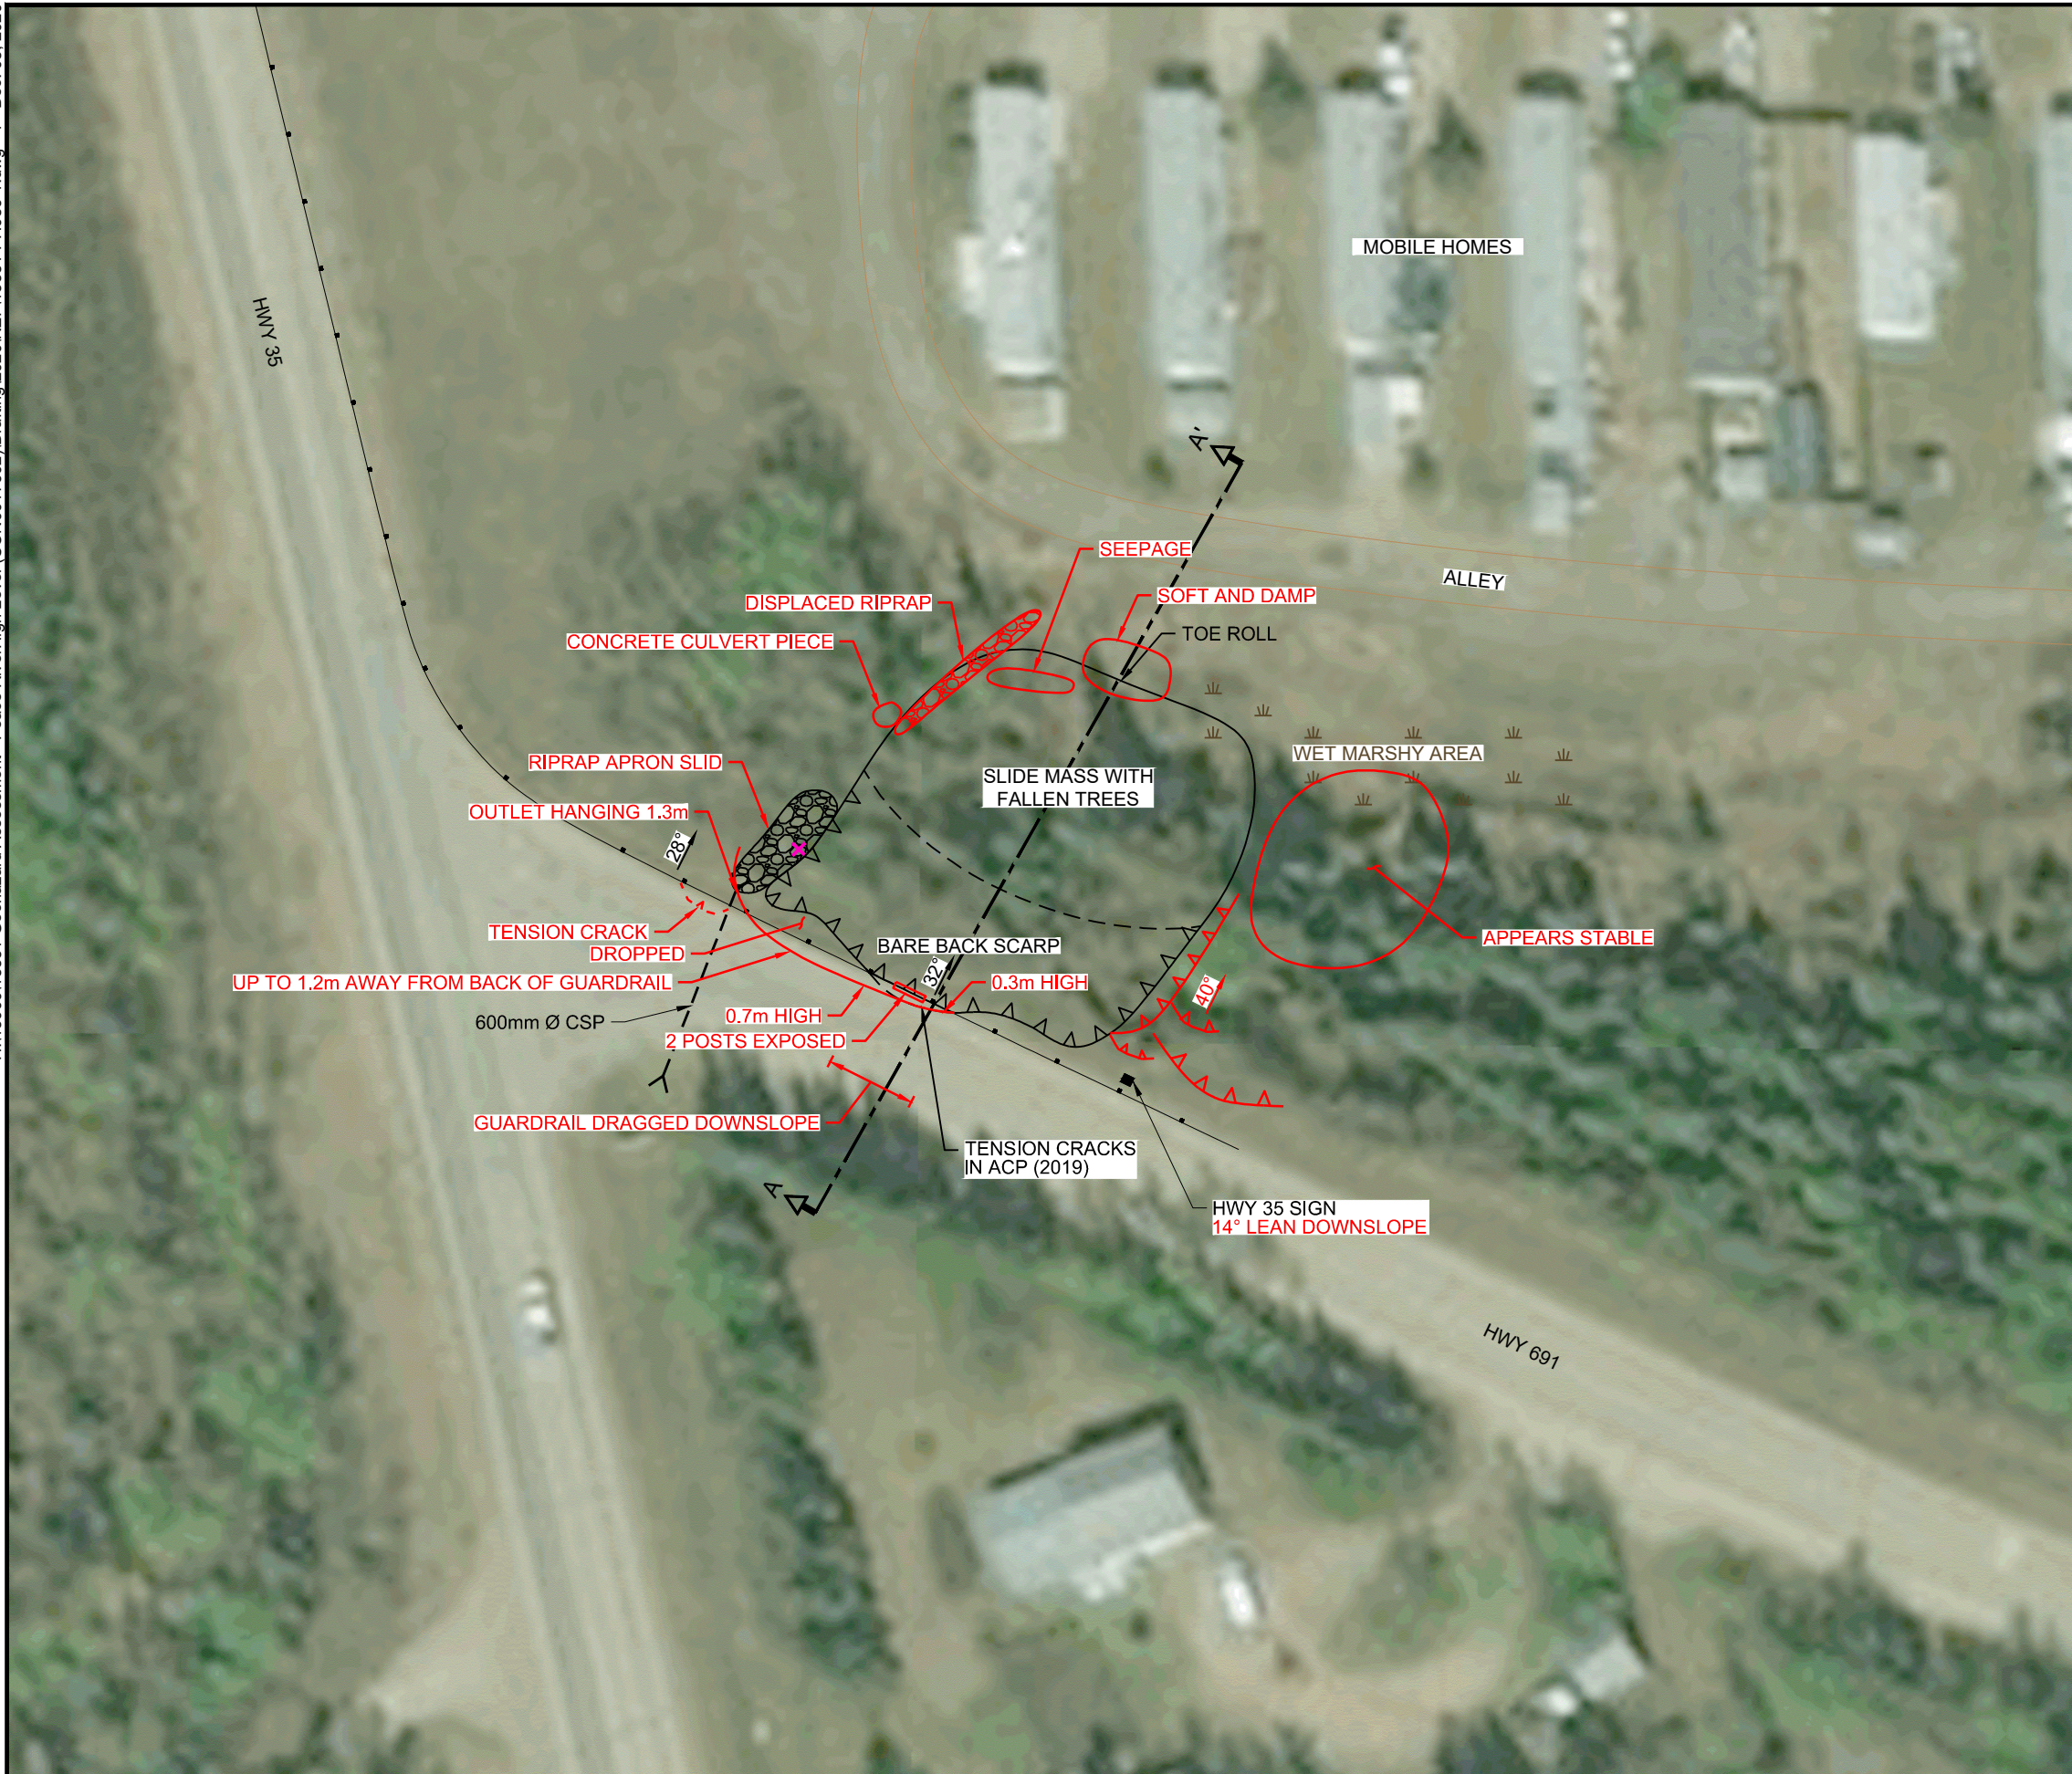
DWG No. 13351-PH086-1-1

Primary Site Issue:	Landslide affecting the side slope of Hwy 691	
Dimensions:	50 m length of highway, 30 m wide, ~11 m high slope Tension cracks extend about 4 m further west The active slide is about 36 m wide parallel to the highway and 20 long in the downslope direction. Tension cracks extend an additional 15 m to the east. The slope is about 11 m high at the slide location. The bare backslope of the slide is inclined at 32 degrees and the side slopes outside the slide are inclined at 28 degrees to the horizontal.	
Date of Remediation:	None to date	
Maintenance:	Warning signs and jersey barriers have been placed at the site	
Observations:	Description	Worsened?
<input checked="" type="checkbox"/> Pavement Distress	2019 tension cracks became scarp in 2020; New tension crack formed at west end.	<input checked="" type="checkbox"/>
<input checked="" type="checkbox"/> Slope Movement	2019 slide mass continues to move and break up. It extended both east and west in 2020.	<input checked="" type="checkbox"/>

The initial movement at the site occurred relatively quickly on July 26, 2019, and was about 36 m in length (measured perpendicular to the Hwy 691). Additional tension cracks were noted in the bush east of the main slide area. Clay till was exposed in the bare backscarp of the landslide. Seepage was observed from a pit-run gravel layer below the pavement and lower in the slope from within the clay till. It is possible that the clay till has lost its cohesion over time and that the wetter-than-average weather in 2019 resulted in an elevated water table which triggered the movement. The landslide has left the slope in an over-steep, unvegetated condition which will likely retrogress into the pavement over time. As observed in 2020, the slide has regressed further into the highway up to 1.2 m. Many of the tension cracks observed in 2019 became part of the scarp in 2020 for a total slide length of 50 m. The culvert outlet riprap apron was displaced by movement and there is a tension crack in the highway extending further west beyond the culvert. At least two guardrail posts were mostly exposed in the central portion of the slide.

- Routine visual monitoring of the site and adjustment of the locations of the barricades and warning signs if/as the landslide backscarp retrogresses further into the paved road surface.

- Consideration could be given to installing 3 rows of soil nails and a reinforced soil covering mesh to reinforce the soil in the upper part of the slope to try to slow future retrogression of the slide until more permanent measures can be put in place. A continuous pipe could also be attached to the end of the culvert to carry water all the way down to the bottom of the slope to reduce the amount of water that is spilt into the slide area. A ballpark cost for these measures is about \$300,000 if a soil nailing rig is currently available in Alberta. The cost could be higher if a rig is mobilized from out of province. This would be a temporary fix that might delay more permanent measures by a few years.
- Alternatively, the culvert could be abandoned and replaced with a new culvert under Hwy 35. The flow would then be discharged on the vegetated slope of the river.

- A possible remedial measure is to realign the highway to a new intersection between about 150 m to 400 m further south depending on the land acquisition on the south side of the residences located in the southeast corner of the intersection. The exact alignment will depend on which properties can be acquired. It is recommended that the abandoned portion of Hwy 691 be removed the slope flattened. This is likely the most expensive option but also the most robust.
- Alternatively, the slope could be buttressed by a toe berm and granular fill. Water from the culvert would need to be controlled via an armoured swale extending down the toe berm or by re-aligning the culvert by boring a new SWSP under Hwy 35 to outlet to the west..

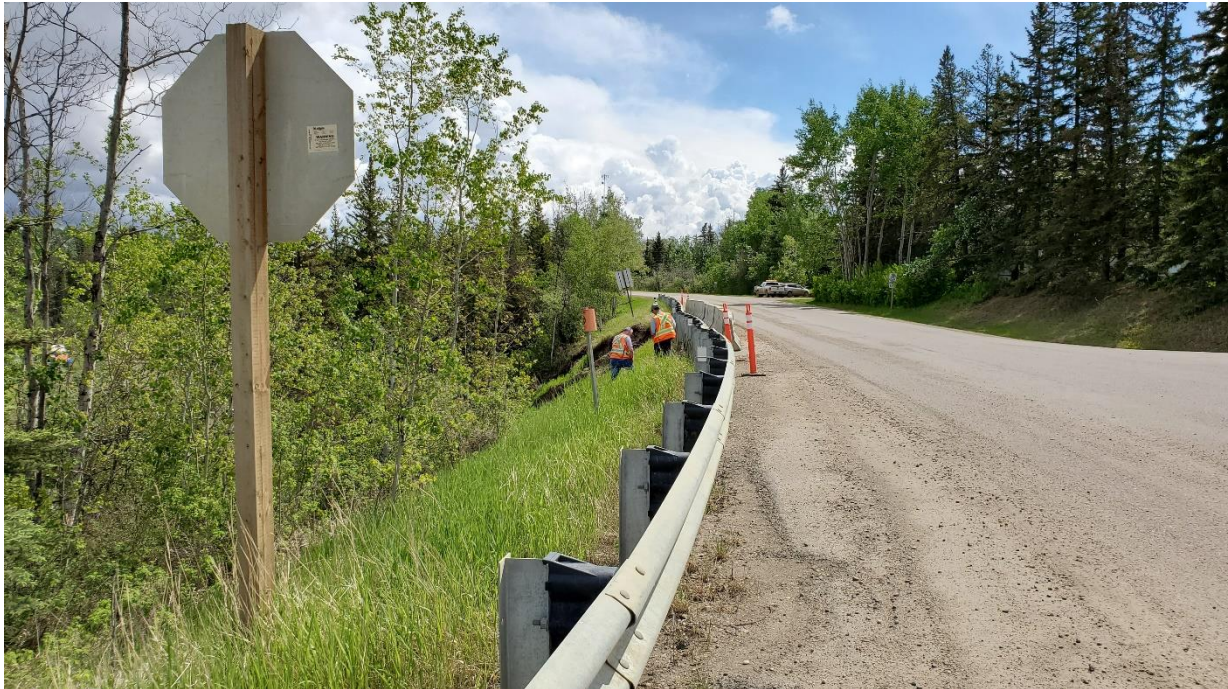
Photo 1 – Looking East along Hwy. 691 toward the landslide.

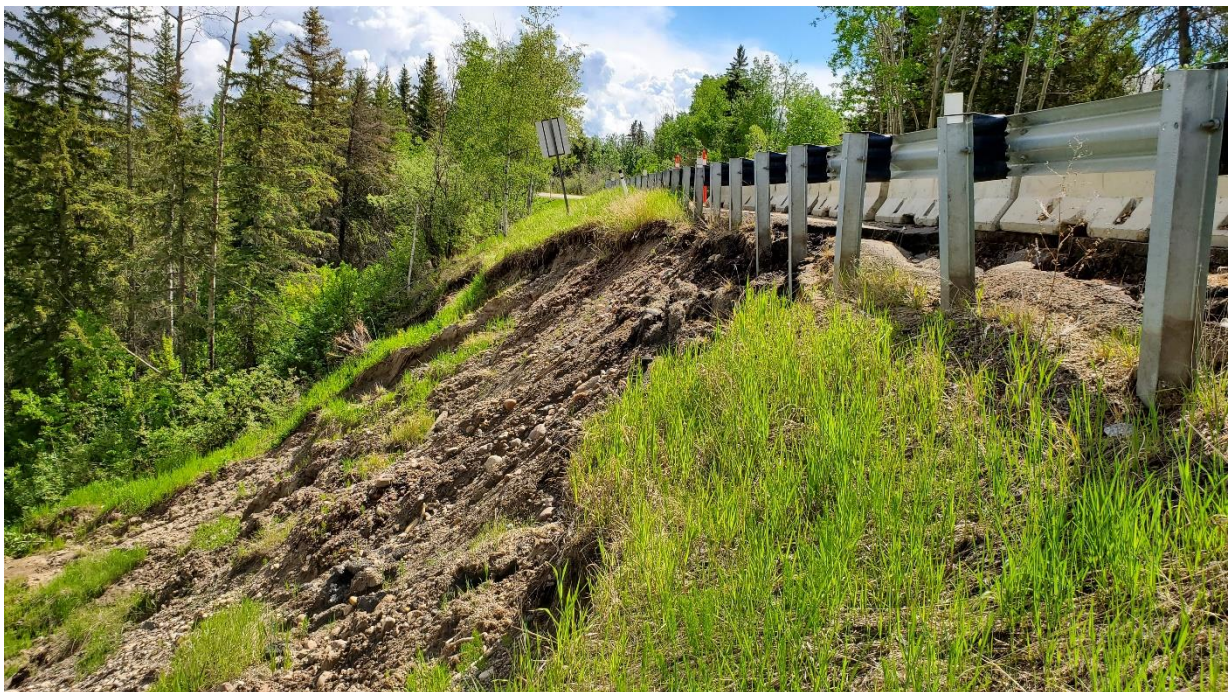
Photo 2, Backscarp of landslide is at the guardrail along Hwy. 691.

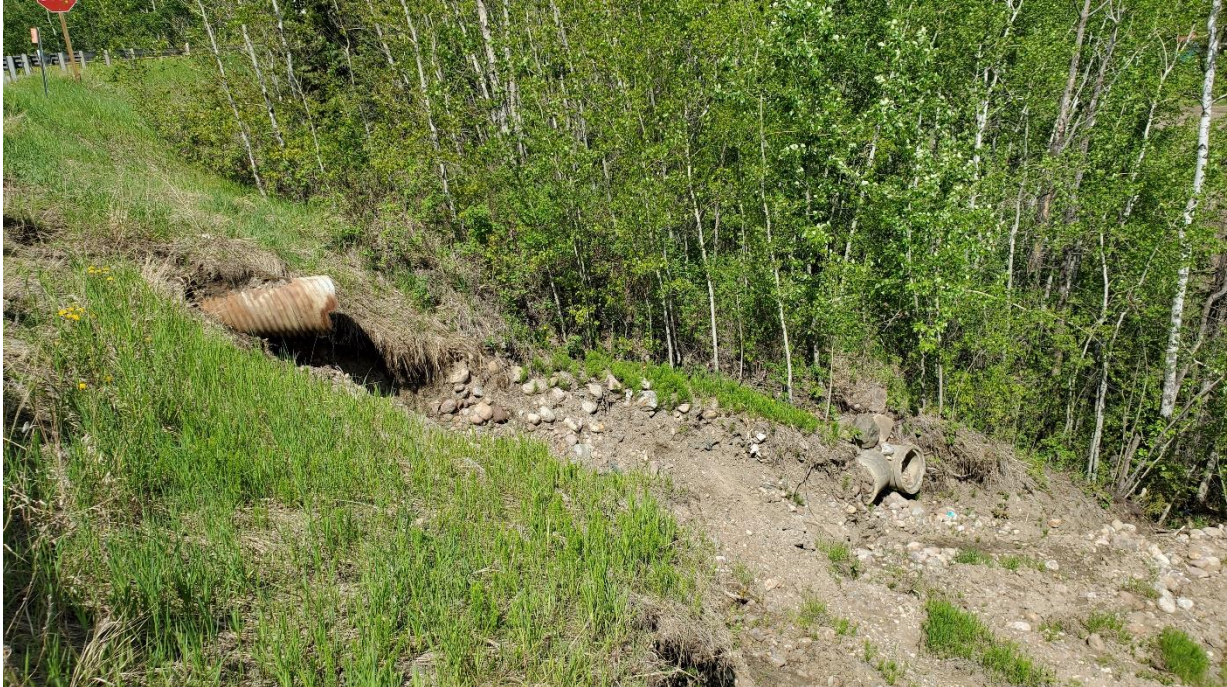
The outlet of a 600 mm dia. C.S.P. centerline culvert drains onto the west flank of the slide from the intersecting ditches of Hwy. 691 and Hwy.35. The downstream riprap apron of the culvert has been disturbed by the slide movement. The outlet of a 600 mm dia. concrete pipe is also present lower on the west flank of the slide but the inlet of this pipe and where it drains from are unknown. The toe of the landslide is about 12 m from an alley that services some mobile homes located at the base of the slope in a residential subdivision.

Photo 3, A 600 mm dia. C.S.P. outlets in the west flank of the slide. A 600 mm dia. concrete pipe piece is located at the flank further down the slope.

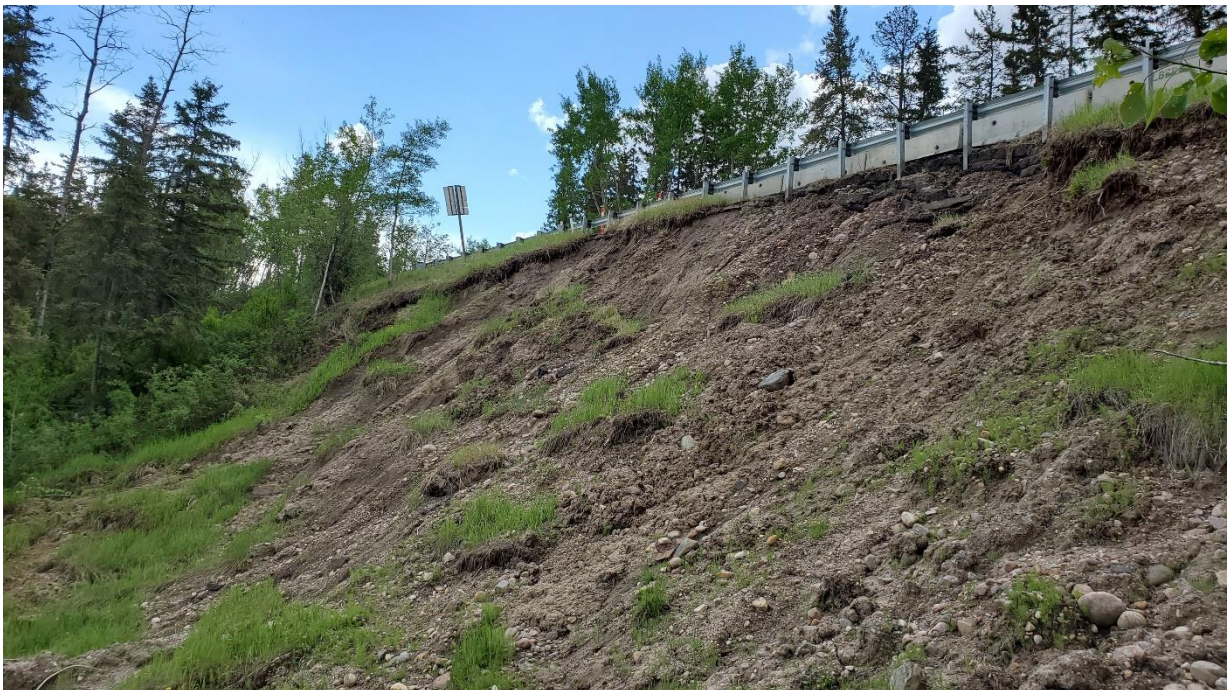
<input checked="" type="checkbox"/> Erosion	Exposed soil of slide mass eroding.	<input type="checkbox"/>
<input checked="" type="checkbox"/> Seepage	Previous seepage from gravel layer not observed in 2020; lower quarter of slope appears to have seepage.	<input checked="" type="checkbox"/>
<input checked="" type="checkbox"/> Bridge/Culvert Distress	600 mm CSP culvert outlet hanging 1.3m in 2020 and riprap apron destroyed by slide movement. Piece of 600 mm concrete culvert on west flank of slope but origin and inlet unknown.	<input checked="" type="checkbox"/>
<input checked="" type="checkbox"/> Other	Area at toe of slide and beyond is soft and wet.	<input type="checkbox"/>
Instrumentation:	There is no instrumentation at this site	
Assessment:	There was a sudden movement/failure in the slope on July 26, 2019. Tension cracks were also noted near the top of the slope in the bush to the east of the main slide area Seepage was noted coming out of the top of the bare backslope from a pit run gravel layer under the pavement as well as lower in the slope from the

Photo 4, Exposed till in the backscarp at the slide mass. Seepage was observed in this face at the time of the callout but appeared dry in June 2020.

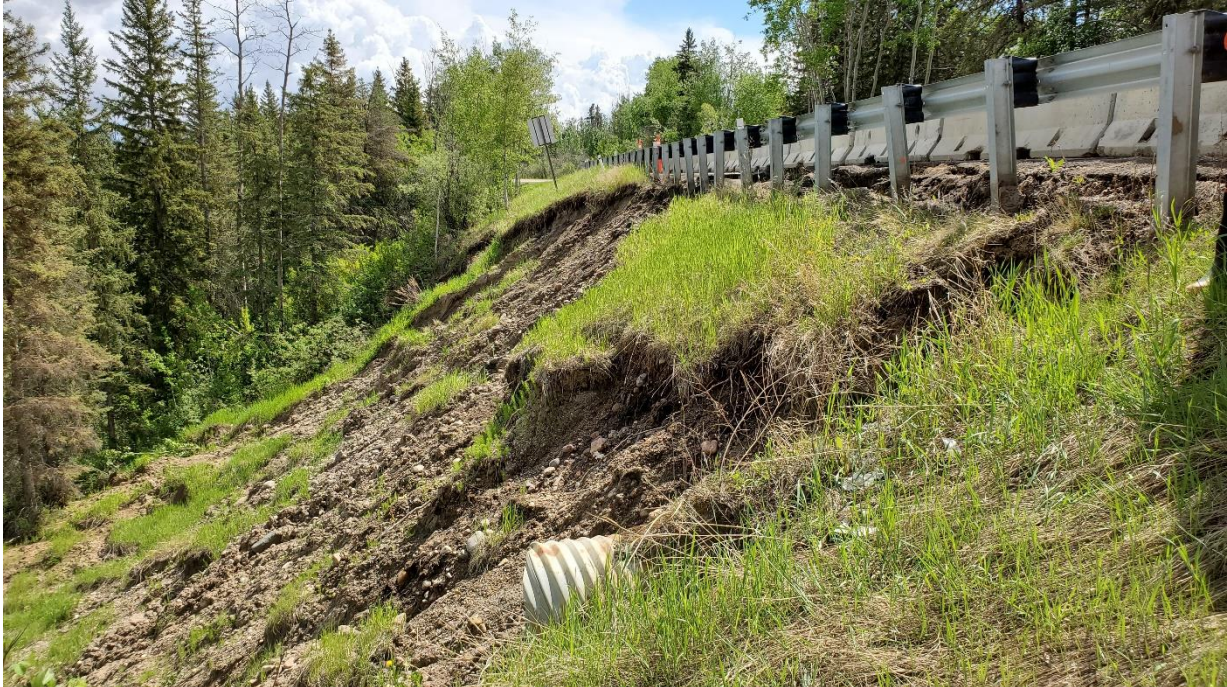
Photo 5, Looking east at the failed slope. The culvert outlet is in the forefront.

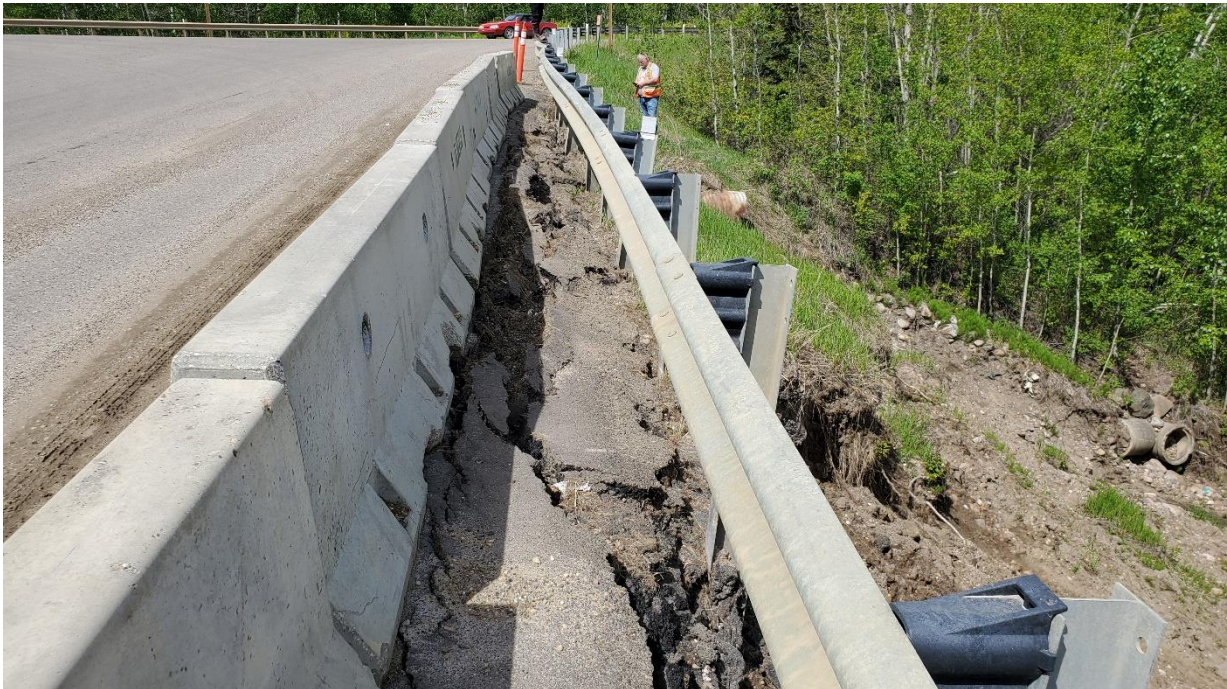
Photo 6, Looking west along Hwy. 691 at the landslide cracks in the highway surface.

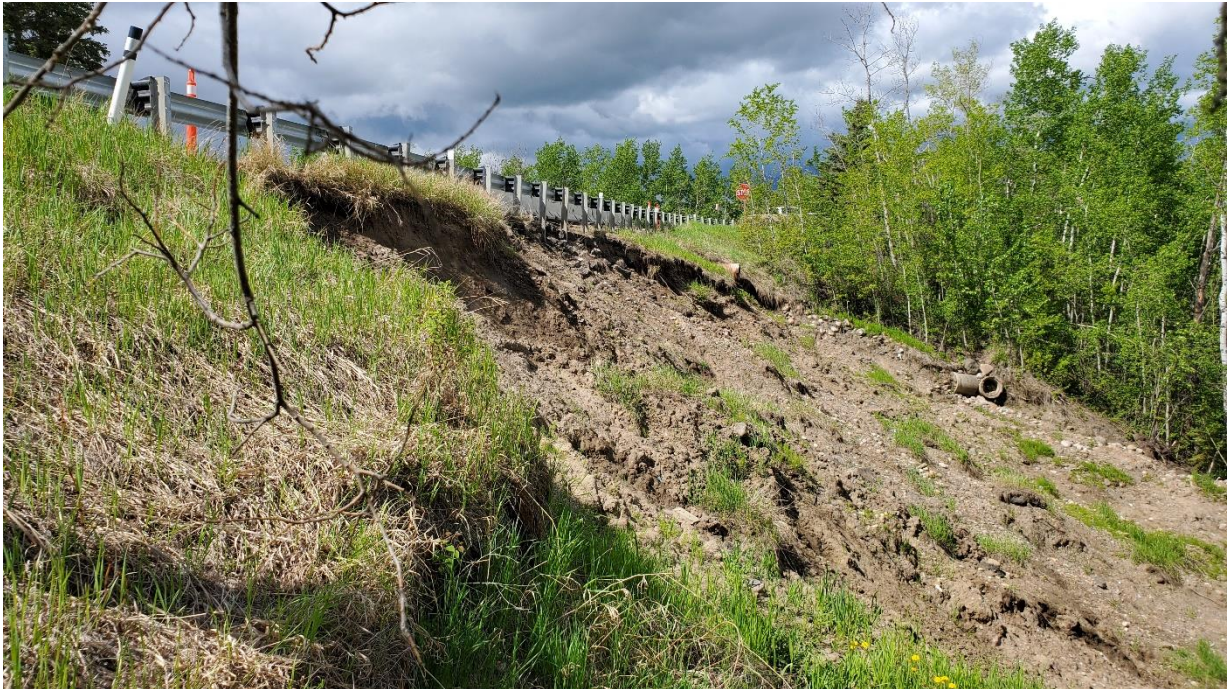
Photo 7, Looking west at the failed slope with slide mass and fallen/tilted trees at toe.

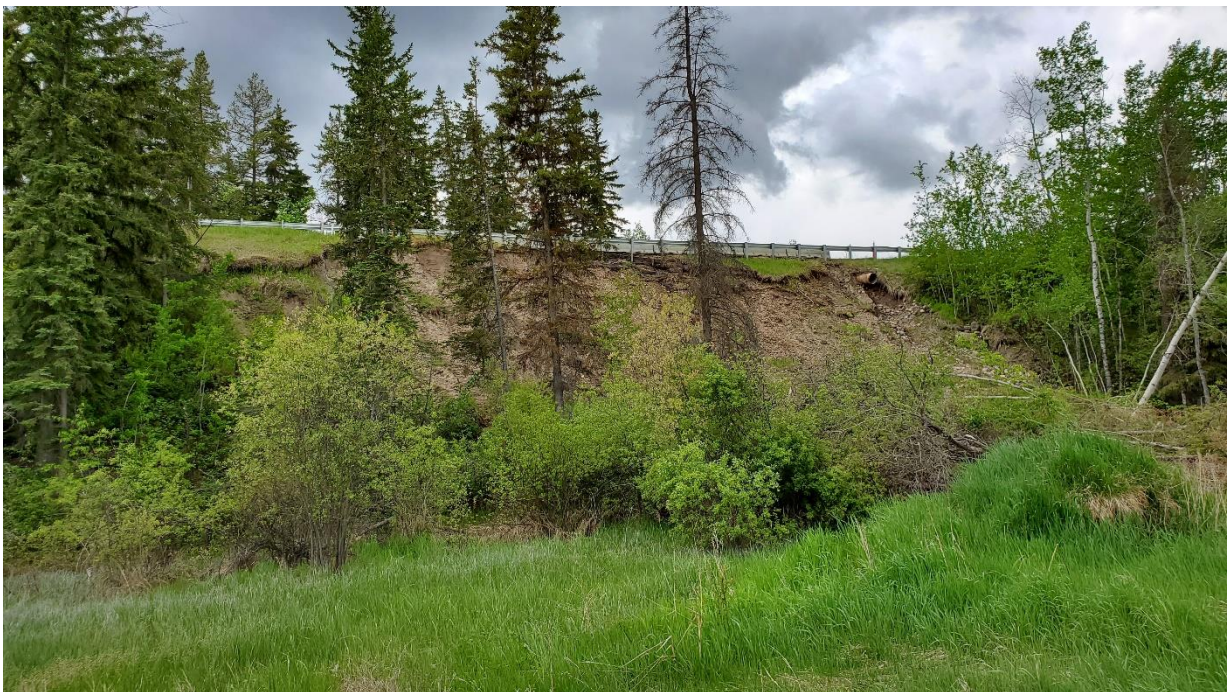
Photo 8, Looking south at the failed slope from the alley behind the mobile homes

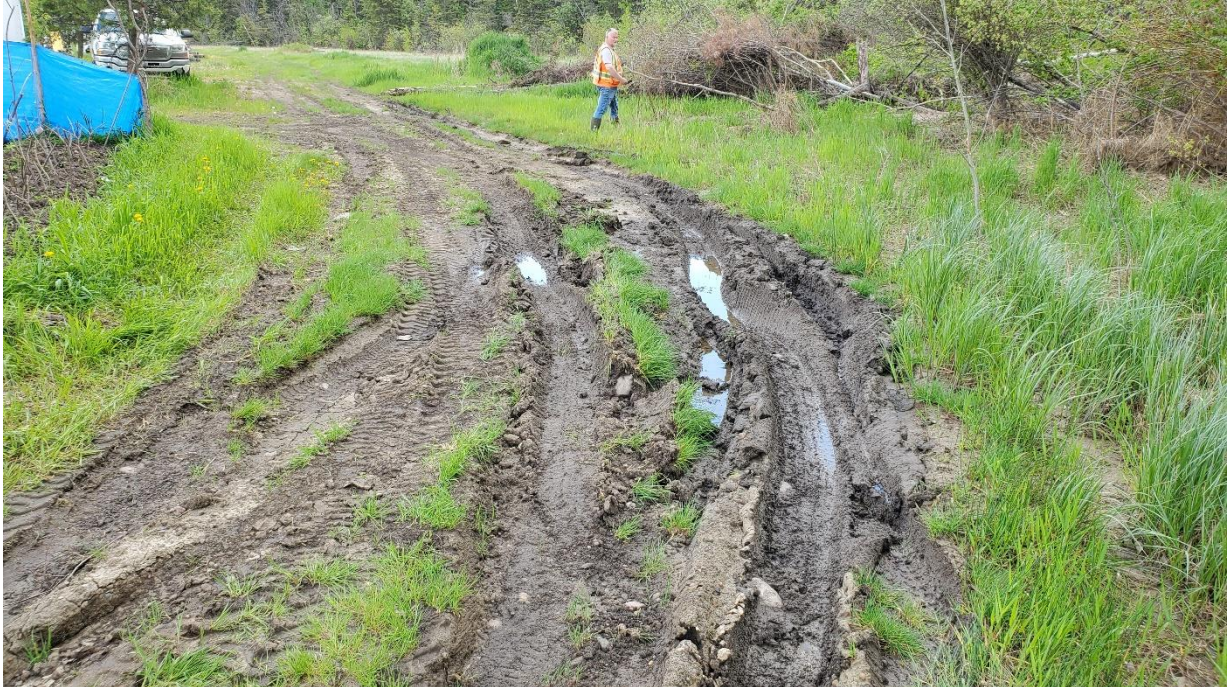
Photo 9, Looking east at wet and soft ground of alley at toe of slide.
