**ALBERTA TRANSPORTATION AND  
ECONOMIC CORRIDORS  
GEOHAZARD ASSESSMENT PROGRAM  
PEACE REGION (PEACE RIVER DISTRICT)  
2025 INSPECTION**

Site Number	Location	Name	Hwy	km
PH091	East of Manning	Embankment Settlement East of Manning	691:02	4.2
<b>Legal Description</b>		<b>UTM Co-ordinates</b>		
SW-25-91-23-W5		11V N 6,308,105	E 465,862

HWY 691:02 km 4.14-4.18  
PH091: 4 km EAST OF MANNING, ALBERTA  
2025 SITE INSPECTION PLAN

DWG No. 32121-PH091-1

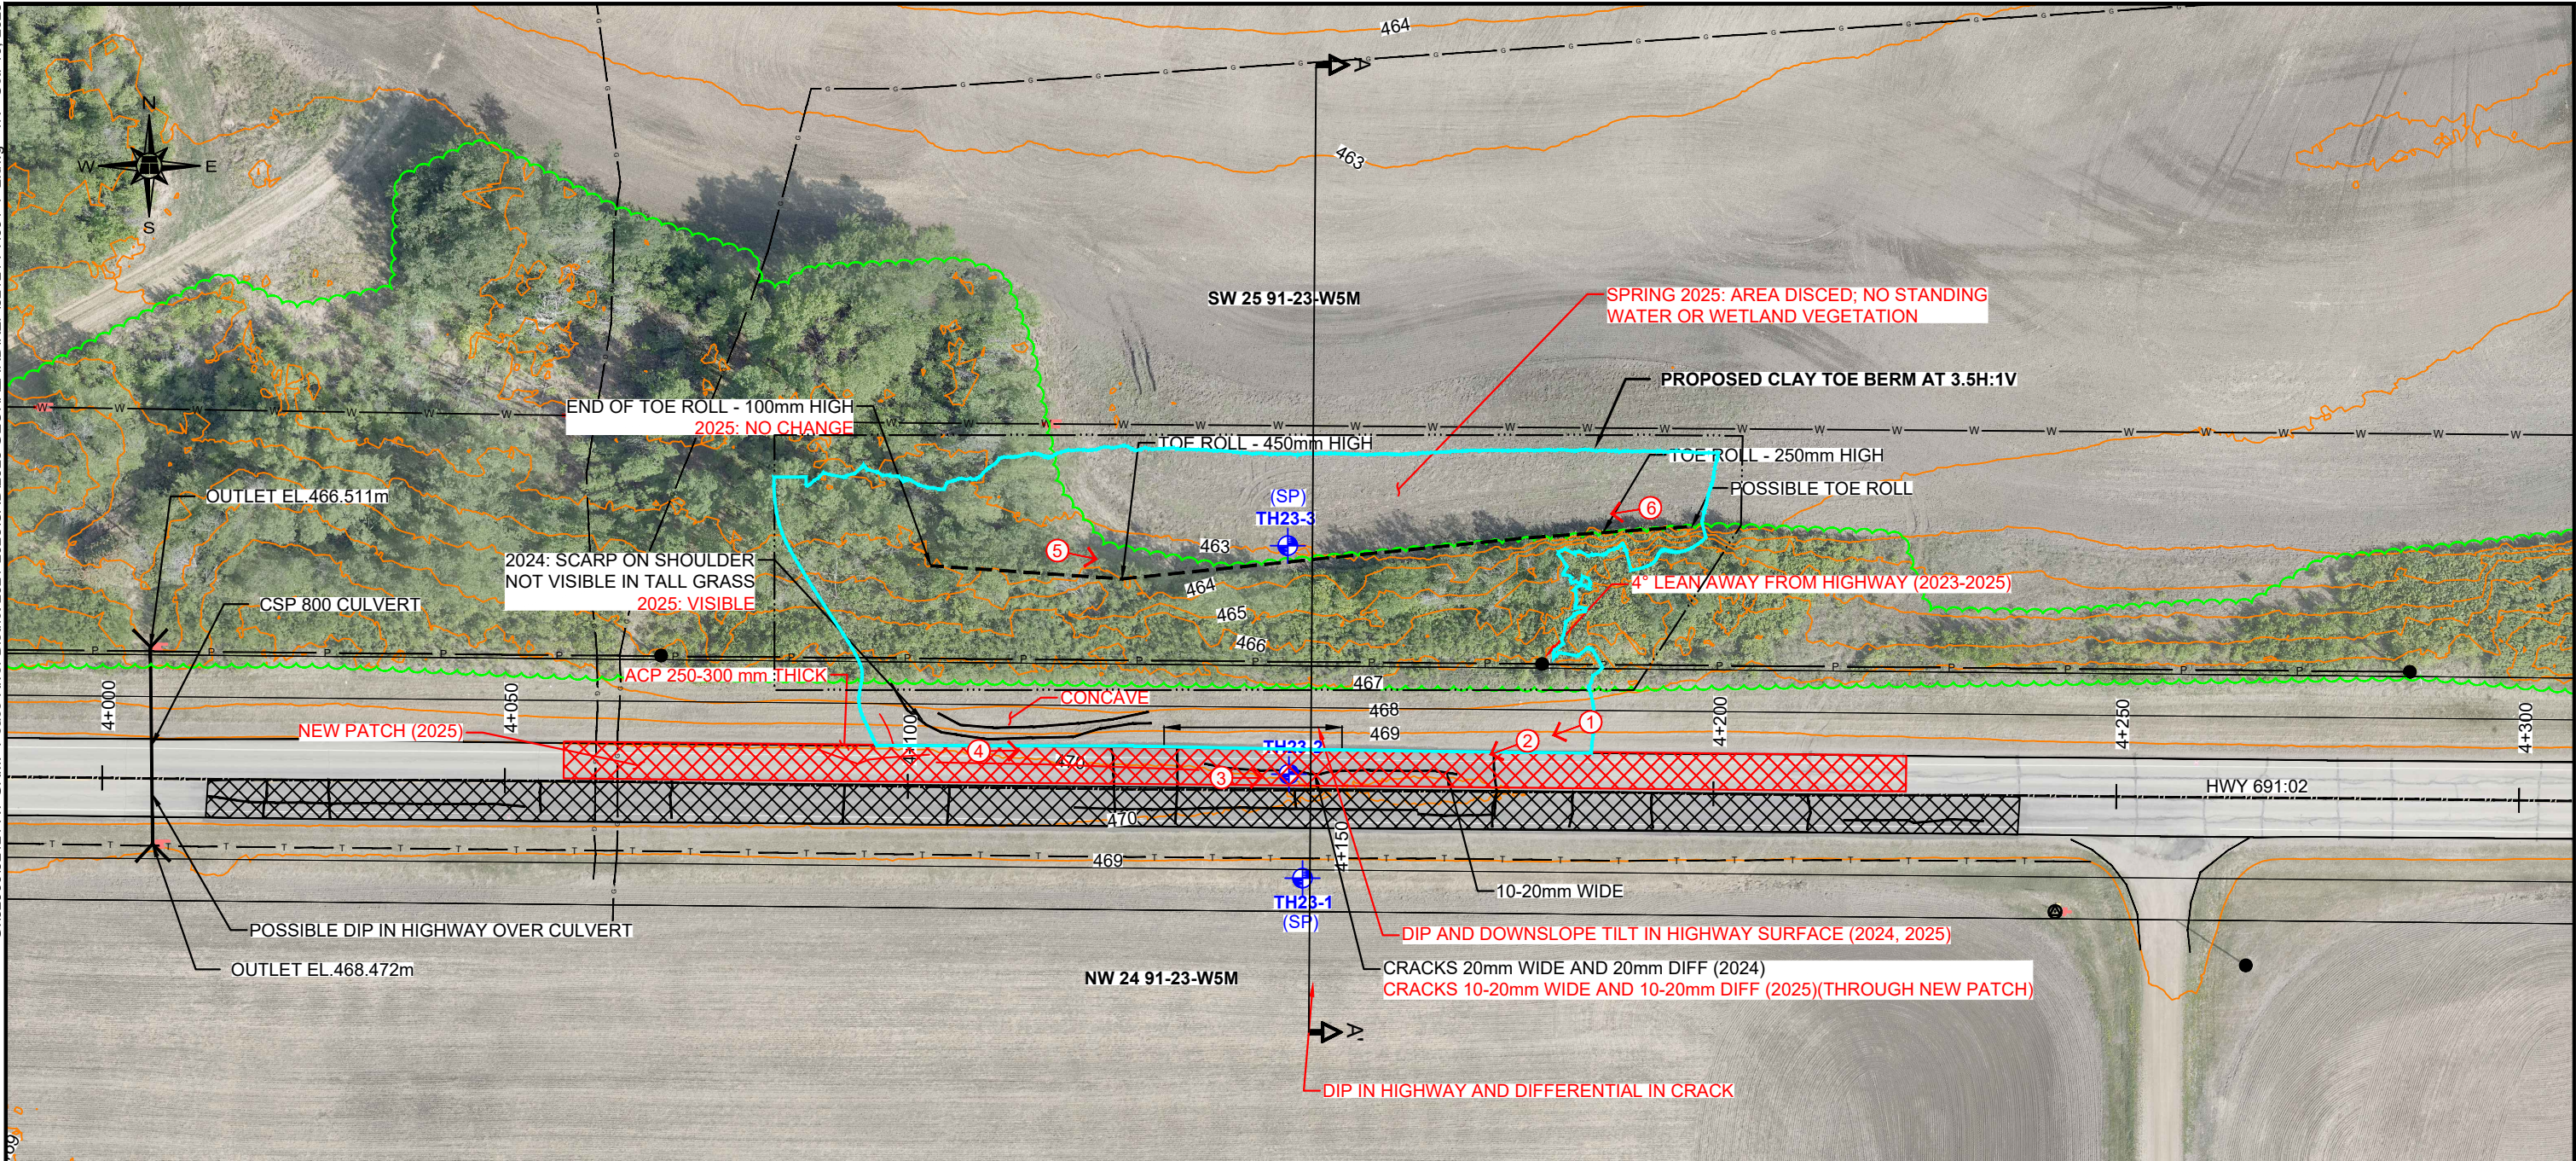
1. FEATURE LOCATIONS ARE APPROXIMATE.
2. MAY 2025 OBSERVATIONS SHOWN IN RED.
3. THE UTILITY LINES SHOWN ON THIS PLAN WERE ONLY SURVEYED IN THE AREAS CLOSE TO THE HIGHWAY. SOME OF THE LINES EXTEND BEYOND THE LIMITS SHOWN ON THE PLAN
4. POWER POLE INCORRECTLY NOTED AS LEANING TOWARDS HIGHWAY ON PREVIOUS INSPECTION PLANS

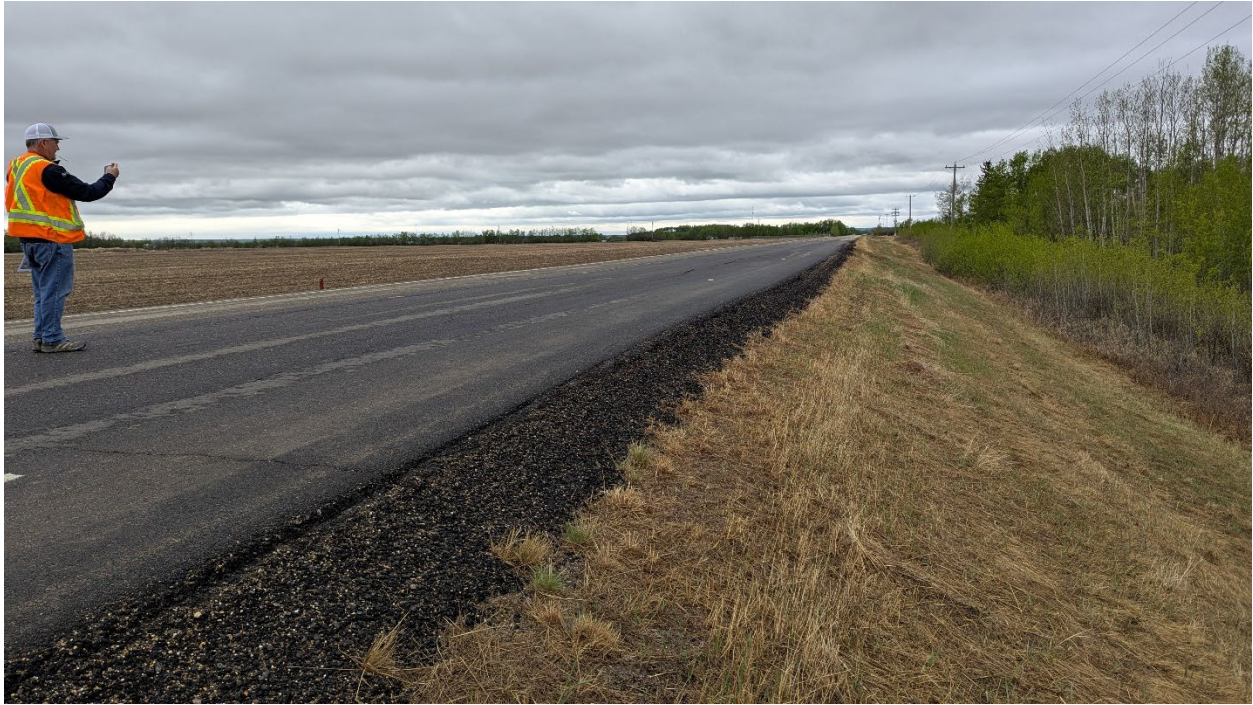
**Photo 1 – Looking west over distressed area where dip is visible in the roadway surface. Note the increasing thickness of asphalt from repeated patching.**

Short-term road maintenance (patching and milling to provide a safe, smooth surface) should continue as required. Sealing of cracks on the road surface would assist in limiting the infiltration of water into the embankment.

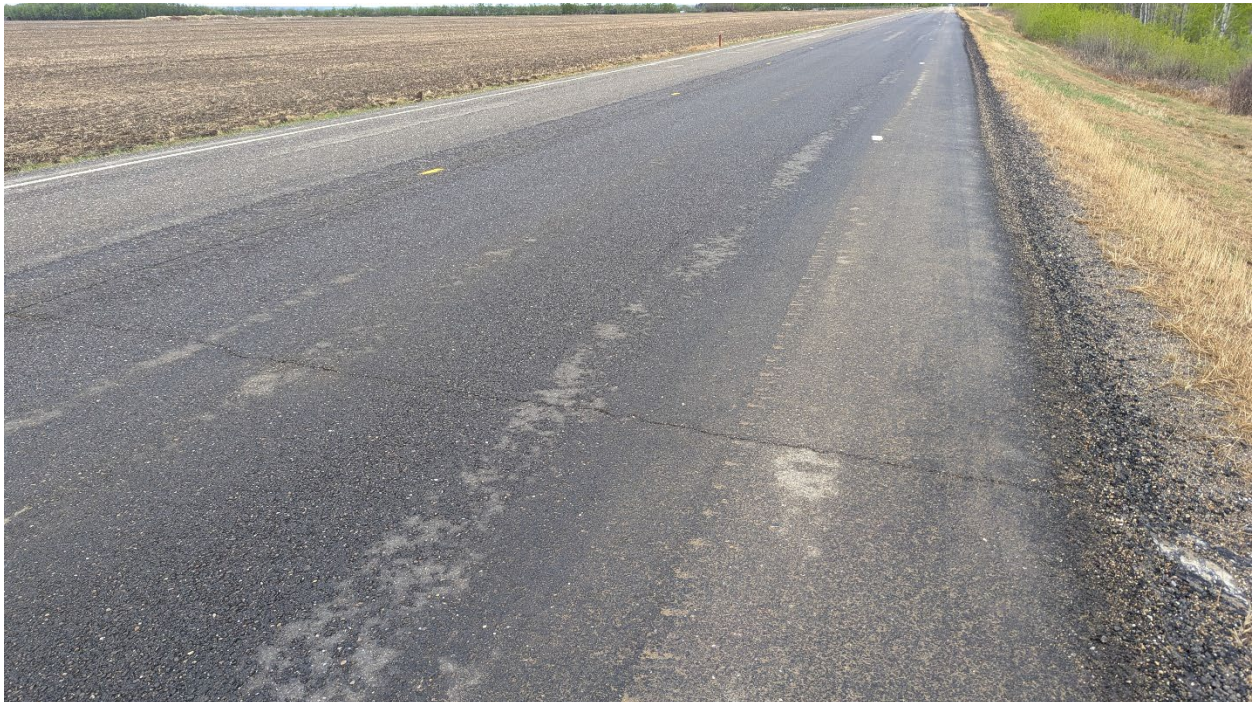
**Photo 2 – Looking west at distressed area.**

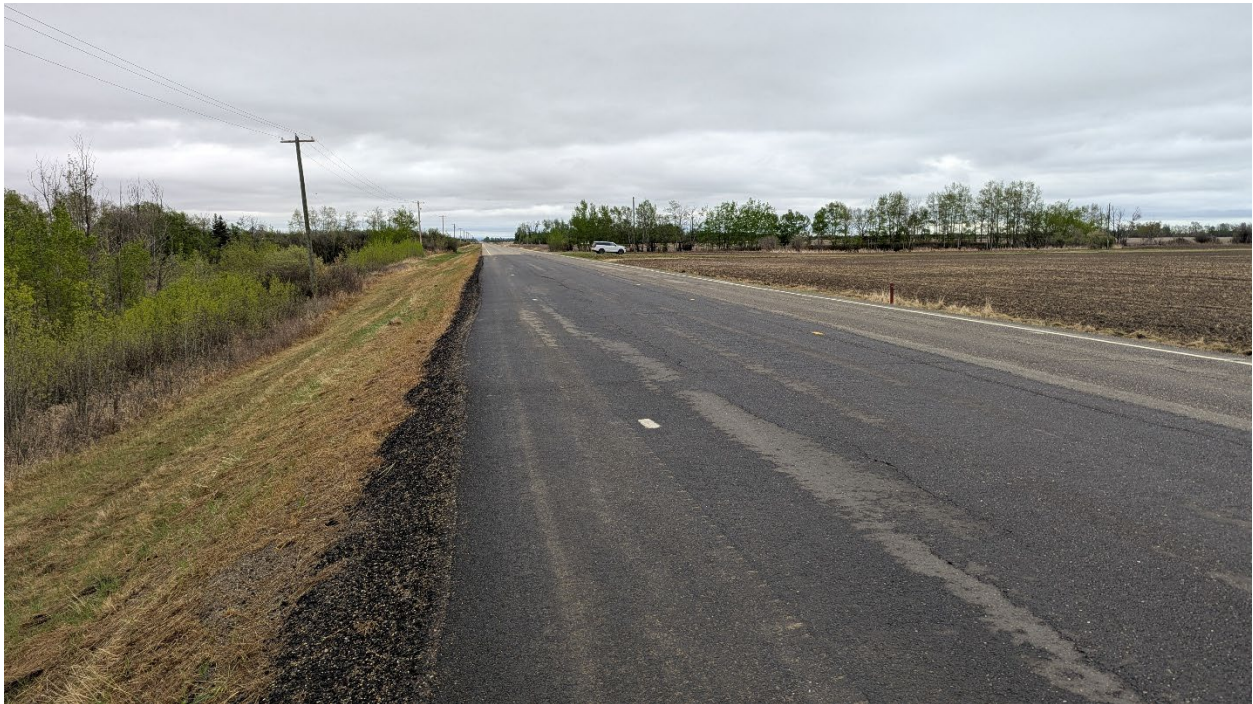
**Photo 3 – Looking east at the central portion of the crack forming in the area of distress.**

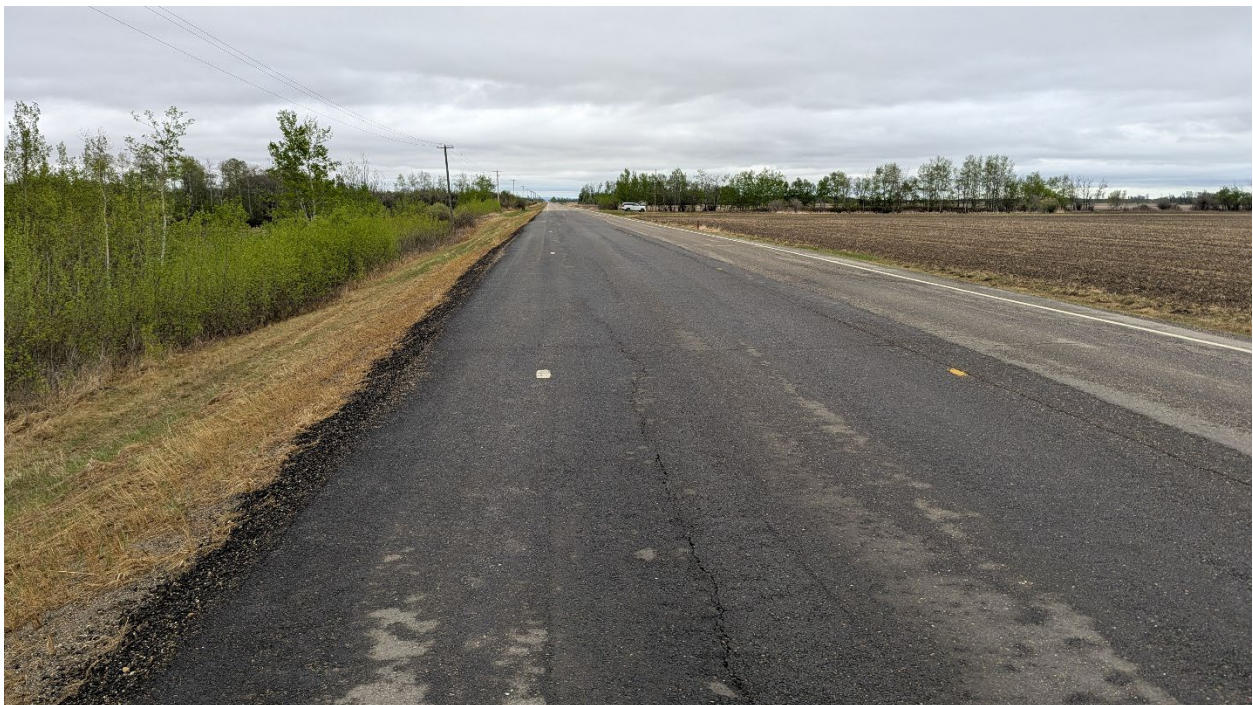
**Photo 4 – Looking east from past the previously patched area.**

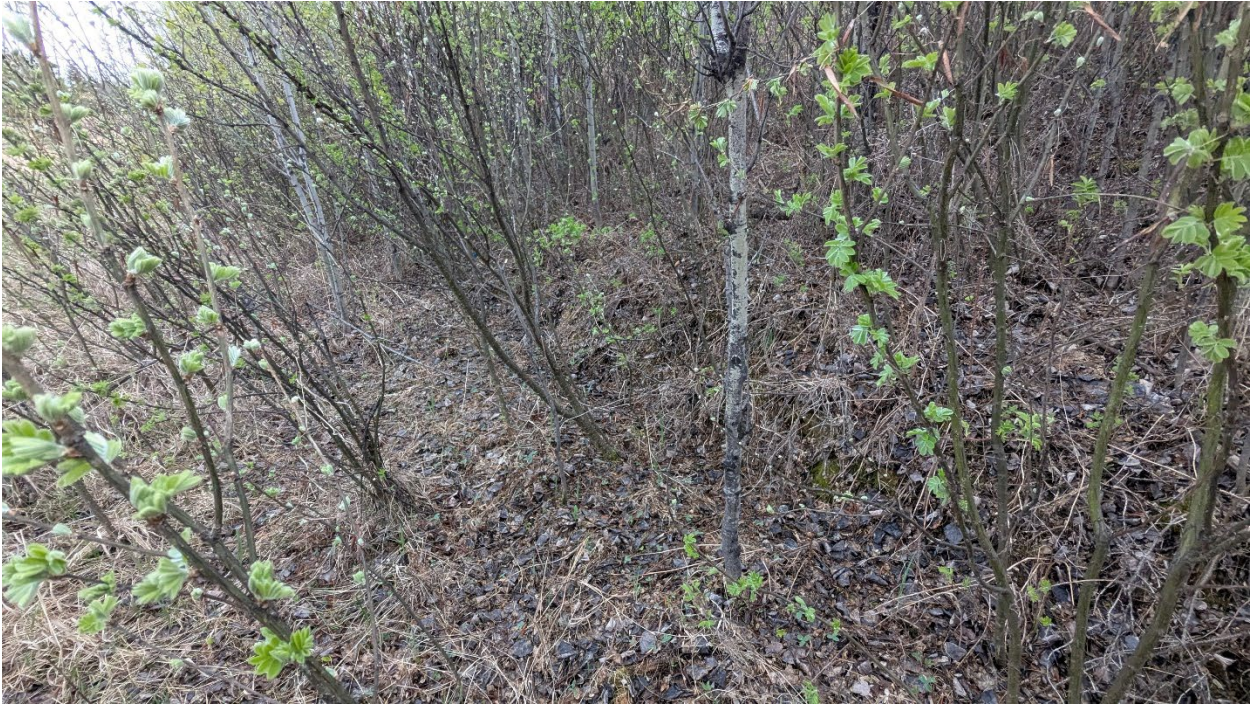
During the call-out, observations at the toe of the slope noted a potential toe roll at the level of the adjacent field, although thick bush somewhat obscured the slope. This possible toe roll was between 200 mm and 400 mm high and spanned a distance of about 50 m and was in line with the main crack noted on the highway. During the 2024 inspection, the toe roll presence was confirmed and was 100 m to 450 mm high.

**Photo 5 – Observed toe roll below the area of distress.**

A toe berm has been designed to stabilize the landslide and the current plan is to construct it in 2026. The sideslope above the toe berm will also be flattened.

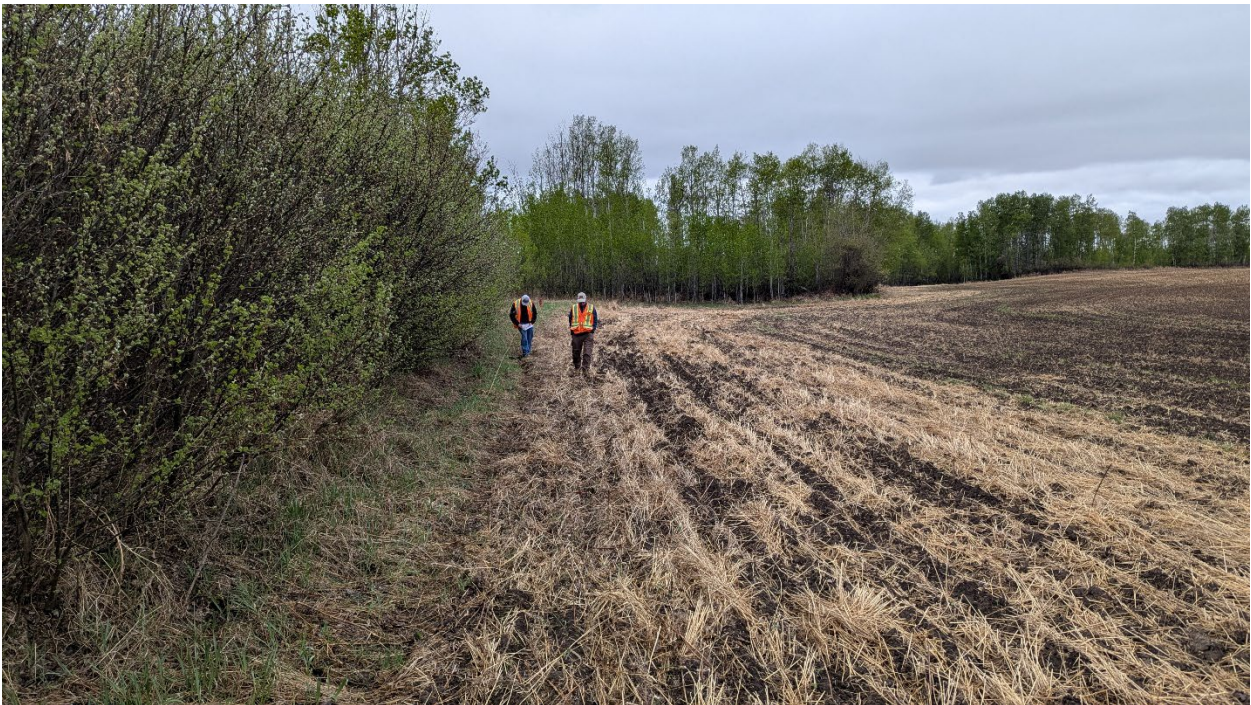
**Photo 6 – Looking west along the toe of the slope.**
