August 5, 2022

**GEOHAZARD RISK MANAGEMENT PROGRAM (CON0022164)
PEACE REGION (PEACE RIVER DISTRICT)**

**SECTION D CALL-OUT REPORT
GRAVINA CREEK: HWY 692:02 km 3.13 – 3.30**

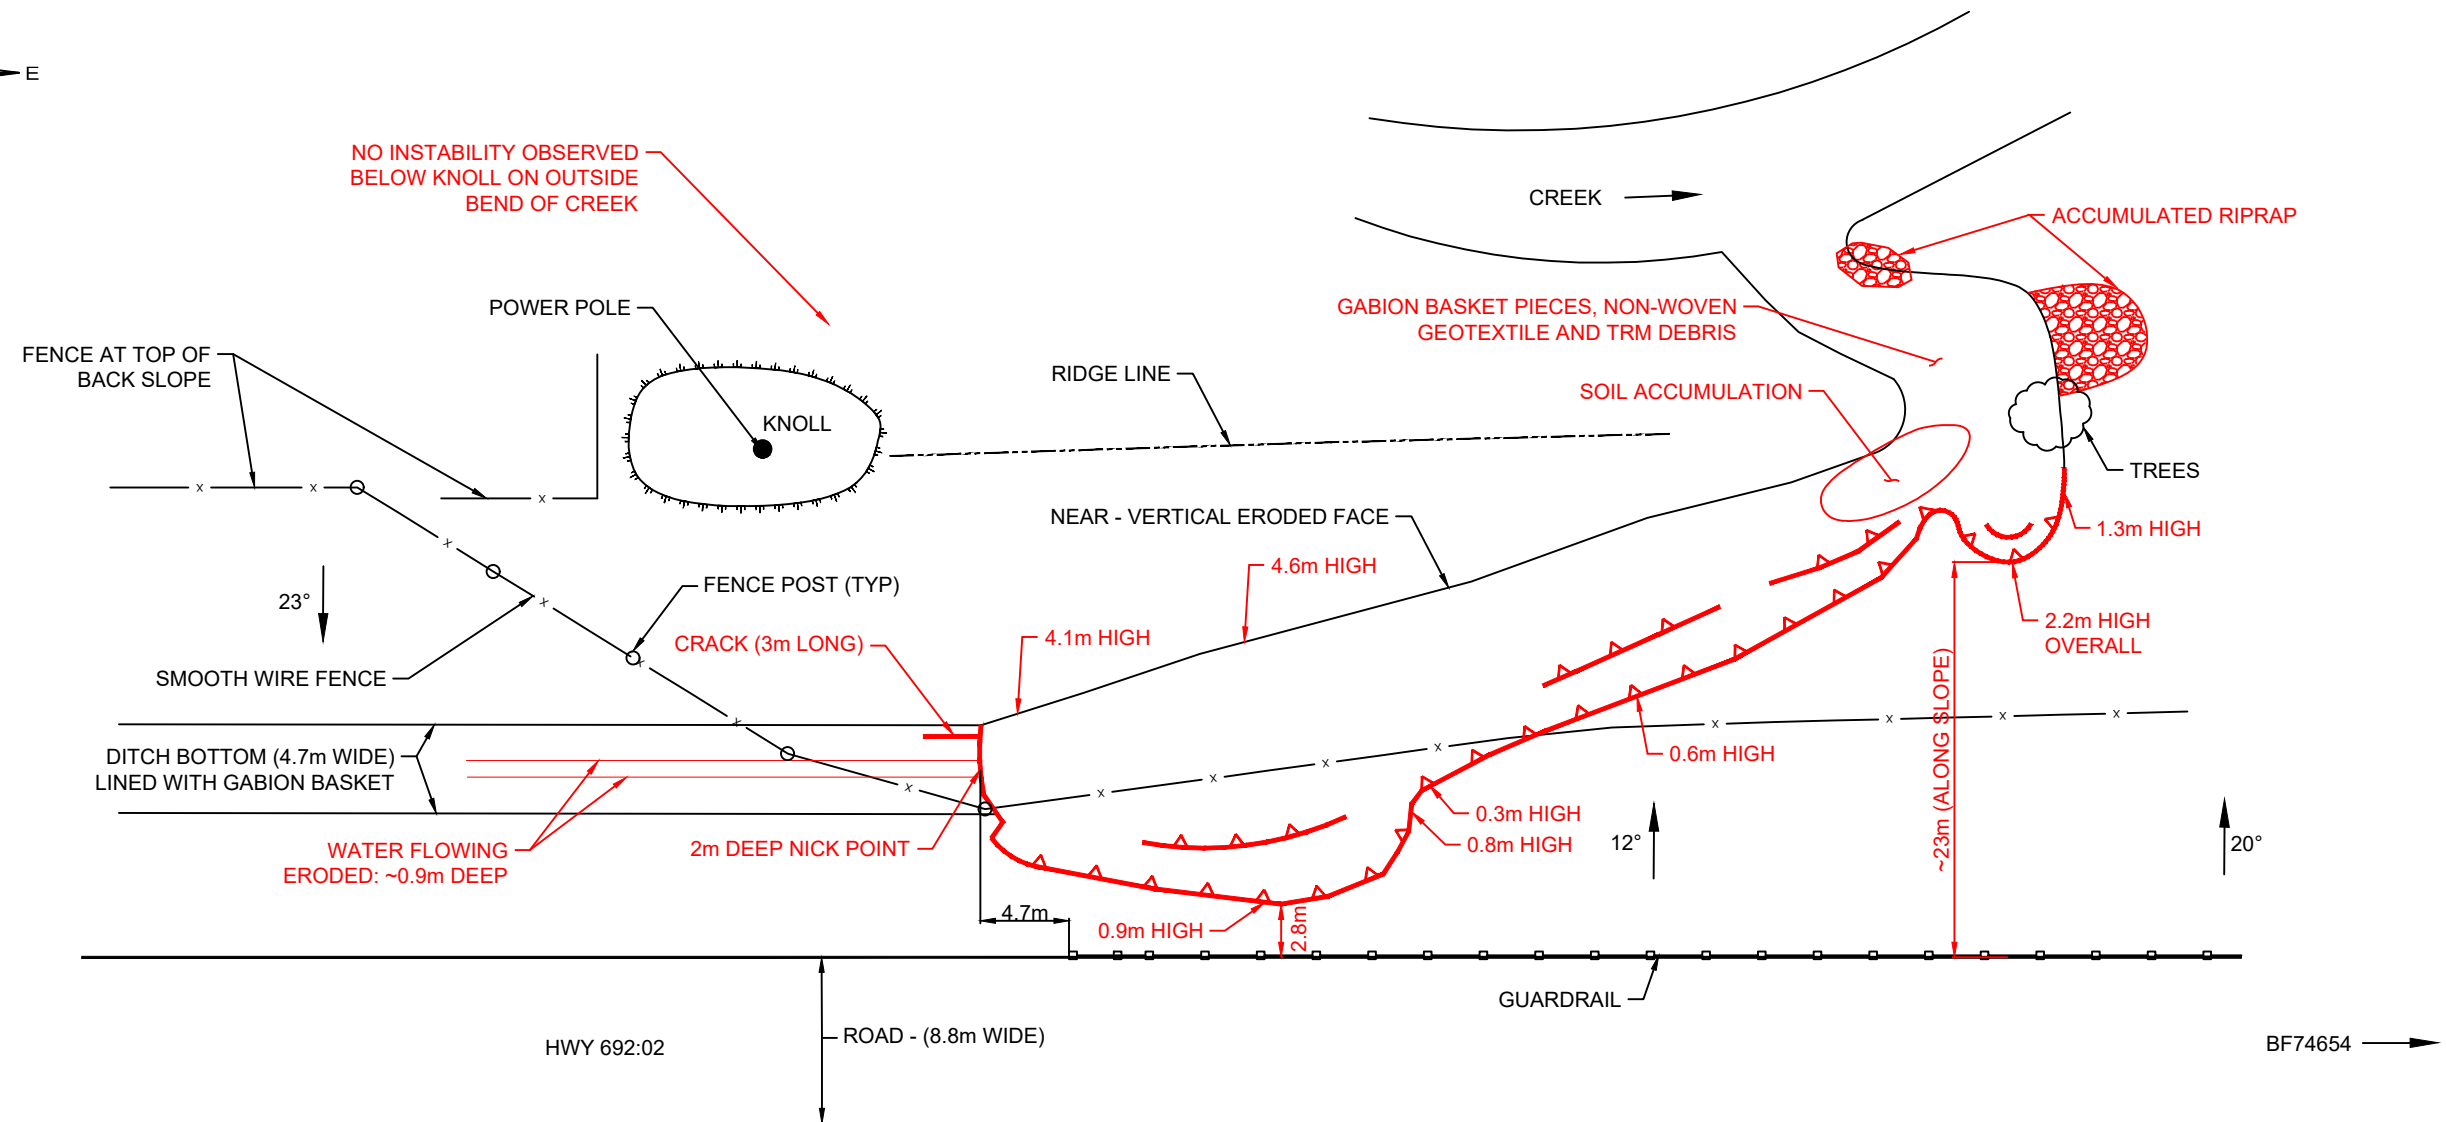
DWG No. 32121-HWY 692:02-CALLOUT-1

Observations made during the site visit are illustrated on the Drawing, attached. The observations were primarily confined to the erosion gully; however, brief observations were also made of the ditch leading upslope (west) to the approach culvert and of the bridge culvert to the east. Selected photographs from the site visit are also included at the end of this letter.

The upslope ditch is lined with a gabion mattress for much of the distance between the approach culvert and the valley. Close to the valley, the water had eroded through, or below the mattress such that it was sagging, to a depth of up to 0.9 m. The nick point of the gully was about 5 m west of the end of the guardrail where a smooth-wire fence crossed the bottom of the ditch. The nick point was almost as wide as the gabion mattress and had a vertical drop of about 2 m. There was a tension crack forming upslope of the nick point on the north side of the gabion mattress. The backslope side (north) of the gully was typically vertical except in a few locations where soil had slumped. The vertical face was up to 4.6 m in height tapering away toward the east. On the embankment side (south), the gully slopes were steep with numerous slump blocks partway down. The slumping was closest to the highway about 11 m east of the start of the guardrail where it was about 2.8 m from the back of the guardrail. The gully was approximately 15 m wide at this point. The gully angles away from the highway toward Gravina Creek.

The gully makes a right-angle bend just before discharging into the creek. At this location, another slump is forming towards the highway which is about 19 m horizontal (23 m measured along the slope) from the guardrail. This smaller slump is about 2.2 m in height overall excluding intermediate slump blocks. At the bend in the gully, there was accumulated soil debris, riprap, and pieces of gabion mattress, nonwoven geotextile, and turf reinforcement mats. Some of the erosion control products might have been placed in those locations but most of the pieces appeared to have been transported from further upstream. There were two piles of riprap noted along this bend that appear to have also been deposited rather than placed there.

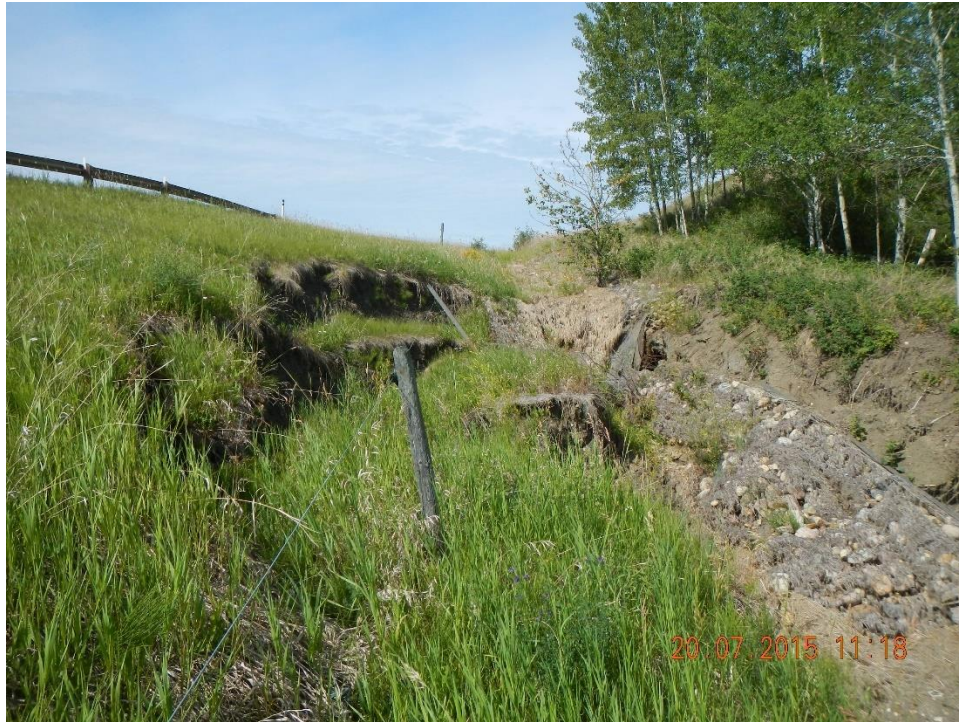
Photo 1 (MCI, July 20, 2015) – Looking west at erosion gully forming.

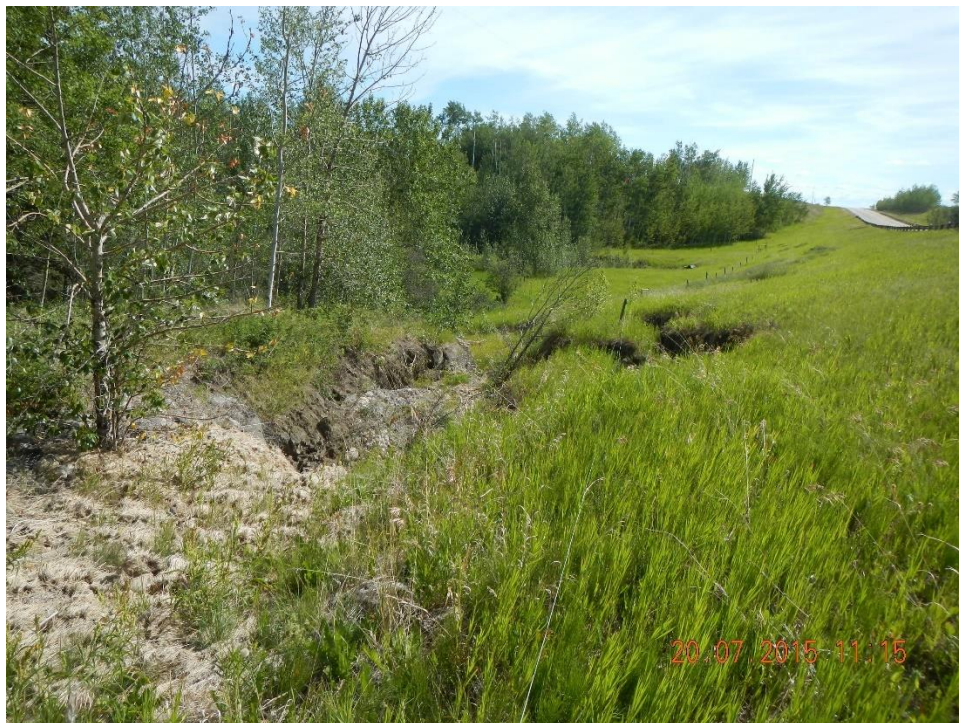
Photo 2 (MCI, July 20, 2015) – Looking east at erosion gully.

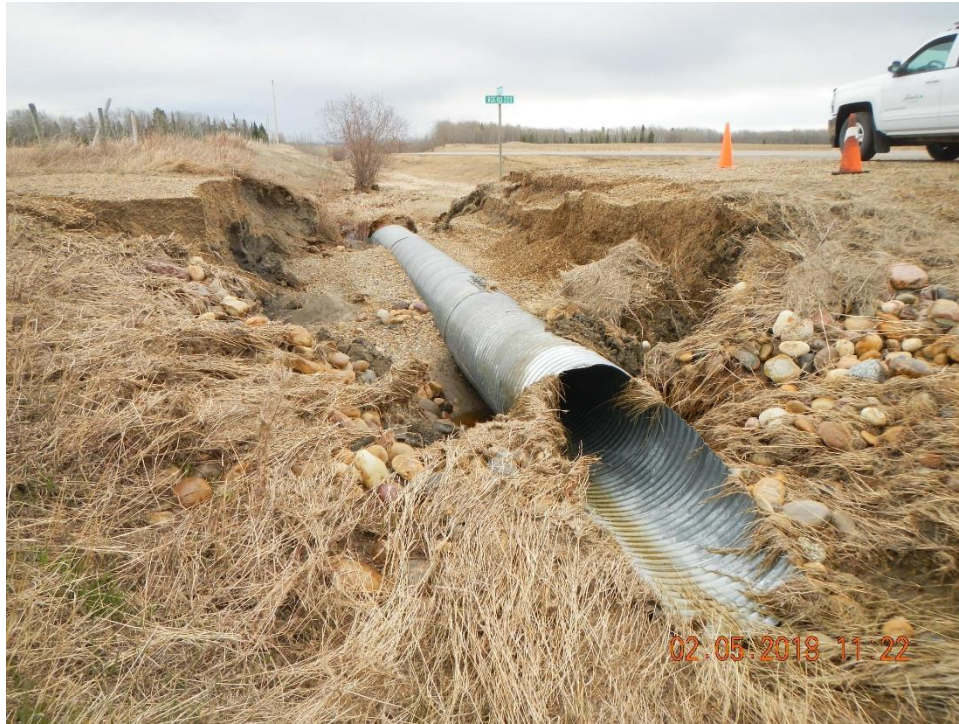
Photo 3 (MCI, May 2, 2018) – Looking east at the approach culvert wash-out.

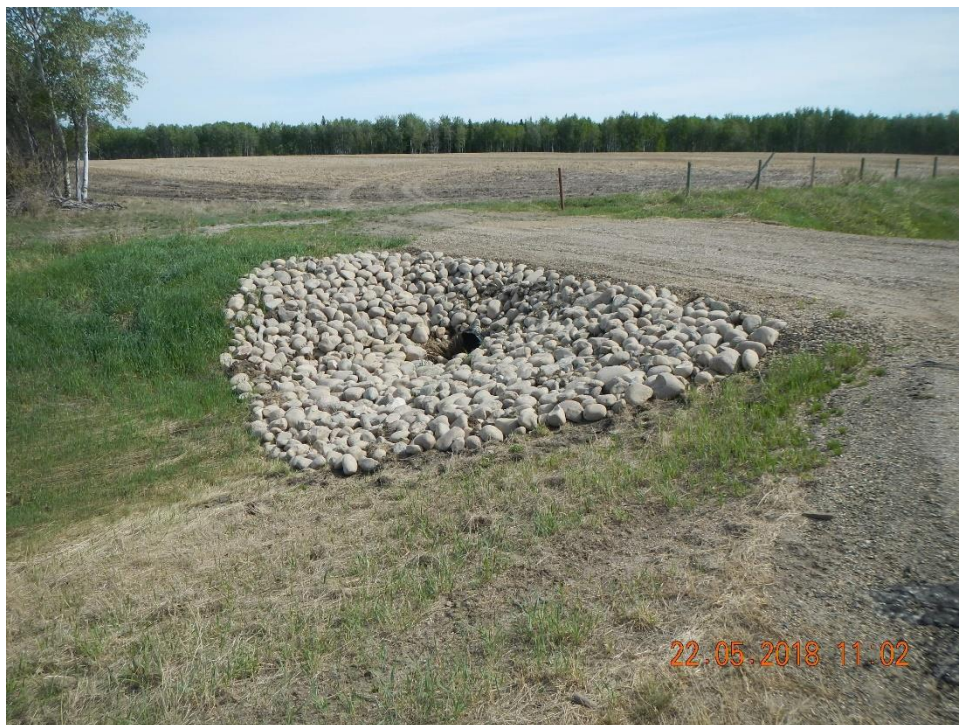
Photo 4 (MCI, May 22, 2018) – Looking northeast at restored approach and culvert inlet riprap.

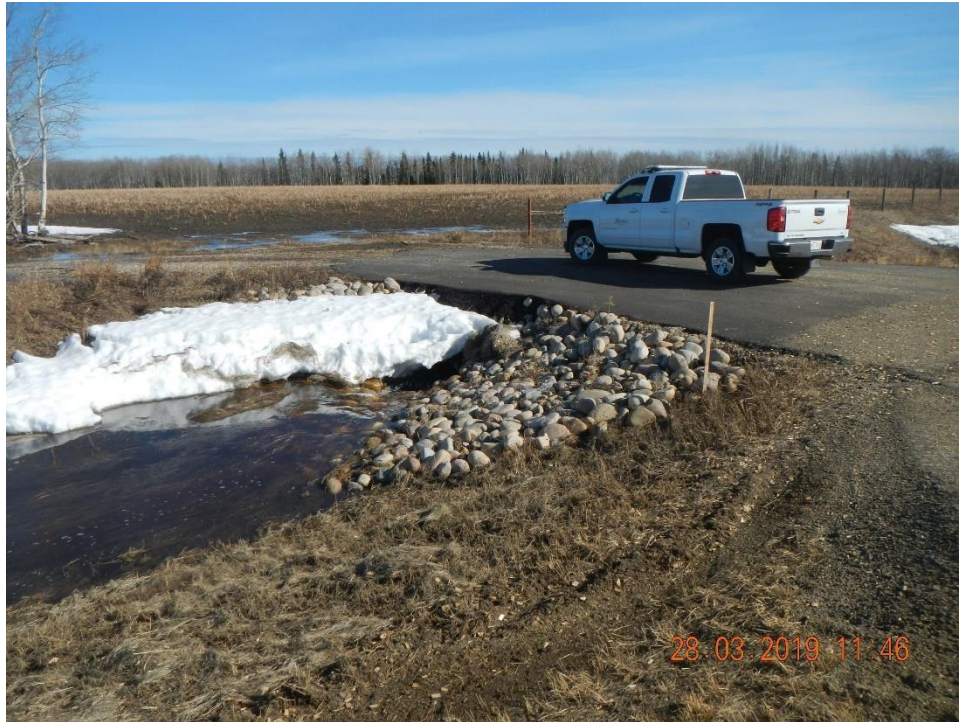
Photo 5 (MCI, March 28, 2019) – Approach culvert inlet under high flow. Approach was paved.

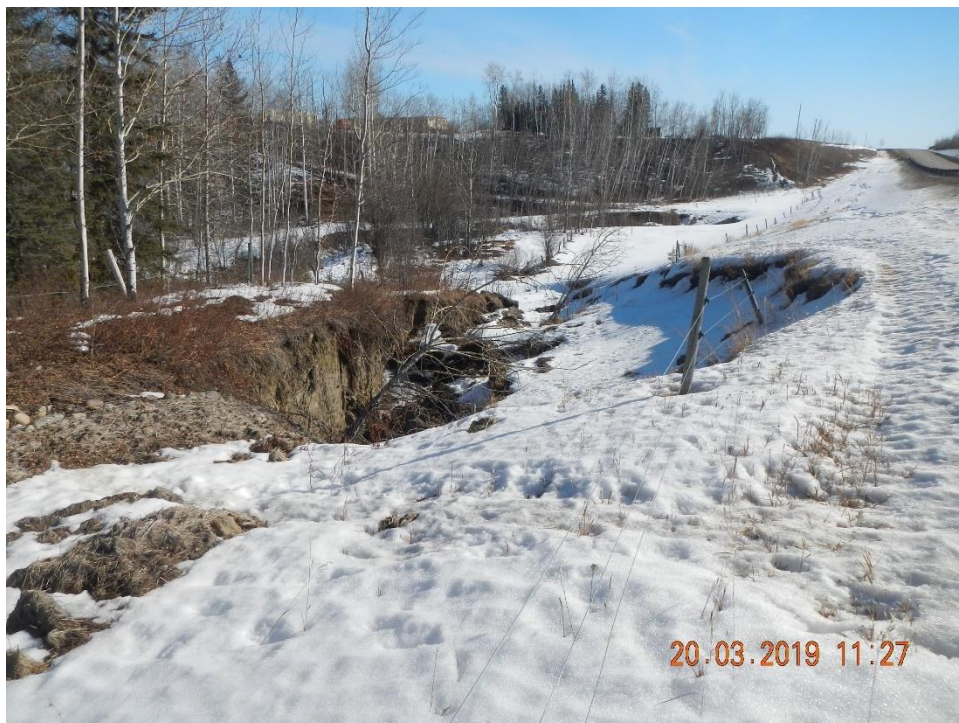
Photo 6 (MCI, March 20, 2019) – Looking east at widening erosion gully.

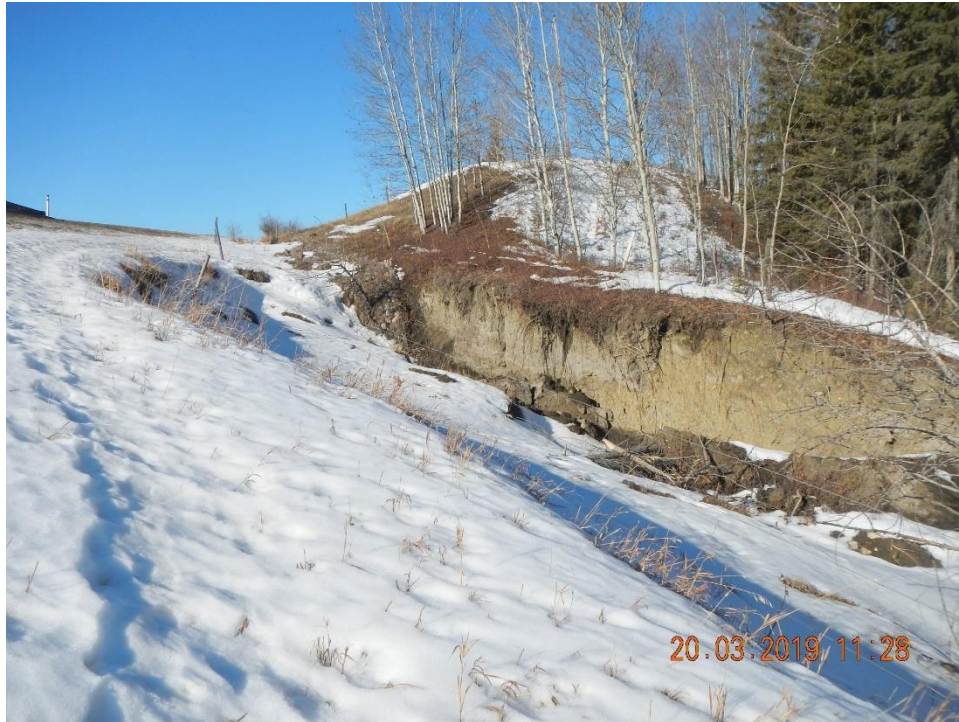
Photo 7 (MCI, March 20, 2019) – Looking west at growing erosion gully.

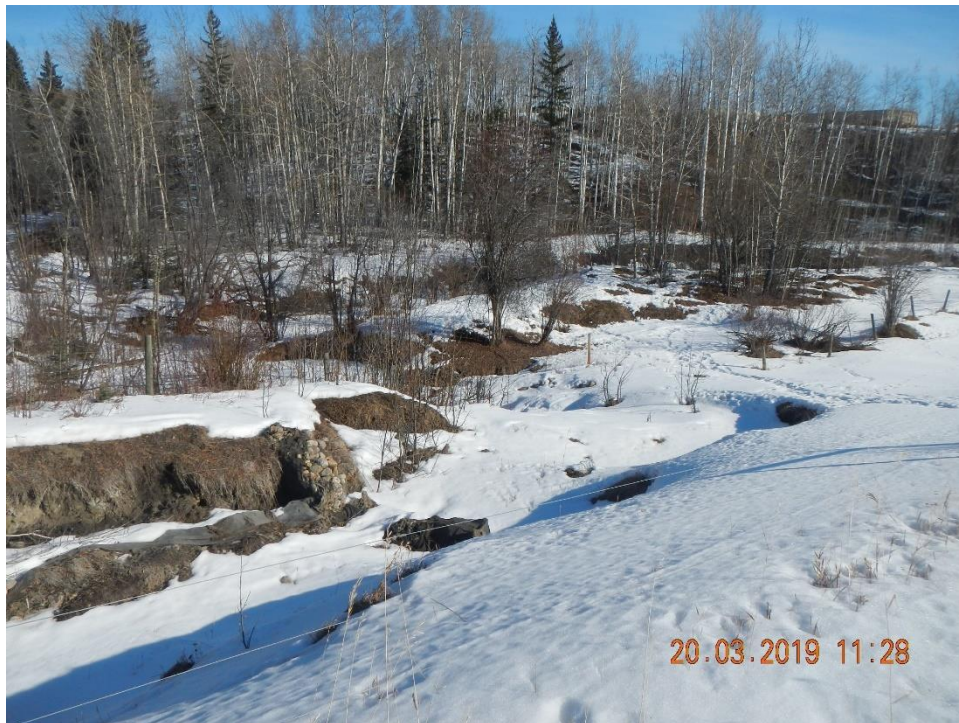
Photo 8 (MCI, March 20, 2019) – Looking north at remnants of the erosion protection.

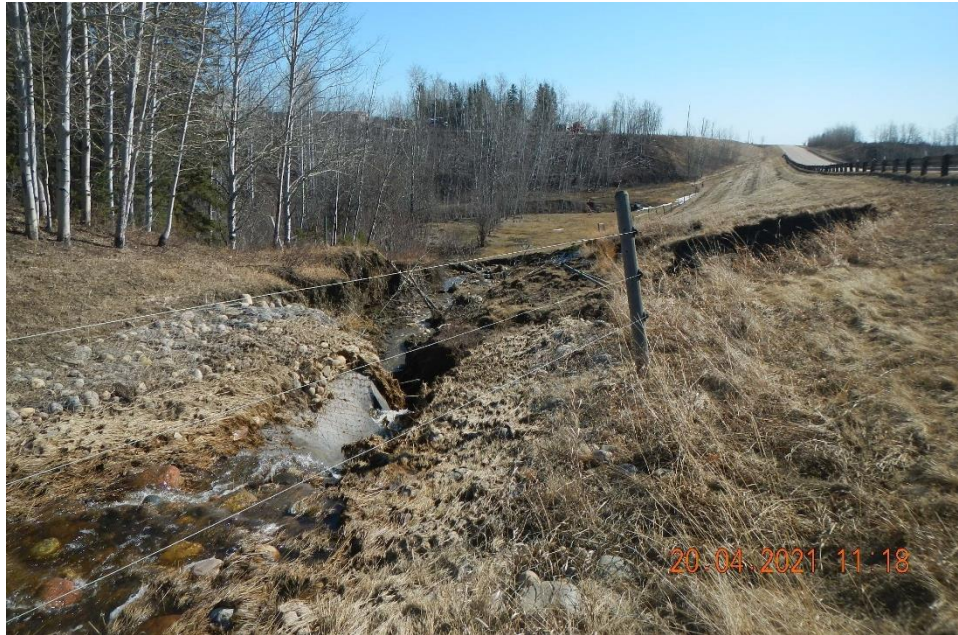
Photo 9 (MCI, April 20, 2021) – Looking east at the erosion gully which has slumped toward the road.

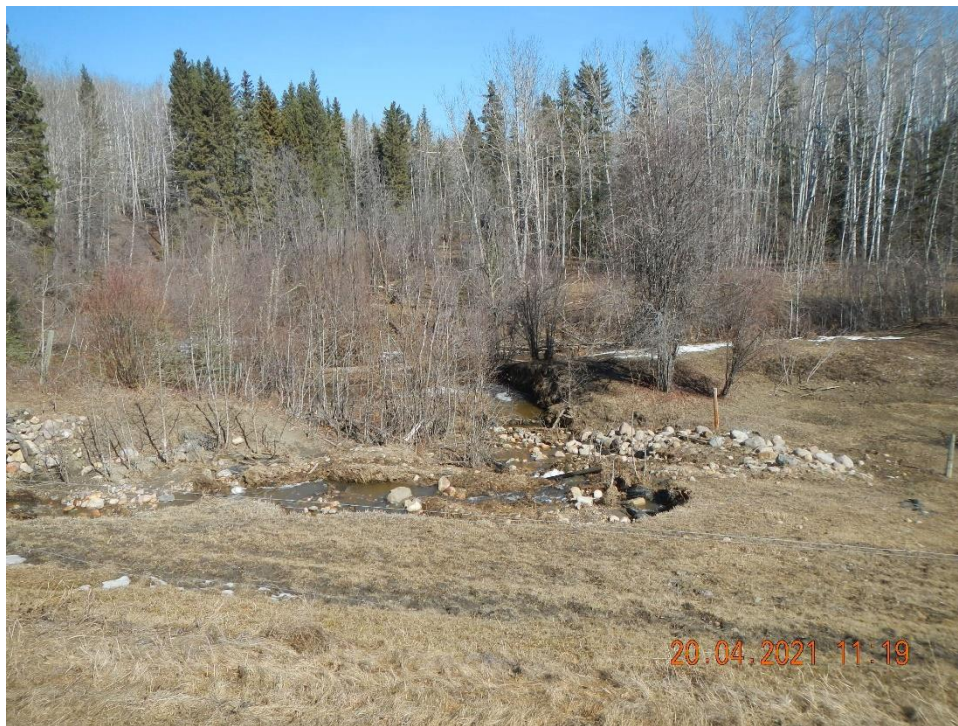
Photo 10 (MCI, April 20, 2021) – Looking north where the ditch discharges to Gravina Creek. A slump has formed at the bend.

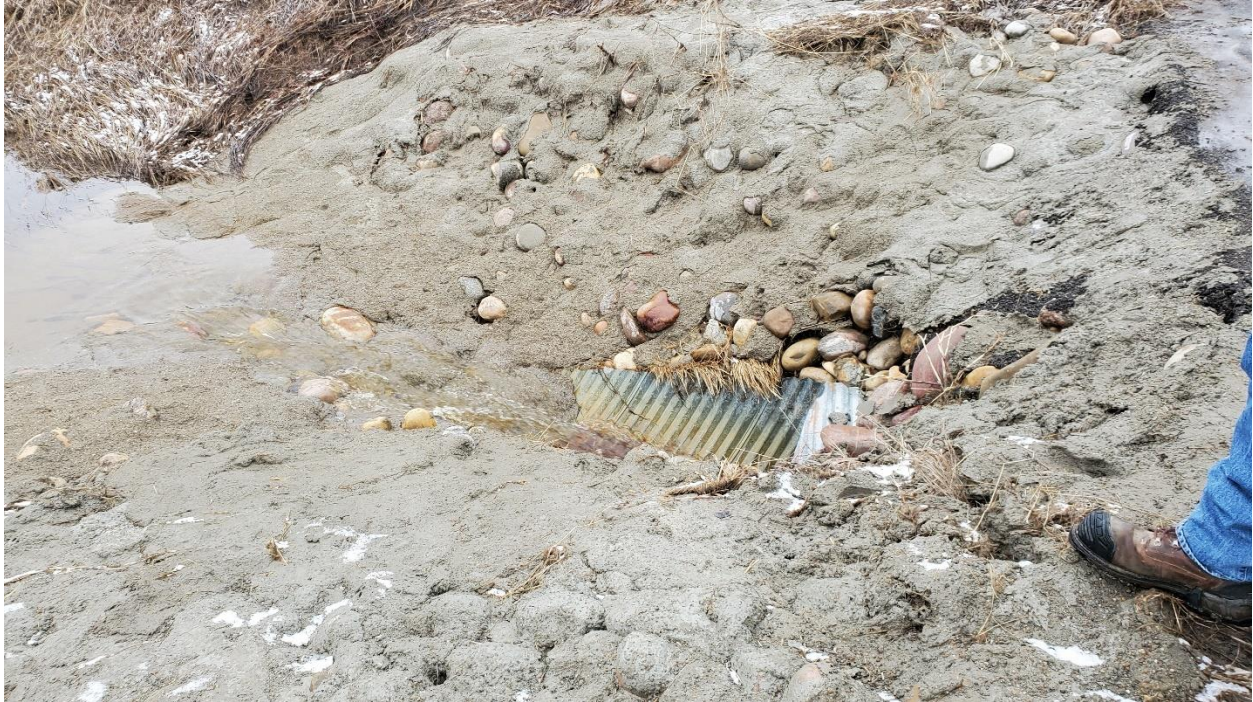
Photo 11 (April 28, 2022) – Grouted riprap at the approach culvert inlet.

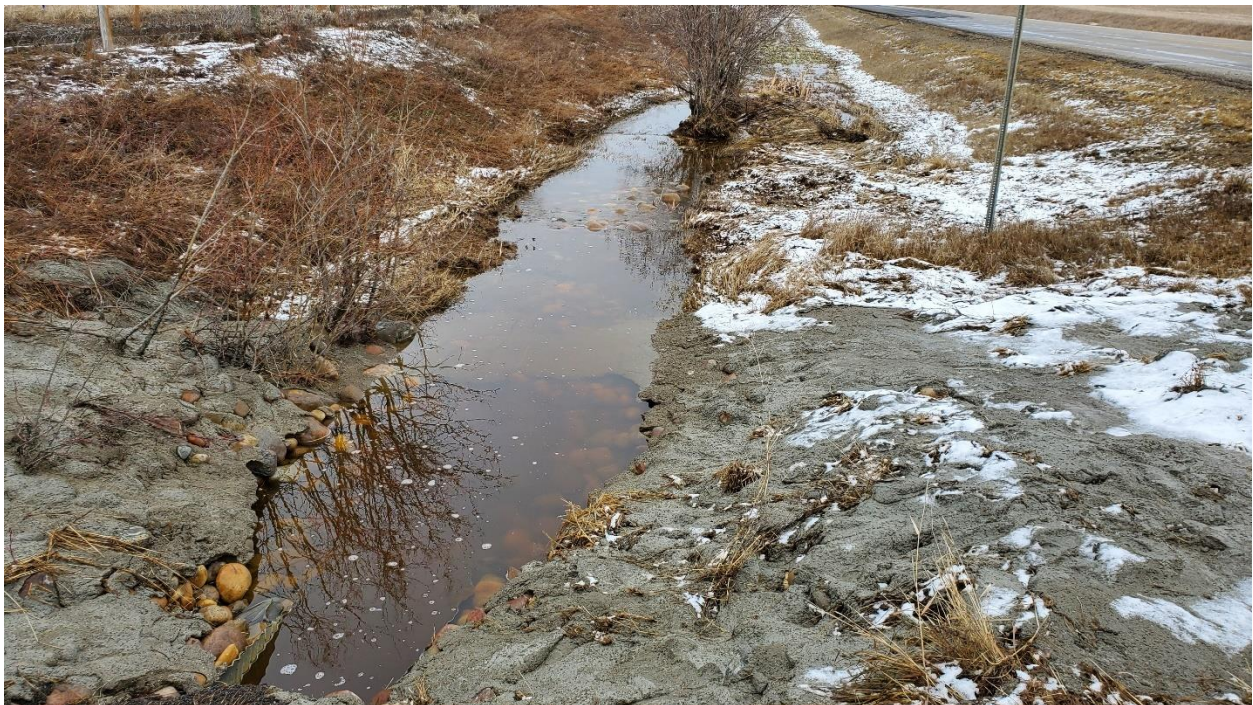
Photo 12 (April 28, 2022) – Looking downstream (east) from approach culvert outlet (riprap also grouted).

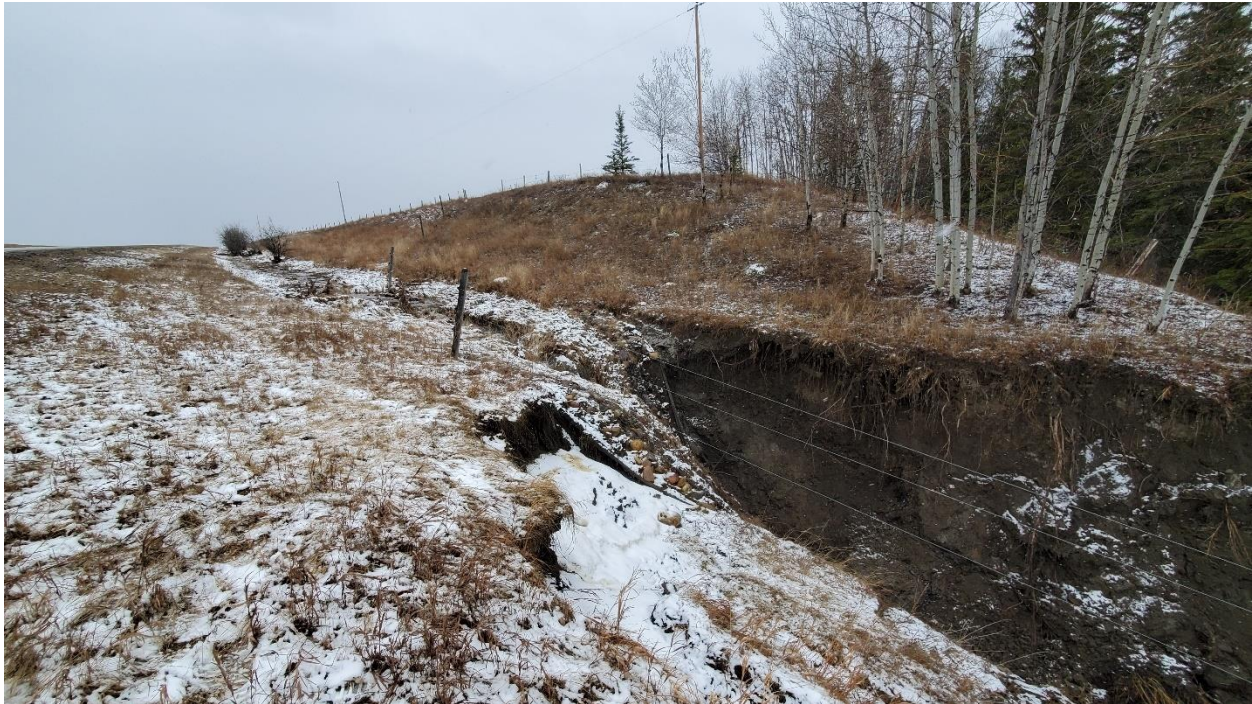
Comparing with the site photographs provided by the MCI, it appears the erosion gully may have regressed up to 2 m since 2019 which is about 0.6 m to 0.7 m per year. With the erosion protection measures (gabion baskets and non-woven geotextile) already undermined, it is anticipated that the nick point will continue to erode upstream. While this will eventually reduce the flow gradient as the gully flattens out, high flows will continue to remove material from the highway embankment side.

Photo 13 (April 28, 2022) – Looking west at the nick point of the gully.

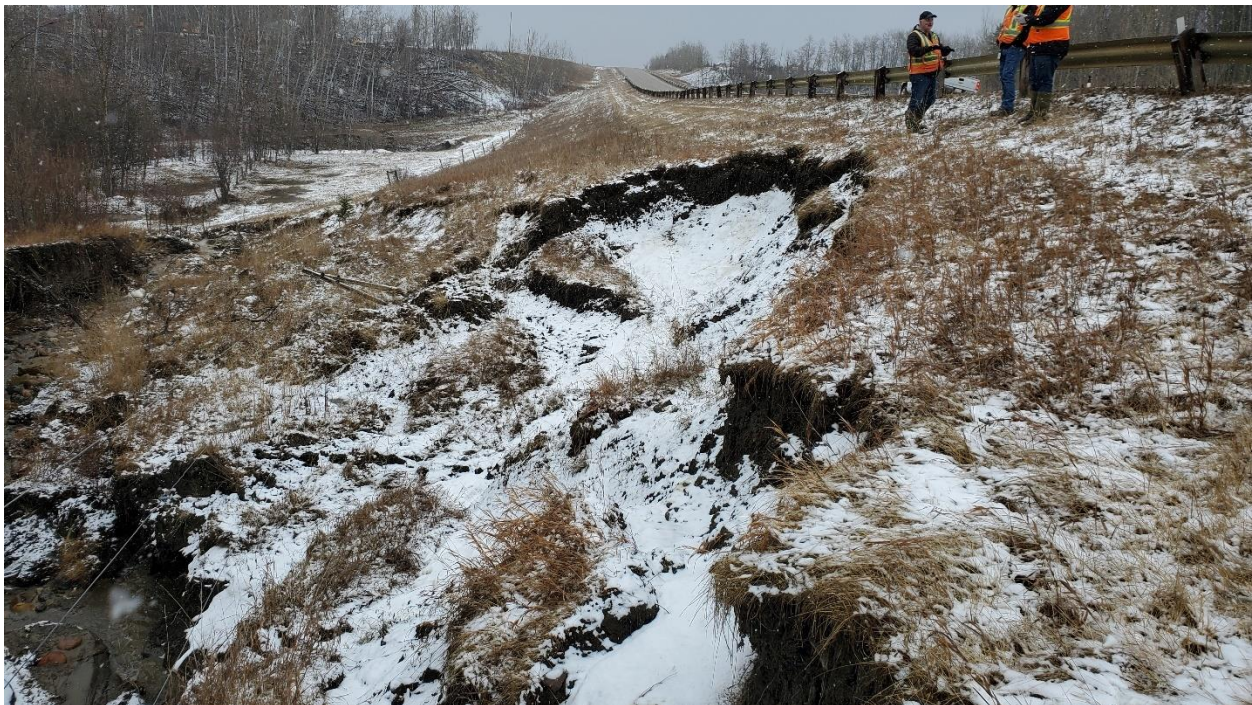
Photo 14 (April 28, 2022) – Looking east at the regression of the slump.

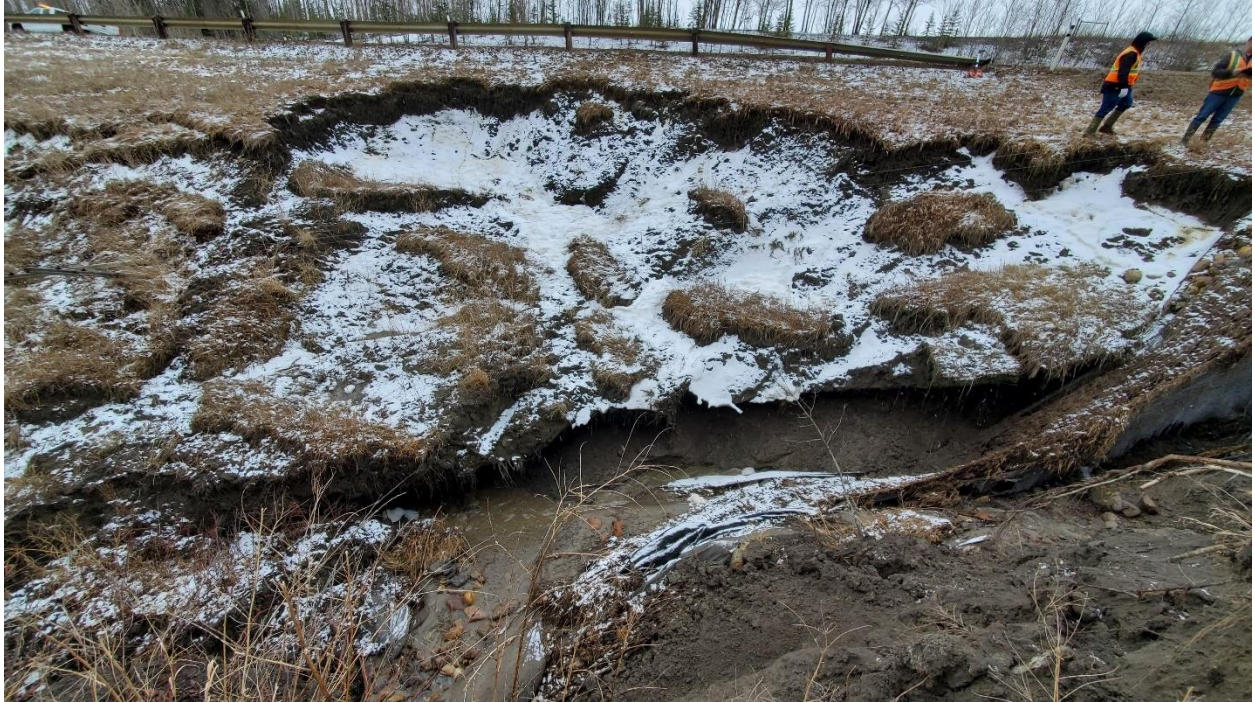
Photo 15 (April 28, 2022) – Looking south at the main slump in the highway embankment.

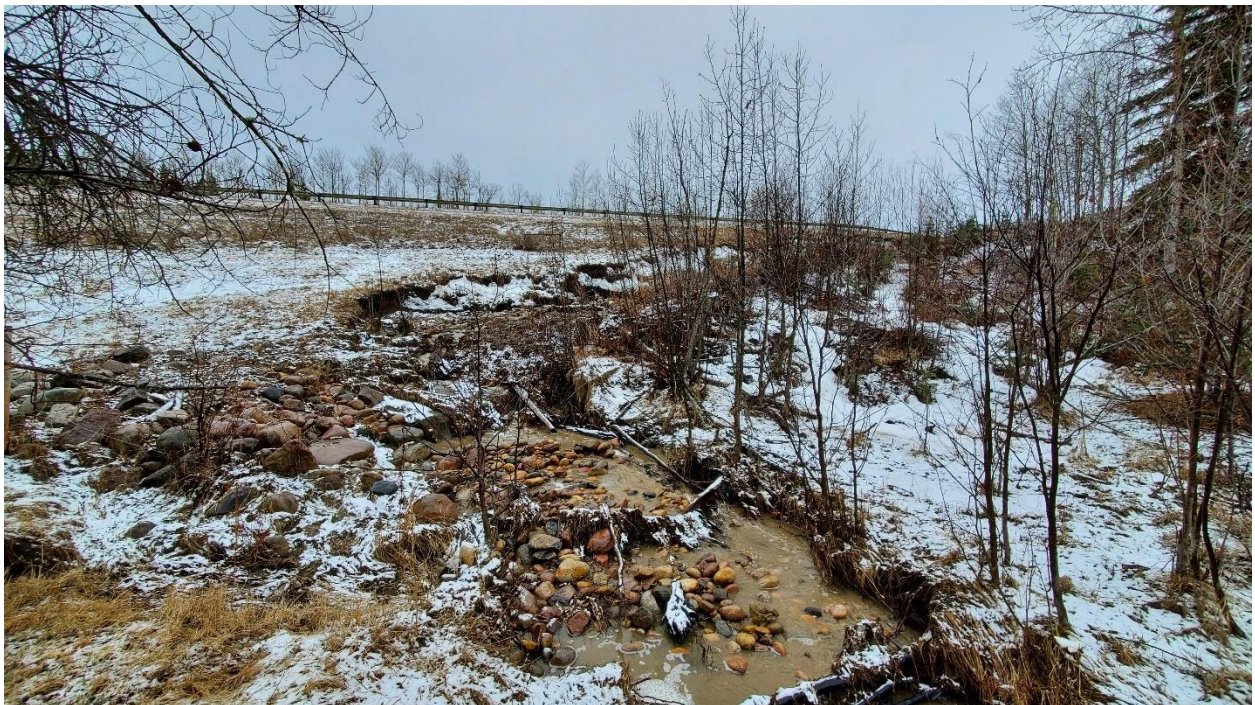
Photo 16 (April 28, 2022) – Looking south downstream of the bend in the erosion gully.

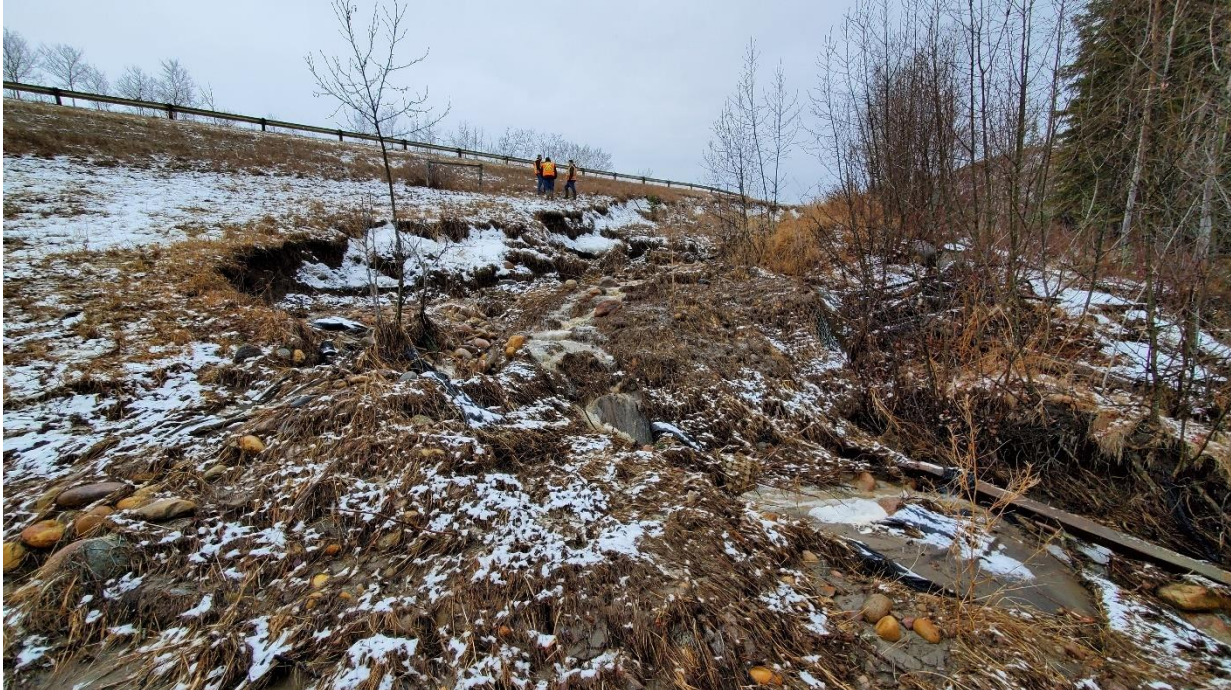
Photo 17 (April 28, 2022) – Looking west at the end of the erosion gully. Pieces of gabion basket are visible.

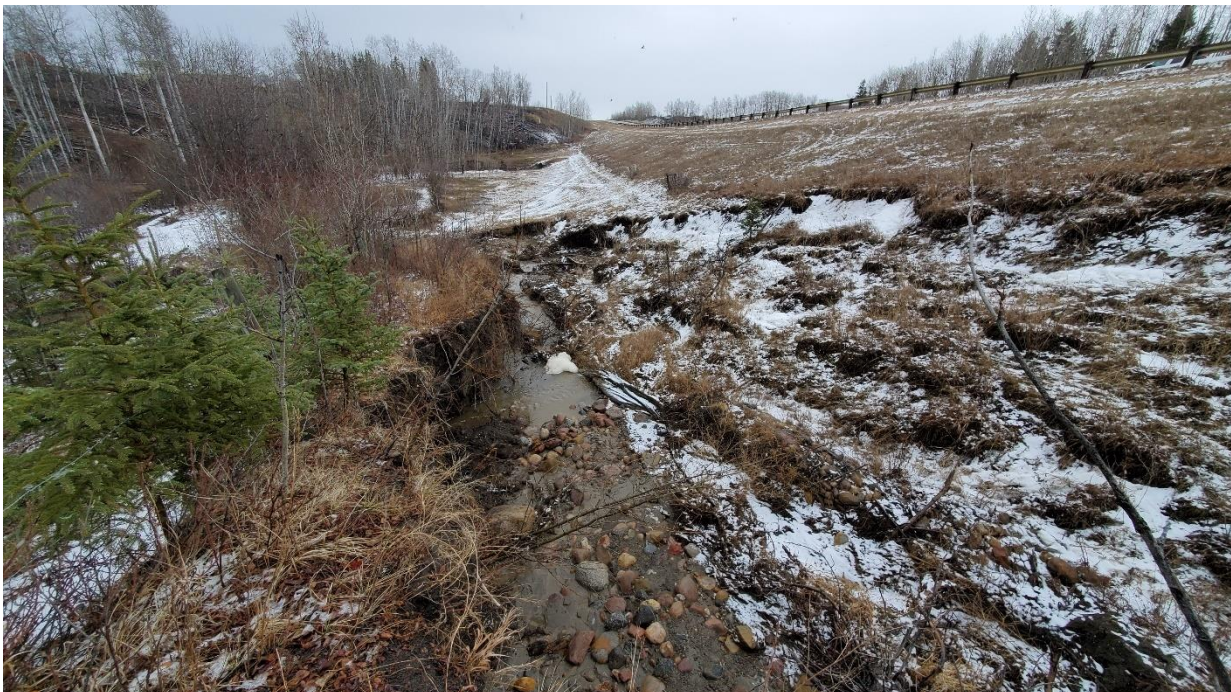
Photo 18 (April 28, 2022) – Looking east along the erosion gully at the east flank of the embankment slump and the undercut north side.
