**ALBERTA TRANSPORTATION AND  
ECONOMIC CORRIDORS  
GEOHAZARD ASSESSMENT PROGRAM  
PEACE REGION (PEACE RIVER DISTRICT)  
2025 INSPECTION**

Site Number	Location	Name	Hwy	km
PH092	North of Manning	Gravina Creek	692:02	3.13-3.30
Legal Description		UTM Co-ordinates		
SW15-95-22-W5M		11 E 491,100	N	6,425,466

Date	PF	CF	Total
<b>Previous Inspection:</b>	30-May-2024	11	4	44 (Erosion)
<b>Current Inspection:</b>	13-May-2025	11	4	44 (Erosion)
<b>Road AADT:</b>	140		<b>Year:</b>	2024
<b>Inspected By:</b>	Rocky Wang, TEC Ken Froese, Thurber Don Proudfoot, Thurber			
<b>Report Attachments:</b>	<input checked="" type="checkbox"/> Photographs <input checked="" type="checkbox"/> Plans <input type="checkbox"/> Maintenance Items

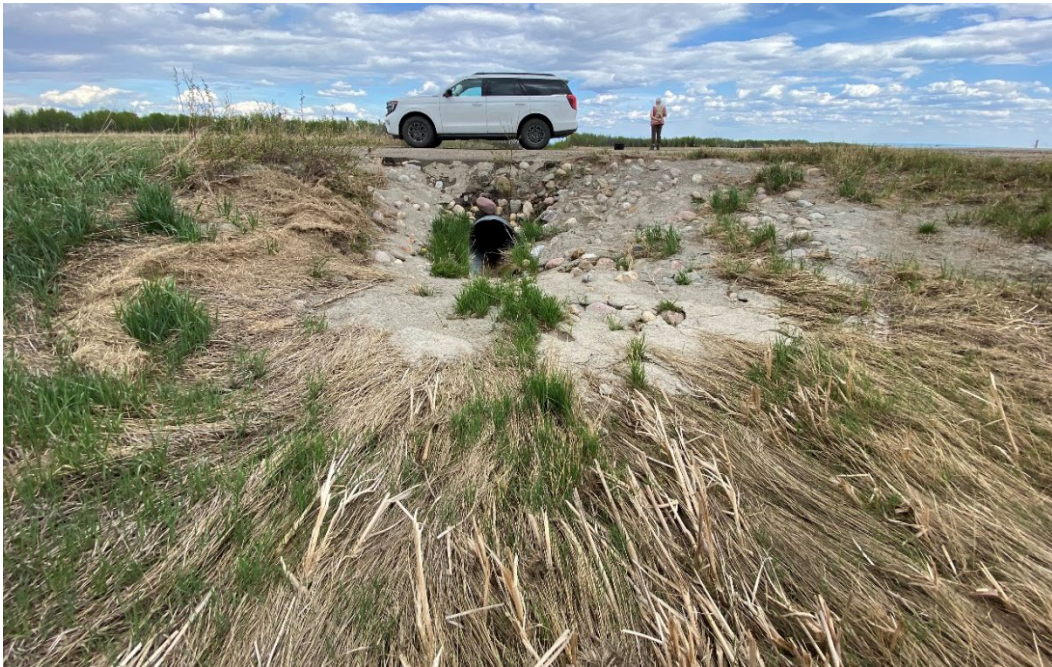
**Photo 1 – Looking east at the grouted riprap at the inlet of the 800 mm dia. culvert at km 2.845 approach.**

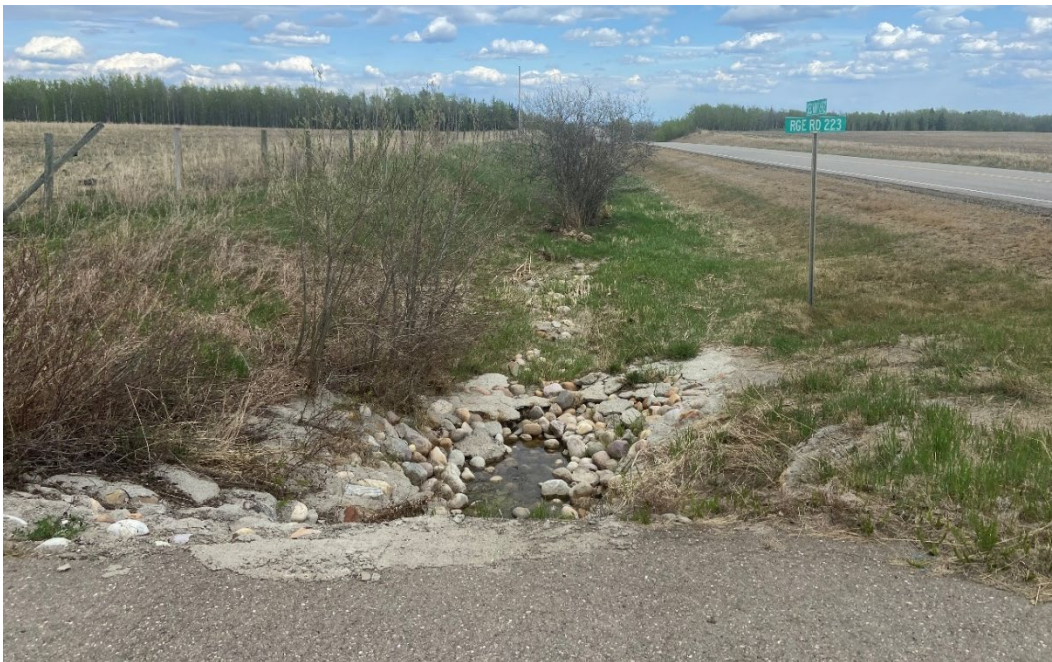
**Photo 2 – Looking east along the north ditch over the outlet of the culvert at the km 2.845 approach. Note the standing water.**

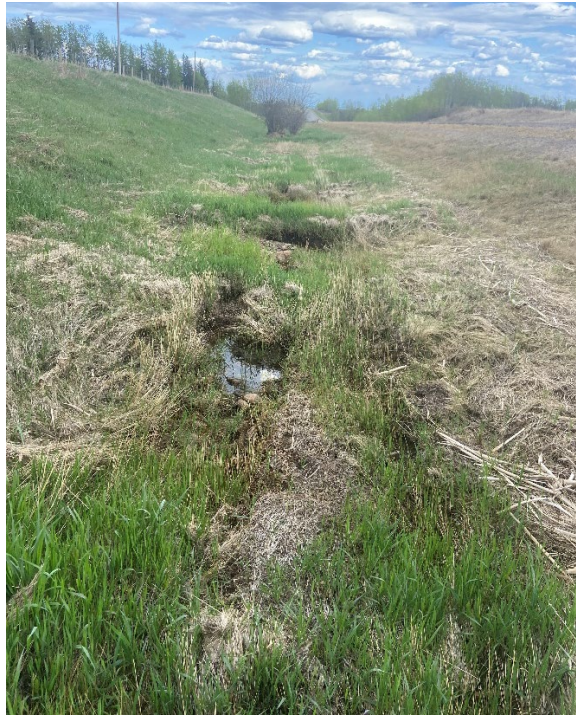
**Photo 3 – Looking east at the damaged gabions with some erosion along the north hwy ditch.**

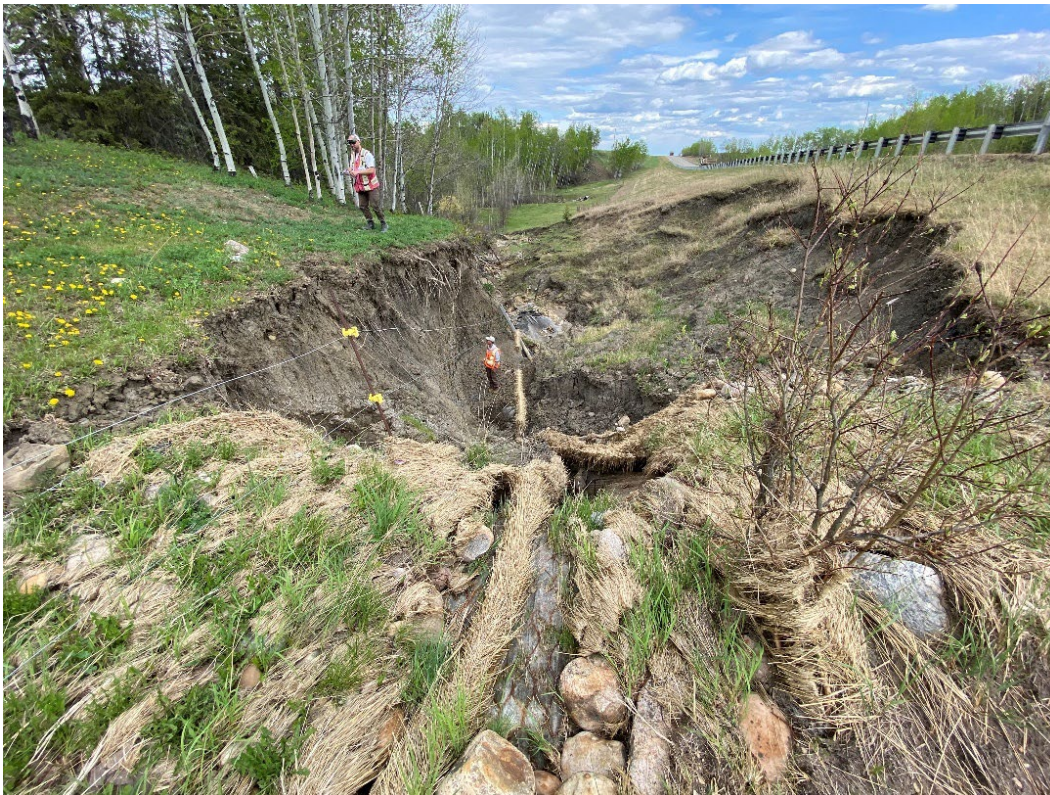
**Photo 4 – Looking east along the north ditch and north hwy embankment at the beginning of the erosion where erosion gully slumping is closest to the highway.**

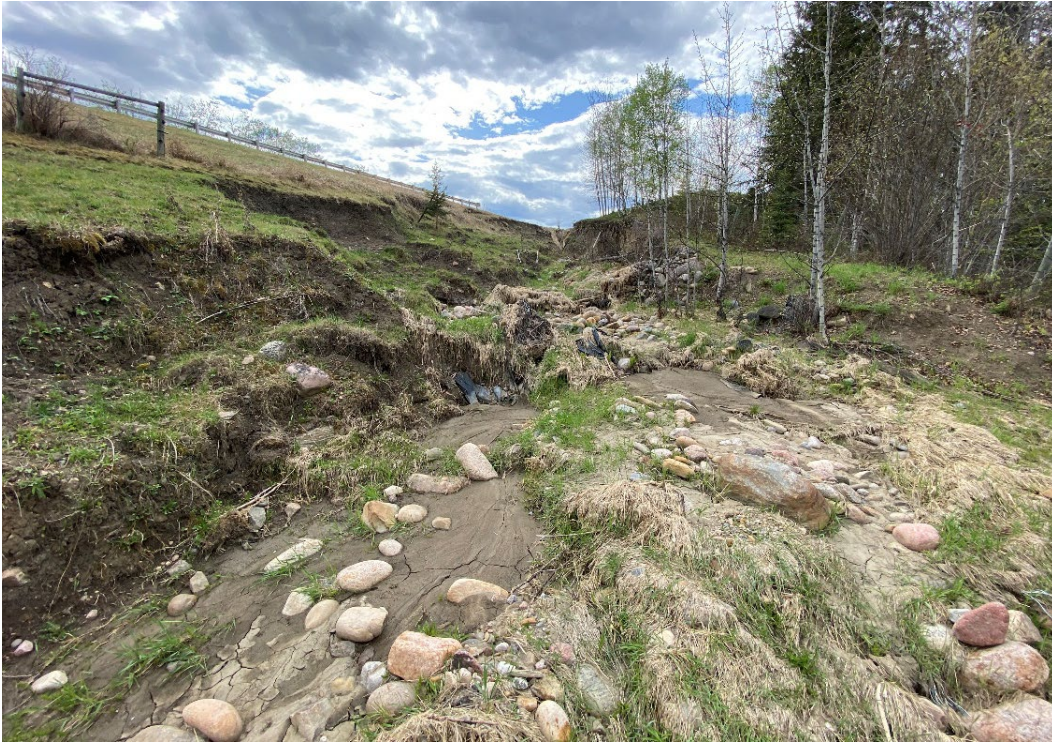
**Photo 5 – Looking southwest at the runoff erosion gully in the north hwy embankment, where the damaged gabion mattress and underlying nonwoven geotextile is exposed.**

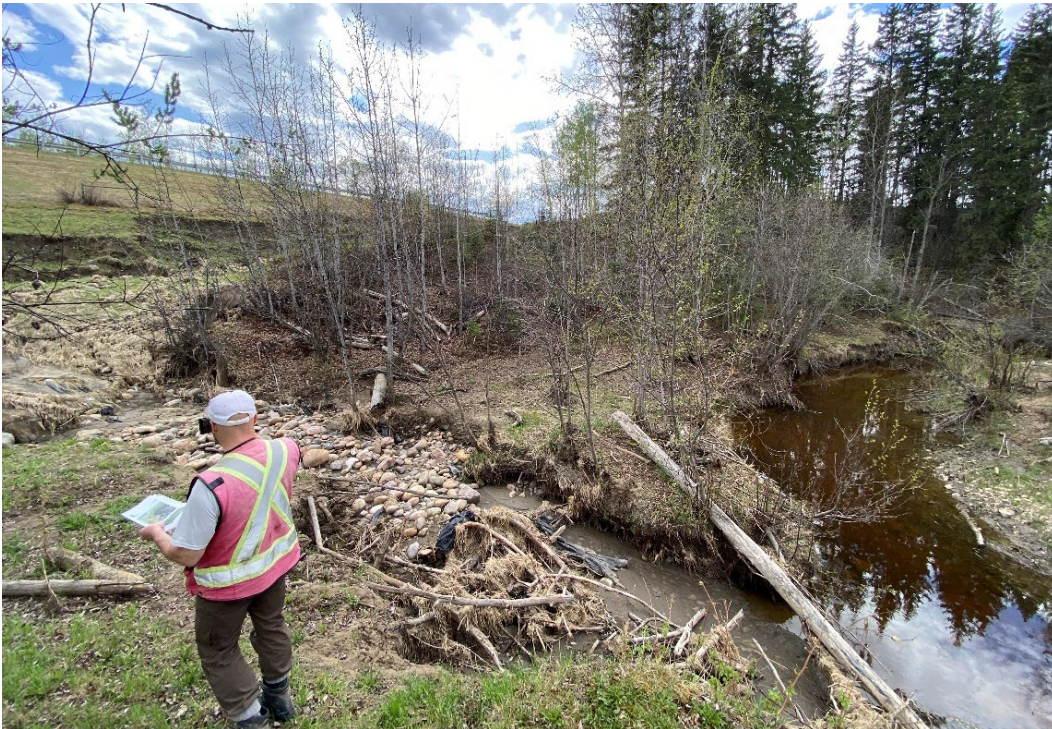
**Photo 6 – Looking southwest near the bottom of the fill where the runoff erosion gully on the north hwy embankment turns to enter Gravina Creek.**

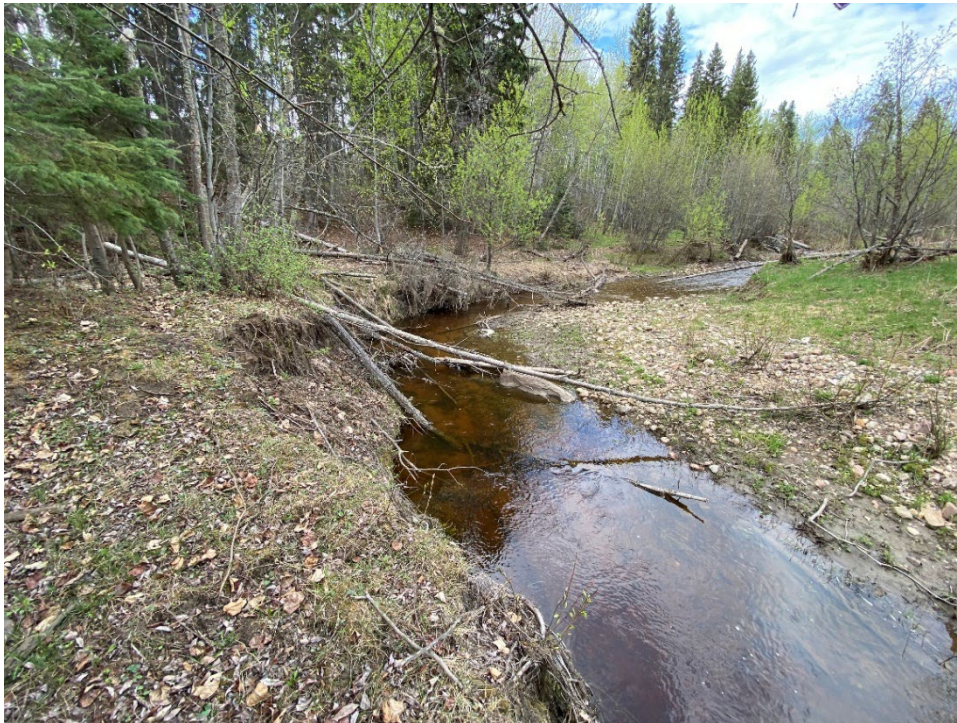
**Photo 7A – Looking west (upstream) along Gravina Creek below the hwy embankment runoff erosion channel.**

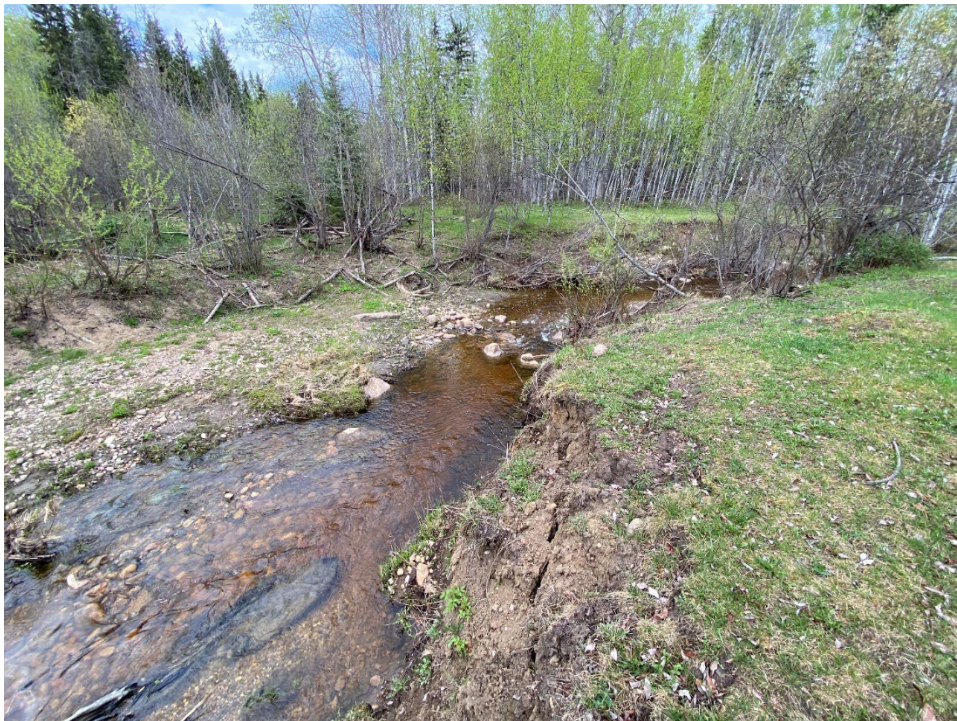
**Photo 7B – Looking east (downstream) along Gravina Creek below the hwy embankment runoff erosion channel**

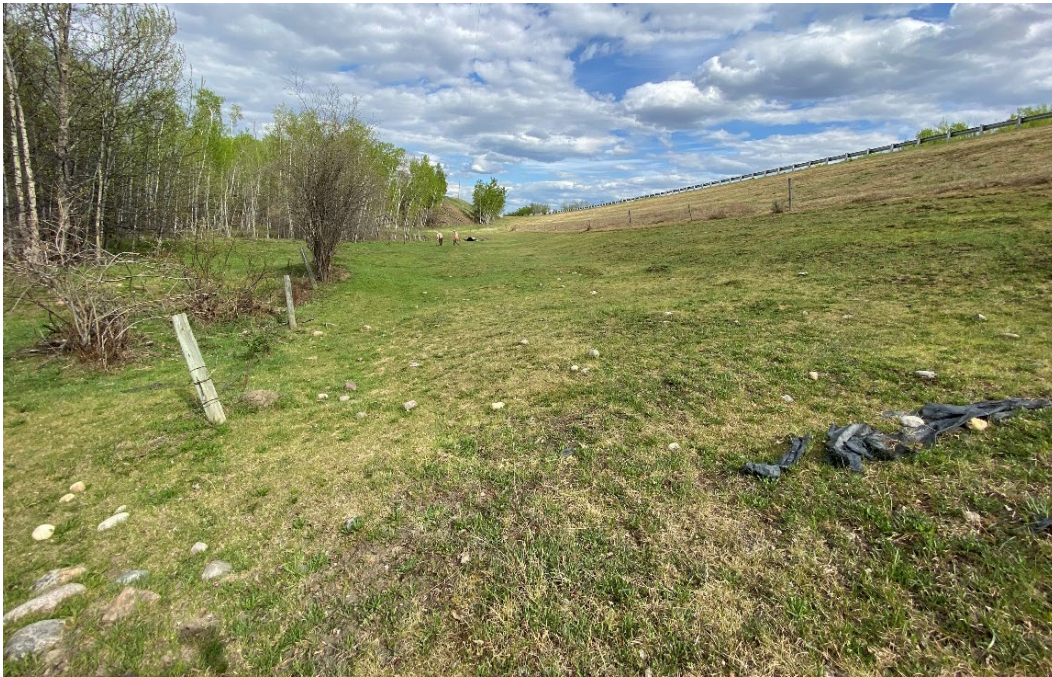
**Photo 8 – Looking east along the area between the hwy right-of-way and Gravina Creek.**

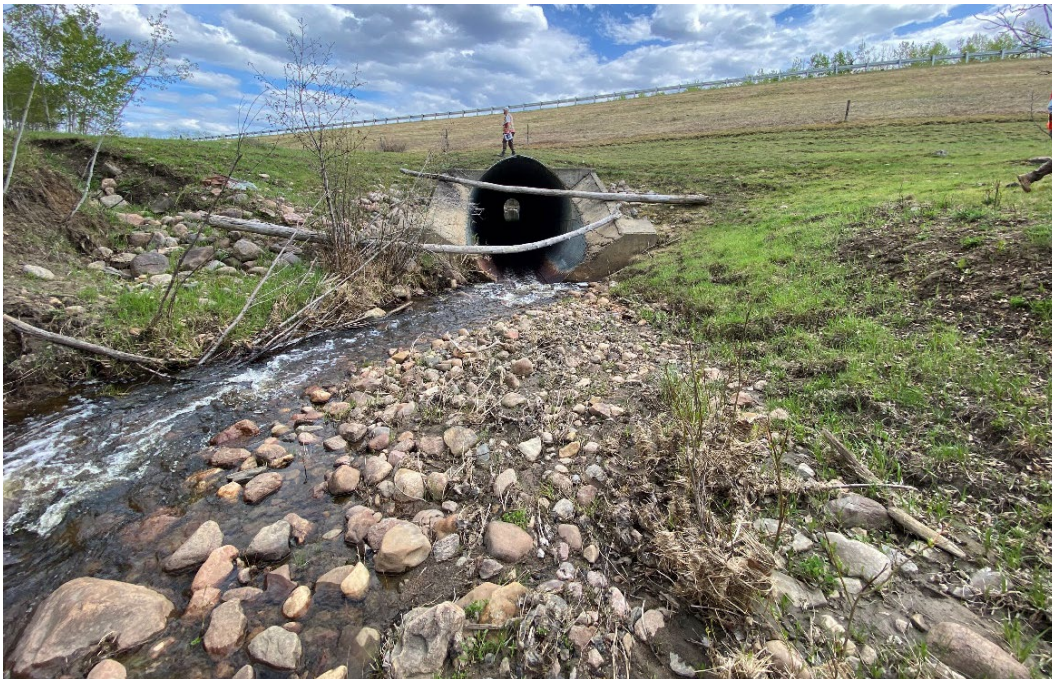
**Photo 9 – Looking southeast at the inlet of the 3.5 m dia. BF culvert. Note the erosion gully on the east channel bank north of the entrance.**

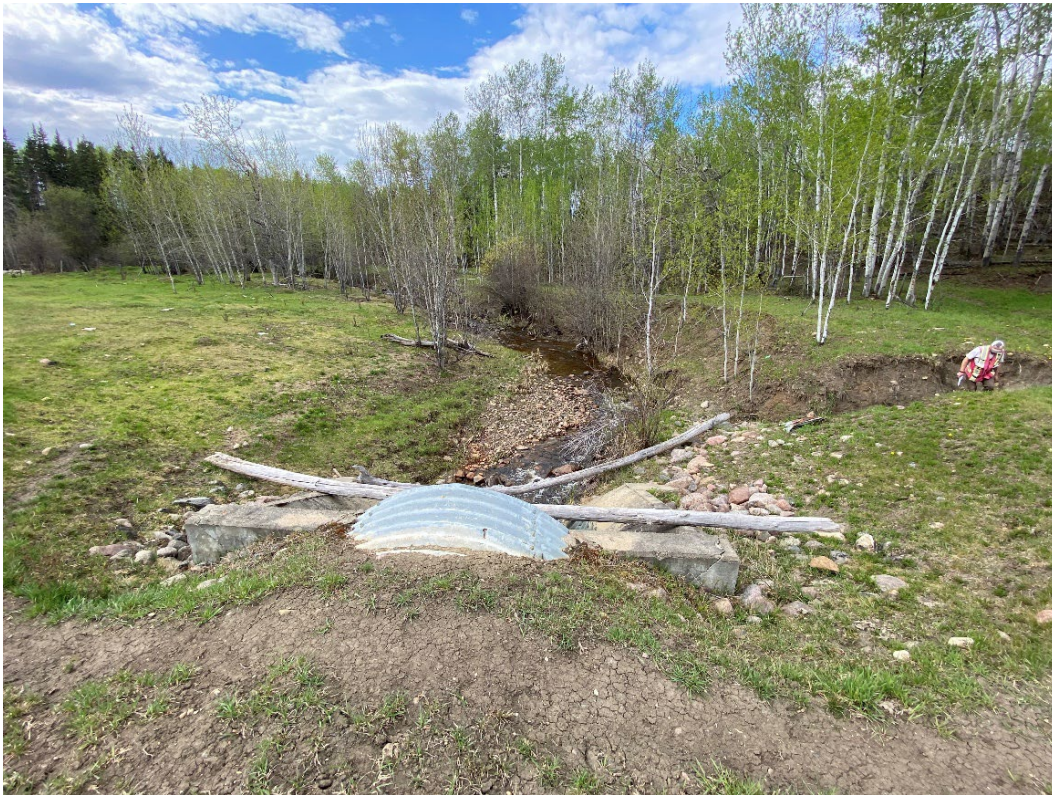
**Photo 10 – Looking northwest overtop the 3.5 m dia. culvert inlet.**

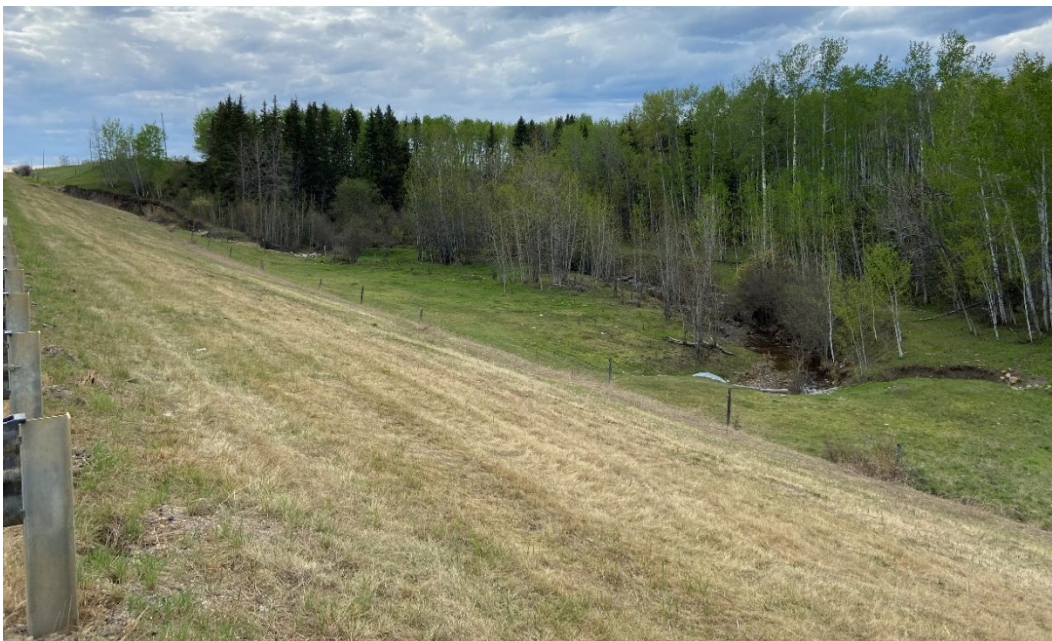
**Photo 11 – Looking northwest at the 3.5 m dia. culvert inlet and the north hwy embankment areas.**

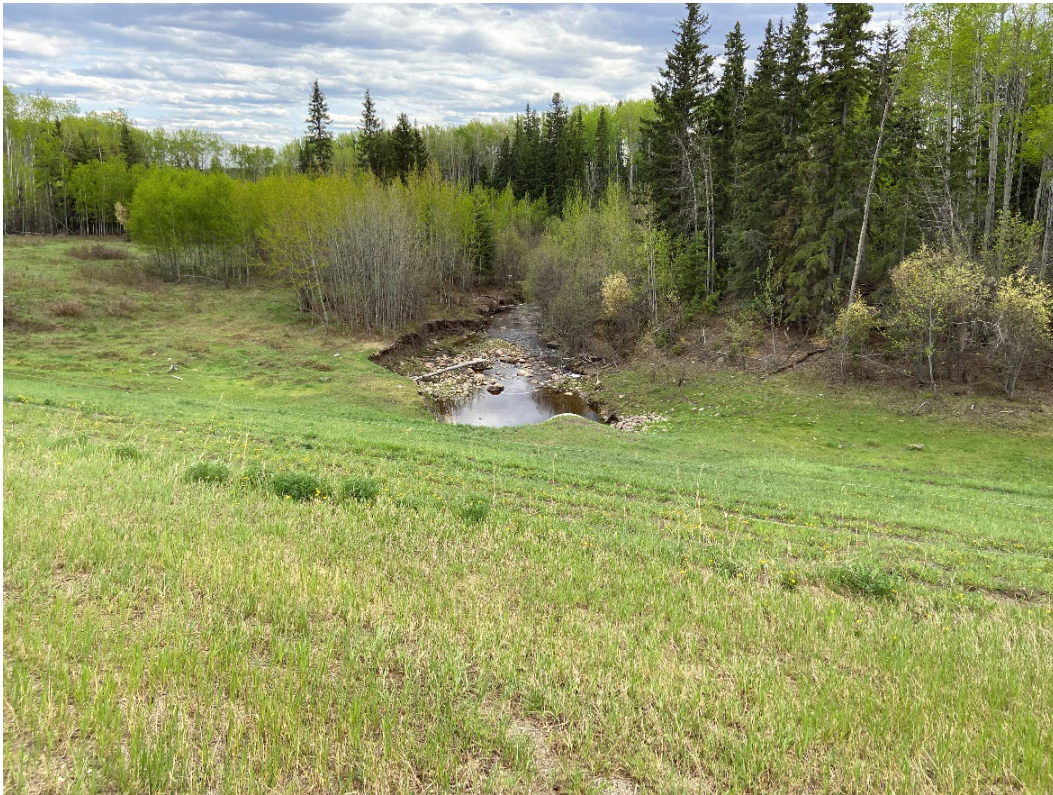
**Photo 12 – Looking southeast over the south hwy embankment and 3.5 m dia. culvert outlet area.**
