**ALBERTA TRANSPORTATION
GEOHAZARD ASSESSMENT PROGRAM
PEACE REGION – HIGH LEVEL
2019 INSPECTION**

Site Number	Location	Name	Hwy	km
PH006-1	North of Paddle Prairie	Tompkins Landing	697:02	16.97-17.62
Legal Description		UTM Co-ordinates		
NW30-103-19-W5M / E25-103-20-W5M		11U E 491,100	N	6,425,466

**PH006-1: HWY 697:02 - TOMPKINS LANDING SLIDE
2019 GEOHAZARD ASSESSMENT**

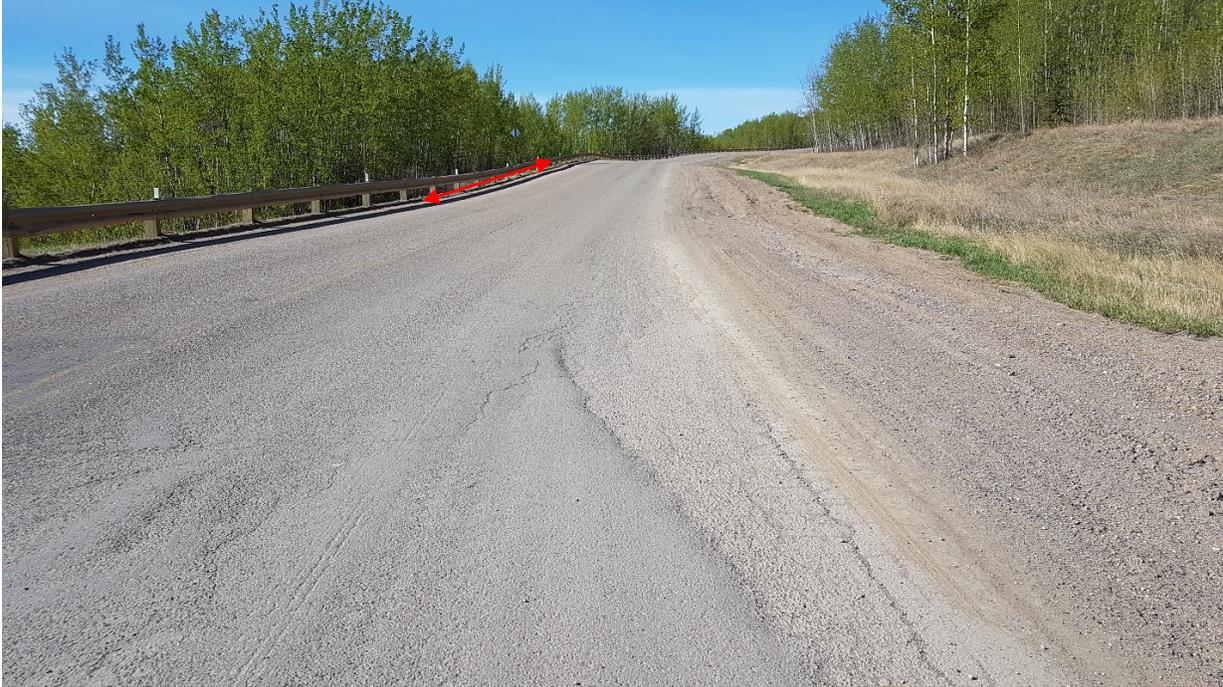
Photo 1 – Looking southwest at one of the dips in the road and recently-patched pothole (was at the centreline of the road).

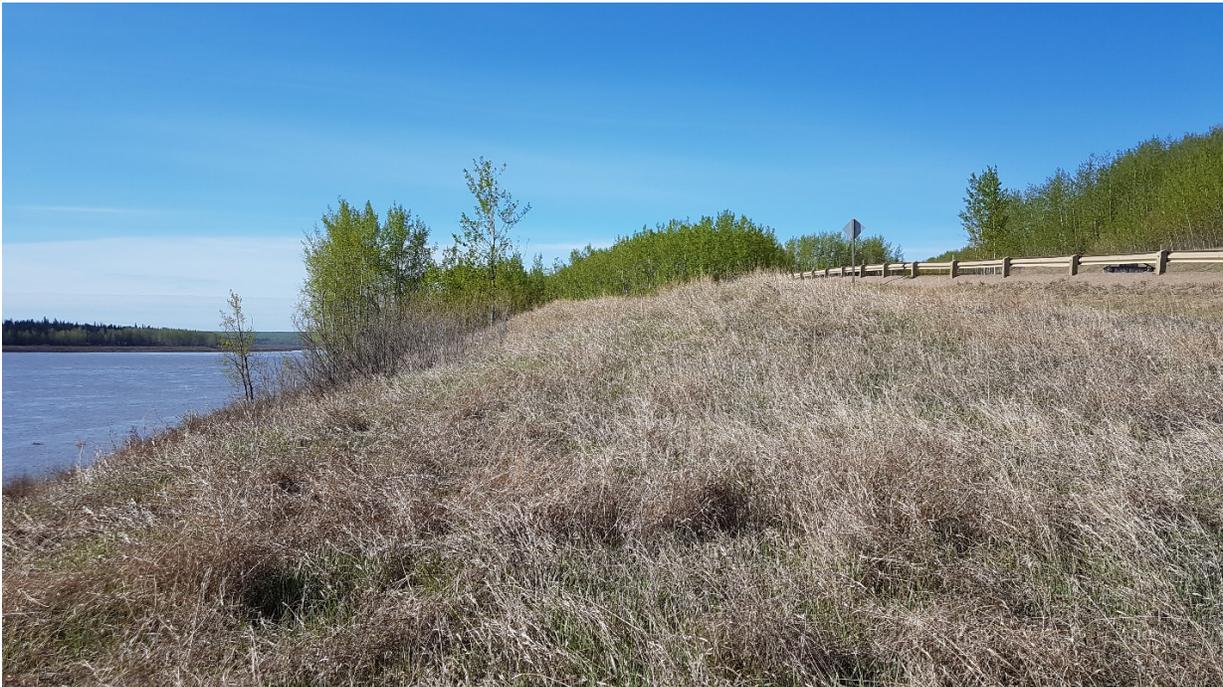
Photo 2 – Looking south at slope with ongoing movement in the northeast portion of the site. Note that much of the vegetation along the river bank was destroyed by flooding in Spring 2018.

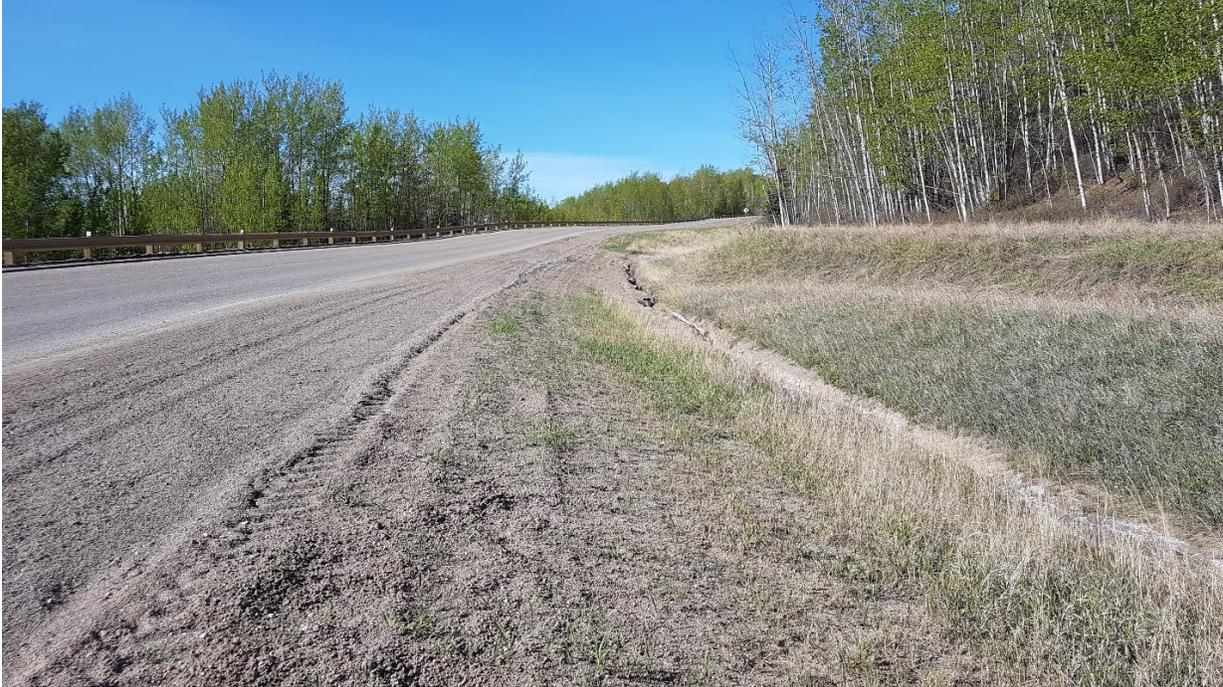
Photo 3 – Looking southwest at erosion in north ditch.

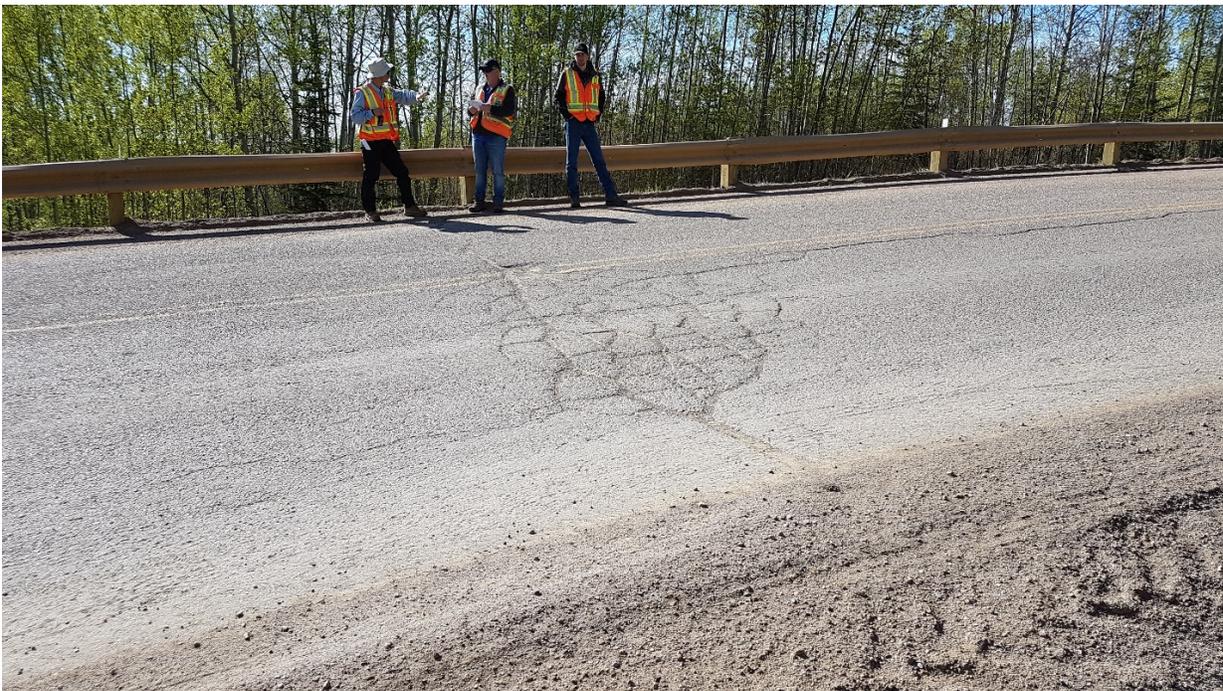
Photo 4 – Alligator cracking near the southwest end of the site.

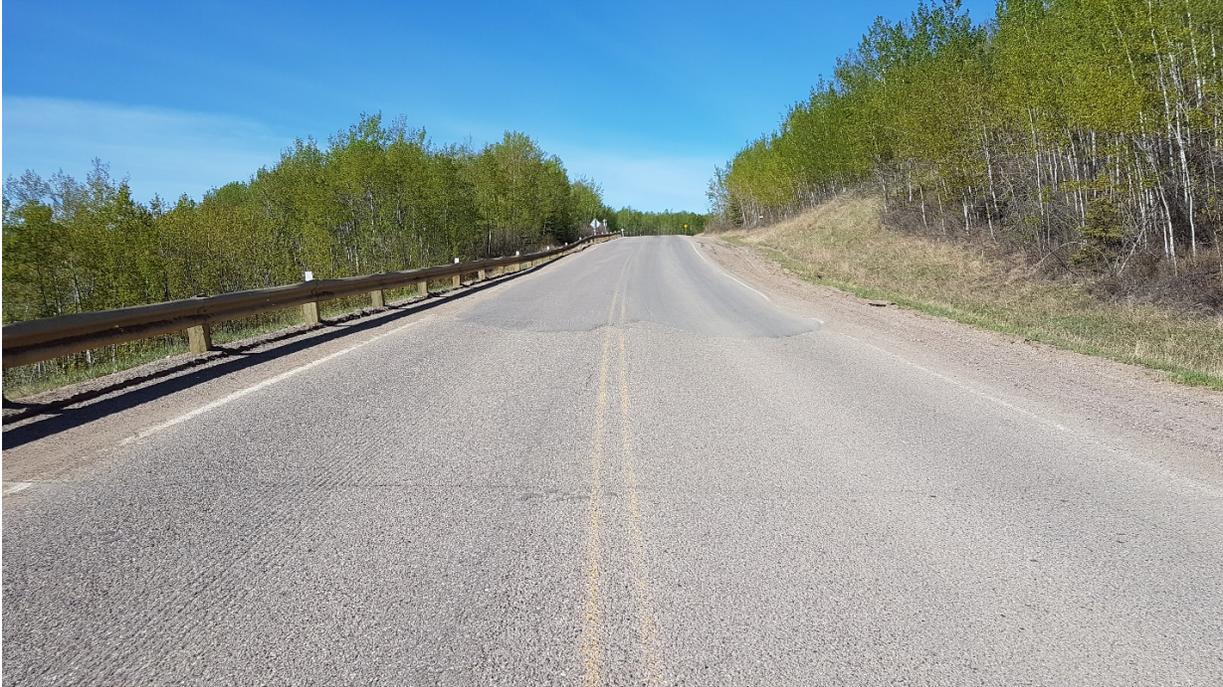
Photo 5 – Looking southwest at recent patch near southwest portion of the site.

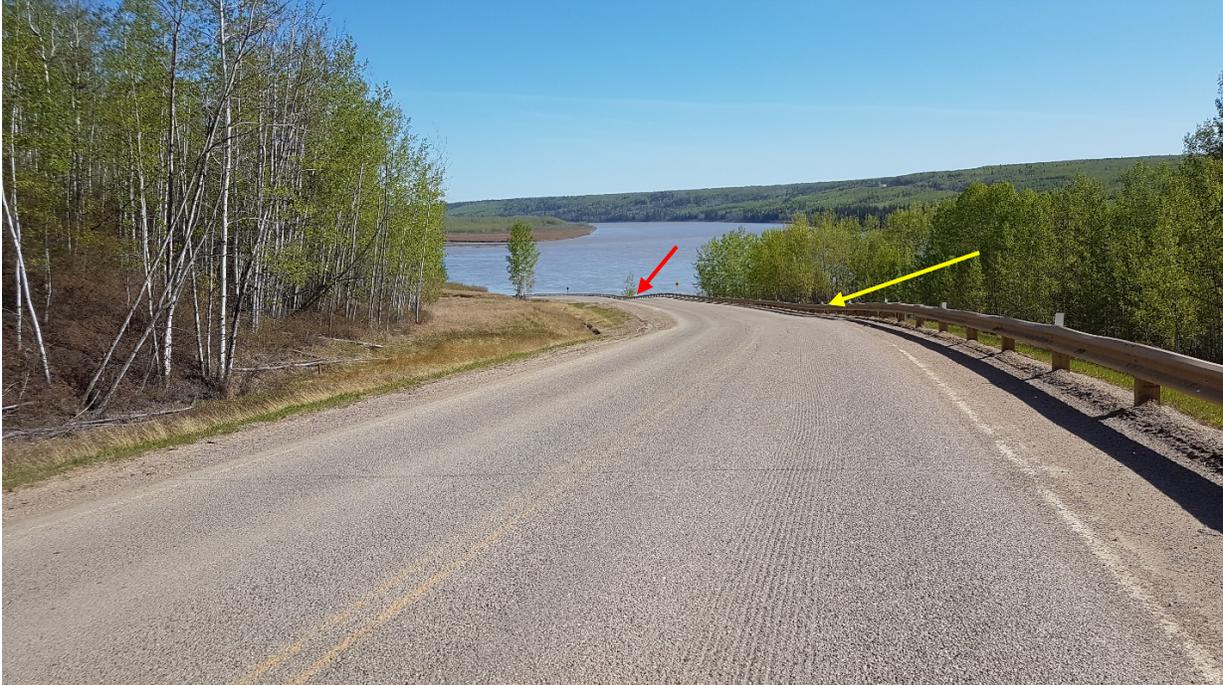
Photo 7 – Looking east at dips in the road (minor with yellow arrow, major with red arrow).

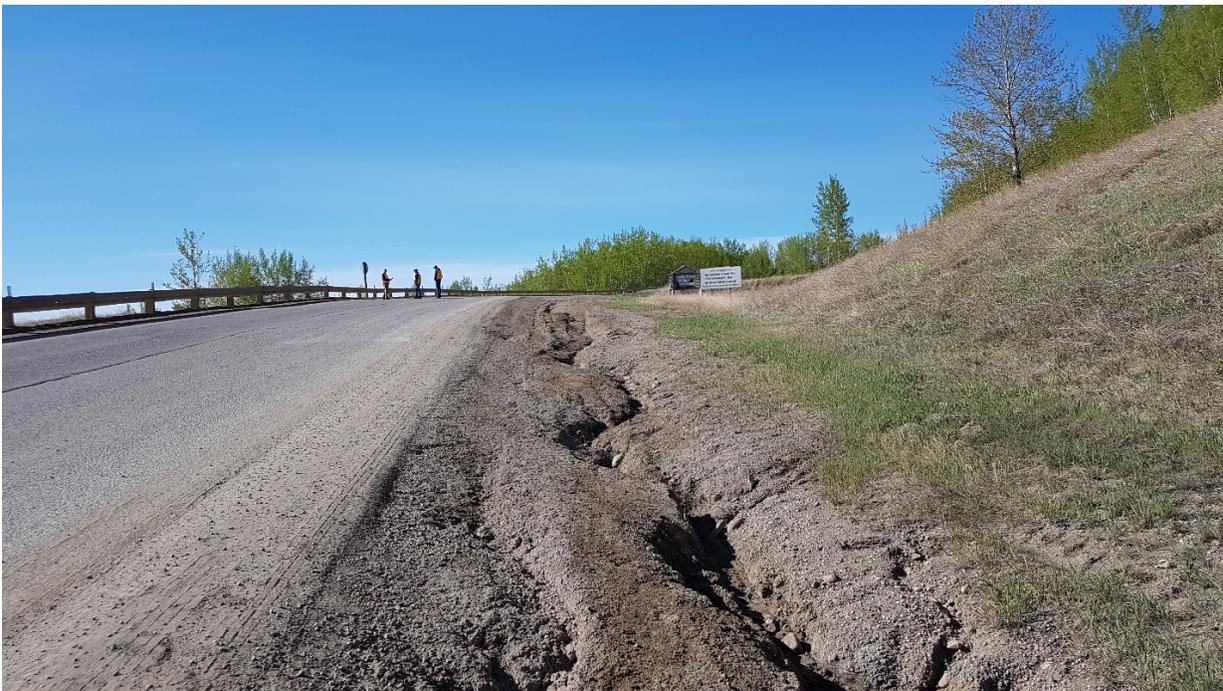
Photo 8 – Looking west at ditch erosion near bottom of valley.

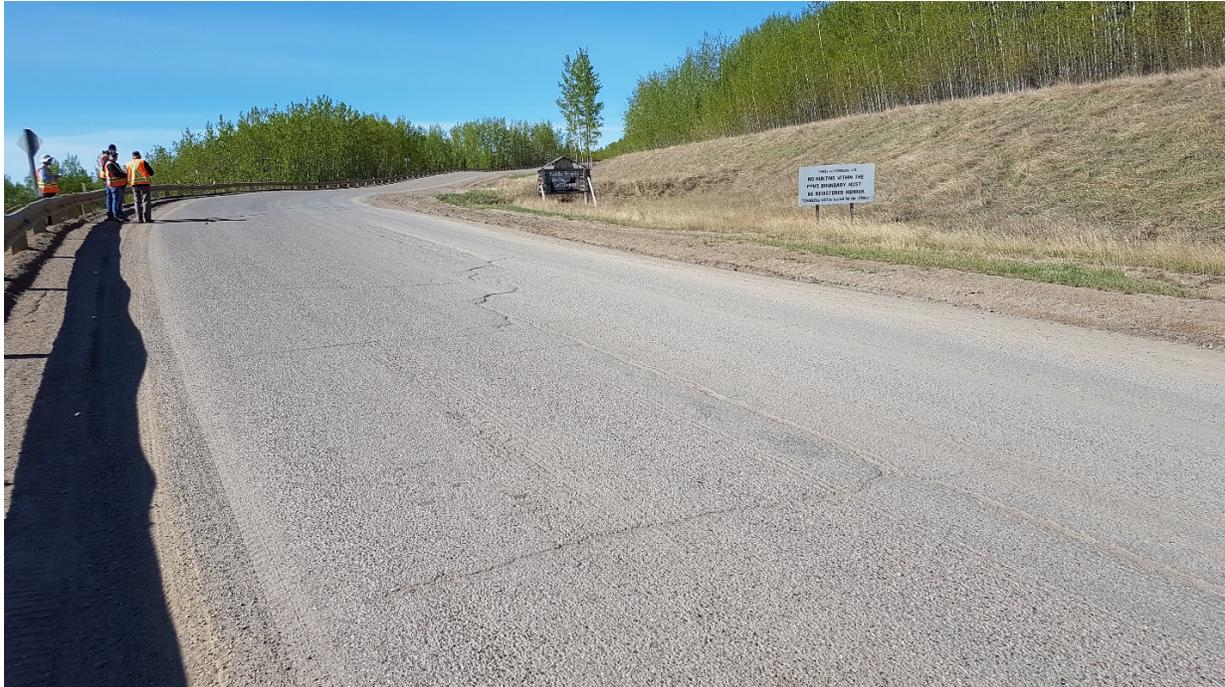
Photo 9 – Cracks on highway near bottom of valley.
