**ALBERTA TRANSPORTATION
GEOHAZARD ASSESSMENT PROGRAM
PEACE REGION – HIGH LEVEL
2020 INSPECTION**

Site Number	Location	Name	Hwy	km
PH006-1	North of Paddle Prairie	Tompkins Landing	697:02	16.97-17.62
Legal Description		UTM Co-ordinates		
NW30-103-19-W5M / E25-103-20-W5M		11U E 491,100	N	6,425,466

PH006-1: HWY 697:02 - TOMPKINS LANDING SLIDE 2020 GEOHAZARD ASSESSMENT

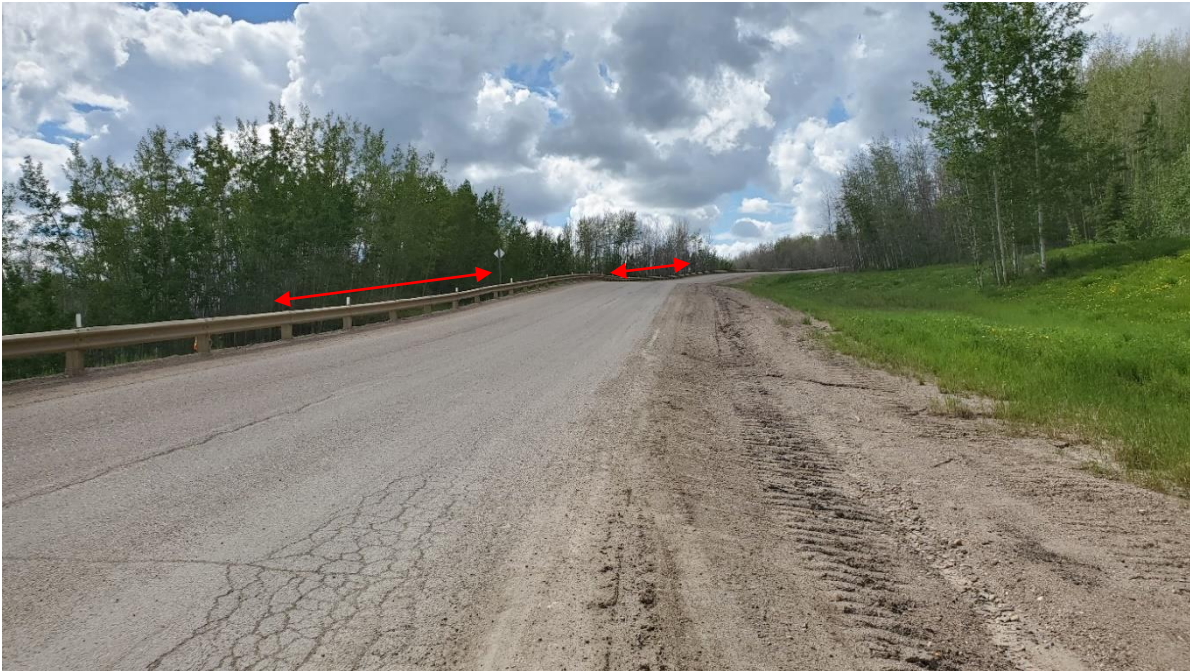
Photo 1 – Looking southwest at one of the dips in the road and deteriorating asphalt surface. A second dip is visible further up the road.

- Routine crack sealing, milling, and patching should be undertaken, as necessary, to maintain a safe riding surface and reduce water infiltration.

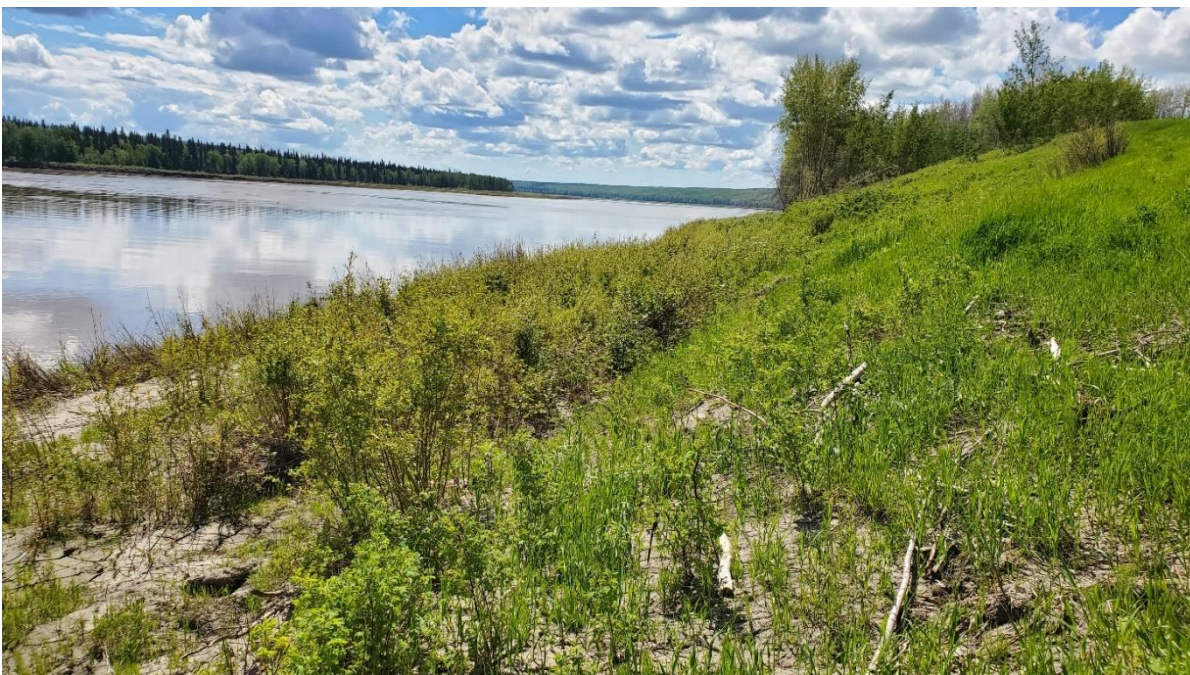
Photo 2 – Looking south at slope with ongoing movement in the northeast portion of the site. Note that much of the vegetation along the river bank was destroyed by flooding in Spring 2018 and covered again with silt and debris in Spring 2020 (higher water level than 2018).

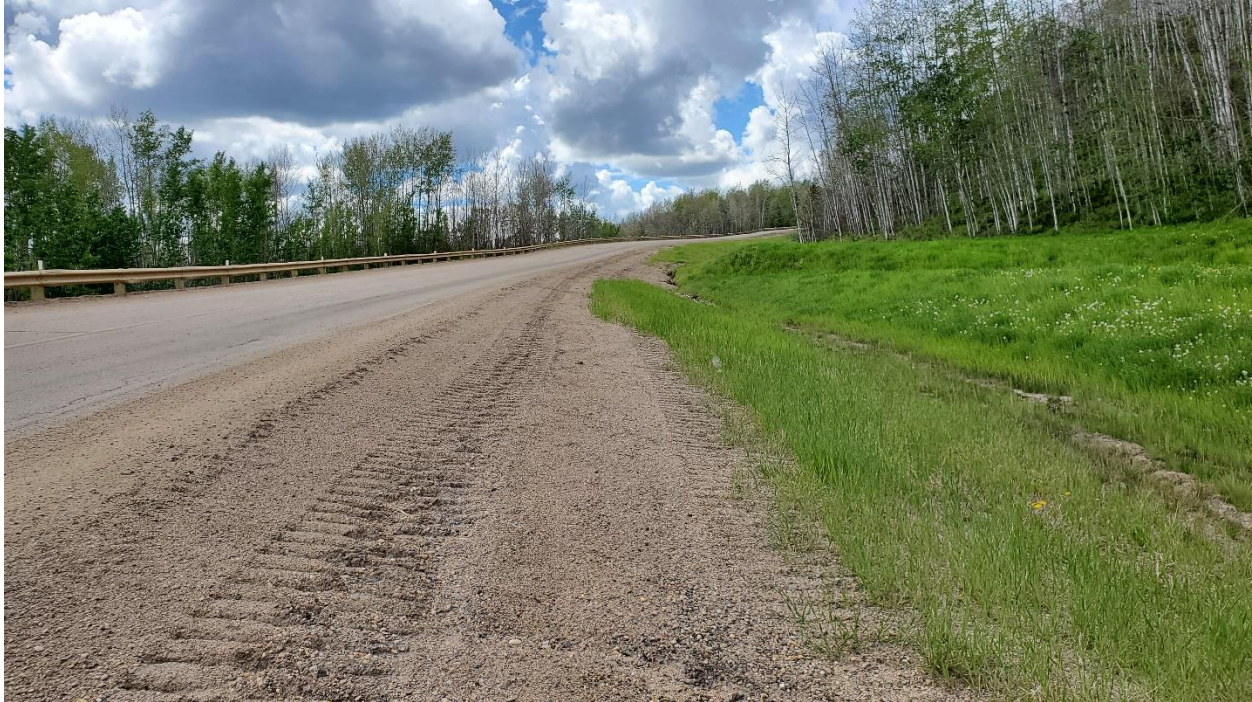
Photo 3 – Looking southwest at erosion in north ditch.

- The erosion gullies should be regraded and protected from future erosion with armour (like riprap) or TRM until vegetation can be re-established. Note that heavy sanding on this hill during winter will limit vegetation development within 2 m of the highway.

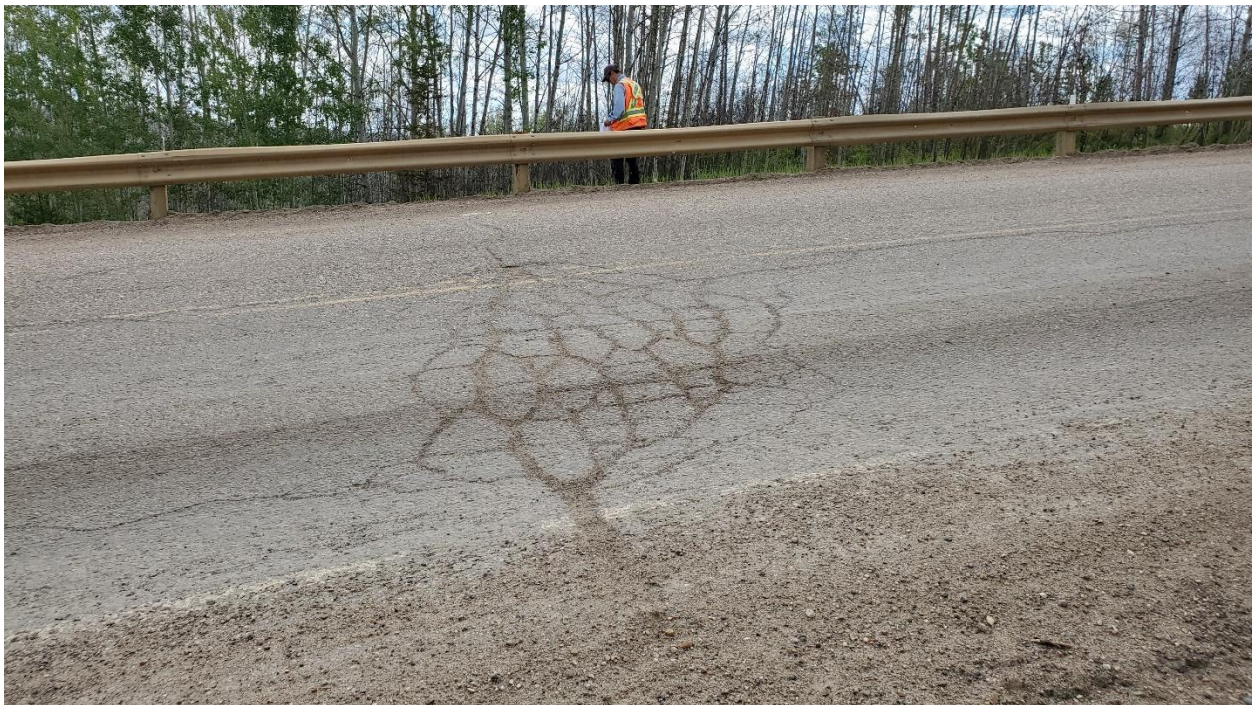
Photo 4 – Alligator cracking near the southwest end of the site.

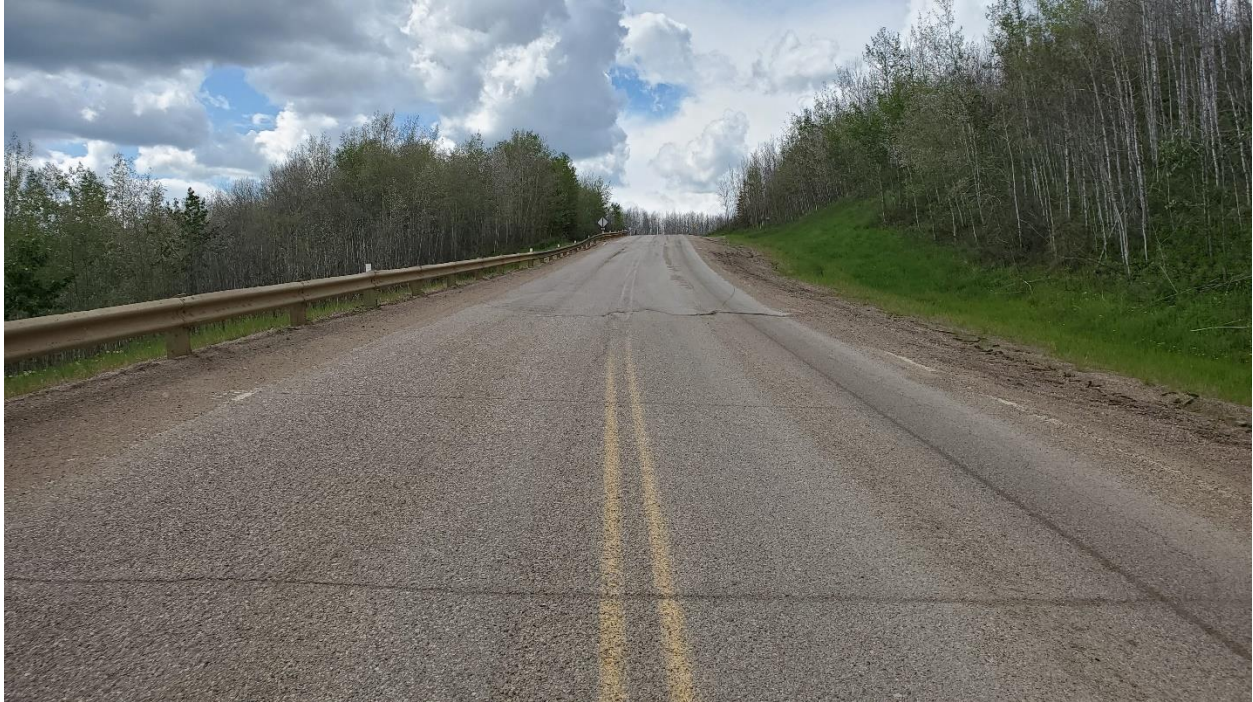
Photo 5 – Looking southwest at recent patch near southwest portion of the site.

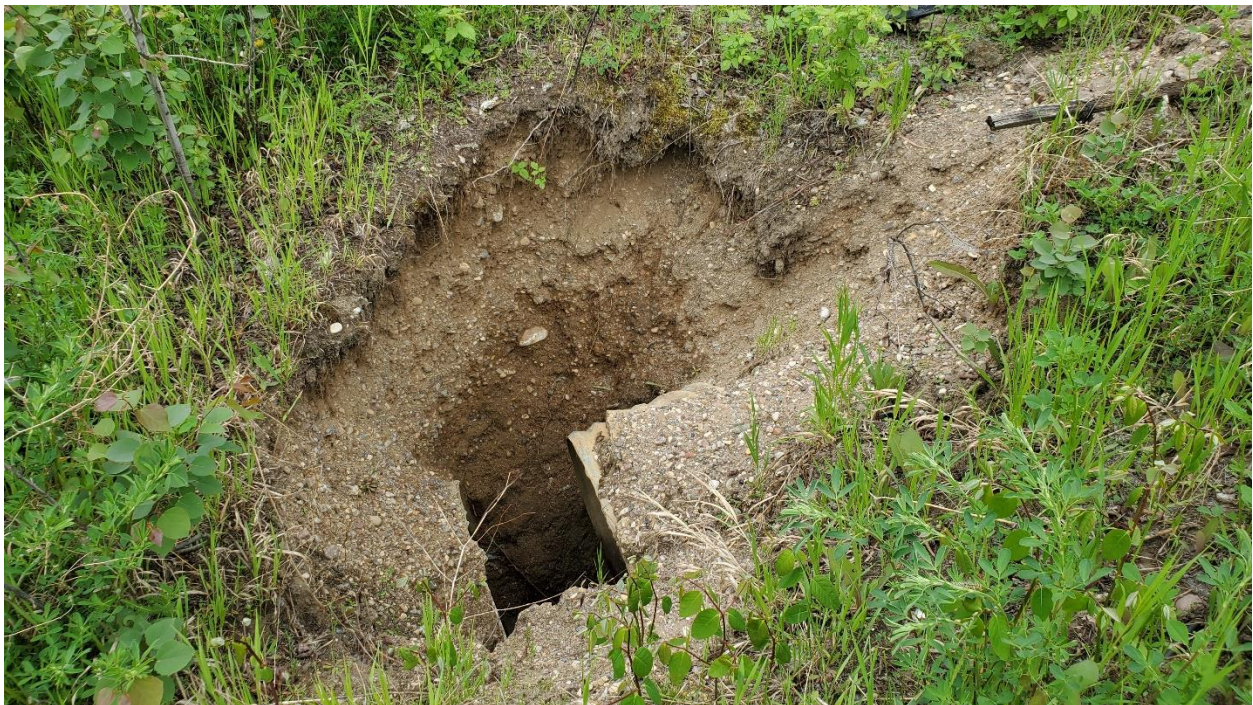
Photo 6 – Sinkhole at separated 800 mm CSP downpipe south of the highway.

- The gap in the 800 mm culvert should be repaired to reduce the amount of runoff into the slide mass. The culvert could be excavated and replaced; alternatively, a collar could be used to span the gap with one end not fastened to allow for future movement. The sinkhole should be backfilled with compacted low- to medium-plastic clay.

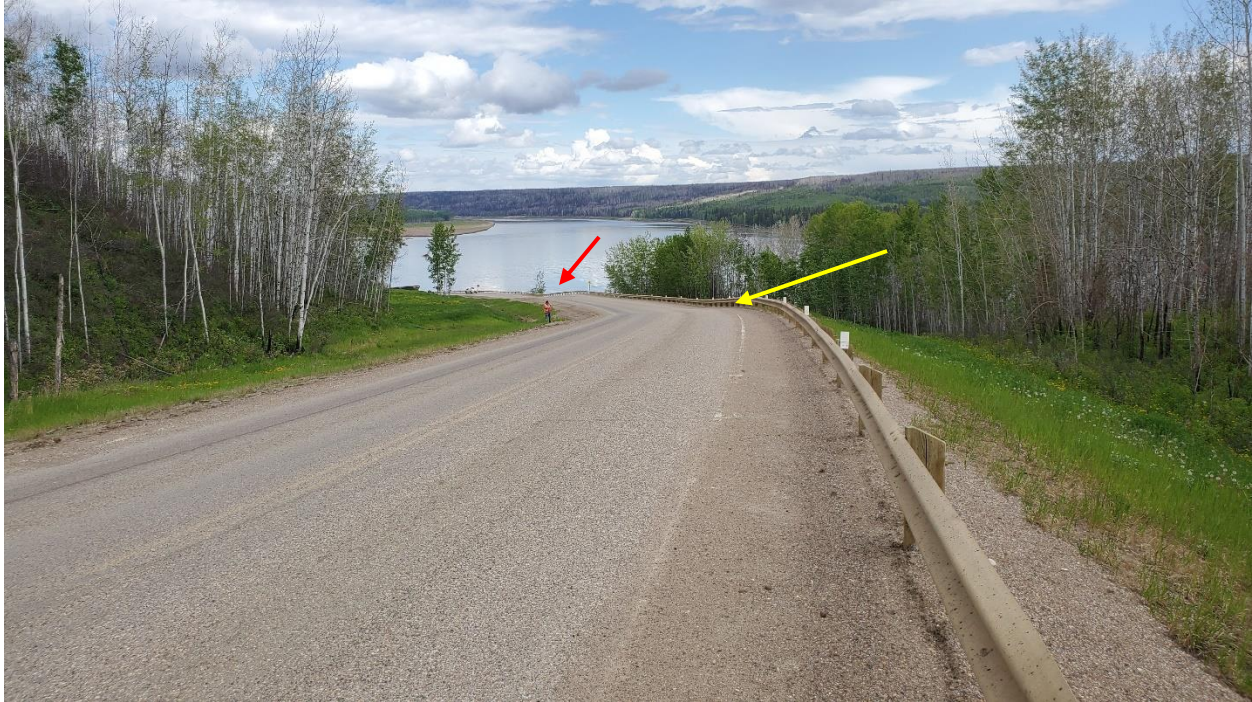
Photo 7 – Looking east at dips in the road (minor with yellow arrow, major with red arrow).

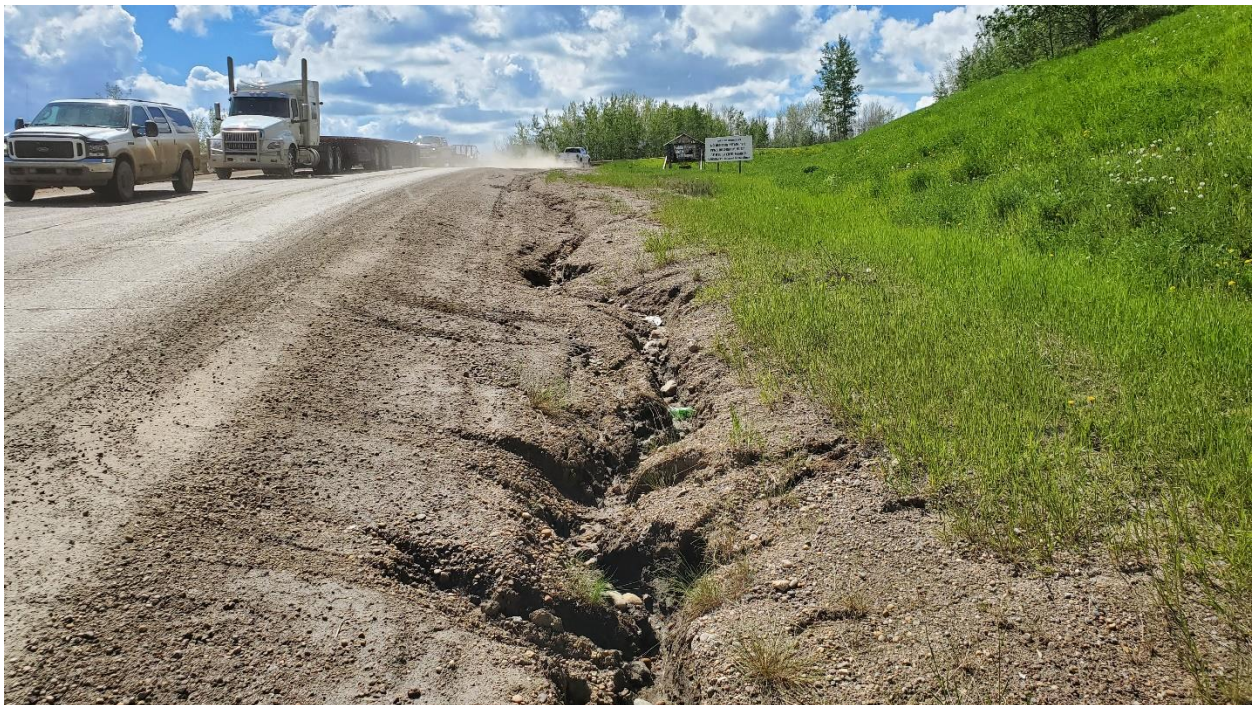
Photo 8 – Looking west at ditch erosion near bottom of valley.

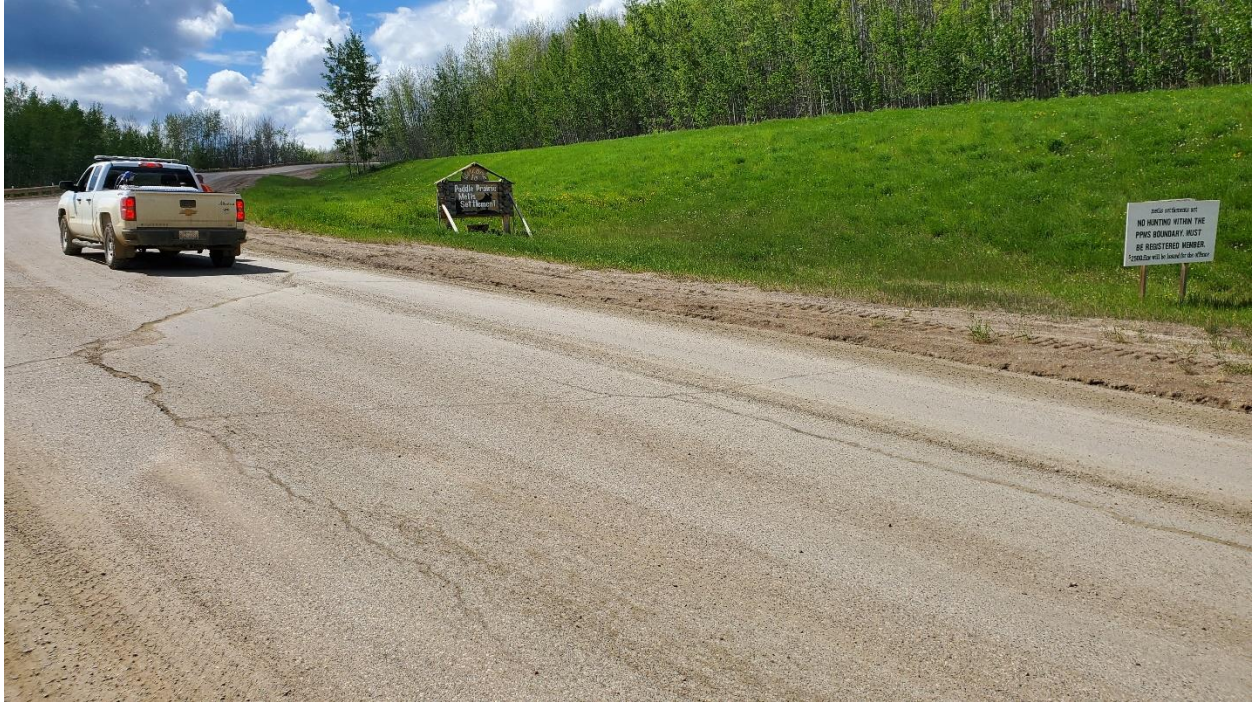
Photo 9 – Cracks on highway near bottom of valley.
