THURBER ENGINEERING LTD.

July 28, 2022

**ALBERTA TRANSPORTATION GRMP (CON0022164)
PEACE REGION (PEACE RIVER DISTRICT)
INSTRUMENTATION MONITORING RESULTS – SPRING 2022**

SITE PH006: HWY 697:02, TOMPKINS LANDING

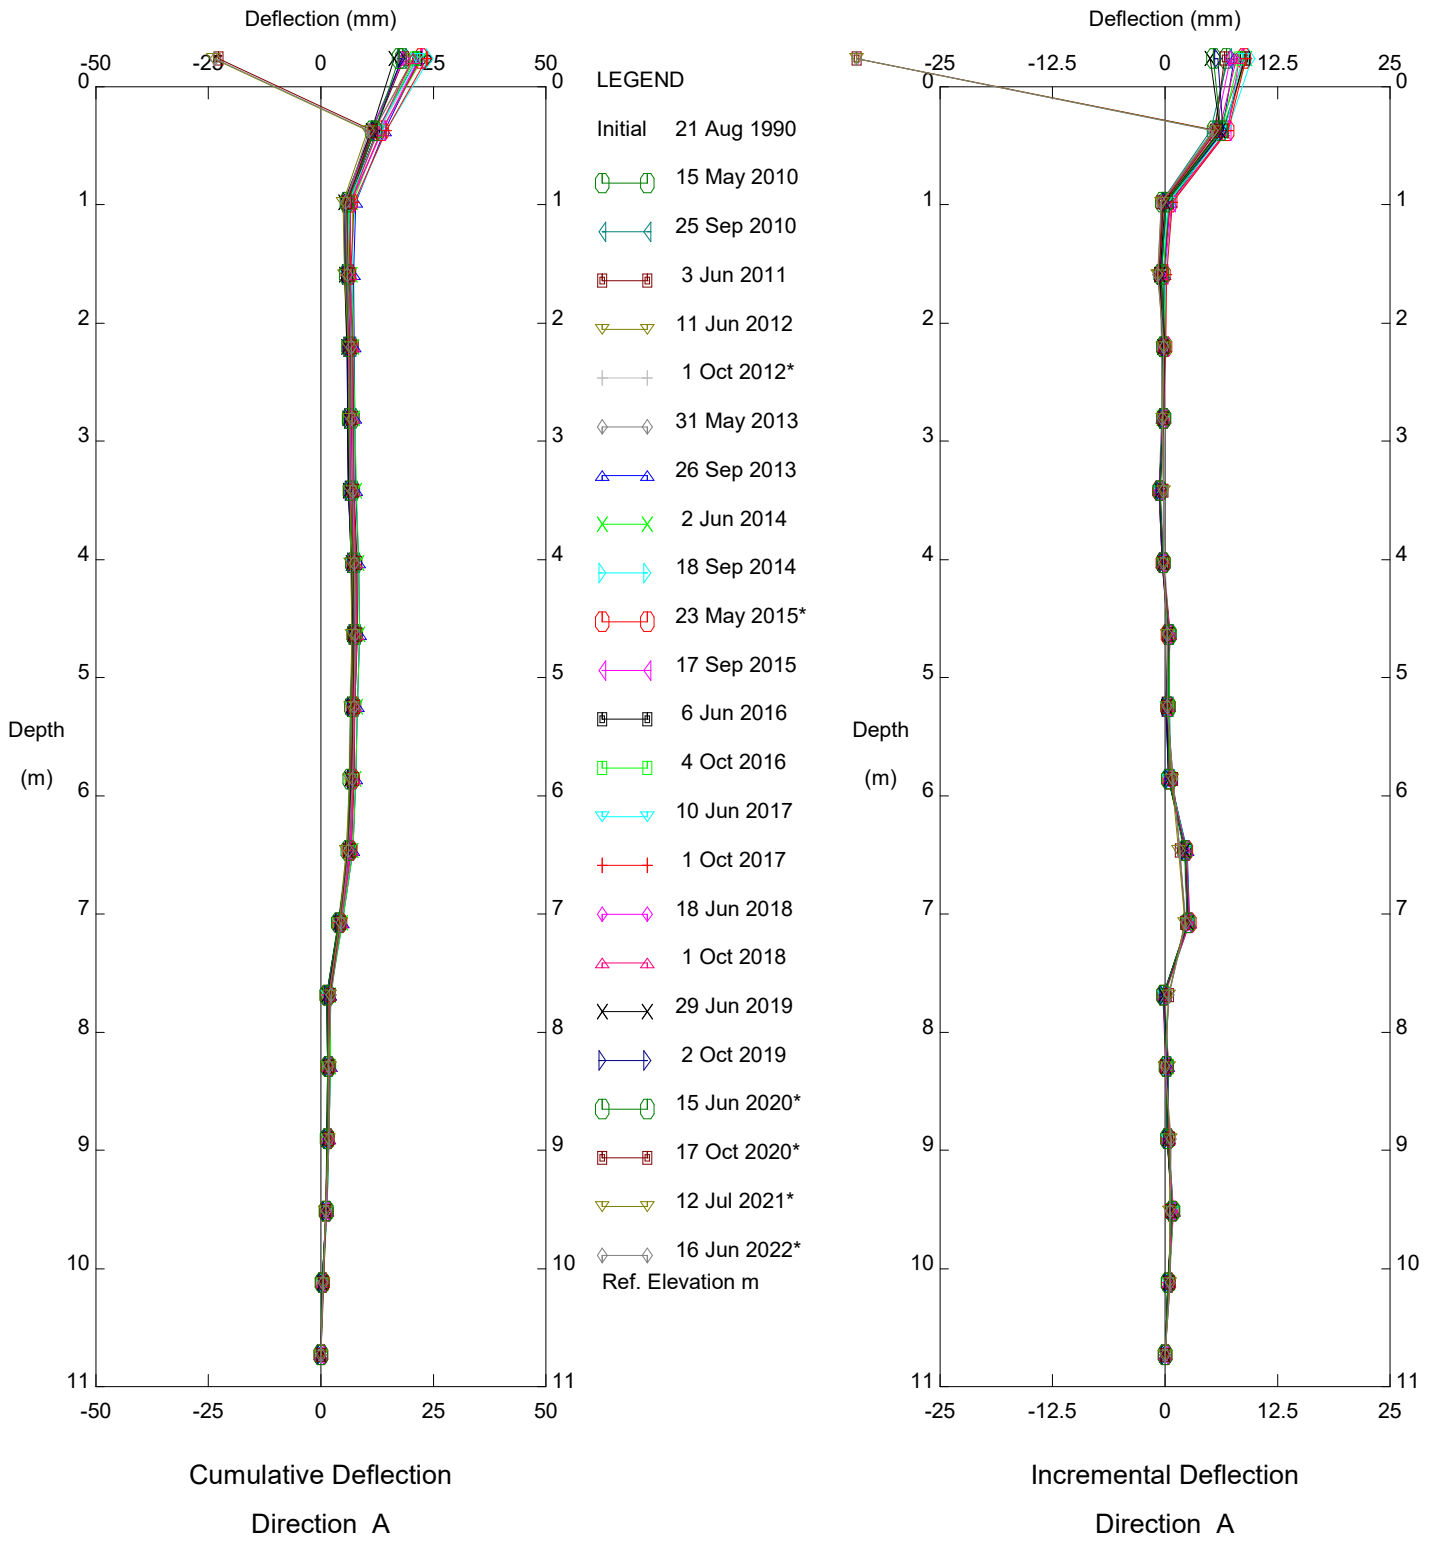
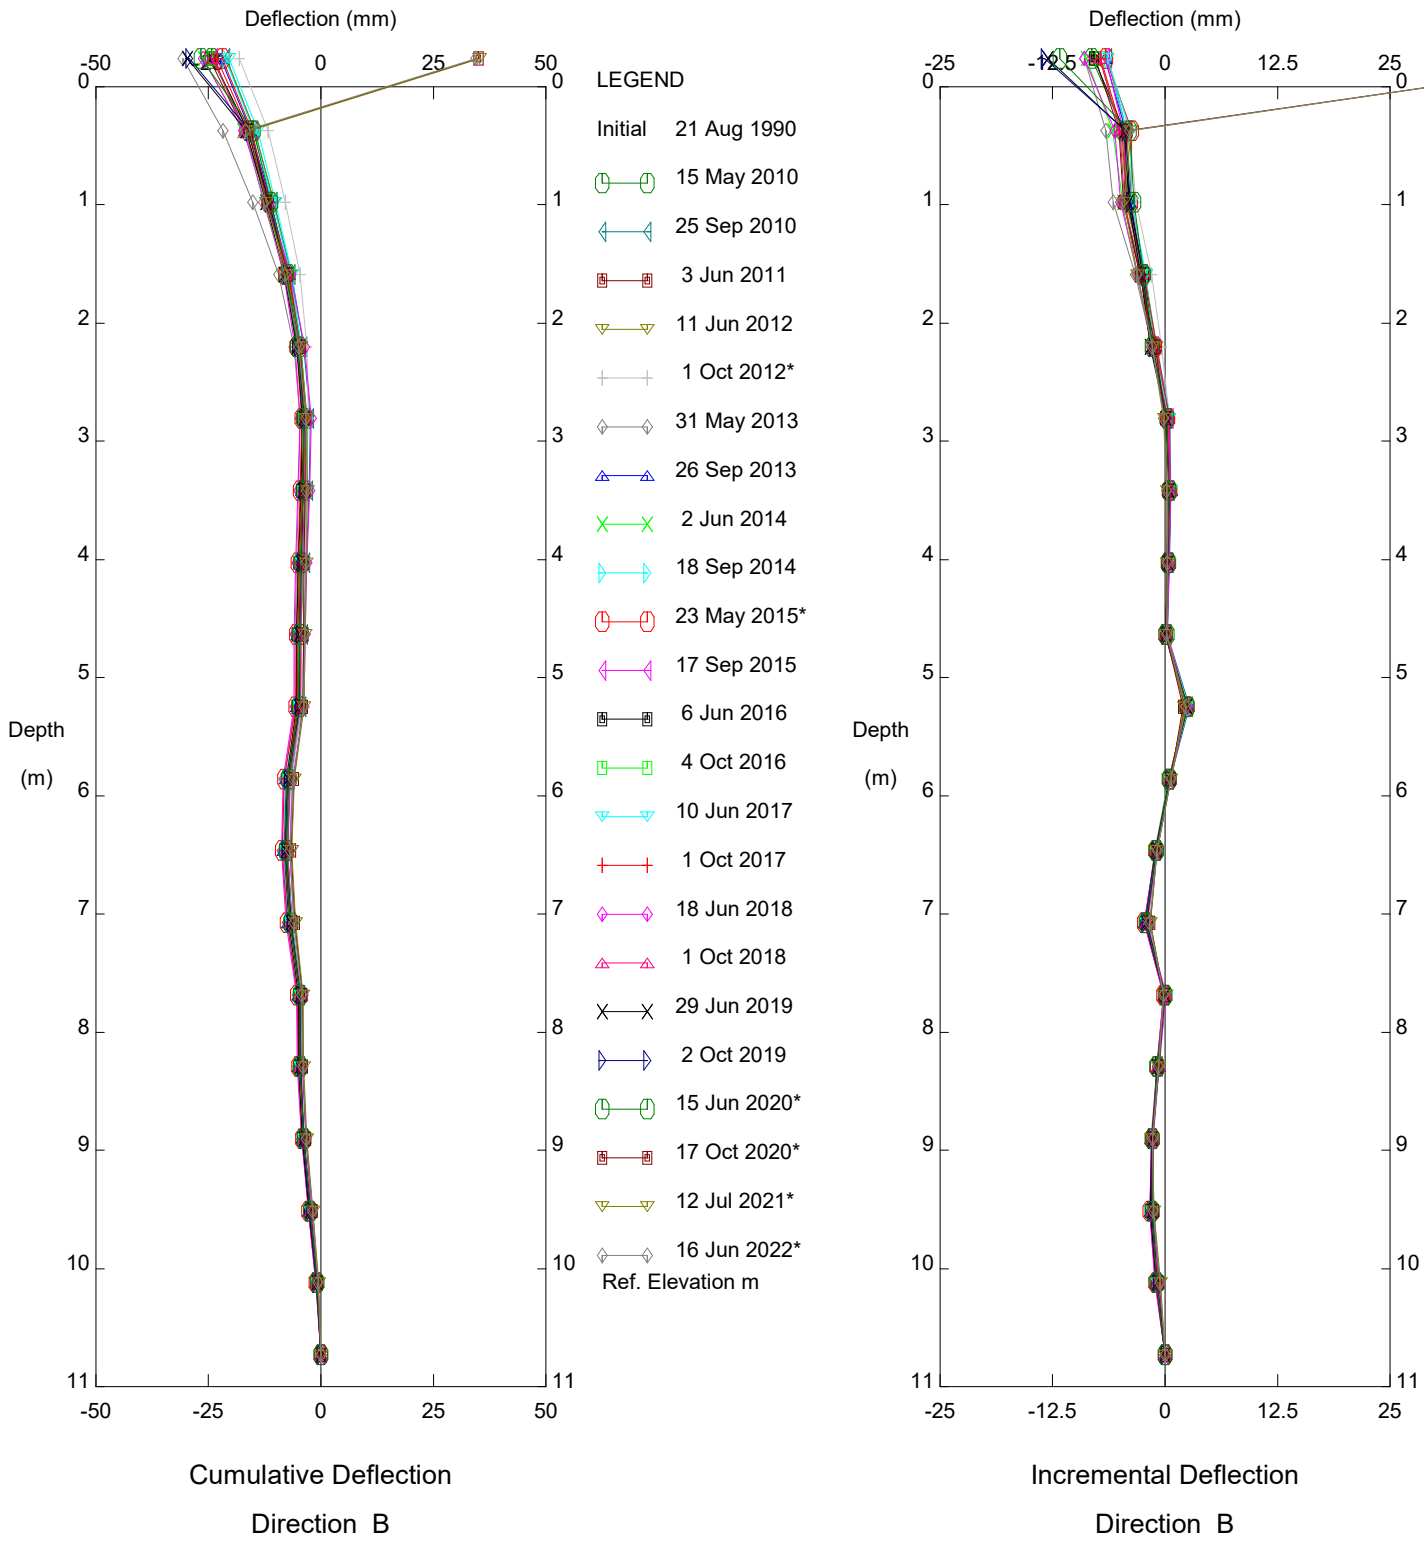
HWY 697:02 - STA. 17+360, Inclinometer SI-1

Slope inclinometer SI-1 continued to show no discernible movement. Both movement zones in SI-5 showed rapid movement shortly after initialization and then have remained relatively constant since at a much slower rate. SI-5 showed a rate of movement of 2.4 mm/yr over 0.1 m to 2.6 m depth, compared to the overall average rate (since initialization) of 3.0 mm/year. The lower zone at SI-5, 2.6 m to 11.1 m depth, had a rate of movement of 18.8 mm/yr since the spring of 2021 readings. The overall rate (since installation in 1996) over this zone is 12.7 mm/year which includes the initial rapid movement. The trend since 2007 is 9.0 mm/yr; however, the rate of movement has accelerated starting in 2019 to 13.9 mm/yr. Slope inclinometer SI-13 showed a rate of movement of 28.8 mm/yr over 1.7 m to 14.5 m depth compared to the overall rate of 11.2 mm/year. From installation in 1998 to the spring of 2020, the overall movement rate was 10.4 mm/yr. Since the fall of 2020, the overall rate has accelerated to 27.9 mm/yr. This pattern of accelerated movement is similar to the pattern observed in SI-5.

SI-1 should be repaired during the next reading cycle. SI-12 is sheared off at 7.9 m below ground surface and should be removed from future readings. PN02-5 is also damaged; however, this instrument would require mechanical excavation to splice on a new section of pneumatic line so it may not be economical to repair this instrument at this time.

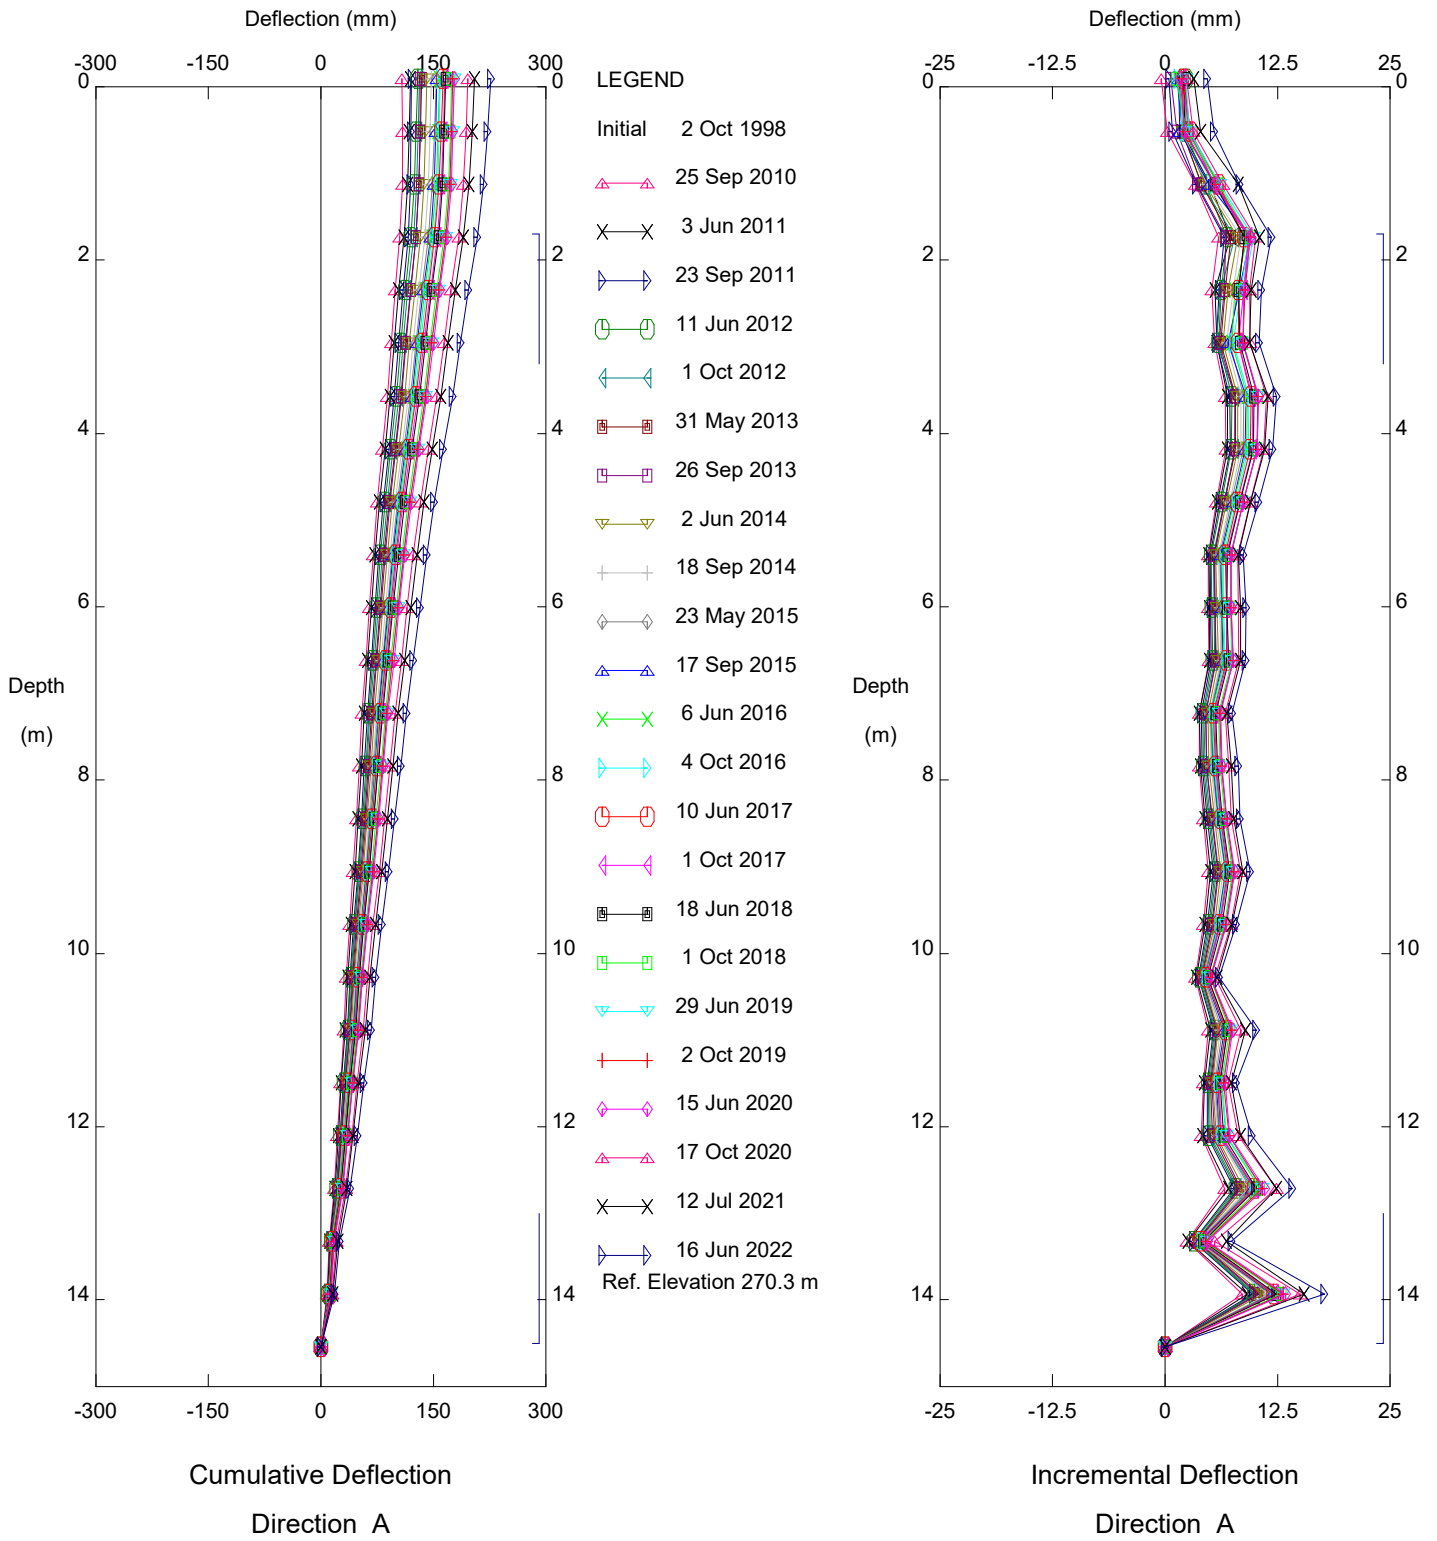
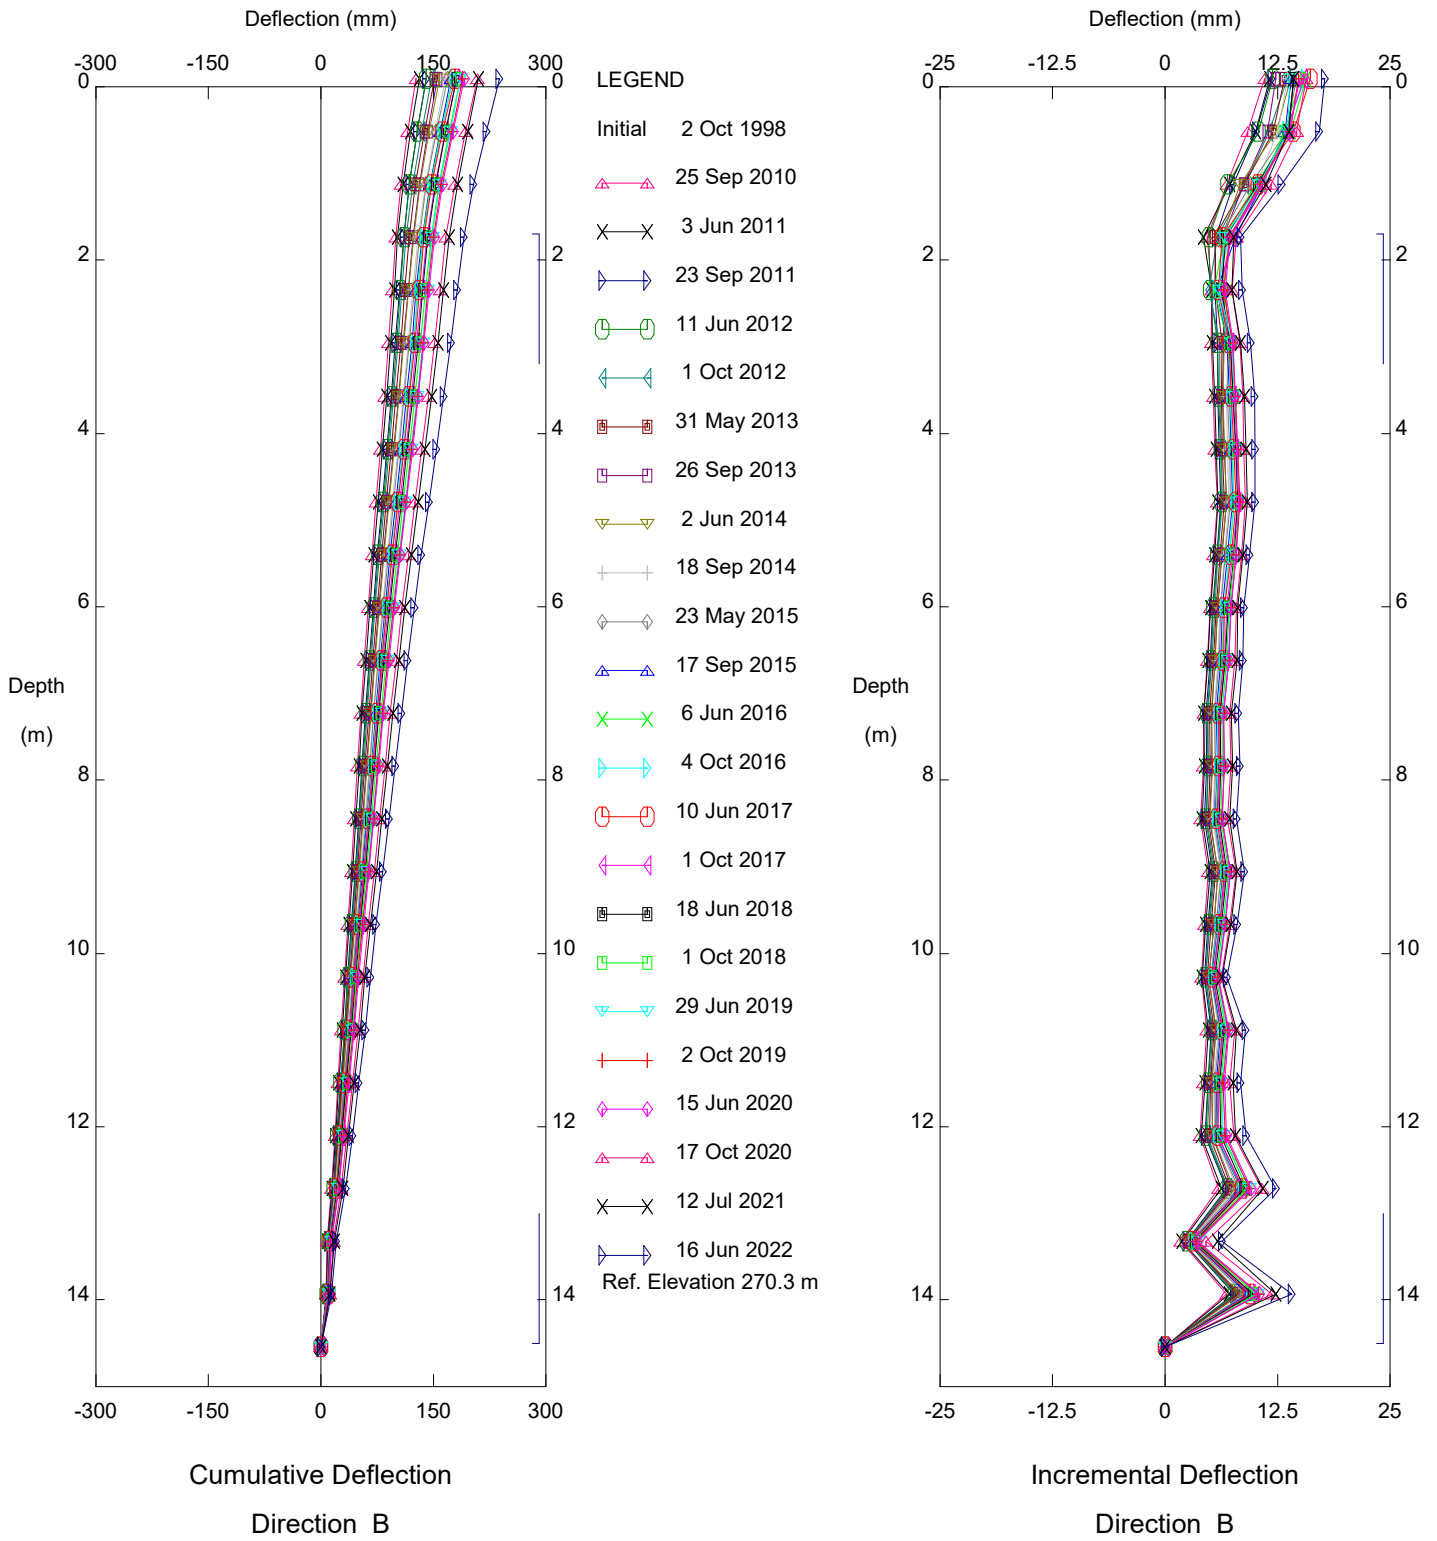
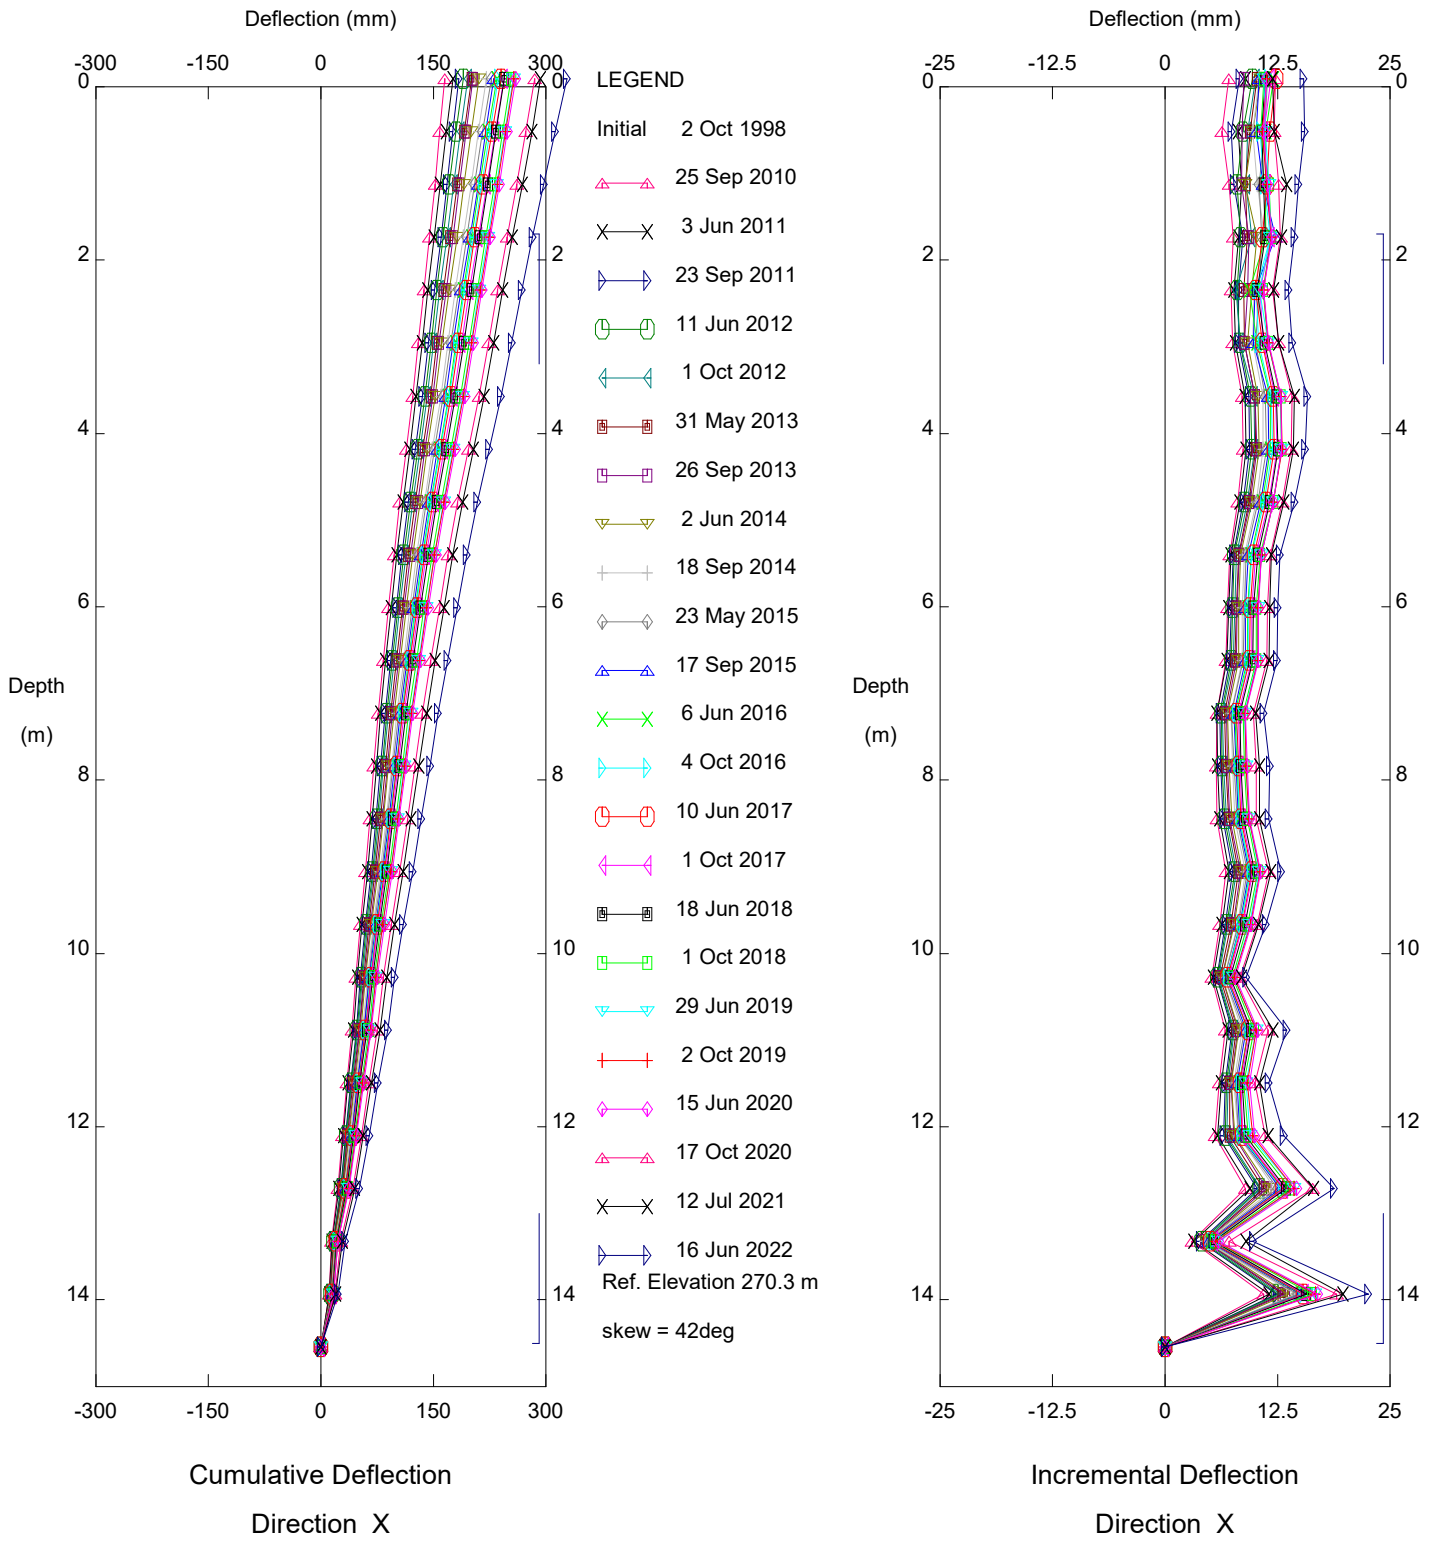
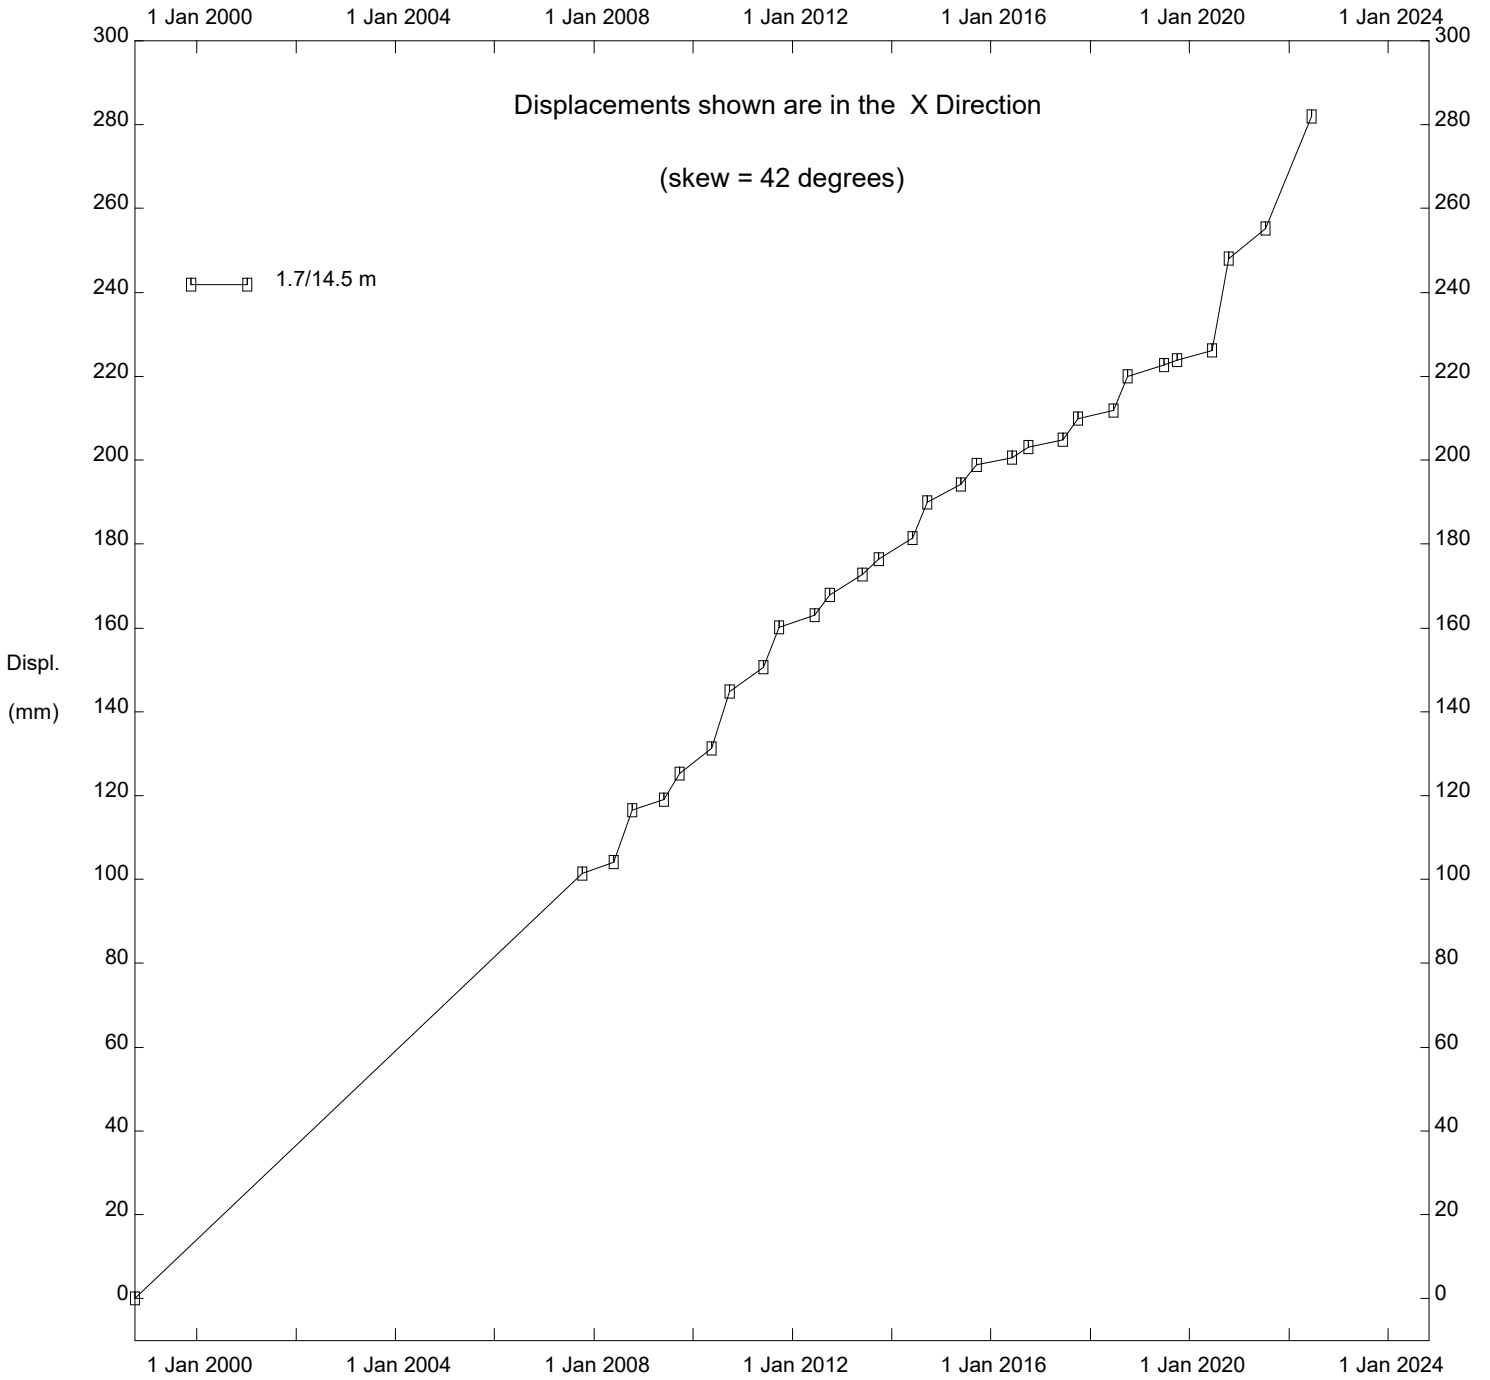
HWY 697:02 - STA. 17+360, Inclinometer SI-13

Based on previous instrument readings and site observations, it appears that the three operational SIs at this site are installed too shallow to fully intercept the main slip surface of the slide but are, nonetheless, moving and significantly within the overall slide blocks.

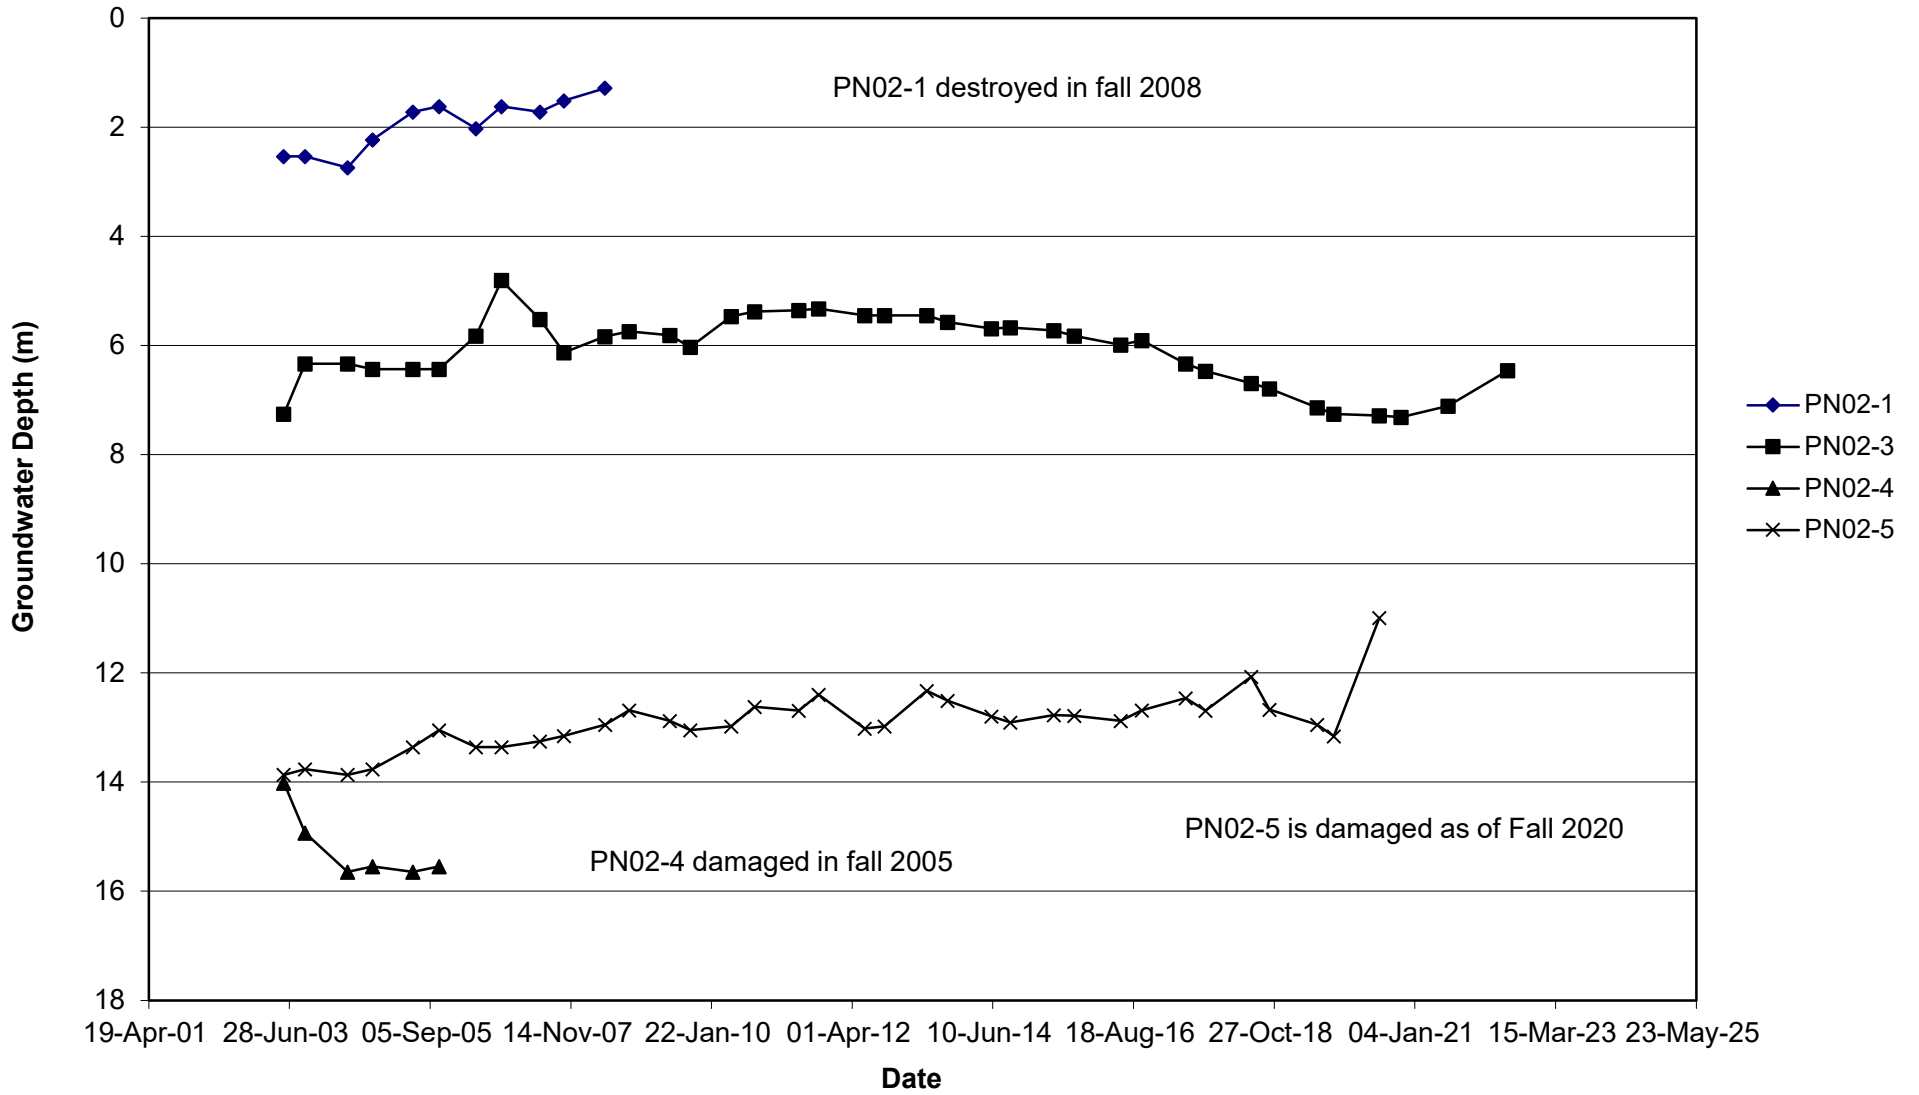
**FIGURE PH006-1
PIEZOMETER DATA FOR HWY 697:02 TOMPKINS LANDING**

The groundwater level increased in pneumatic piezometer PN02-3 by 0.65 m since the spring of 2021 readings which is a reversal in the overall trend of decreasing water level that had occurring since 2011 although the readings are within the historical range. Pneumatic piezometer readings are summarized in Table PH006-2 in this report and are plotted on in Figure PH006-1 in Appendix A.
