ALBERTA TRANSPORTATION AND
ECONOMIC CORRIDORS GRMP
PEACE REGION – (PEACE RIVER DISTRICT)
INSTRUMENTATION MONITORING - SPRING 2025

Site Number	Location	Name	Hwy	km
PH006	North of Paddle Prairie	Tompkins Landing	697:02	Km 17.5
Legal Description:		UTM Co-ordinates		
12-30-103-19 W5		11U E 491173.98	N	6425582.21

Current Monitoring:	12-Jun-2025	Previous Monitoring	24-May-2024
Instruments Read By:	Mr. Niraj Regmi, G.I.T., and Mr. Godfred Etiendem, of Thurber

**PH006: HWY697:02 - TOMPKINS LANDING SLIDE
INSTRUMENTATION LOCATIONS**

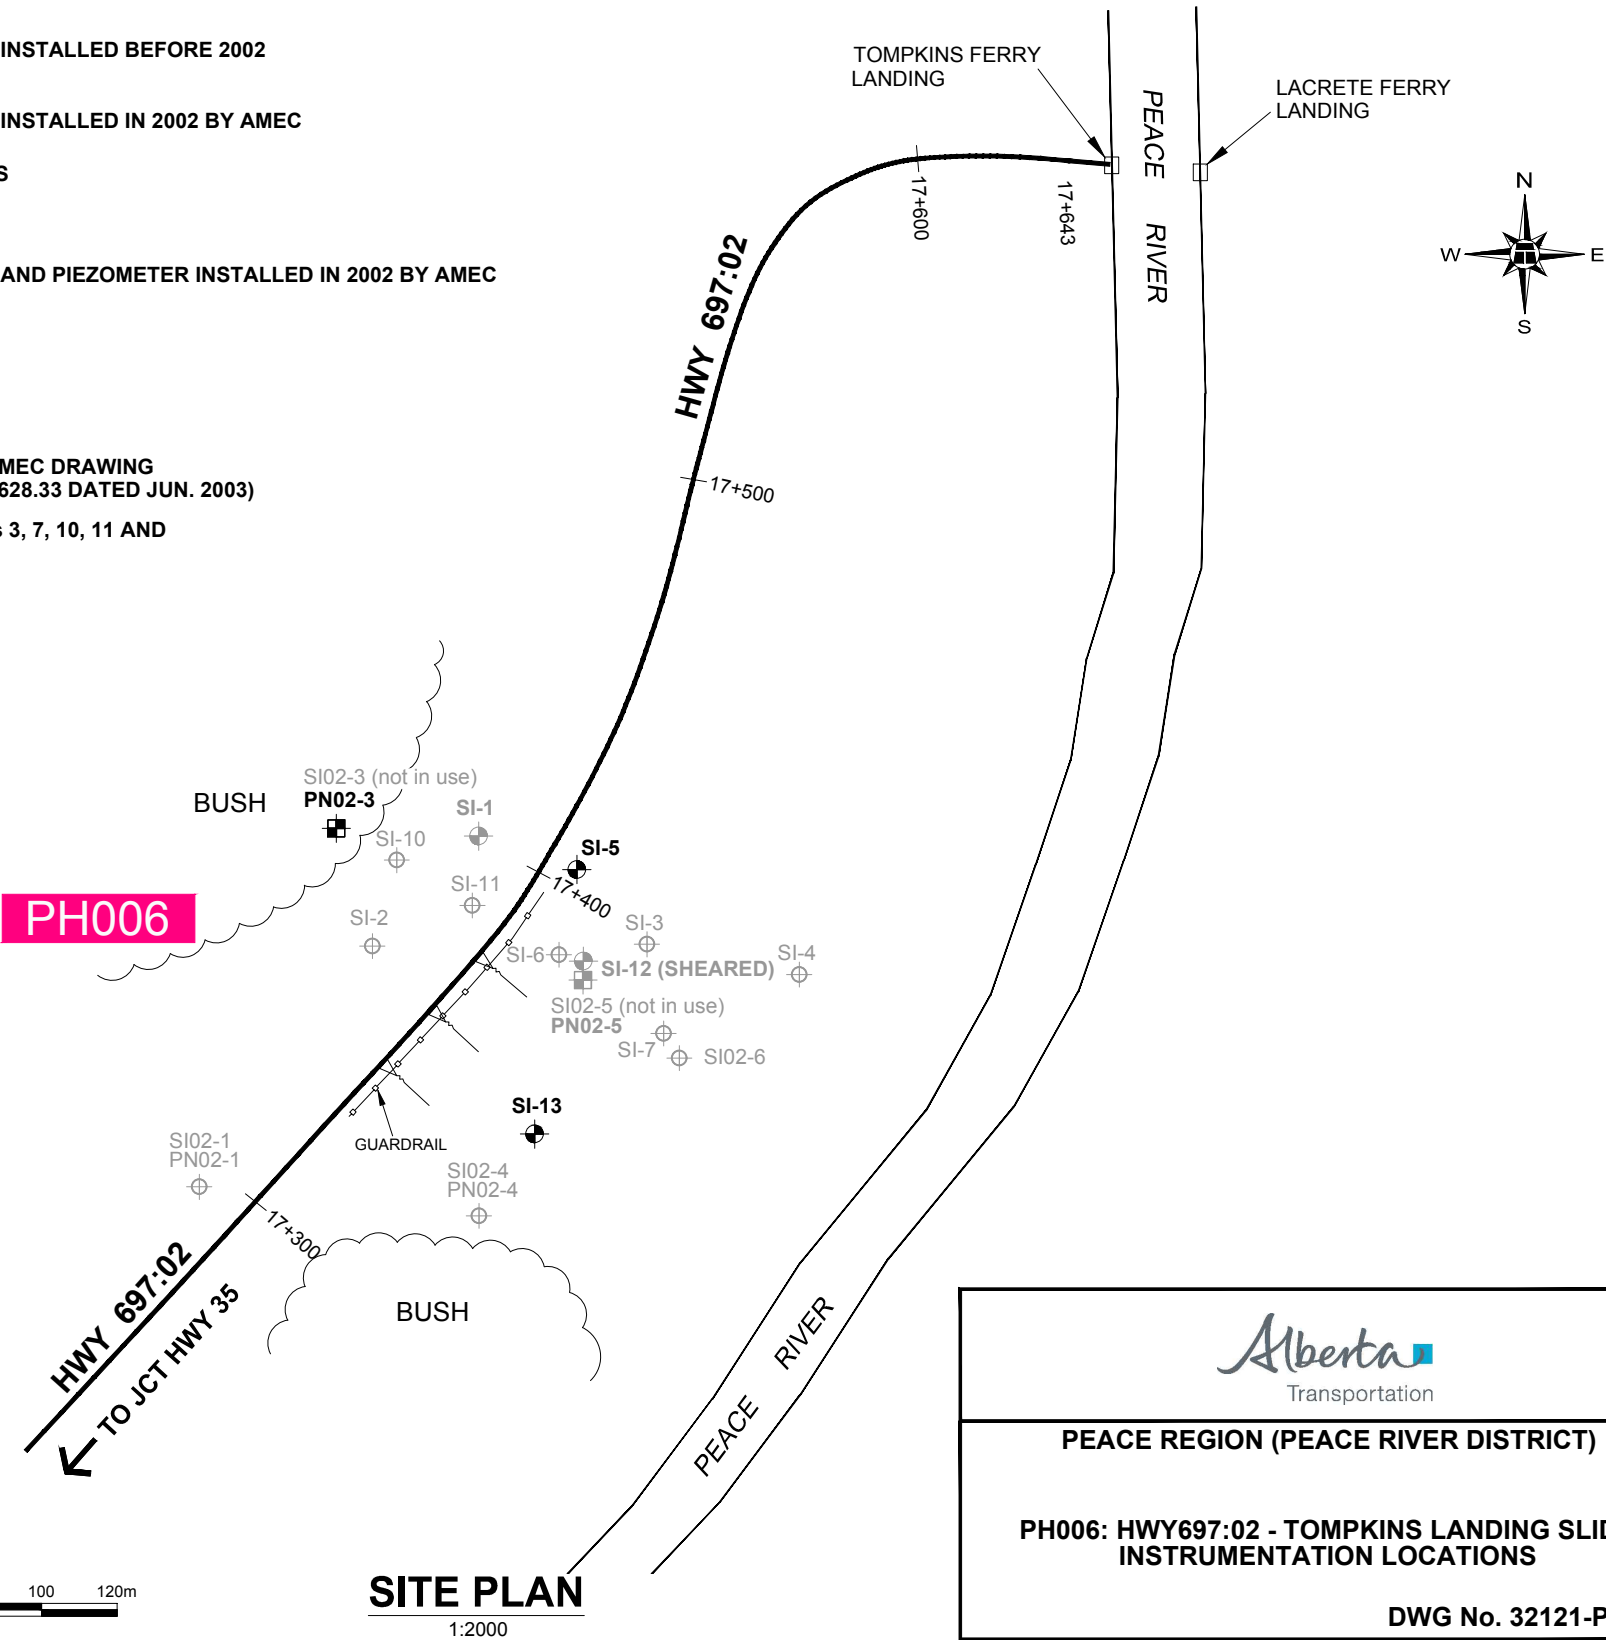
DWG No. 32121-PH006

Drawing 32121-PH006 in Appendix A provides a sketch of the approximate locations of the monitoring instrumentation for this site.

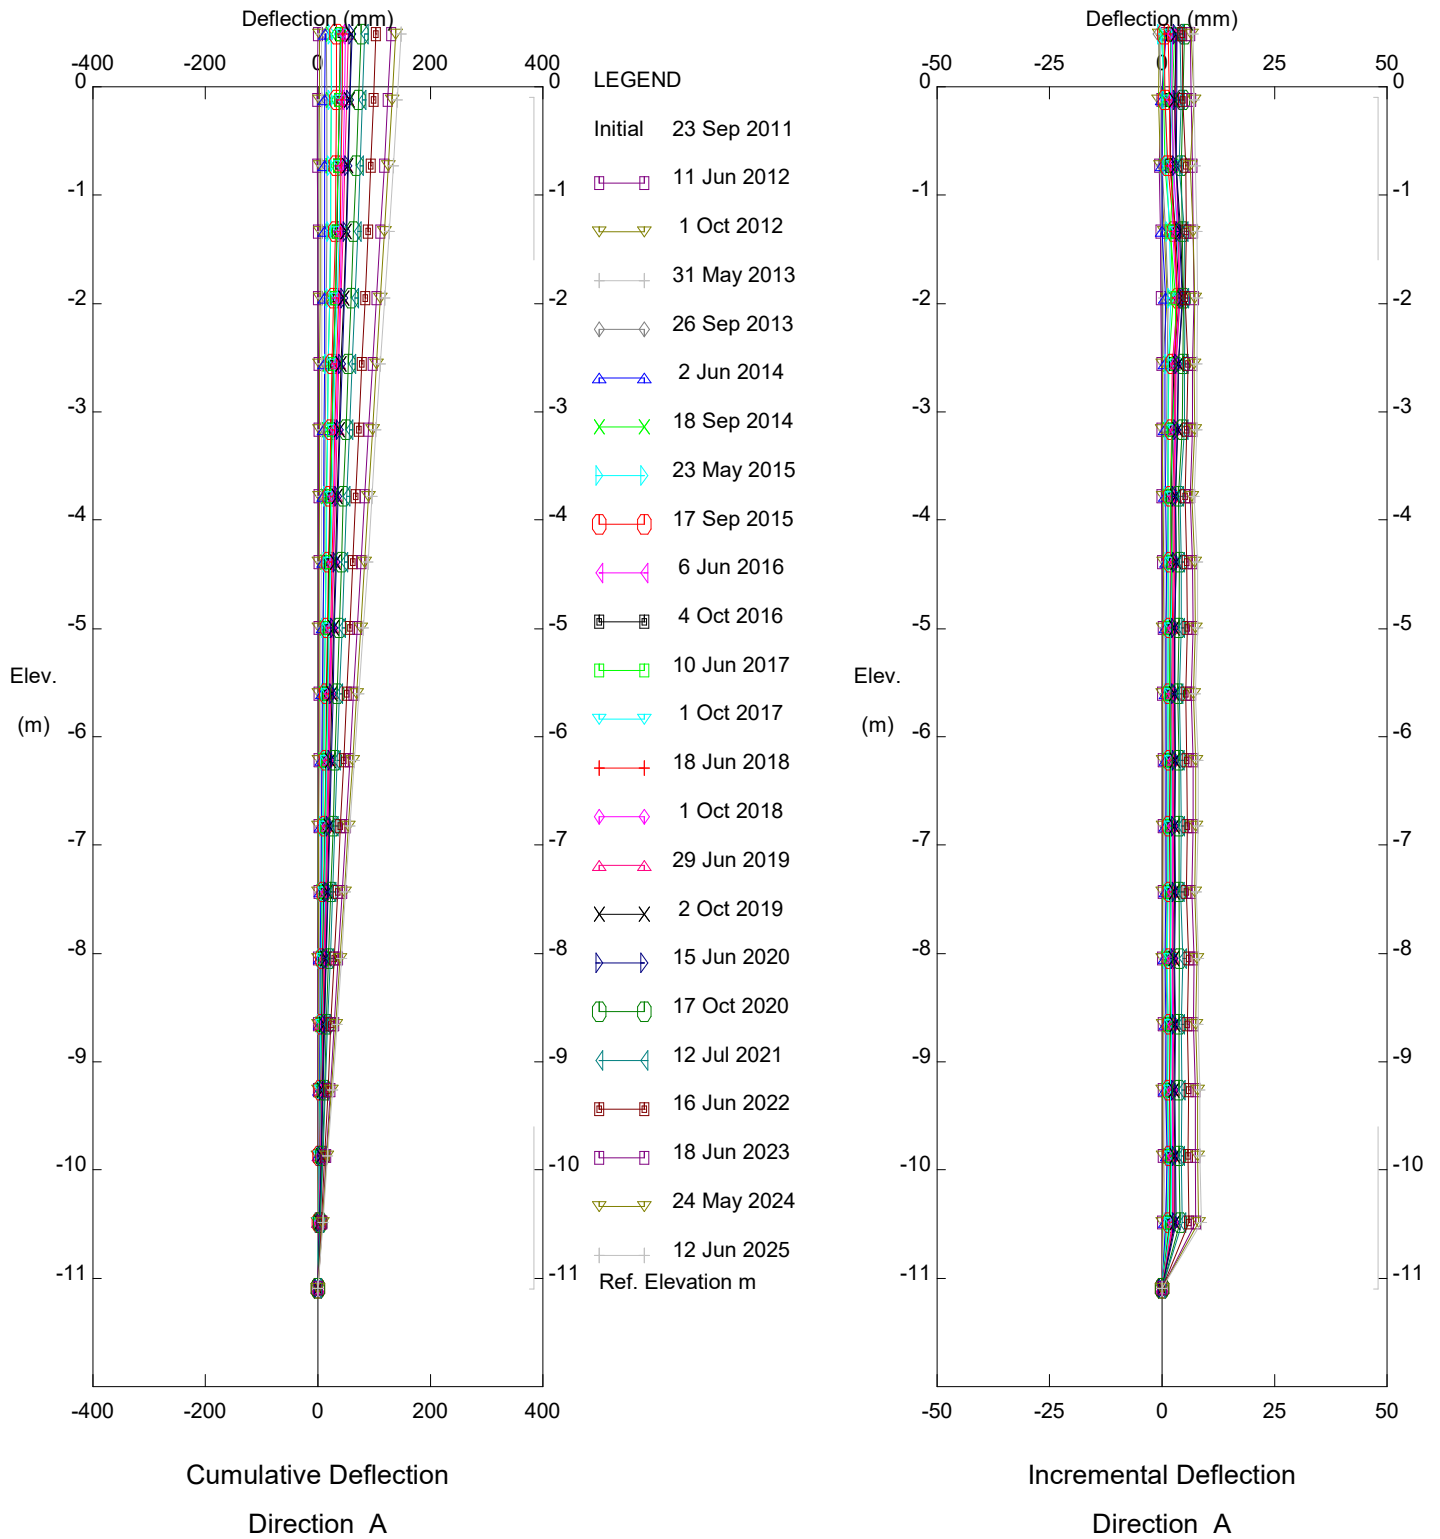
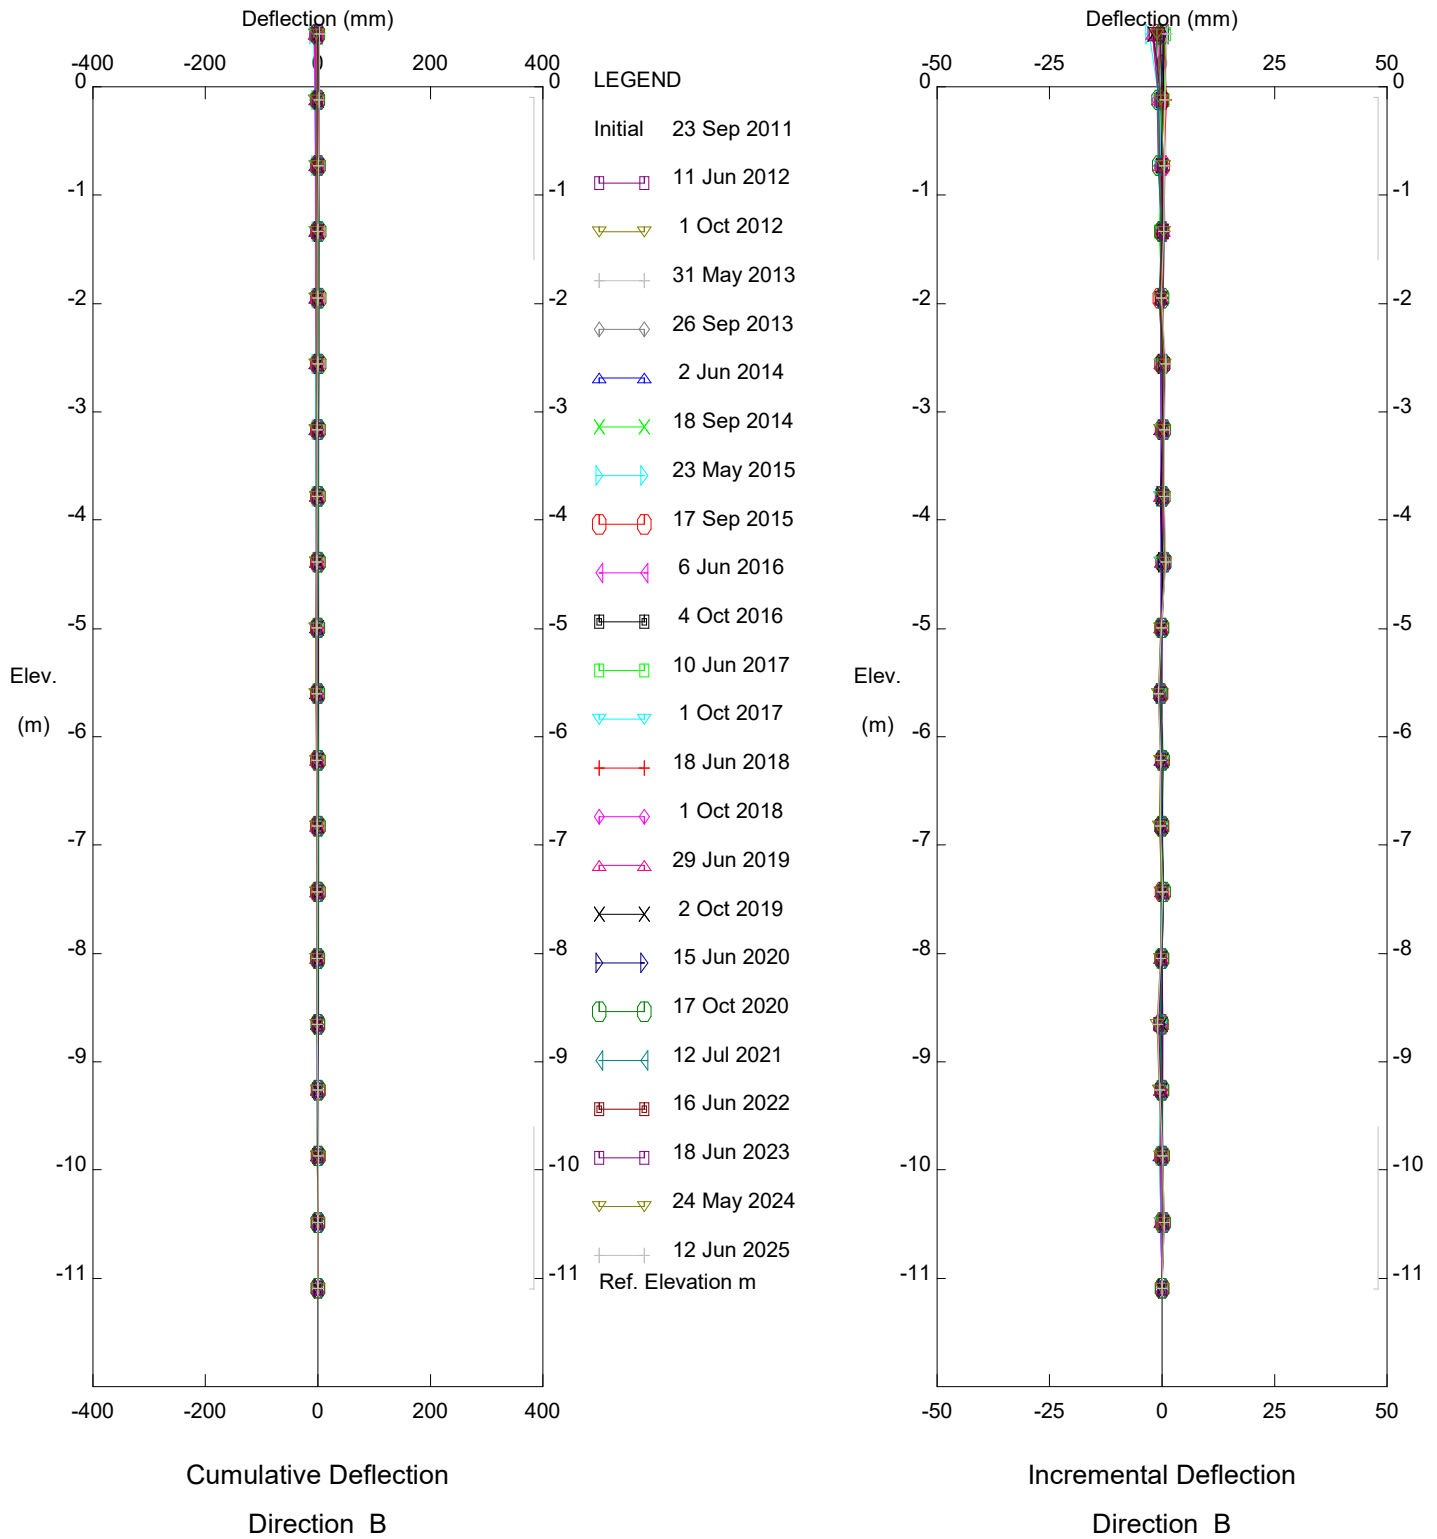
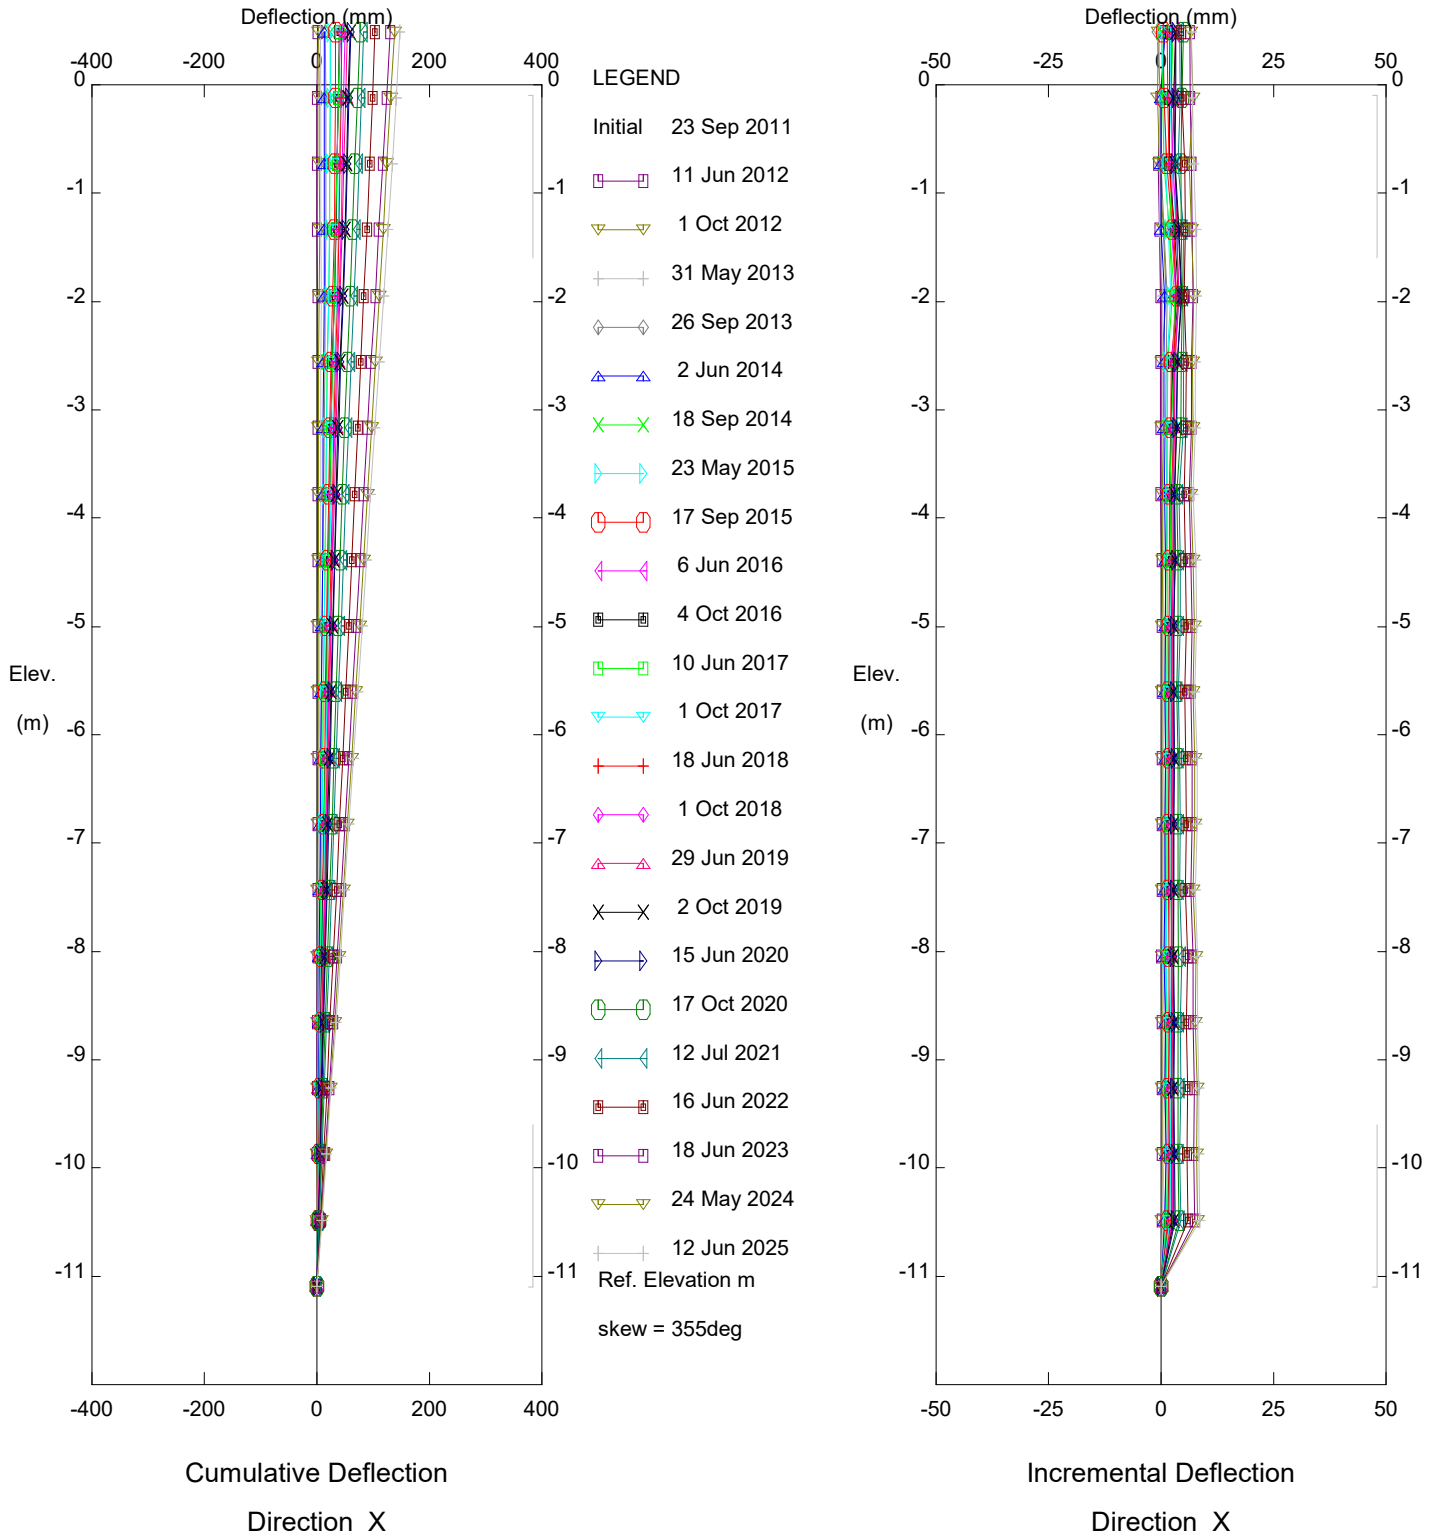
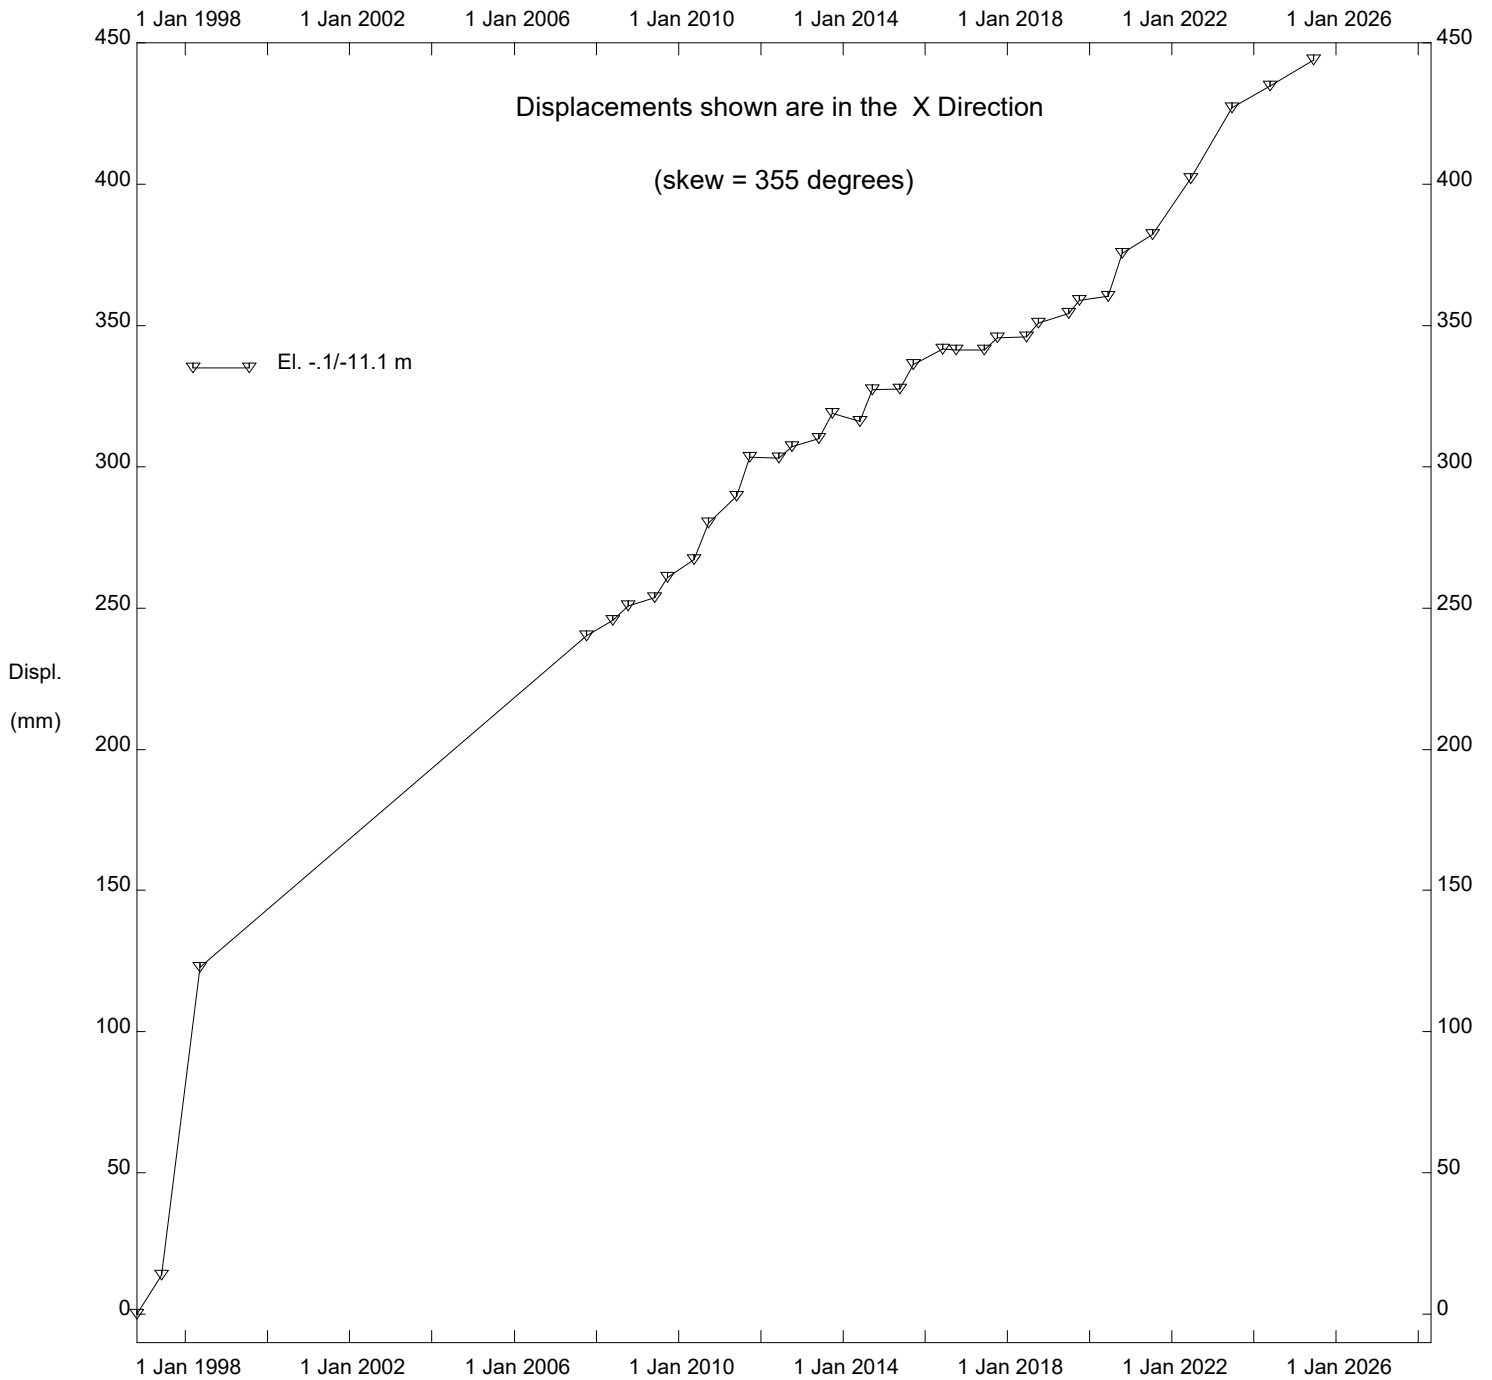
HWY 697:02 - STA. 17+360, Inclinometer SI-5

Discussion	
Zones of New Movement:	None
Interpretation of Monitoring Results:	<p>SI-5 showed a movement rate of 8.8 mm/yr over 0.1 m to 11.1 m depth since the spring of 2024 readings. This rate is consistent with the long term trend since 1999. Of note, there are long periods of time where movement rates exceed or fall short of the long term trendline. Since the fall of 2020, the movement rate is about 15 mm/yr indicating that there has been some recent acceleration in the slide movements.</p> <p>Slope inclinometer SI13 showed a rate of movement of 10.3 mm/yr over 1.7 m to 14.5 m depth compared to the overall rate of 13.0 mm/year. From installation in 1998 to the spring of 2020, the overall movement rate was 10.4 mm/yr. Since the fall of 2020, the overall rate has accelerated to 21.5 mm/yr. This accelerated movement coincides with the acceleration observed in SI-5 and an increase in groundwater level as noted below.</p> <p>Based on previous instrument readings and site observations, it appears that the two operational SIs at this site were installed too shallow to intercept the main slip surface of the slide; however, they are nonetheless moving significantly within the overall slide blocks.</p> <p>The groundwater level increased in pneumatic piezometer PN02-3 by 0.05 m since the spring of 2024. PN02-3 showed a trend of increasing</p>

groundwater levels between the fall of 2020 and the spring of 2023 but has since levelled off within the historic range of the instrument.
Future Work:	The instruments should be read again during the spring of 2026.
Instrumentation Repairs:	SI-1 and PN02-5 are damaged and would require significant additional cost to investigate and repair. If TEC requests Thurber can refine a cost estimate for investigation and repair of the damaged instruments at this site.
Additional Comments:	This road surface at this site will be converted to gravel during the summer of 2025 which will include lowering of the highway profile, regrading of the upslope ditch, and replacement of damaged culverts.

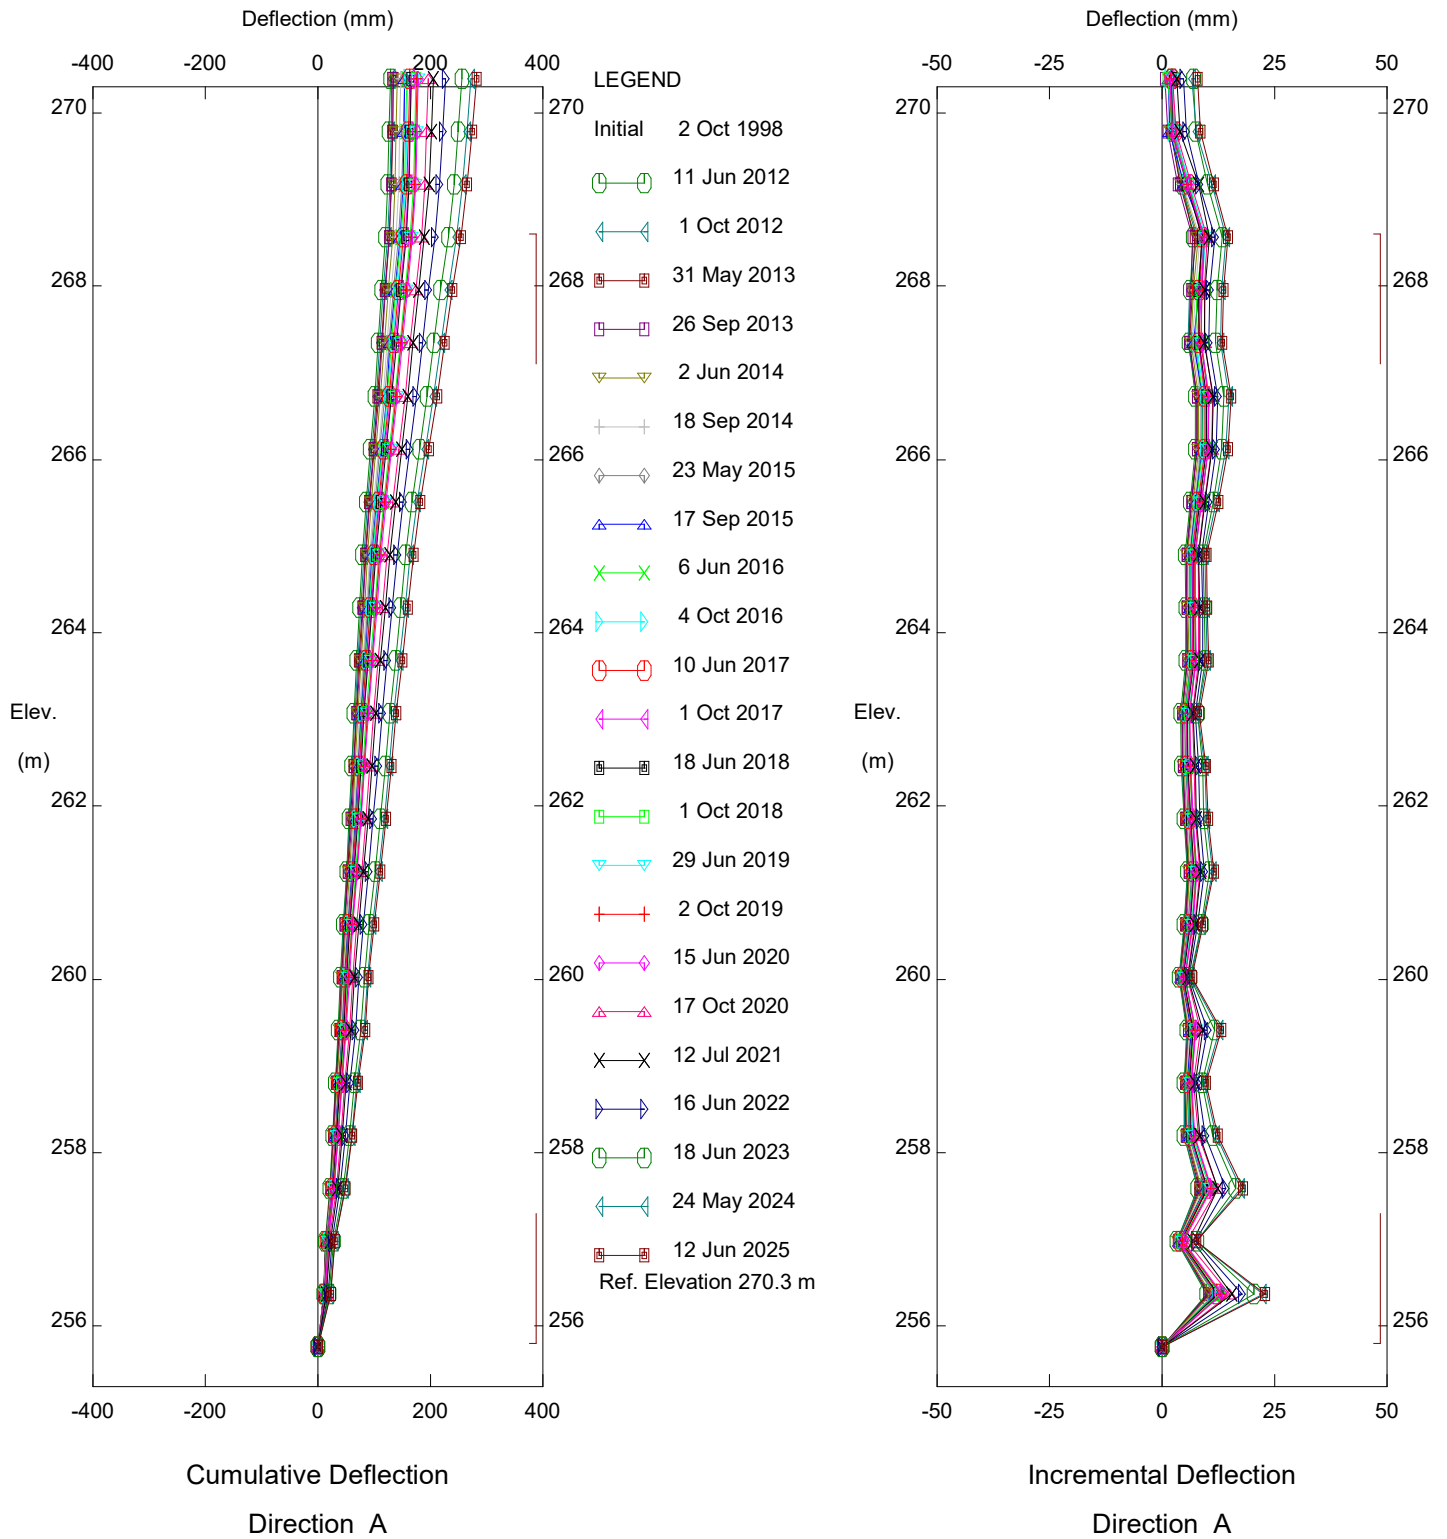
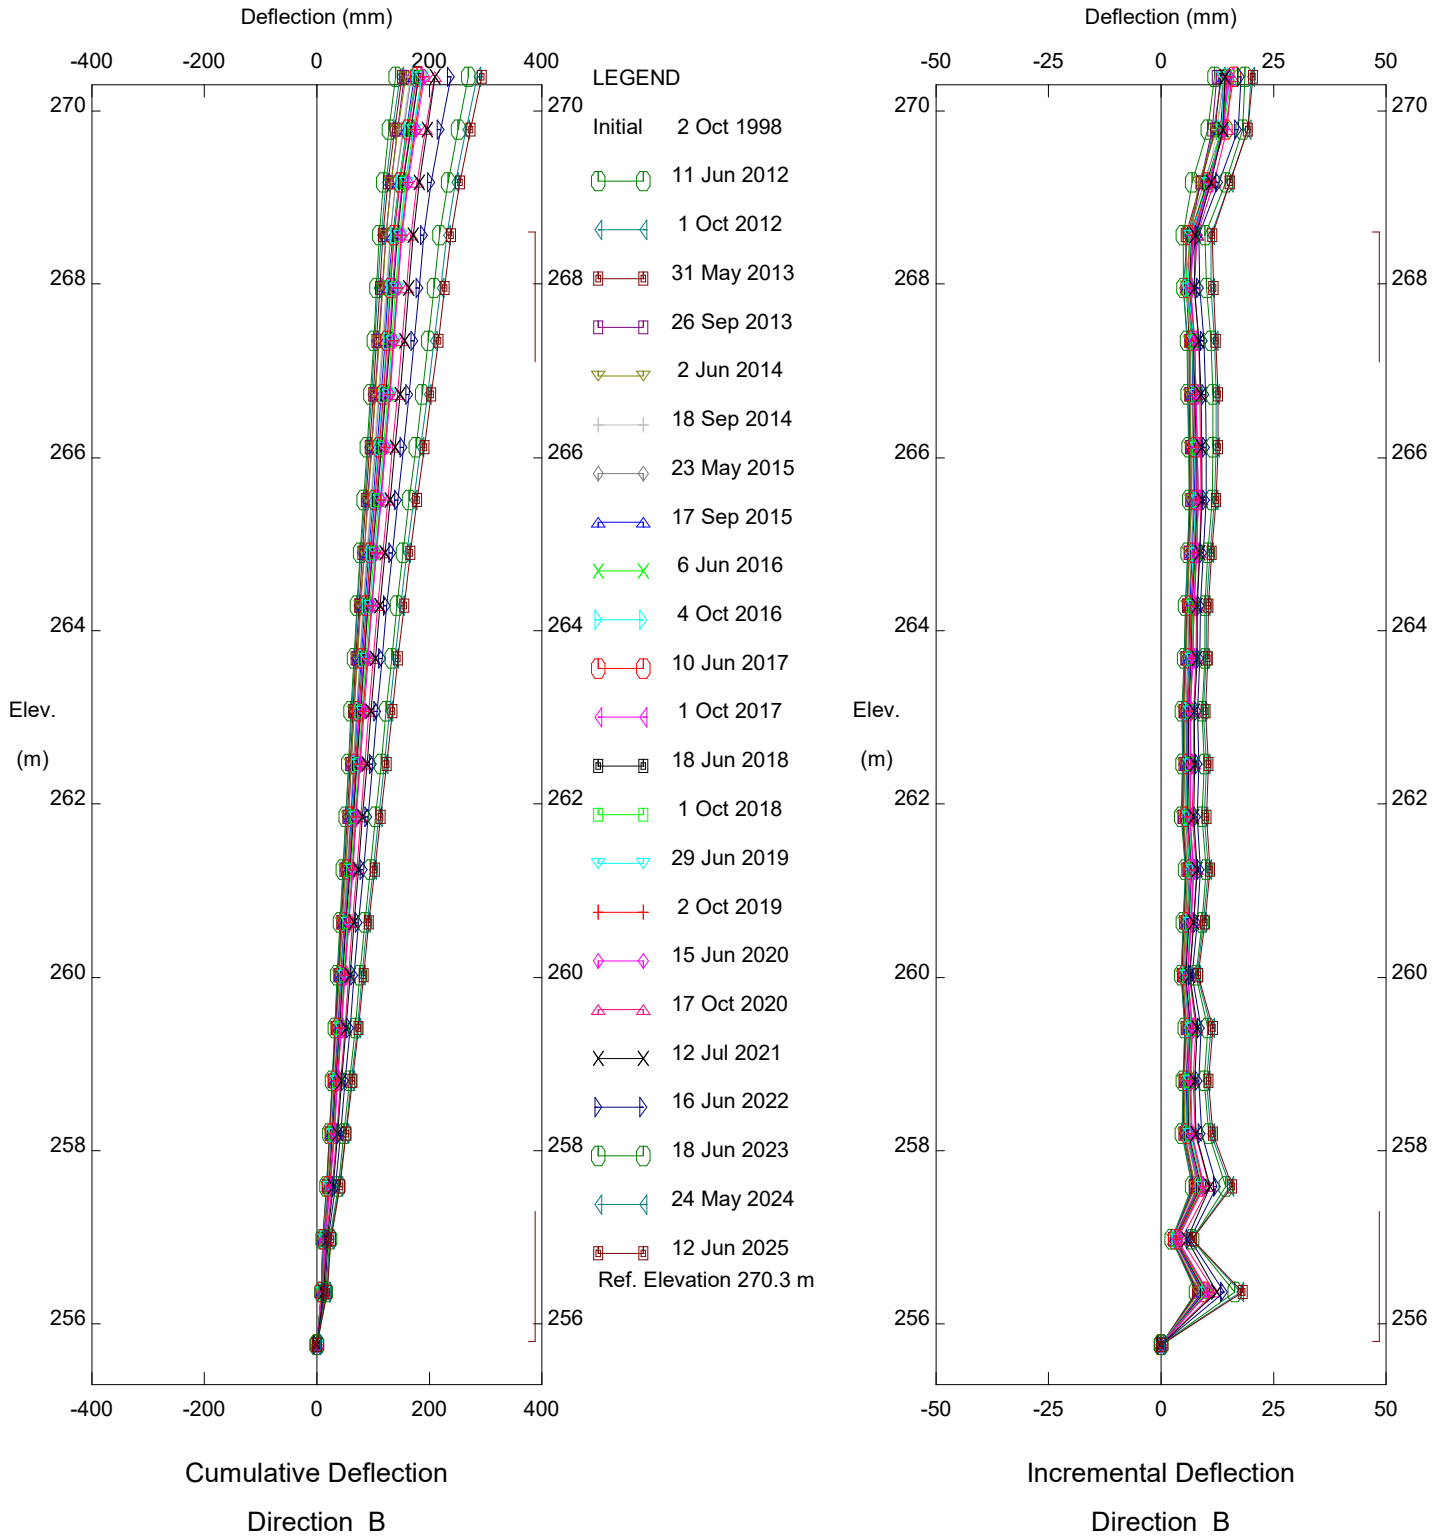
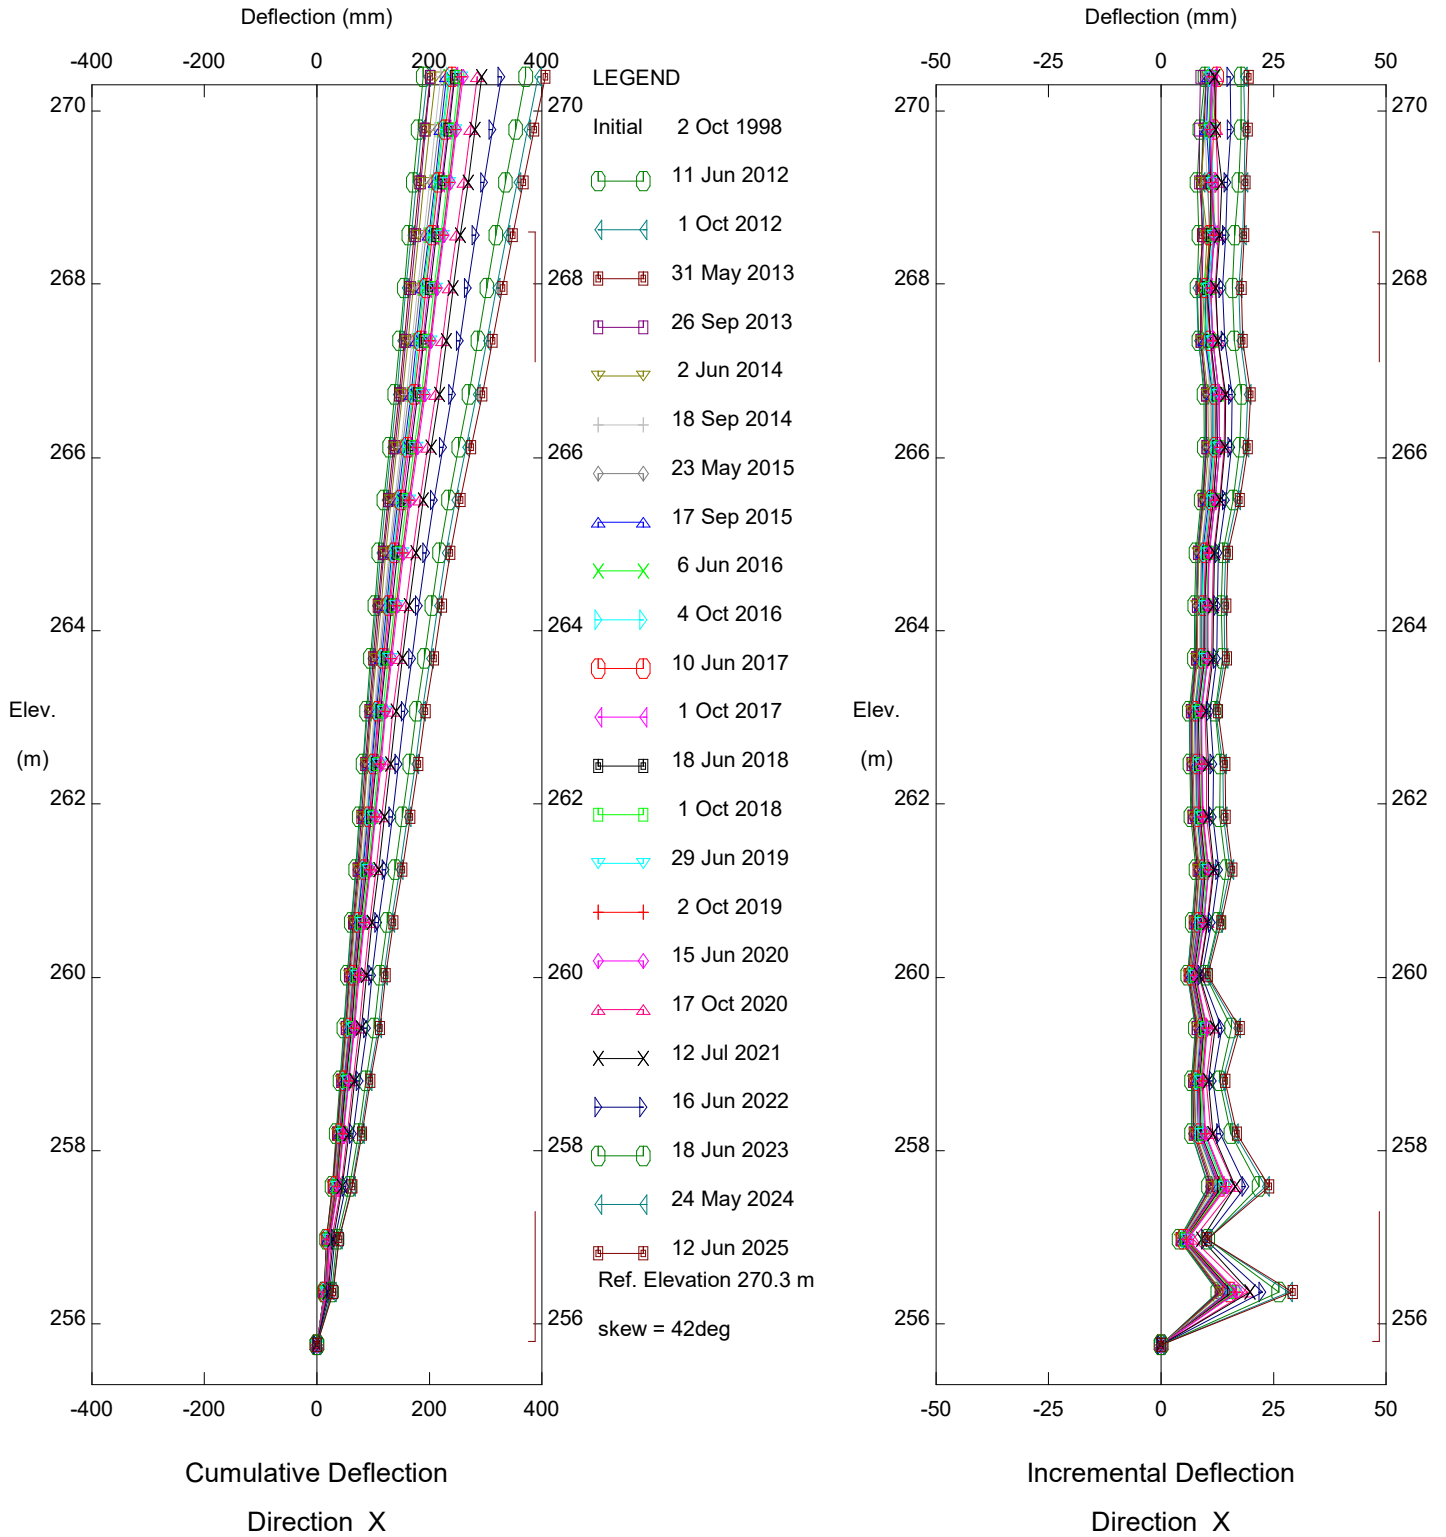
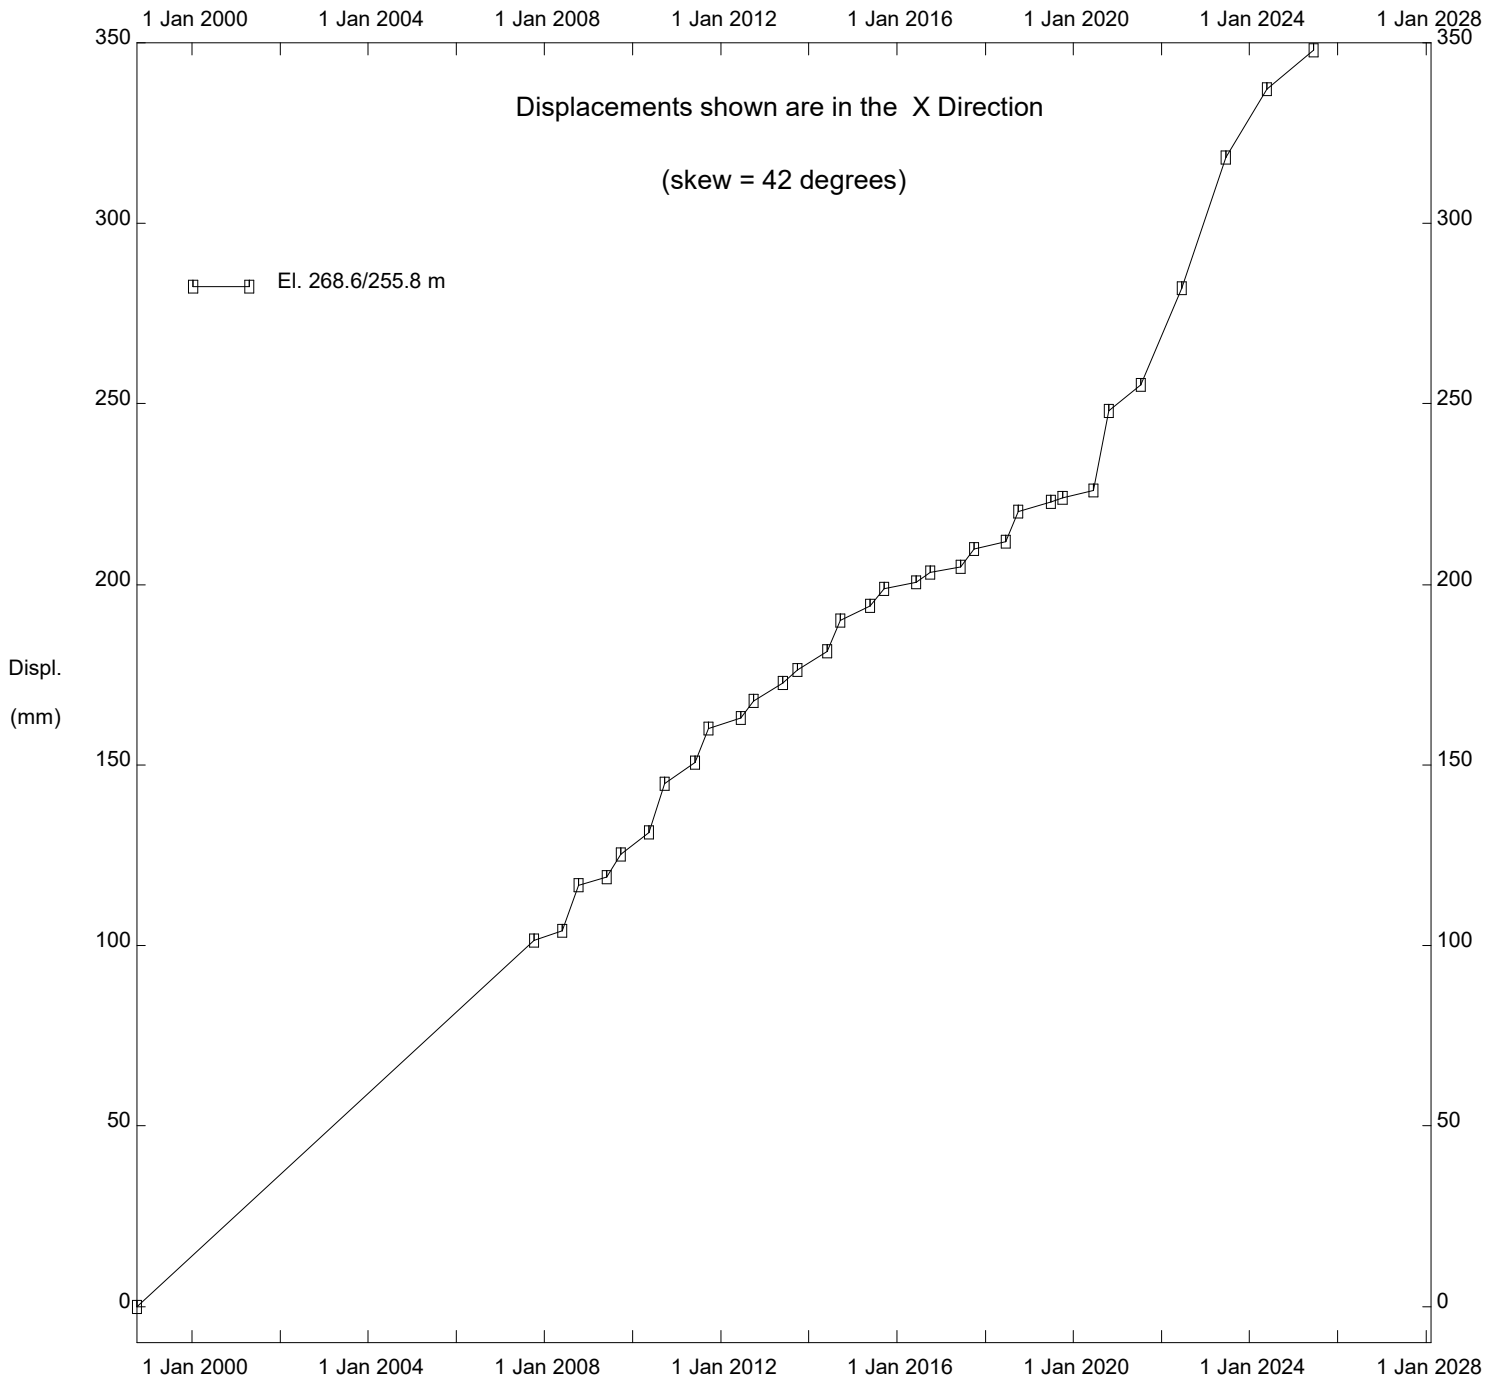
HWY 697:02 - STA. 17+360, Inclinometer SI-13

14.6 mm over 11.5 m to 12.8 m depth in 100° direction	8.4 mm/yr in Oct. 1998			N/A	N/A	N/A
SI-13	Oct. 2, 1998	348.1 mm over 1.7 m to 14.5 m depth in 113° direction	64.5 mm/yr in October 2020	Operational	May 24, 2024	10.9	10.3	-10.0
