ALBERTA TRANSPORTATION AND
ECONOMIC CORRIDORS GRMP
PEACE REGION – (PEACE RIVER DISTRICT)
INSTRUMENTATION MONITORING - SPRING 2025

Site Number	Location	Name	Hwy	km
PH006	North of Paddle Prairie	Tompkins Landing	697:02	Km 17.5
Legal Description:		UTM Co-ordinates		
12-30-103-19 W5		11U E 491173.98	N	6425582.21

Current Monitoring:	12-Jun-2025	Previous Monitoring	24-May-2024
Instruments Read By:	Mr. Niraj Regmi, G.I.T., and Mr. Godfred Etiendem, of Thurber

**PH006: HWY697:02 - TOMPKINS LANDING SLIDE
INSTRUMENTATION LOCATIONS**

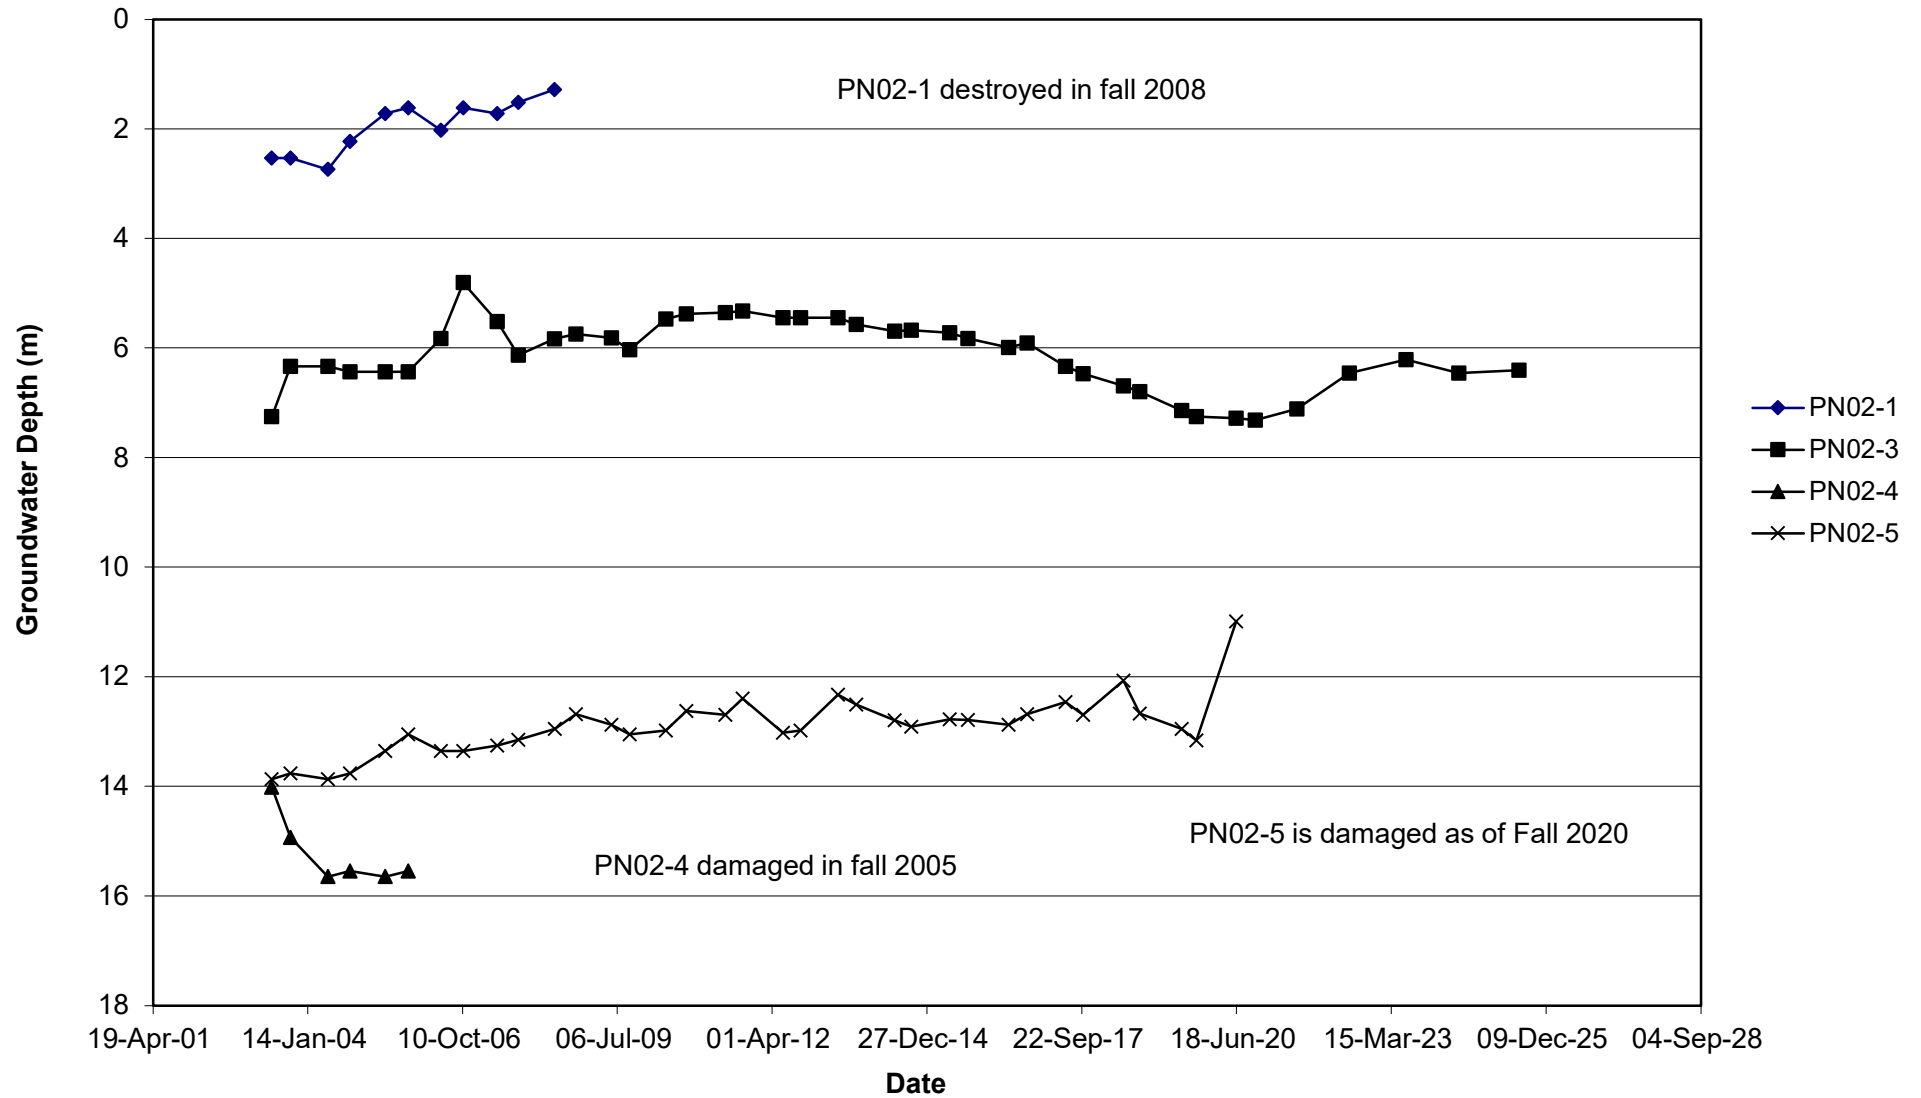
FIGURE PH006-1
PIEZOMETER DATA FOR HWY 697:02 TOMPKINS LANDING

Discussion	
Zones of New Movement:	None
Interpretation of Monitoring Results:	<p>SI-5 showed a movement rate of 8.8 mm/yr over 0.1 m to 11.1 m depth since the spring of 2024 readings. This rate is consistent with the long term trend since 1999. Of note, there are long periods of time where movement rates exceed or fall short of the long term trendline. Since the fall of 2020, the movement rate is about 15 mm/yr indicating that there has been some recent acceleration in the slide movements.</p> <p>Slope inclinometer SI13 showed a rate of movement of 10.3 mm/yr over 1.7 m to 14.5 m depth compared to the overall rate of 13.0 mm/year. From installation in 1998 to the spring of 2020, the overall movement rate was 10.4 mm/yr. Since the fall of 2020, the overall rate has accelerated to 21.5 mm/yr. This accelerated movement coincides with the acceleration observed in SI-5 and an increase in groundwater level as noted below.</p> <p>Based on previous instrument readings and site observations, it appears that the two operational SIs at this site were installed too shallow to intercept the main slip surface of the slide; however, they are nonetheless moving significantly within the overall slide blocks.</p> <p>The groundwater level increased in pneumatic piezometer PN02-3 by 0.05 m since the spring of 2024. PN02-3 showed a trend of increasing</p>

groundwater levels between the fall of 2020 and the spring of 2023 but has since levelled off within the historic range of the instrument.
Future Work:	The instruments should be read again during the spring of 2026.
Instrumentation Repairs:	SI-1 and PN02-5 are damaged and would require significant additional cost to investigate and repair. If TEC requests Thurber can refine a cost estimate for investigation and repair of the damaged instruments at this site.
Additional Comments:	This road surface at this site will be converted to gravel during the summer of 2025 which will include lowering of the highway profile, regrading of the upslope ditch, and replacement of damaged culverts.
