**ALBERTA TRANSPORTATION
GEOHAZARD ASSESSMENT PROGRAM
PEACE REGION – HIGH LEVEL
2016 INSPECTION**

Site Number	Location	Name	Hwy	km
PH074-1	Northeast of La Crete Ferry Crossing	East Peace River Hill Frost Heaves	697:02	20.04
Legal Description		UTM Co-ordinates		
SW32-103-19-W5M		11U E 493,300	N	6,426,612

**PH074-1: HWY 697:02 AT km 18.62
GEOHAZARD ASSESSMENT**

DWG No. 13351-PH074-1

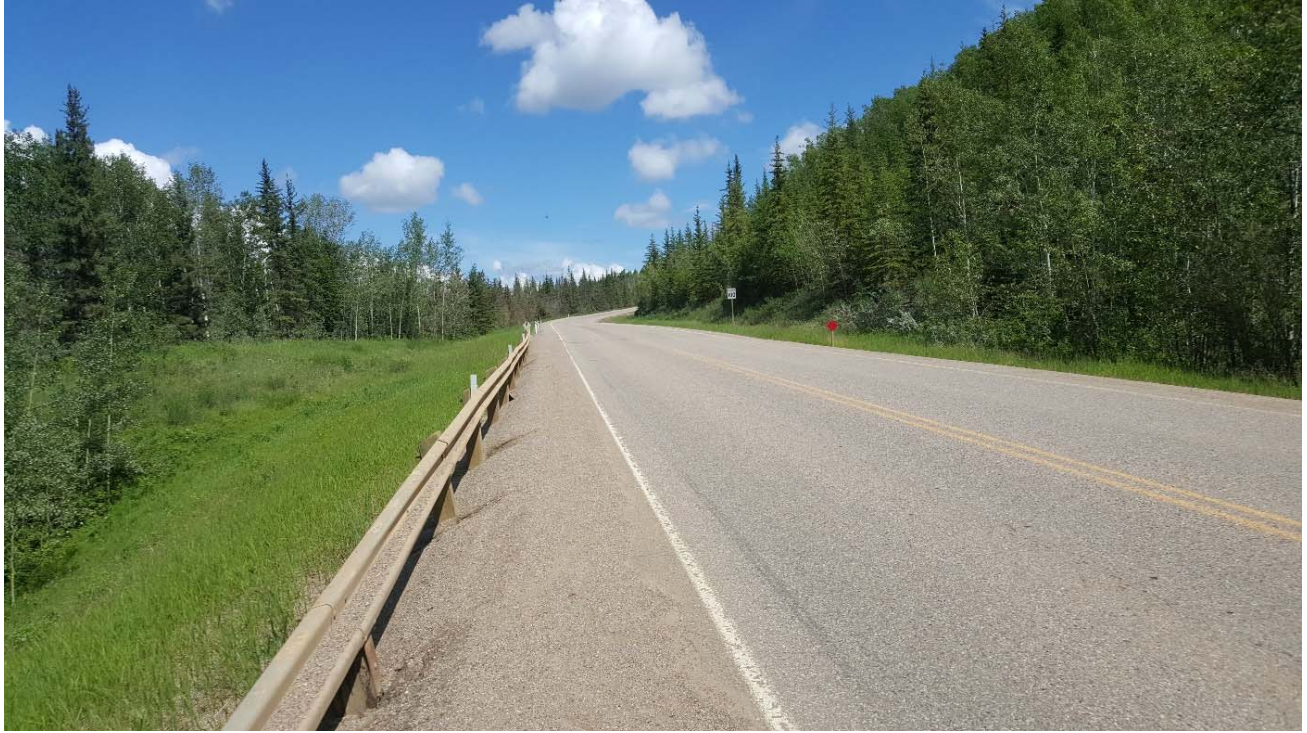
Based on discussions with Alberta Transportation maintenance personnel, the humps at either end of the embankment fill are more pronounced in winter and only minor during the summer. The humps have posed a pavement smoothness issue for many years.

As the humps occur at either end of the embankment fill, the cause is likely a combination of long-term settlement of the fill over the culvert combined with frost heaving at the cut-fill contacts in the winter. Exposed soils observed in the vicinity are sand and silt which are highly frost-susceptible when given access to water. The difference in magnitude of the frost heaving may reflect greater groundwater presence on the northeast (uphill) side which would increase the amount of frost heave. The scarp in the embankment above the outlet may have been triggered by the scour bowl that has formed at the culvert outlet. There were no signs of recent movement on this scarp; however, the slope below is steeper than the embankment fill above.

Photo 1 – Looking northeast at hump in the highway.

- Asphalt patching and milling, as required, to smooth the abrupt changes in the pavement profile.

- Consideration could be given to the use of horizontal drains beneath the roadway ditches to lower the water table. Installation of insulation beneath the roadway surface may be required as an additional later measure to reduce the amount of frost heave if control of the groundwater is insufficient to solve the problem.

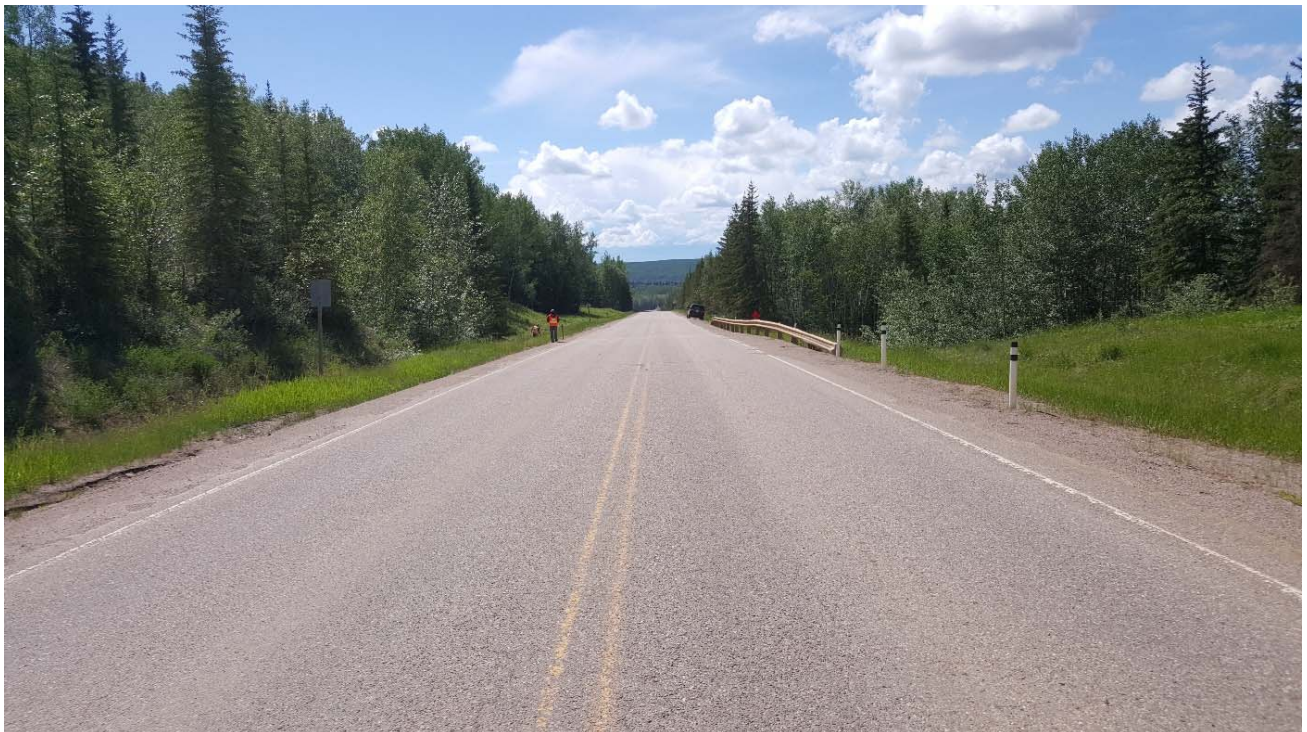
Primary Site Issue:	Seasonal humps on highway at each edge of embankment fill.	
Dimensions:	12.5 m high embankment	
Date of Remediation:	None	
Maintenance:	None	
Observations:	Description	Worsened?
<input checked="" type="checkbox"/> Pavement Distress	Highway embankment is depressed over the culvert embankment fill with humps at each end: 60 m long on NE side and only slight at SW side. Transverse cracks have formed at these humps.	<input checked="" type="checkbox"/>
<input checked="" type="checkbox"/> Slope Movement	There is a scarp on the embankment slope above the culvert outlet which appears vegetated and relatively stable.	<input type="checkbox"/>
<input checked="" type="checkbox"/> Erosion	The erosion gully on the southeast side of the embankment has extended to the bottom of the fill and a new gully has formed in the southeast ditch (NE of the culvert). Minor erosion was noted on the northwest embankment slope.	<input checked="" type="checkbox"/>

Photo 2 – Looking southwest from northeast end at dip in highway.

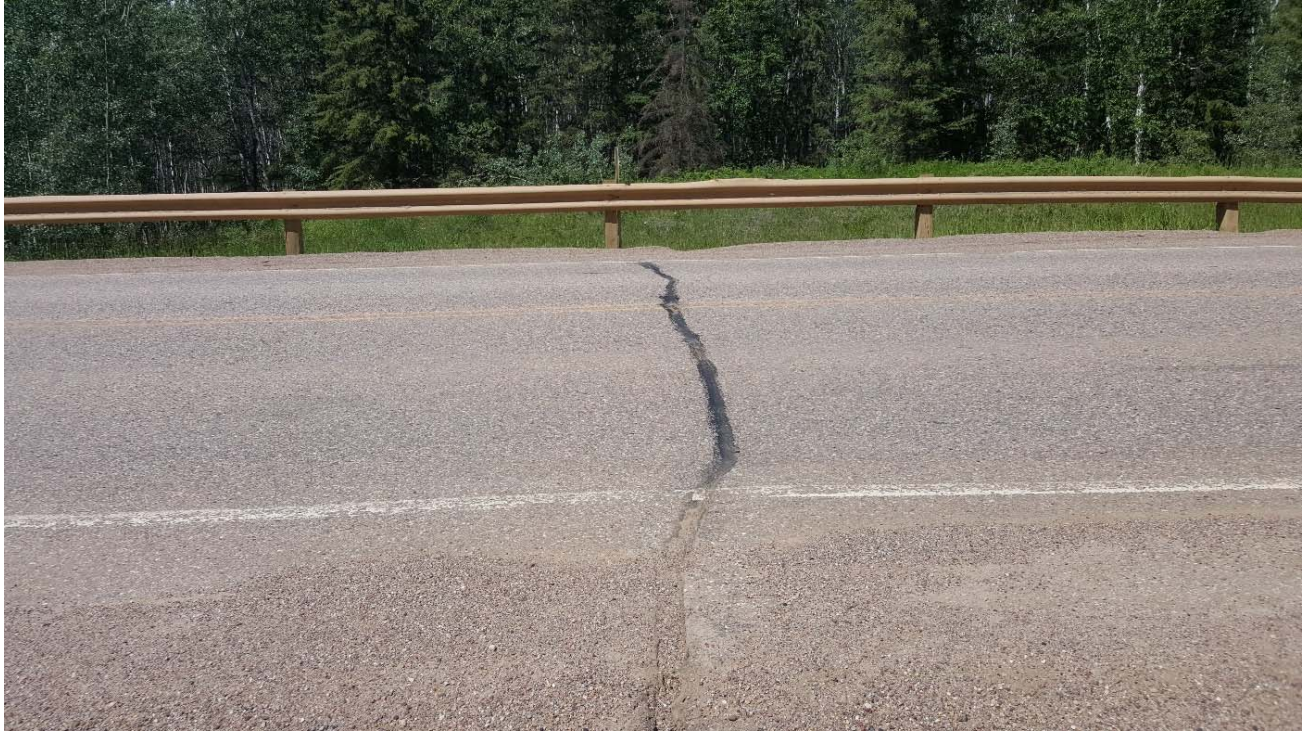
Photo 3 – Looking northwest at crack at northeast end of embankment fill.

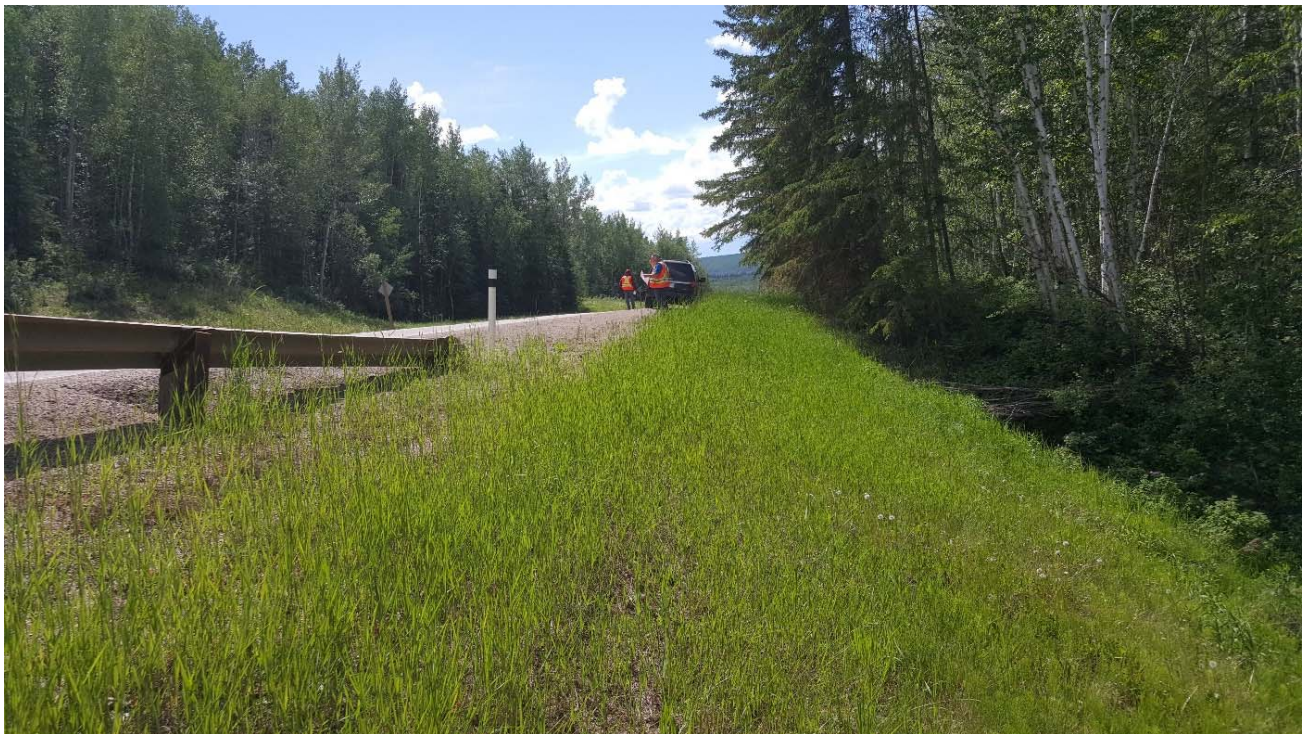
Photo 4 – Looking southwest at northwest sideslope.

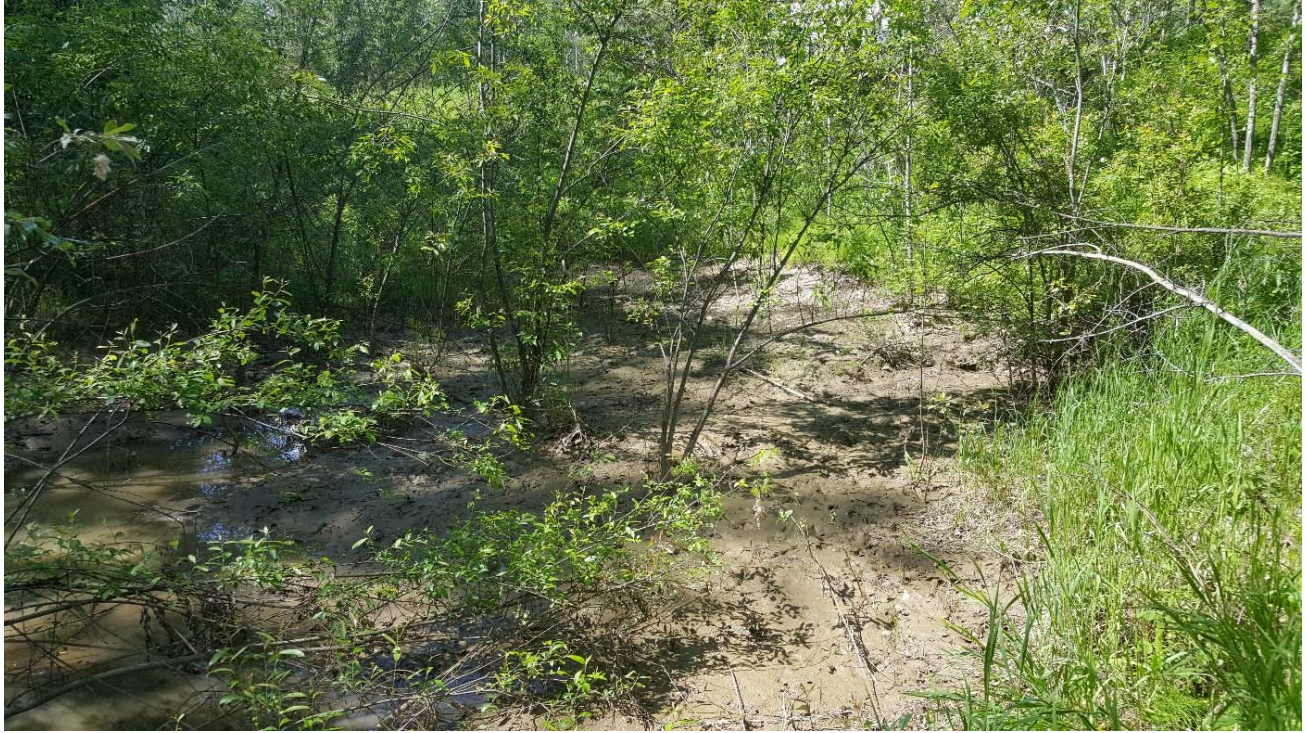
<input type="checkbox"/> Seepage		<input type="checkbox"/>
<input checked="" type="checkbox"/> Bridge/Culvert Distress	Silt had been accumulated at inlet of 600 mm culvert. This appears to have been cleared by the 2016 inspection.	<input type="checkbox"/>
<input type="checkbox"/> Other		<input type="checkbox"/>
Instrumentation:		
None.

Photo 5 – Silt accumulation upslope of inlet.

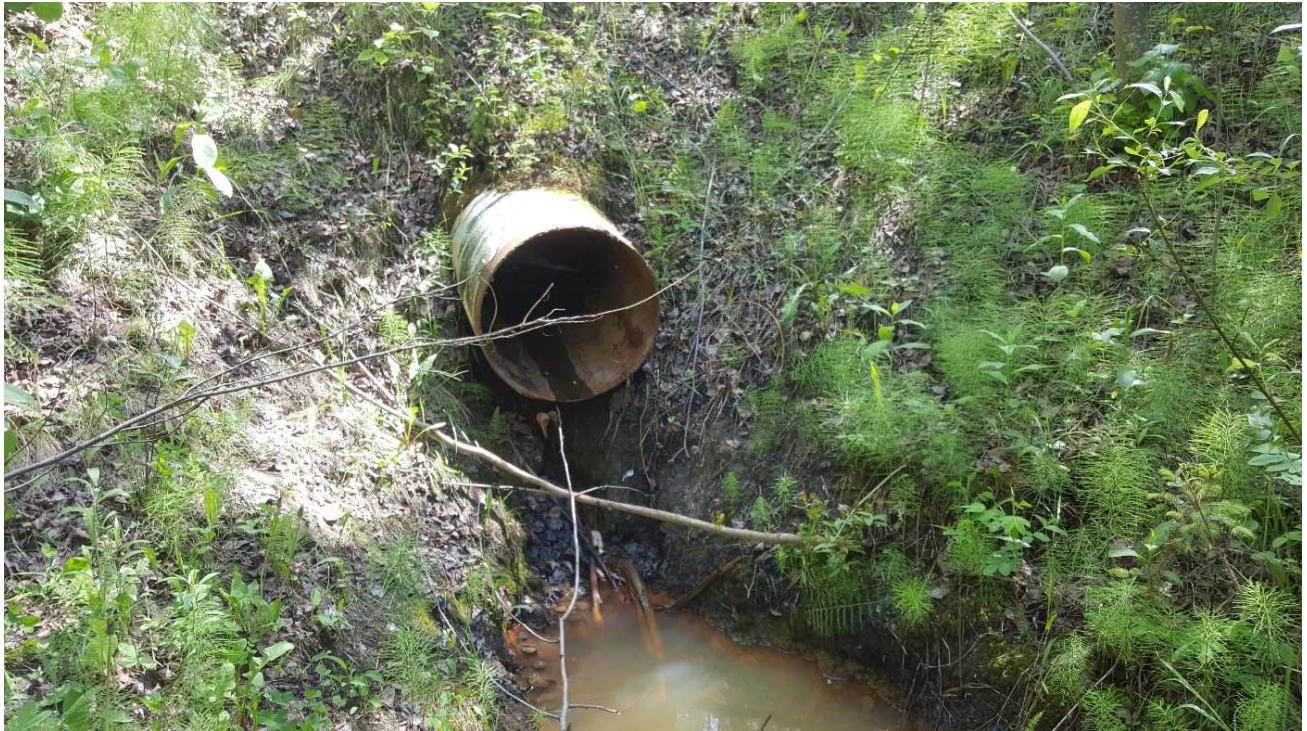
Photo 6 – Hanging culvert outlet.
