**ALBERTA TRANSPORTATION
GEOHAZARD ASSESSMENT PROGRAM
PEACE REGION – HIGH LEVEL
2020 INSPECTION**

Site Number	Location	Name	Hwy	km
PH074-1	Northeast of La Crete Ferry Crossing	East Peace River Hill Frost Heaves	697:02	20.04
Legal Description		UTM Co-ordinates		
SW32-103-19-W5M		11U E 493,300	N	6,426,612

**PH074-1: HWY 697:02 AT km 18.62
2020 GEOHAZARD ASSESSMENT**

DWG No. 13351-PH074-1

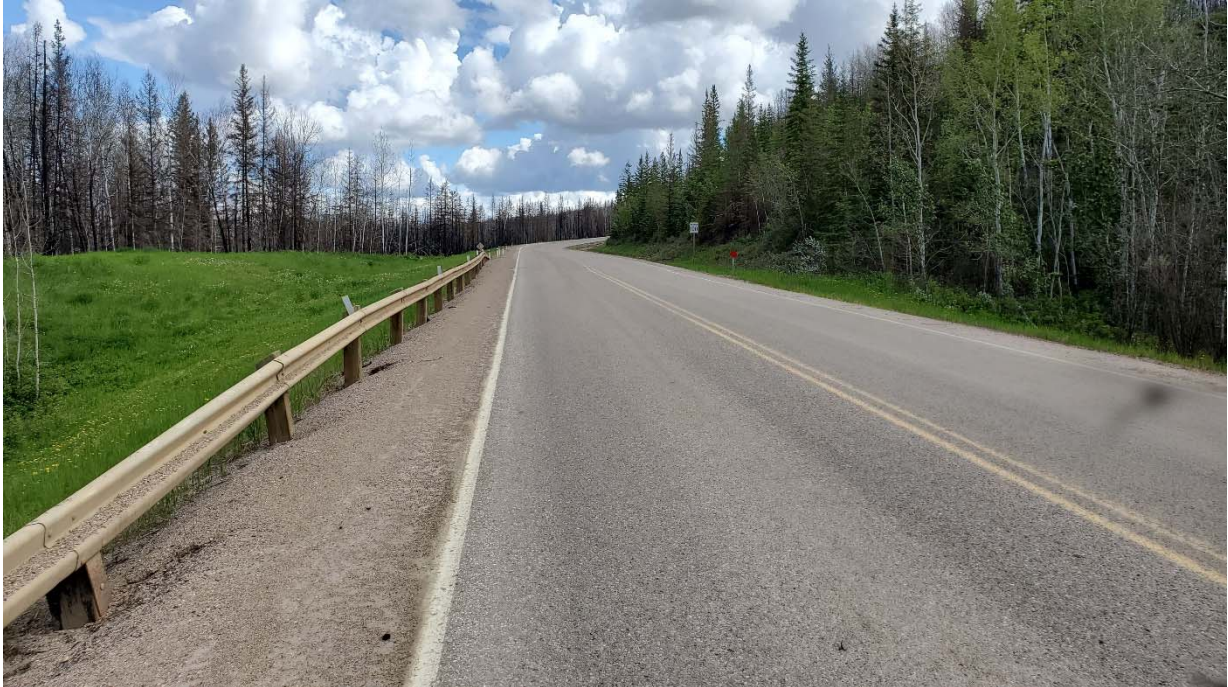
As the humps occur at either end of the embankment fill, the cause is likely a combination of long-term settlement of the fill over the culvert combined with frost heaving at the cut-fill contacts in the winter. Exposed soils observed in the vicinity are sand and silt which are highly frost-susceptible when given access to water. The difference in magnitude of the frost heaving may reflect greater groundwater presence on the northeast (uphill) side which would increase the amount of frost heave. The scarp in the embankment above the outlet may have been triggered by the scour bowl that has formed at the culvert outlet. There were no signs of recent movement on this scarp; however, the slope below is steeper than the embankment fill above.

Photo 1 – Looking northeast at hump in the highway.

- Asphalt patching and milling, as required, to smooth the abrupt changes in the pavement profile.

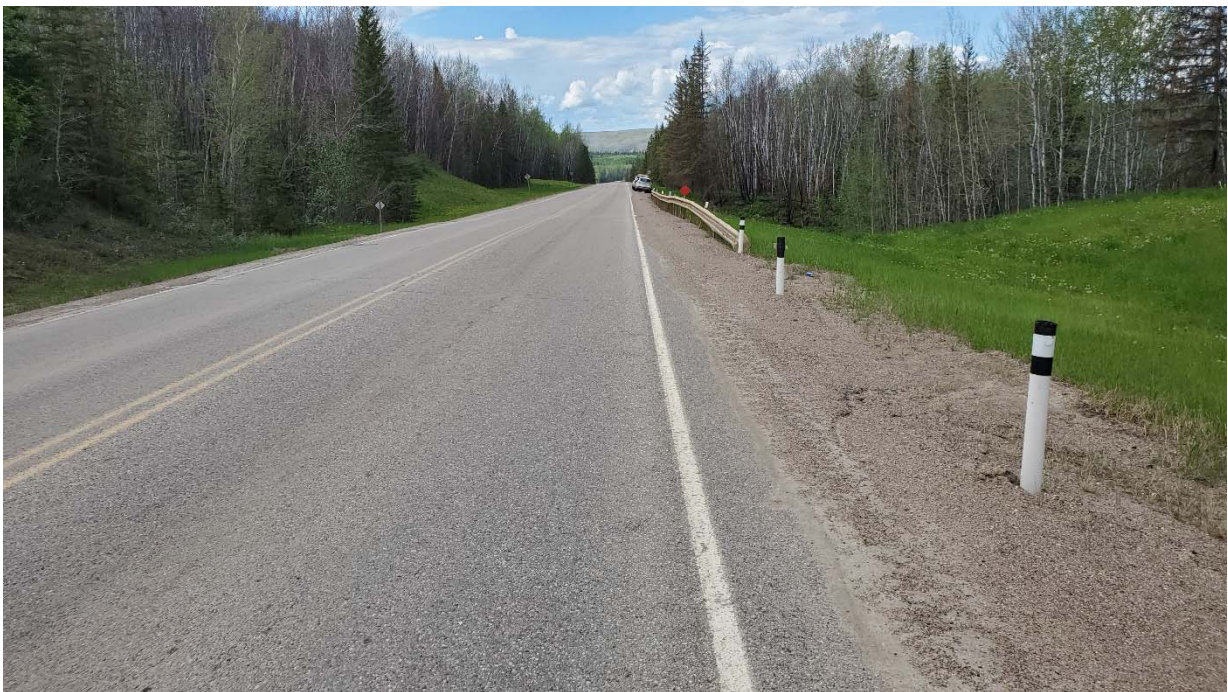
Photo 2 – Looking southwest from northeast end at dip in highway.

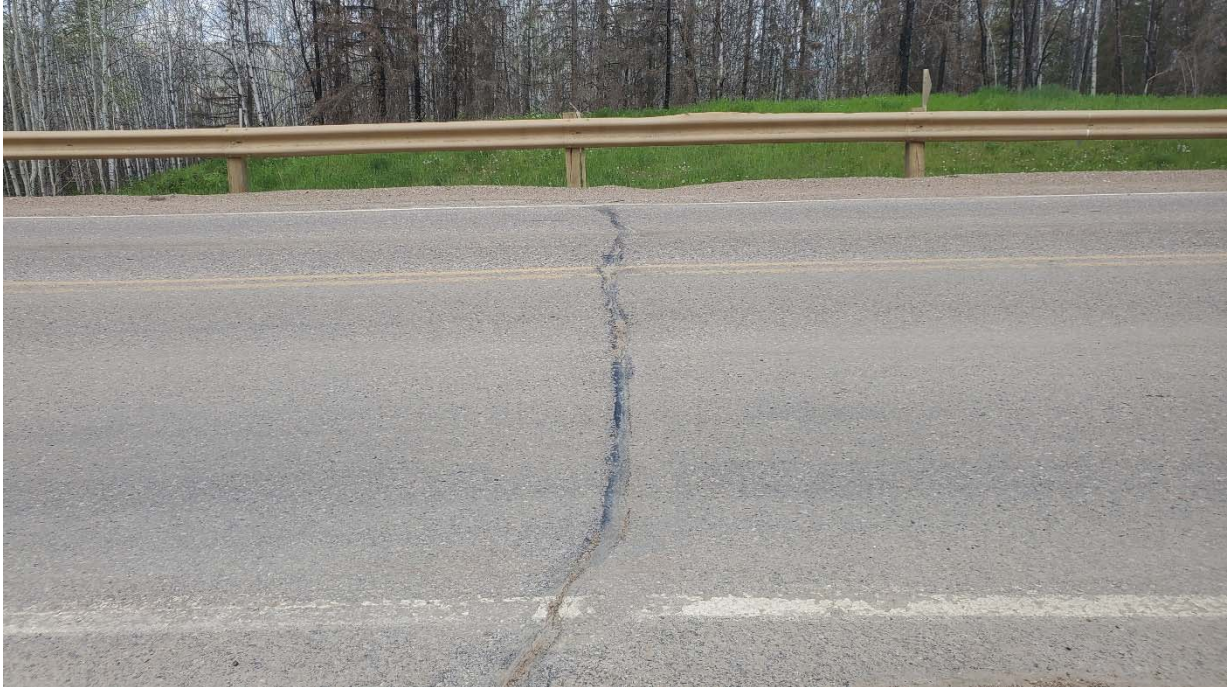
Photo 3 – Looking northwest at crack at northeast end of embankment fill.

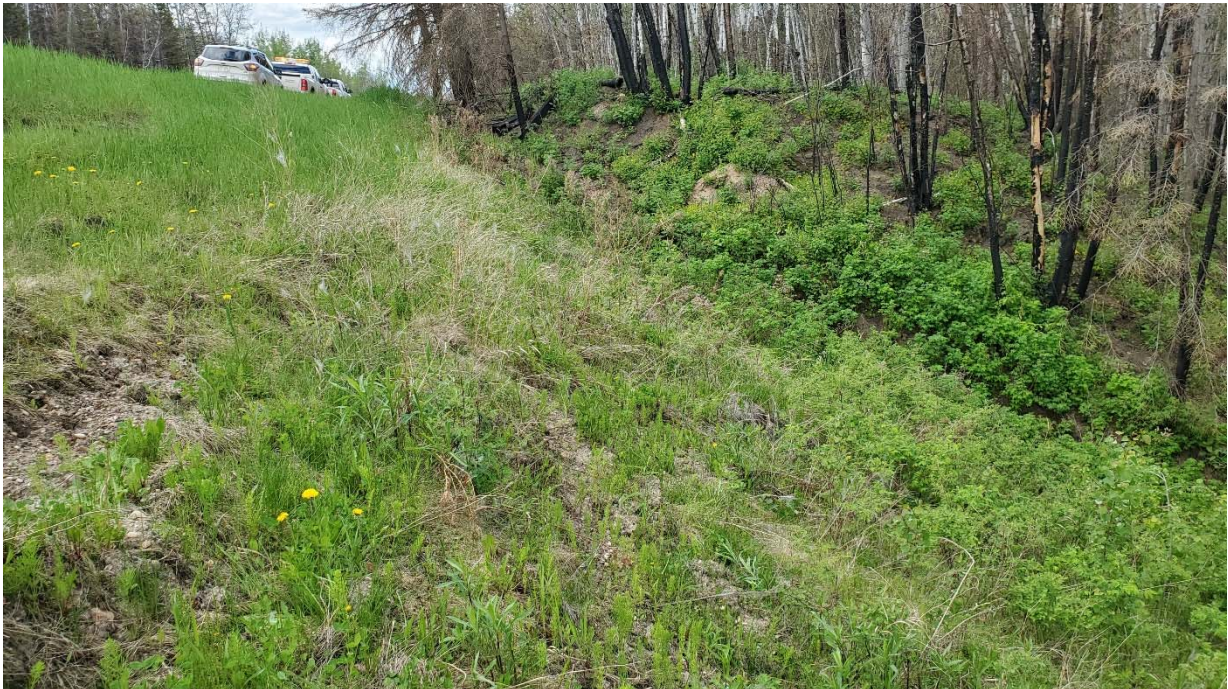
Photo 4 – Looking southwest at northwest sideslope.

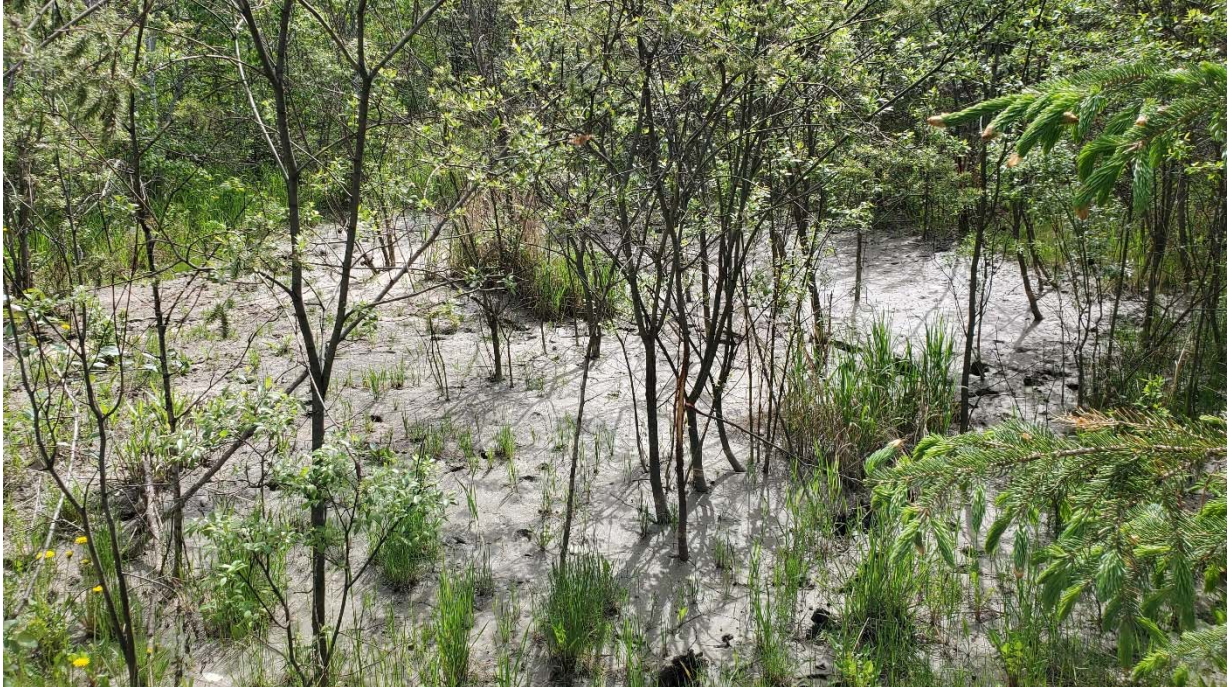
<input type="checkbox"/> Seepage		<input type="checkbox"/>
<input checked="" type="checkbox"/> Bridge/Culvert Distress	Silt had been accumulated at inlet of 600 mm culvert. This appears to have been cleared by the 2016 inspection. The inlet was again covered in 2020.	<input checked="" type="checkbox"/>
<input type="checkbox"/> Other		<input type="checkbox"/>
Instrumentation:	None.	
Assessment:	Based on discussions with Alberta Transportation maintenance personnel, the humps at either end of the embankment fill are more pronounced in winter and only minor during the summer. The humps have posed a pavement smoothness issue for many years.

Photo 5 – Silt accumulation upslope of inlet.

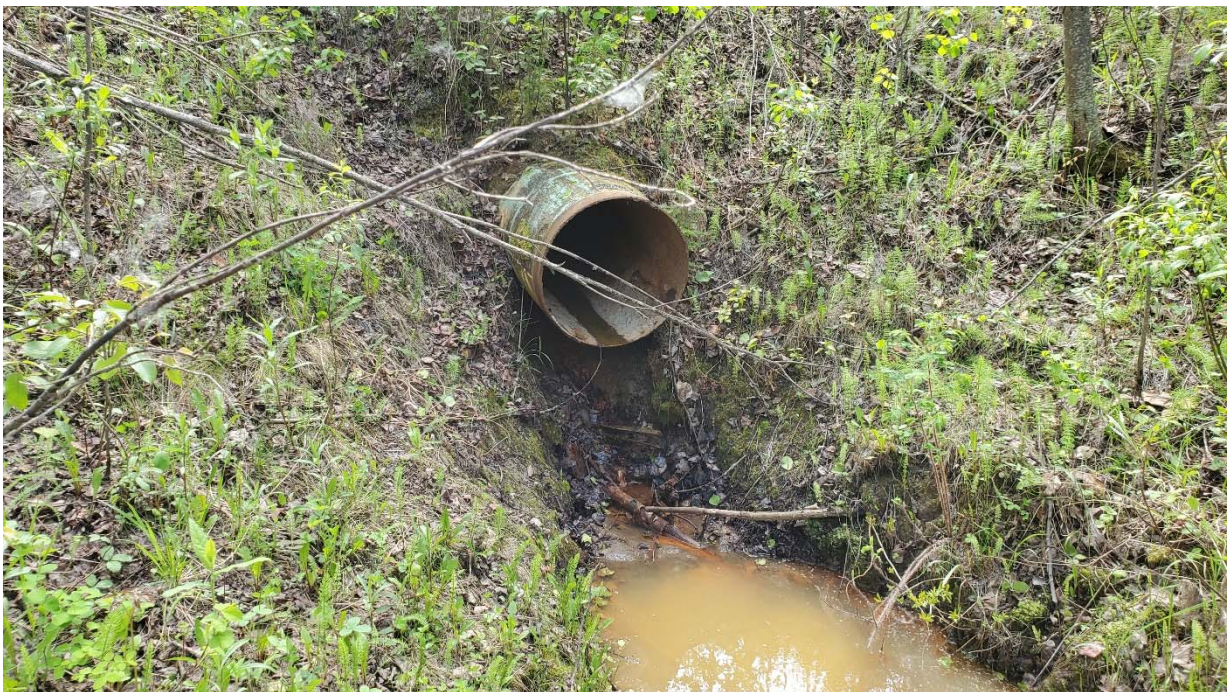
Photo 6 – Hanging culvert outlet.
