**ALBERTA TRANSPORTATION
GEOHAZARD ASSESSMENT PROGRAM
PEACE REGION – HIGH LEVEL
2017 INSPECTION**

Site Number	Location	Name	Hwy	km
PH011-1 PH011-2	North of Peace River	Whitemud River (km 42.6 and km 43.2)	743:02	42.4 to 42.8 43.2
Legal Description		UTM Co-ordinates		
NE36-87-21-W5M & SW1-88-21-W5M		11U E 487,302	N	6,272,372

PH011-1: HWY 743:02 WHITEMUD RIVER, km 42.6 AND km 43.2 GEOHAZARD ASSESSMENTS

DWG No. 13351-PH011-1-1

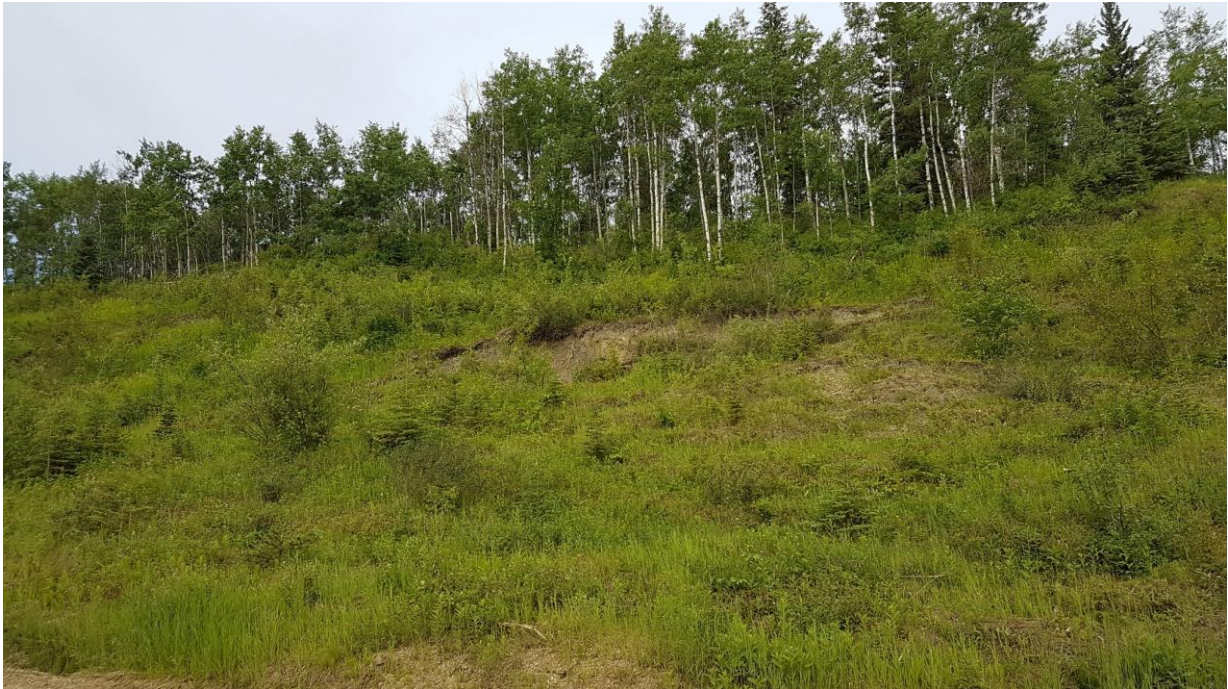
Primary Site Issue:	Backslope slumping, minor erosion, and slope ravelling.	
Dimensions:	150 m backslope slump at km 42.3 to km 42.45; repaired culvert embankment from km 42.45 to km 42.7; 50 m backslope ravelling at km 43.2	
Date of Remediation:	2010: Culvert replaced and embankment rebuilt at km 42.6.	
Maintenance:	2017: Ditch cleanout at km 43.2	
Observations:	Description	Worsened?
<input type="checkbox"/> Pavement Distress	Highway is gravel-surfaced.	<input type="checkbox"/>
<input checked="" type="checkbox"/> Slope Movement	<p>KM 42.4 (Bankslope south of culvert):</p> <ul style="list-style-type: none"> Continued west bankslope slumping on the south end of the site leading to debris build up at the ditch. Toe roll still 1.2 m high near north part of this slump. <p>KM 42.6 (Culvert – main site):</p> <ul style="list-style-type: none"> Sideslopes re-constructed in 2010. Tension cracks observed previously have not changed. <p>KM 43.2 (Shale slope north of culvert):</p> <ul style="list-style-type: none"> Additional shallow sloughing of shale slope. Some additional vegetation growth noticed. 	<input checked="" type="checkbox"/>

Photo 1 – Looking west at backslope failures at the south end of the site (km 42.4).

- KM 42.4, West Backslope: Flatten the backslope to a shallower slope and incorporate 3 m wide benches at 6 m height intervals with controlled drainage paths at the ends of the benches. Re-establish the highway ditch and line it with TRM and synthetic ditch barriers at intervals.

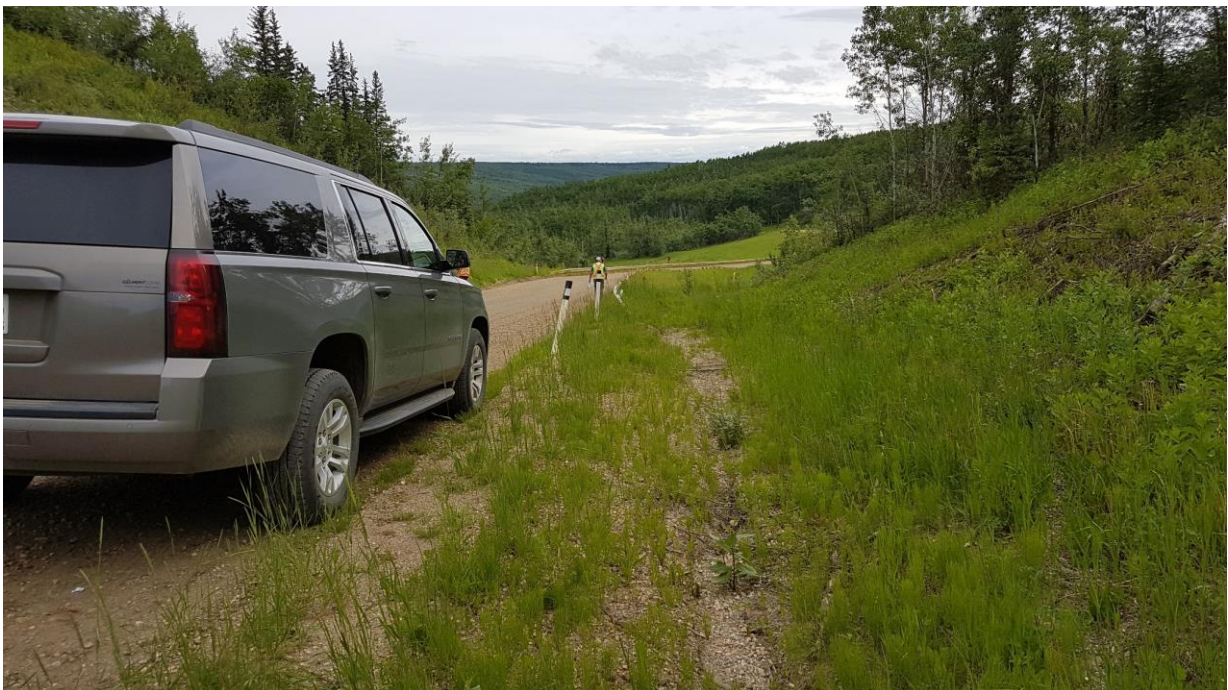
<input checked="" type="checkbox"/> Erosion	<p>KM 42.4:</p> <ul style="list-style-type: none"> Erosion of southwest ditch reduced from 0.6 m deep to 0.2 m by roadway gravel. Erosion in southeast ditch similar to 2015. <p>KM 42.6:</p> <ul style="list-style-type: none"> Gully on east sideslope slightly worse, erosion at end of riprap swales near inlet (slightly worse) and outlet (worse) of culvert, and on west sideslope (same). 	<input checked="" type="checkbox"/>

Photo 2 – Looking north at east ditch erosion at the south end of the site (km 42.4).

- KM 42.4, West Ditch: Remove material from the ditch as required to maintain flow. Excavated material should be disposed of outside of the valley. Erosion protection may be required to minimize downcutting by water flow.
- KM 42.4, East Ditch: The erosion appears to have stabilized for the present; however, consideration could be given to regrading the ditch and lining with erosion control product (ECP) and synthetic ditch checks.
- KM 43.2: Continued to remove material from the ditch as required to maintain flow.

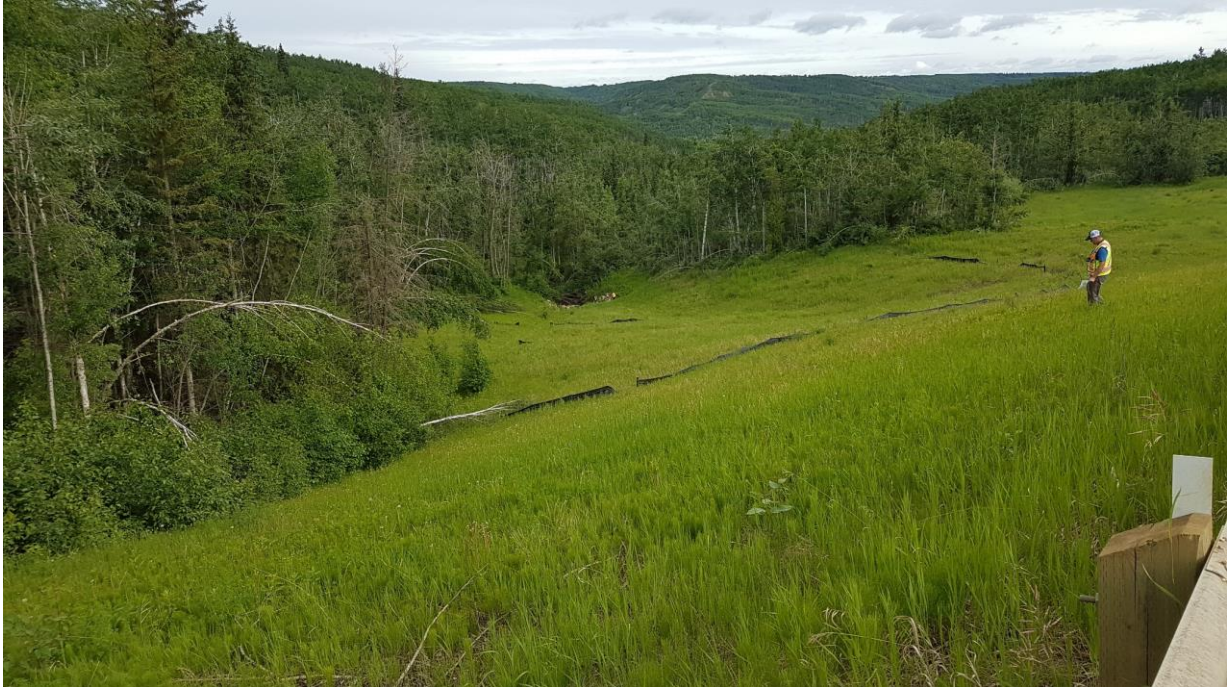
Photo 3 – Looking west toward culvert outlet along west sideslope.

- KM 42.6, West Sideslope: The erosion features forming should be excavated and replaced with compacted granular material and protected with ECP. It is recommended that the silt fences at this site be removed as they are no longer required and, at this specific location, may be contributing to erosion.
- KM 42.6: Erosion beneath the riprap at the culvert aprons (both inlet and outlet) should be excavated salvaging the existing rock, backfilled with compacted granular, and regraded and the riprap reinstalled with non-woven geotextile. The repairs should be tied into the riprap aprons to prevent similar issues in the future.

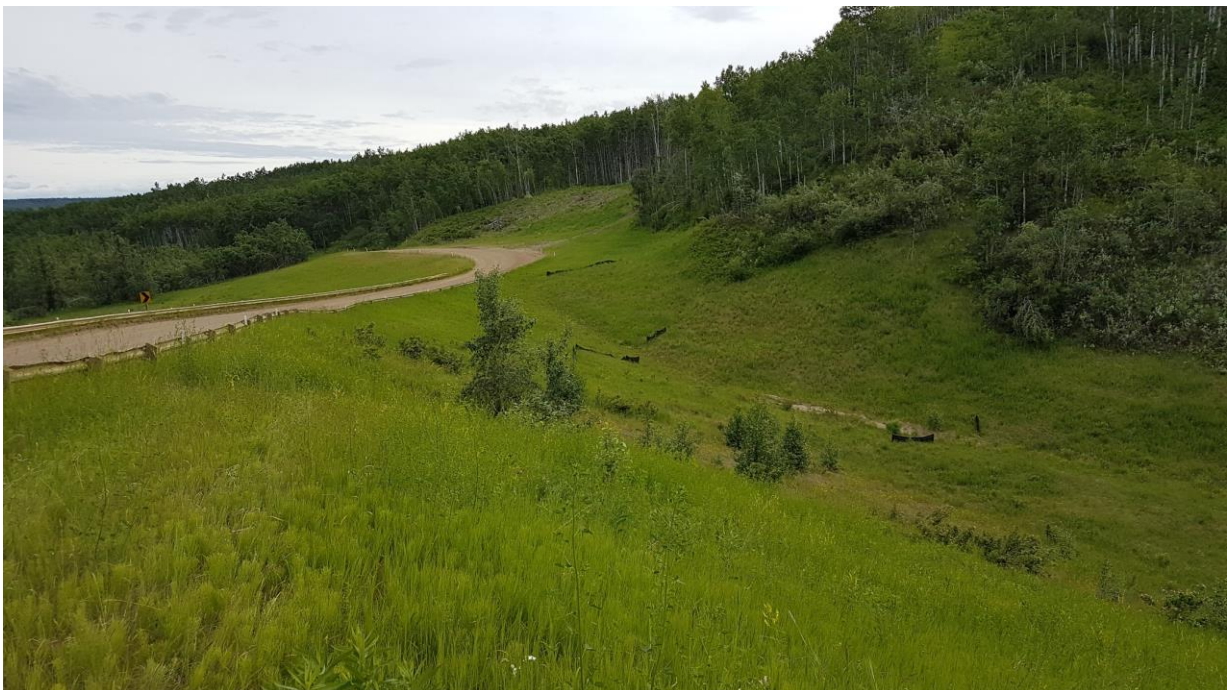
Photo 4 – Looking north at east sideslope above culvert inlet.

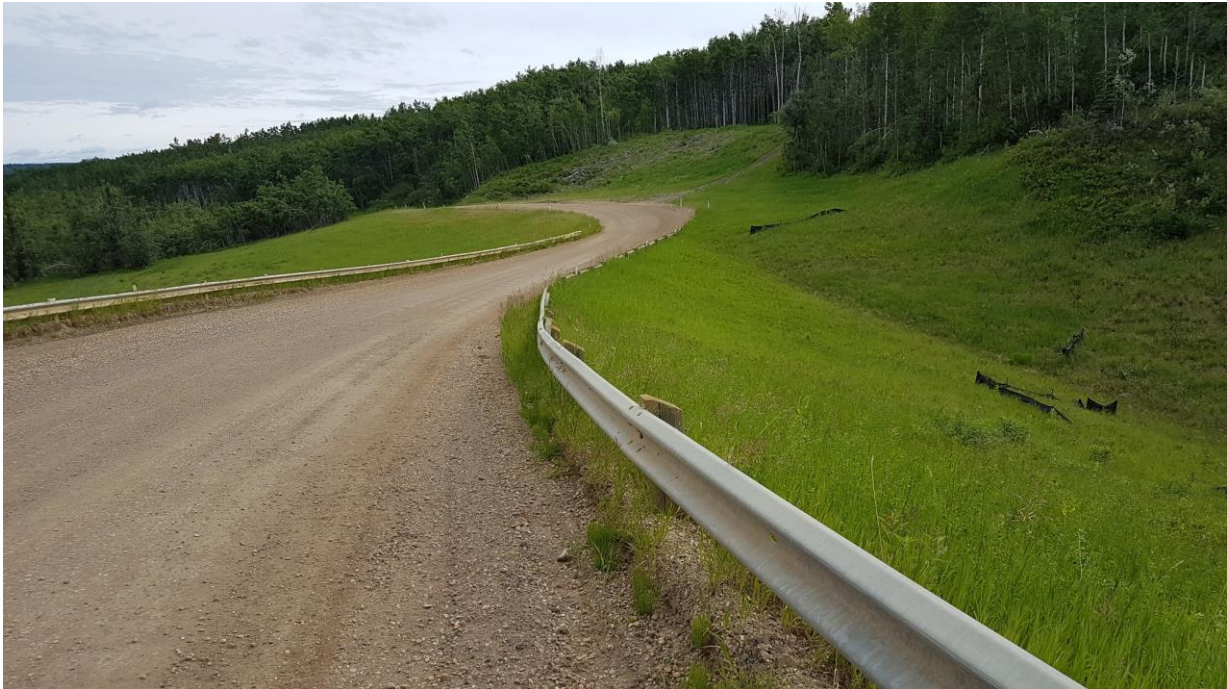
Photo 5 – Looking north at along east guardrail.

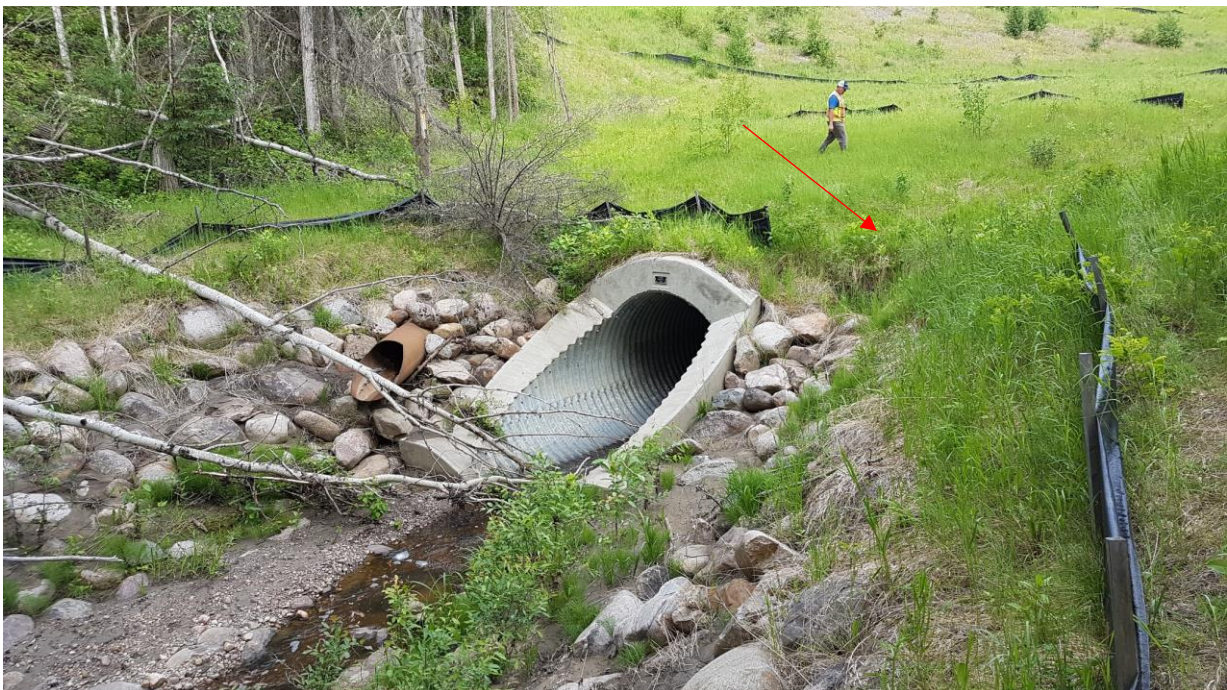
Photo 6 – Looking northwest at culvert inlet. Note erosion to right of culvert above the riprap (red arrow).

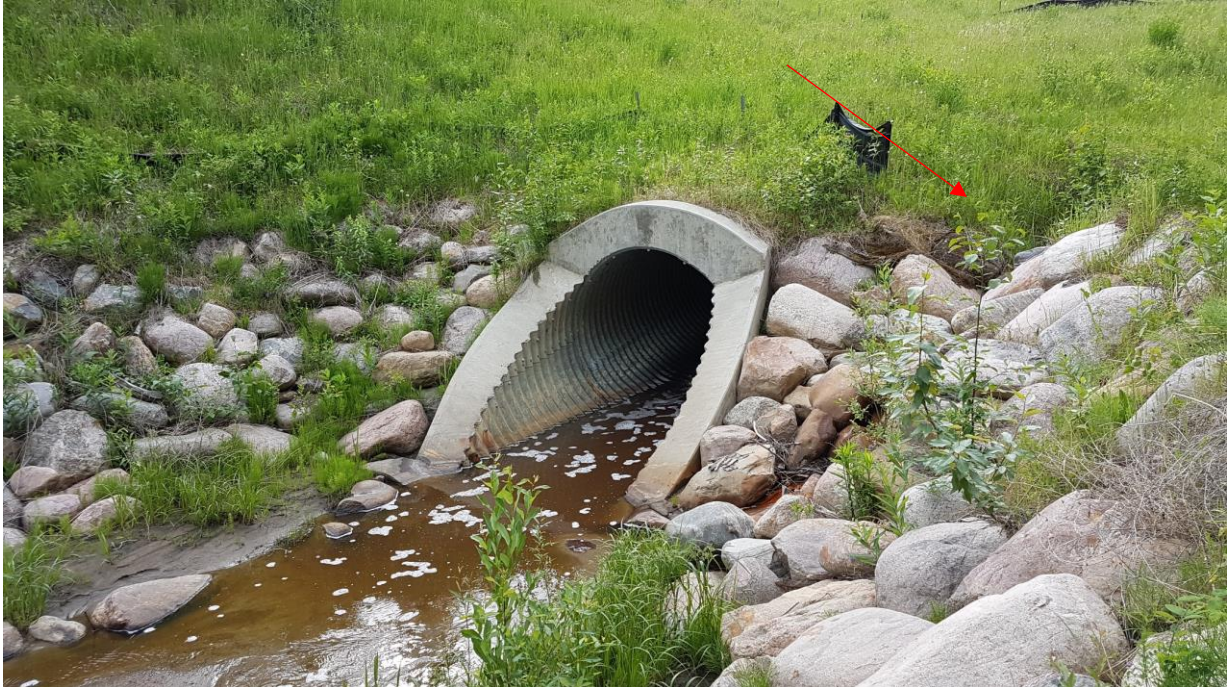
Photo 7 – Looking southeast at culvert outlet. Note erosion below the riprap on the right side of the culvert (red arrow).

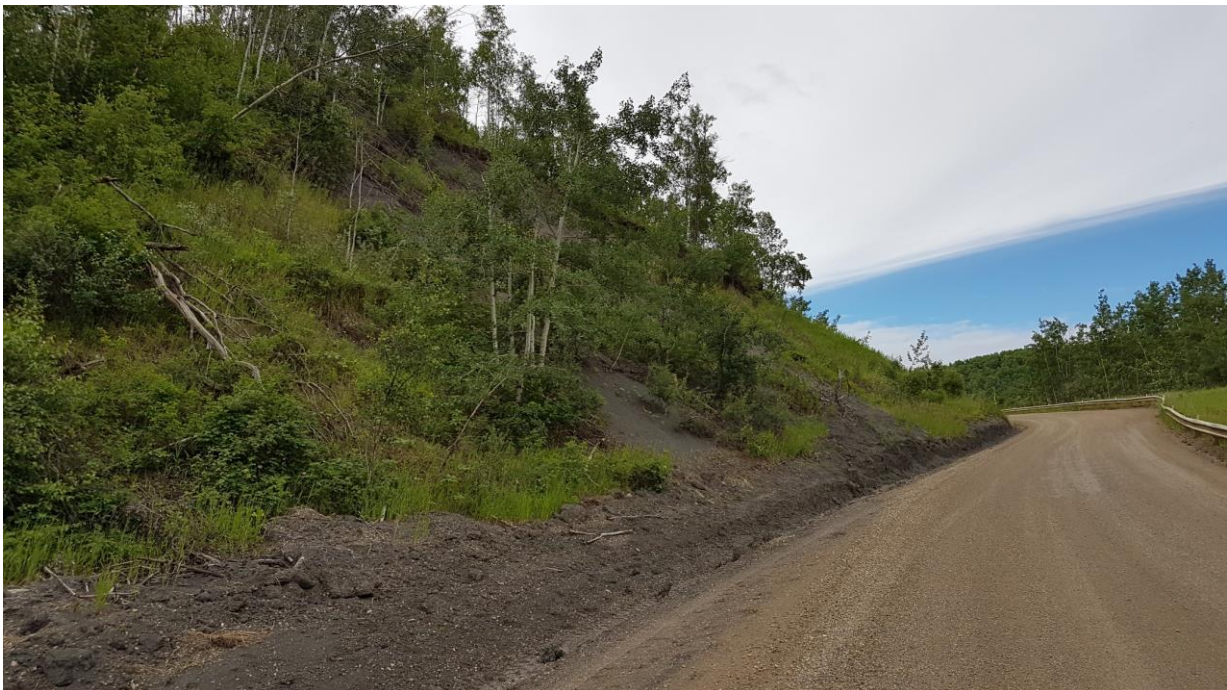
Photo 8 – Looking southeast at ravelling shale slope (km 43.2).
