**ALBERTA TRANSPORTATION  
GEOHAZARD ASSESSMENT  
PEACE REGION (PEACE RIVER DISTRICT)  
2021 INSPECTION**

**THURBER ENGINEERING LTD.**

| Site Number | Location | Name | Hwy | km |
|---|---|---|---|---|
| PH011-3 | North of Peace River | Whitemud River (km 42.8) | 743:02 | 42.8 |

**PH011-3: HWY 743:02  
2021 SITE INSPECTION PLAN**

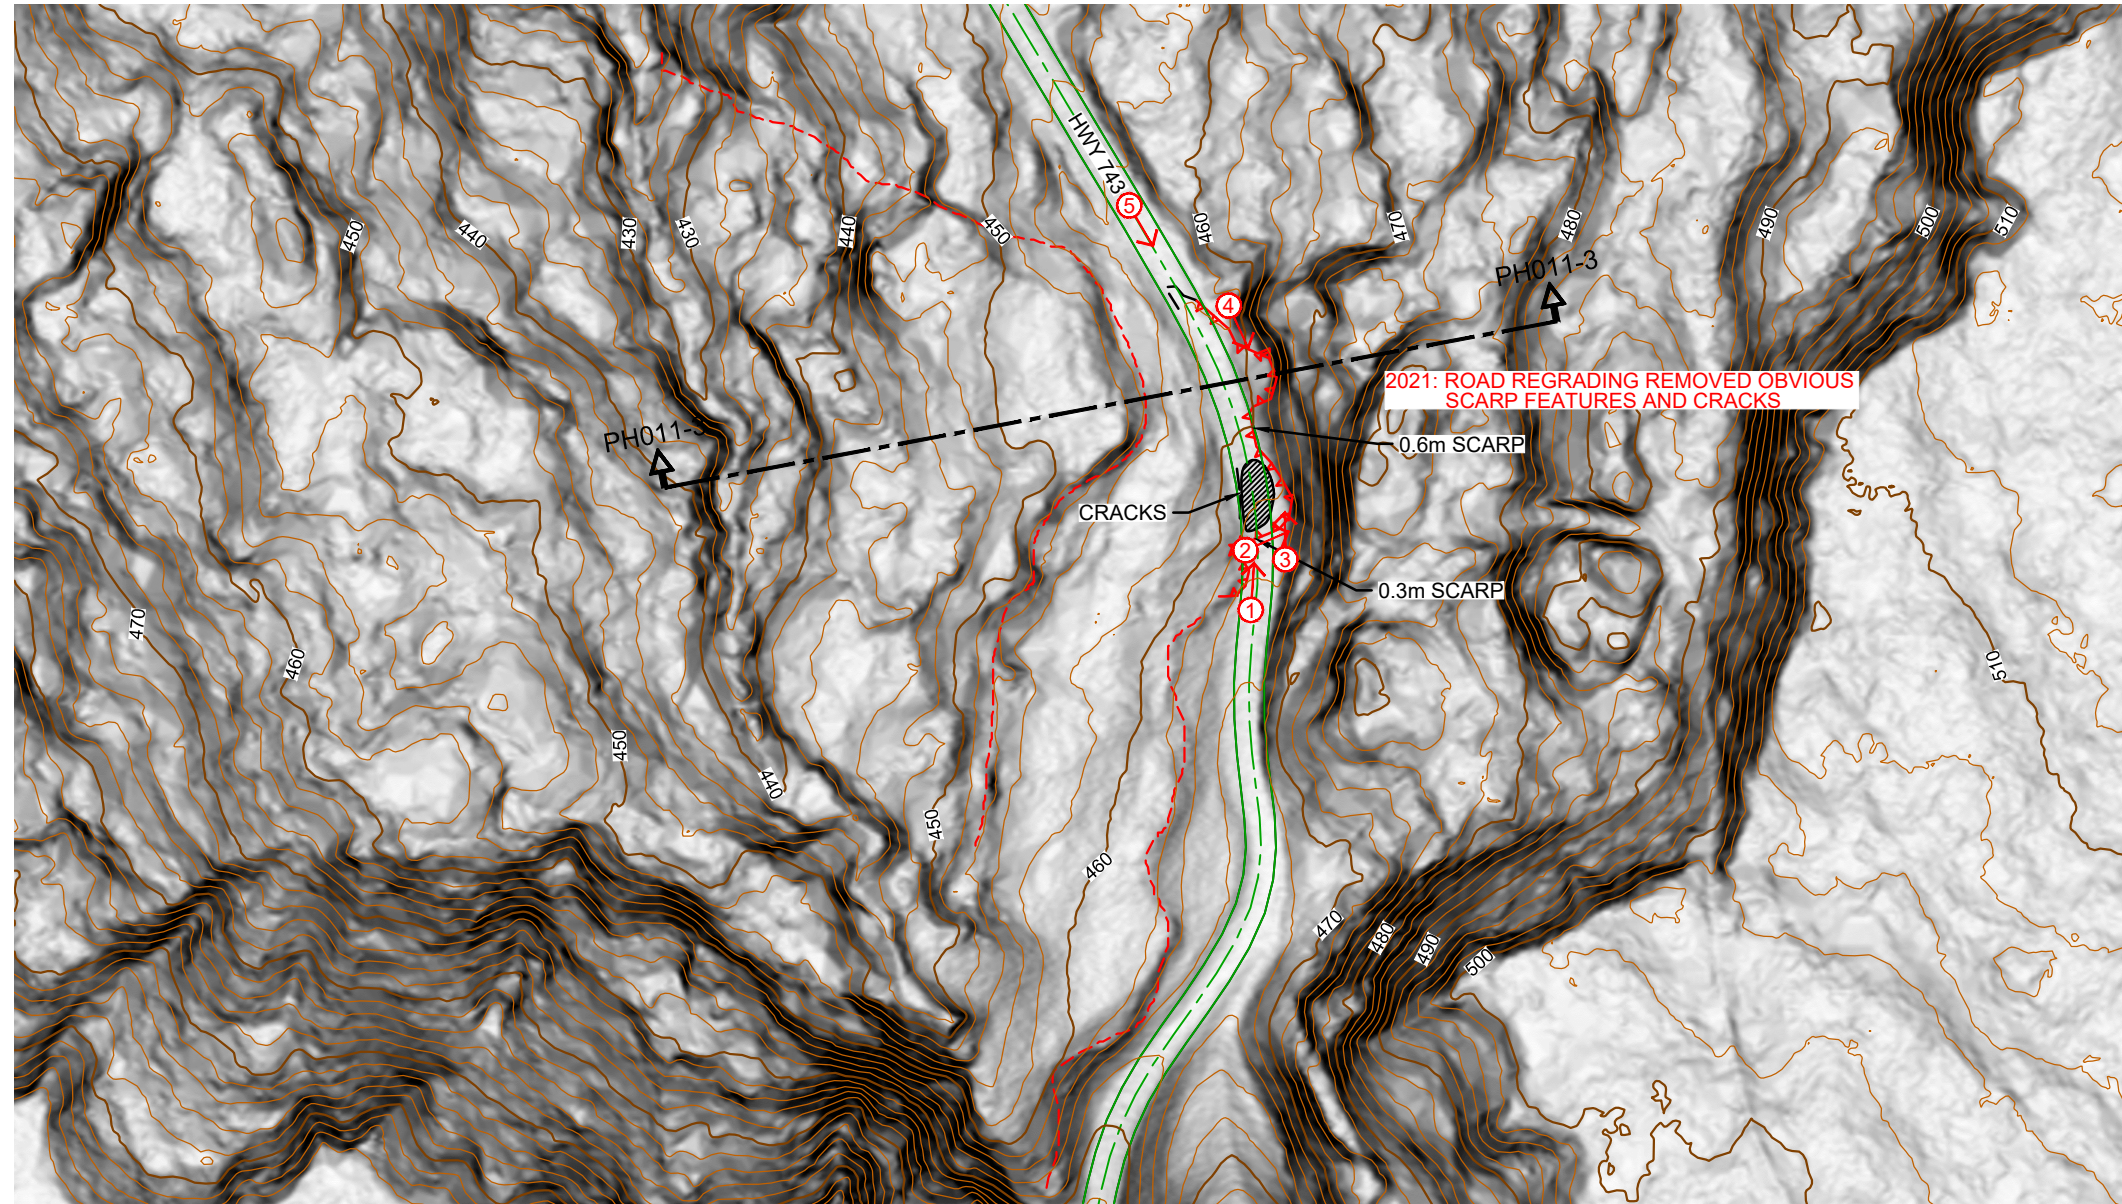
**DWG No. 32121-PH011-3**

| <input checked="" type="checkbox"/> Slope Movement | Cracks and dip across roadway indicate slope movement. LiDAR indicates historical landslide scarps on slope above and below roadway. | <input checked="" type="checkbox"/> |

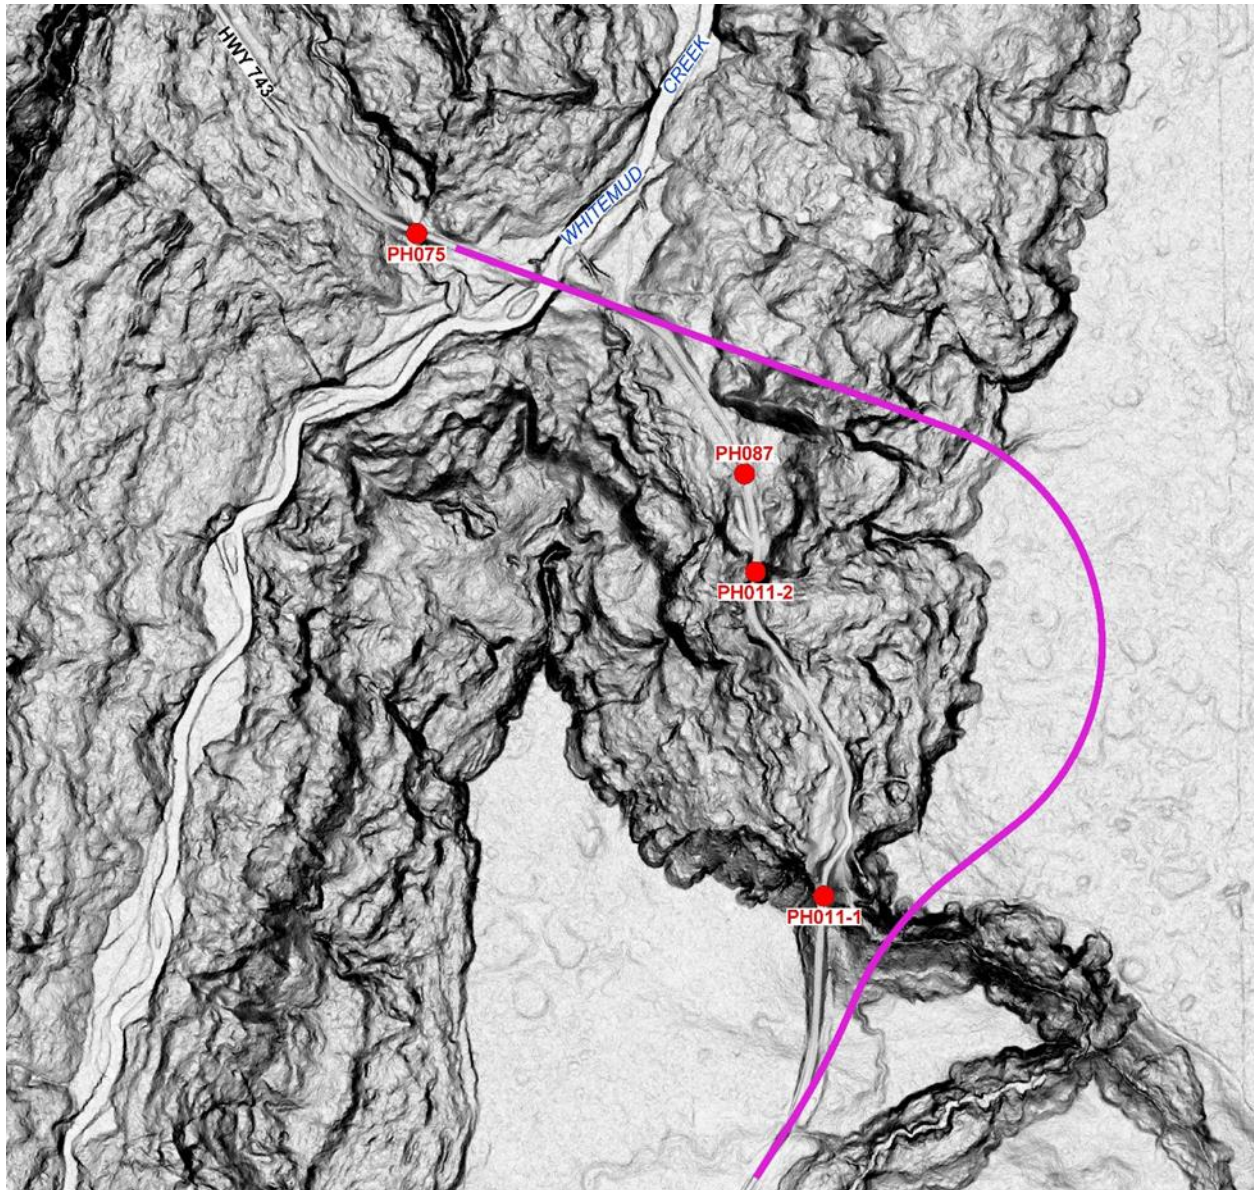
The site is located on Highway 743:02 on a sidehill alignment ascending the valley slope of a tributary to the Whitemud River. LiDAR provided by Alberta Transportation (Figure 1) shows that the valley slope has been affected by historic landslide movements. It is considered that higher groundwater levels in the years leading into 2020 have re-activated a large slide block which is now affecting about 100 m of the road surface. At the centre of the disturbance the highway is located about 25 m above the creek. The valley slope surface, as shown by the cross-section on Dwg. No.32121-PH011-3, is hummocky, indicating the presence of several possible retrogressive slide blocks between the creek and the road. Movements are slow enough at this site that routine grading is currently able to maintain a safe highway surface.

Figure 1: Proposed long term realignment for Hwy 743:02 south of the Whitemud Creek

- The highway could be realigned south of the Whitemud Creek bridge to rise out of the valley perpendicular to the valley slope and then curve back to cross the tributary creek east of PH011-1, as shown approximately on Figure 1 below. The curved alignment is required due to the proximity of the Peace River valley to the east of the Whitemud Creek valley. This re-alignment would be expensive, and as there would be limited fills, the excavated material would need to be hauled out of the valley and stockpiled well back (at least 300 m) from the valley crest. This would also require a significant new road segment on the uplands to bring the new alignment back to the existing highway, as well as a new bridge file culvert and embankment fill at the tributary crossing.

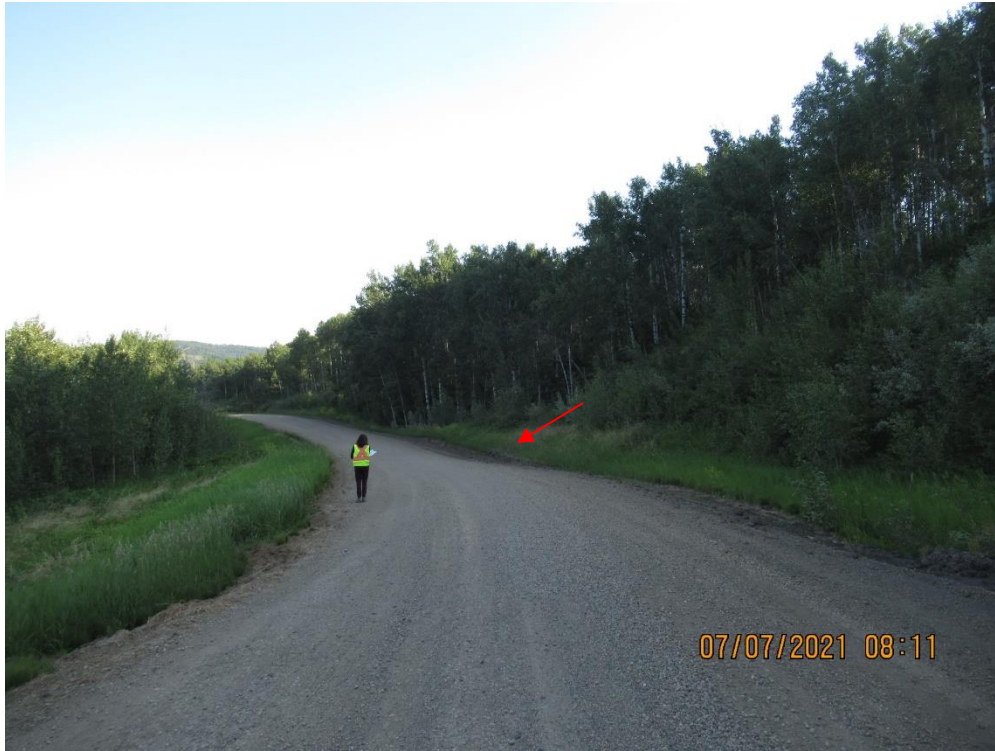
| <input checked="" type="checkbox"/> Pavement Distress | Cracks crossing both lanes and dip in gravel road surface. | <input type="checkbox"/> |

Photo 1 – Looking north at landslide site identifiable by the dip in the highway surface.

- The cracks and slumping at this site are still limited in extent such that the road can still be used at this location with care and at slow speeds. Slide warning signs and a 30 km/hr speed limit are recommended. Frequent visits by the AT Maintenance Contractor are also recommended to ensure that the roadway remains safe for the travelling public as this slide could continue to move and further damage the road, especially following heavy periods of precipitation and the coming spring thaw when groundwater levels could be higher.
- At the PH011-1 (km 42.4) site, the exposed slope should be textured (dozer walking up and down the slope), seeded, and covered with a temporary erosion control blanket. Consideration should be given to using a permanent control blanket in the ditch where flow will be concentrated.

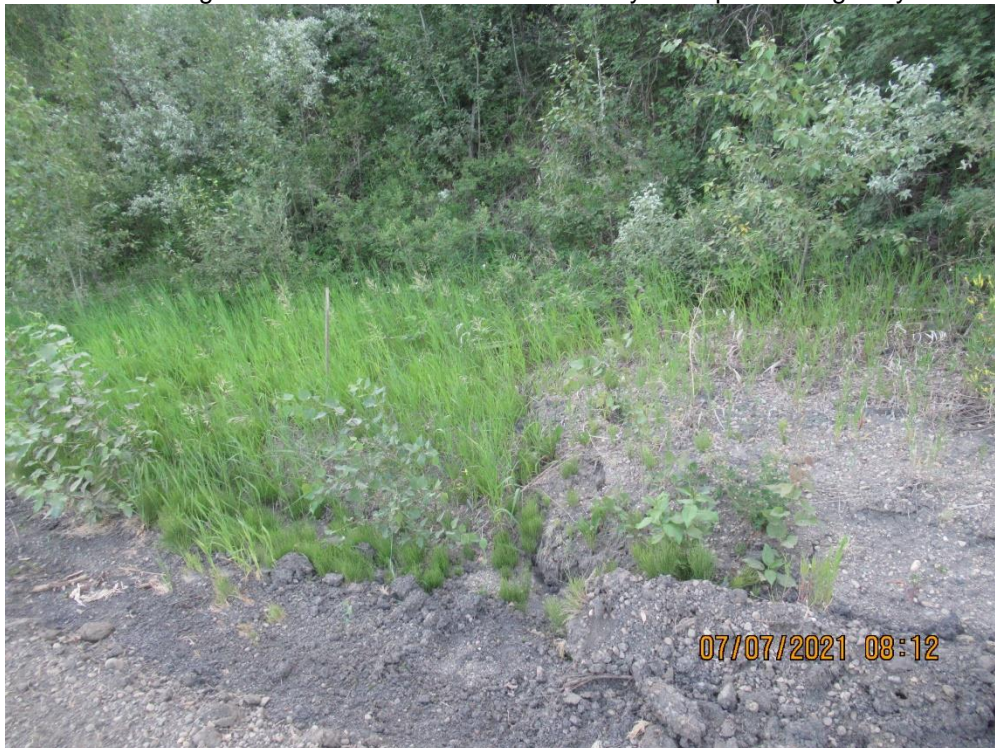
Photo 2 – Scarp crack at the edge of the road

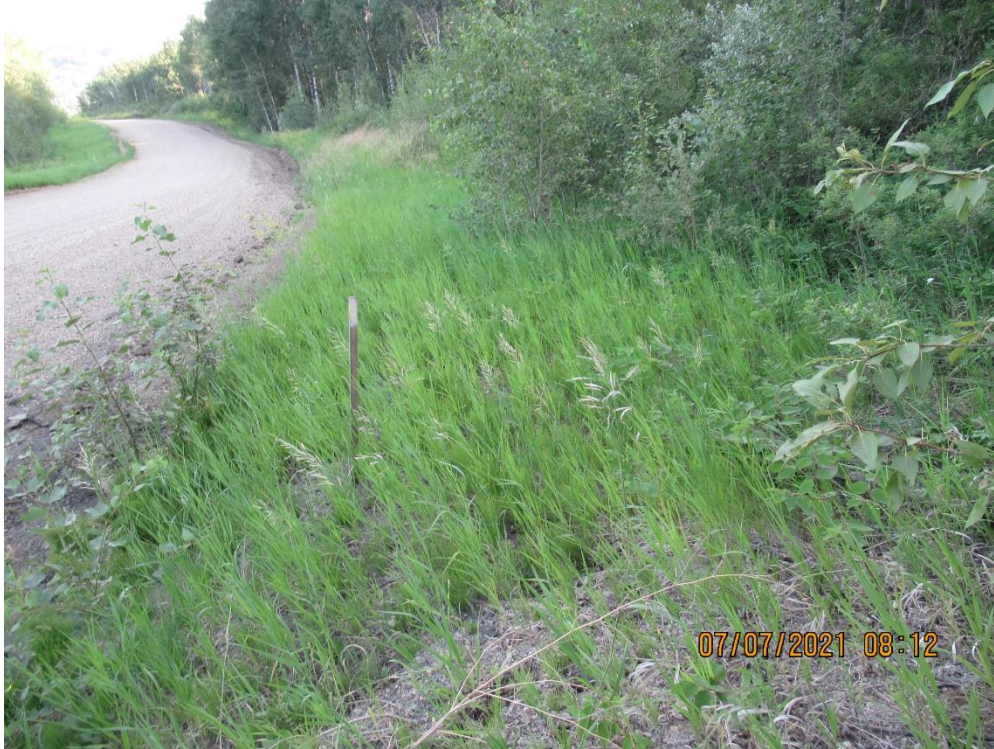
Photo 3 – Looking north along backscarp crack (in the grass).

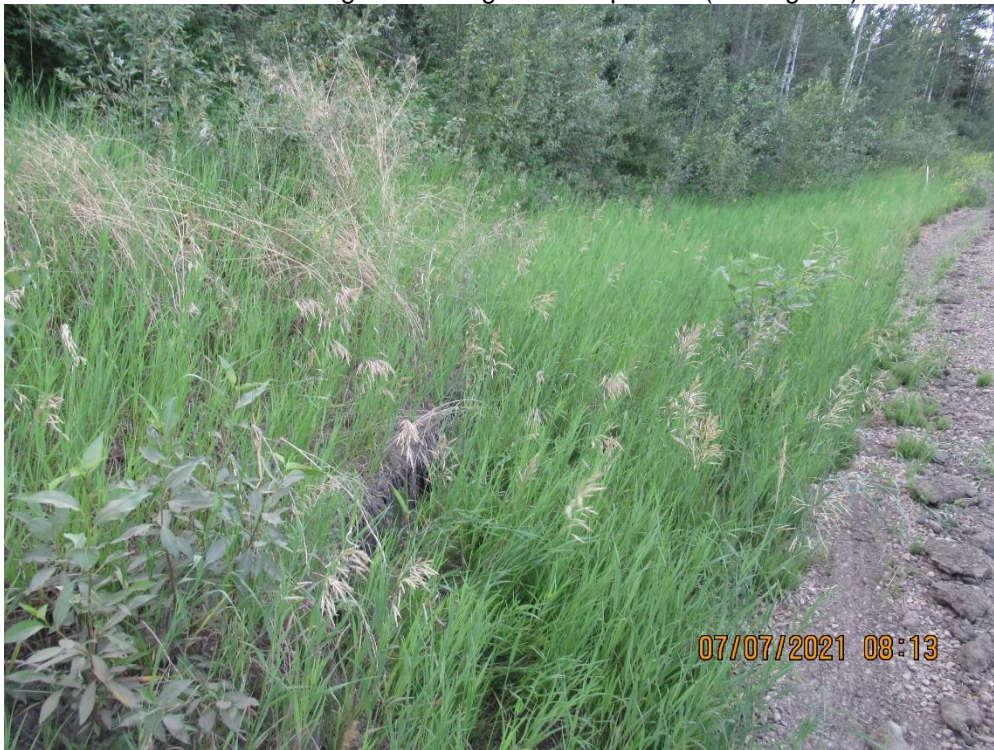
Photo 4 – Looking south at open crack along backscarp of slide at edge of highway.

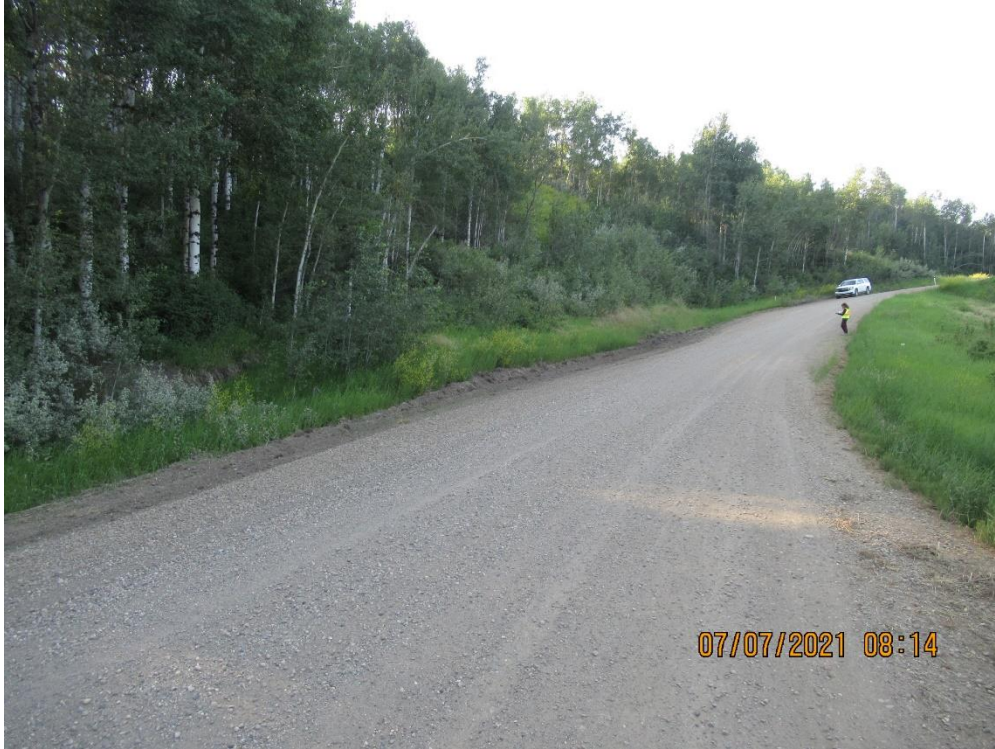
Photo 5 – Looking south toward the landslide.

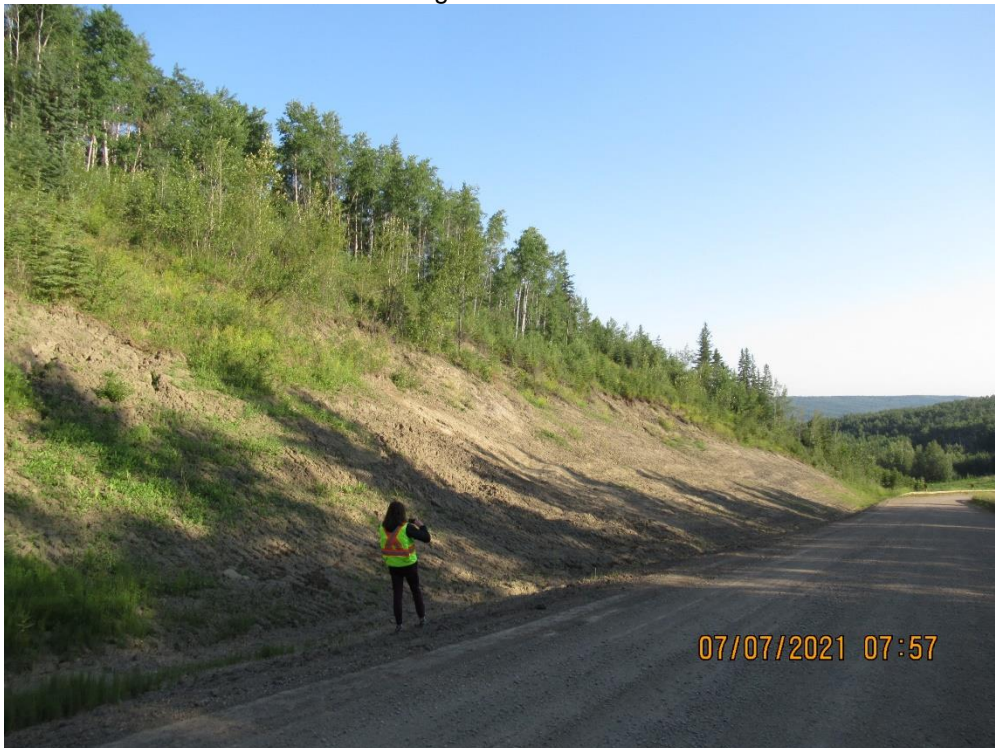
As part of the site inspection, a brief assessment was undertaken of the PH011-1 backslope cut done in Fall 2020. The purpose of that work, which was done in conjunction with the detour constructions, was to remove some of the sloughed material that was blocking the highway ditch and infringing onto the highway surface. The work did not include erosion control measures. There was some fresh shallow slumping noted at the south end of the cut. The backslope will likely continue to slough and require some further maintenance in the future. It would need to be cut back to a flatter angle to improve stability and provide a longer term solution

Photo 6 (PH011-1) – Looking at reggraded backslope failure area at PH011-1 site (km 42.4).

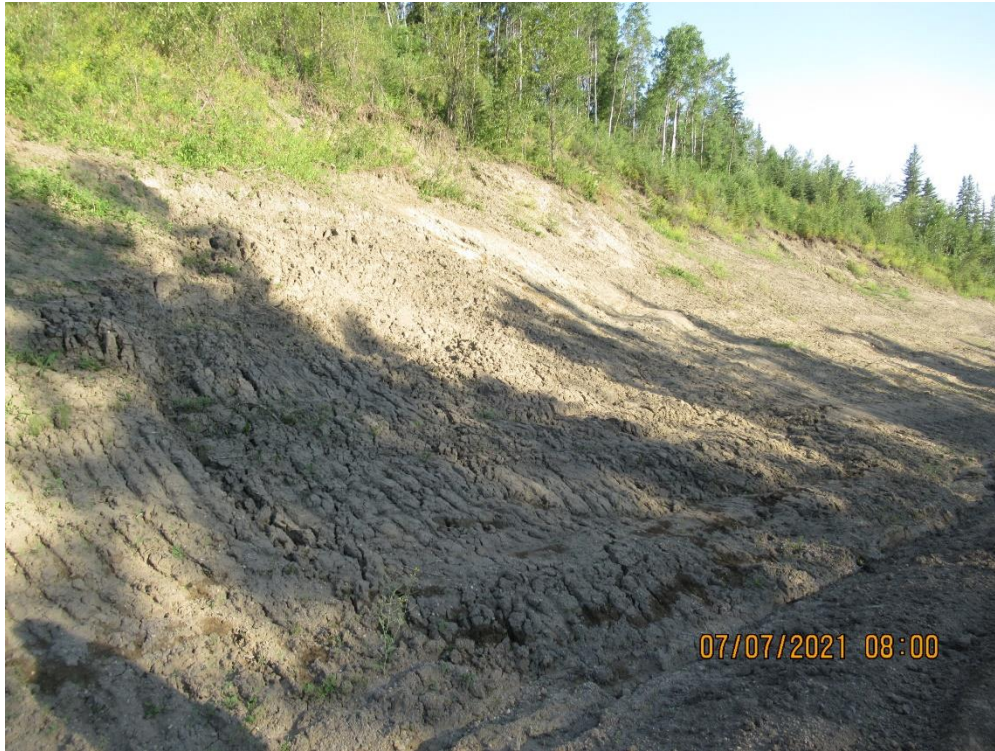
Photo 7 (PH011-1) – Shallow slump forming at south end of the PH011-1 backslope regrading.
