ALBERTA TRANSPORTATION AND ECONOMIC CORRIDORS GEOHAZARD ASSESSMENT PROGRAM PEACE REGION (PEACE RIVER DISTRICT) 2025 INSPECTION

Site Number	Location	Name		Hwy	km
PH011-1 PH011-2 PH011-3	North of Peace River	Whitemu	d River	743:02	42.4 to 42.8 43.2 42.8
Legal Description		UTM Co-ordinates			
PH011-1: NE36-87-21-W5M		11V N	6,272,980	E 4	87,129
PH011-2: SW01-88-21-W5		11V N	1 6,272,980	E 4	87,129
PH011-3: SW01-88-21-W5		11V N	1 6,272,586	E 4	87,326

Client: Alberta Transportation and Economic Corridors Inspection Date: May 13, 2025 File No.: 32121 Page 1 of 5

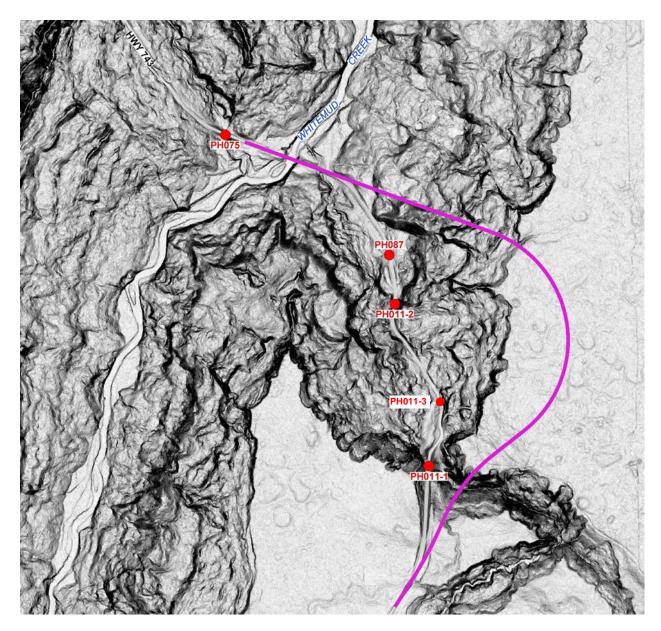
Figure 1: Proposed long-term realignment for Hwy 743:02 south of the Whitemud Creek

The highway could be realigned south of the Whitemud Creek bridge to rise out of the valley perpendicular to the valley slope and then curve back to cross the tributary creek east of PH011-1, as shown approximately on Figure 1 below. The curved alignment is required due to the proximity of the Peace River valley to the east of the Whitemud Creek valley. This re-alignment would be expensive, and as there would be limited fills, the excavated material would need to be hauled out of the valley and stockpiled at least 300 m from the valley crest. This would also require a significant new road segment on the uplands to bring the new alignment back to the existing highway, as well as a new bridge file culvert and embankment fill at the tributary crossing.

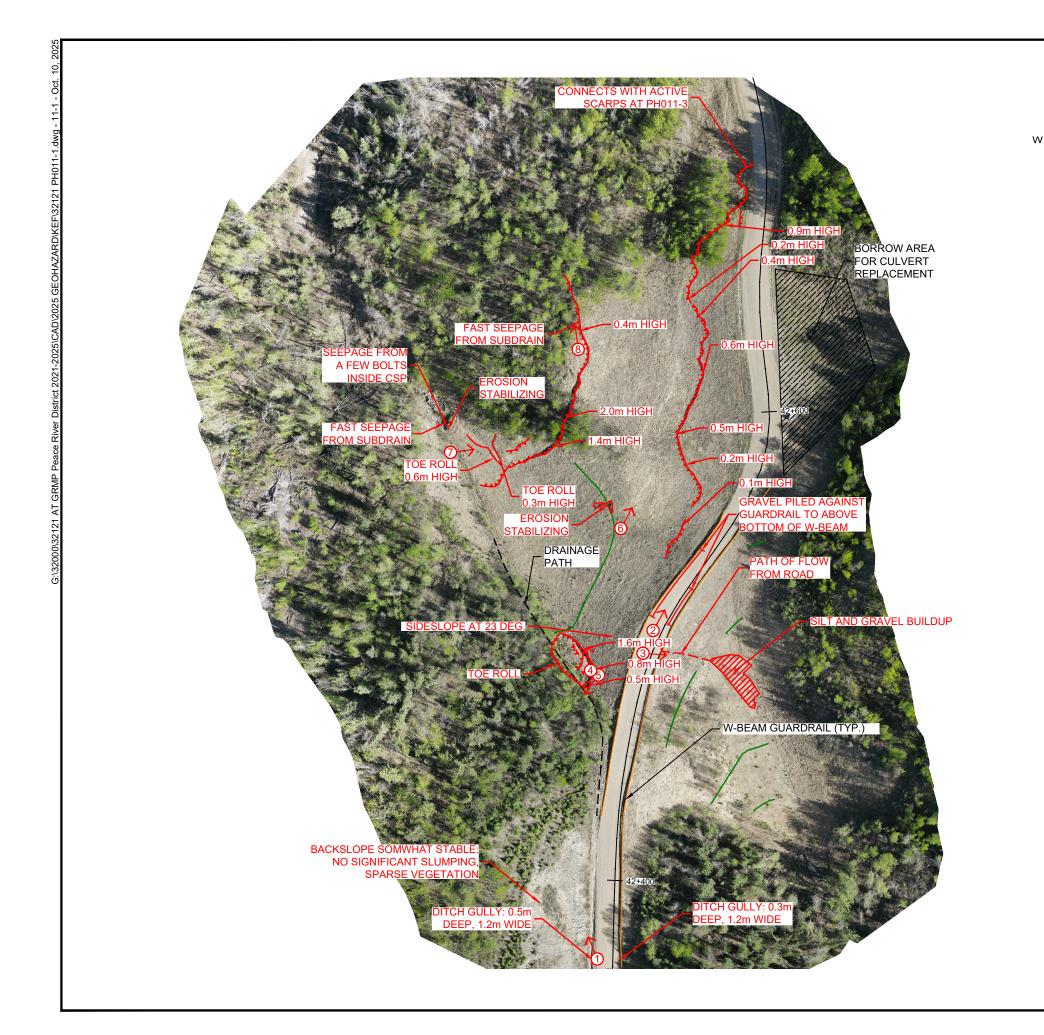
DWG No. 32121-PH011-1

PH011-1 had not been formally inspected since 2017 since there were no active issues at the bridge culvert. However, as there are ongoing minor slumping and erosion at the backslope, it was typical practice to stop briefly at the site during the Geohazard inspection tour to take a few pictures. During the 2025 inspection, a quick walk across the site noted that there were fresh scarps across the west embankment so a more-thorough inspection was undertaken and the UAV was flown to capture recent imagery.

During the Fall 2020 work to repair the highway from the landslides, some of the slumped material that was blocking the highway ditch and infringing onto the highway surface was removed from the backslope. The work did not include erosion control measures. The backslope has continued to slump somewhat since but, as of 2025, has become semi-stable with vegetation re-establishing. Ideally, the entire slope would be cut back to a flatter angle to improve stability and provide a longer term solution. There are gullies eroding in both ditches that should also be better protected.

At the main culvert site, it was noted that grading practices have resulted in gravel pushed up against the guardrail to the bottom of the W-Beam on the west side (significantly reducing its effectiveness) and material spilling or running onto the east side resulting in a build up partway down the slope. Of greater concern are the landslide features that have formed on the west side of the embankment. There is a slump that has formed in upper portion of the SW quadrant in the drainage channel from the west ditch. This feature is about 25 m by 12 m with a scarp between 0.5 m and 1.6 m in height. There was a clear toe roll identified in the drainage channel.

Further north, there are scarp cracks associated with large slow moving landslide. The upper one was approximately 120 m long in the open area but continued north in the tree line where it connects with the newer PH011-3 site. The scarp heights was 0.1 m high closer to the culvert and increasing up to 0.9 m at the north in the tree line. The lower scarp was more pronounced with scarp heights up to 2 m and two toe rolls near the culvert outlet and SW drainage channel. This lower scarp was at least 90 m long (measured parallel to the road) where it could be readily mapped in the open area. The more noticeable scarps suggesting increased movement is the reason for increasing the Risk Level at this subsite.

- At the PH011-1 (km 42.4) site, the exposed backslope should be textured (dozer walking up and down the slope), seeded, and covered with a temporary erosion control blanket. Consideration should be given to using a permanent control blanket in the ditch where flow will be concentrated.

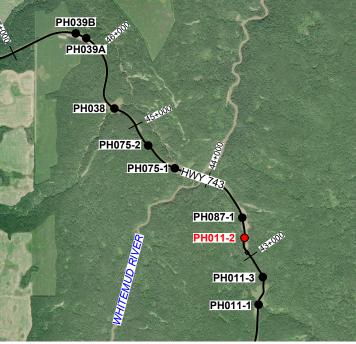
DWG No. 32121-PH011-2

The shale backslope at PH011-2 (Drawing 32121-PH011-2) has continued to ravel onto the highway surface and the accumulated debris had resulted in one-lane closure at the time of the 2025 inspection hence the increase in Risk Level at this subsite. In 2023, there was evidence of scarp cracks opening up at the top of the slope which did not appear worse in 2025; however, a mid-slope scarp had also opened up so there remains the potential for a larger mass to fail at this location. Excavated material has been stockpiled just north of the site and should be removed to the designated stockpile outside the south end of the valley.

- At the PH011-2 (km 43.2) site, the slumped material should be removed from the side of the road and hauled to the disposal area located just south of the valley. Consideration should be given to cutting back the slope to reduce the amount of material that could ravel/slide onto the highway.

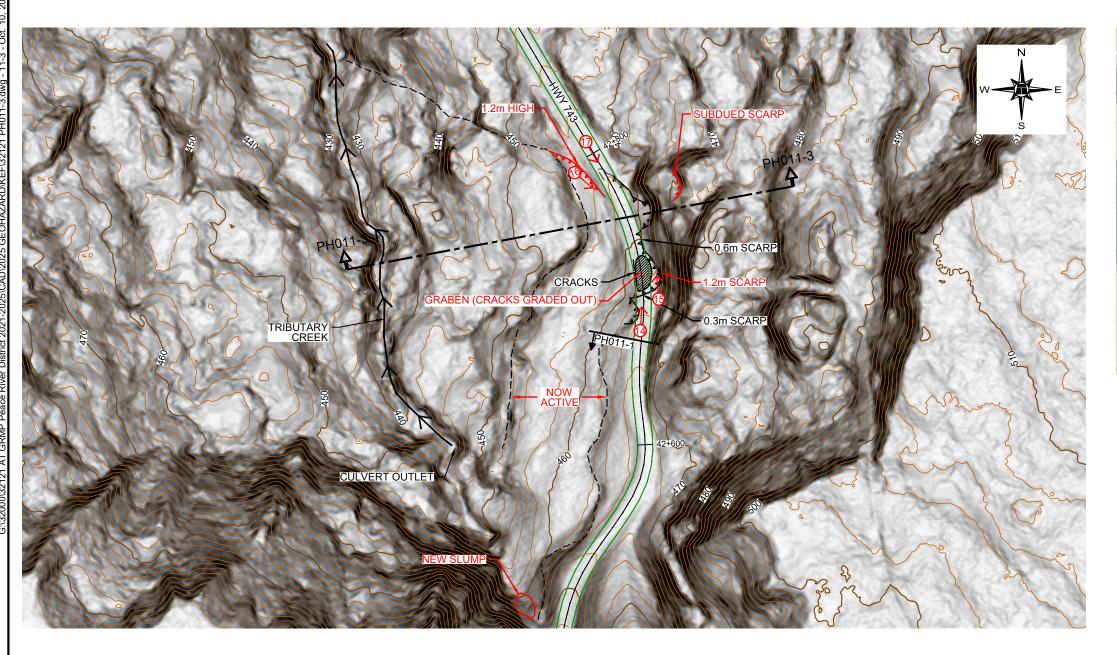
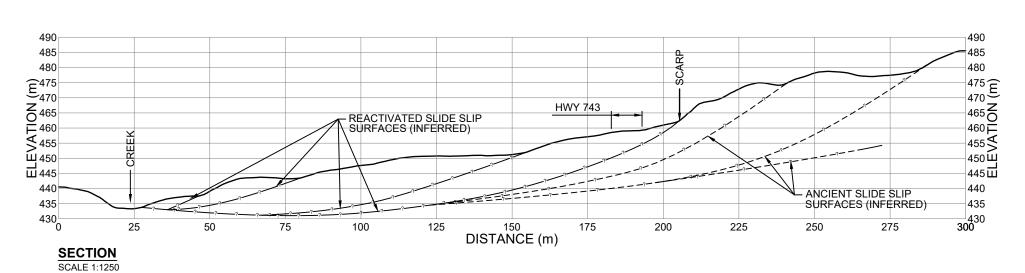
DWG No. 32121-PH011-3

The landslide at PH011-3 is affecting about 100 m of the road surface. At the centre of the disturbance, the highway is located about 25 m above the creek. The valley slope surface, as shown by the crosssection on Drawing 32121-PH011-3, is hummocky, indicating the presence of several possible retrogressive slide blocks between the creek and the road. Movements are slow enough at this site that routine grading is currently able to maintain a safe highway surface. However, the ditches are narrow and poorly-drained. There was a fresh scarp observed at the north end of the site on the west side of the highway and up above the highway on the east side. The new movements seen at PH011-1 could indicate that additional movement should be expected at this site since they are part of the same larger landslide block.

- The cracks and slumping at PH011-3 can be managed with routine grading to provide a safe roadway surface. If possible, cutting an upslope ditch that could drain the site could be advantageous for controlling movement rates.

PH011-3: A vertical realignment of the roadway through the slide could be carried out if the road condition worsens. The reprofiling could lower the road a few meters through the slide zone by taking out the hump in the road profile starting from south of the site. The slide area itself could be further unloaded by subexcavating some of the soil and replacing it with EPS light-weight fill. A subdrain could also be installed along the upslope side of the road to locally lower the groundwater and the shoulder of the road in the slide zone could be cut down to take a bit of the weight of the slide block.

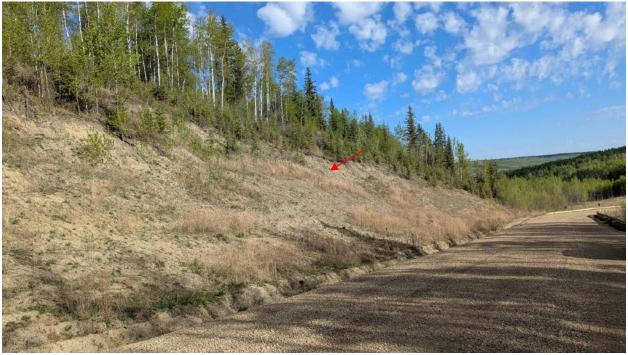
Photo 1 (PH011-1) - Looking at regraded backslope failure area at PH011-1 site (km 42.4).

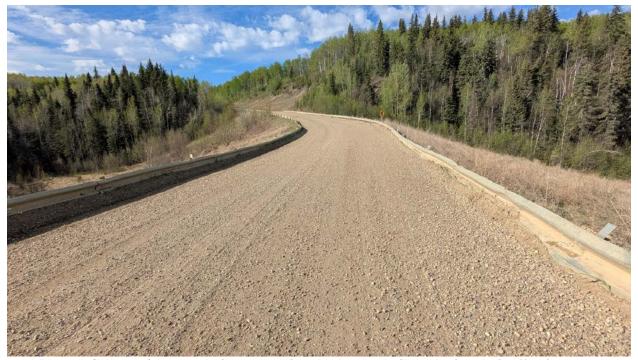
Photo 2 (PH011-1) - Gravel piles up against both guardrails reducing their effectiveness.

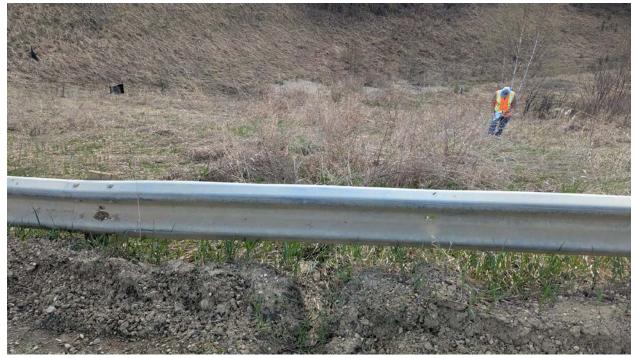
Photo 3 (PH011-1) – Erosion gully through windrow below guardrail accumulated gravel down below.

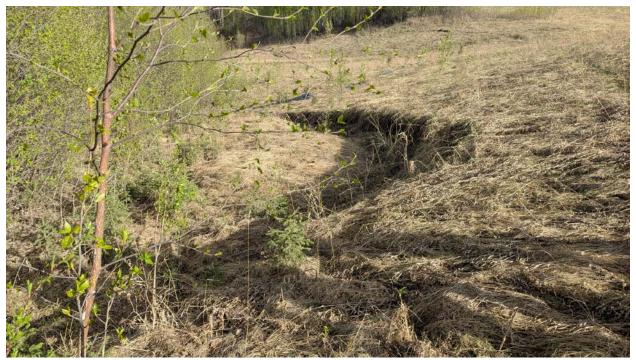
Photo 4 (PH011-1) - Looking NW at slump in NW quadrant into drainage channel.

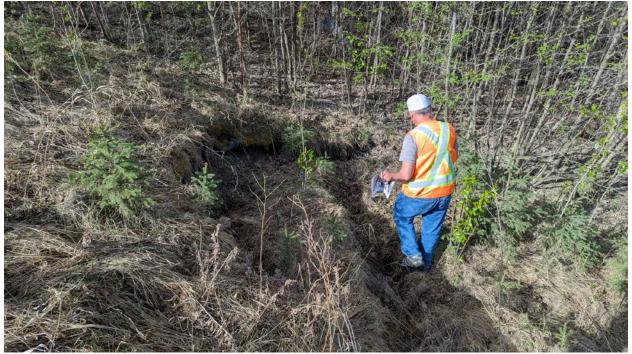
Photo 5 (PH011-1) - Looking west at slump in NW quadrant into drainage channel.

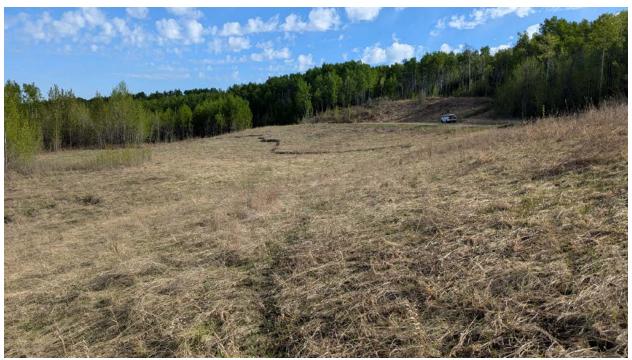
Photo 6 (PH011-1) – Looking north across west slope at upper of the re-activated scarps.

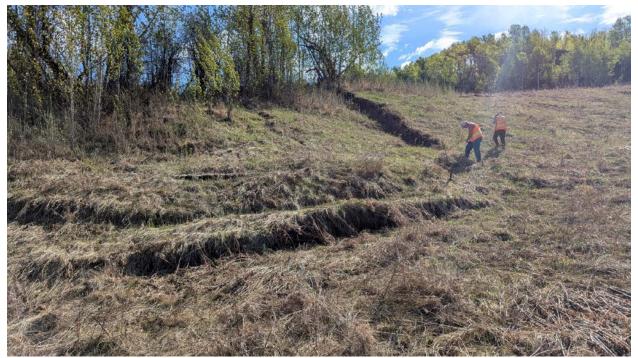
Photo 7 (PH011-1) - Looking west across toe roll and south end of the lower re-activated scarp.

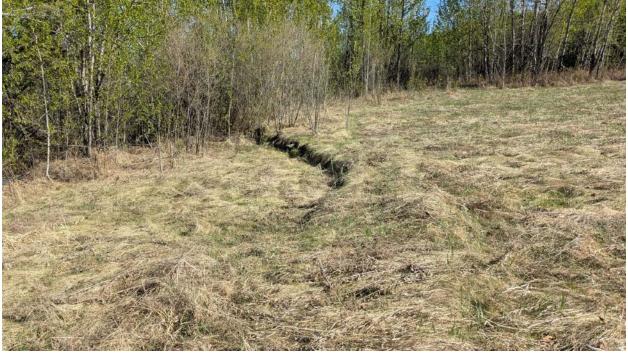
Photo 8 (PH011-1) – Looking north at the north end of the lower re-activated scarp.

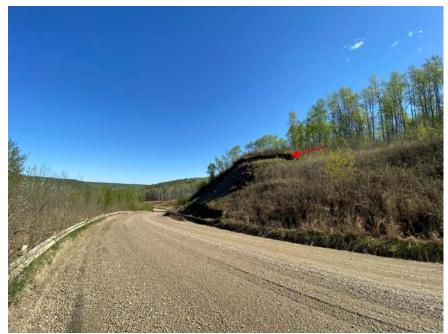
Photo 9 (PH011-2) – Looking north at failing backslope and new scarp above the highway (red arrow).

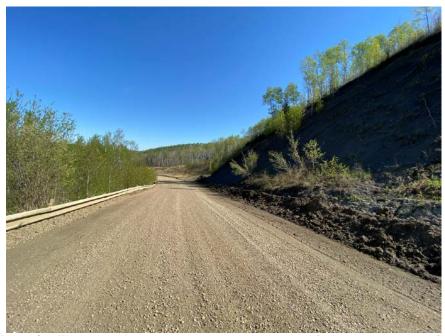
Photo 10 (PH011-2) – There has been a recent movement on this backslope resulting in material accumulating onto the east shoulder of the highway.

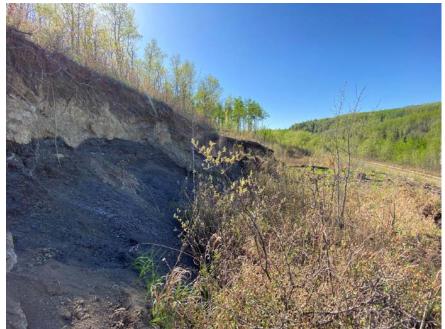
Photo 11 (PH011-2) – Recent scarp movement at the top of the slope.

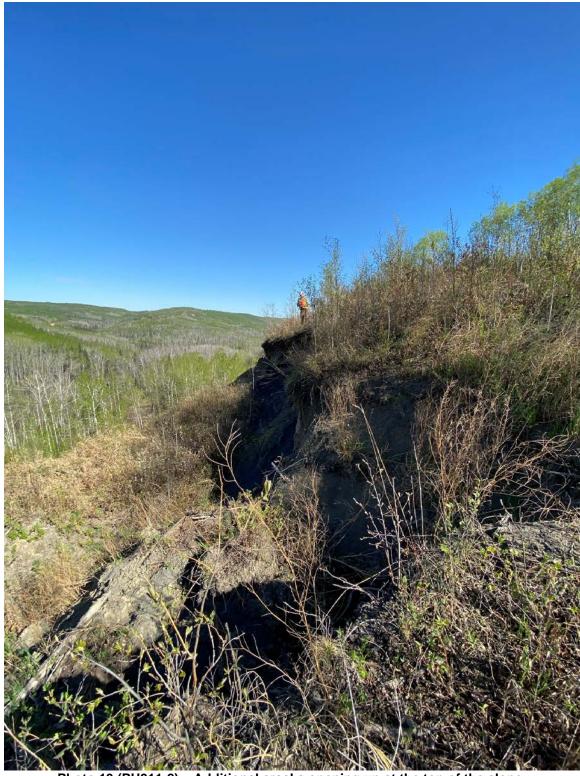
Photo 13 (PH011-2) - Additional cracks opening up at the top of the slope.

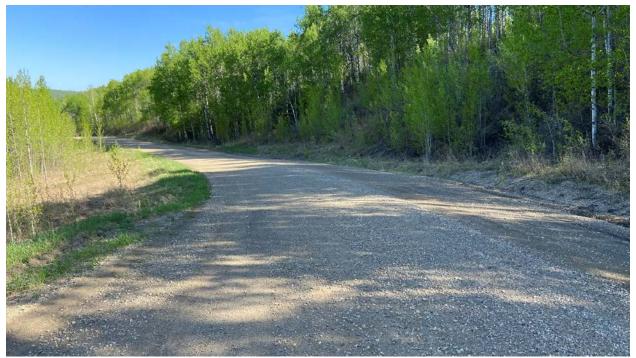
Photo 14 (PH011-3) – Looking north at landslide site identifiable by the dip in the highway surface.

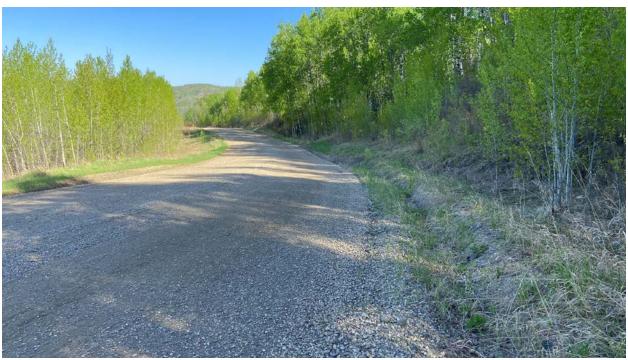
Photo 15 (PH011-3) – Looking north along backscarp crack (in the grass and less visible in 2025).

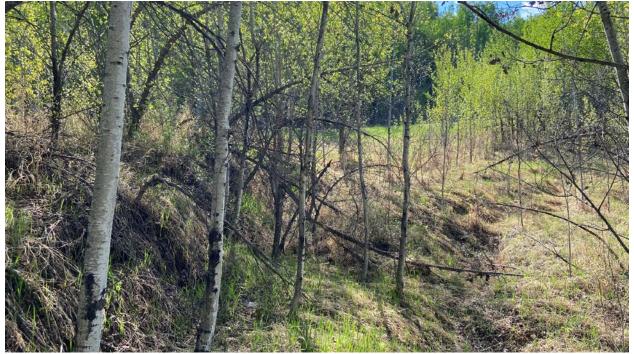
Photo 16 (PH011-3) - Looking south where a new scarp has opened at the north end of the site.

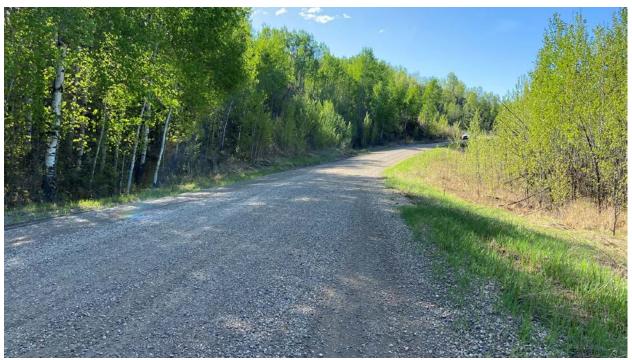
Photo 17 (PH011-3) – Looking south toward the landslide.
