**ALBERTA TRANSPORTATION
GEOHAZARD ASSESSMENT PROGRAM
PEACE REGION – HIGH LEVEL
2020 INSPECTION**

Site Number	Location	Name	Hwy	km
PH038-1	North of Town of Peace River	Whitemud River (km 45.5) (Was Station 45+350)	743:02	45.3
Legal Description		UTM Co-ordinates		
S11-88-21-5		11V N 6,274,373	E 485,755

**PH038-1: HWY 743:02 WHITEMUD RIVER, km 45.3
(WAS STA 45+350)**

2020 GEOHAZARD ASSESSMENT

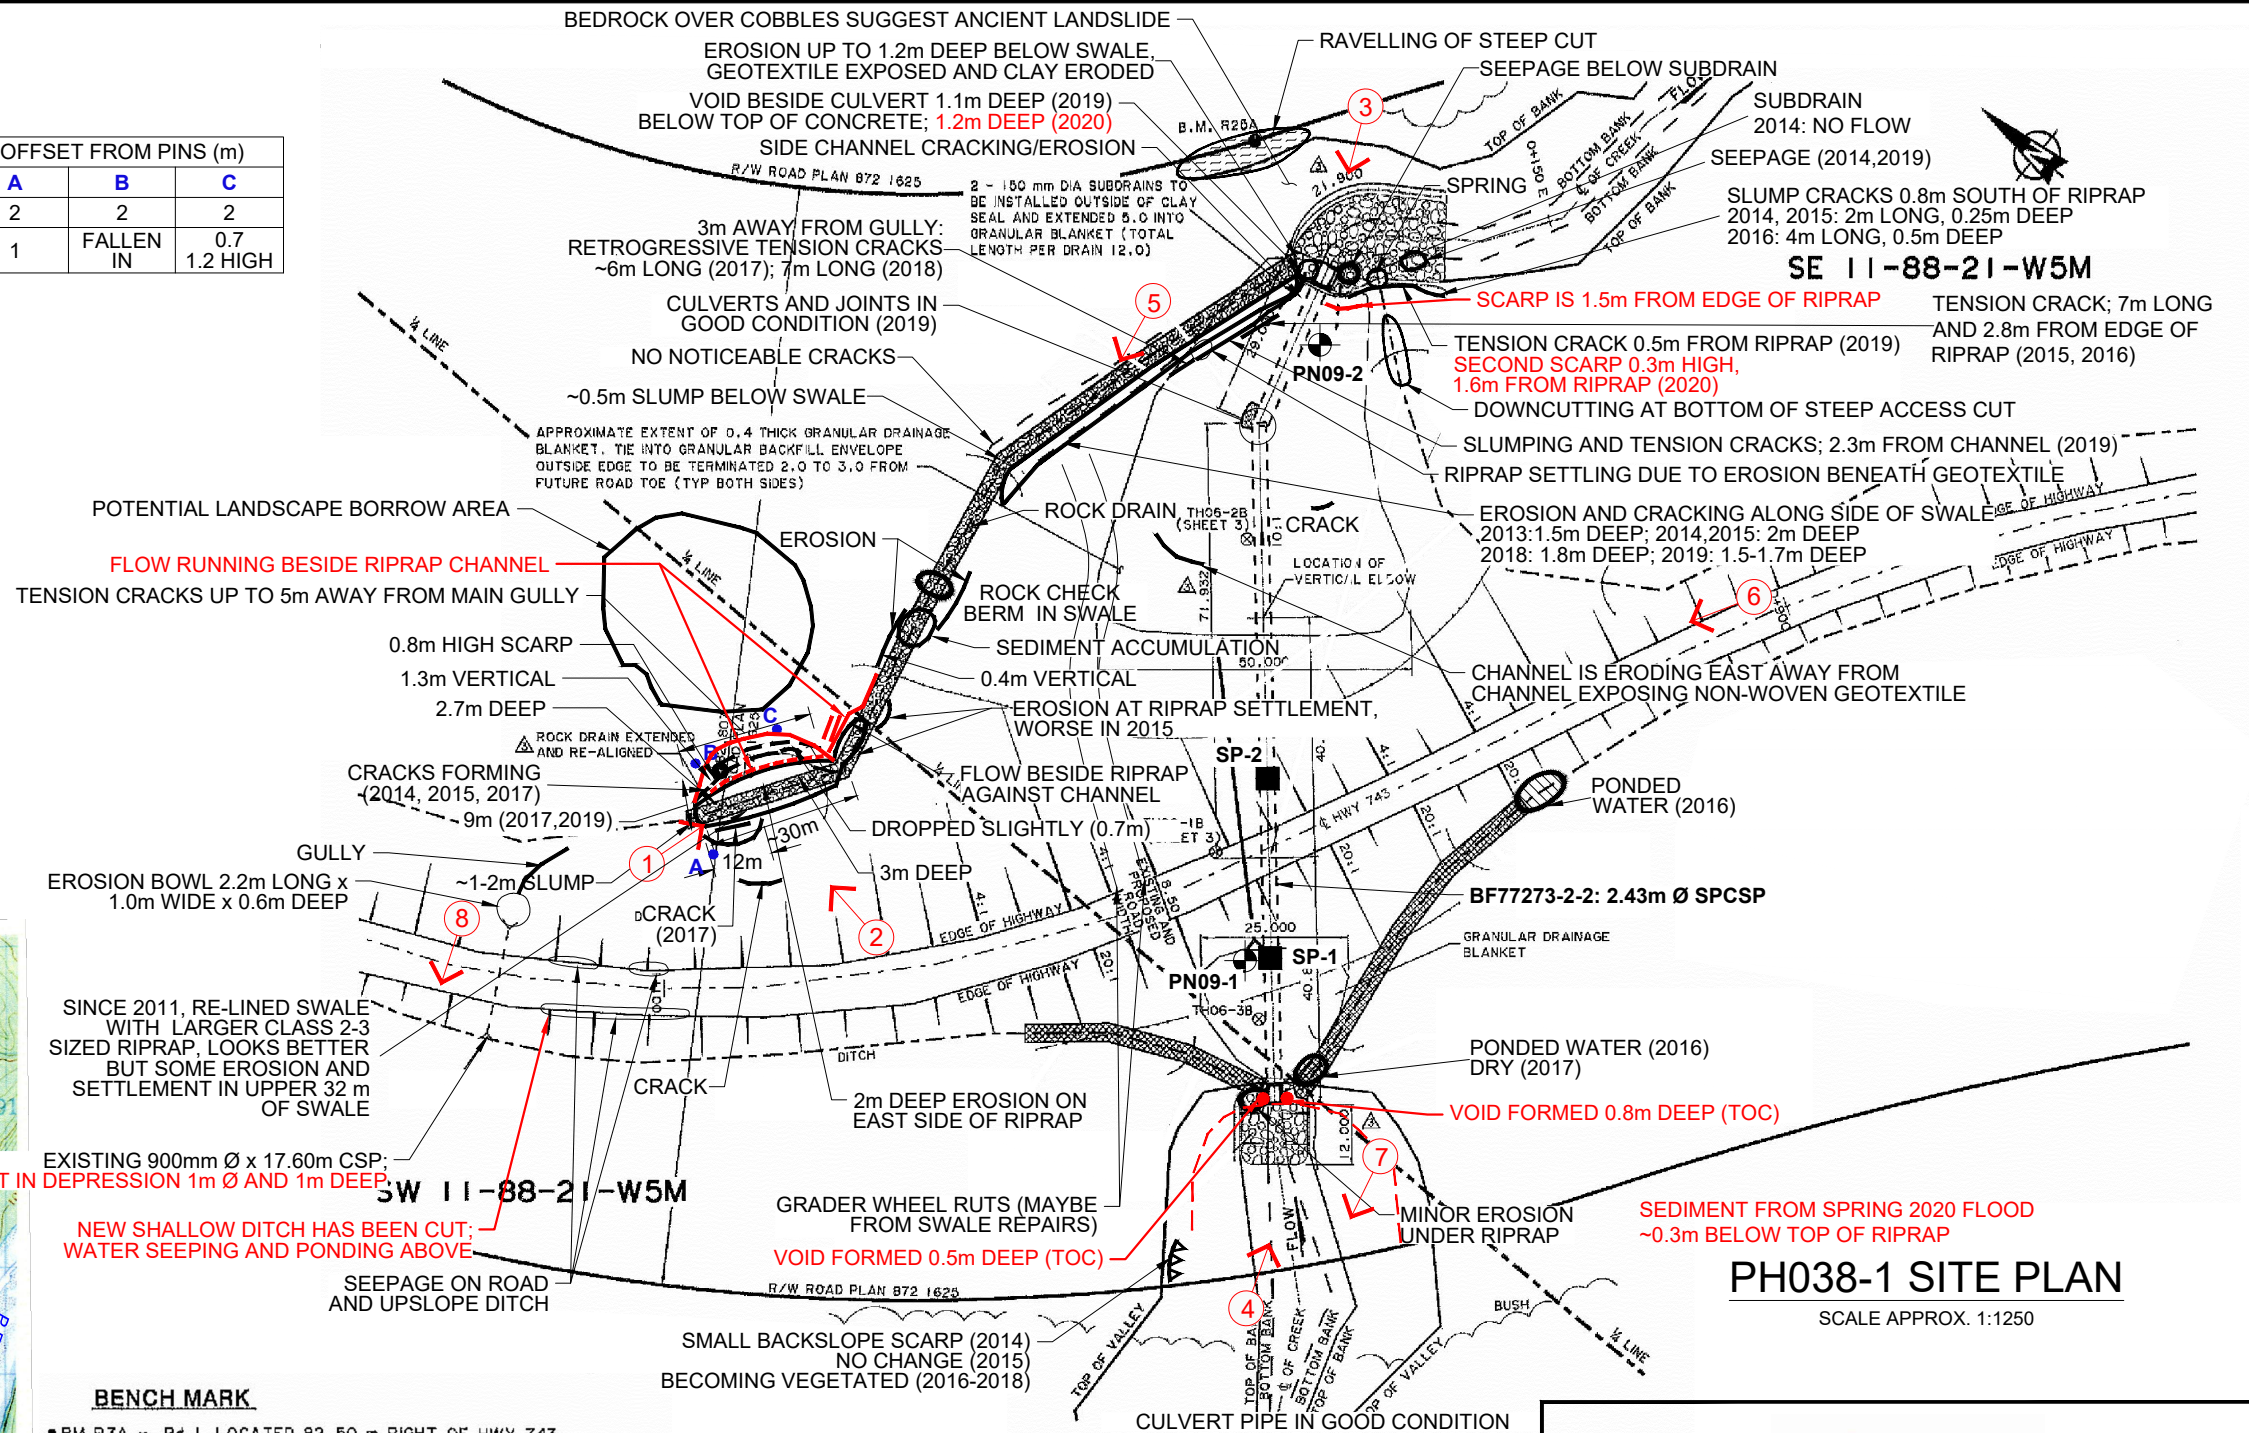
DWG No. 13351-PH038-1-1

1. FEATURE LOCATIONS ARE APPROXIMATE.
2. JUNE 2020 OBSERVATIONS SHOWN IN RED.

OFFSET FROM PINS (m)		
	A	B	C
2019	2	2	2
2020	1	FALLEN IN	0.7 1.2 HIGH

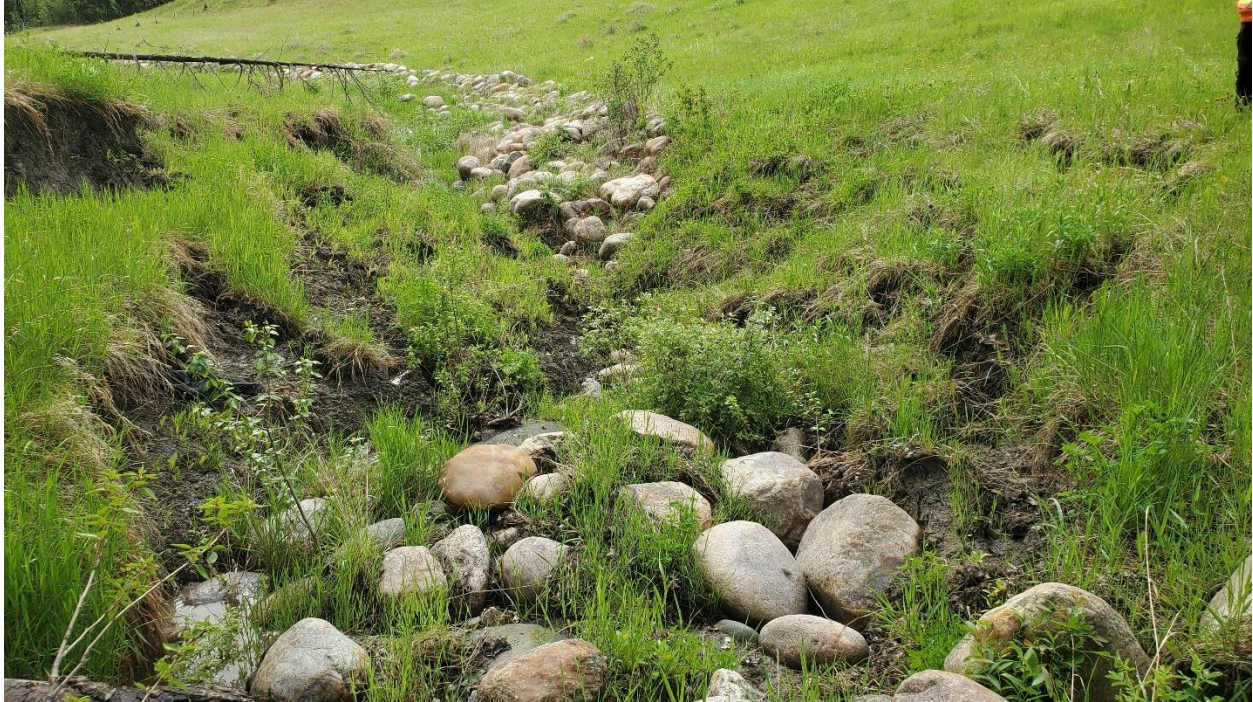
The main drainage swale was relined with larger Class 2-3 sized riprap in 2011. However, significant erosion and settlement has developed especially in the upper, steeper, 30 m of the swale where tension cracks and slumping have formed on both sides of the swale and have worsened yearly since 2016. Possible tension cracks were noted in 2017 south partway up the highway embankment which could be related to the movement local to the drainage channel but were not changed in 2018. Erosion, settlement, and cracking was also present at several other locations along the swale and have continued to worsen each year. Erosion and settlement along the drainage swale also extends closer to the toe of the bank (near the culvert outlet). The deterioration of this rock swale is likely a result of poor compaction, poor fill quality, and possible gaps in geotextile. Water flow is getting outside of the channel upslope so can erode behind the riprap for the remainder. Pins to monitor regression of this feature were installed in 2019 at 2 m from the main scarps and the distance had dropped to 1 m or less in 2020

Photo 1 – Looking at west end of drainage swale.

- The rock swale should be completely reconstructed: remove and salvage the existing riprap, excavate the wet or soft subgrade at the base of the channel to a depth of 1 m over a 10 m width, place and compact borrow material, flatten the sideslopes, install new non-woven geotextile, and replace the rock riprap. The subgrade should be compacted with a sheepsfoot compactor. Borrow material could be taken from the knoll located northeast of the channel.
- The voids forming below the concrete headwalls should be grouted if other repairs be undertaken.

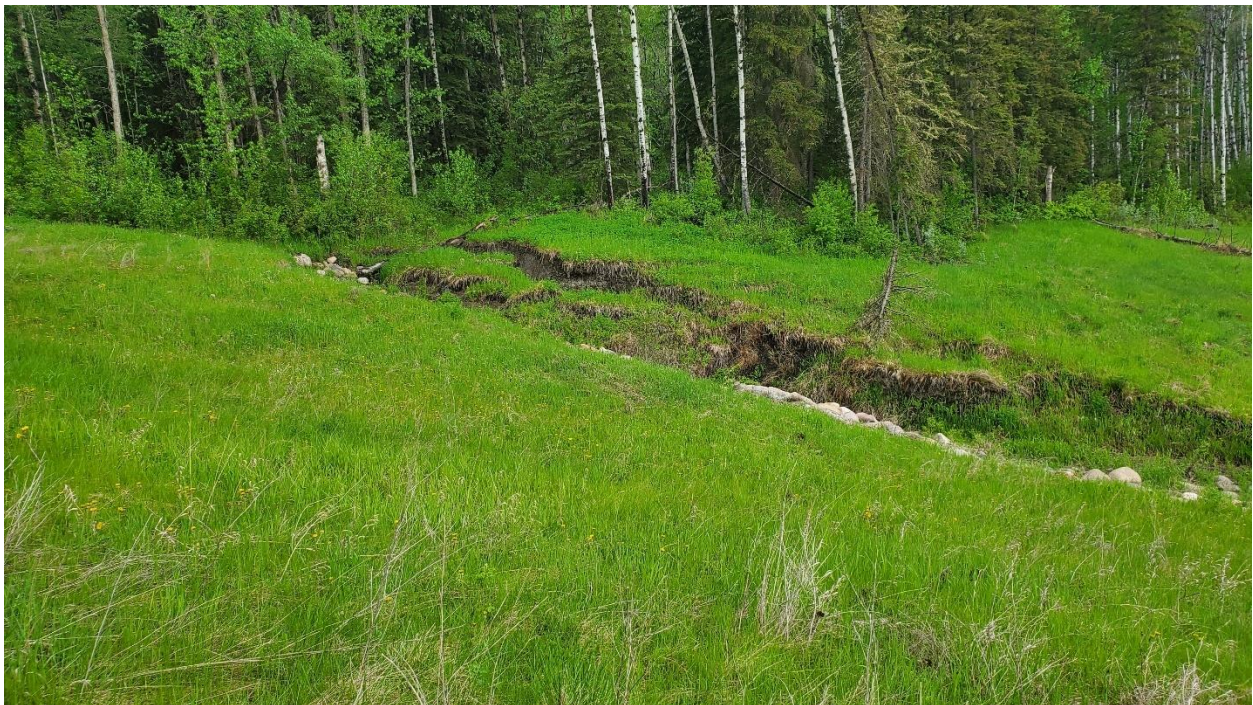
Photo 2 – Looking north at erosion on north side of drainage swale.

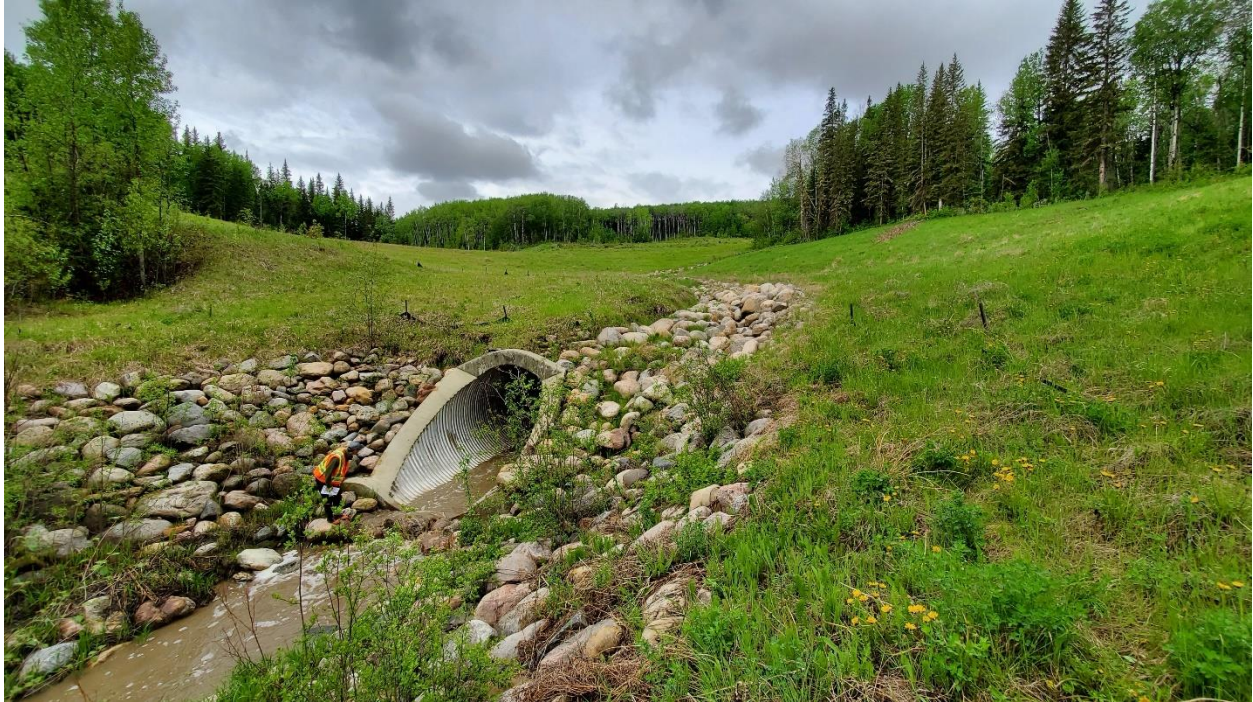
Some erosion and shallow slump cracks are present in the fill at the culvert outlet but have not worsened noticeably since the previous inspection with the exception of an erosion void noted in 2019 forming at the culvert outlet. In 2020, voids were also documented below the concrete headwall at the inlet as well. Based on the height of deposited sediment at the inlet, the flows in the spring of 2020 were significant.

Photo 3 – Looking west at culvert outlet.

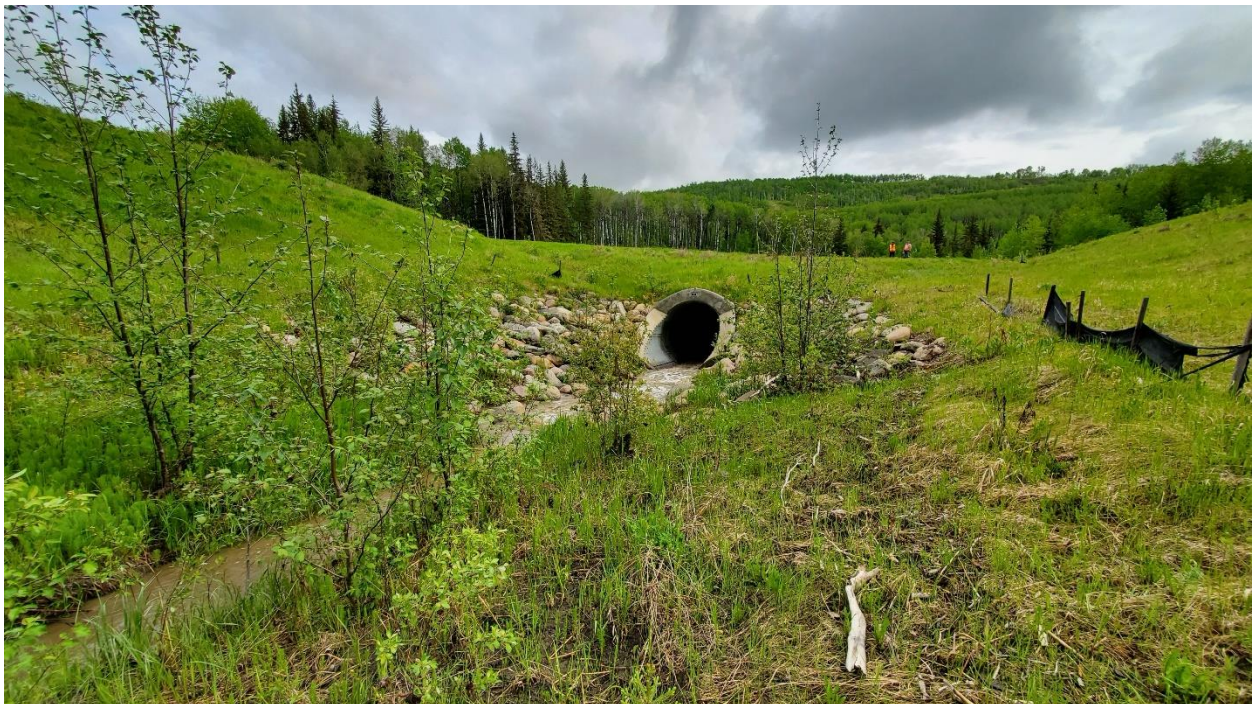
Photo 4 – Looking northeast at culvert inlet.

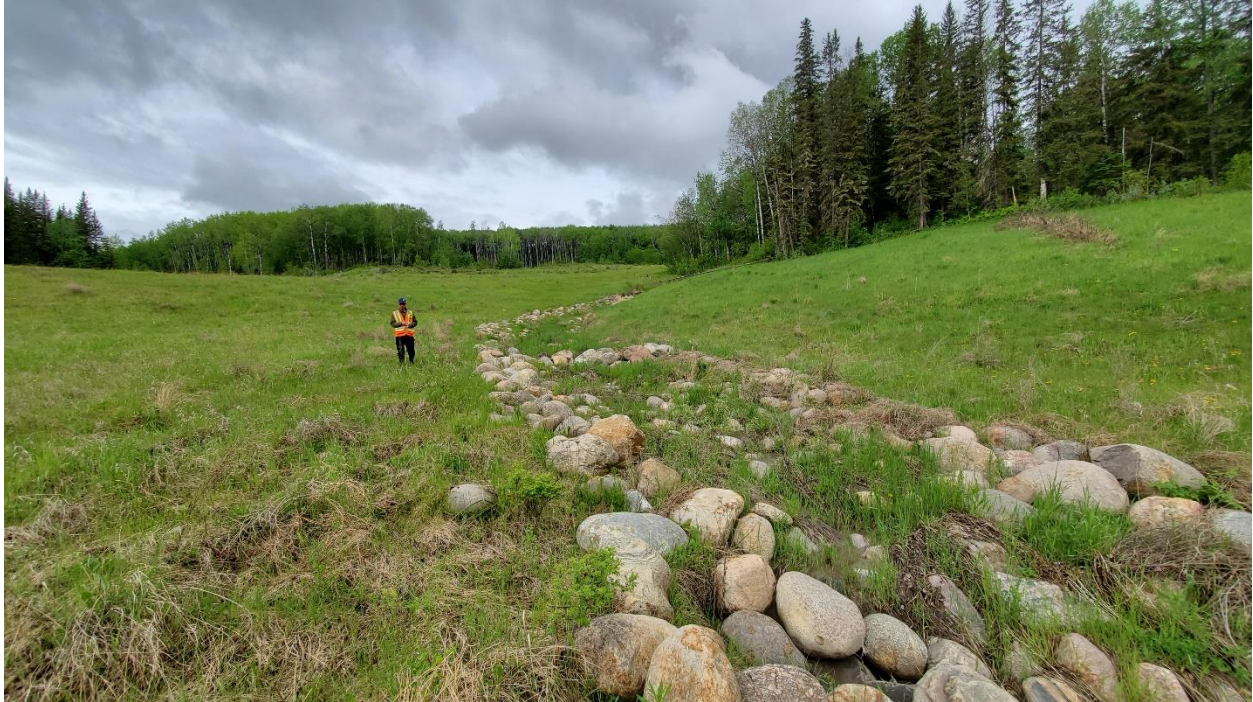
Photo 5 – Looking west at swale near the culvert outlet.

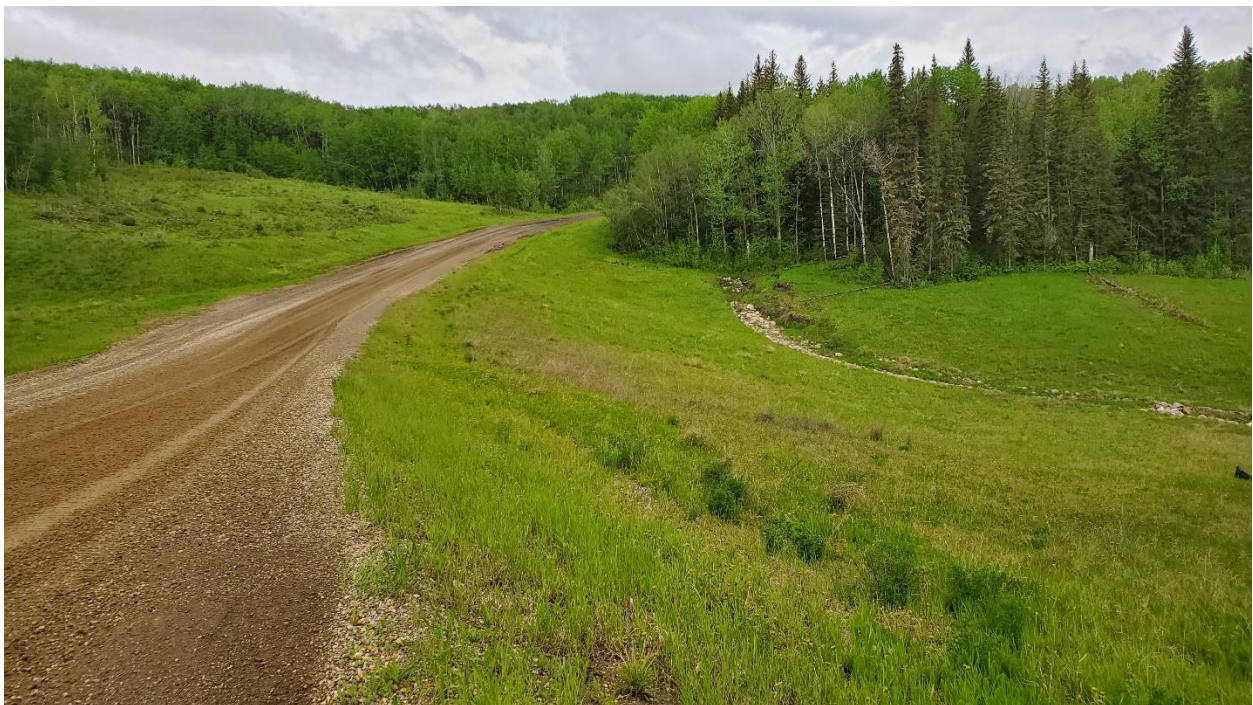
The embankment fill slopes appeared to be in good condition with no signs of global instability and is well vegetated.

Photo 6 – Looking northwest at road and north side slope.

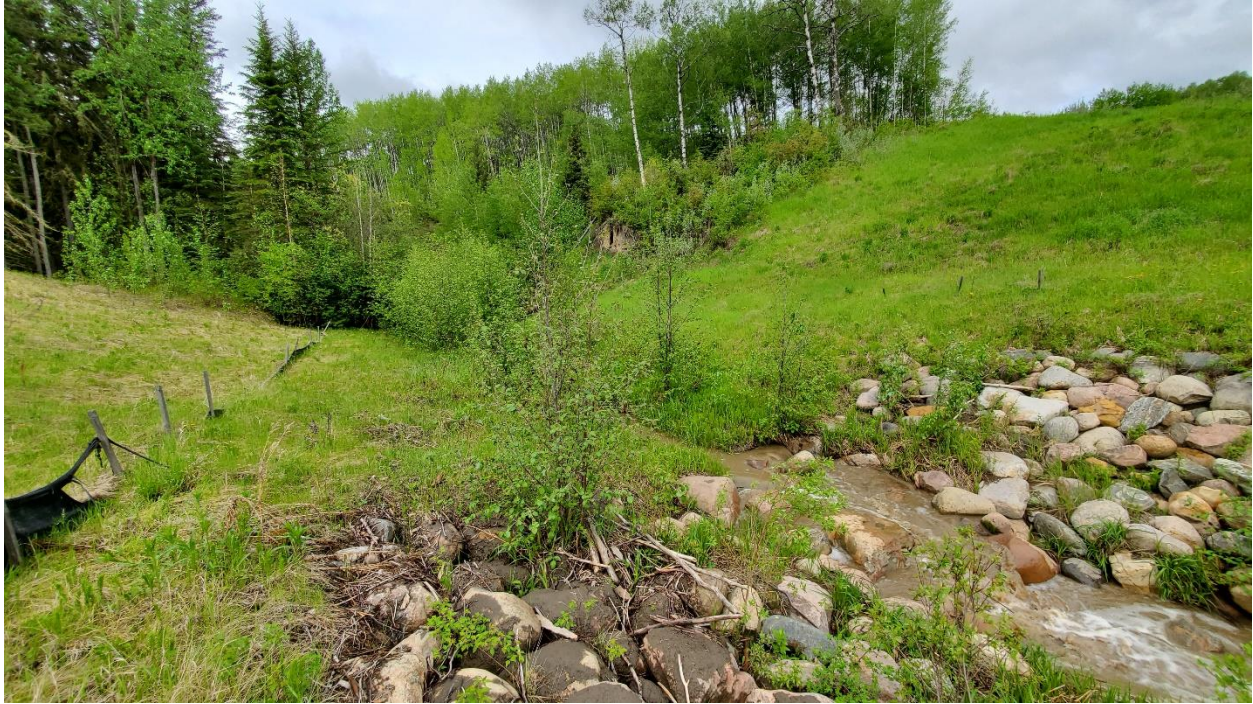
Photo 7 – Looking west at shallow slumps on backslope at culvert inlet.

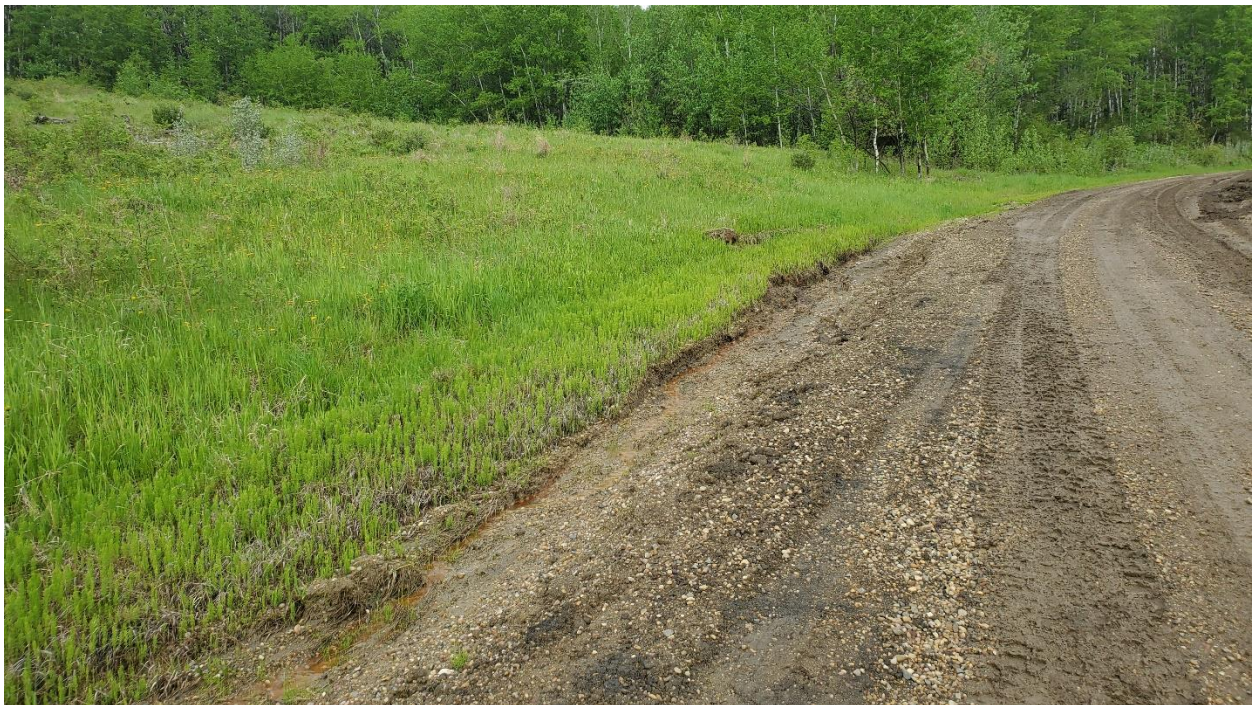
Photo 8 – Looking at seepage along west side of road near the north end of the site.

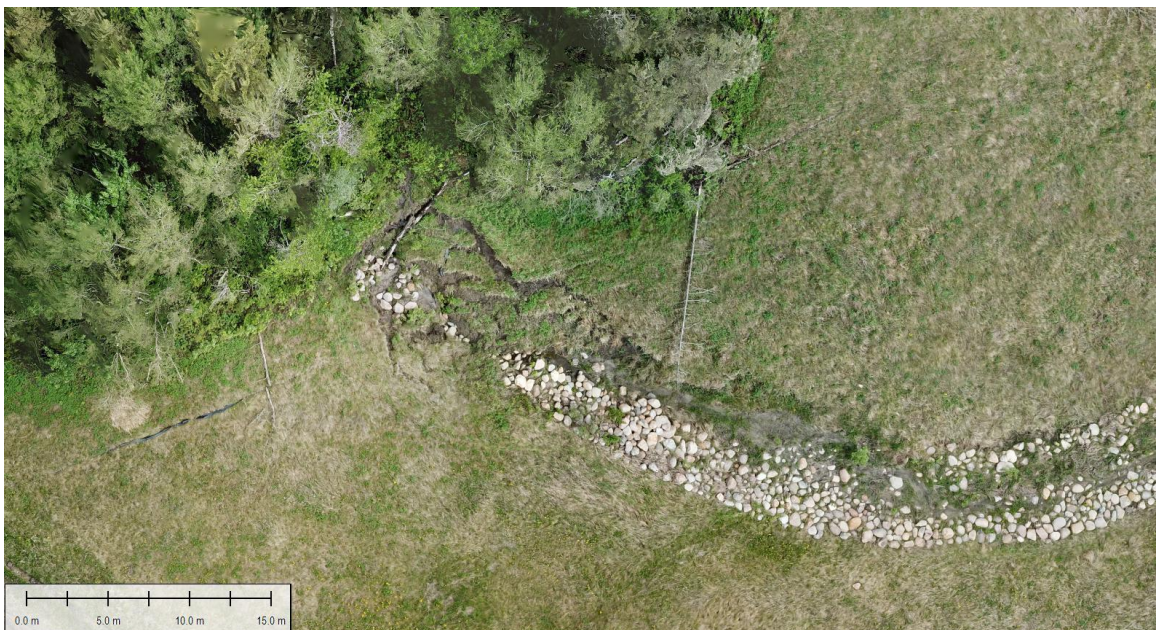
UAV 2020 Orthoimage – Slumping at start of riprap channel
