**ALBERTA TRANSPORTATION
GEOHAZARD ASSESSMENT
PEACE REGION (PEACE RIVER DISTRICT)
2021 INSPECTION**

Site Number	Location	Name	Hwy	km
PH038-1	North of Town of Peace River	Whitemud River (km 45.5)	743:02	45.3
Legal Description		UTM Co-ordinates		
S11-88-21-5		11V N 6,274,373	E 485,755

**PH038-1: HWY 743:02 WHITEMUD RIVER, km 45.3
2021 GEOHAZARD ASSESSMENT**

DWG No. 32121-PH038-1-1

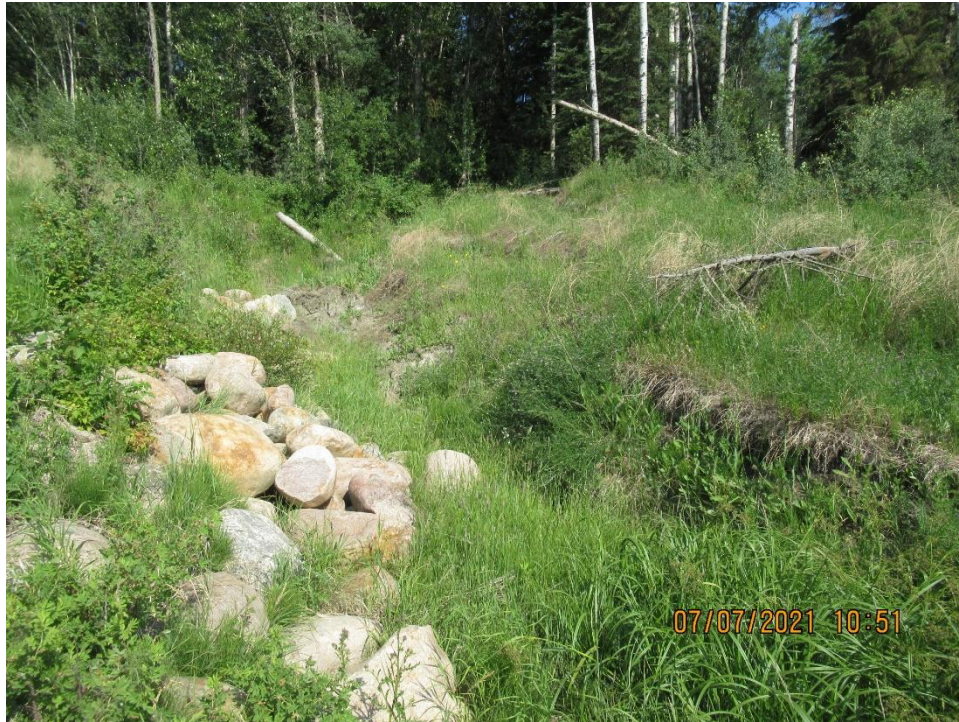
Significant erosion and settlement has developed especially in the upper, steeper, 30 m of the swale where tension cracks and slumping have formed on both sides of the swale and have worsened yearly since 2016. Erosion, settlement, and cracking was also present at several other locations along the swale and have continued to worsen each year. Erosion and settlement along the drainage swale also extends closer to the toe of the bank (near the culvert outlet). The deterioration of this rock swale is likely a result of poor compaction, poor fill quality, and possible gaps in geotextile. Water flow is getting outside of the channel upslope so can erode behind the riprap for the remainder. Pins to monitor regression of this feature were installed in 2019 at 2 m from the main scarps and the distance had dropped to 1 m or less in 2020 but were not measured in 2021. In 2021, it also appeared that some of this erosion had stabilized with vegetation becoming established.

Photo 1 – Looking at west end of drainage swale.

- A subdrain should be installed along the south ditch discharging into the riprap channel leading to the culvert inlet. Consideration should also be given to installing at or along the spring on the north shoulder as well.
- The rock swale should be completely reconstructed: remove and salvage the existing riprap, excavate the wet or soft subgrade at the base of the channel to a depth of 1 m over a 10 m width, place and compact borrow material, flatten the sideslopes, install new non-woven geotextile, and replace the rock riprap. The subgrade should be compacted with a sheepsfoot compactor. Borrow material could be taken from the knoll located northeast of the channel.
- The voids forming below the concrete headwalls should be grouted if the other repairs are undertaken.

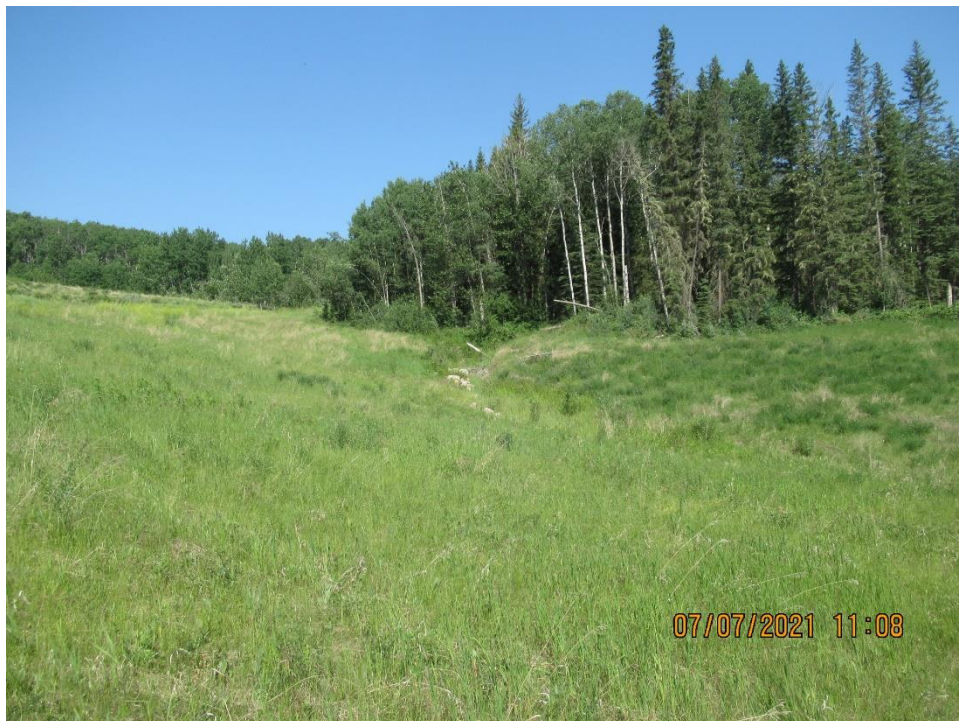
Photo 2 – Looking west at drainage swale.

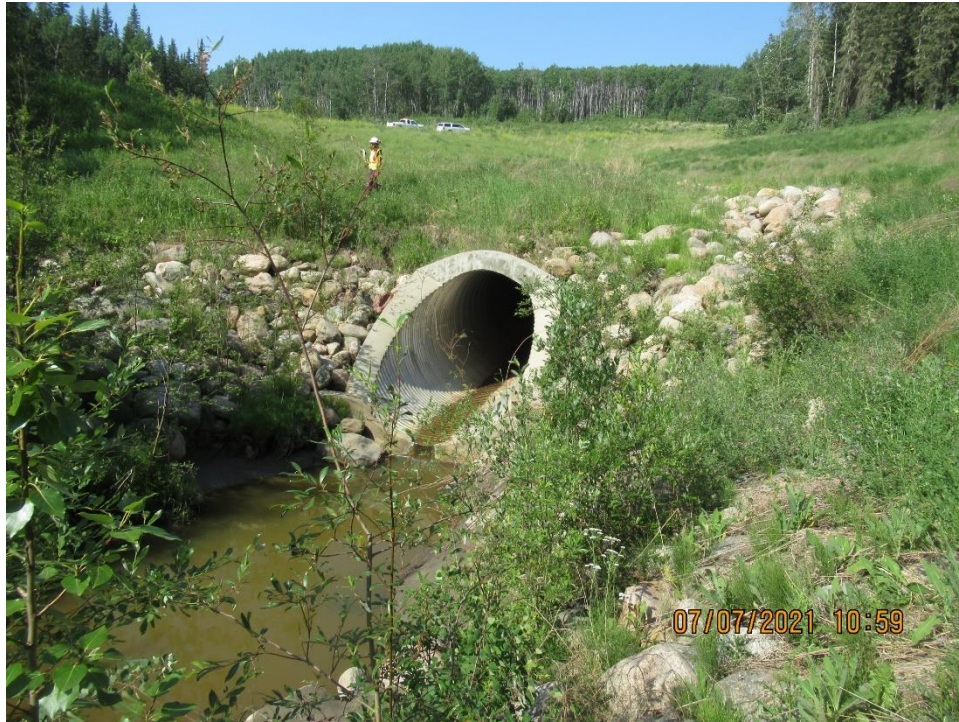
Some erosion and shallow slump cracks are present in the fill at the culvert outlet but have not worsened noticeably since the previous inspection with the exception of an erosion void noted in 2019 forming at the culvert outlet. In 2020, voids were also documented below the concrete headwall at the inlet as well. Based on the height of deposited sediment at the inlet, the flows in the spring of 2020 were significant. No further deterioration was observed in 2021.

Photo 3 – Looking west at culvert outlet.

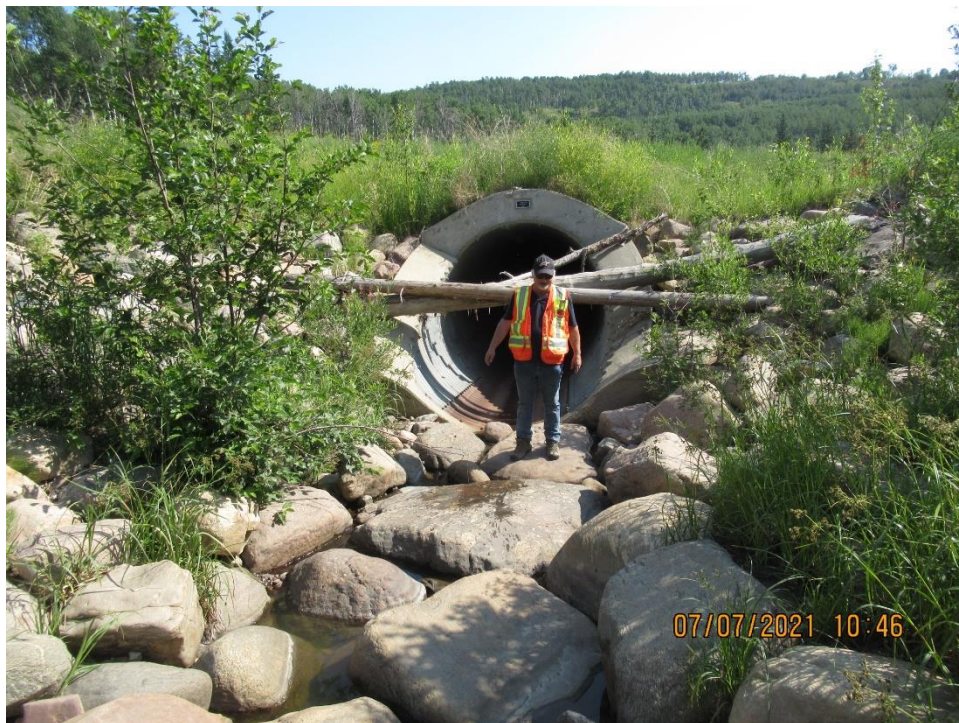
Photo 4 – Looking northeast at culvert inlet.

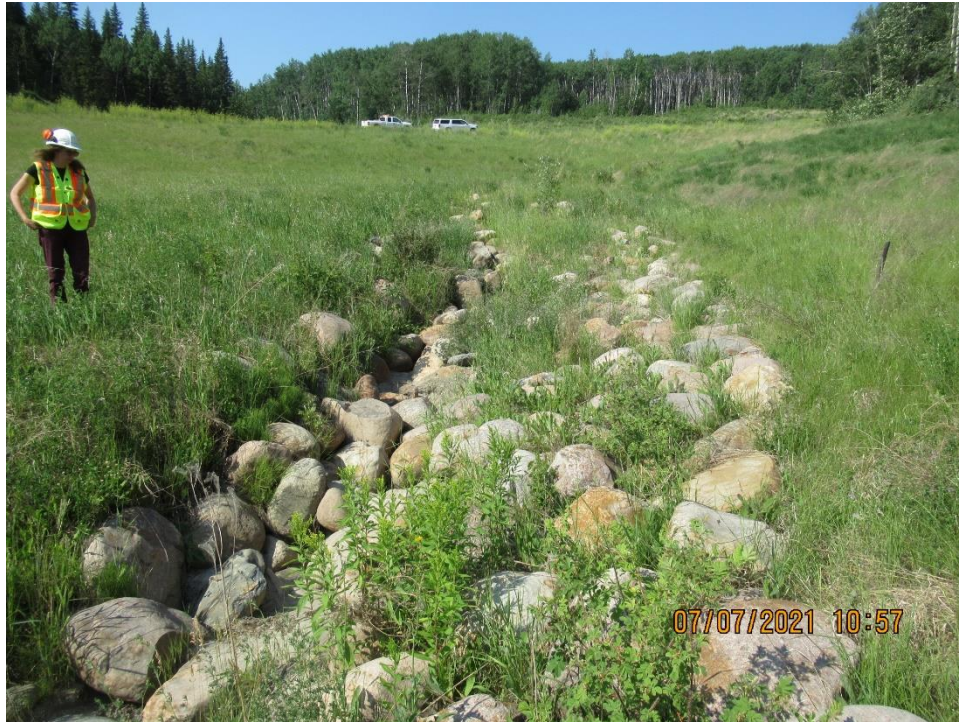
Photo 5 – Looking west at swale near the culvert outlet.

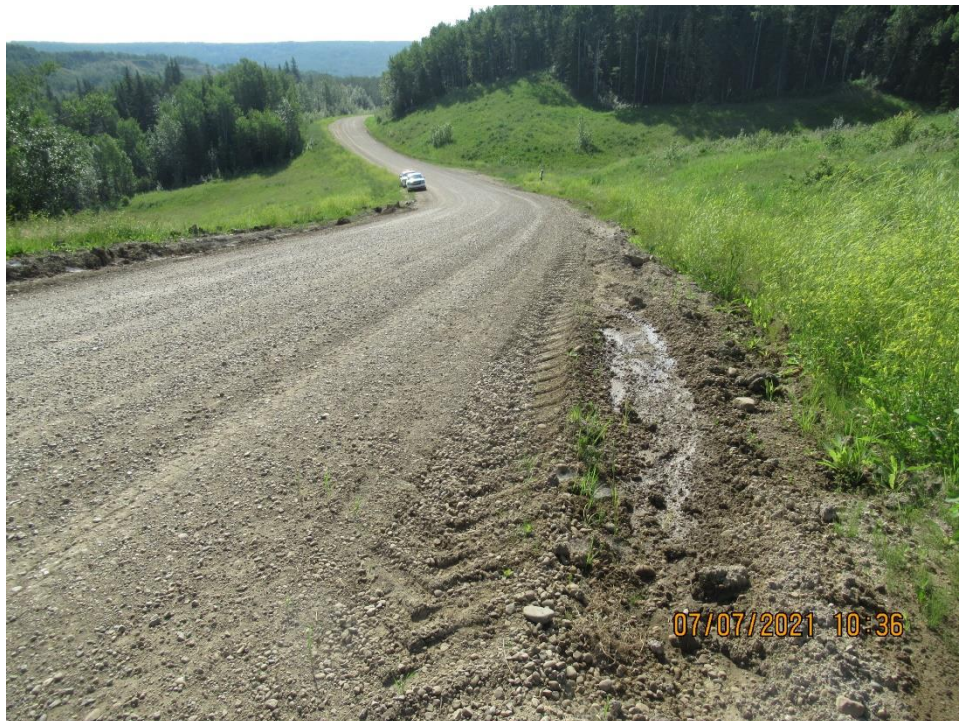
Photo 6 – Looking southeast at road and seepage along south ditch.

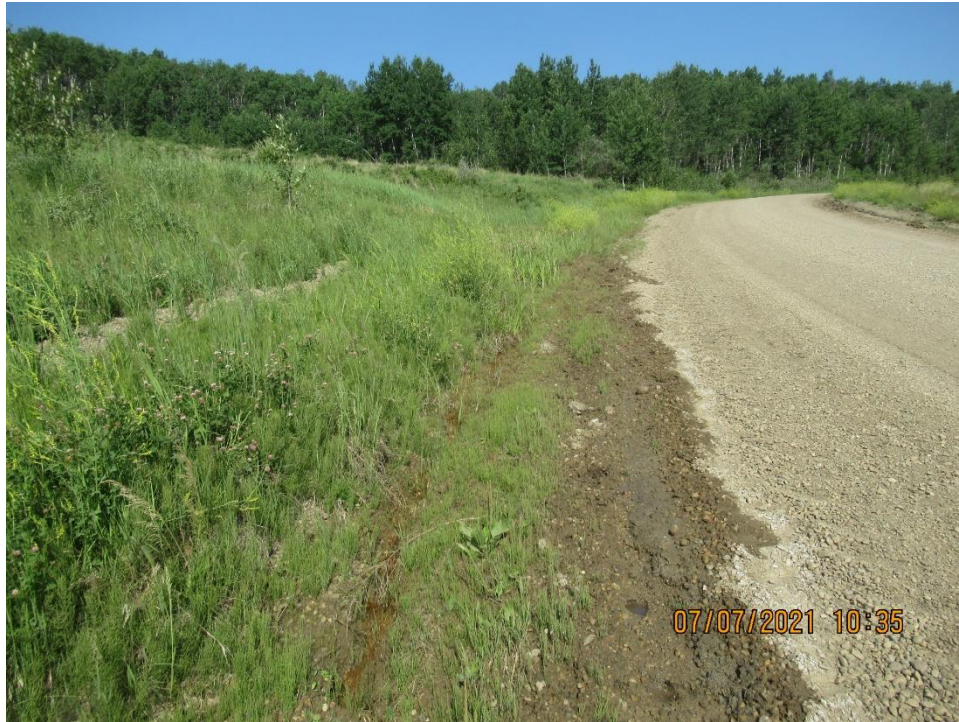
Photo 7 – Looking at seepage along west side of road near the north end of the site.

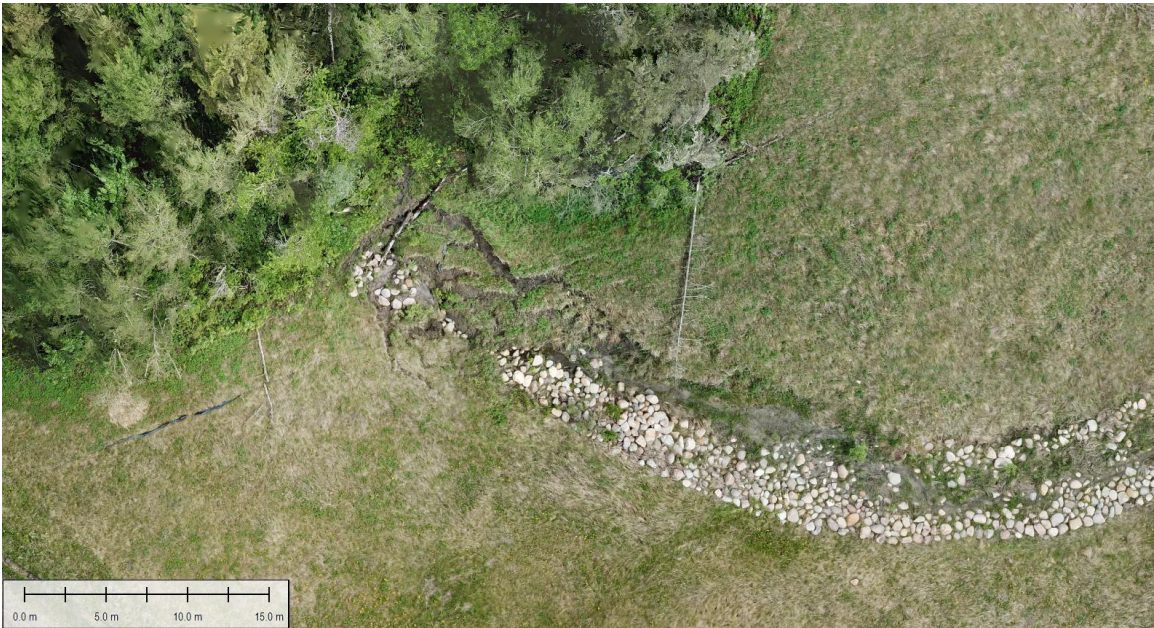
UAV 2020 Orthoimage – Slumping at start of riprap channel
