**ALBERTA TRANSPORTATION
GEOHAZARD ASSESSMENT PROGRAM
PEACE REGION – HIGH LEVEL
2020 CALLOUT**

Site Number	Location	Name	Hwy	km
PH075-2	North of Town of Peace River	Whitemud River (km 44.8)	743:02	44.8
Legal Description		UTM Co-ordinates		
NE02-88-21-W5		11V N 6273979	E 486113

PH075-2 AUGUST 4, 2020 CALL OUT PLAN

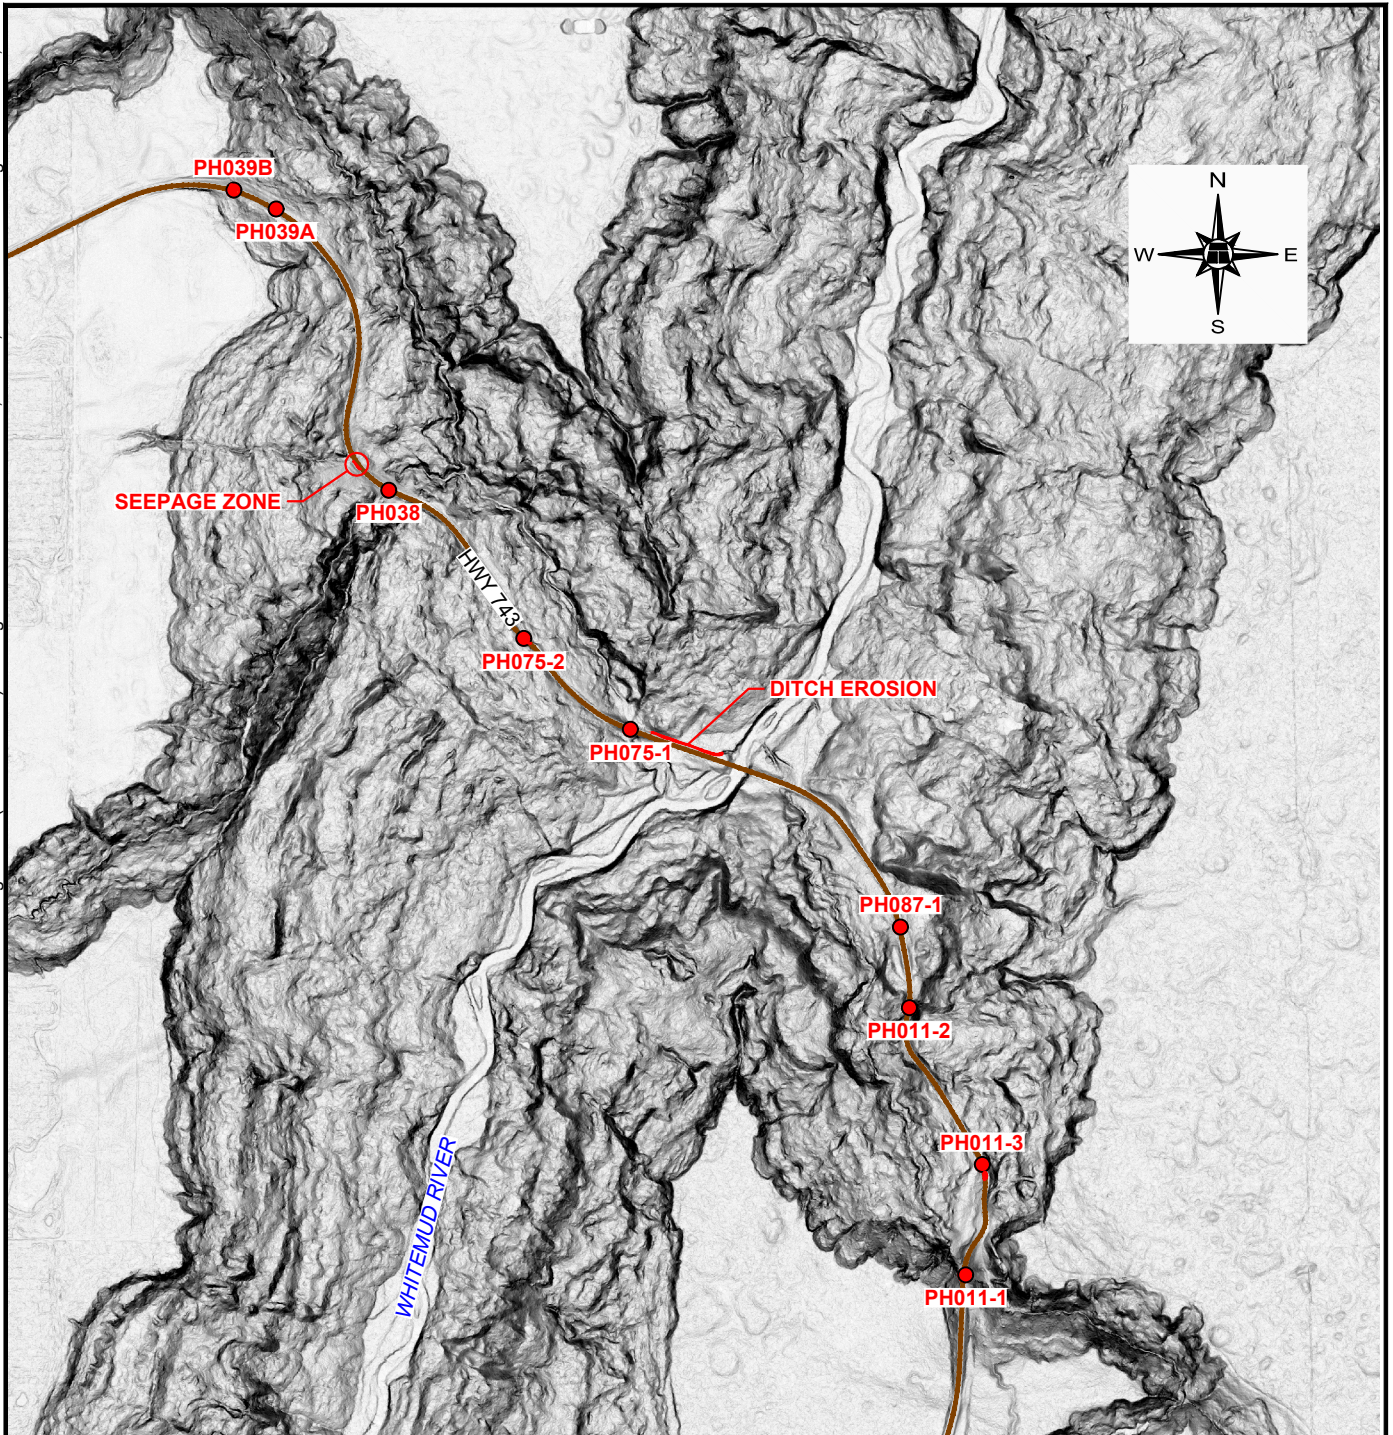
FIGURE 1

The site is located on Highway 743:02 on a sidehill alignment ascending the valley slope of a tributary to the Whitemud River. LiDAR provided by Alberta Transportation (Figure 1) shows that the valley slope has been affected by historic landslide movements. It is considered that recent higher groundwater levels have re-activated a large slide block which is now affecting about 55 m of the road surface. At the centre of the disturbance the highway is located about 25 m above the creek. The valley slope surface, as shown by the cross-section on Dwg. No.13351-PH075-2, is hummocky, indicating the presence of several retrogressive slide blocks between the creek and the road.

There is a zone of steady seepage at PH038, at about Km 45.4 (see Figure 1), that has been noted during previous visits to that site. The amount of water seeping out of the ground at that locations was higher this year than previous years and had created a soft yielding surface in the shoulder area under traffic loading repetitions.

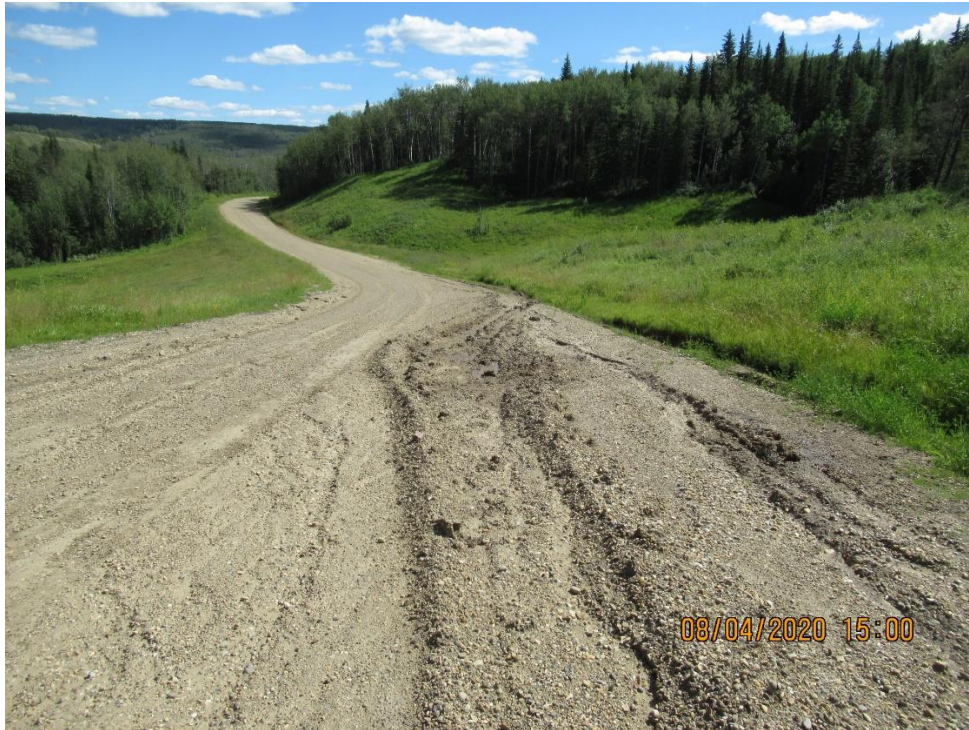
<input checked="" type="checkbox"/> Seepage	A zone of steady seepage was observed at Site PH038 (approx. km 45.4) in the uphill shoulder of the highway, making the road surface soft at that location (photo 1).	<input checked="" type="checkbox"/>	<input type="checkbox"/>
<input type="checkbox"/> Culvert Distress		<input type="checkbox"/>	<input type="checkbox"/>
<input type="checkbox"/> Other		<input type="checkbox"/>	<input type="checkbox"/>
Instrumentation:	None.

Photo 1 – Looking south at seepage and rutting in road surface at PH038.

A subdrain should be installed below the ditch to intercept and drain away groundwater to the inlet of the bridge file pipe at PH038. The subdrain would need to be about 150 m in length and located deep enough to place it below the frost penetration depth (say about 3 m). The road surface should also be excavated down about 1 m, underlain by a wicking geogrid (frost-wick layer) that drains into the subdrain, and then backfilled with free draining gravel.

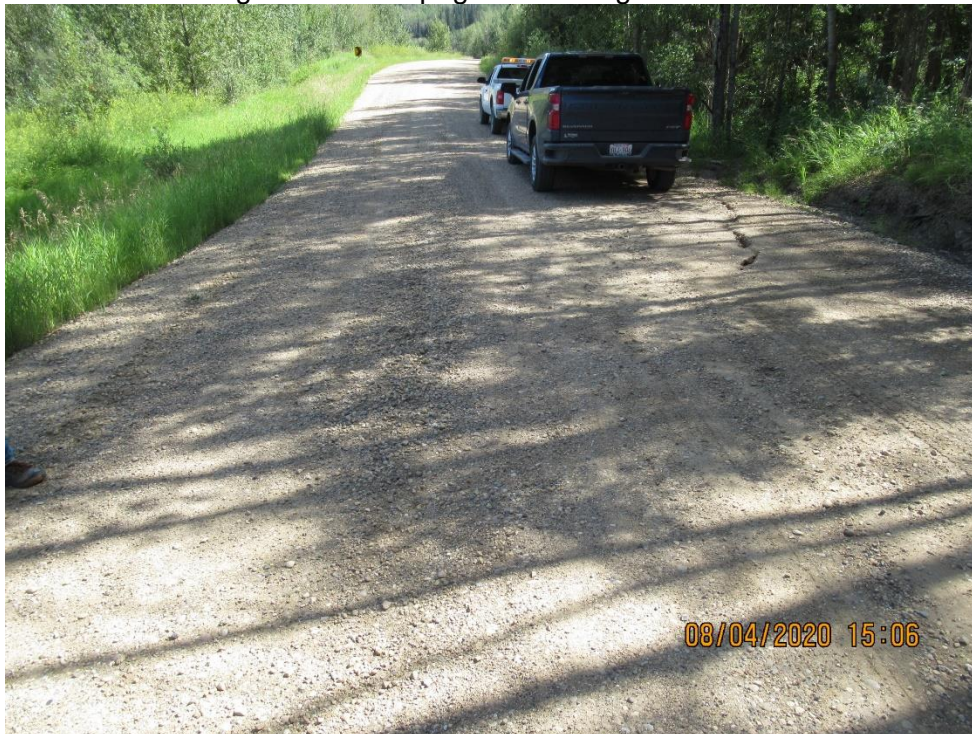
Primary Site Issue:	A landslide scarp has developed in the surface of a two laned gravelled road.		
Dimensions:	55 m wide along the shoulder, approx. 275 m wide at the creek and 160 m long from the highway to the creek.		
Date of any remediation:			
Maintenance:	Highway officially closed on July 13, 2020 due to landslide movements at other sites.	Worsened?	
Observations:	Description	Yes	No
<input checked="" type="checkbox"/> Pavement Distress	Cracks and dip in gravel road surface.	<input checked="" type="checkbox"/>	<input type="checkbox"/>
<input checked="" type="checkbox"/> Slope Movement	Cracks and dip across roadway indicate slope movement. LiDAR indicates historical scarps on slope above and below roadway.	<input checked="" type="checkbox"/>	<input type="checkbox"/>
<input checked="" type="checkbox"/> Erosion	Erosion occurring in east ditch sporadically over 200 m length between Km 44.3 to 44.1 south of PH075-1 (photo 4 and 5)	<input checked="" type="checkbox"/>	<input type="checkbox"/>

Photo 2 – Looking south at north end of PH075-2 slide

The most practical solutions available at the PH075-2 landslide site involve monitoring and re-aligning the highway away from the current slide cracks.

- The cracks and slumping at this site are still limited in extent such that the road can still be used at this location with care and at slow speeds. Slide warning signs and a 30 km/hr speed limit are recommended. Frequent visits by the AT Maintenance Contractor are also recommended to ensure that the roadway remains safe for the travelling public as this slide could continue to move and further damage the road, especially following heavy periods of precipitation and the coming spring thaw when groundwater levels could be higher.

- A localized realignment of the roadway around the slide could be carried out if the road condition worsens.
- A local driven steel pile wall might also be considered to provide temporary support to the road but might become distorted and fall out of service over time if the larger slide blocks move again.

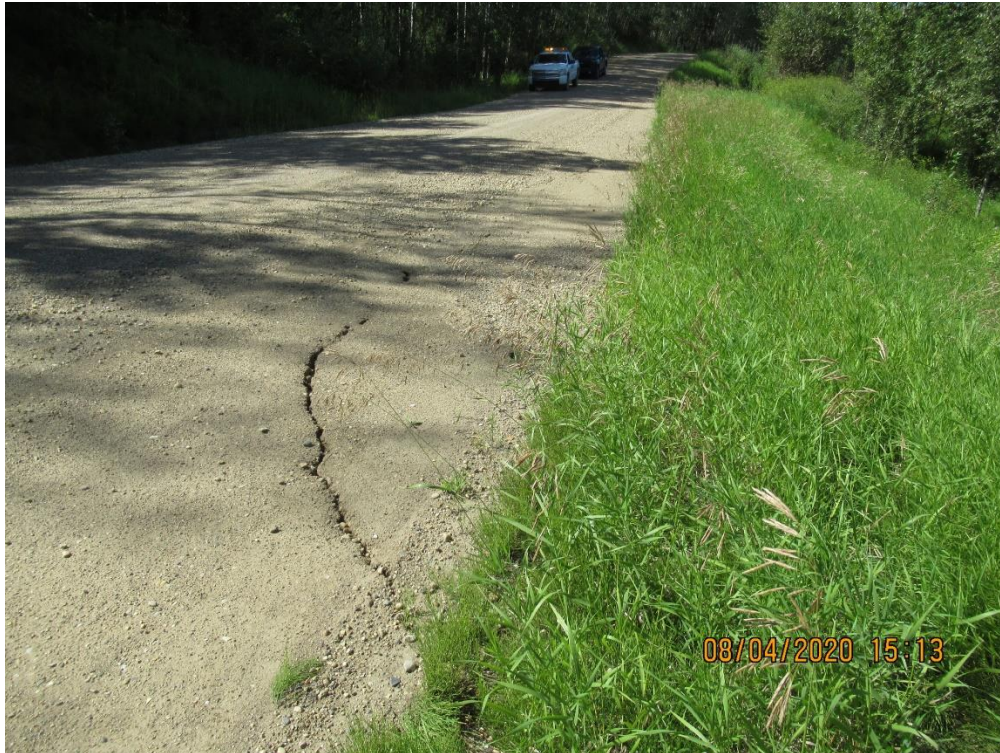
Photo 3 – Looking north along scarp in highway shoulder at south end of PH075-2 Site.

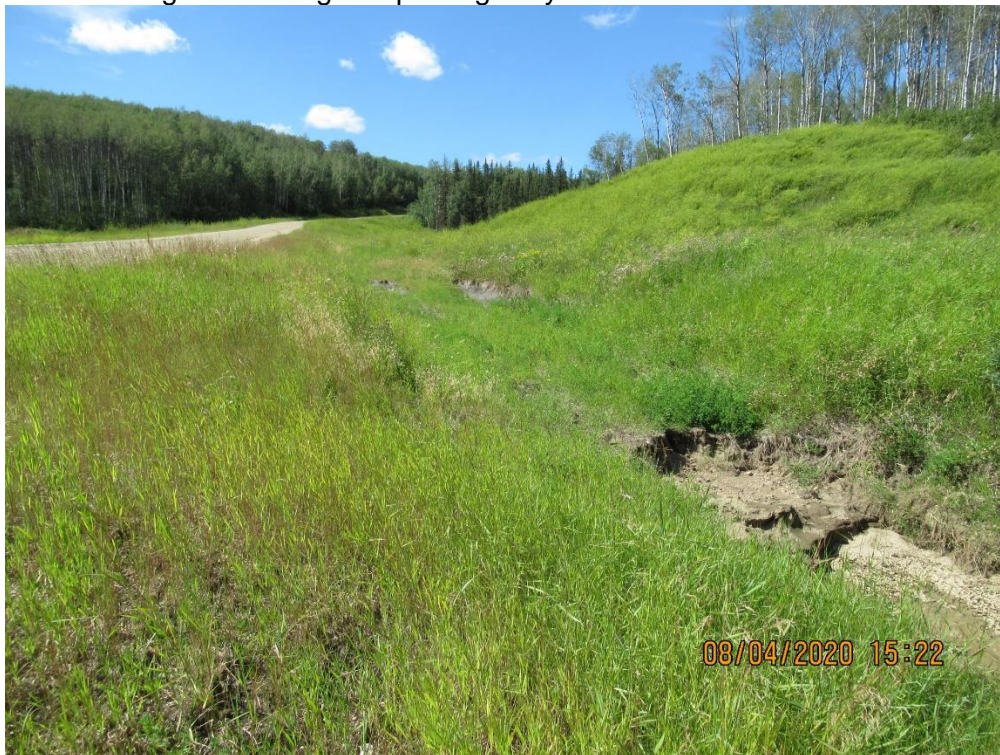
Ditch erosion occurred downstream of a centreline culvert this spring between km 44.3 and 44.1. The grader operator from LaPrairie indicated that the culvert might have been frozen and that higher than usual meltwater runoff by-passed the inlet and carried on down to the river creating patches of erosion through the grass covered ditch. The LiDAR shows a gully in the riverbank at the end of the erosion section suggesting that this may have also happened before in the past.

Photo 4 – Looking north at erosion in east ditch between Site Pho75-1 and the river.

Spring steaming of the culvert might prevent a reoccurrence of the bypass flow. The eroded ditch areas should be backfilled with gravel, covered with seeded topsoil, and TRM.

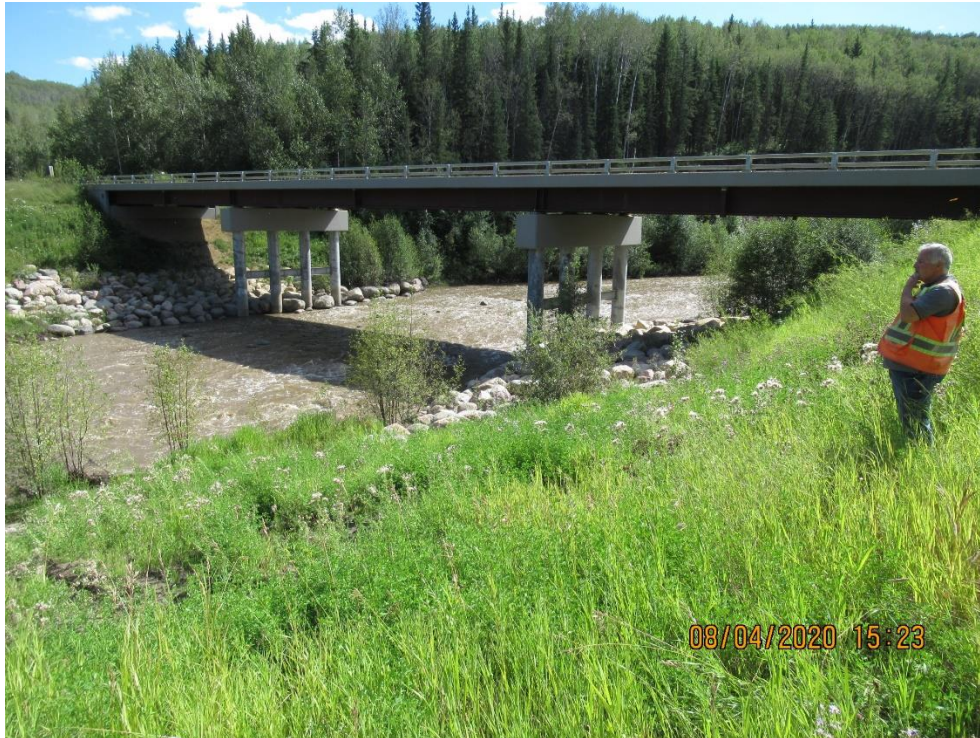
Photo 5 – Run off from ditch erosion went down the riverbank at this location.
