**ALBERTA TRANSPORTATION
GEOHAZARD ASSESSMENT PROGRAM
PEACE REGION – HIGH LEVEL
2020 INSPECTION**

Site Number	Location	Name	Hwy	km
PH075-1	North of Peace River	Whitemud River (Sta. 44+380)	743:02	44.4
Legal Description		UTM Co-ordinates		
NE2-88-21-W5M		11U E 486,395	N	6,273,737

**PH075-1: HWY 743:02 AT km 44.4
2020 GEOHAZARD ASSESSMENT**

DWG No. 13351-PH075-1-1

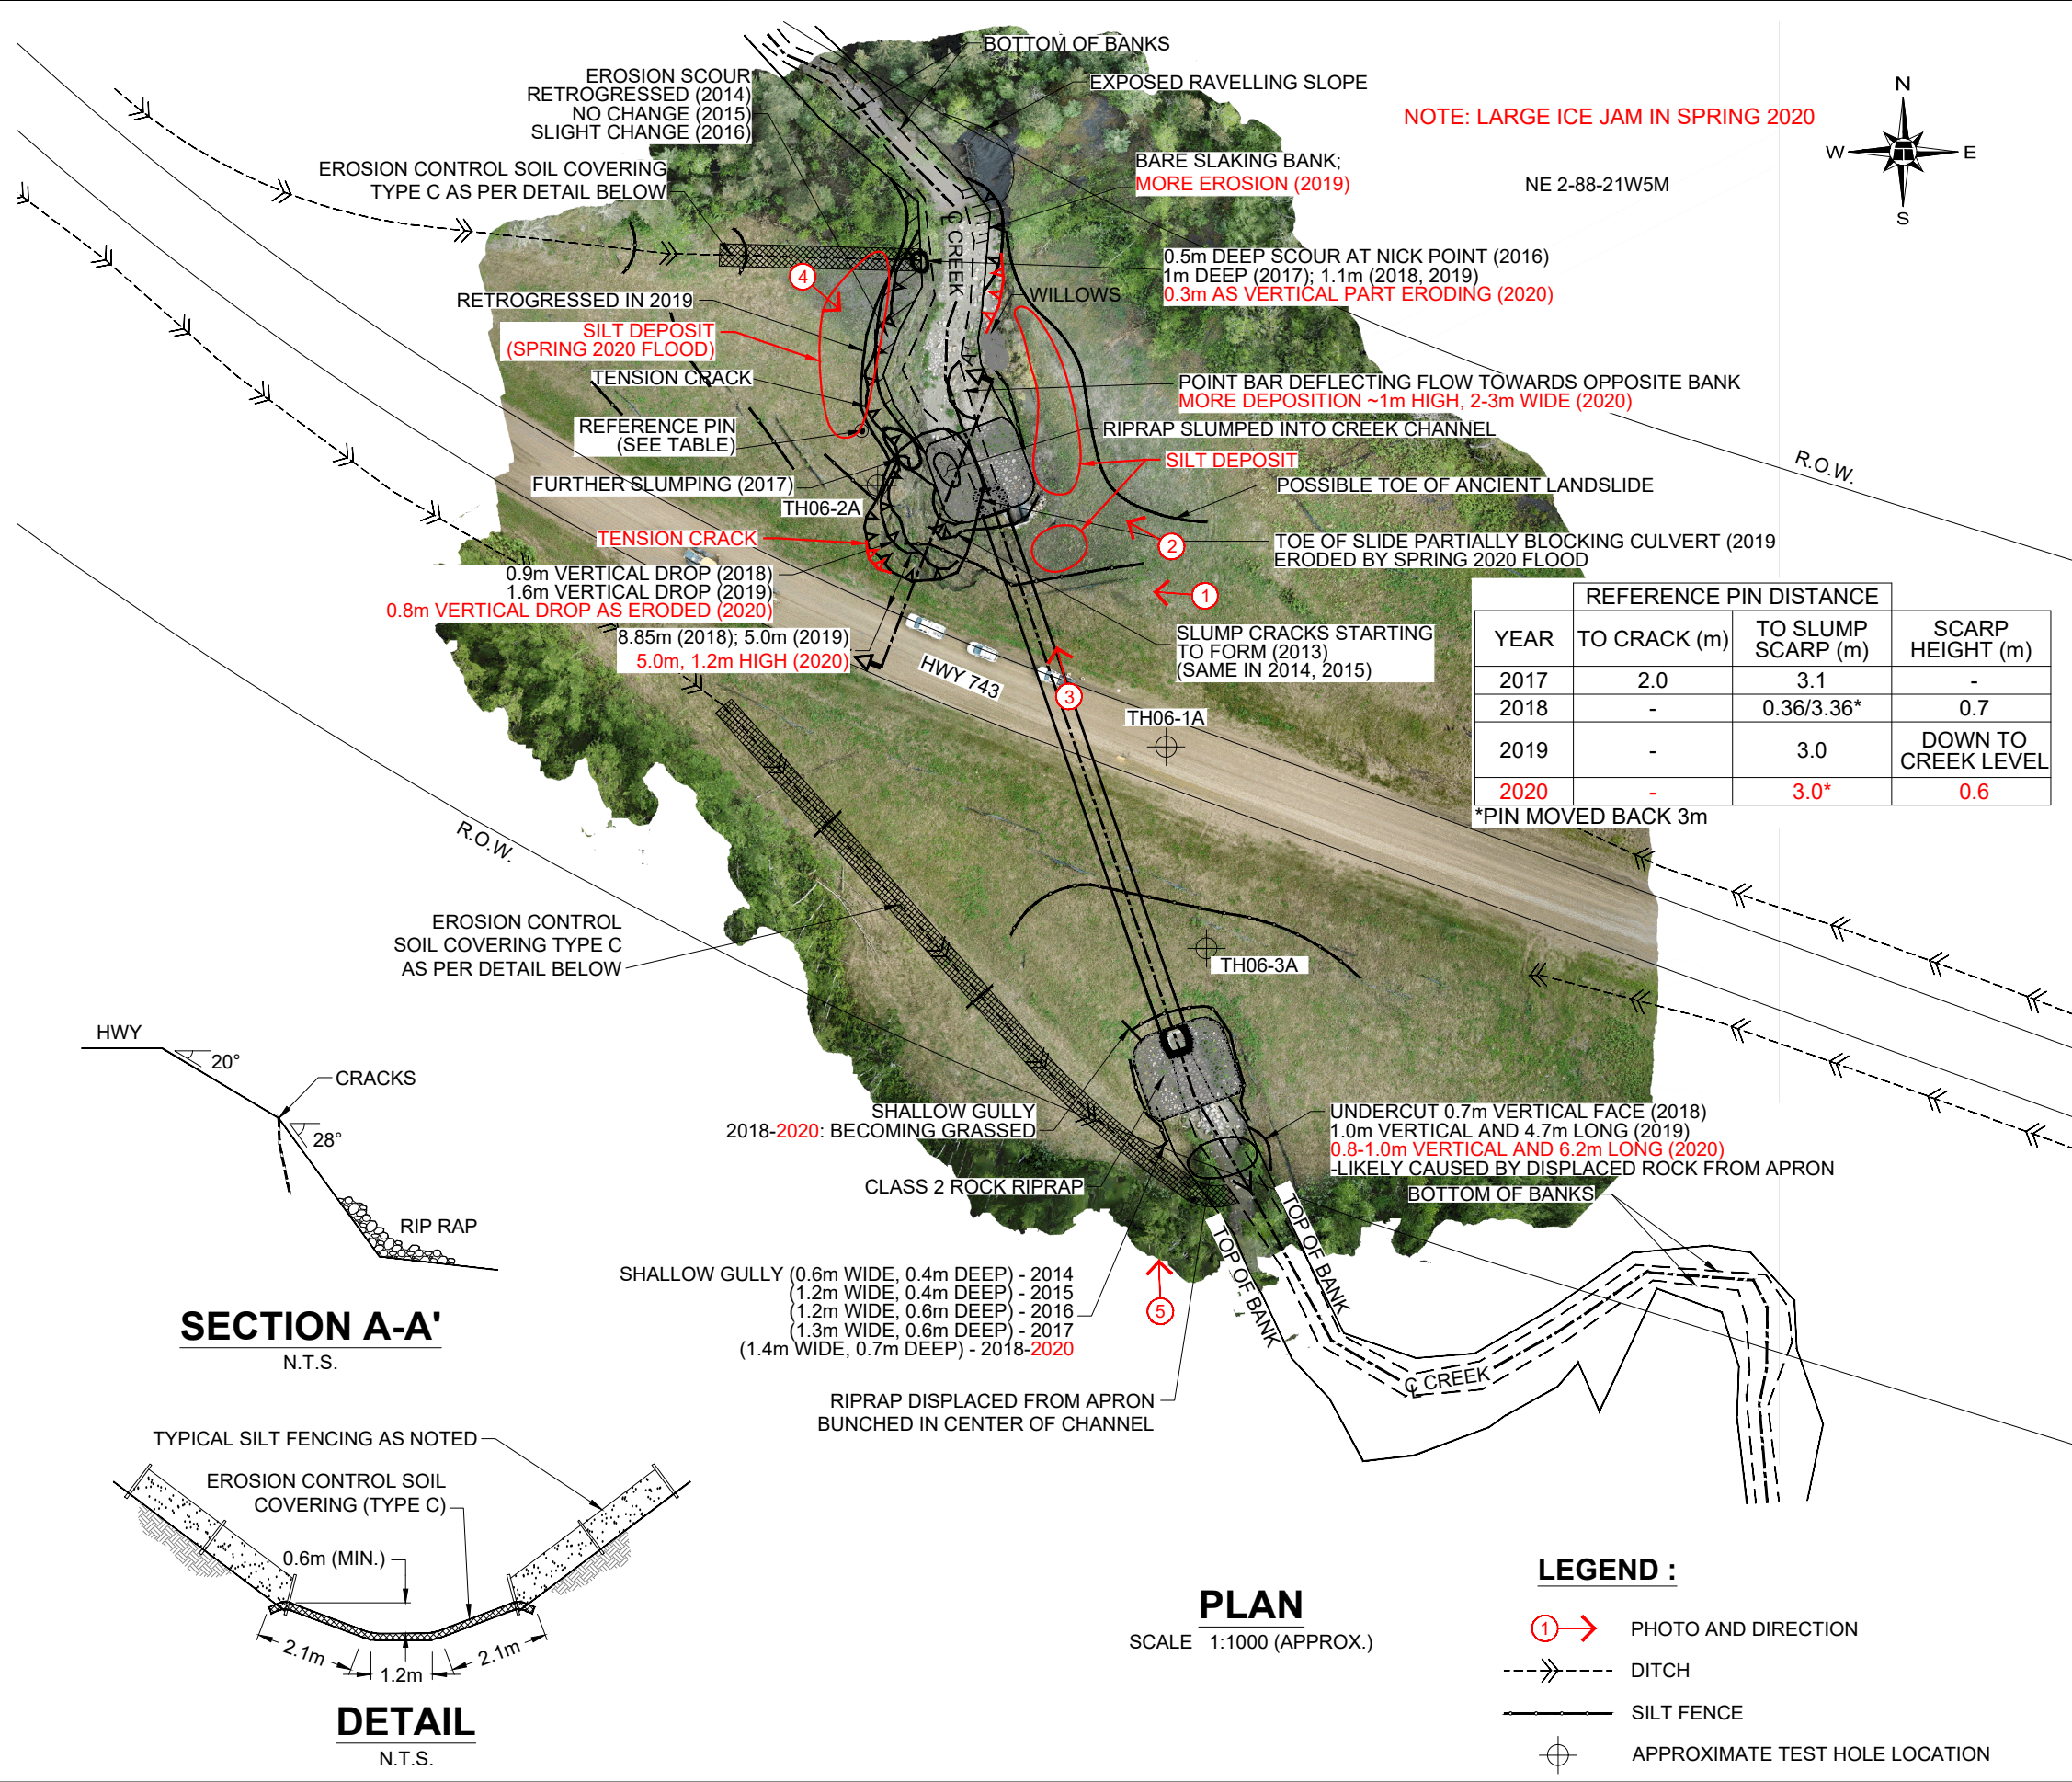
PLAN
SCALE 1:1000 (APPROX.)

NOTE: LARGE ICE JAM IN SPRING 2020

SHALLOW GULLY (0.6m WIDE, 0.4m DEEP) - 2014
 (1.2m WIDE, 0.4m DEEP) - 2015
 (1.2m WIDE, 0.6m DEEP) - 2016
 (1.3m WIDE, 0.6m DEEP) - 2017
 (1.4m WIDE, 0.7m DEEP) - 2018-2020

RIPRAP DISPLACED FROM APRON
 BUNCHED IN CENTER OF CHANNEL

UNDERCUT 0.7m VERTICAL FACE (2018)
 1.0m VERTICAL AND 4.7m LONG (2019)
 0.8-1.0m VERTICAL AND 6.2m LONG (2020)
 LIKELY CAUSED BY DISPLACED ROCK FROM APRON

0.9m VERTICAL DROP (2018)
 1.6m VERTICAL DROP (2019)
 0.8m VERTICAL DROP AS ERODED (2020)

0.5m DEEP SCOUR AT NICK POINT (2016)
 1m DEEP (2017); 1.1m (2018, 2019)
 0.3m AS VERTICAL PART ERODING (2020)

POINT BAR DEFLECTING FLOW TOWARDS OPPOSITE BANK
 MORE DEPOSITION ~1m HIGH, 2-3m WIDE (2020)

TOE OF SLIDE PARTIALLY BLOCKING CULVERT (2019)
 ERODED BY SPRING 2020 FLOOD

TENSION CRACK

FURTHER SLUMPING (2017)

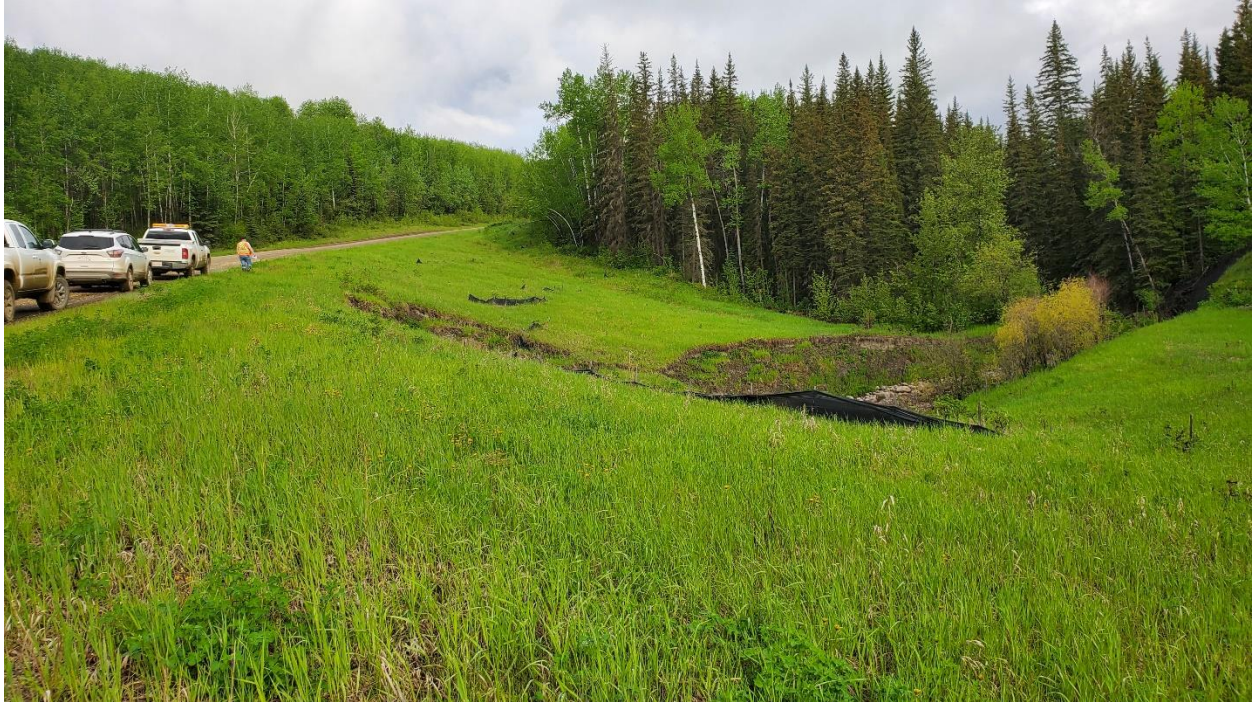
Photo 1 – Looking west at north sideslope.

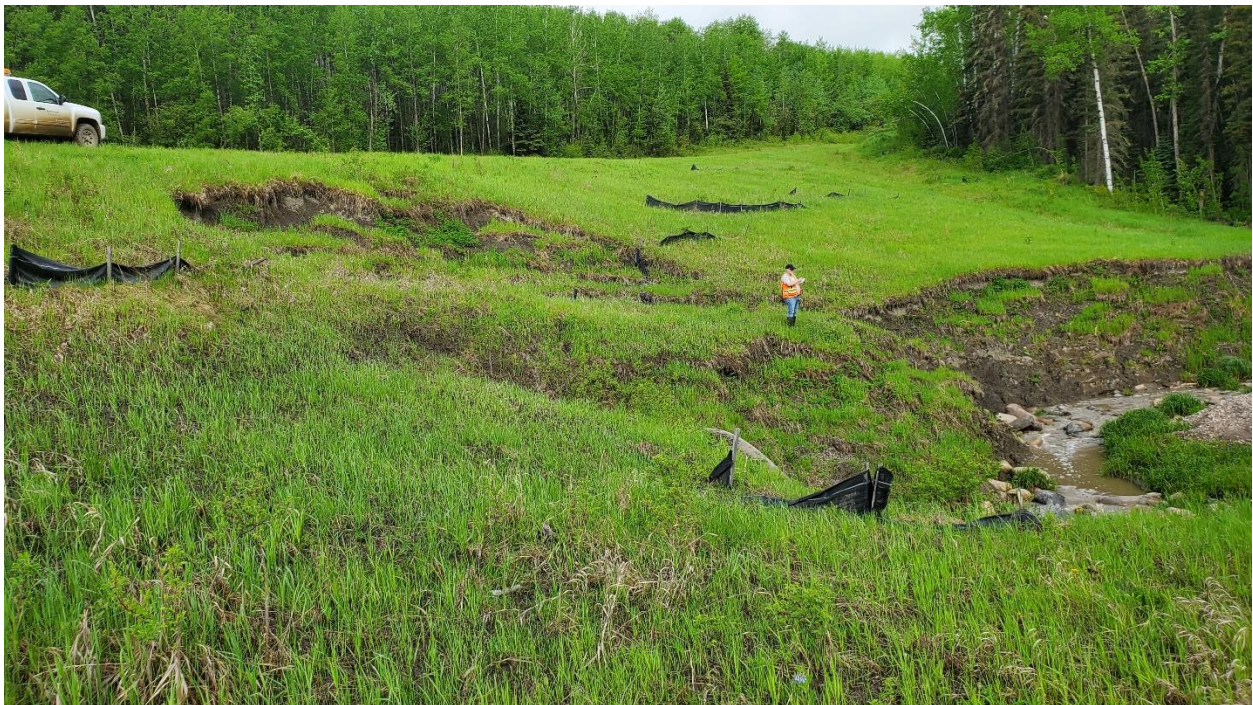
The creek bank at the culvert inlet has regressed significantly since 2017 triggered by heavy runoff in Spring 2018. The spring of 2020 also had significant runoff and there was an ice jam at this site (reported by MCI). The scarps above the culvert have formed into numerous slump blocks 5 m (slope distance) from the edge of the gravel surfacing (was 8.85 m in 2018). Slumping continues to worsen along the west bank of the creek moving further into the slope than the tension cracks first mapped in 2017. In 2018, the pin installed 2 m upslope of the tension crack was only 0.36 m from the resulting scarp and was shifted 3 m further upslope. The pin was 3.0 m from the scarp in 2019 and had to be reset again in 2020. The slumping of the riverbank is undermining the embankment and is causing instability which will impact the highway and has started to impact the culvert obstructing the inlet slightly.

The embankment slope above the riprap was about 2H:1V which is steeper than usual for a slope constructed using clay in this area. This steeper slope will likely result in more rapid retrogression if the channel experiences similar water flows. The ongoing slumping on the west side at the culvert inlet has displaced much of the riprap apron which increases the vulnerability of the slope to future high water events. Furthermore, the point bar forming on the east side of the channel also concentrates flow into the west bank. This point bar had increased in size noticeably in 2020.

Photo 2 – Looking northwest at creek bank slumping upstream of the culvert inlet.

- Rebuild the west bank north of the existing riprap upstream of the culvert inlet at a flatter slope and protect with additional riprap.
- The steep embankment slope above the culvert inlet needs to be stabilized. As the slope is now failing, it should be rebuilt with geogrid-reinforced granular material. A stability analyses should be undertaken to assess the potential effectiveness of these measures.
- Line the shallow gully on the west bank at the culvert outlet with riprap to limit deterioration. The mound of riprap downstream of the outlet should be redistributed to create a flow path down the centre of the channel rather than the unprotected sides.

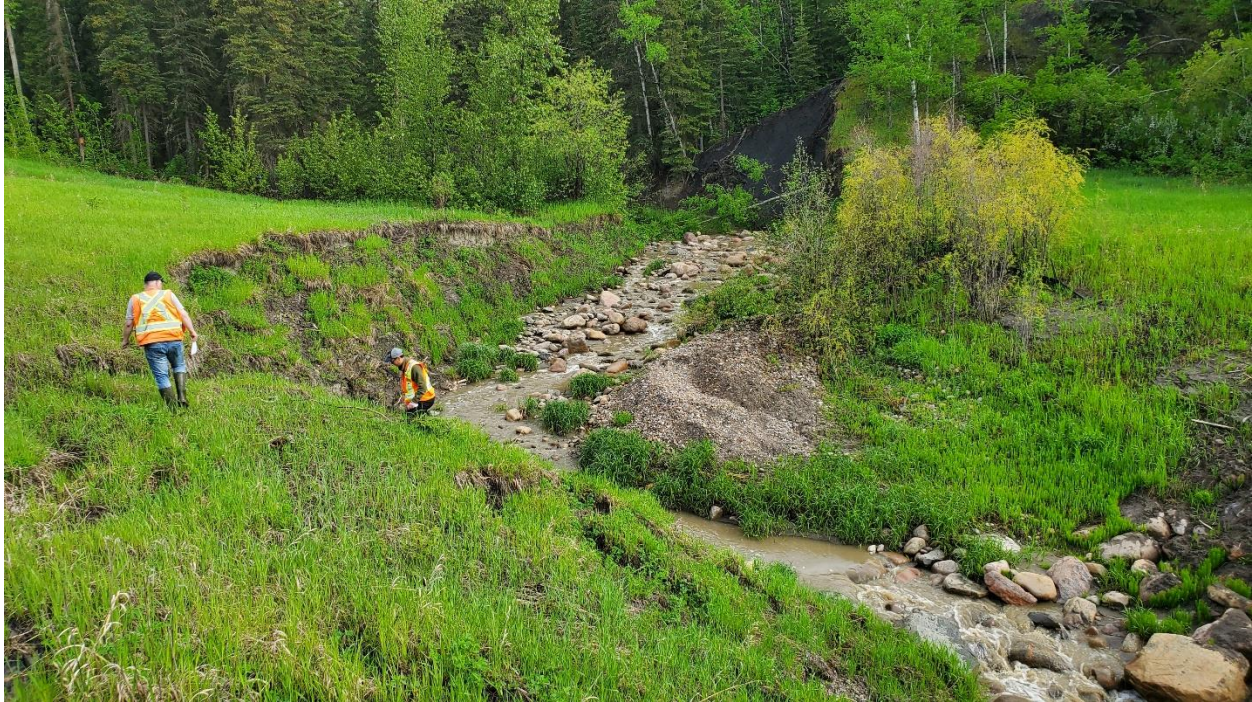
Photo 3 – Looking north at creek bank slumping upstream of the culvert inlet. Note fresh material deposits on the right-hand side of the channel.

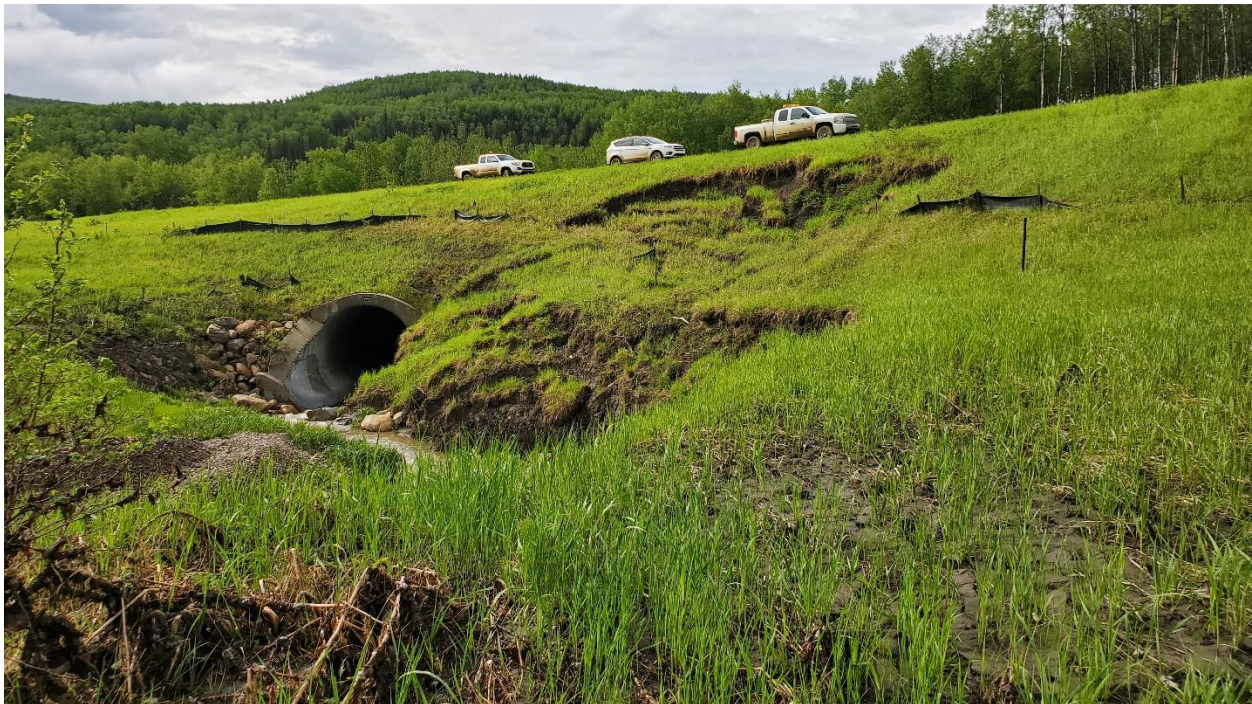
Photo 4 – Looking south at culvert inlet.

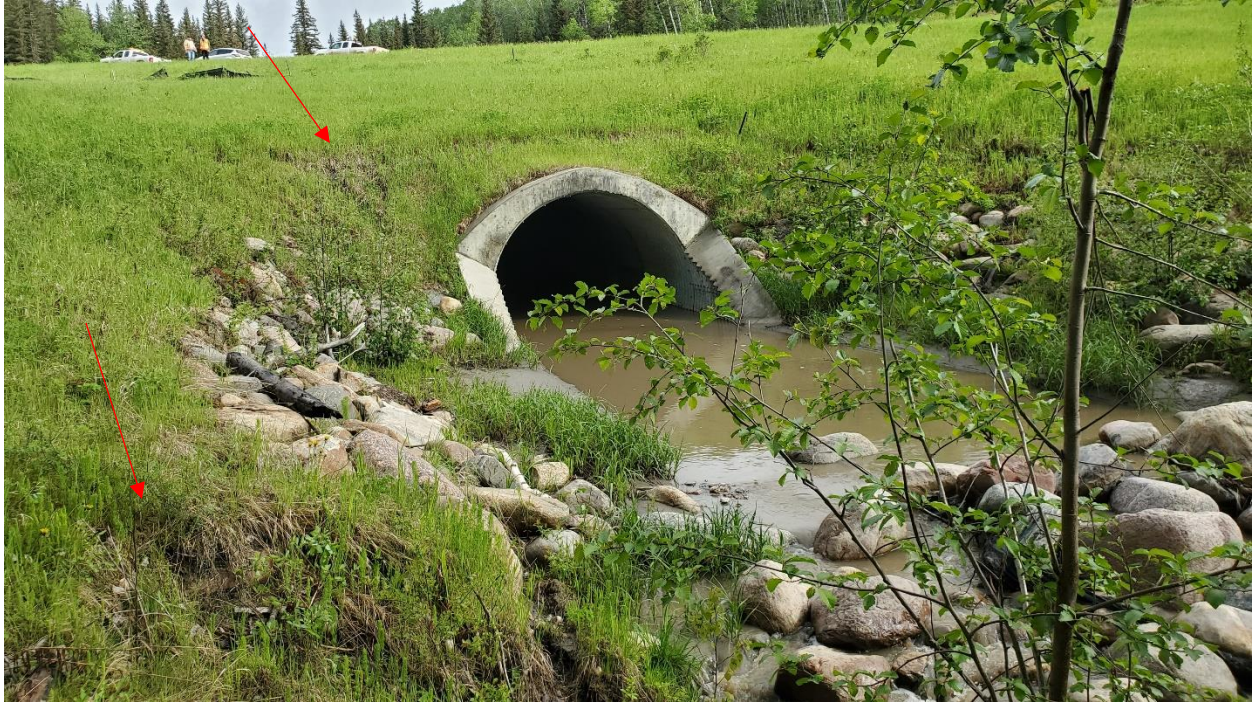
The shallow gully that formed at the west side of the top of the outlet riprap has started to vegetate and did not appear to have increased in size since 2017. This gully has likely formed due to surface runoff short-cutting out of the ditch channel. It was also observed that the displaced riprap from the culvert outlet apron is mounded in the centre of the channel forcing flow around causing the increasing undercut on the east bank. The length of affected bank was slightly longer in 2020.

Photo 5 – Looking north at culvert outlet and shallow gullies (arrows)

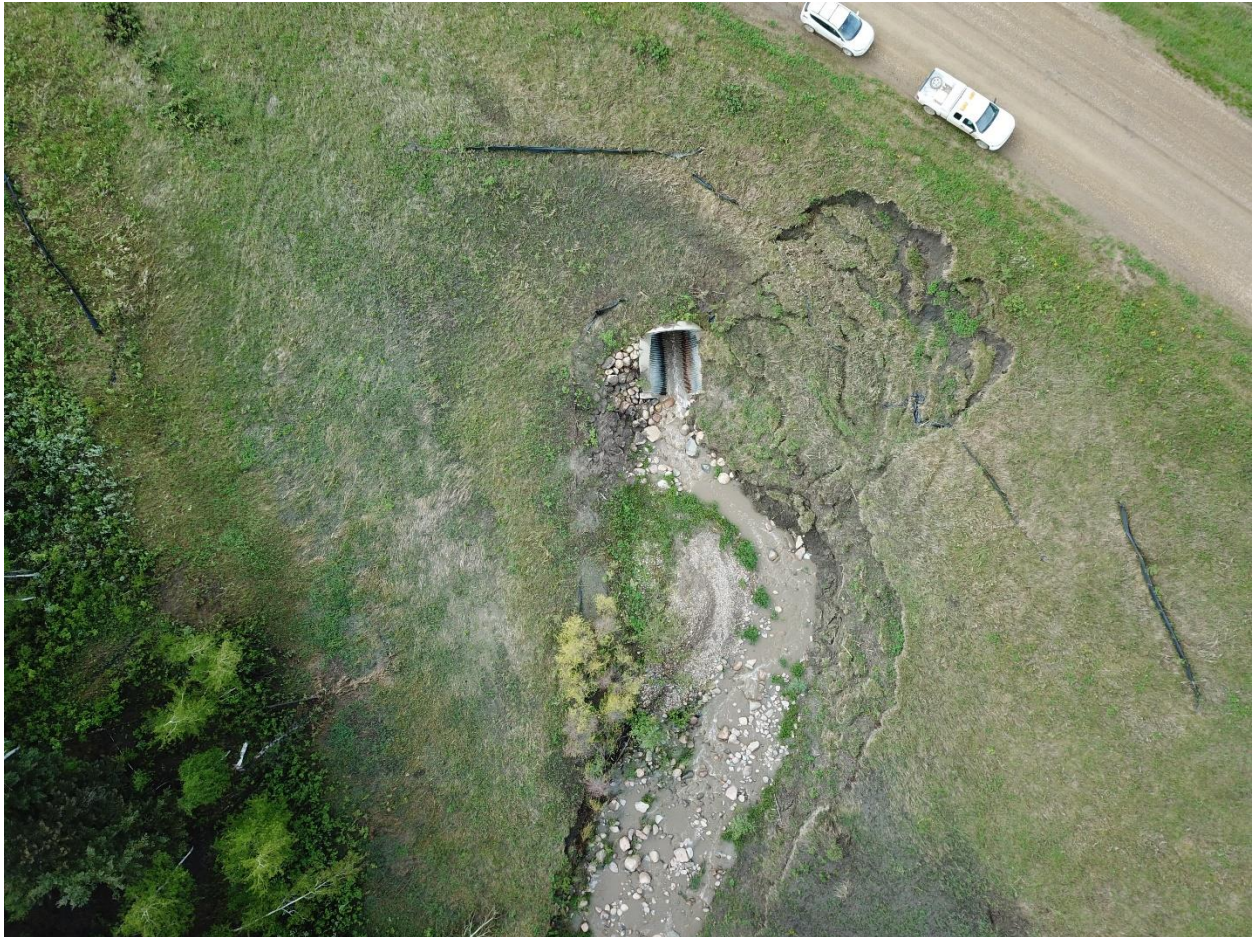
2020 UAV Image of slumping around culvert inlet.
