**ALBERTA TRANSPORTATION
GEOHAZARD ASSESSMENT
PEACE REGION (PEACE RIVER DISTRICT)
2021 INSPECTION**

Site Number	Location	Name	Hwy	km
PH075-1	North of Peace River	Whitemud River (km 44.4)	743:02	44.4
PH075-2		Whitemud River (km 44.8)		44.8
Legal Description		UTM Co-ordinates		
NE2-88-21-W5M		11U E 486,395 486,112	N	6,273,737 6273,982

**PH075-1: HWY 743:02 AT km 44.4
2021 GEOHAZARD ASSESSMENT**

**PH075-2: HWY 743:02
2021 SITE INSPECTION PLAN**

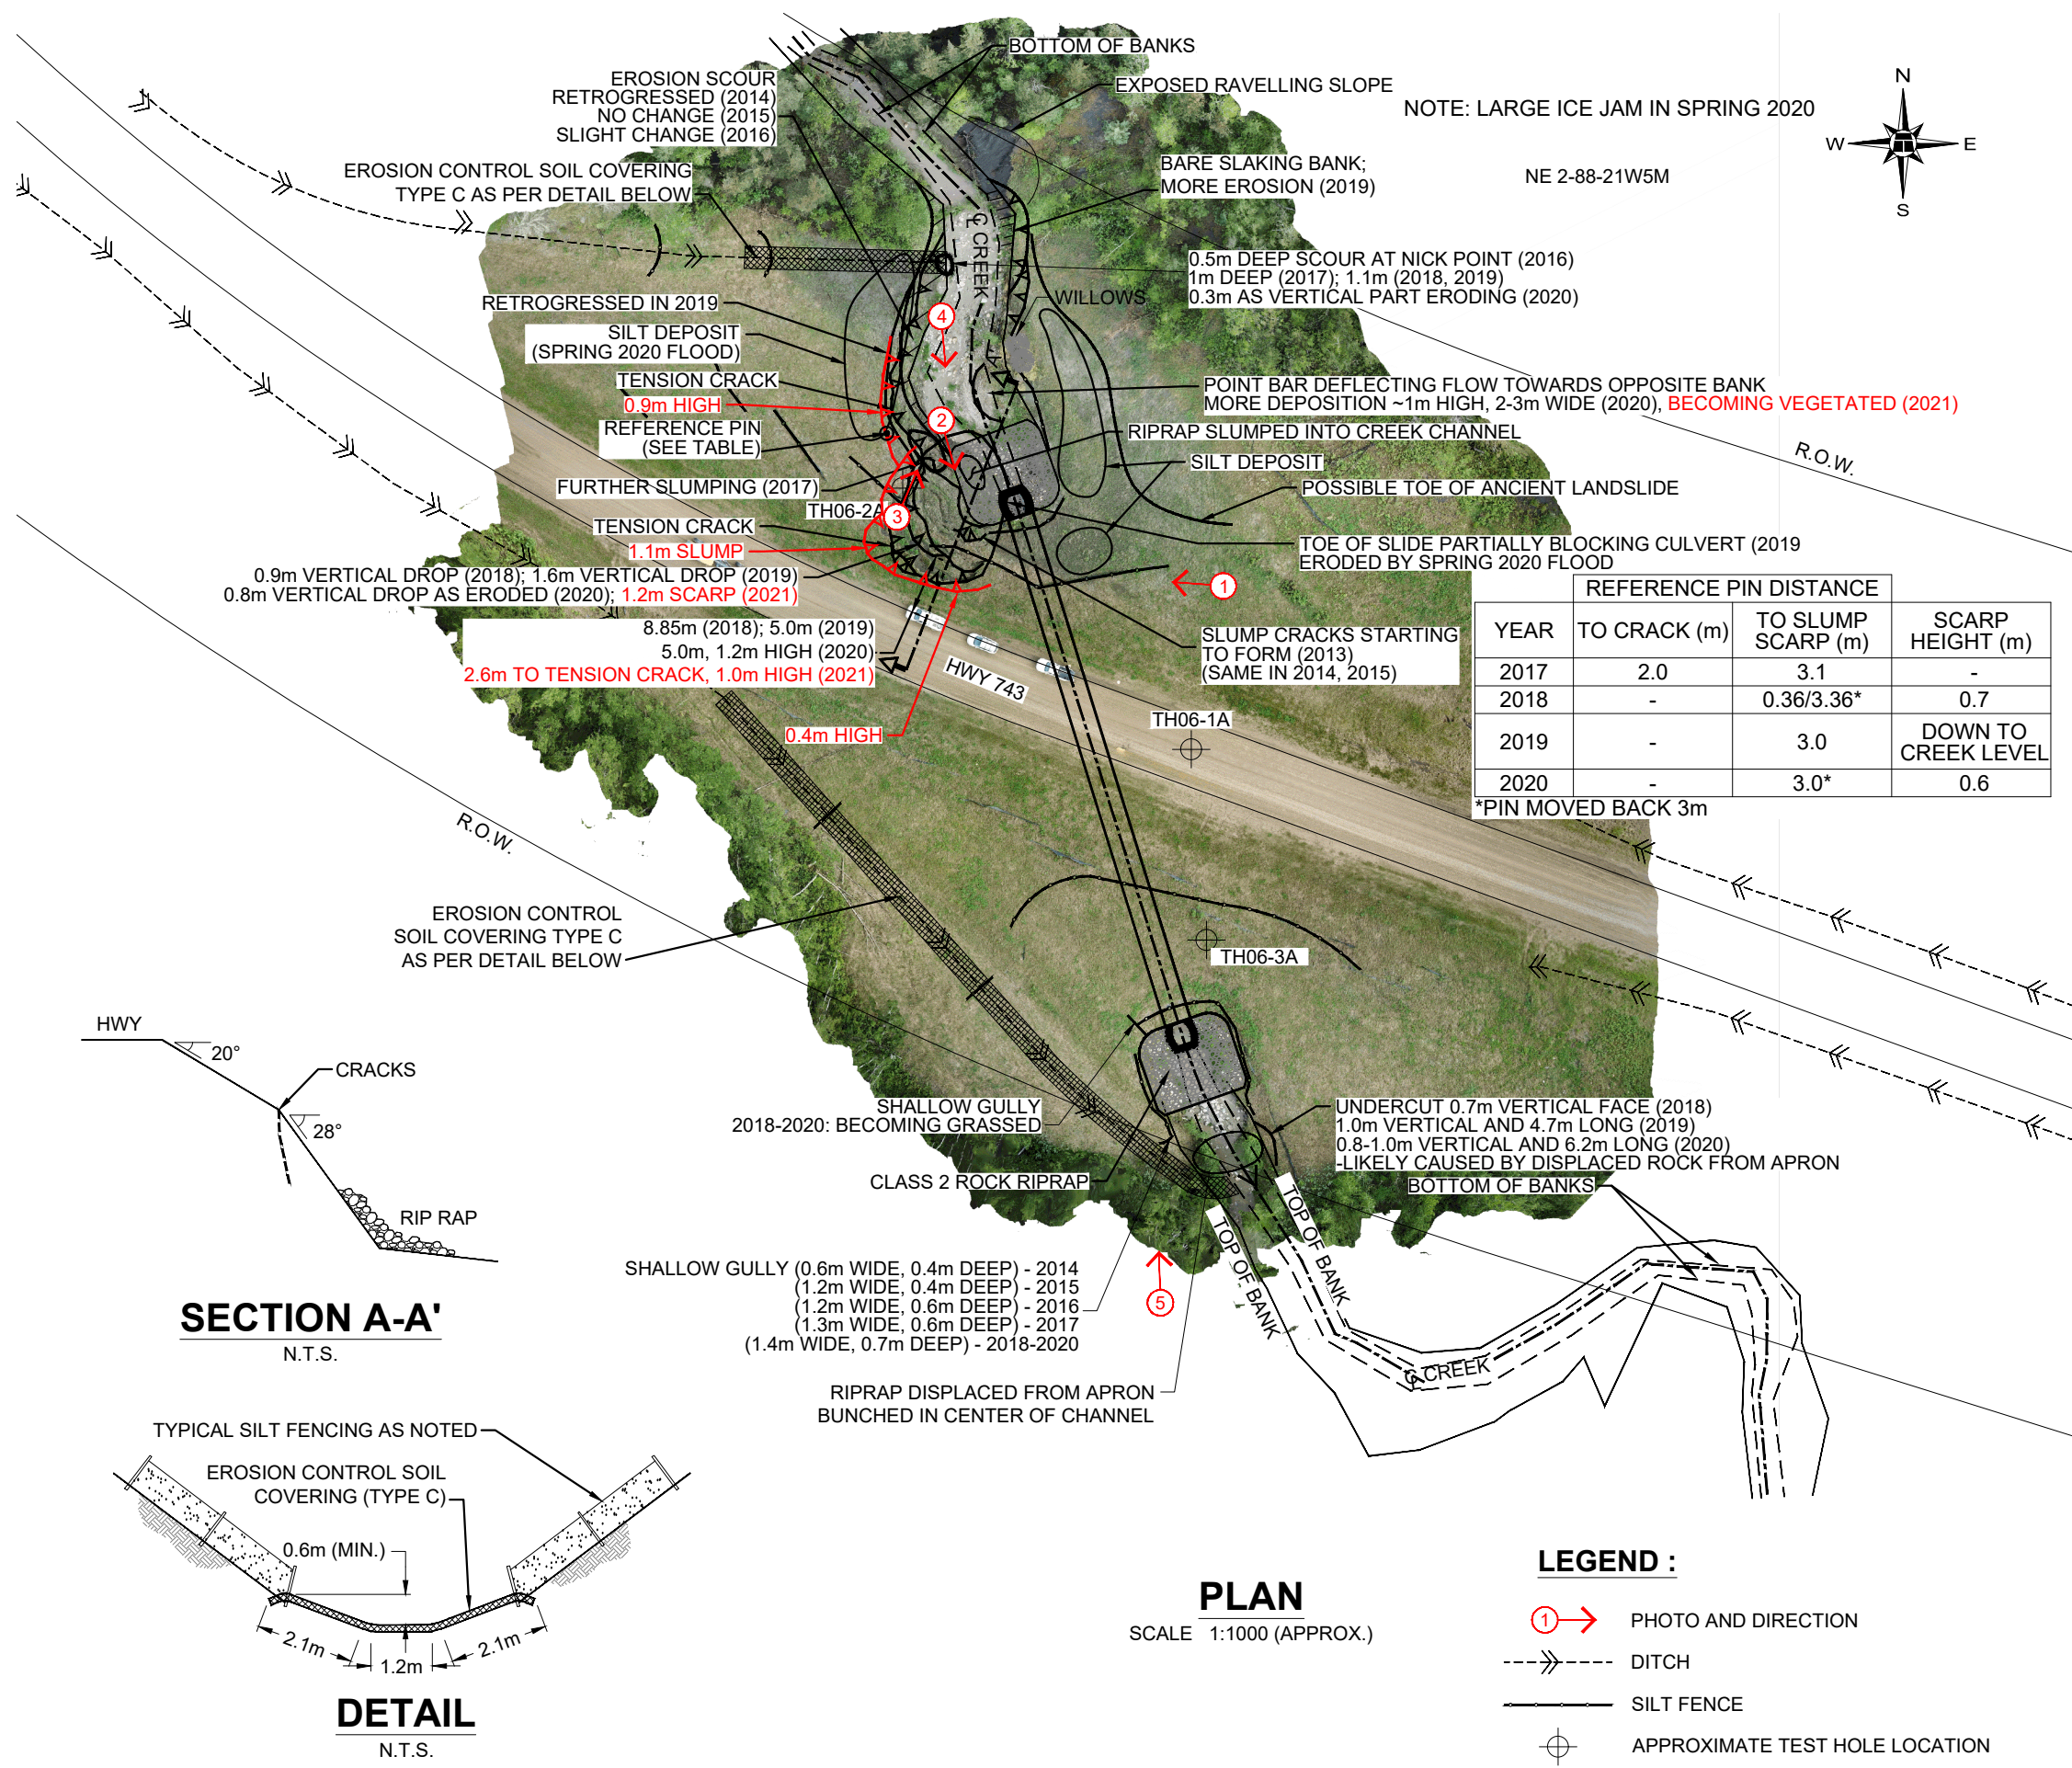
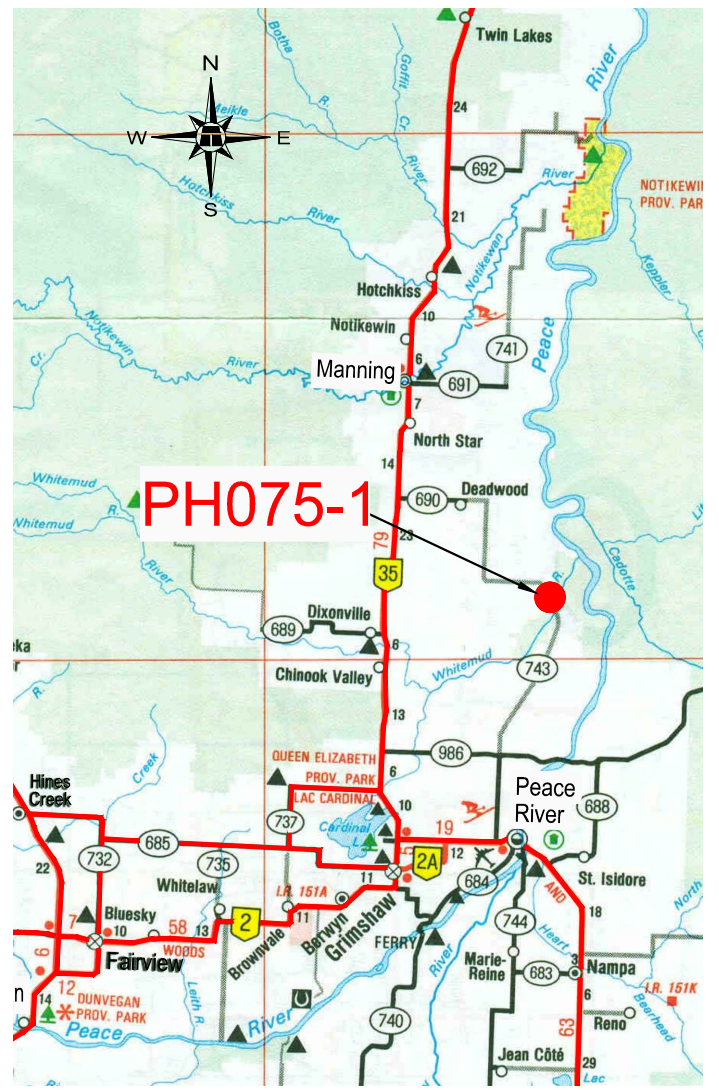
DWG No. 32121-PH075-1-1

Primary Site Issue:	PH075-1: Creek bank erosion and slumping of over-steepened slope above culvert inlet. PH075-2: Retrogressive landslide scarp through both lanes	
Dimensions:	PH075-1: 40 m of creek bank erosion PH075-2: 55 m wide along the shoulder, approx. 275 m wide at the creek and 160 m long from the highway to the creek.	
Date of Remediation:	2009: Culvert replaced and sideslopes rebuilt.	
Maintenance:	Highway closed on Jul 13, 2020, until detours opened in Fall 2020.	
PH075-1 Observations:	Description	Worsened?
<input type="checkbox"/> Pavement Distress	Highway is gravel-surfaced.	<input type="checkbox"/>
<input checked="" type="checkbox"/> Slope Movement	Slump above culvert regressed significantly in 2018 and continues to move. There is major bank slumping upstream of the culvert and minor bank slumping downstream of the outlet.	<input checked="" type="checkbox"/>
<input checked="" type="checkbox"/> Erosion	Slump on the west side of the creek at the inlet has continued to retrogress since 2015; erosion at end of north ditch channel relatively stable.	<input type="checkbox"/>

YEAR	REFERENCE PIN DISTANCE		
	TO CRACK (m)	TO SLUMP SCARP (m)	SCARP HEIGHT (m)
2017	2.0	3.1	-
2018	-	0.36/3.36*	0.7
2019	-	3.0	DOWN TO CREEK LEVEL
2020	-	3.0*	0.6

*PIN MOVED BACK 3m

- Site 1: Rebuild the west bank north of the existing riprap upstream of the culvert inlet at a flatter slope and protect with additional riprap.
- Site 1: The steep embankment slope above the culvert inlet needs to be stabilized. As the slope is now failing, it should be rebuilt with geogrid-reinforced granular material. A stability analyses should be undertaken to assess the potential effectiveness of these measures.
- Site 1: Line the shallow gully on the west bank at the culvert outlet with riprap to limit deterioration. The mound of riprap downstream of the outlet should be redistributed to create a flow path down the centre of the channel rather than the unprotected sides.

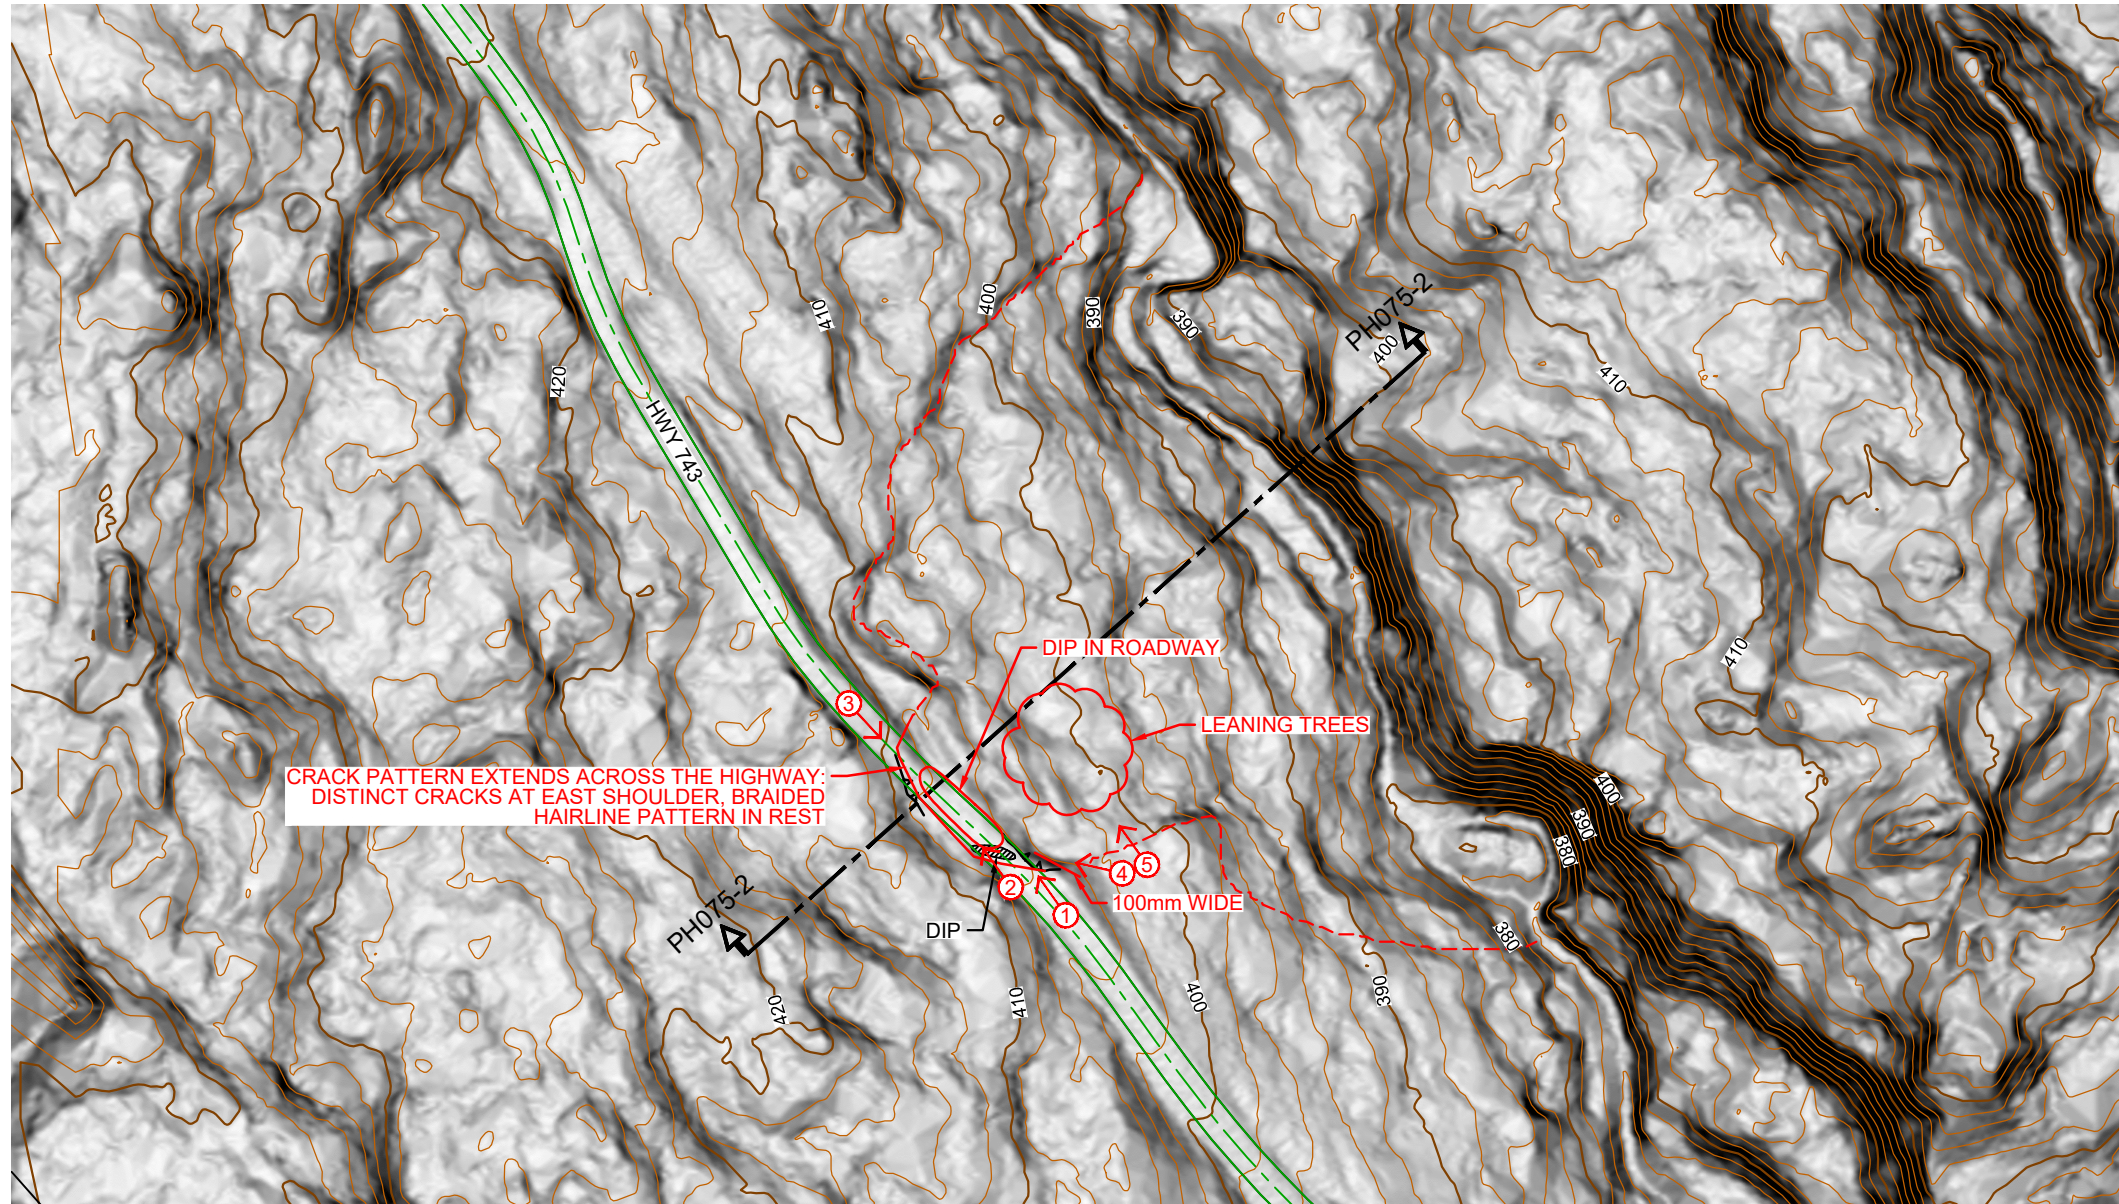
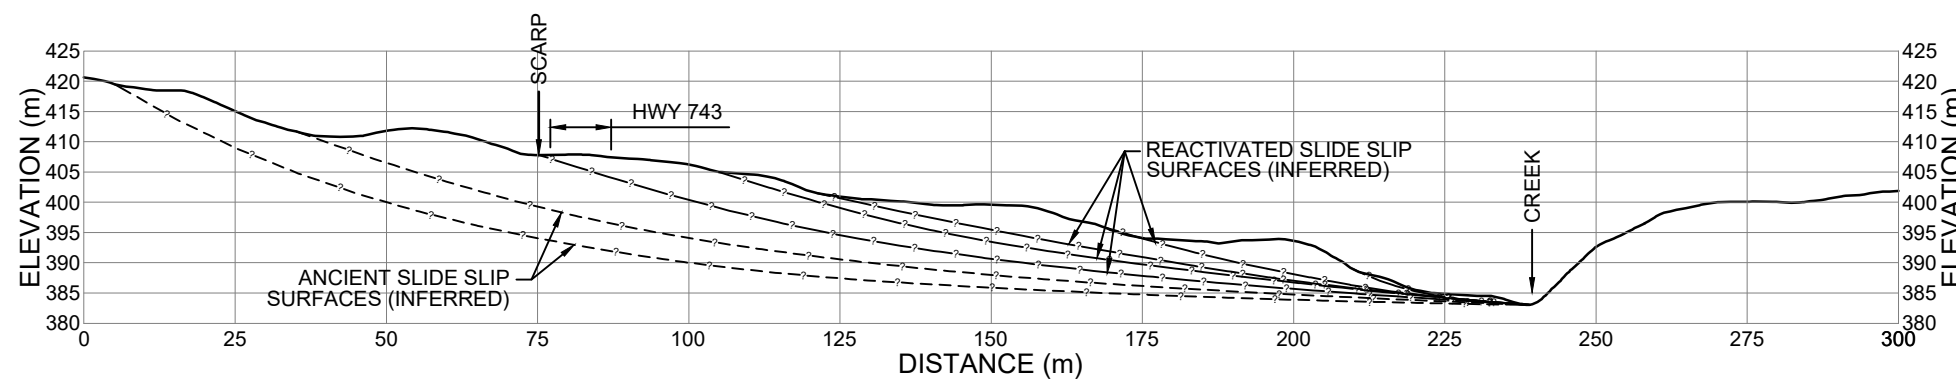
DWG No. 32121-PH075-2

PH075-2 (Drawing 32121-PH075-2)		
<p>The slide at PH075-2 was first noticed during a callout inspection of other sites on Hwy 743 on August 4, 2020, shortly after movements closed the highway. The site is located on a sidehill alignment ascending the valley slope of a tributary to the Whitemud River. LiDAR provided by Alberta Transportation shows that the valley slope has been affected by historic landslide movements. Similar to the other sites along this highway that moved during the summer of 2020, it was likely that higher groundwater levels re-activated a large slide block which affected about 55 m of the road surface. The highway is located about 25 m vertically above the creek. The valley slope surface, as</p>

shown by the cross-section on Dwg. No.13351-PH075-2, is hummocky, indicating the presence of several retrogressive slide blocks between the creek and the road. The dip encompasses the entire roadway surface at this location and trees at the toe of the embankment are being to lean.

- The maintenance contractor and/or MCI should review these sites frequently, particularly after significant rainfall events, to ensure that the highway is not impacted by further slumping.
- At Site 2, the cracks and dip are limited in extent such that the road can still be used at slow speeds. Slide warning signs and a 30 km/hr speed limit are recommended.

- Site 2: A localized realignment to the west of the roadway around the slide could be carried out if the road condition worsens.
- Site 2: A local driven steel pile wall might also be considered to provide temporary support to the road but might become distorted over time if the larger slide blocks move again.

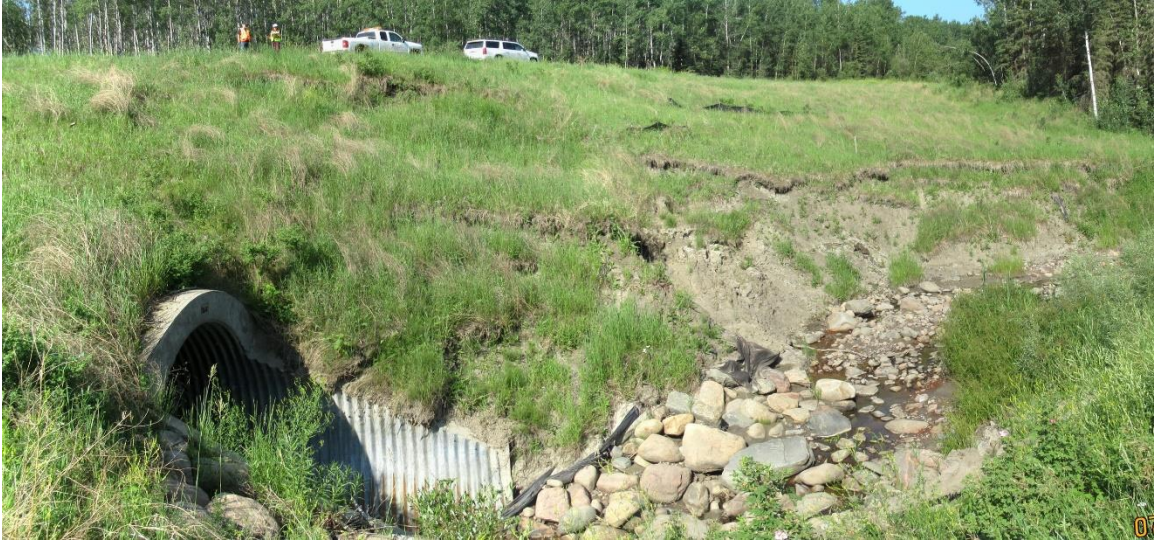
Site 1, Photo 1 – Looking west at north sideslope.

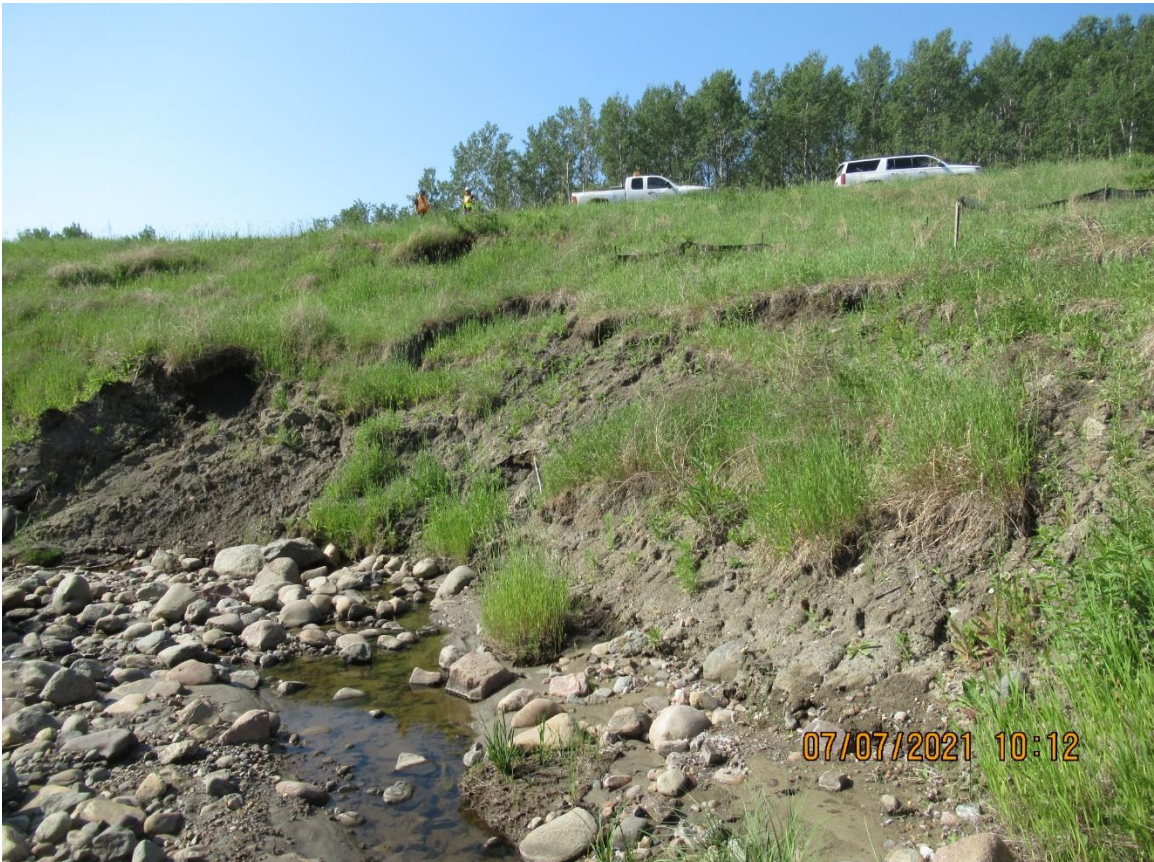
Site 1, Photo 2 – Looking southeast at creek bank slumping upstream of the culvert inlet.

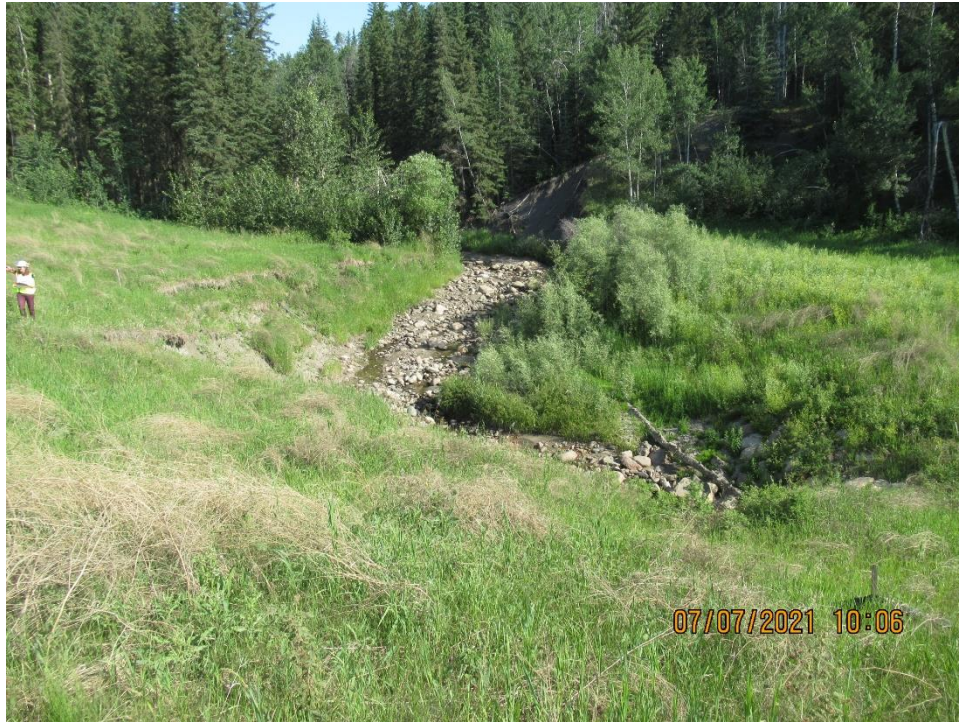
Site 1, Photo 3 – Looking north at creek bank slumping upstream of the culvert inlet. Note fresh material deposits on the right-hand side of the channel.

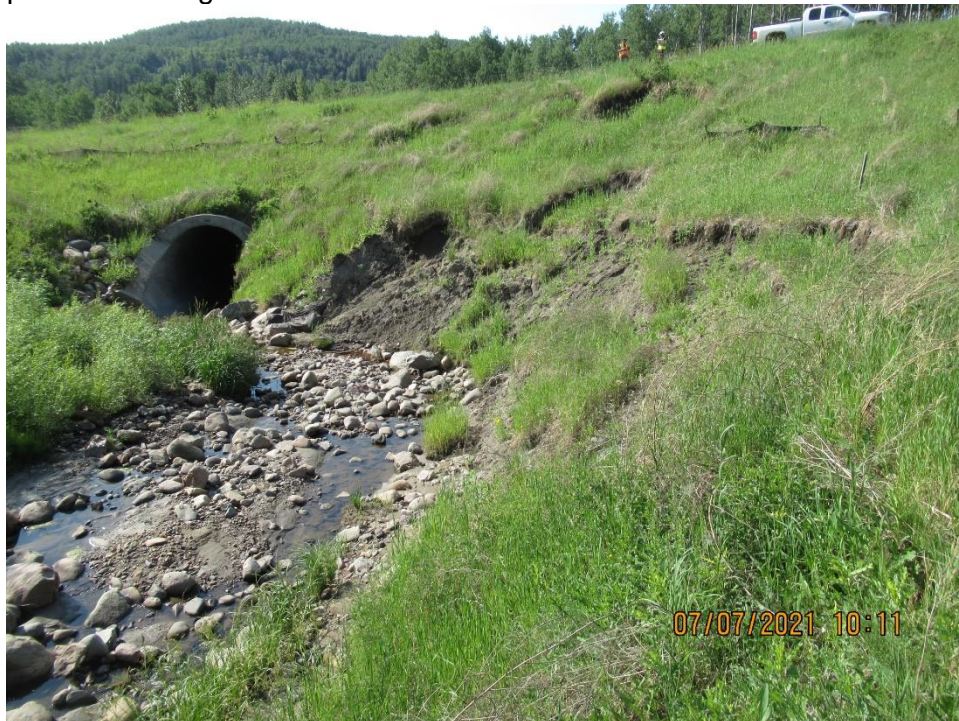
<input type="checkbox"/> Seepage		<input type="checkbox"/>
<input checked="" type="checkbox"/> Bridge/Culvert Distress	No signs of distress in the culvert itself; however, slide movements are obstructing flow at the inlet and sediment is accumulating at the outlet.	<input checked="" type="checkbox"/>
<input type="checkbox"/> Other		<input type="checkbox"/>
PH075-2 Observations:	Description	Worsened?
<input type="checkbox"/> Pavement Distress	Cracks and dip in gravel road surface.	<input checked="" type="checkbox"/>
<input checked="" type="checkbox"/> Slope Movement	The dip encompasses the entire roadway surface and trees at the toe are leaning	<input checked="" type="checkbox"/>

Site 1, Photo 4 – Looking south at culvert inlet.

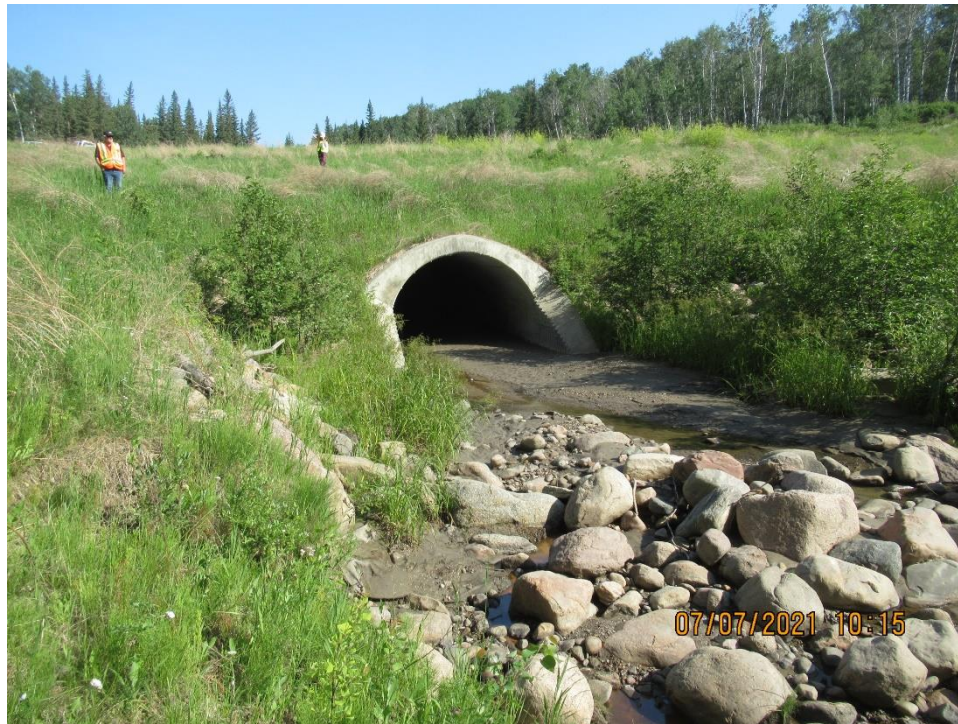
Site 1, Photo 5 – Looking north at culvert outlet

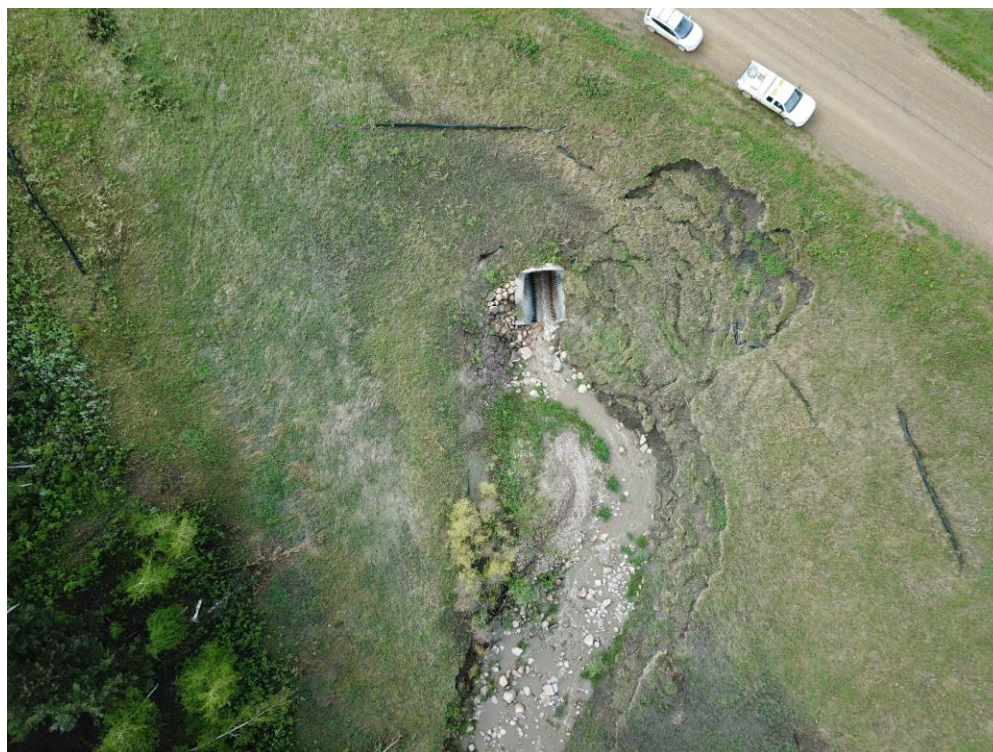
2020 UAV Image of slumping around Site 1 culvert inlet.

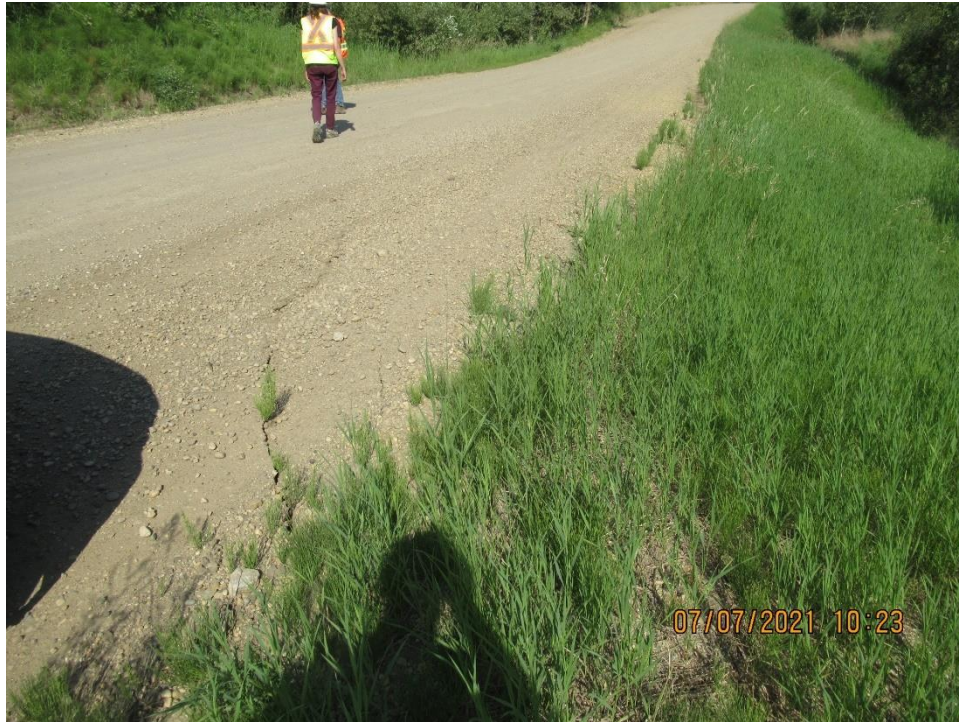
Site 2, Photo 1 – Looking north along scarp in highway shoulder at south end of PH075-2 Site.

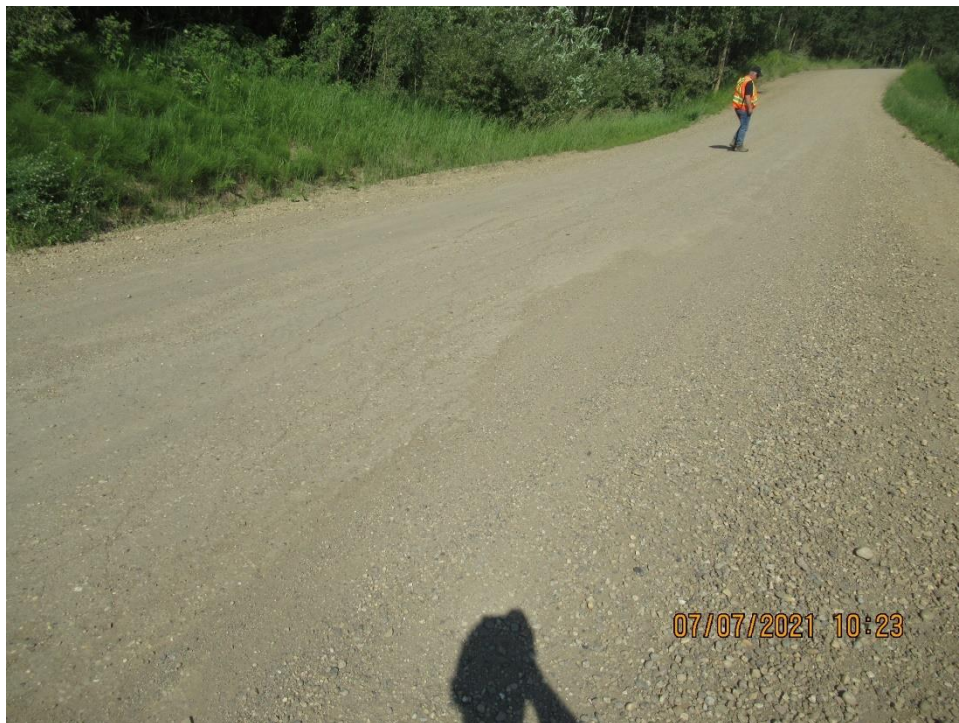
Site 2, Photo 2 – Looking north at scarp cracks in middle of site.

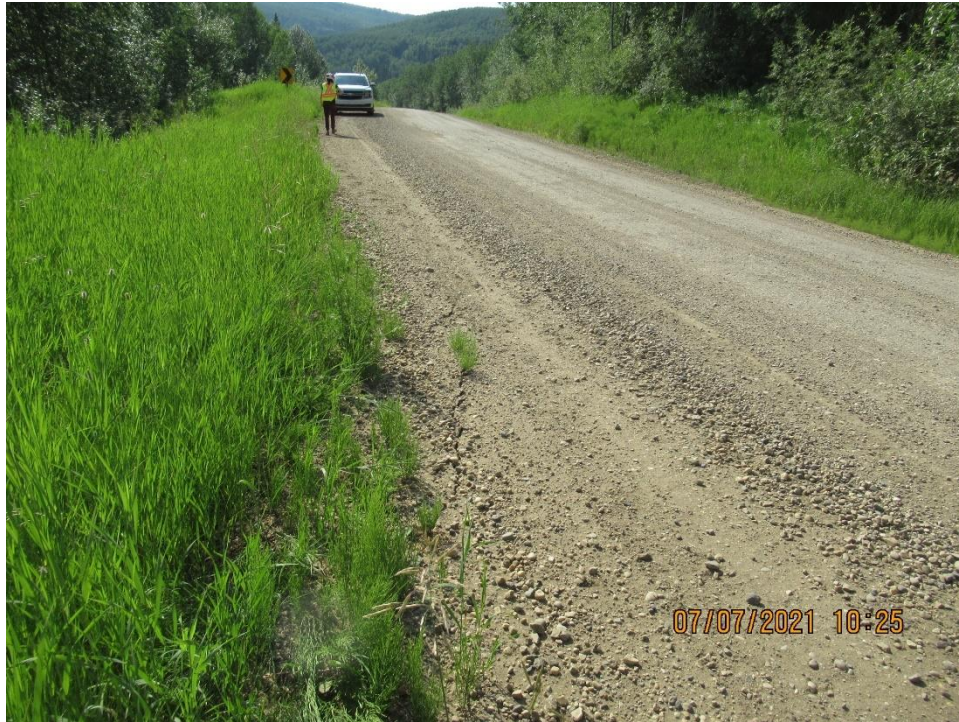
Site 2, Photo 3 – Looking at north end of cracks.

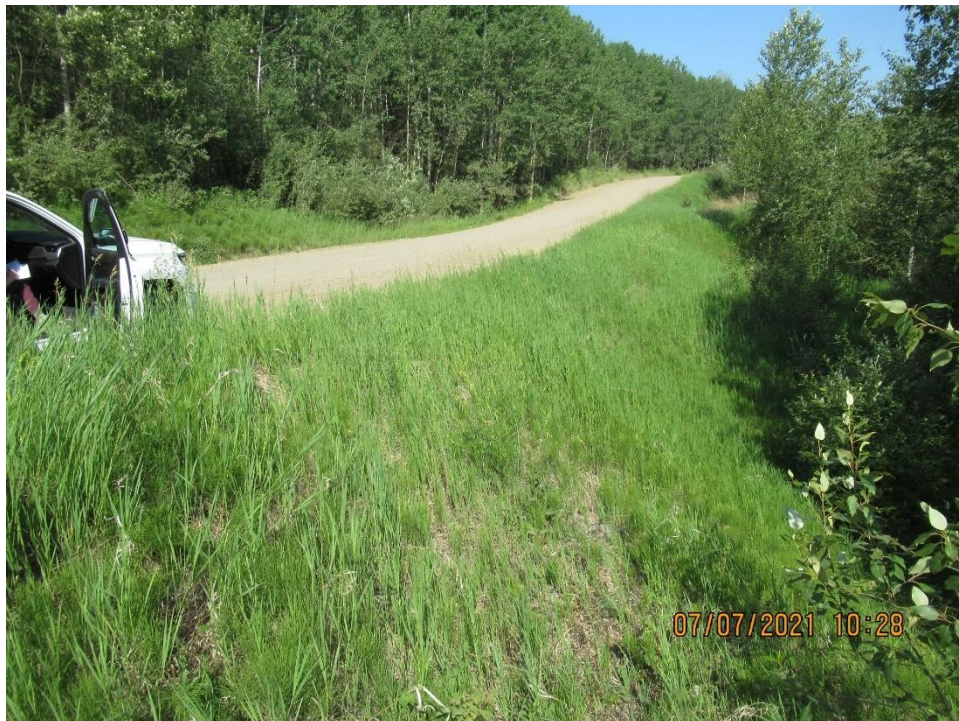
Site 2, Photo 4 – Looking at dip in highway surface over the slide.

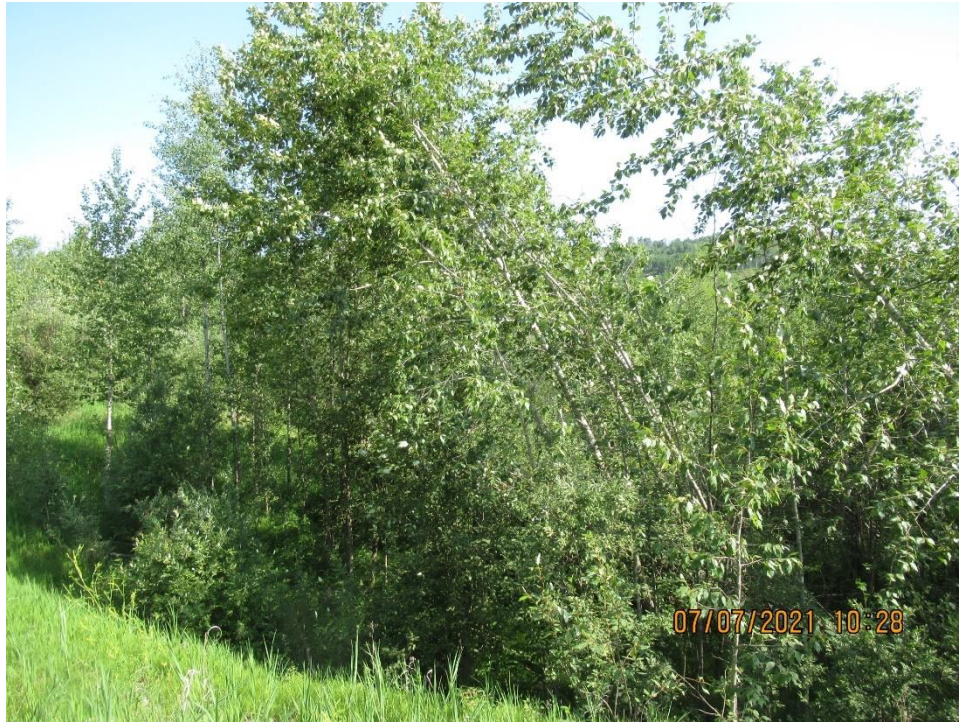
Site 2, Photo 5 – Rotating trees at the toe of the highway embankment.
