**ALBERTA TRANSPORTATION  
GEOHAZARD ASSESSMENT PROGRAM  
PEACE REGION – HIGH LEVEL  
2020 CALLOUT**

Site Number	Location	Name	Hwy	km
PH087	North of Town of Peace River	Whitemud River (km 46.2)	743:02	43.4
Legal Description		UTM Co-ordinates		
NW1-88-21-W5		11V N 6,273,215	E 487,109

**2020 CALL OUT PLAN**

**DWG No. 13351-PH087-1**

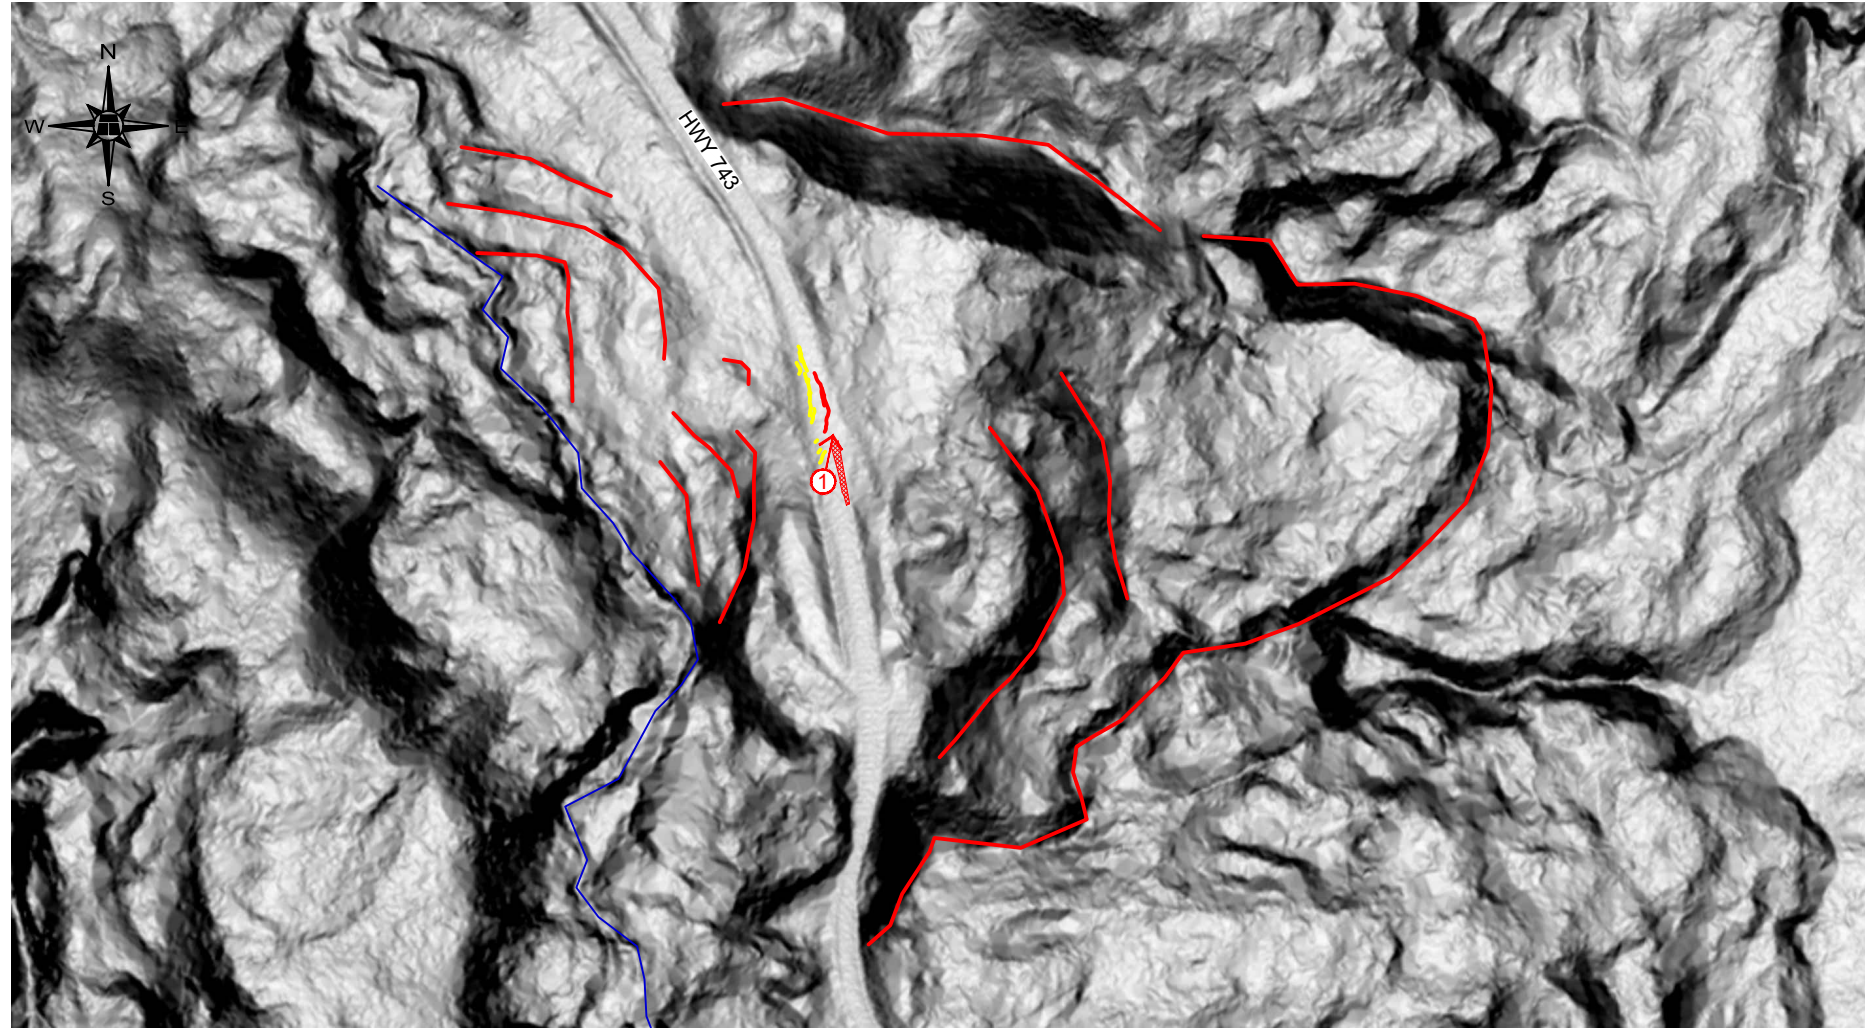
**SITE PLAN - 2008 LIDAR**  
SCALE 1:4000

LiDAR provided by Alberta Transportation shows an unstable valley slope leading down to a tributary stream of the Whitemud Creek. Drawing 13351-PH087-1 shows the LiDAR image (grey-shaded by slope angle from white at 0° to black at 35°) with the major scarps identified along with the one arcing through the highway (and associated cracks). The terrain shows indications of a developing retrogression pattern bounded to the northeast by a significant scarp face whose south face is 35 m high and standing at 34°. There is also instability moving in a perpendicular direction on the north side of this feature. This drawing also shows the scarps and cracks identified from field observations and confirmed from UAV imagery. The digital elevation model (DEM) from the UAV imagery was created using structure-from-motion (SfM) techniques as is shown in Detail A. Detail B shows the orthoimage assembled as part of the SfM process.

The conclusion is that this movement at the highway is part of an ongoing larger, retrogressive slide complex likely driven by the downcutting of the tributary channel which is about 135 m horizontal away and 20 m lower in elevation. The heavier-than-normal rainfall this year has likely also contributed both through raising of the groundwater table and increased river flows. The LiDAR also shows that the slope above the highway has also been subject to historical movement. It is probable that the movement seen at the highway is part of a re-activation of the retrogressive movement which will presumably continue up the slope if not otherwise remediated.

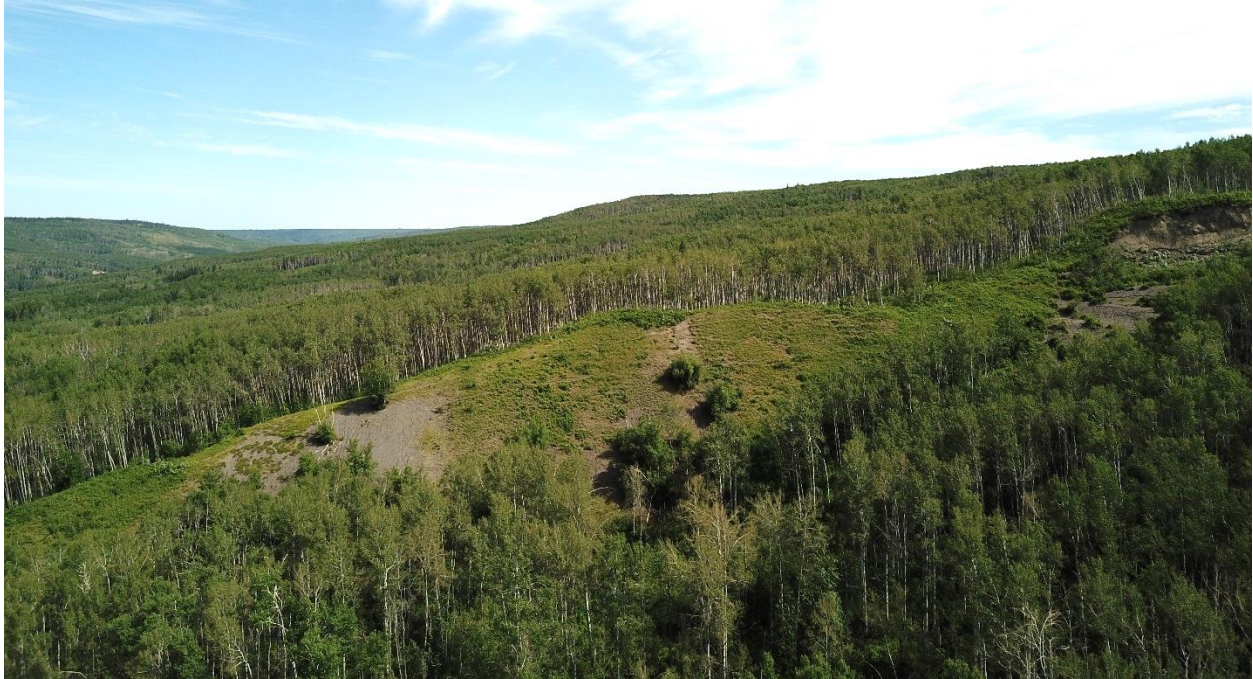
Photo 1 – Looking north at natural ridge northeast of the site (UAV photo).

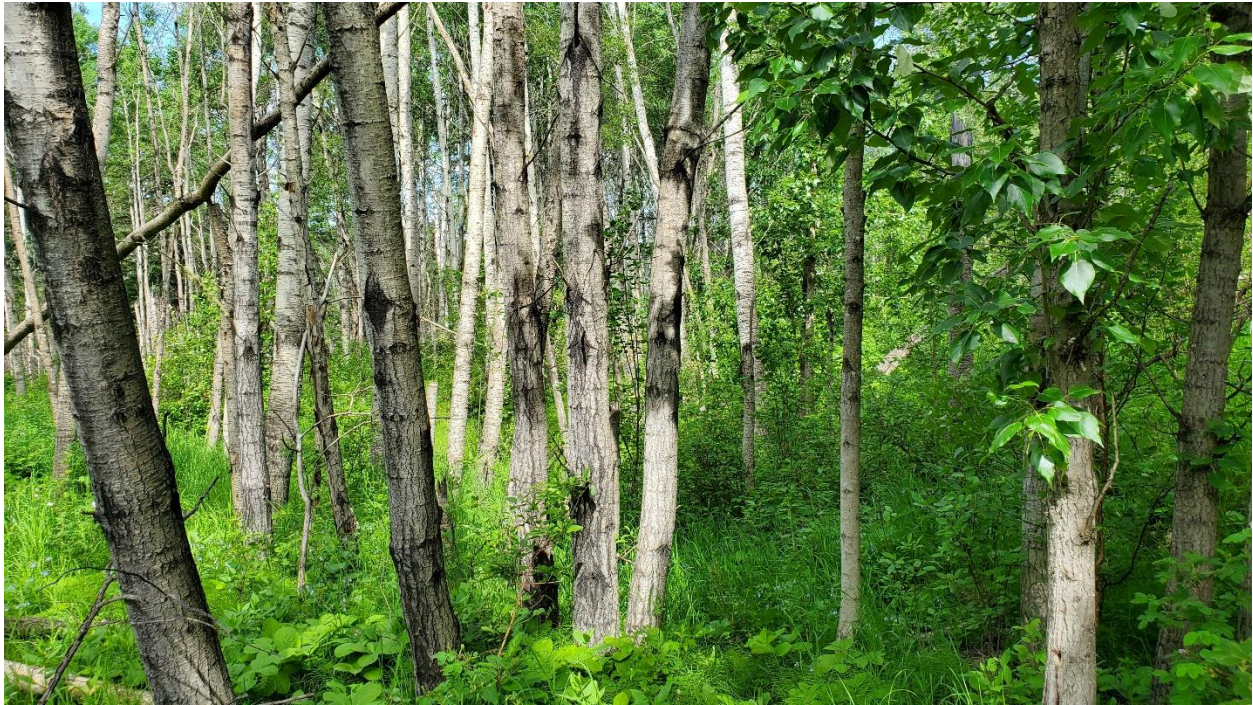
Photo 2 – Looking at dead birch trees downslope of the slide.

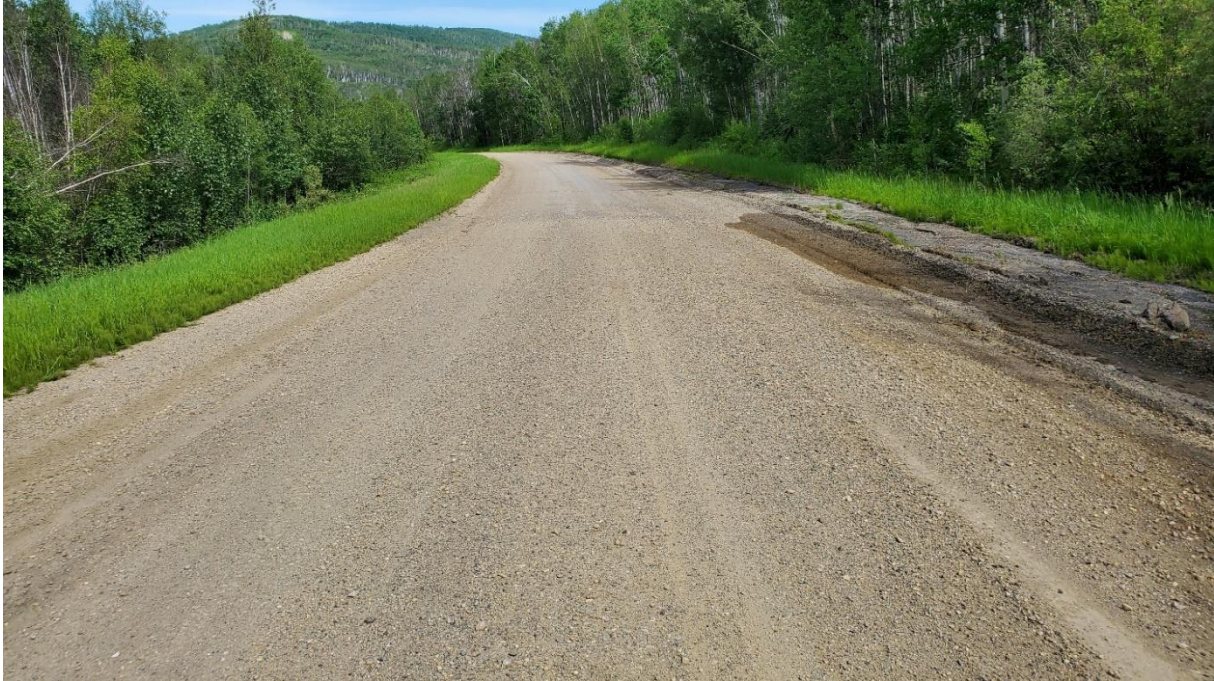
Photo 3 – Looking north at the slide located just beyond (north) of the seepage in the east ditch. There was no obvious vertical distortion of the roadway surface at the time of the callout inspection.

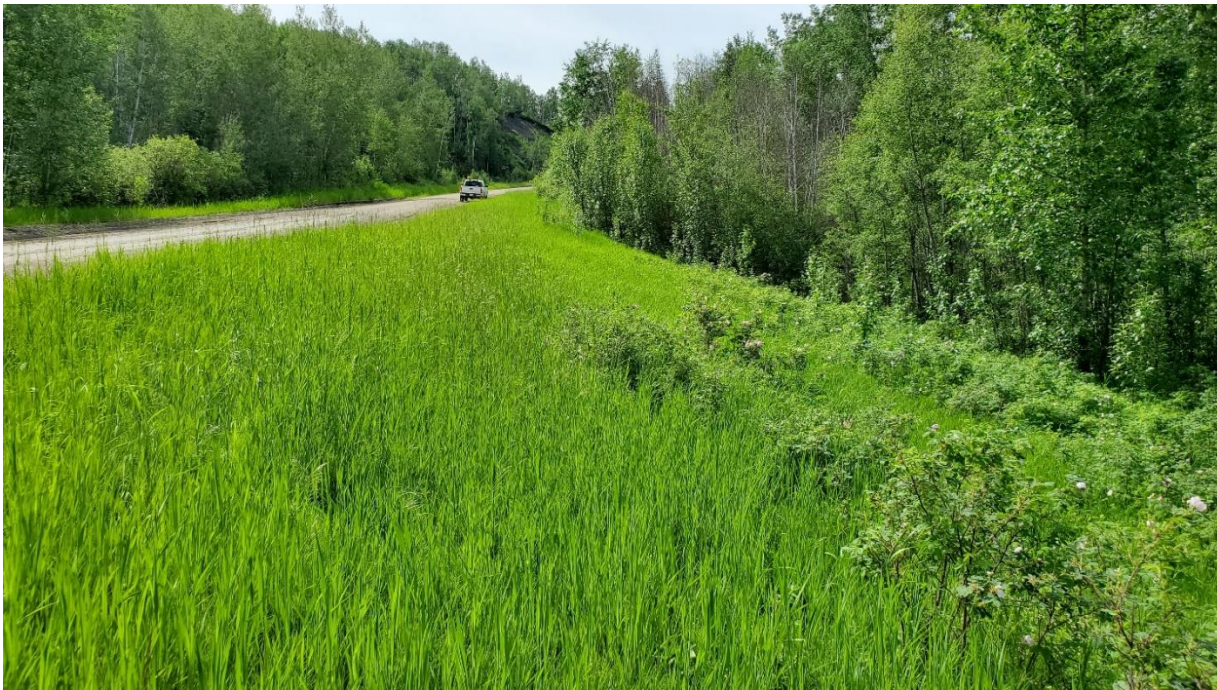
Photo 4 – Looking south at the sideslope of the highway below the slide.

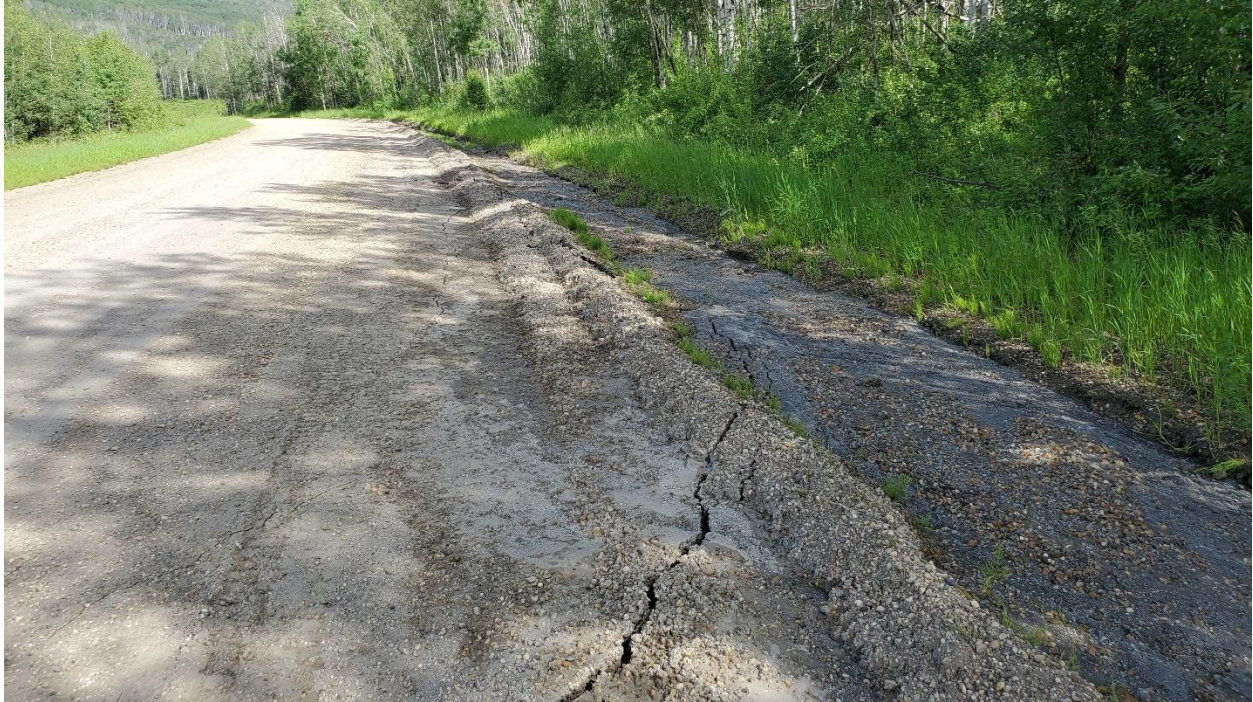
Photo 5 – Looking north at the main scarp crack cutting through the low graded berm. Note the wet material accumulated behind the berm from seepage further south.

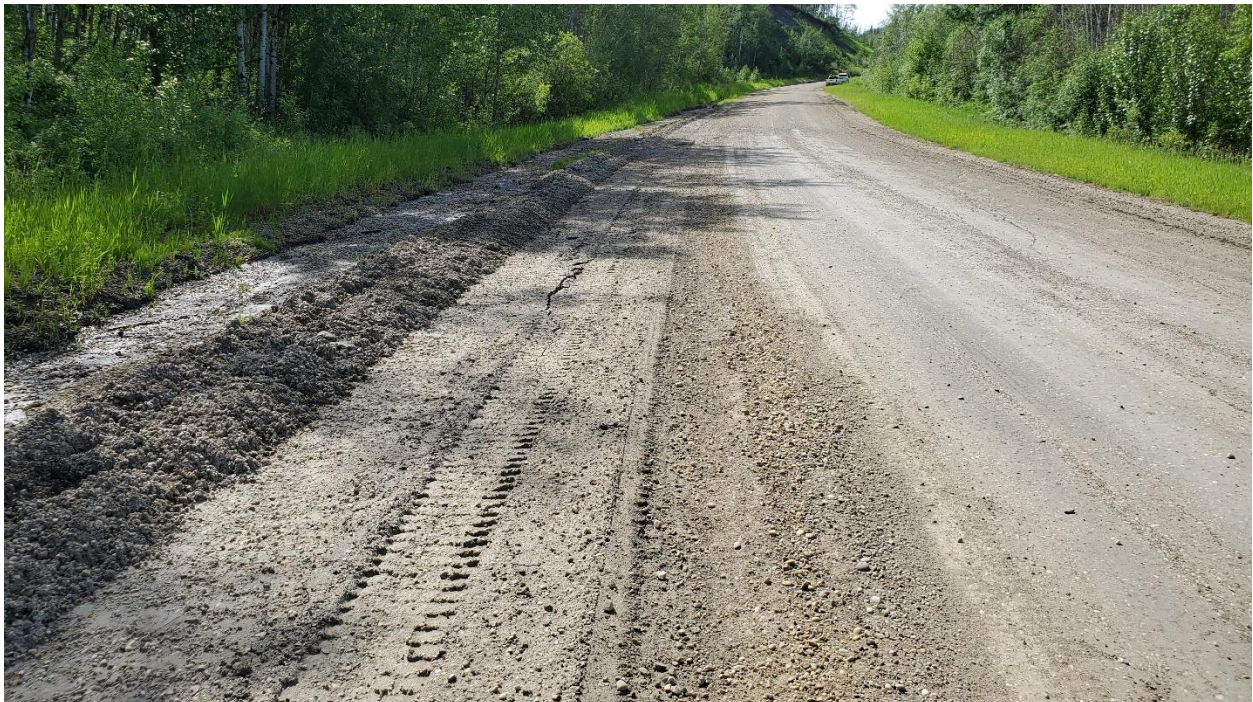
Photo 6 – Looking south at the main scarp crack in the east ditch. The "shale slope" sub-site of PH011 is visible in the background at the curve in the road.

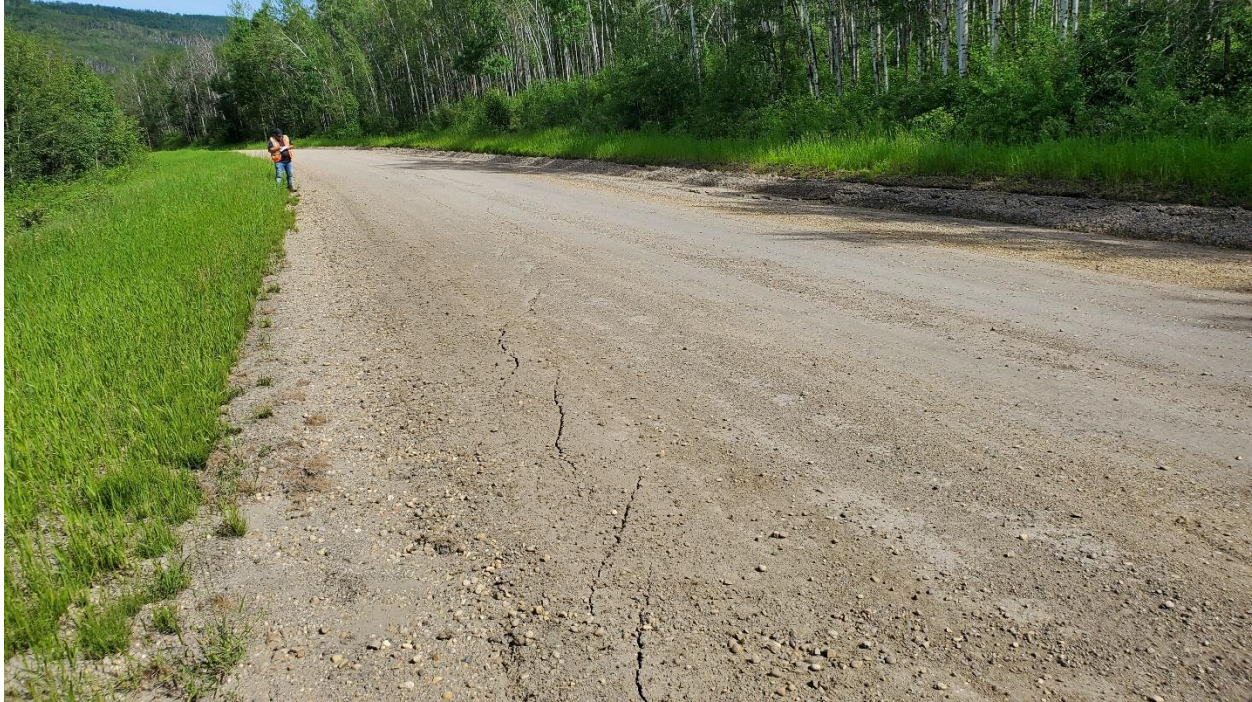
On the west side of the roadway surface, the cracks were typically less than 20 mm in width with no vertical differential and did not typically extend across the roadway. Some of the pattern was likely obscured by routine grading. On the east side of the highway, the cracks were typically 20 mm to 30 mm in width and up to 70 mm of vertical differential was observed in the ditch where they had not been graded. Some of the cracks were open enough to measure depths up to 100 mm. There was an overall depression of the roadway surface in the vicinity of the east cracks. There was water flowing down the ditch from the south and accumulating in the ditch near the slide. The grader operator related that he creates a low berm of gravel along the shoulder to try to keep the water off of the roadway. There was recent seepage on the roadway surface and ditch and deposition in the ditch from previous run-off and/or seepage. The east ditch was wet and soft.

Photo 7 – Looking north at tension cracks on the west side of the roadway.

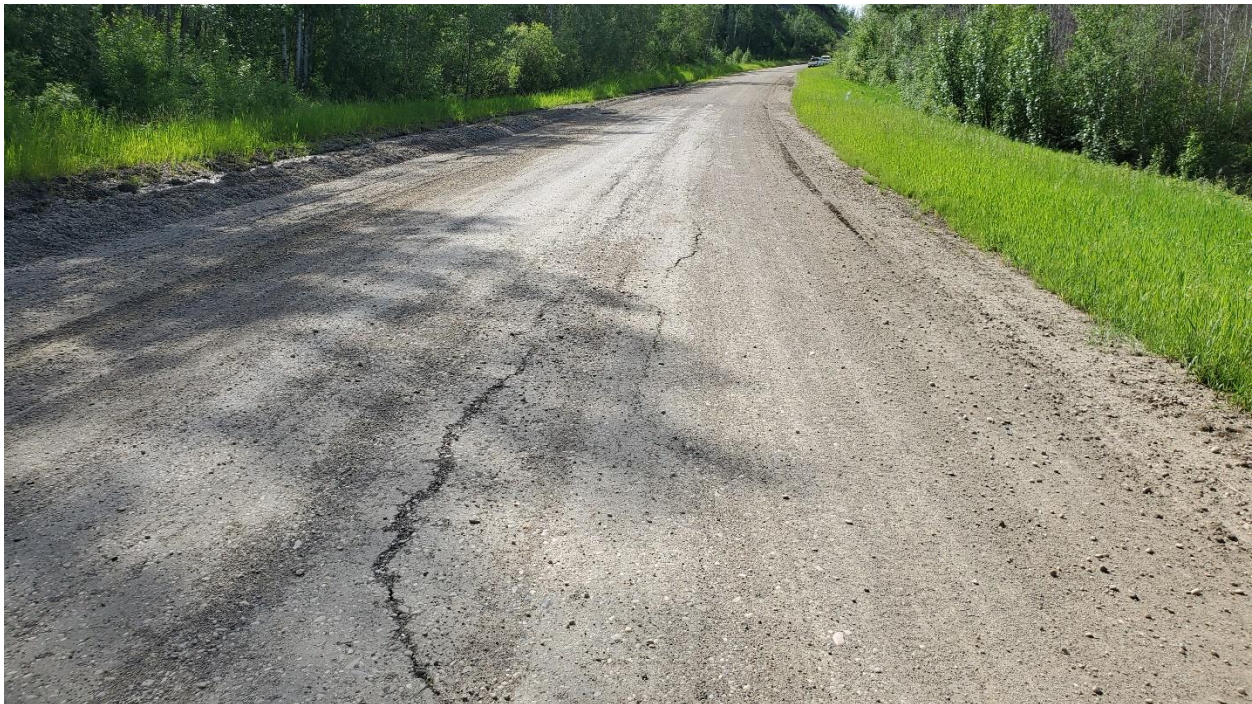
Photo 8 – Looking south at tension cracks on the west side of the roadway.

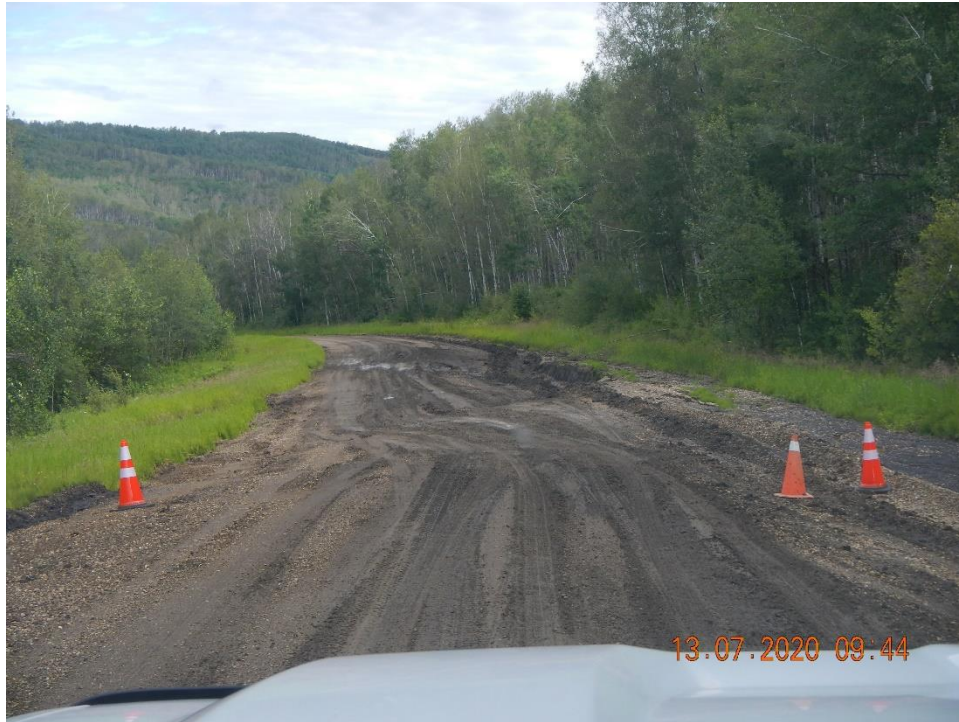
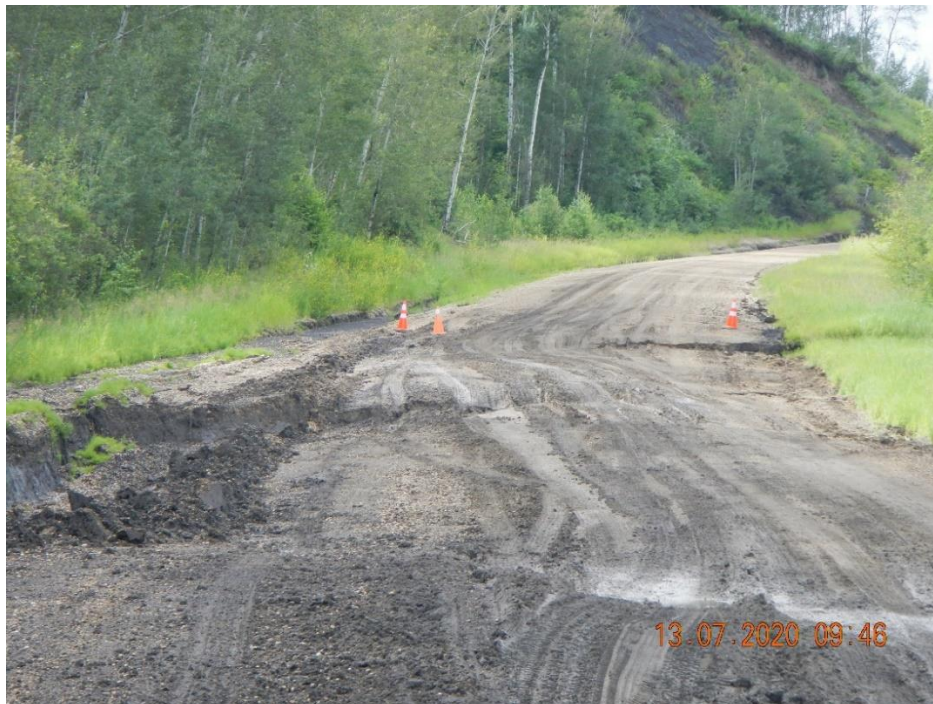
Additional photographs from Erwin Kurz, AT MCI, were provided to Thurber on July 13, 2020 (select ones attached below). These photos show that the slide at PH087 has continued to move requiring ongoing grading to maintain the highway surface. Combined with increased movement at a second set of sites on the north side of the valley (PH039A and B), the highway has been temporarily closed. A higher Risk Level of 91 has been assigned to this site based on the July 13, 2020 conditions.

Kurz, July 13, 2020 – Looking south at PH087 site.

Kurz, July 13, 2020 – Looking north at PH087 site.

- The highway should be kept closed until the movement rates have subsided which will likely require a significant reduction in rainfall amount. The roadway should be inspected routinely to assess the relative rates of movement.
- Once movement has subsided, the roadway should be regraded minimizing the amount of material placed and lowering the grade were feasible. The resulting undulations where the roadway crosses scarps may necessitate warning signs and a reduced speed limit.
- Once opened, frequent visits by the AT Maintenance Contractor are recommended to ensure that the roadway remains safe for the travelling public as this slide will deteriorate.
