**ALBERTA TRANSPORTATION  
GEOHAZARD ASSESSMENT  
PEACE REGION (PEACE RIVER DISTRICT)  
2021 INSPECTION**

Site Number	Location	Name	Hwy	km
PH087-1	North of Town of Peace River	Whitemud River (km 43.4)	743:02	43.4
Legal Description		UTM Co-ordinates		
NW1-88-21-W5		11V N 6,273,215	E 487,109

Date	PF	CF	Total RISK LEVEL
<b>Previous Inspection:</b>	4-August-2020	13	7	91
<b>Current Inspection:</b>	7-July-2021	11	4	44
<b>Road AADT:</b>	110	<b>Year:</b>	2020	
<b>Inspected By:</b>	Kristen Tappenden, TRANS Ed Szmata, TRANS Chase Milligen, TRANS Don Proudfoot, Thurber			
<b>Report Attachments:</b>	<input checked="" type="checkbox"/> Photographs <input checked="" type="checkbox"/> Plans <input type="checkbox"/> Maintenance Items

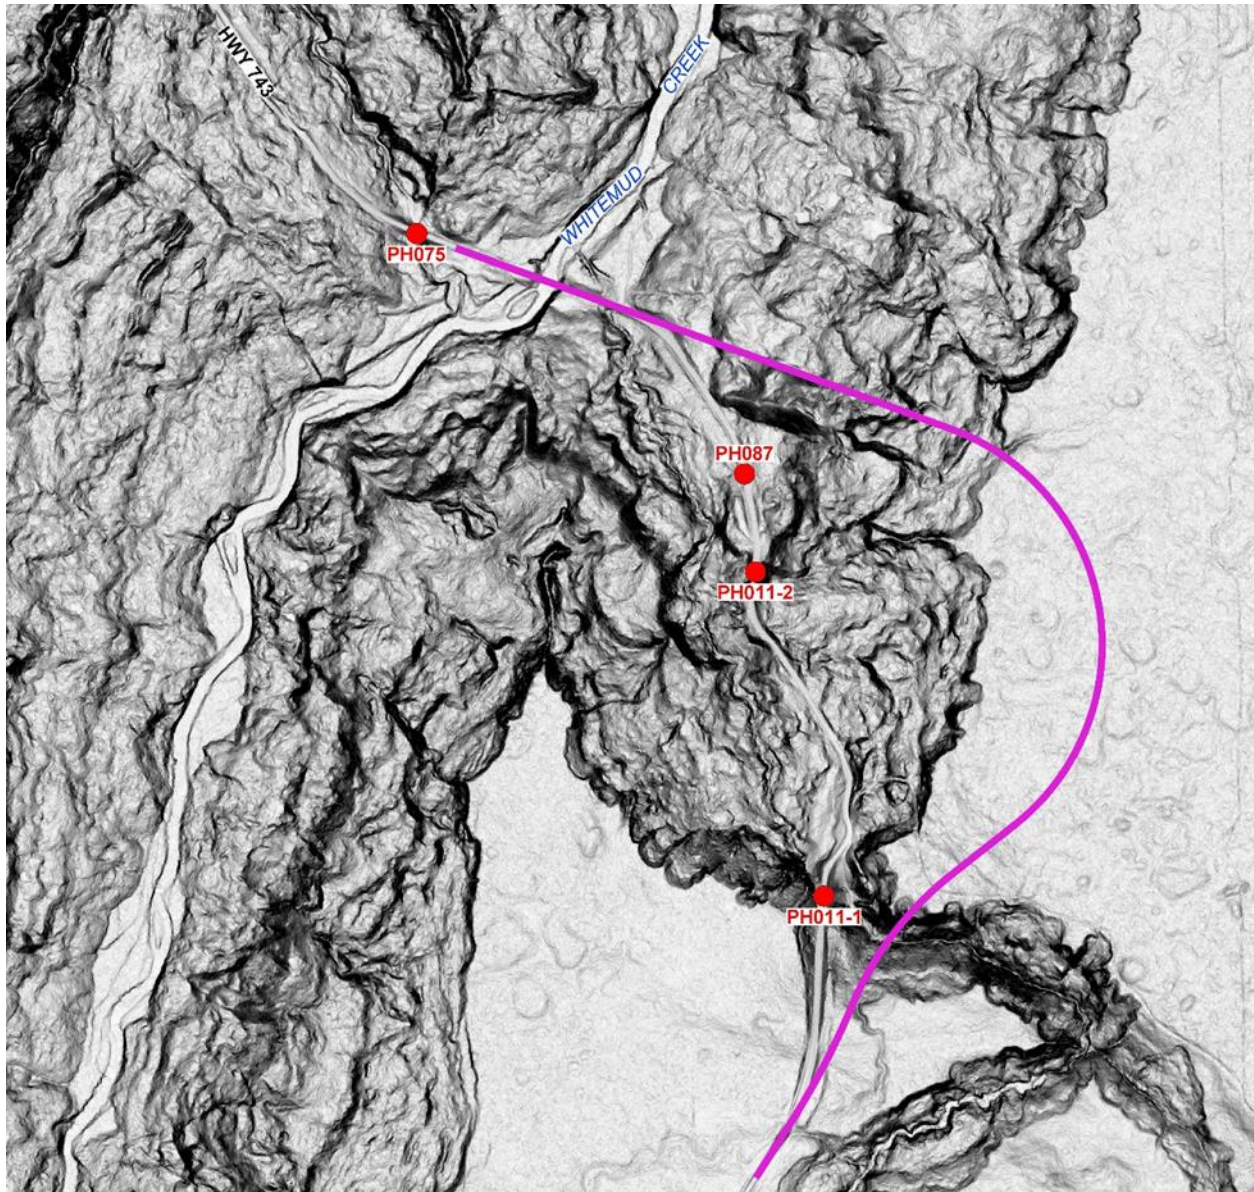
Figure 1: Proposed long term realignment for Hwy 743:02 south of the Whitemud Creek

- The highway could be realigned south of the Whitemud Creek bridge to rise out of the valley perpendicular to the valley slope and then curve back to cross the tributary creek east of PH011-1, as shown approximately on Figure 1 below. The curved alignment is required due to the proximity of the Peace River valley to the east of the Whitemud Creek valley. This re-alignment would be expensive, and as there would be limited fills, the excavated material would need to be hauled out of the valley and stockpiled well back (at least 300 m) from the valley crest. This would also require

a significant new road segment on the uplands to bring the new alignment back to the existing highway, as well as a new bridge file culvert and embankment fill at the tributary crossing.

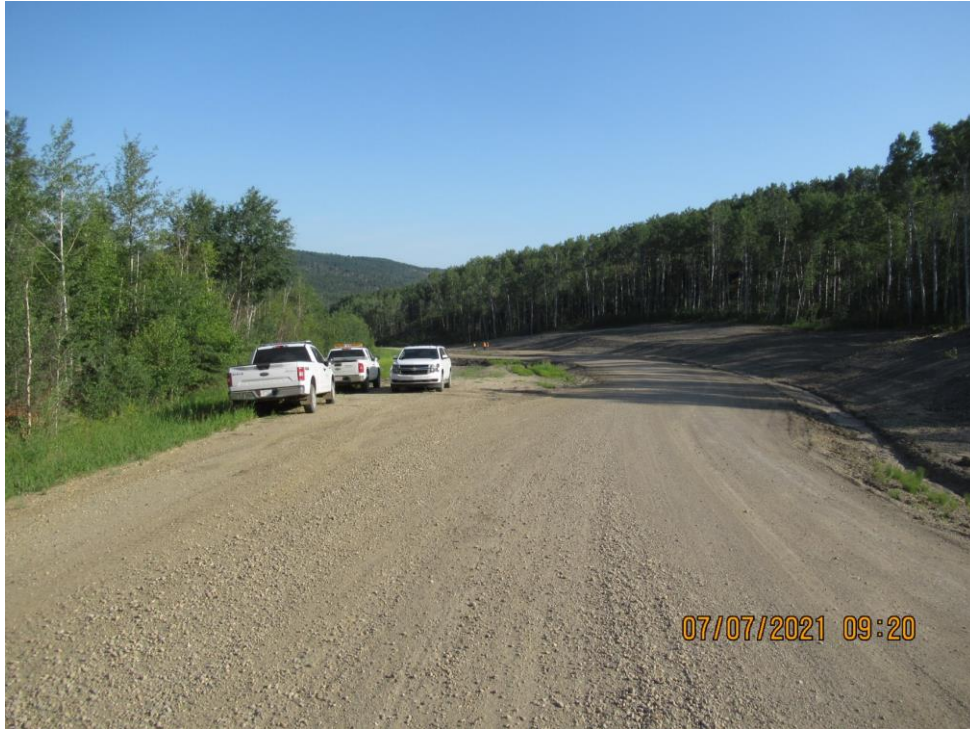
Photo 1 – Looking north at the landslide area. Trucks are parked along the old alignment with the temporary detour on the right. Note erosion in ditch at toe of backslope.

- The detour roadway should be inspected routinely to assess if movement is occurring (in the roadway or significant slumps in the backslope).
- Seeding and erosion control blankets (temporary type on the backslope and TRM in the bottom of the ditch) should be used to limit erosion of the ditch and backslope.
- A swale should be constructed at the top of the backslope where the majority of the seepage is occurring and subdrains should be installed to manage the water in the soft spot in the middle of the detour and along the backslope ditch. Additional subdrains could be installed if other seepage is observed.

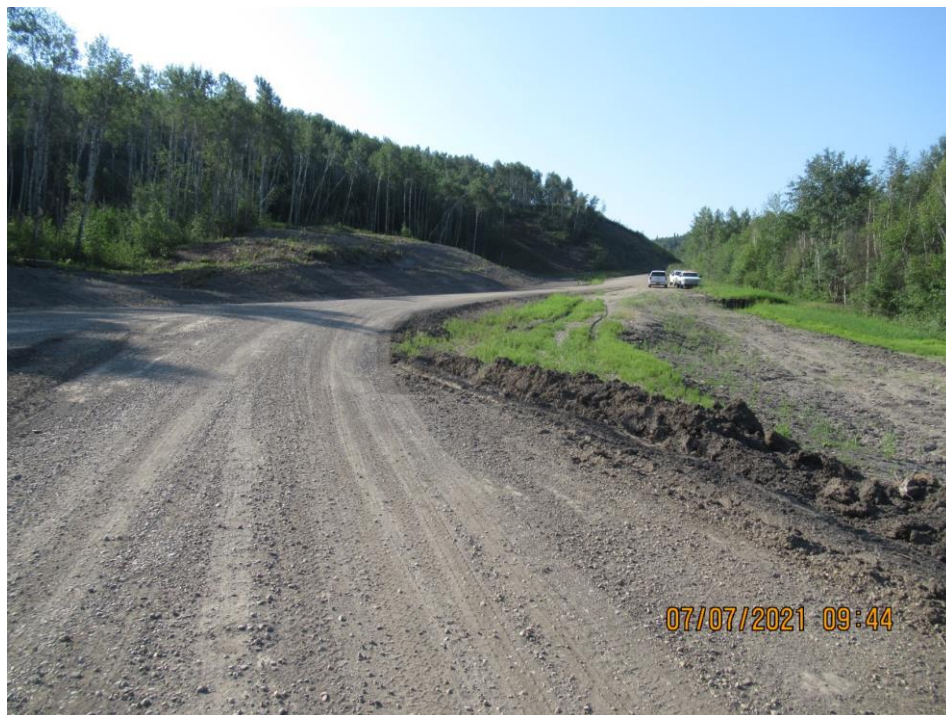
Photo 2 – Looking south along the alignment. Scarp through the old road visible in front of the trucks.

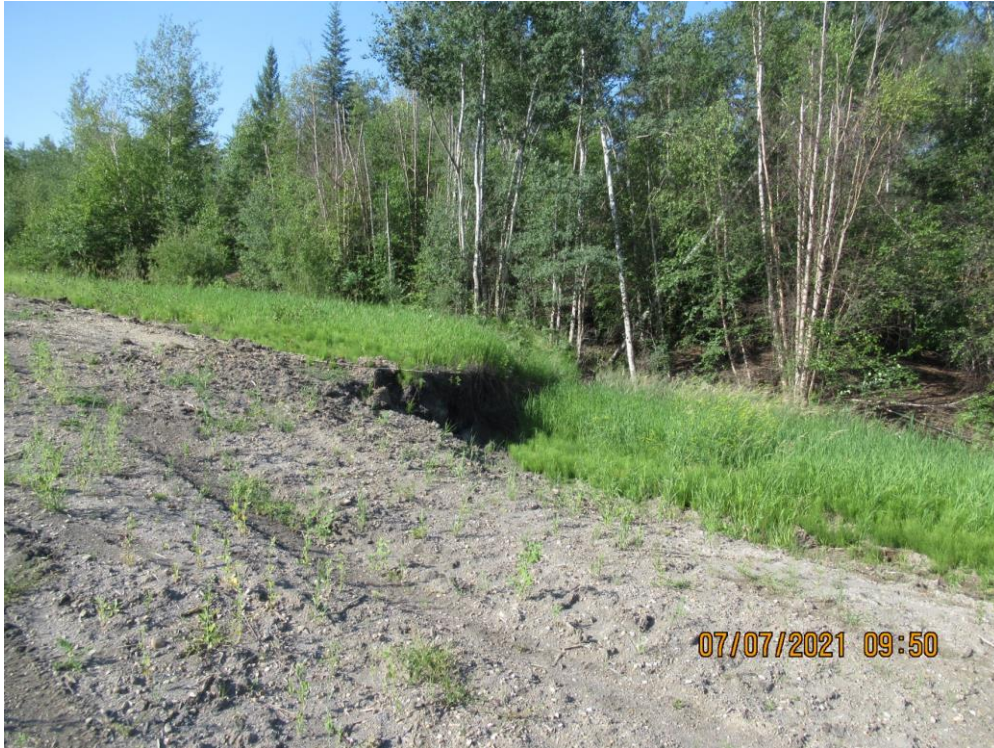
Photo 3 – Looking southwest at the south side of the landslide scarp.

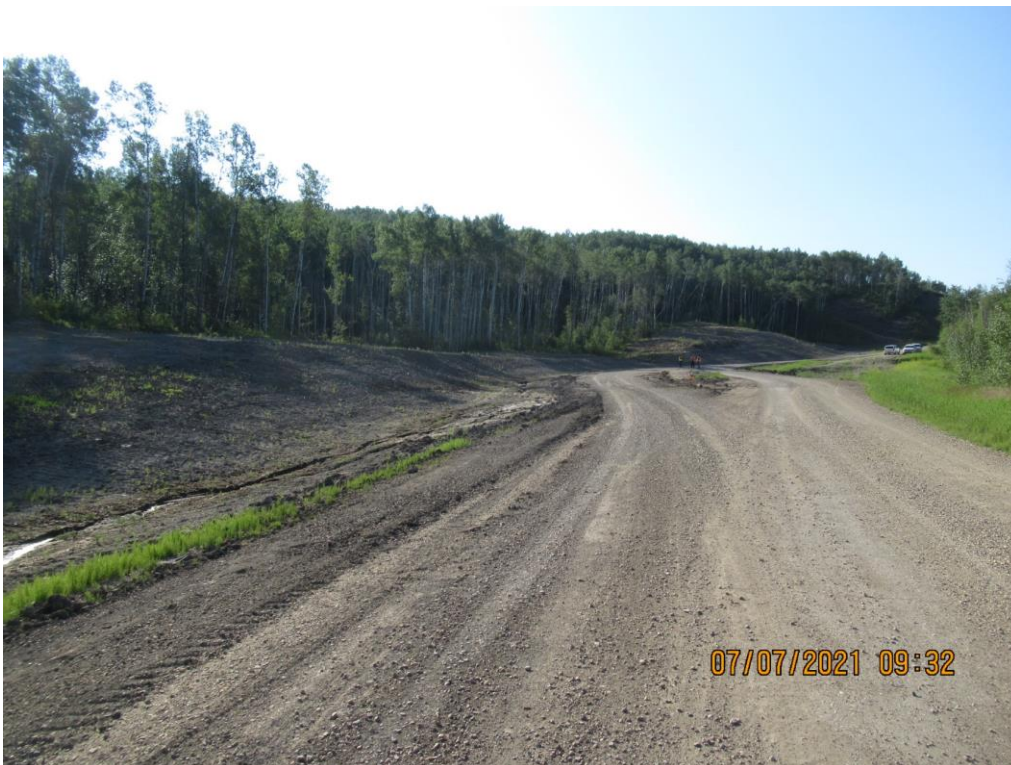
Photo 4 – Looking south at the north end of the detour where it splits around a soft area.

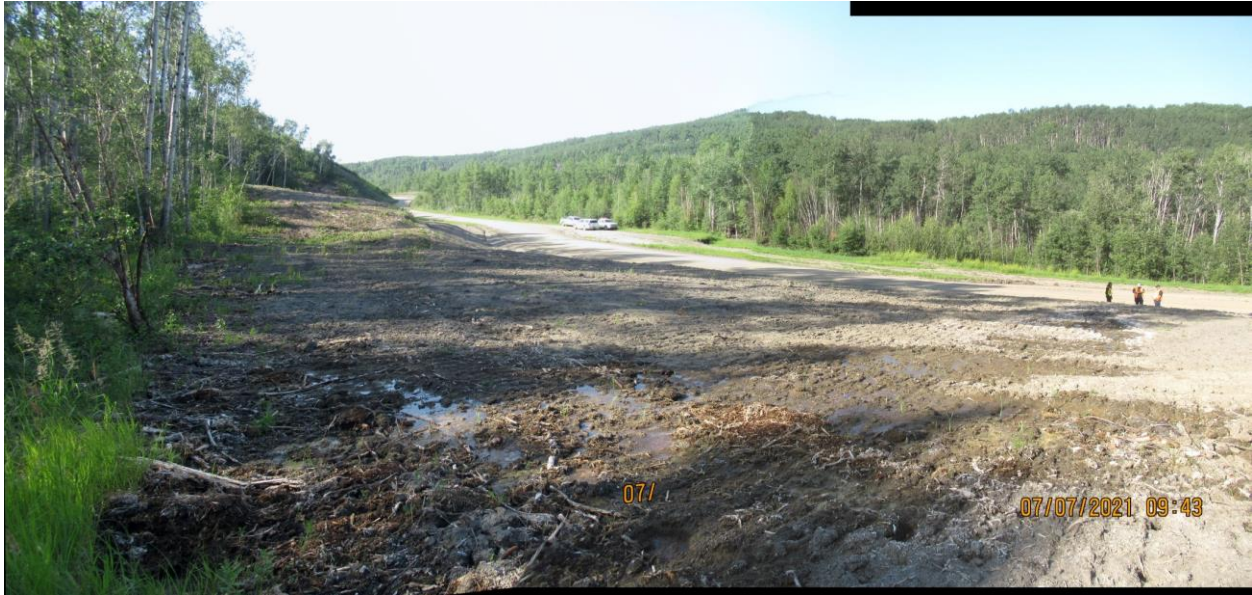
Photo 5 – Looking south at seepage accumulating at top of new backslope.

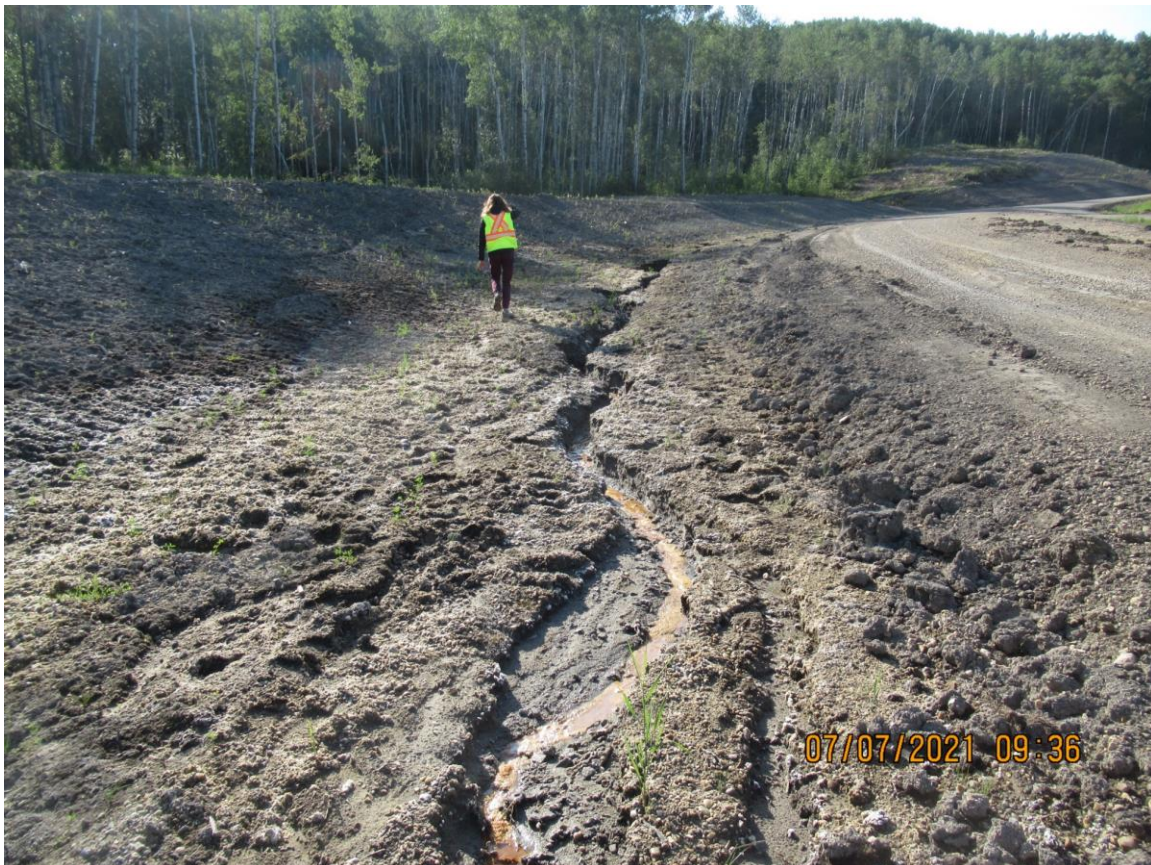
Photo 6 – Looking at erosion at north end of the ditch at the toe of the new backslope.

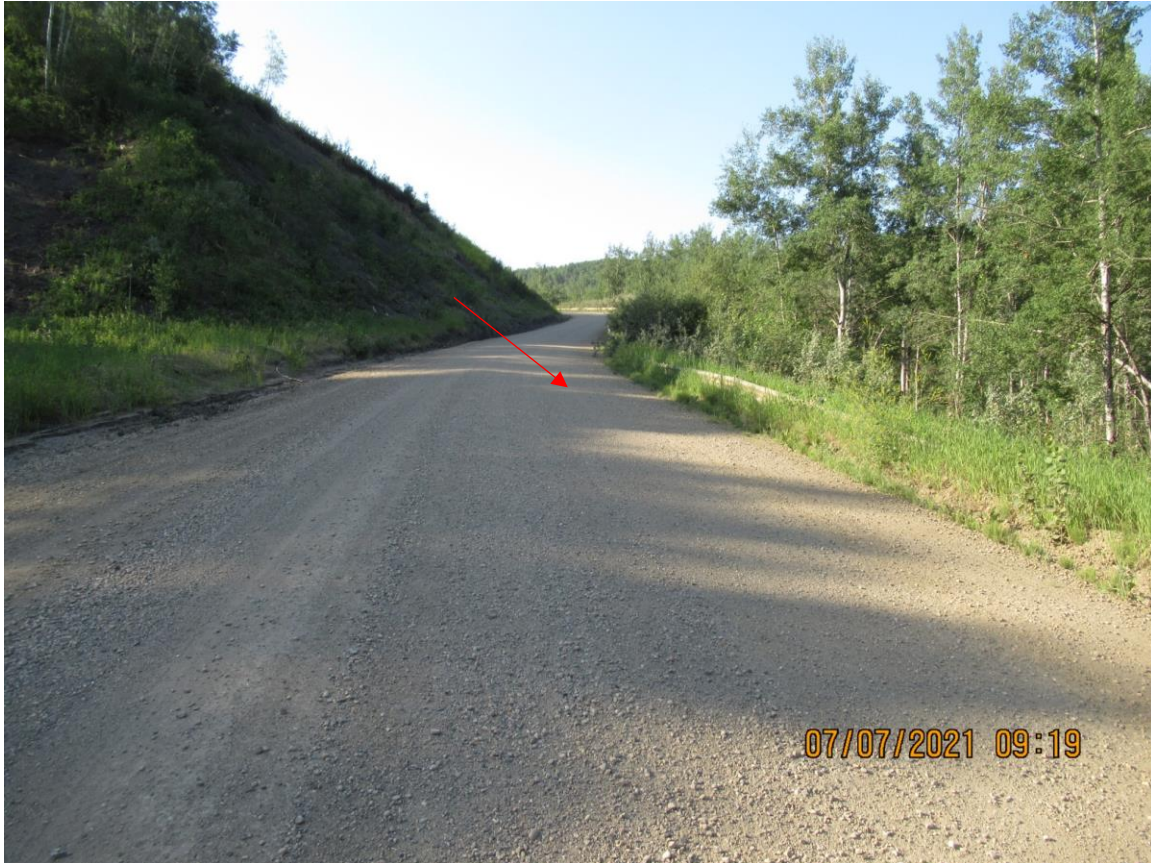
Photo 7 – Looking south towards the south landslide lobe and high shale backslope (PH011-2) on left. The cracks are at the guardrail but had been graded out at the time of the photo.
