ALBERTA TRANSPORTATION AND  
ECONOMIC CORRIDORS  
GEOHAZARD ASSESSMENT PROGRAM  
PEACE REGION (PEACE RIVER DISTRICT)  
2025 INSPECTION

| Site Number | Location | Name | Hwy | km |
|---|---|---|---|---|
| PH087-1 | North of Town of Peace River | Whitemud River (km 43.4) | 743:02 | 43.4 |

| | Date | PF | CF | Total RISK LEVEL |
|---|--|---|---|---|
| Current Inspection: | 13-May-2025 | 9 | 3 | 27 |

PH087-1: HWY 743:02  
2025 SITE INSPECTION PLAN

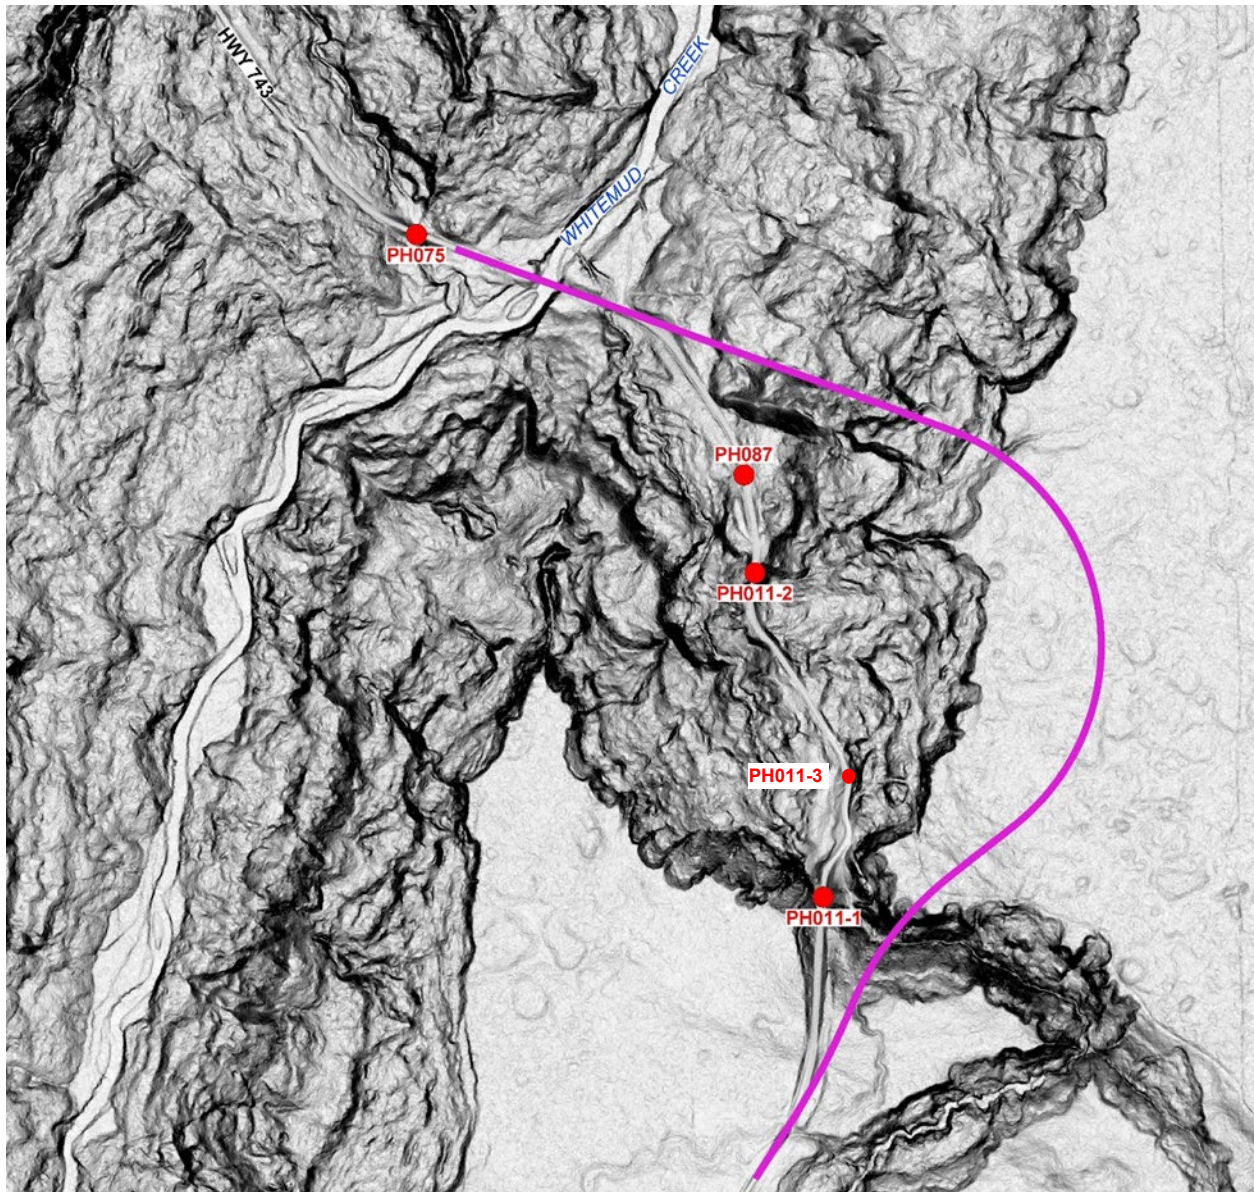
**Figure 1: Proposed long term realignment for Hwy 743:02 south of the Whitemud Creek**

- The highway could be realigned south of the Whitemud Creek bridge to rise out of the valley perpendicular to the valley slope and then curve back to cross the tributary creek east of PH011-1, as shown approximately on Figure 1 below. The curved alignment is required due to the proximity of the Peace River valley to the east of the Whitemud Creek valley. This re-alignment would be expensive, and as there would be limited fills, the excavated material would need to be hauled out of the valley and stockpiled well back (at least 300 m) from the valley crest. This would also require a significant new road segment on the uplands to bring the new alignment back to the existing highway, as well as a new bridge file culvert and embankment fill at the tributary crossing.

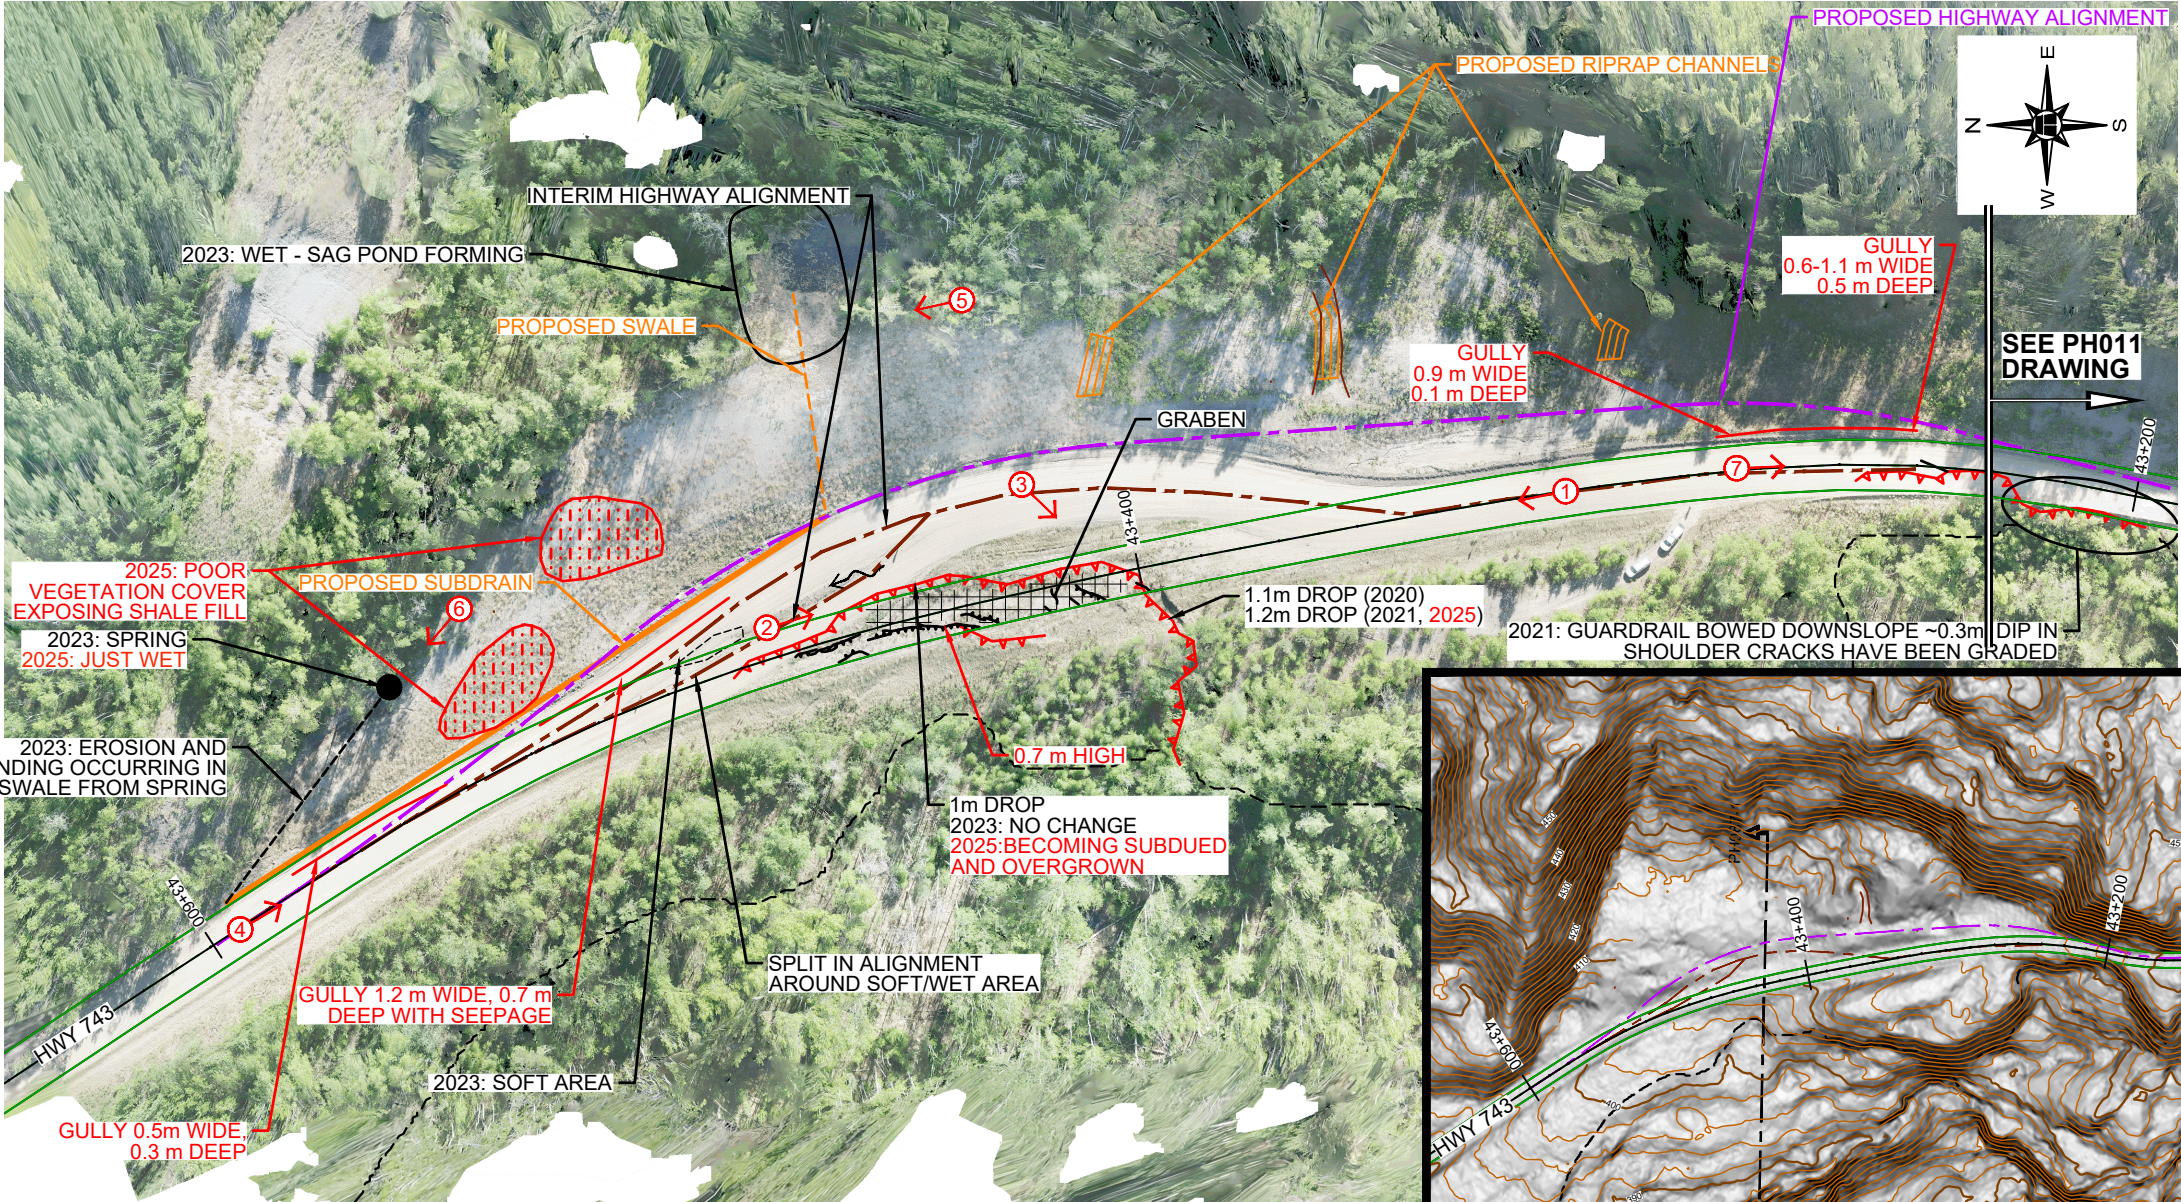
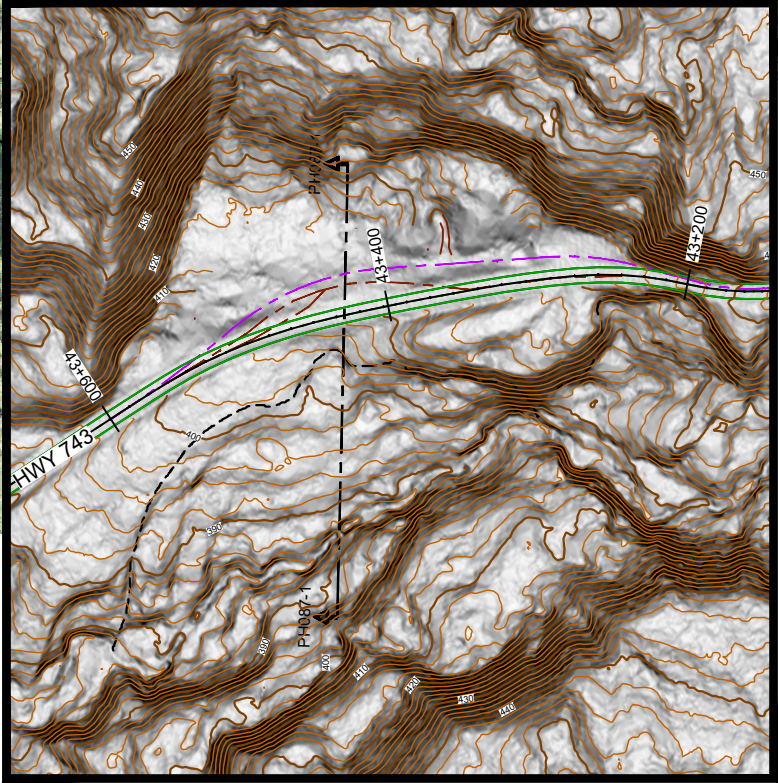
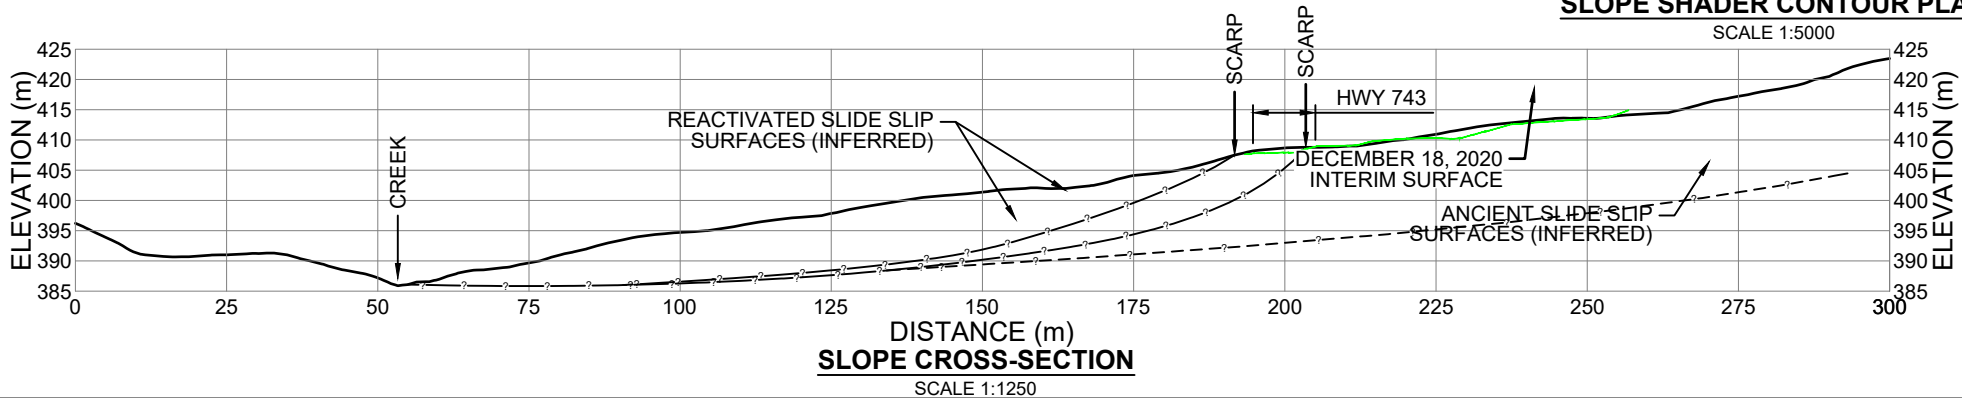
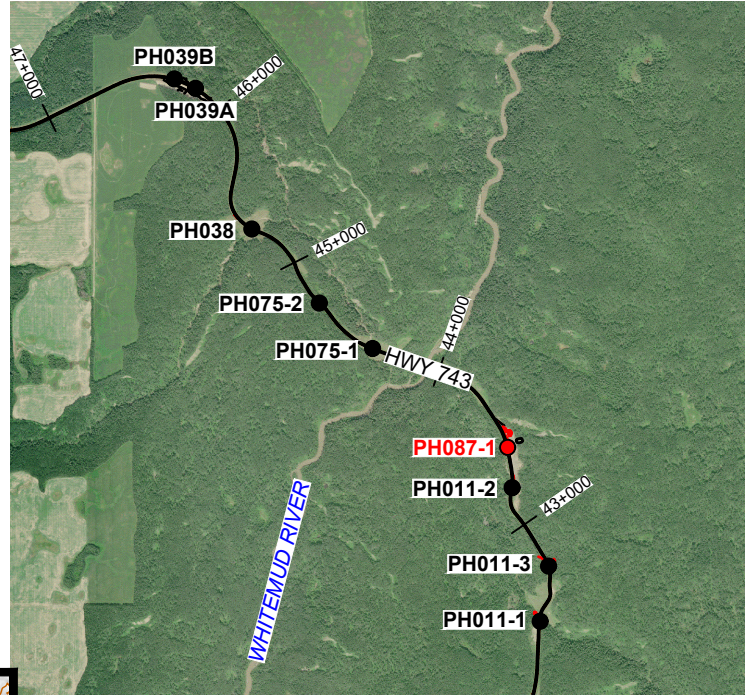
DWG No. 32121-PH087-1

LiDAR provided by Alberta Transportation shows an unstable valley slope leading down to a tributary stream of the Whitemud Creek. The inset on Drawing 13351-PH087-1 shows the LiDAR image (grey-shaded by slope angle from white at 0° to black at 35° and steeper). The terrain shows indications of a developing retrogression pattern bounded to the northeast by a significant scarp face whose south face is 35 m high and standing at 34°. There is also instability moving in a perpendicular direction on the north side of this feature.

- A further shift into the backslope may be required if additional retrogression occurs. Thurber designed a higher speed detour, as shown in purple on Dwg. No. 32121-PH087-1, which could be constructed as the medium-term solution. The detour constructed in 2020 is the alignment shown in brown on the drawing which was limited due to weather and available funding.

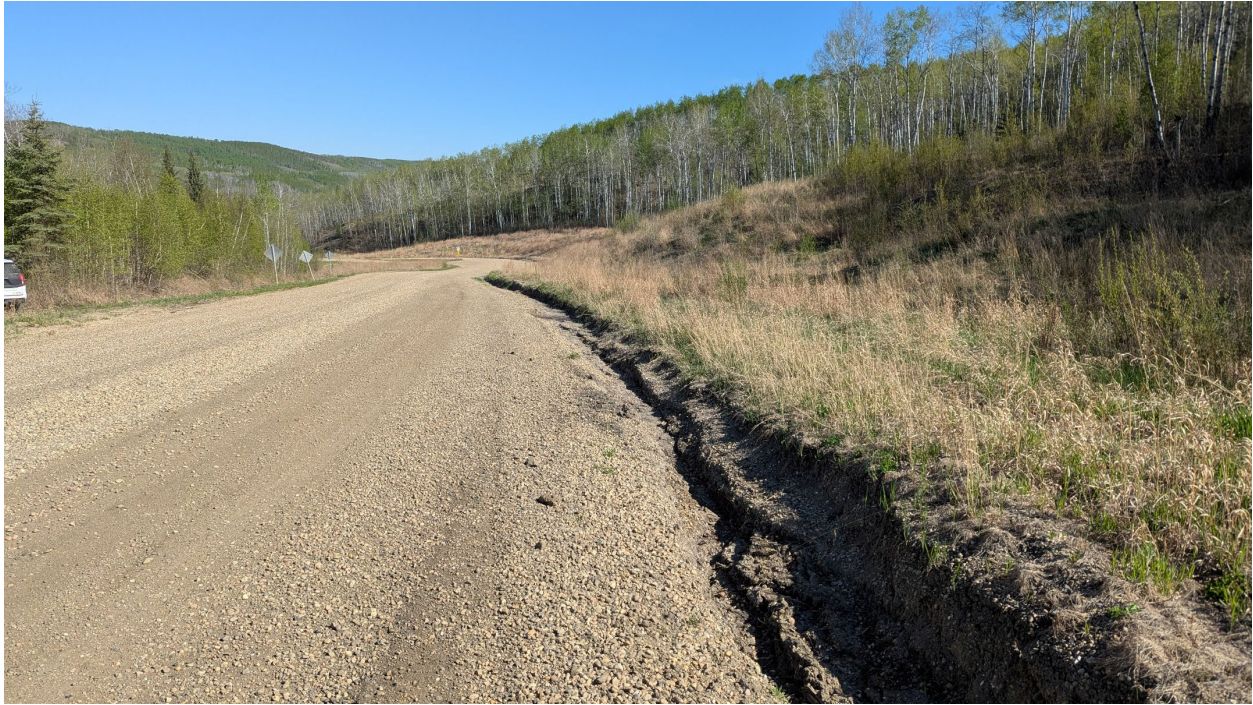
**Photo 1 – Looking north at the landslide area. Vegetation in the foreground has grown over the clay material spread from PH011-2.**

- The channel at the north end of the site should be armoured (TRM or riprap) to protect against erosion from the seepage.
- Clay excavated from the PH011-2 site should be hauled to the stockpile site south of the valley rather than spread out at this site and the upslope ditch re-established.

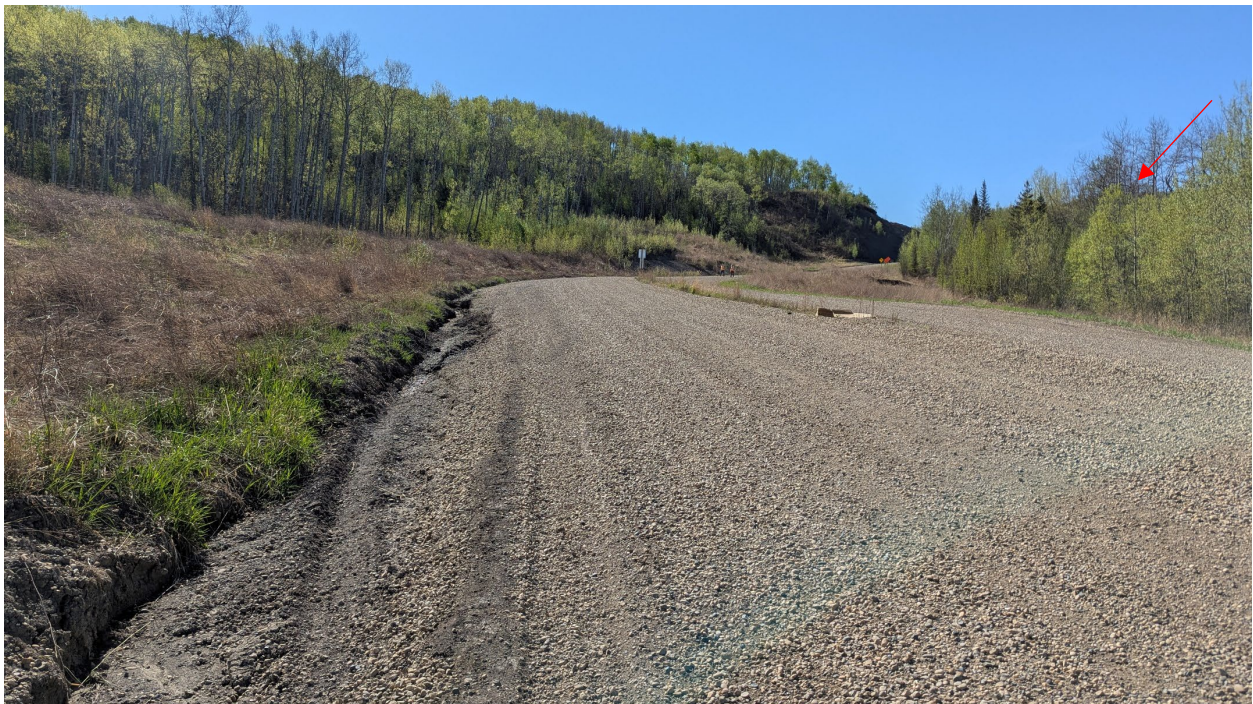
**Photo 2 – Looking south along the alignment. Scarp through the old road denoted by arrow. Note that there is only a shallow v-ditch that has been cut by the grader and it is starting to downcut from erosion.**

- The detour roadway should be inspected routinely to assess if movement is occurring (in the roadway or significant slumps in the backslope).
- More seeding and erosion control blankets (temporary type on the backslope and TRM in the bottom of the ditch) should be used to limit erosion of the ditch and backslope.

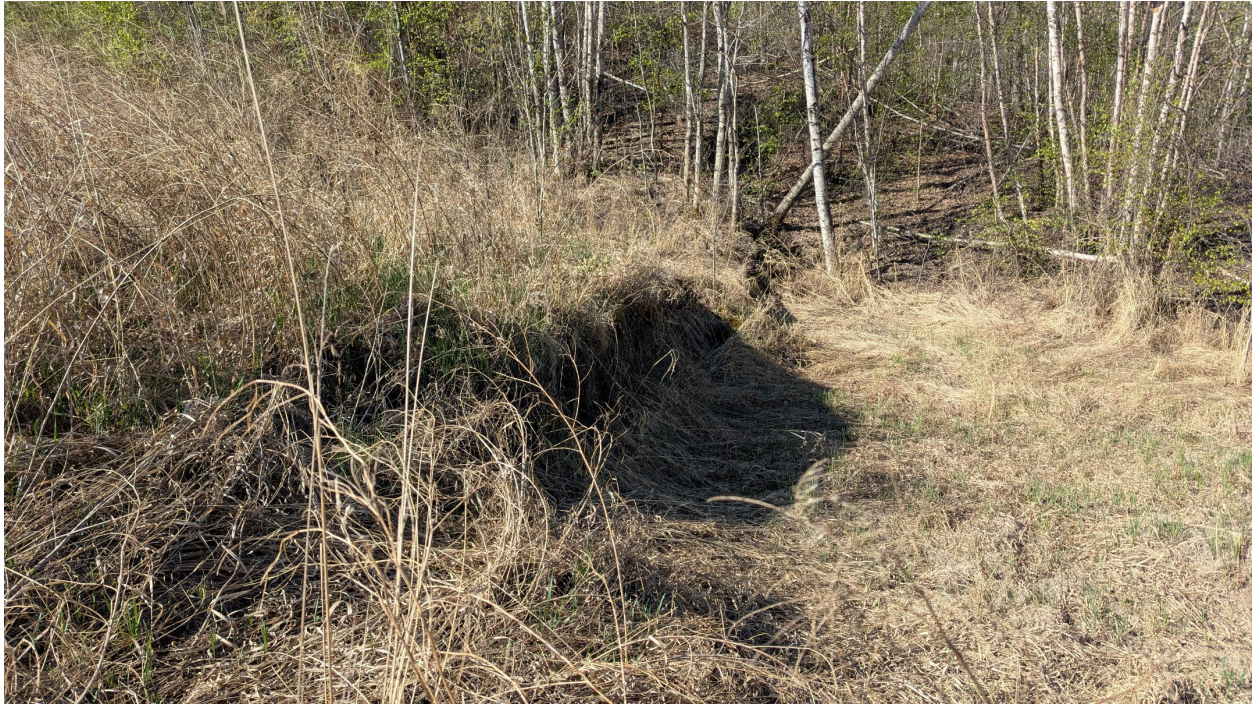
**Photo 3 – Looking southwest at the south side of the landslide scarp. It does not appear to have changed since the 2021 inspection.**

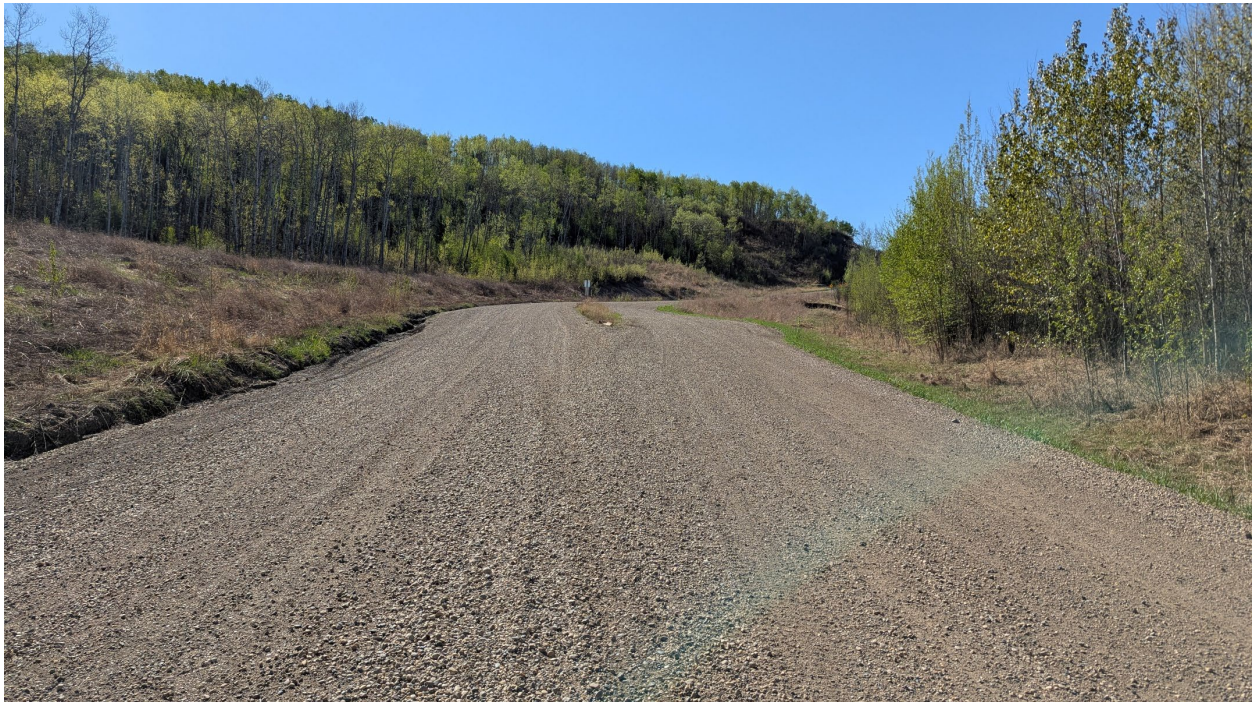
**Photo 4 – Looking south at the north end of the detour where it splits around a previously-soft area. Upslope ditch has less erosion than at the previous inspection.**

- Subdrains should be installed to manage the water along the backslope ditch and at the soft area where the alignment is split. Additional subdrains could be installed if other seepage areas are observed.

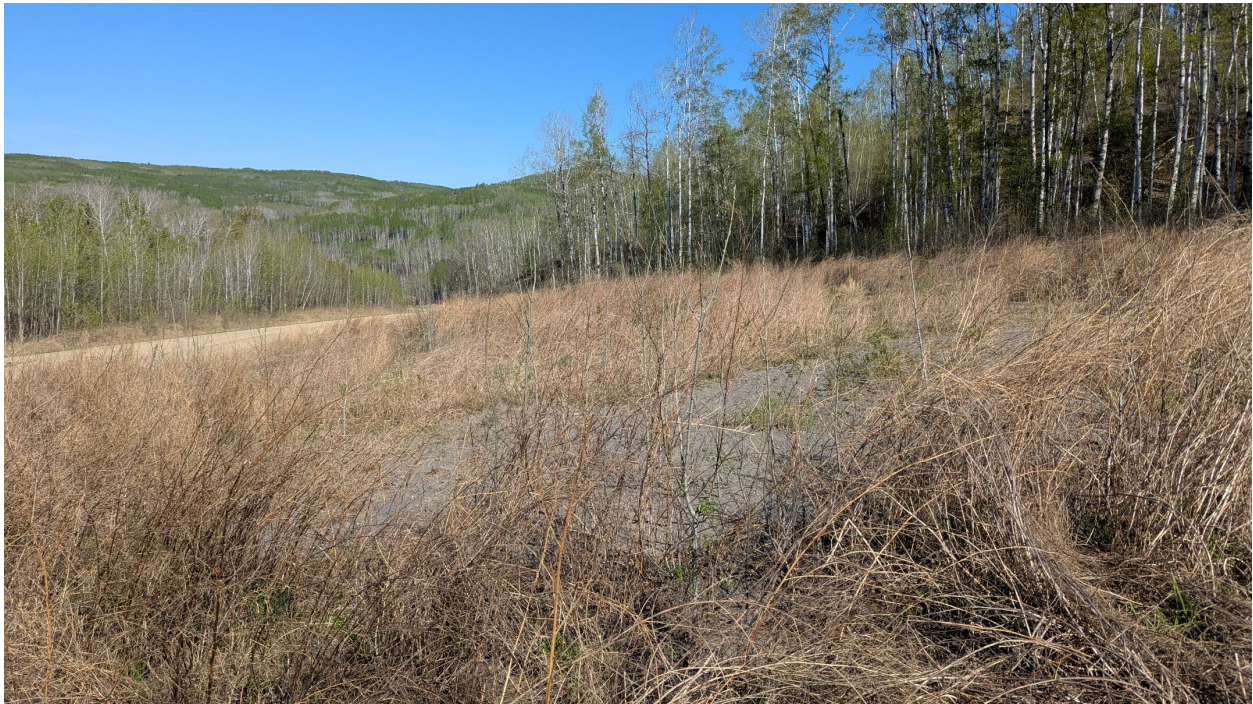
| <input checked="" type="checkbox"/> Erosion | Some erosion occurring in the new ditch from spring and surface runoff. Vegetation growth on the shale fill material is poor in some locations. | <input checked="" type="checkbox"/> |

**Photo 5 – Looking north at poor vegetation coverage at top of new backslope. It has improved only marginally since 2023.**

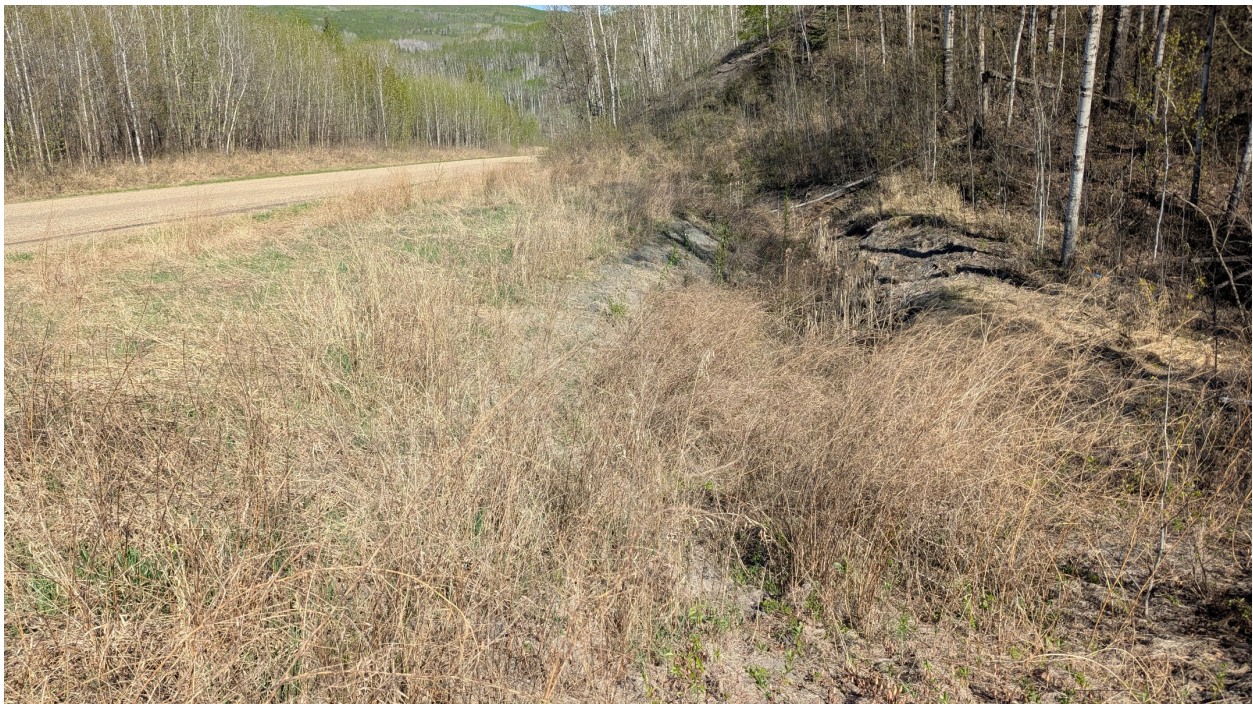
**Photo 6 – Looking north along the drainage channel at the north end of the site.**

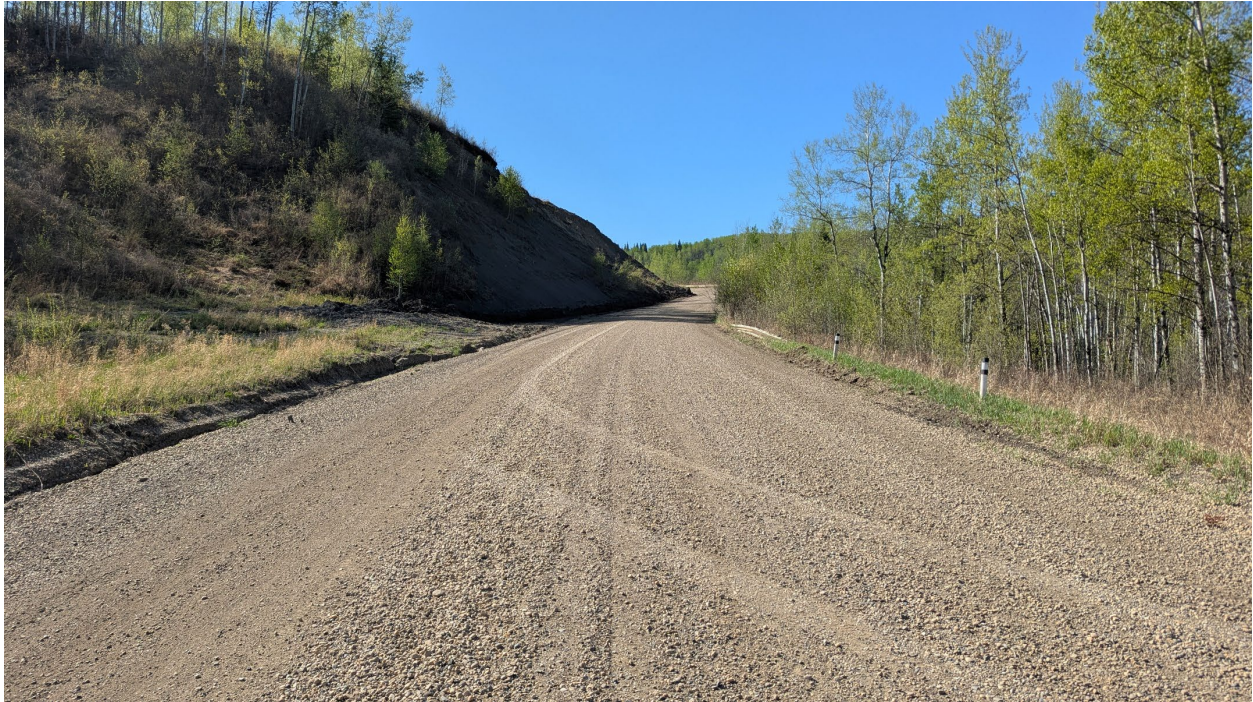
**Photo 7 – Looking south towards the south landslide lobe and high shale backslope (PH011-2) on left. Ongoing grading has obscured the cracks at the guardrail from the south lobe of the slide.**

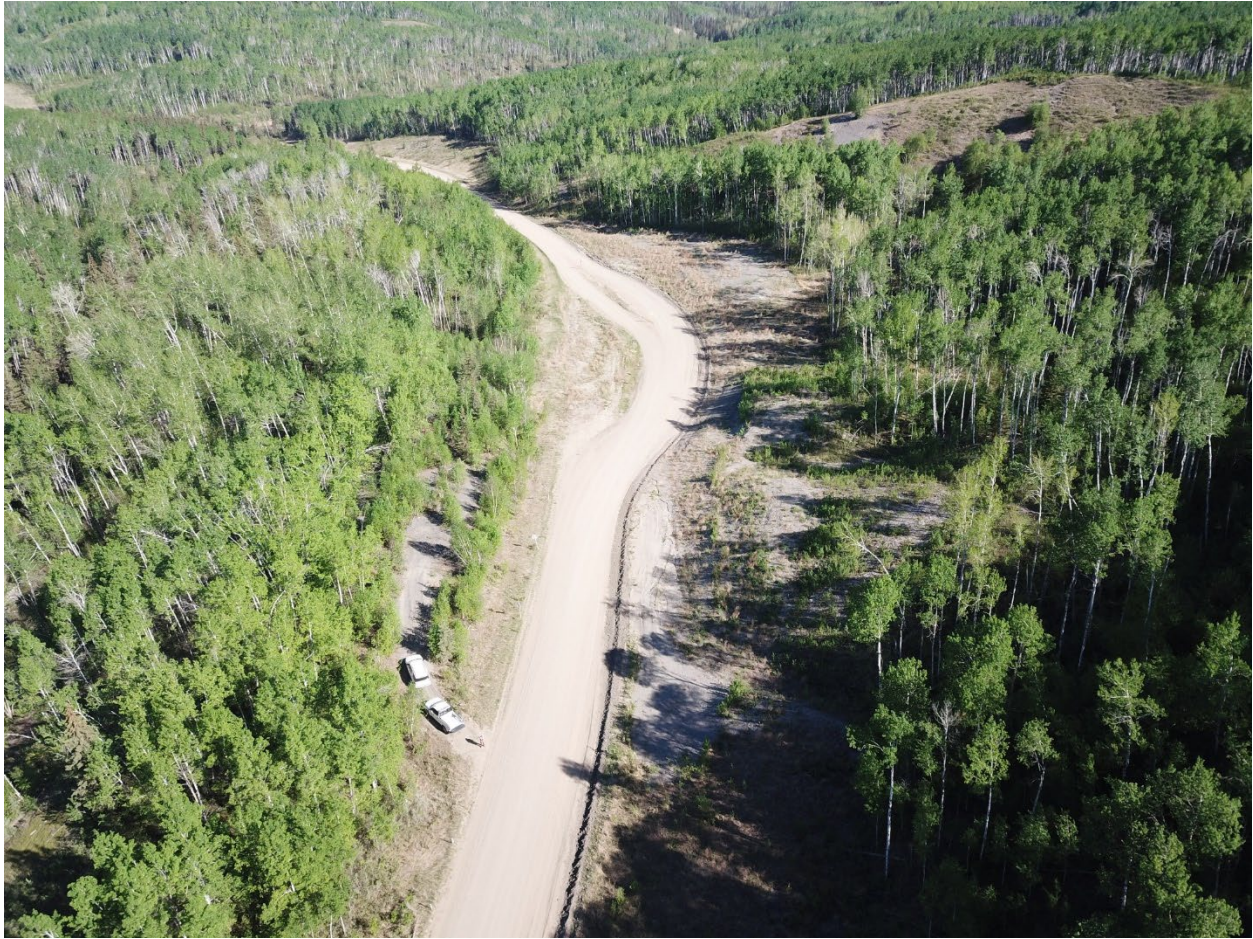
**UAV Photo 2023 – Looking north toward the site: trucks are parked on the approach that was previously used for slumped soil from the PH011-2 backslope site. The bare area on the right side of the highway is where PH011-2 material has been spread recently. The detour around the slide is visible further north.**
